# How the Bircher Fire of 2000 Affected Erosion in Mesa Verde National Park

Aurora Bouchier

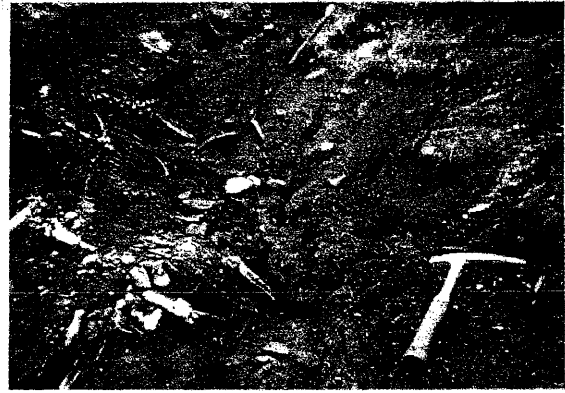
**Photo 1.** Rills which formed along a hillslope.

the hillslopes. This sediment traveled from the hillsides into the channel either from small debris flows, debris slides, or during a storm, by being transported in rills (Florsheim, 1991) (see Photo

None of the changes seen in the transect were as large as expected. I believe that a base level of erosion in the drainages had already been achieved by the time I started my study. Sediment was moving from the hillslopes (as evident from the numerous rills which formed along the hillsides, sometimes right above a transect which did not display a change) and along the drainage, but the actual drainages were not changing as expected. The numerous rills which did form on the slopes are consistent with Florsheim's study.

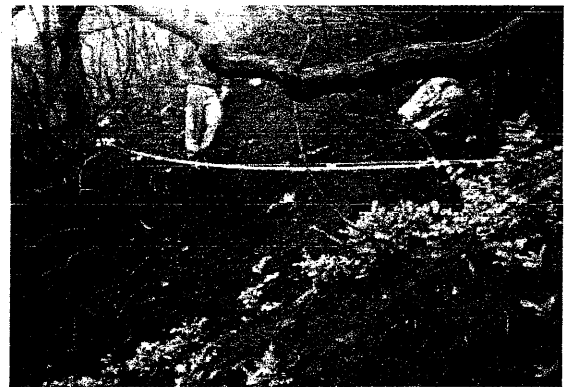
**Photo 3.** An example of a transect. Thin white line is the horizontal line and the thick white line is the metric tape measure.

For this project a series of transects were set up and measured. Each transect consists of two pieces of rebar hammered a foot or more into the ground, one on either side of the drainage. Then a piece of light line was strung taut between the rebar stakes. This line was tied so that it was horizontal (which was determined using a line level). A metric tape-measure was also strung between the rebar stakes to ease measuring (see Photo 3). Finally, a second metric tape-measure with a pendulum bob attached was used to measure the depth from the taut line to the ground.

This depth was measured every ten centimeters along the transect. Each transect

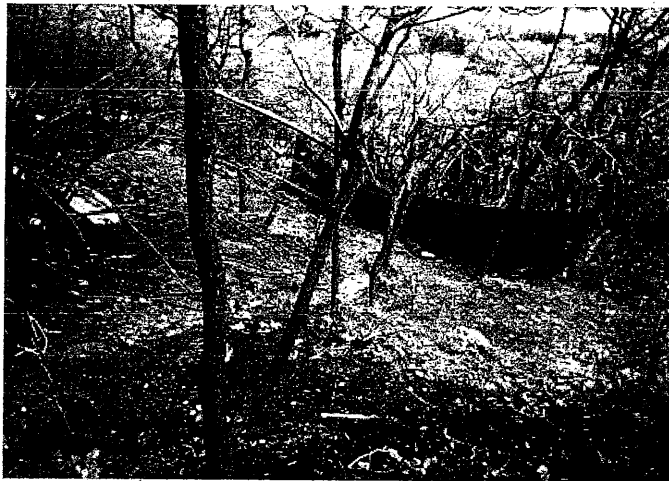
**Photo 4.** Example of a sediment catchment.

Additionally, sediment catchments were set up below the lowest transects. These catchments consist of a long section of black mesh cloth strung across the drainage and held up by wooden stakes which were driven a foot or more into the ground (see Photo 4). Each catchment was placed at a point where the drainage is still a bit constricted but starting to fan out and deposit material. At the base of drainage 1 a restroom blocks the path of the drainage. Right around the restroom the ground was dug out and leveled to make the foundation for the restroom, and the fire sediment has since started filling this flat area. Due to its placement, the restroom at

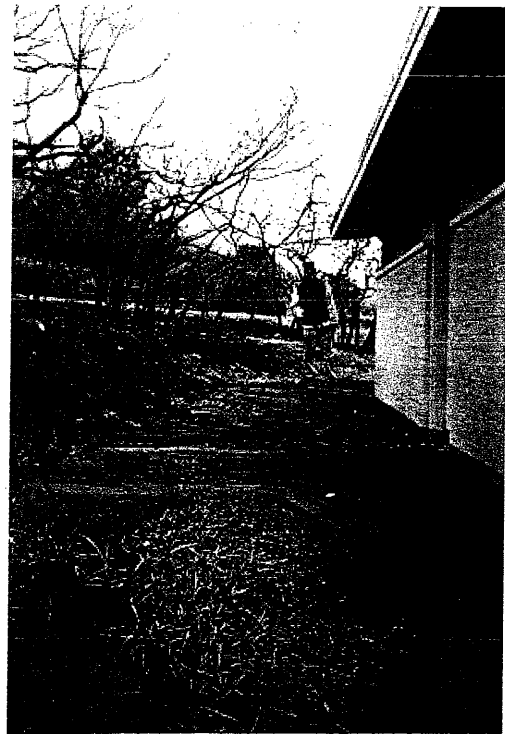
**Photo 5.** Catchment at the base of drainage 1.

the base of drainage 1 was used as a “natural” catchment (see Photo 5) and no other catchment was set up along drainage 1 (see Map 3).

In the first drainage the top transect (or T1) had an estimated 0.425 cubic meter gain, which was unexpected. However, due to the intensive winds during the second set of measurements I am not real confident in the accuracy of these measurements. Another factor which points to this transect's data being faulty is the fact that this change in sediment is on the order of ten times the changes seen in the other transects. Although this was by far the longest transect, it was in the order of two or three times the length of the other transects (not ten fold), so this data is thrown out. The slight gain in material from the middle transect (T2) was expected given this transect's location. Similarly, the slight loss in material from the bottom transect (T3) was also expected. The "natural" sediment catchment at the base of this drainage caught a minimum of 3.4 cubic meters, consisting primarily of fine grained sands and ash with occasional burned logs up to nearly a meter in length. Before the drainage actually runs into the restroom some water paths split off from the main drainage path, leaving piles of sediment in other locations, which is why only a minimum of 3.4 cubic meters was caught and measured for this drainage.
