Subject: Trip Report for Travel to Glen Canyon National Recreation Area (GLCA) September 24-28, 2001

PURPOSE: The purpose of this trip was to assess the functional condition of several riparian areas and associated uplands on the Kaiparowits Plateau. Additionally, GLCA staff is interested in any recommendations the assessment team could make regarding potential restoration of the sites in question.

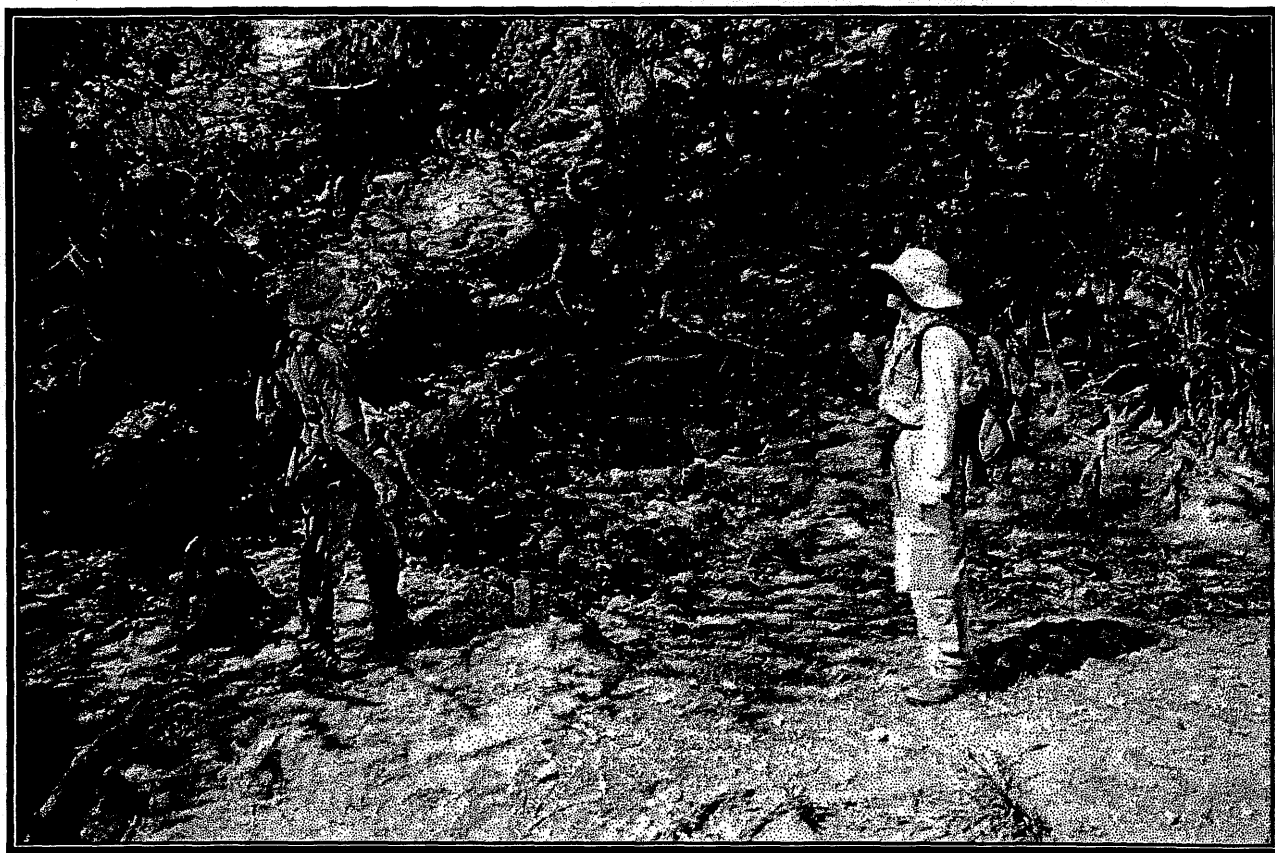
Figure 2 shows that the lower portion of this spring system continues onto the floodplain and right bank of the ephemeral channel. However, because the water source is clearly the non-riverine spring feature, we decided that it was most appropriate to evaluate the functional condition of this site using the PFC assessment method developed for non-riverine or "lentic" riparian and wetland areas. The reference for the lentic system assessment method is "A User Guide to Assessing Proper Functioning Condition and the Supporting Science for Lentic Areas" (USDI - Bureau of Land Management Technical Reference TR 1737-16, 1999). This method uses essentially the same concepts and terminology as described above for lotic areas, but the evaluation sheets are modified somewhat for non-riverine landscape positions and processes. The resulting functional ratings of "proper functioning condition," "functional-at risk" and "nonfunctional" are also the same.

Results of the lentic PFC assessment for Cottonwood Spring are documented in Table 1. The assessment team determined that trampling and trailing has altered surface flow and soil-water movement patterns. Hoof action has created depressions that allow ponding and ridges that redirect surface flow or allow local drying. Loss of soil-binding vegetation has also begun to allow transport of sediment from higher to lower elevations of the spring system, which further alters hydrologic conditions and sediment budgets. Observed precipitation of calcium carbonate and/or sodium salts at the soil surface near the margins of the site may be evidence that these areas are drying. We are concerned that such possible alterations in soil chemistry could hinder recovery of historic vegetation communities.

Responses to the vegetation section of the checklist indicate severe disturbance to wetland/riparian vegetation. Most notably, the majority of the site was completely lacking in vascular plants. As stated previously, there is one mature cottonwood (sex unknown) at the site, but no evidence of cottonwood recruitment. Site conditions are suitable for willows, but none were observed. Herbaceous species in the small patches of remaining vegetation included *Poa* sp. (probably *Poa pratensis*), *Carex aurea*, *Juncus bufonius*, and *Epilobium ciliatum*, all of which exhibited very limited cover, low vigor, and low reproductive potential. The lack of woody vegetation may be altering soil and water temperature regimes, and is likely altering the water budget at the site through impacts on evapotranspiration rates.

Figure 2. Cottonwood Spring, Carter Canyon. (Rating = Nonfunctional)

Although the site has been substantially degraded, the assessment team felt that it could be returned to a functional wetland-riparian system with reasonable effort. Key steps would be to: 1) exclude livestock; 2) allow revegetation from the existing seed bank; and 3) reintroduce native woody species from cuttings. Control of exotic plants such as *Poa pratensis* may be necessary, and plantings of native herbaceous species (plugs) may be desirable if recovery from the seedbank is insufficient. It may not be possible to fully restore this site to pre-disturbance conditions, at least in the near term, because of soil disturbance, hydrologic changes, and soil chemistry changes discussed above.

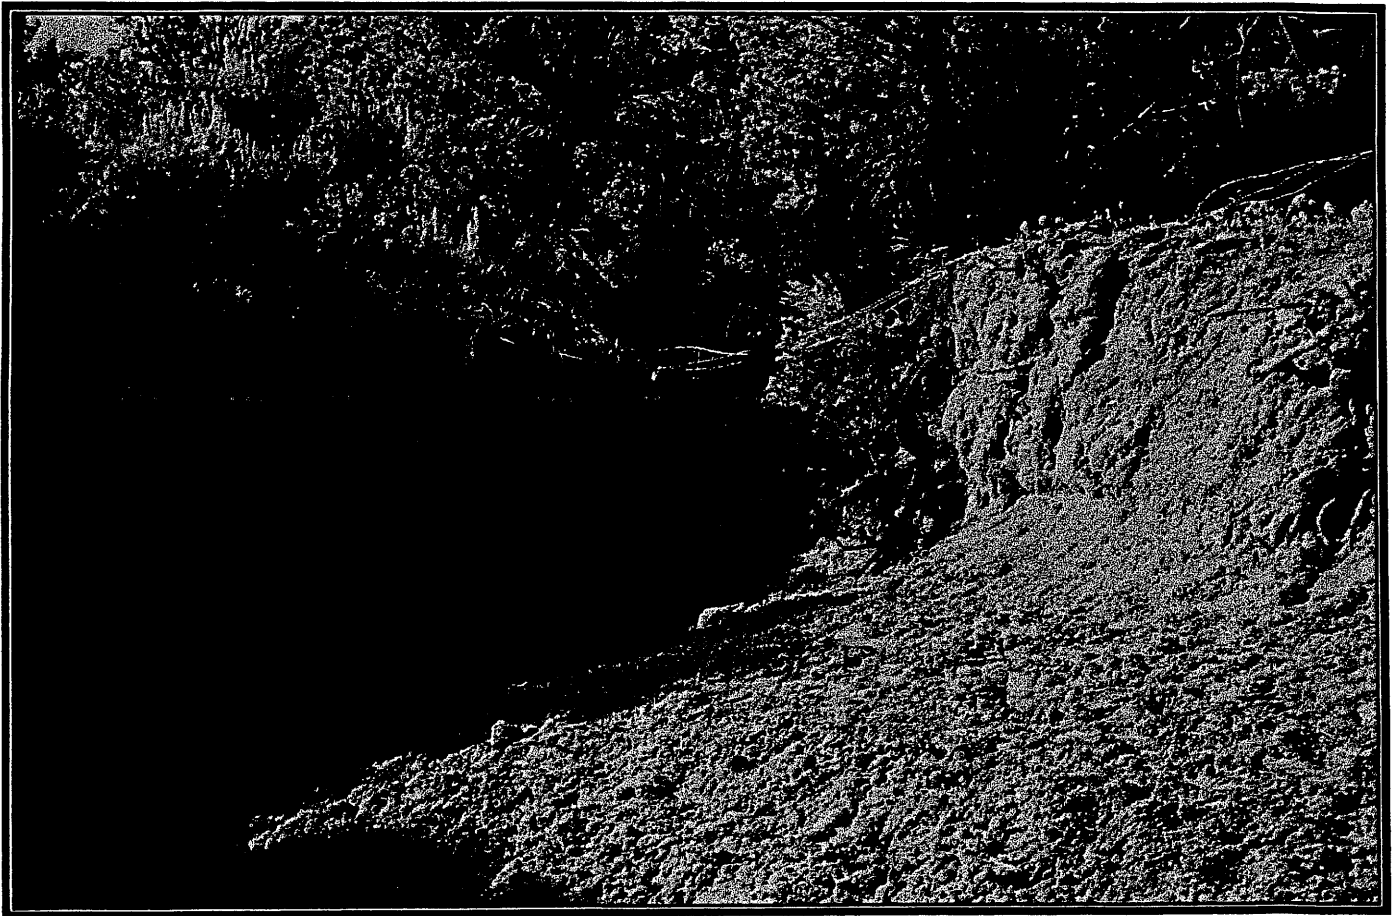
The almost complete lack of riparian and wetland vegetation evident in Figures 4 and 5 is reflected in the negative responses to all vegetation checklist items in Table 2. We observed no cottonwoods, willows, or other woody riparian plants in any age class. Although moisture was evident at the soil surface at the bottom of the channel, herbaceous cover was either totally absent or was less than 20% in the few existing patches of vegetation. This vegetation was predominantly "cheatgrass" (*Bromus tectorum*), a non-native, annual, upland species. Only one wetland species, hairy willow-herb (*Epilobium ciliatum*), was found sporadically in the few vegetated areas and these plants exhibited low vigor. Evidence of trampling by livestock was extensive as can be seen in Figure 5. The upper 10-12 feet of the banks were almost completely devoid of vegetation, root systems, or woody debris capable of dissipating energy during high flows.

Figure 5. Hanging Fence, Carter Canyon headwaters channel. (Rating = Nonfunctional)

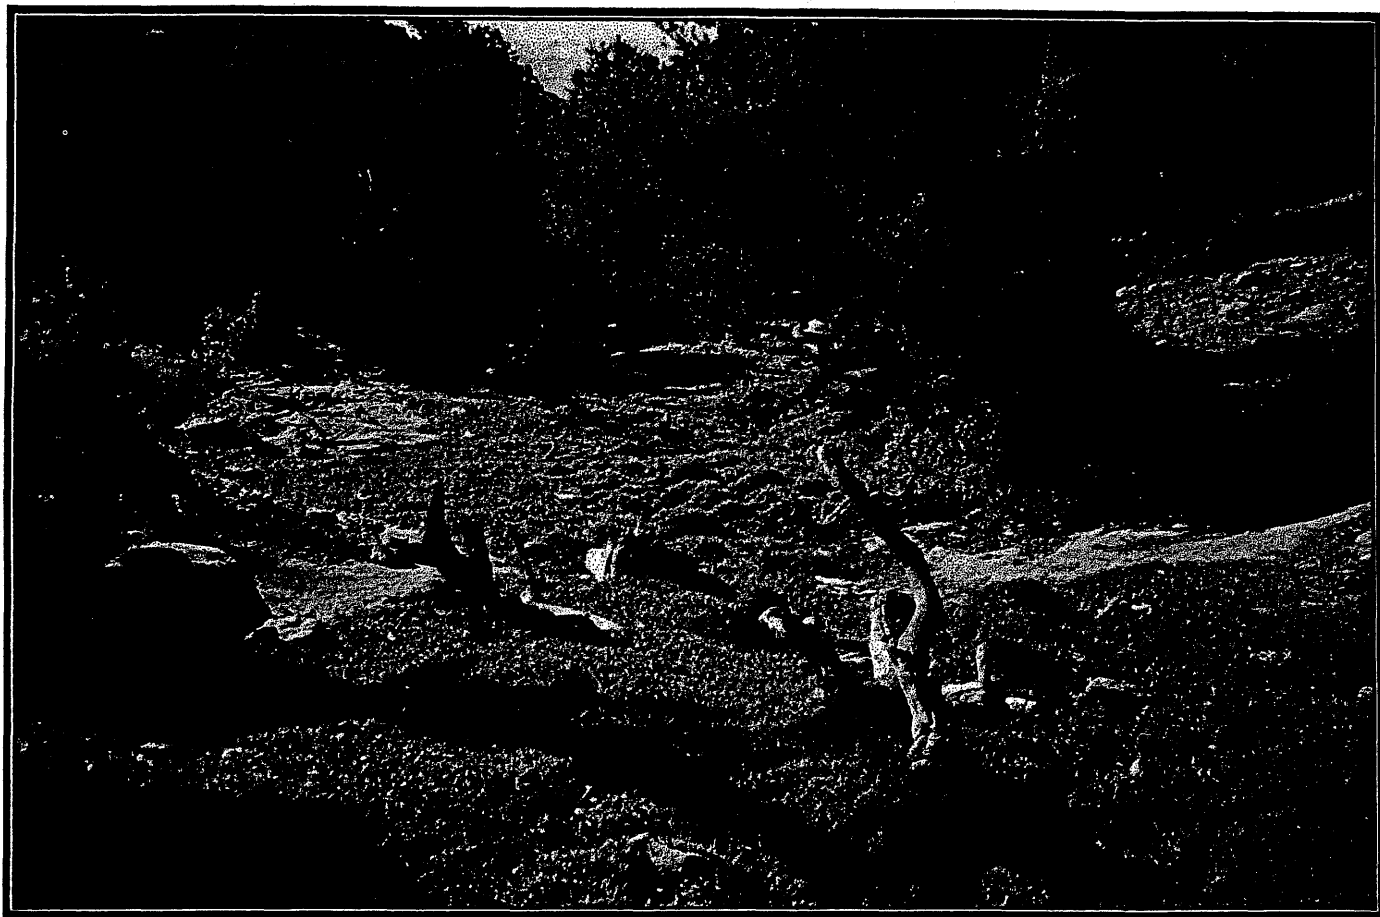
Figure 7. East End Spring. Note small mounds and irregular surface formed by grazing activity and periodic frost action.

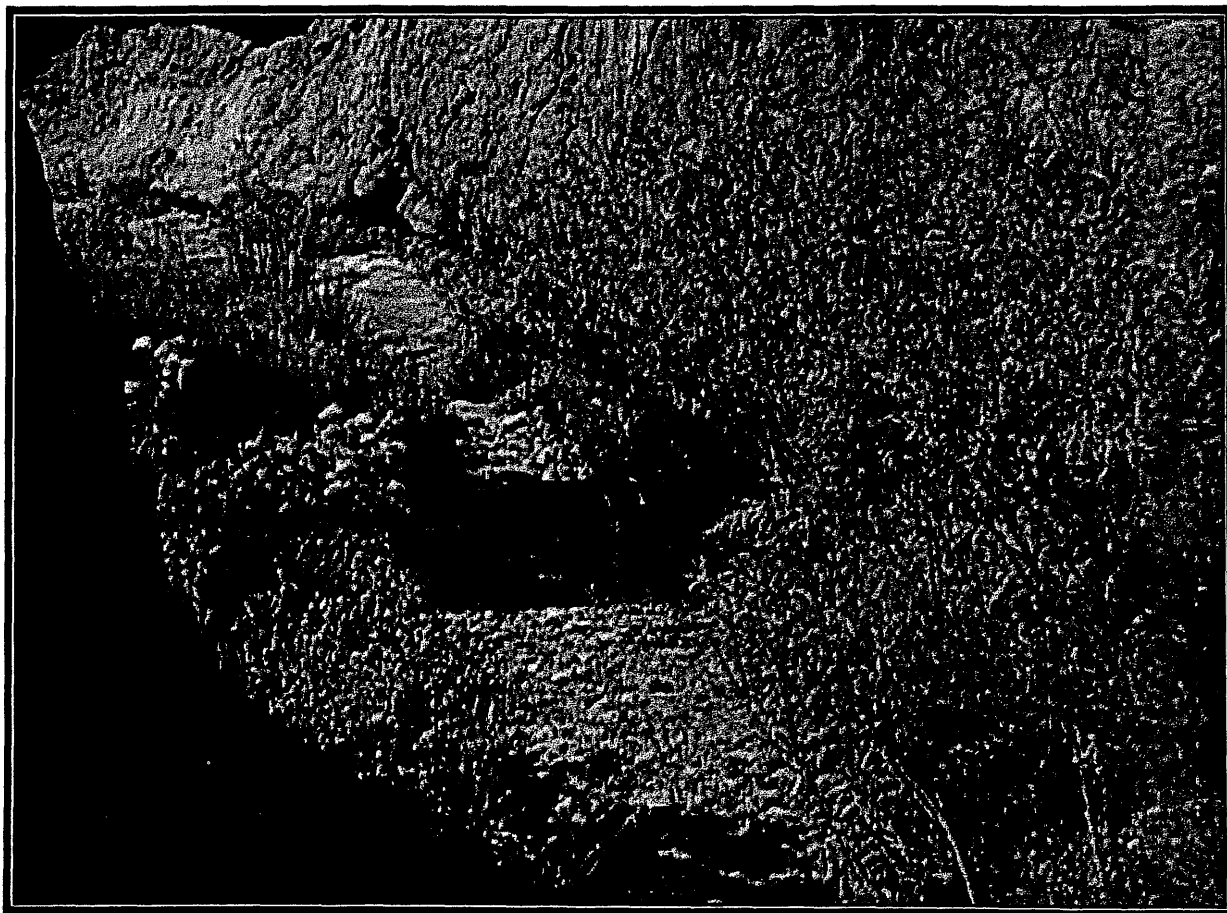
In the lower end of this drainage we found a channel reach that is apparently inaccessible to livestock due to large rock obstructions and several substantial vertical drops (see map in Figure 1). We saw this as an opportunity to evaluate the functional condition of a riparian area within the Lake allotment that is free of direct use by livestock. Figure 8 shows a portion of the reach looking downstream and Table 4 provides documentation for the lotic system PFC evaluation we completed for this site.

Based on the discussion above and the annotated checklist responses in Table 4, we rated this channel reach as being in "proper functioning condition." No management actions are necessary at this location.

Figure 8. Functional riparian zone, lower Fork Canyon.
