## Background

Table 1. **General Summary** of 98-2 & 99-2, removal of the remaining M8 and Lower M - Line

## **Chronological Excavation Narrative:**

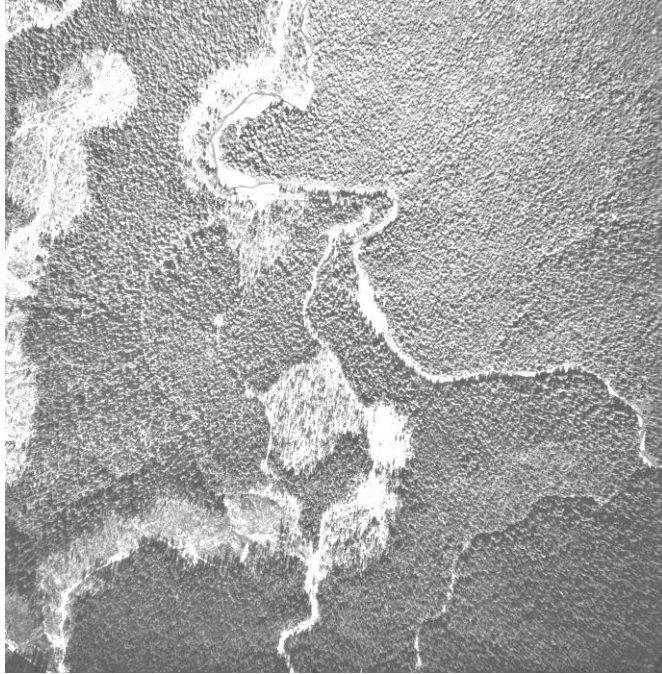
Figure 3. 1954 photo, prior to M-8 construction, M-Spur unit logged.

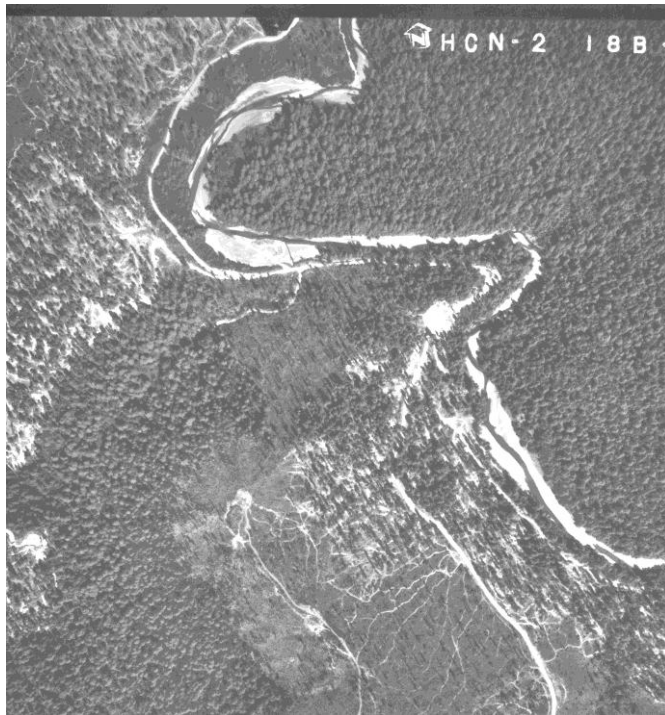
Figure 4. 1962 photo. M-8 selective logged, Otter Camp and gravel access road in place.

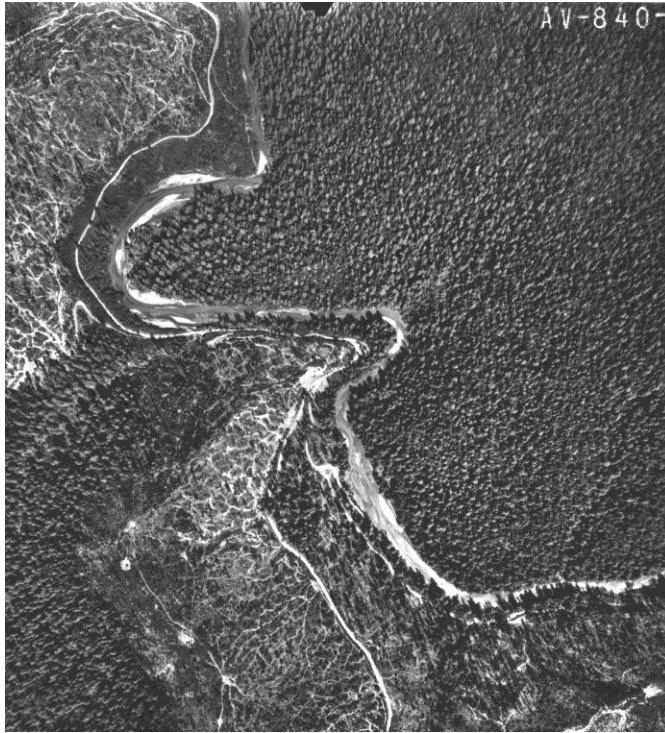
Figure 5. 1968 photo. Point logged above M-Line and residuals removed in Otter Creek bowl (above M-Line)

The remaining vegetation along the M-Line and M8 presently exists similar to what is shown in the 1968 air photo. The unit(s) along the M8 were selectively logged with an intact grove of old growth the can been to the southwest of Otter Camp. Redwood and Douglas Fir with some Hemlock, Tan Oak and Cedar represent second growth trees that have revegetated the project units. As is typical through out the park, Alder trees are prevalent on severely disturbed soils.

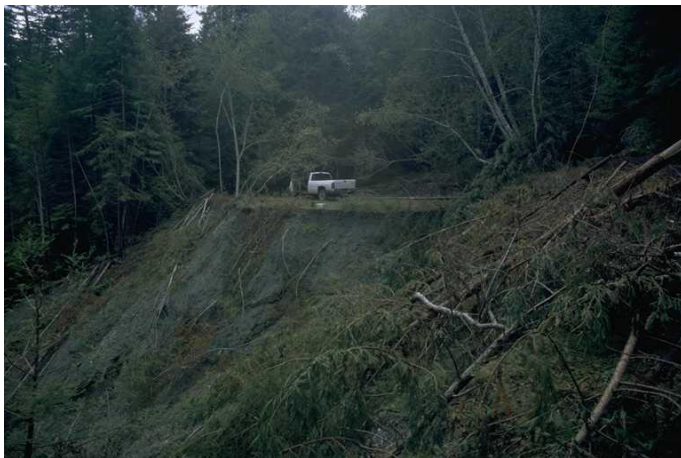
Figure 7. M Line / M8 junction following 1997 storm.

The New Years Day storm of 1997 caused 4 road fill failures occurred along the M-8 and another 4 failures along the Lower M-Line between the M-8 junction and Tom McDonald Creek.. The junction of the M-8 and M-Line failed, delivering between 10,000 and 15,000 cubic yards of sediment into Redwood Creek. Another large fill failure (approx. 3000 yd<sup>3</sup>s) occurred near station 11+00 on the M-Line. The M-8 had a several small fill failures (less than 1000 yd<sup>3</sup>s) and some problems at the Otter Camp stream crossing. A large slope failure (approx. 2000 yd<sup>3</sup>s), triggered by a culvert on the M-Line, deposited sediment and organic debris on the upstream side of the M-8 crossing at Otter Camp (station 80+75). Otter Camp was a large landing / road junction on the M-8 that had been used for access to Redwood Creek gravel mining, administrative access and camping.

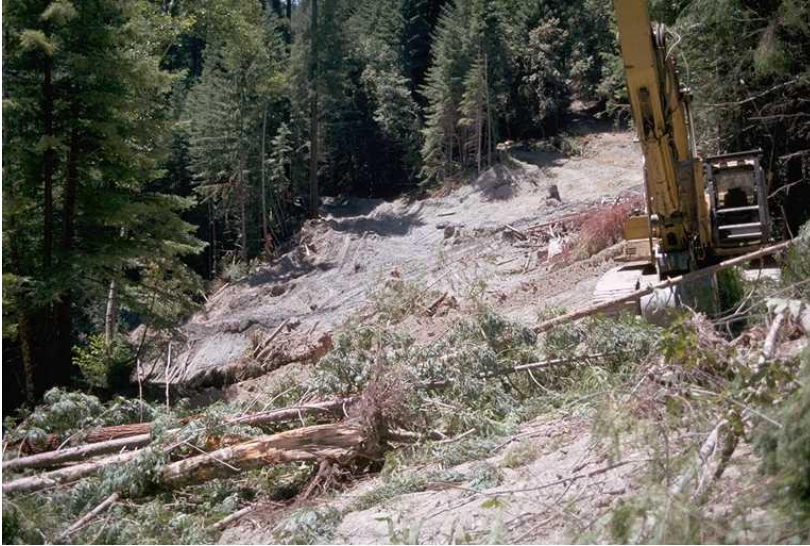
Figure 8. M Line / M8 junction removal in progress during 1999 season.

The junction:

The upstation end of the junction was consistent with the adjacent bid items producing a somewhat benchy topography with a number of small 'holes'. The holes appear to be related to springs that had been buried during road construction. This type of topography followed suit until the M Line came to a series of stream crossings.
