**Summary Report**

**WATERSHED RESTORATION UNIT 02-03**

**Removal of a Portion of The Lower B500 Road**

**Redwood National and State Parks**

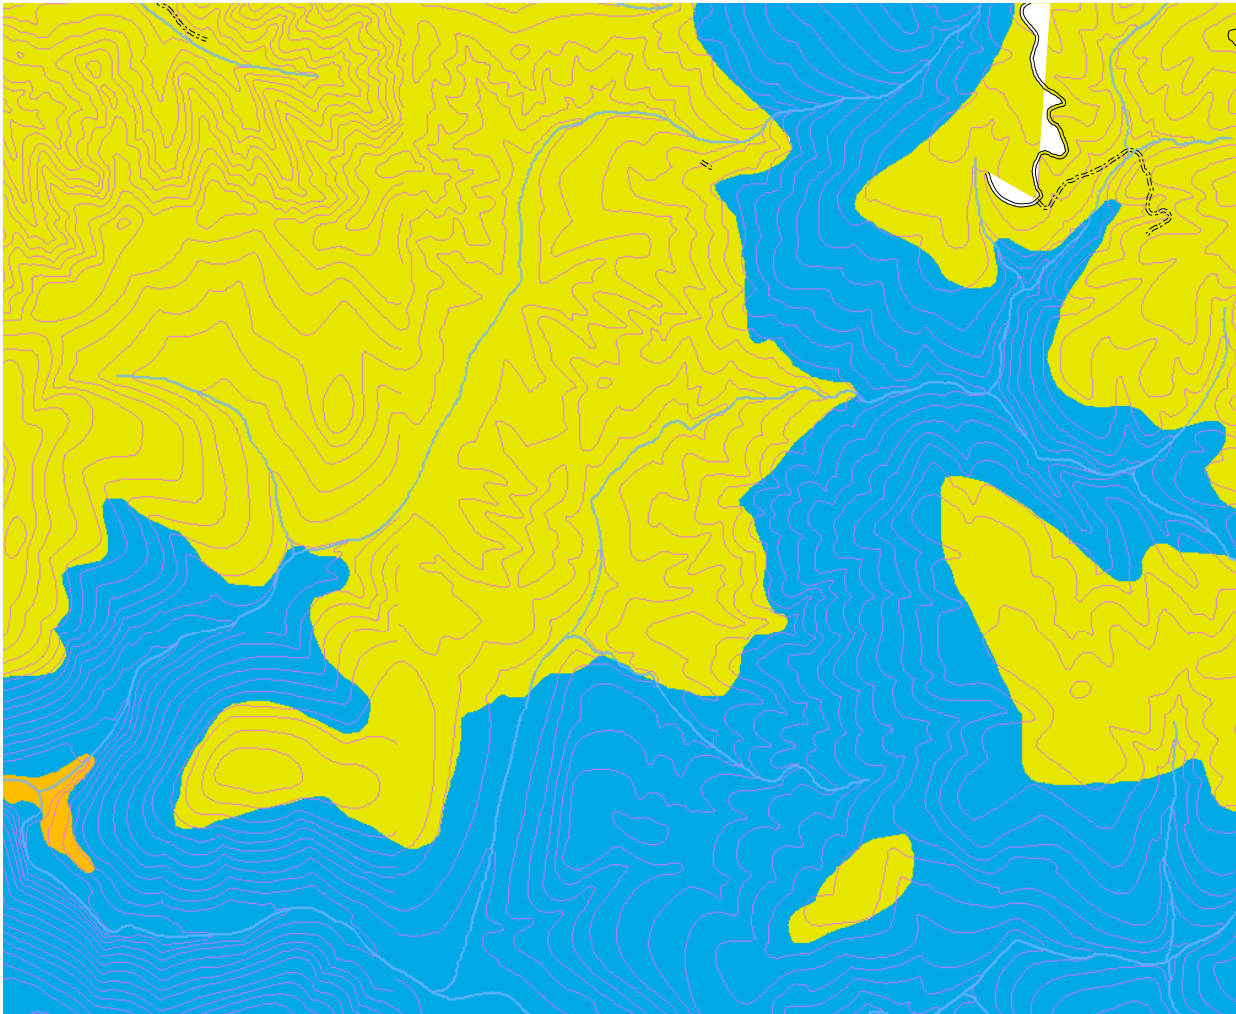
The Prairie Creek Formation (Gold Bluffs unit) and the Franciscan Assemblage (Lacks Creek unit) (see Figure 2.) are juxtaposed along the Lost Man Fault, a high angle fault trending north-northwest to south-southeast that crosses the western portion of the project area (Kelsey and Trexlor, 1989). According to Kelsey and Trexlor (1989), the Lost Man Fault displaces the Franciscan basement upward along its east-side, exposing it near the headwaters of both tributaries. Activity of the Lost Man Fault during the late Pleistocene to Holocene is not known (Kelsey and Trexlor, 1989).

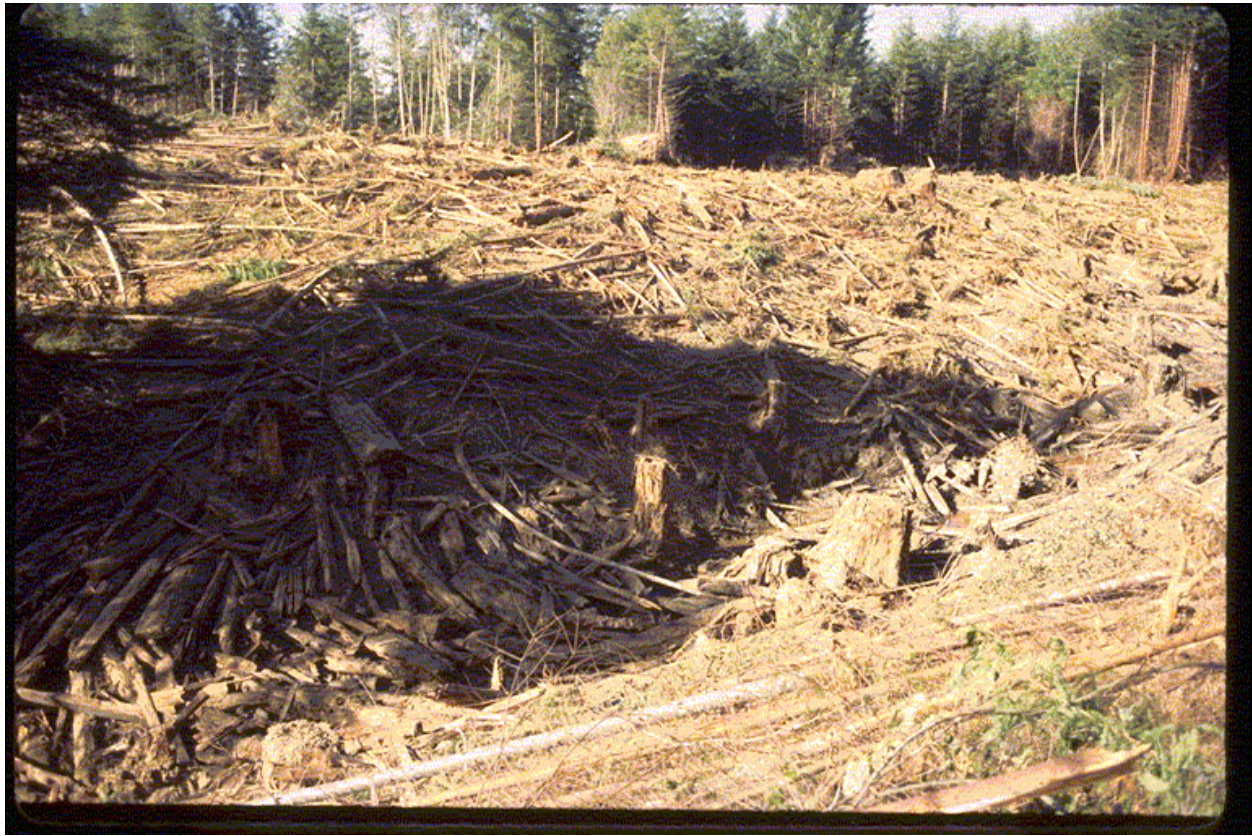
Figure 3. Vegetative debris mulching on excavation sideslopes provides for control of surface and fluvial erosion (this depicts a heavy rate of mulch application). Note the excavated stream channel with large woody debris placement in the foreground.

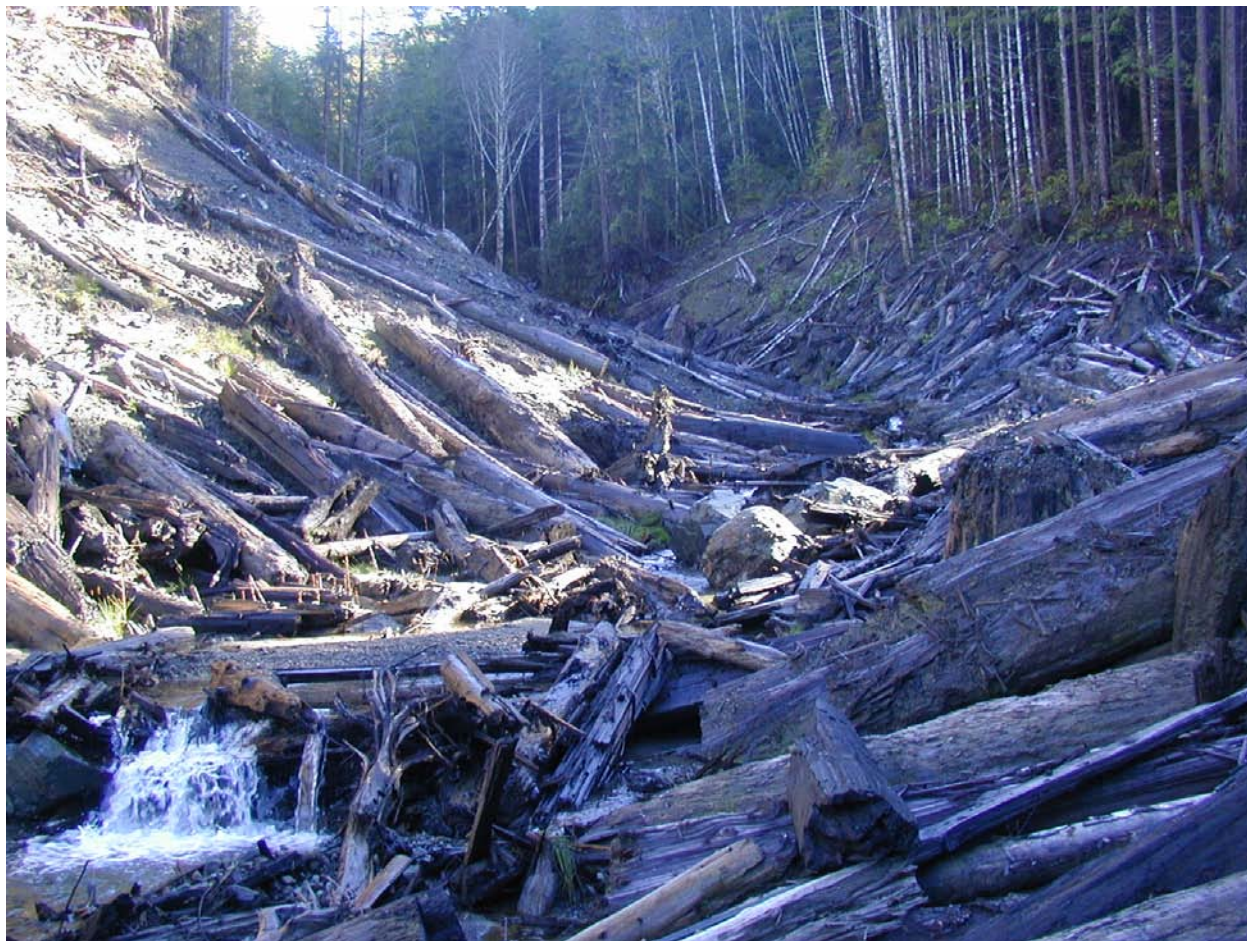
Figure 4. A stream crossing excavation with extensive woody debris placement. This photo was taken after the first winter following excavation.

Fortunately this is usually possible. In addition, large woody debris encountered during excavation is placed in arrangements that mimic natural accumulations observed in stream channels. In most cases, abundant woody debris is available for placement in stream crossing excavations. Figure 4 shows a completed stream crossing excavation with extensive woody debris placement as it appeared in spring, 2001, following a relatively mild winter. While channel scour will occur even with woody debris placement, the extent of scour will be minimized, much of the sediment is trapped within the excavated reach, and the channel will have the structural elements needed to re-establish a natural morphology relatively quickly with this approach.
