# HOPEWELL FURNACE NATIONAL HISTORIC SITE WATER QUALITY SURVEY

**Report to the National Park Service**

**February 2005**

# **HOPEWELL FURNACE NATIONAL HISTORIC SITE WATER QUALITY SURVEY**

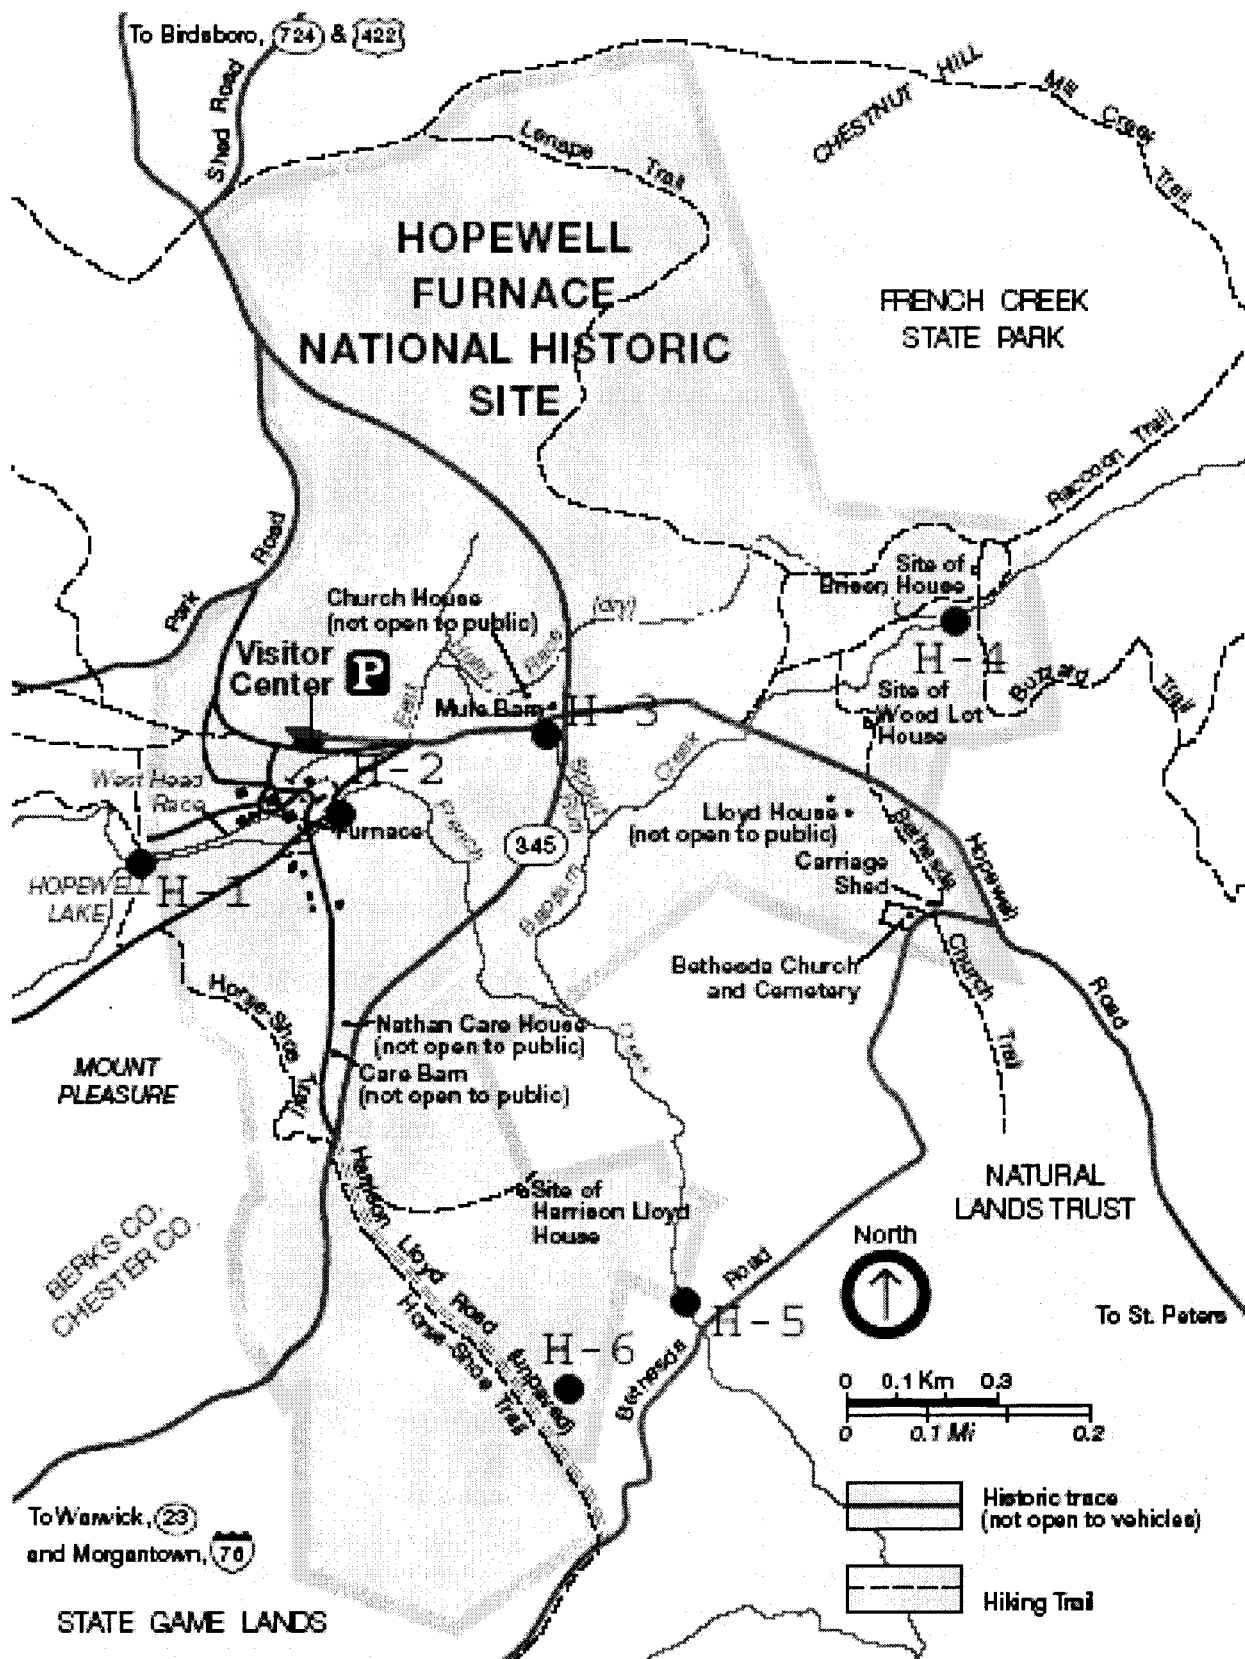
Figure 1. Hopewell Furnace National Historic Site (general map)

Hopewell Furnace NHS has an area of 848.06 contiguous acres, with no inholdings (Figure 1). It is divided between two townships, Union and Warwick, which lie within Berks and Chester counties, Pennsylvania, respectively. Approximately two-thirds of Hopewell Furnace NHS is bordered by French Creek State Park, a park of primarily recreational value, which receives substantial summer tourism. Agricultural lands and low-density residential development border the remaining one-third.

The NPS and the Civilian Conservation Corps created at least one landfill of unknown content near the southern boundary of Hopewell Furnace NHS. Its approximate location is known (H-6 in Figure 1), and levels of  $\text{NO}_3\text{-N}$  and  $\text{SO}_4$  were found to be relatively elevated when it was sampled in 1992 (Sharpe and Neff 1993).

French Creek receives significant quantities of flow from two creeks within Hopewell Furnace NHS (Figure 1). Spout Creek, a spring-fed stream three-quarters of a mile in length, flows southeast from hills above the Hopewell Furnace NHS historic zone. Stream channel width increases from two feet to four feet along its reach, and the entire stream is densely shaded. Water flows at a moderate velocity over a rocky streambed, where small pools and shelters are common. Flows in Spout Creek are moderately affected by dry weather periods. Baptism Creek is a tributary of French Creek, and is approximately two and a half miles in length. It is fed by springs, and also by Spout Creek at a confluence just southeast of the intersection of Hopewell Road and Route 345. The stream is characteristically similar to Spout Creek, with a slightly wider and deeper stream channel, and a marginally greater flow. Baptism Creek flows into Hopewell Furnace NHS from an east-northeasterly direction, crosses the eastern half of the park, and empties into French Creek near the Chester County line in the southern portion of Hopewell Furnace NHS. Areas of poorly drained, seepy land along the banks of French Creek to the southeast of the historic zone constitute wetlands within Hopewell Furnace NHS. Several small, unnamed, spring-fed streams drain these wetlands and enter French Creek in the woodlands near the southern boundary of the park.

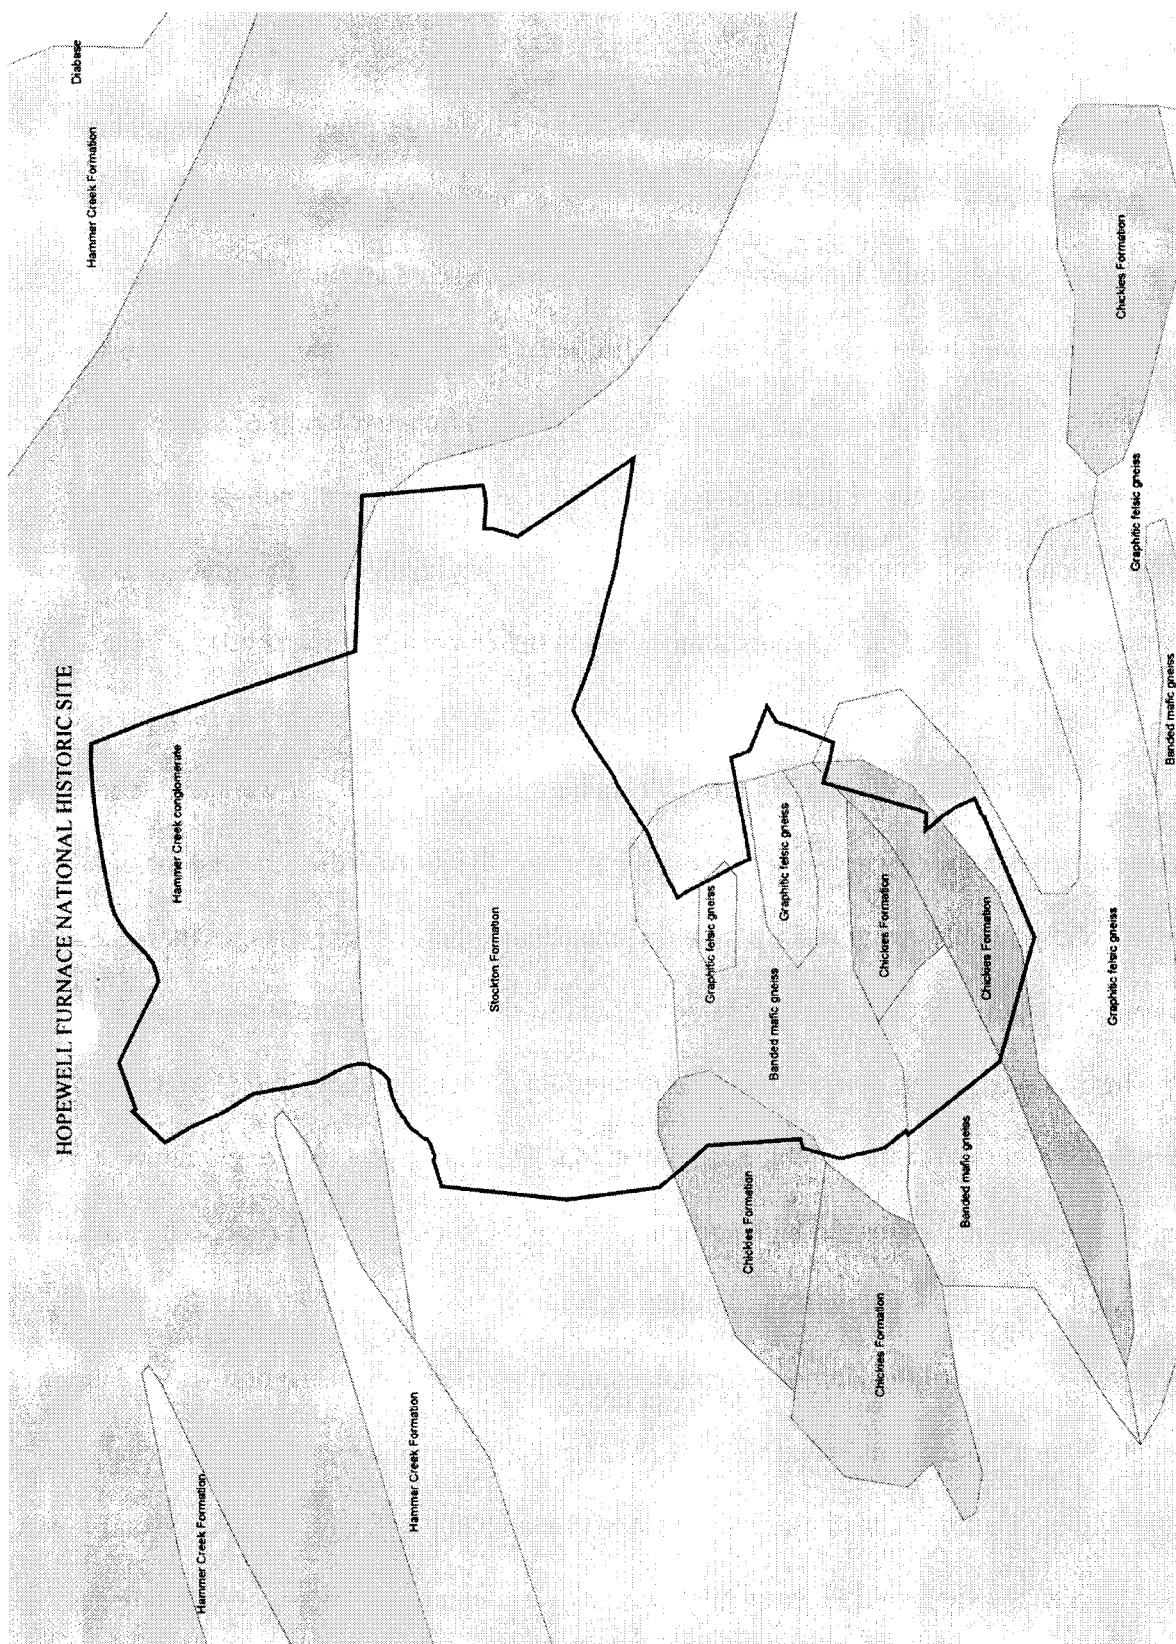
Figure 3. Geologic map of Hopewell Furnace NHS area

Most of Hopewell Furnace NHS is situated on the border of extensive Triassic Basin “redbeds,” which are composed of sandstones and conglomerates (Figure 3). These rocks were deposited during a long period of erosional activity, when large quantities of sediments were produced, transported into lowland basins, and lithified. The resultant sedimentary rocks, known as the Hammer Creek and Stockton Formations, contain significant volumes of stored water, and are considered to be sources of high quality groundwater in southeastern Pennsylvania. The Stockton Formation underlies and is recharged through the valley floor in the upper reaches of French Creek Basin. Bedding dips north-northwest in the Hopewell Furnace NHS region at angles of 5 to 25 degrees. The middle member of the Stockton, a moderately-sorted, poorly cemented, arkosic sandstone, typically has the best hydrologic qualities for well production. The water supply wells presently in use at Hopewell Furnace NHS were drilled in the Stockton Formation, and probably pump mainly from the middle member. Lateral changes in the texture and porosity of the sandstones and conglomerates cause site-specific variations in well yields.
