# **FAN LAKE & FALL RIVER RESTORATION: SITE CHARACTERIZATION, DESIGN ELEMENTS, AND RECOMMENDATIONS**

**Prepared for: Rocky Mountain National Park, National Park Service Water Resources  
Division**

David J. Cooper, Ph.D. and Edward A. Gage, M.S.  
Department of Forest, Rangeland and Watershed Stewardship  
Colorado State University  
Fort Collins, CO

March 2006

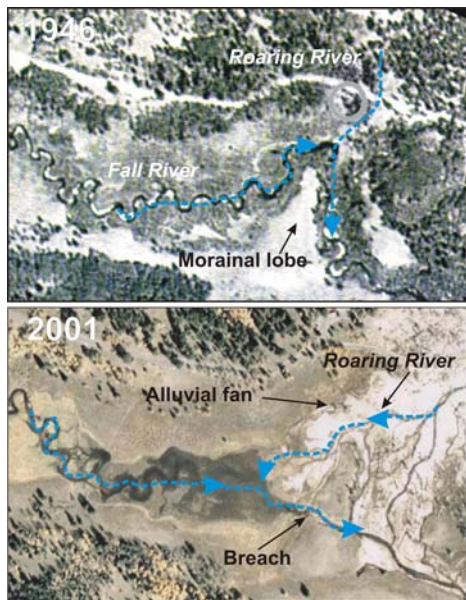
**Figure 4. Aerial photographs of study area from 1946, before the formation of Fan Lake, and in 2001, afterwards illustrating changes in the direction of flow for the Fall and Roaring Rivers. Note that the Roaring River now flows further west along or near the historic Fall River channel, while the Fall River now flows east, exiting the restoration area through breach in the morainal lobe created in 1995**

Significant changes to the hydrologic functioning of the site are indicated from the aerial photographs. Prior to the formation of Fan Lake, the Fall River flowed north around the morainal lobe that, with the formation of the alluvial fan, ultimately impounded it. The Roaring River entered to the east of this feature, discharging into the Fall River near the middle of where the alluvial fan was deposited (Figure 4). Following the formation of the Fan Lake, the course of the Roaring River shifted, flowing west of the alluvial fan and moraine. Likewise, the contemporary path of the Fall River differs largely from its pre-lake configuration. It now flows through the middle of the moraine

where it was breached by NPS staff in 1995 (Figure 4).

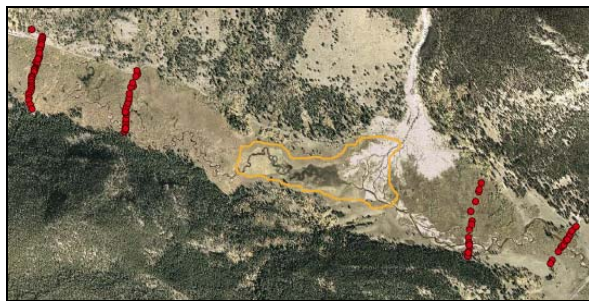
**Figure 10.** Locations of reference cross-section used to develop design channel configuration. Red dots indicate location of survey point; the 1990 boundary of Fan Lake is also indicated.

Reference cross-sections were identified from survey data collected in 2002 by the authors and NPS staff (Figure 10). These data were used in the development of design cross-sections (Figure 11). Existing topography as well as proposed topographic surfaces for the restoration design are presented in the attached maps (Appendix 2).

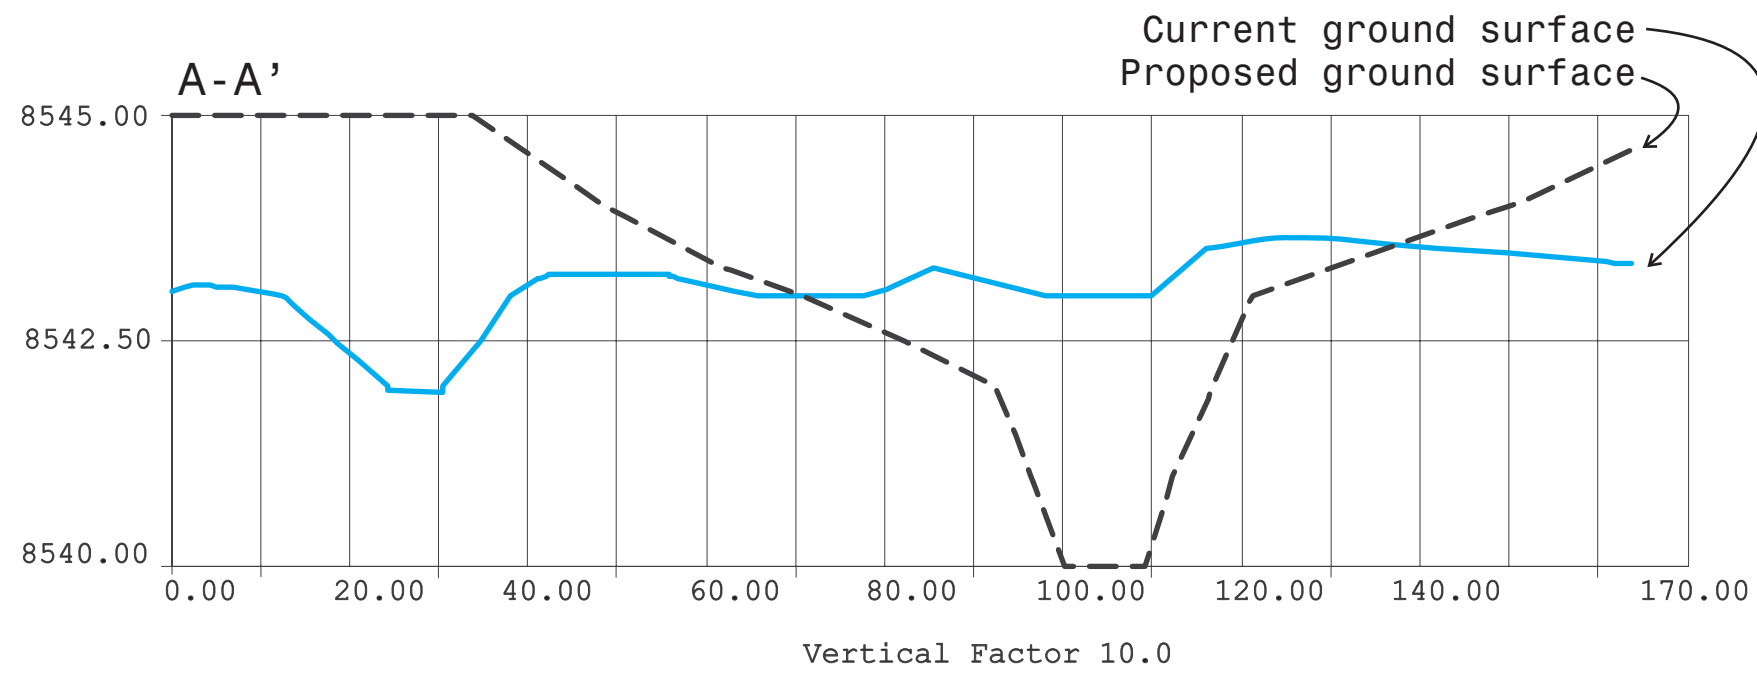
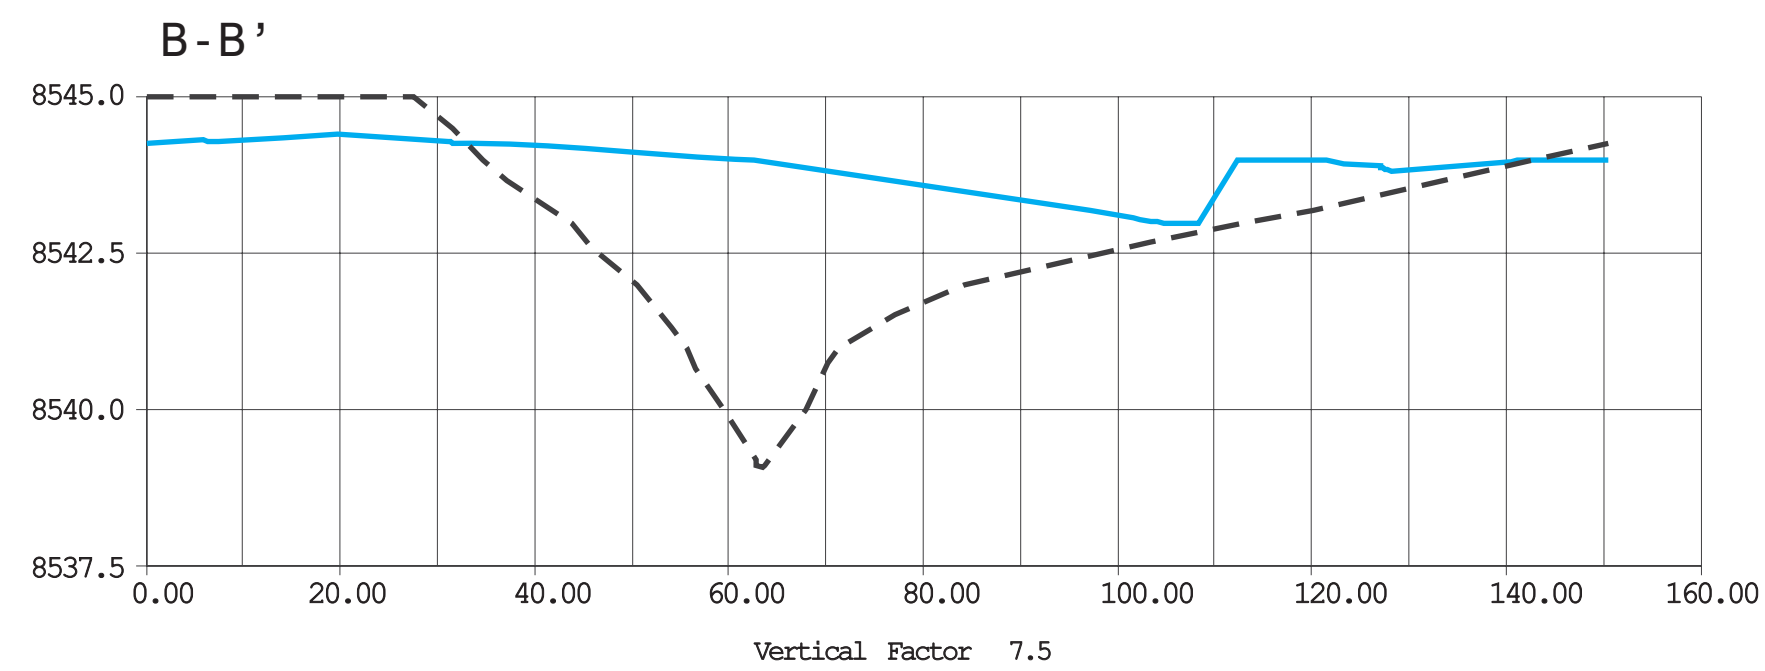
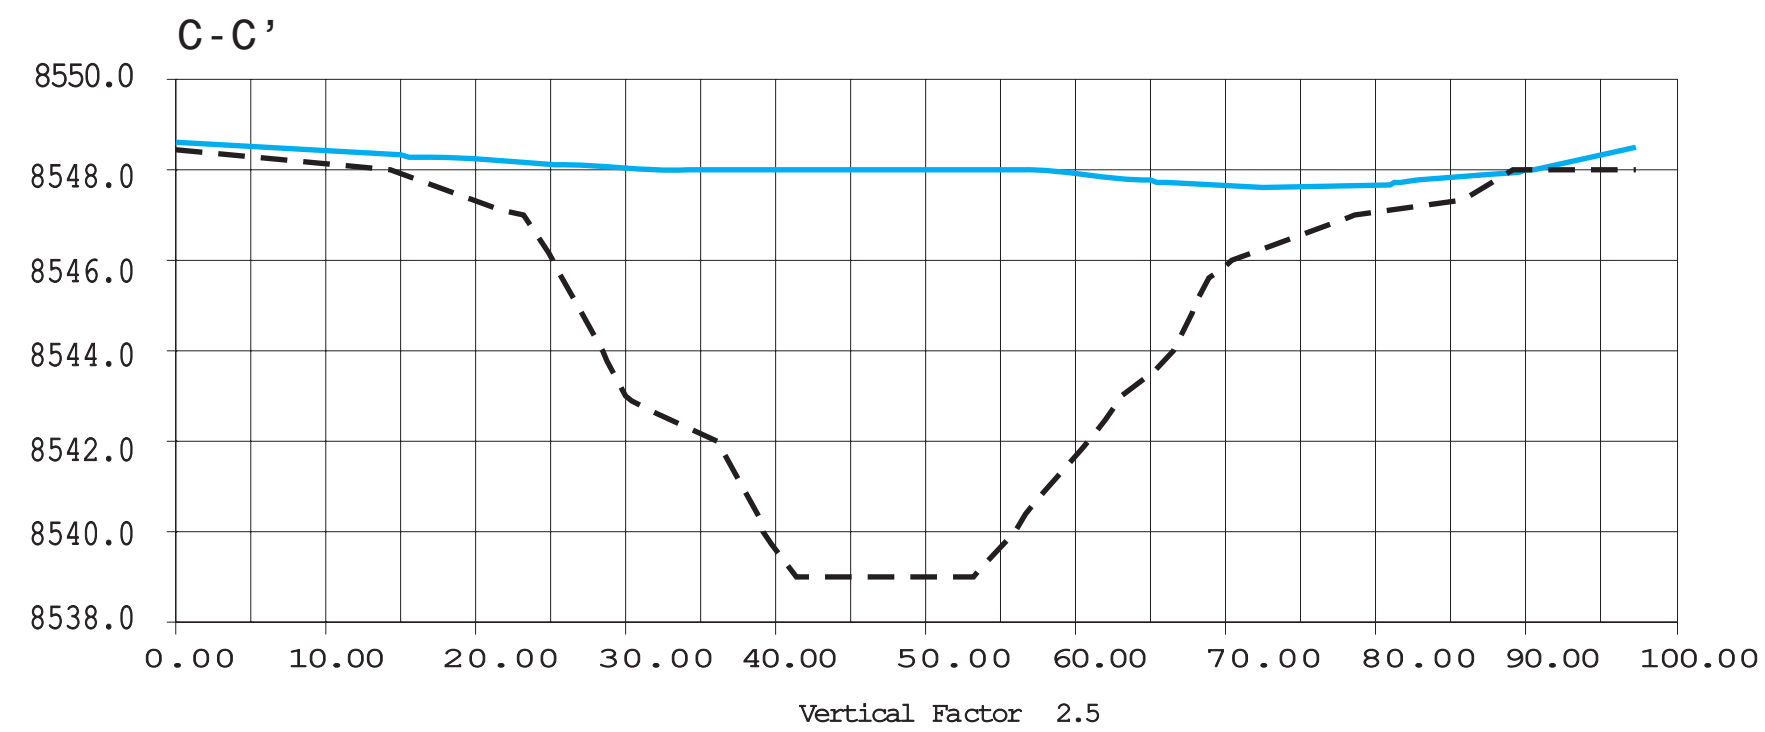
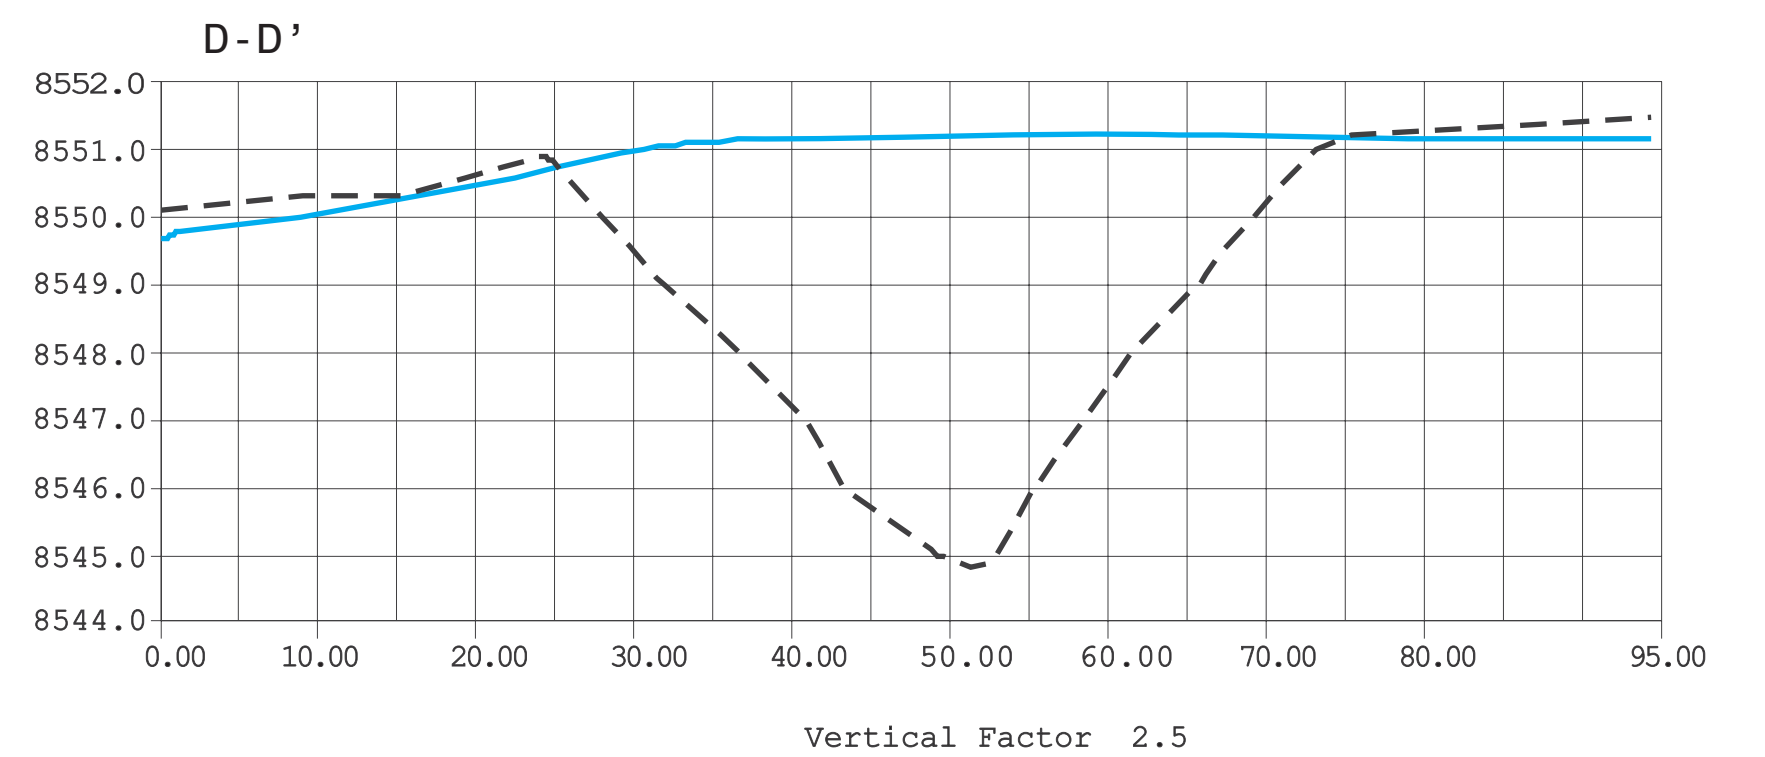
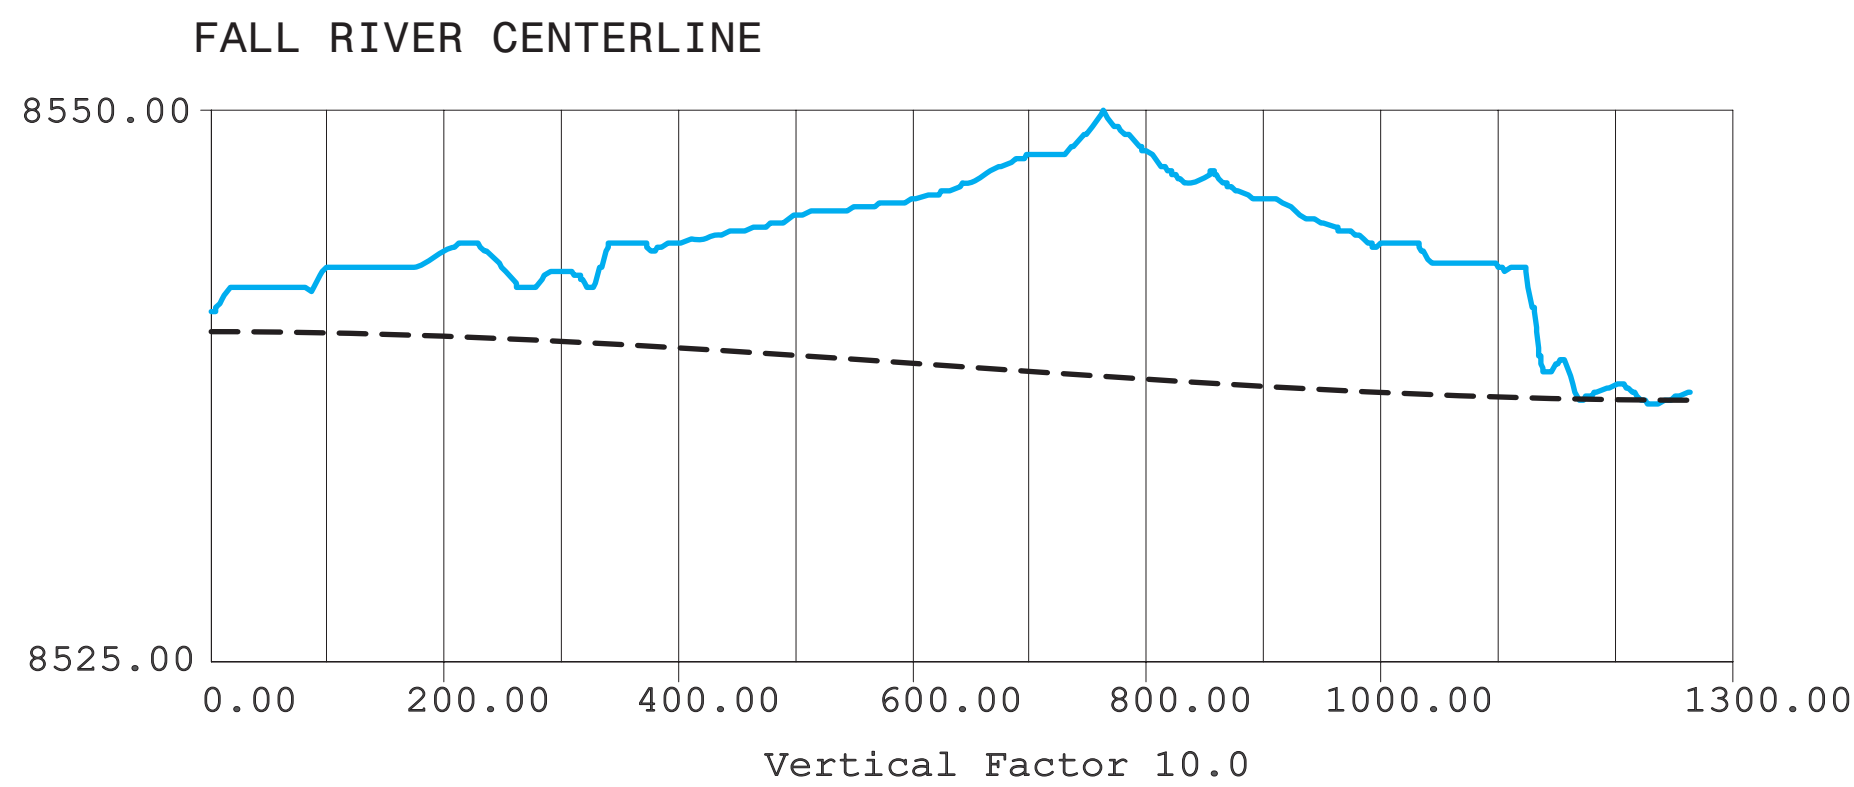
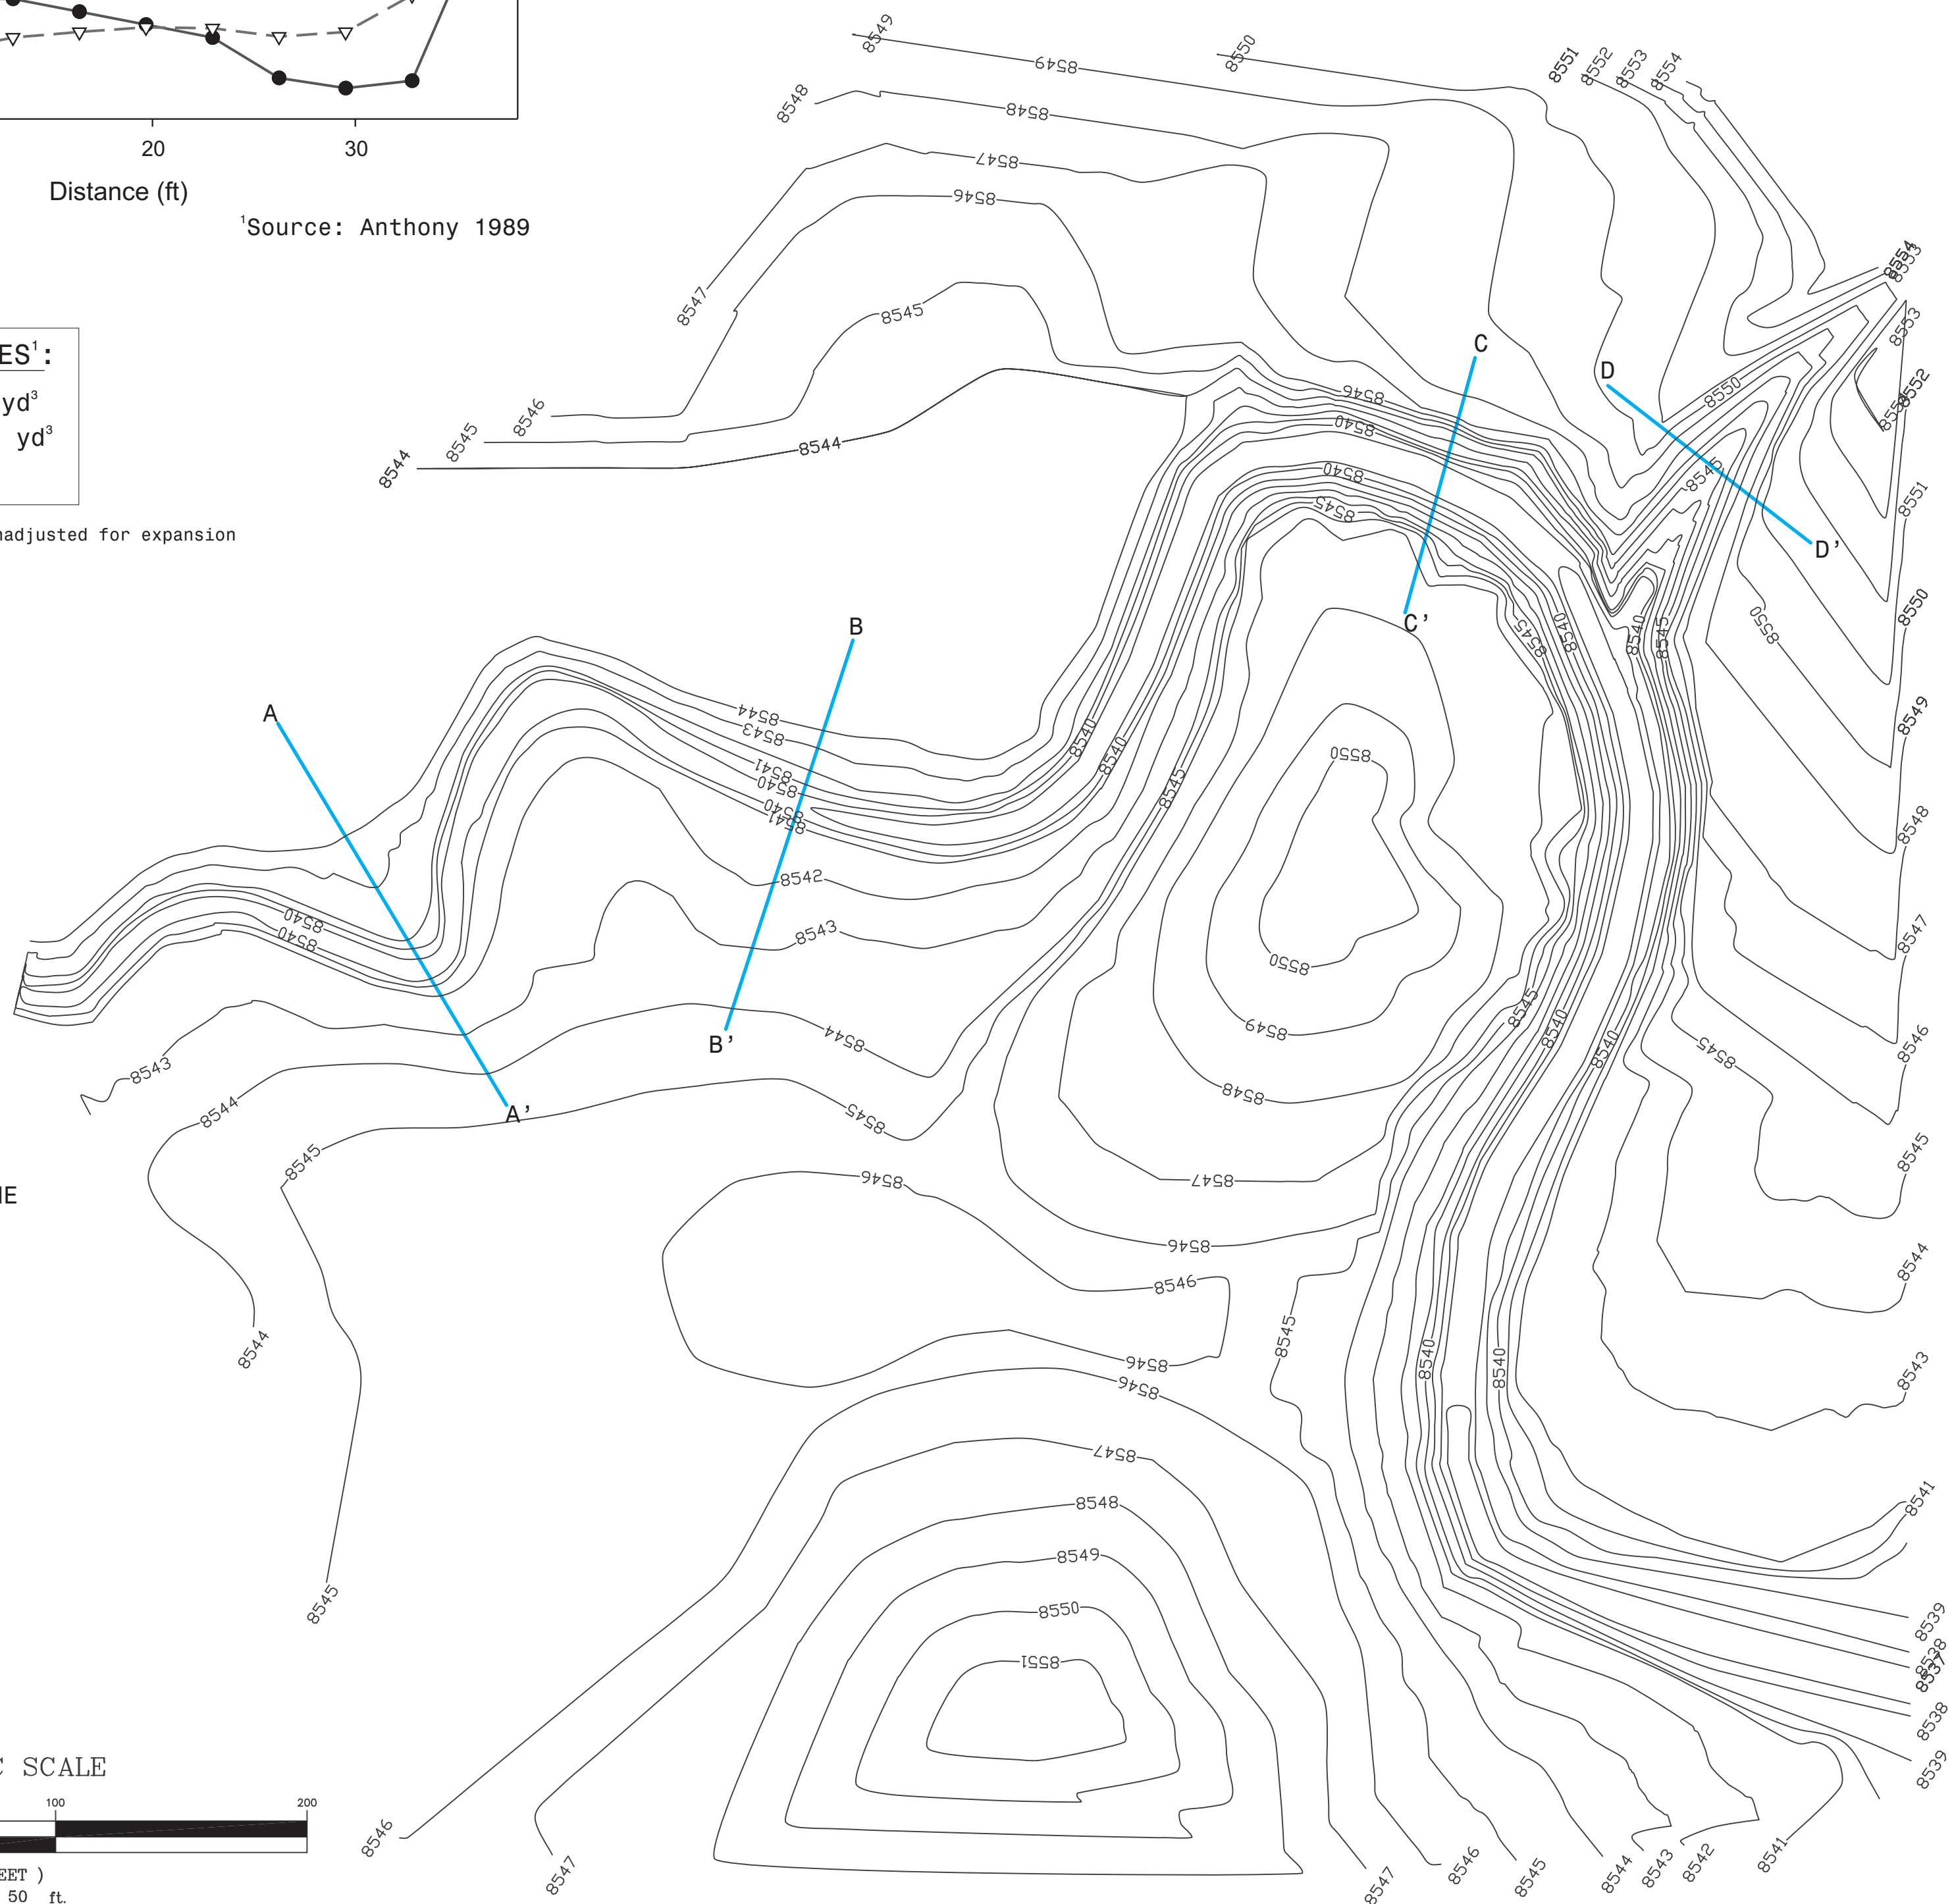
VOLUME ESTIMATES<sup>1</sup>:

TOTAL CUT: 9591 yd<sup>3</sup>  
TOTAL FILL: 9194 yd<sup>3</sup>  
NET: 397 yd<sup>3</sup>

<sup>1</sup> Grid method, values unadjusted for expansion or contraction
