ARIZONA STRIP BIGHORN SHEEP RECOVERY EFFORTS

FY 1985

Bureau of Land Management, Arizona Strip District  
and  
Arizona Game and Fish Department

## ARIZONA STRIP BIGHORN SHEEP RECOVERY EFFORTS - FY 1985

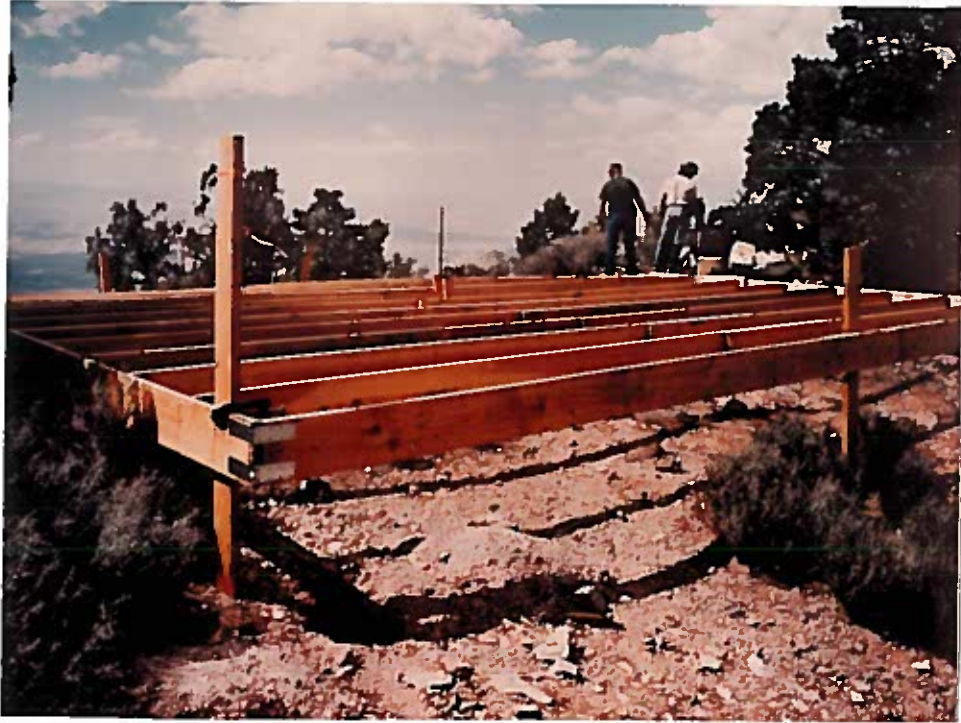
Figure 3. AGFD projects crew building the apron for Mirage Wildlife Water Catchments, Virgin Mountains.

Chamberlain Canyon Catchment--was completed shortly after the end of the fiscal year. In addition, materials for Cunningham, Grand Gulch, and Ferguson Pockets Catchments were purchased with construction planned for mid-year 1986. The AGFD projects crew provided the majority of the labor for construction of the four completed wildlife catchments (Figures 3 & 4).

This water catchment consists of a 1,500 ft<sup>2</sup> aluminum apron, two 2,150-gallon fiberglass storage tanks and a ground-level drinking trough. This project was identified during revision of the Black Rock HMP. Materials, tools, supplies and the AGFD crew were flown into and out of the site using a Bell 206III Jet Ranger helicopter. Bighorn sheep had been seen within ½ mile of the site prior to project feasibility. The storage tanks were partially full of water within one week of project completion. The BLM personnel ferried materials and painted the apron and storage tanks a camouflage pattern. Tanks were placed below the ridgeline and the apron among trees to minimize visual impacts. The facility was fenced on two sides to eliminate livestock access to the site.

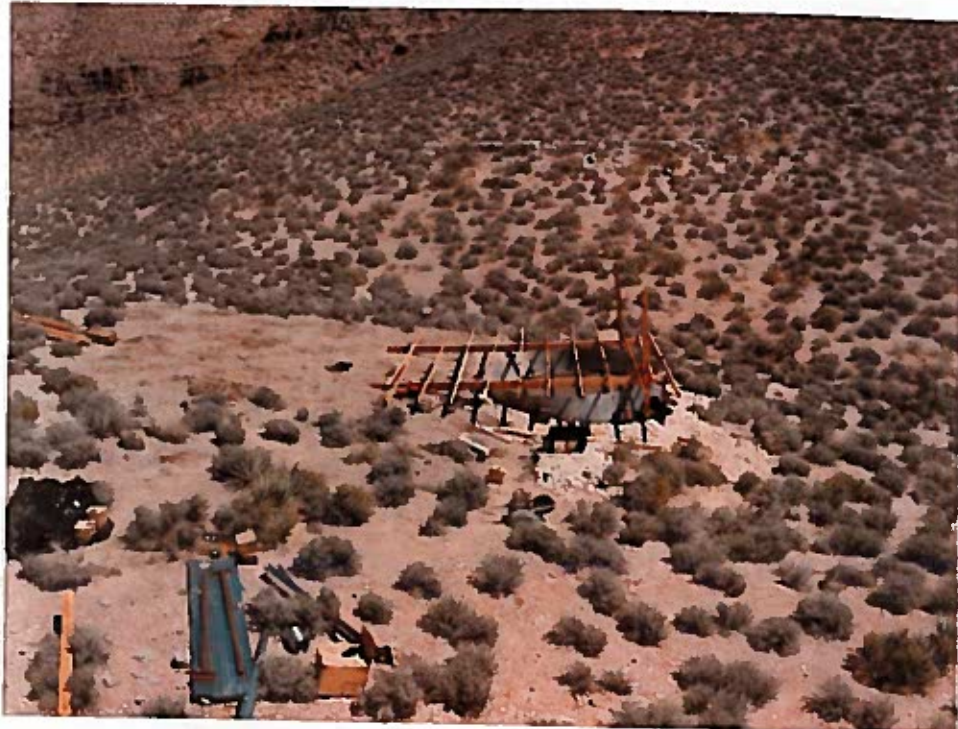
Figure 4. Overlook Wildlife Water Catchment during construction. Note placement of steel storage tank under apron, Grand Wash Cliffs.

This water catchment consists of a 1,200 ft<sup>2</sup> aluminum apron built over a 5,000-gallon bolt together steel tank with a Hypolon™ liner. A ground-level drinking trough is included in the project. This project was built under the Parashaunt HMP. Materials, tools, supplies and the AGFD crew were flown into and out of the site using a Bell 206III Jet Ranger helicopter. Bighorn are known to use the cliffs nearby the catchment site. The BLM personnel ferried materials and painted the apron and all above-ground facilities a camouflage pattern. The facility was placed near escape sheep cover and in the least visible location.

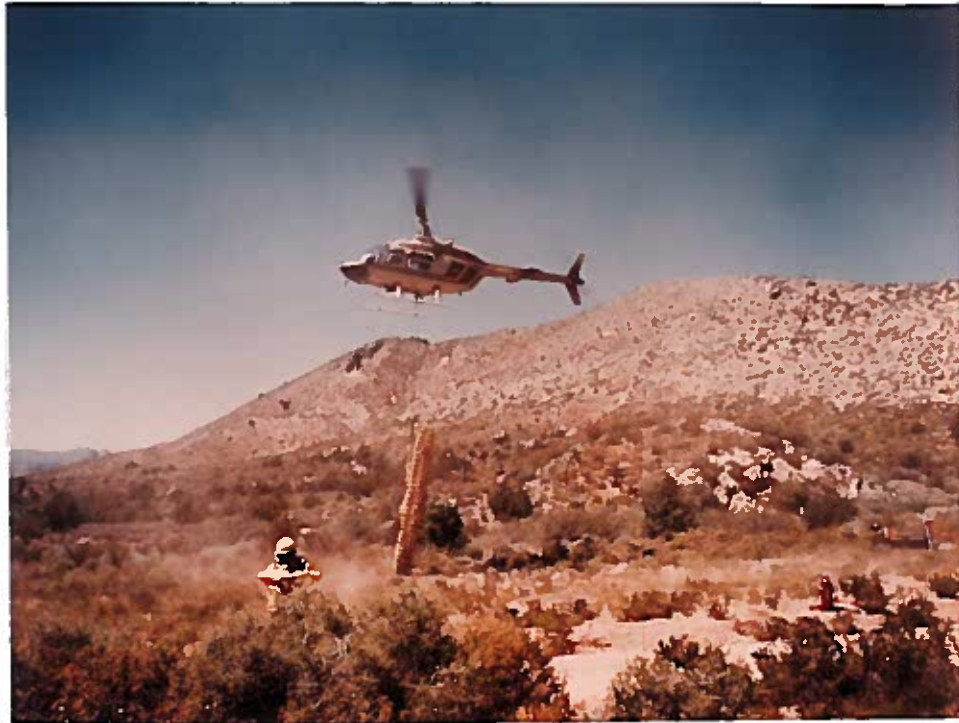
Figure 5. Helicopter slingloading construction materials to the Mirage Wildlife Catchment site, Virgin Mountains.

Two of the catchments--Overlook and Mirage--required the use of a helicopter to slingload materials, tools, camp gear and personnel to and from the sites. BLM fire helitack personnel and wildlife biologists were on hand to oversee the operation (Figure 5). BLM biologists also assisted with labor in the physical construction of the catchments. Total helicopter cost incurred in the construction of the catchments was approximately \$21,000 for 1985.

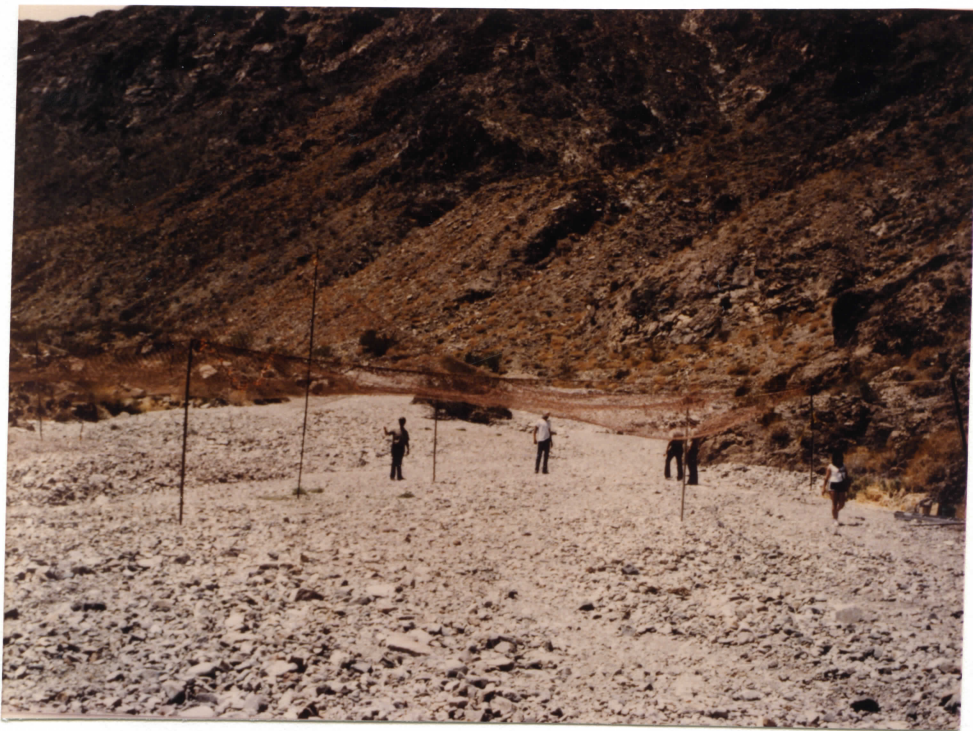
Figure 6. AGFD and ADBHSS personnel setting up drop net at Indian Cove on Lake Mead, Arizona.

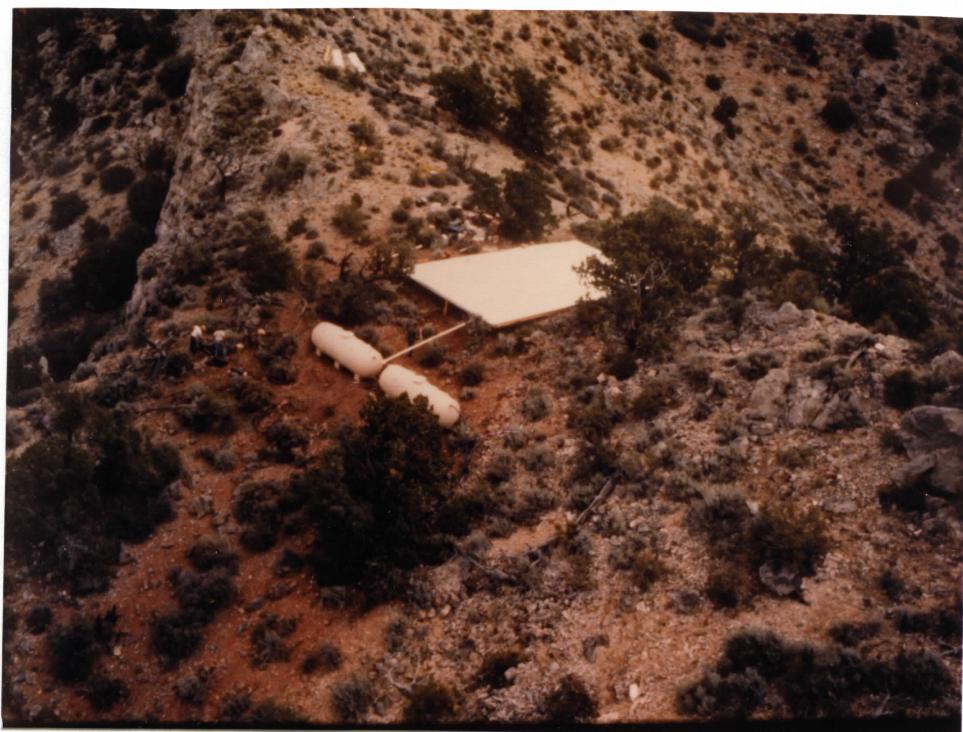
Mirage Catchment near completion prior to camouflage paint.  
Note topography and AGFD construction crew.
