## Historic Structure Report: CCC Buildings

## HISTORIC STRUCTURE REPORT CCC BUILDINGS

**Bandelier National Monument**  
New Mexico

**1988**

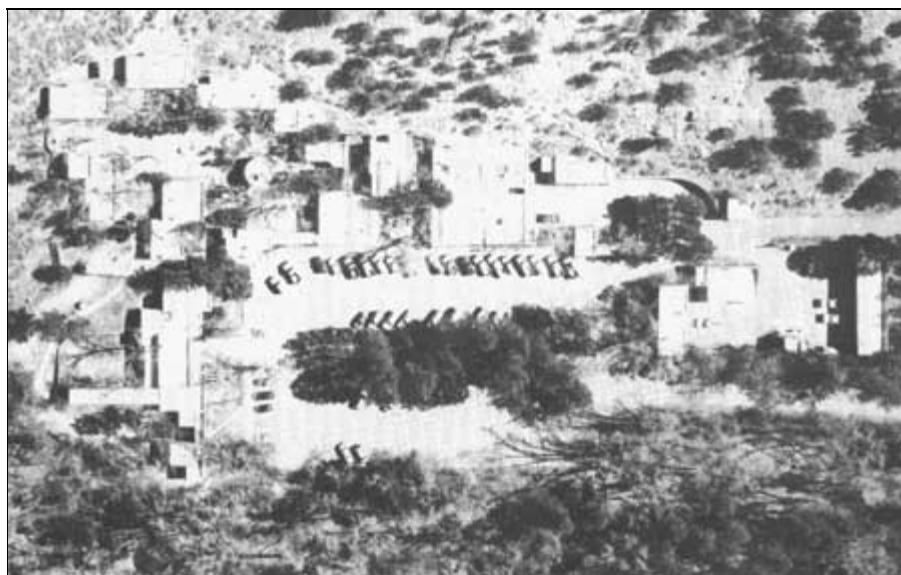
Figure 1. This 1987 aerial photograph of the CCC building complex at Bandelier National Monument shows the majority of the structures and their layout around the central parking plaza. The structures are nestled into the narrow building site in Frijoles Canyon. The rito (creek) serves as the western edge, and the talus slopes of the canyon cliffs define the eastern edge. Some character-defining features of the pueblo revival style are evident, including the courtyards, parapets, building masses, and terracing.

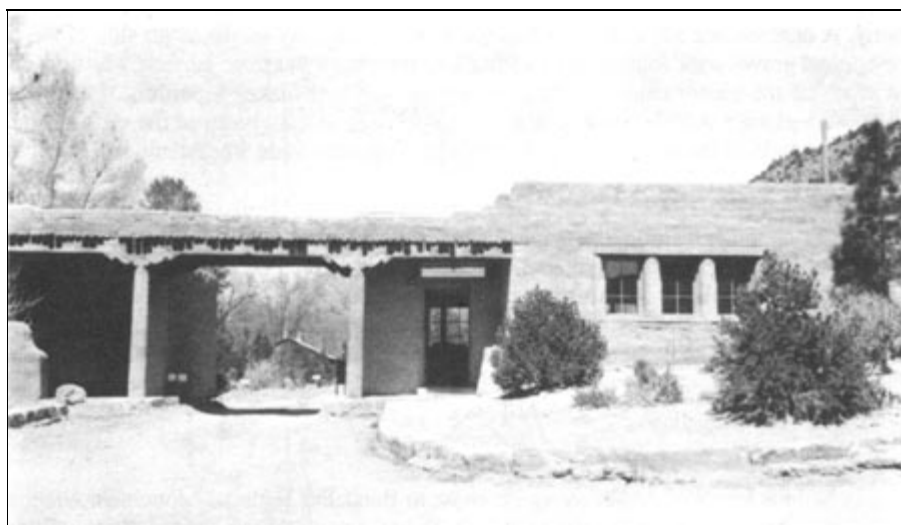
Figure 143. The front facade of the visitor center at the original drive-through, 1940. The opening has now been filled in. Many evergreen trees and native grass have been replaced with rank deciduous trees and refining lawn.

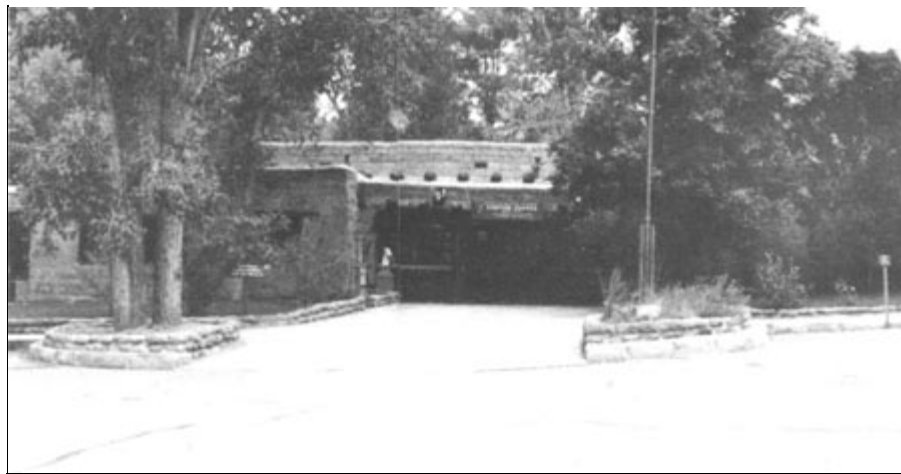
Figure 144. The front facade of the visitor center, 1988. Note the dense growth hiding much of the architecture.

This heavy vegetation causes several problems. The dense shading of wood architectural features causes deterioration of wood members, which can lead to insect infestation and rot. The roots of trees and the trees themselves press against buildings and crack the stone walls. In addition, the dense shading slows the drying of wood and masonry surfaces.

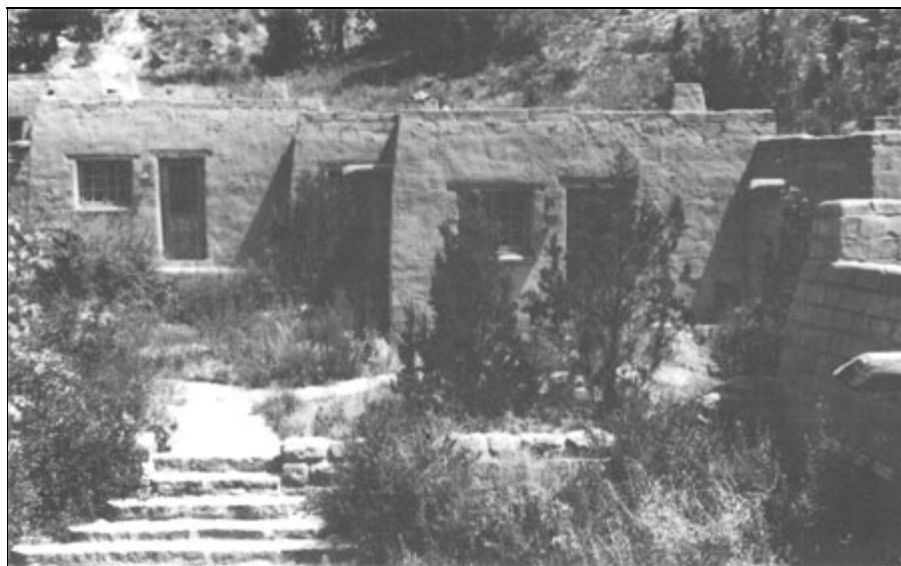
Figure 187. Juniper planted in the cabin courtyard, 1940.

Trim the 8-inch juniper (original tree) southwest of B-27 (figures 187 and 188).

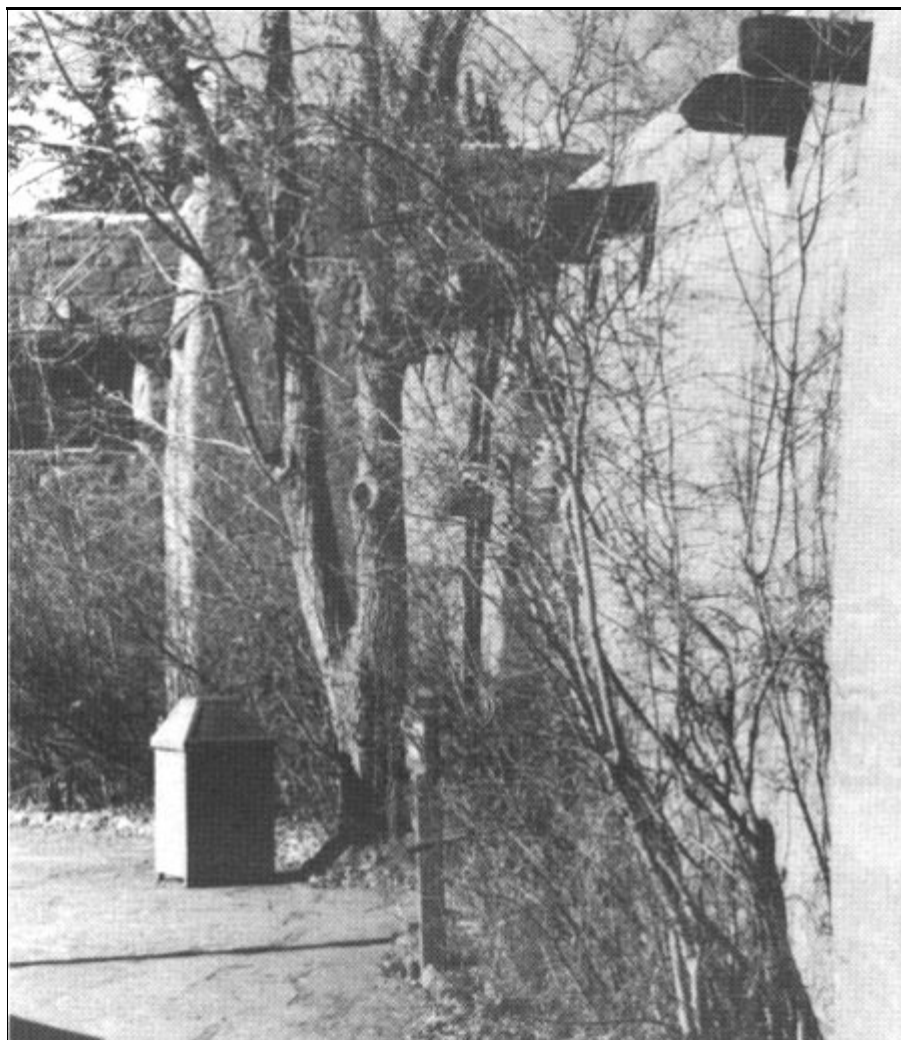
Figure 194. The parking area north wall, 1988. The box elder tree should be pruned up to raise the canopy.

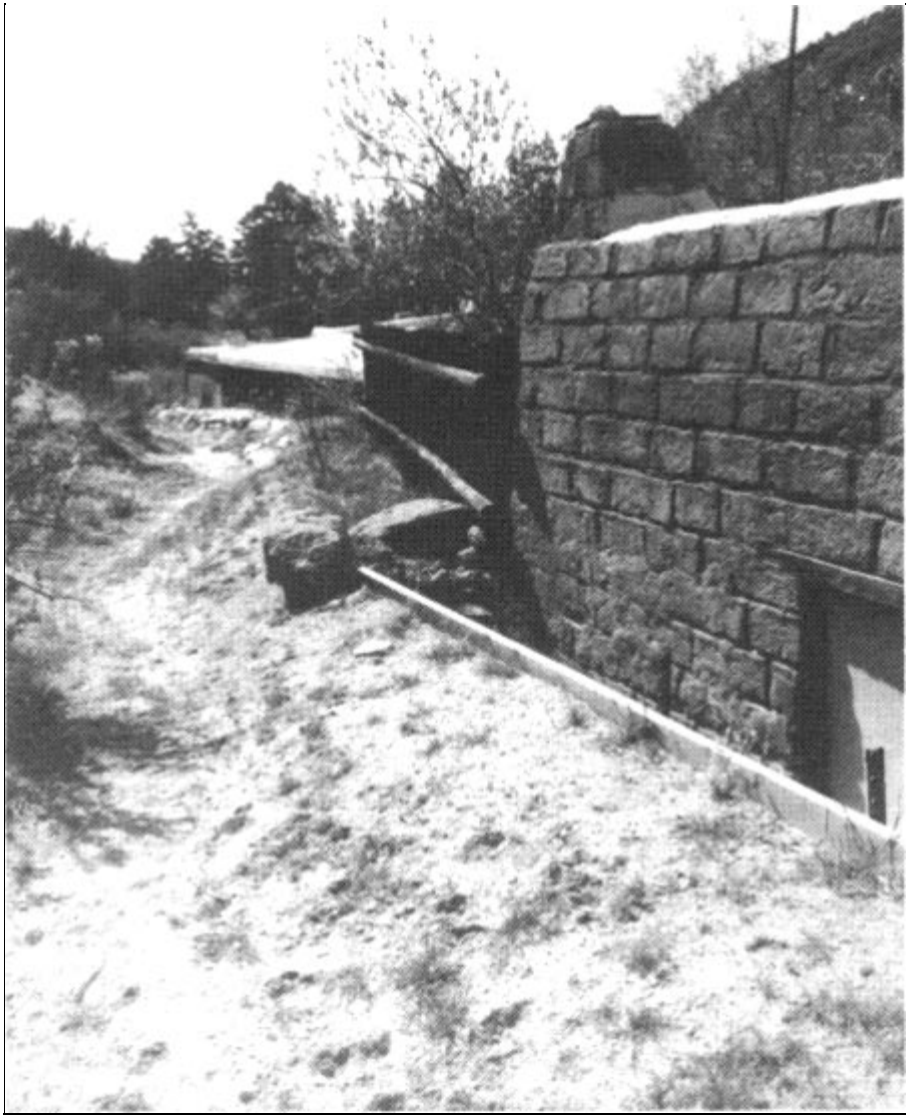
The diversion ditch uphill from the northern tier of cabins currently does not drain to the catch basin. The ditch is so porous that even a downpour immediately percolates into the ground. In addition, major downpours create a soil erosion condition that fills the ditch and the courtyards. In view of the porosity of the soil on this slope, moisture should percolate down to bedrock. However, in some isolated areas it does not percolate, and moisture seeps into building walls. The subsurface soil under the trench is a maze of utility lines (see figure 146).

Figure 196. View of 1940 diversion ditch. Porous soil allows very little water to follow the ditch.

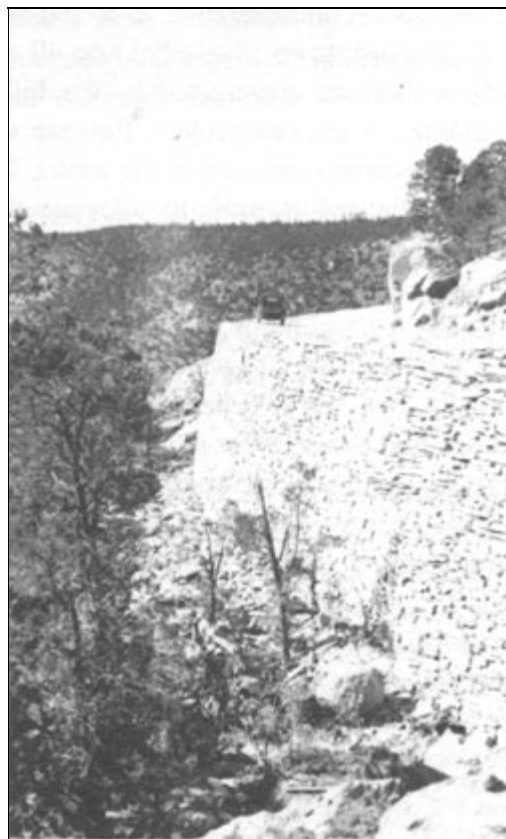
Figure 3. By the mid-1930s the controversial entrance road was completed. The retaining wall supporting a portion of the roadbed was 225 feet long and up to 30 feet high. (Photo circa 1935: Bandelier)

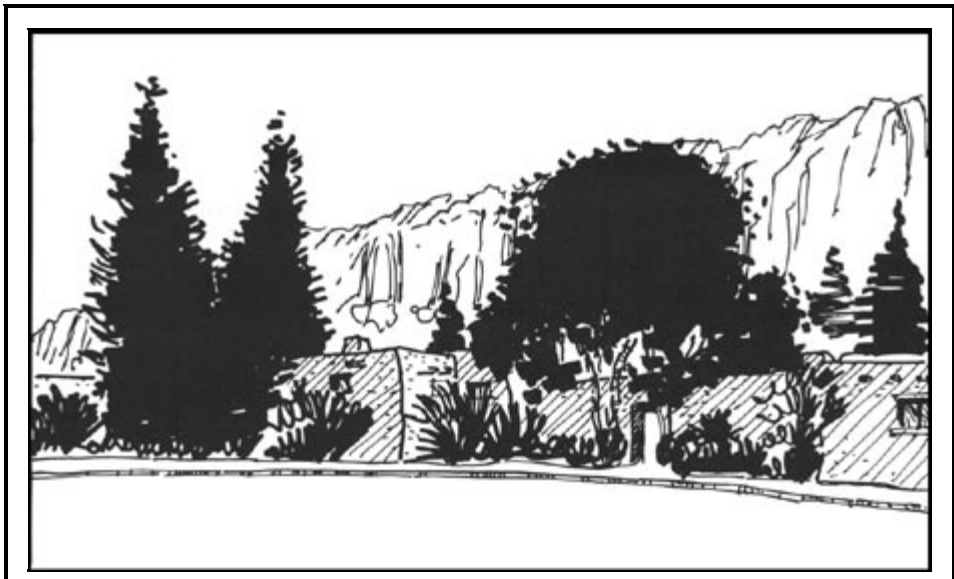
Figure 147. Existing appearance of the cabin courtyard facade.

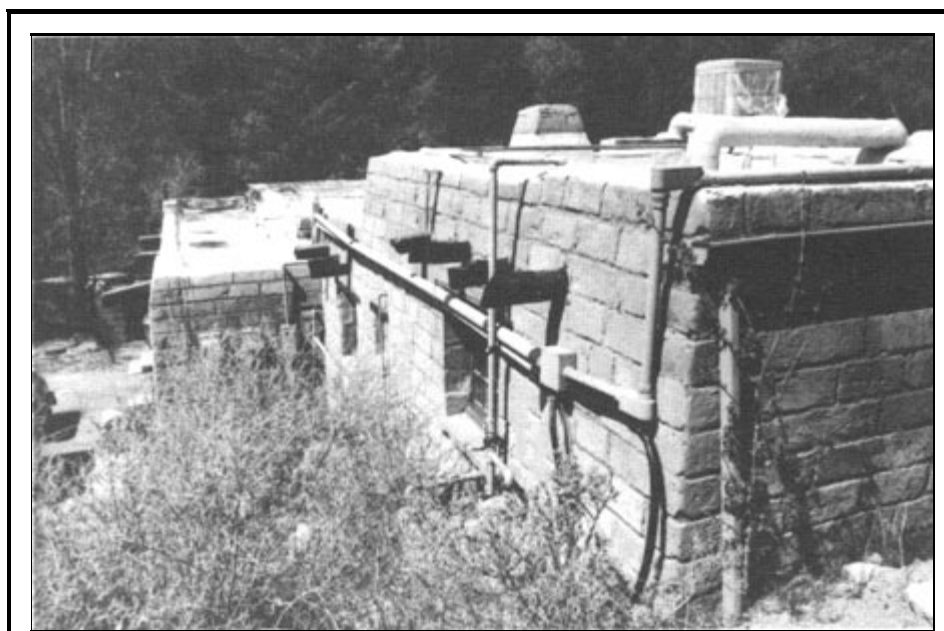
Figure 153. Rear of B-16, showing clutter of electrical and gas conduit and HVAC ductwork. (Photo: Copeland for NPS)
