**FEDERAL INTERAGENCY  
RIPARIAN ASSESSMENT AND RECOMMENDATIONS  
FOR ACHIEVING WATER QUALITY  
MANAGEMENT GOALS**

**SANTA ROSA ISLAND  
CHANNEL ISLANDS NATIONAL PARK**

**Technical Report NPS/NRWRD/NRTR-98/202**

June 1995

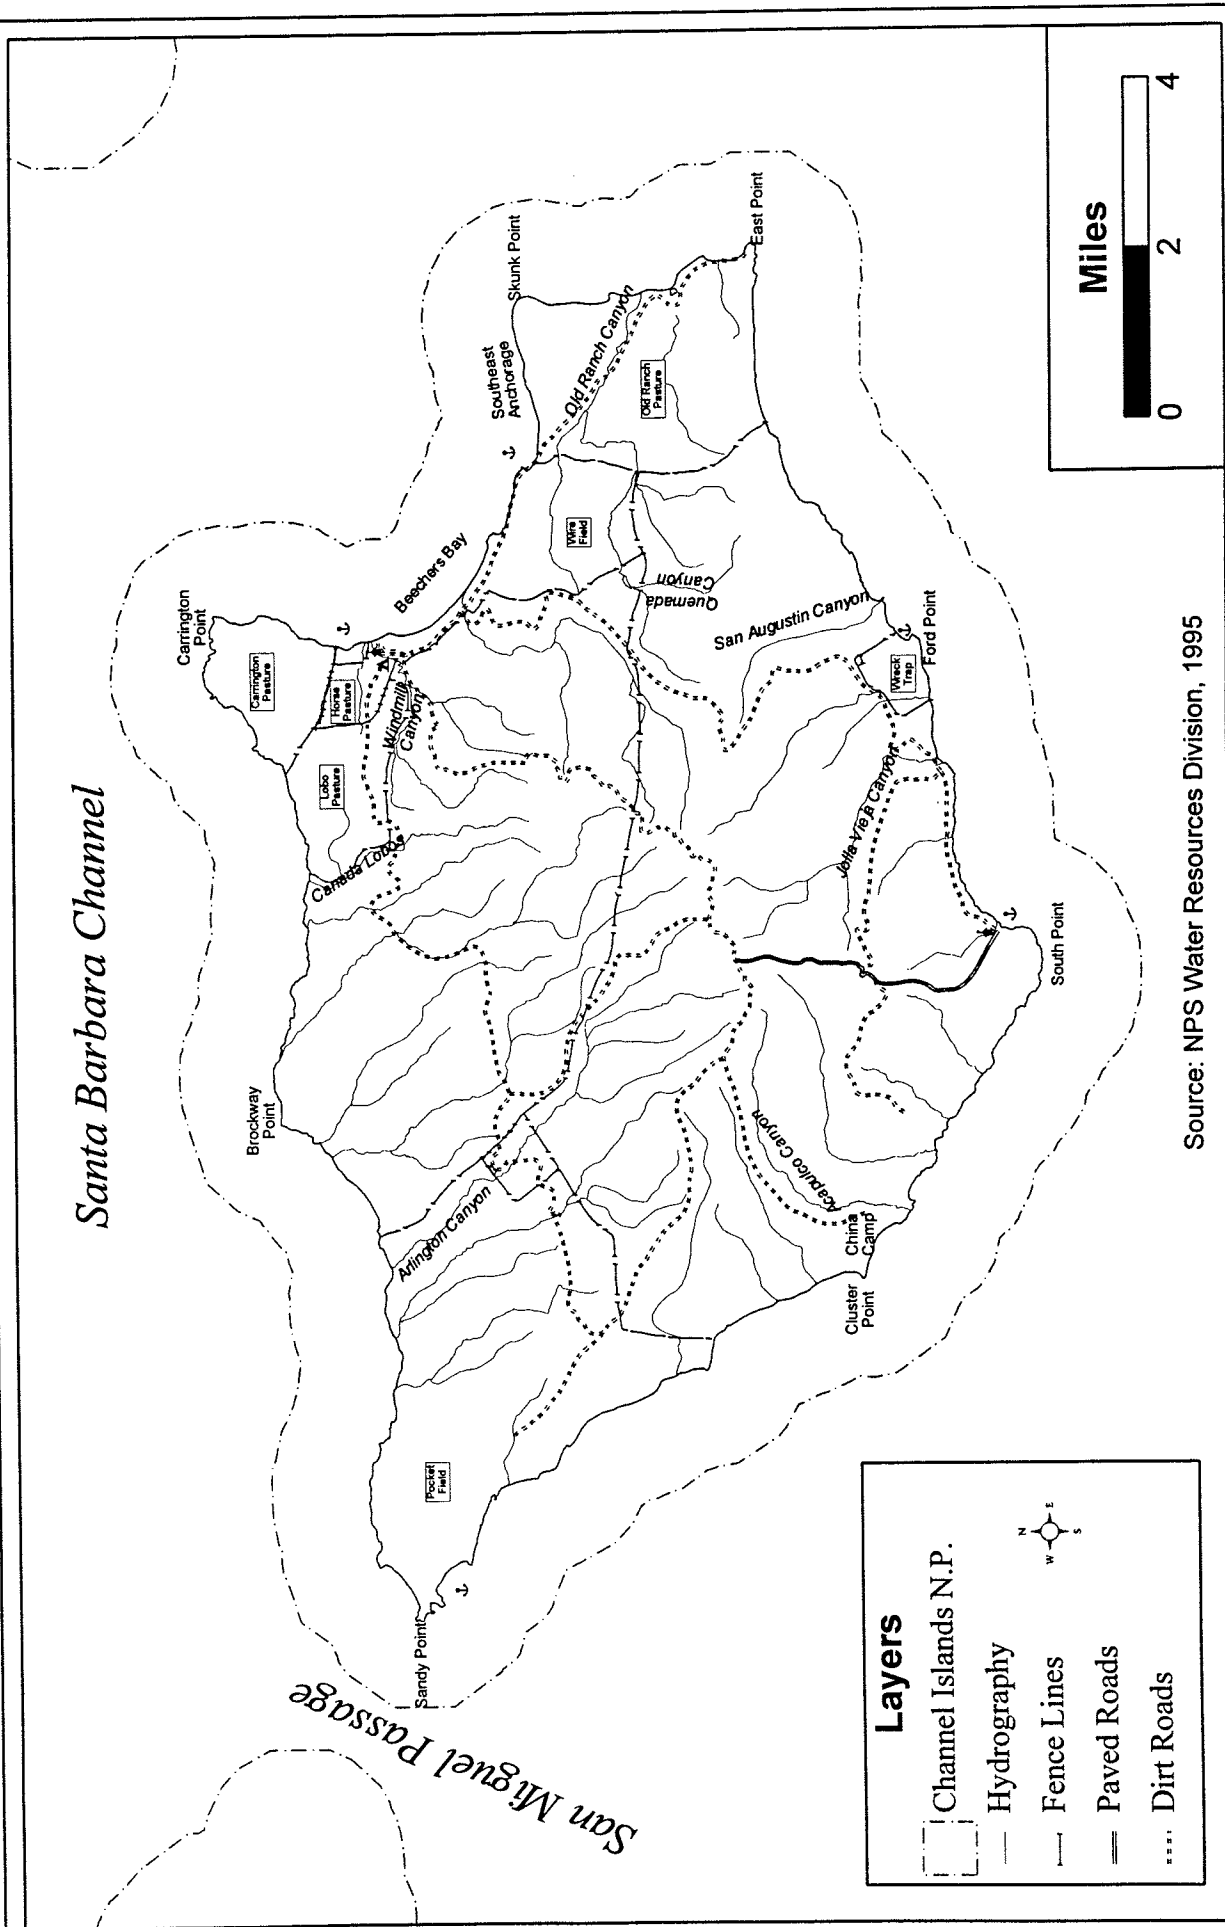
# Figure 2. Channel Islands National Park Santa Rosa Island

Located about 15 miles south of Santa Barbara, CA, the 54,000 acre Santa Rosa Island is one of five islands that comprise Channel Islands National Park (Figure 1). With the 1574 foot Soledad Peak at its hub, a highly-dissected, radial drainage network has evolved on the Island. There are 18 second-order intermittent and perennial drainages on the Island, including Windmill Canyon, Cherry Canyon, Water Canyon, Quemada Canyon (includes Old Ranch Canyon), San Augustine Canyon, Wreck Canyon, Jolla Vieja Canyon, Trancion Canyon, Acapulco Canyon, Whetstone Canyon, Bee Canyon, Cañada Garañon, Tecolote Canyon, Arlington Canyon, Soledad Canyon, Verde Canyon, and Cañada Lobos (Figure 2).

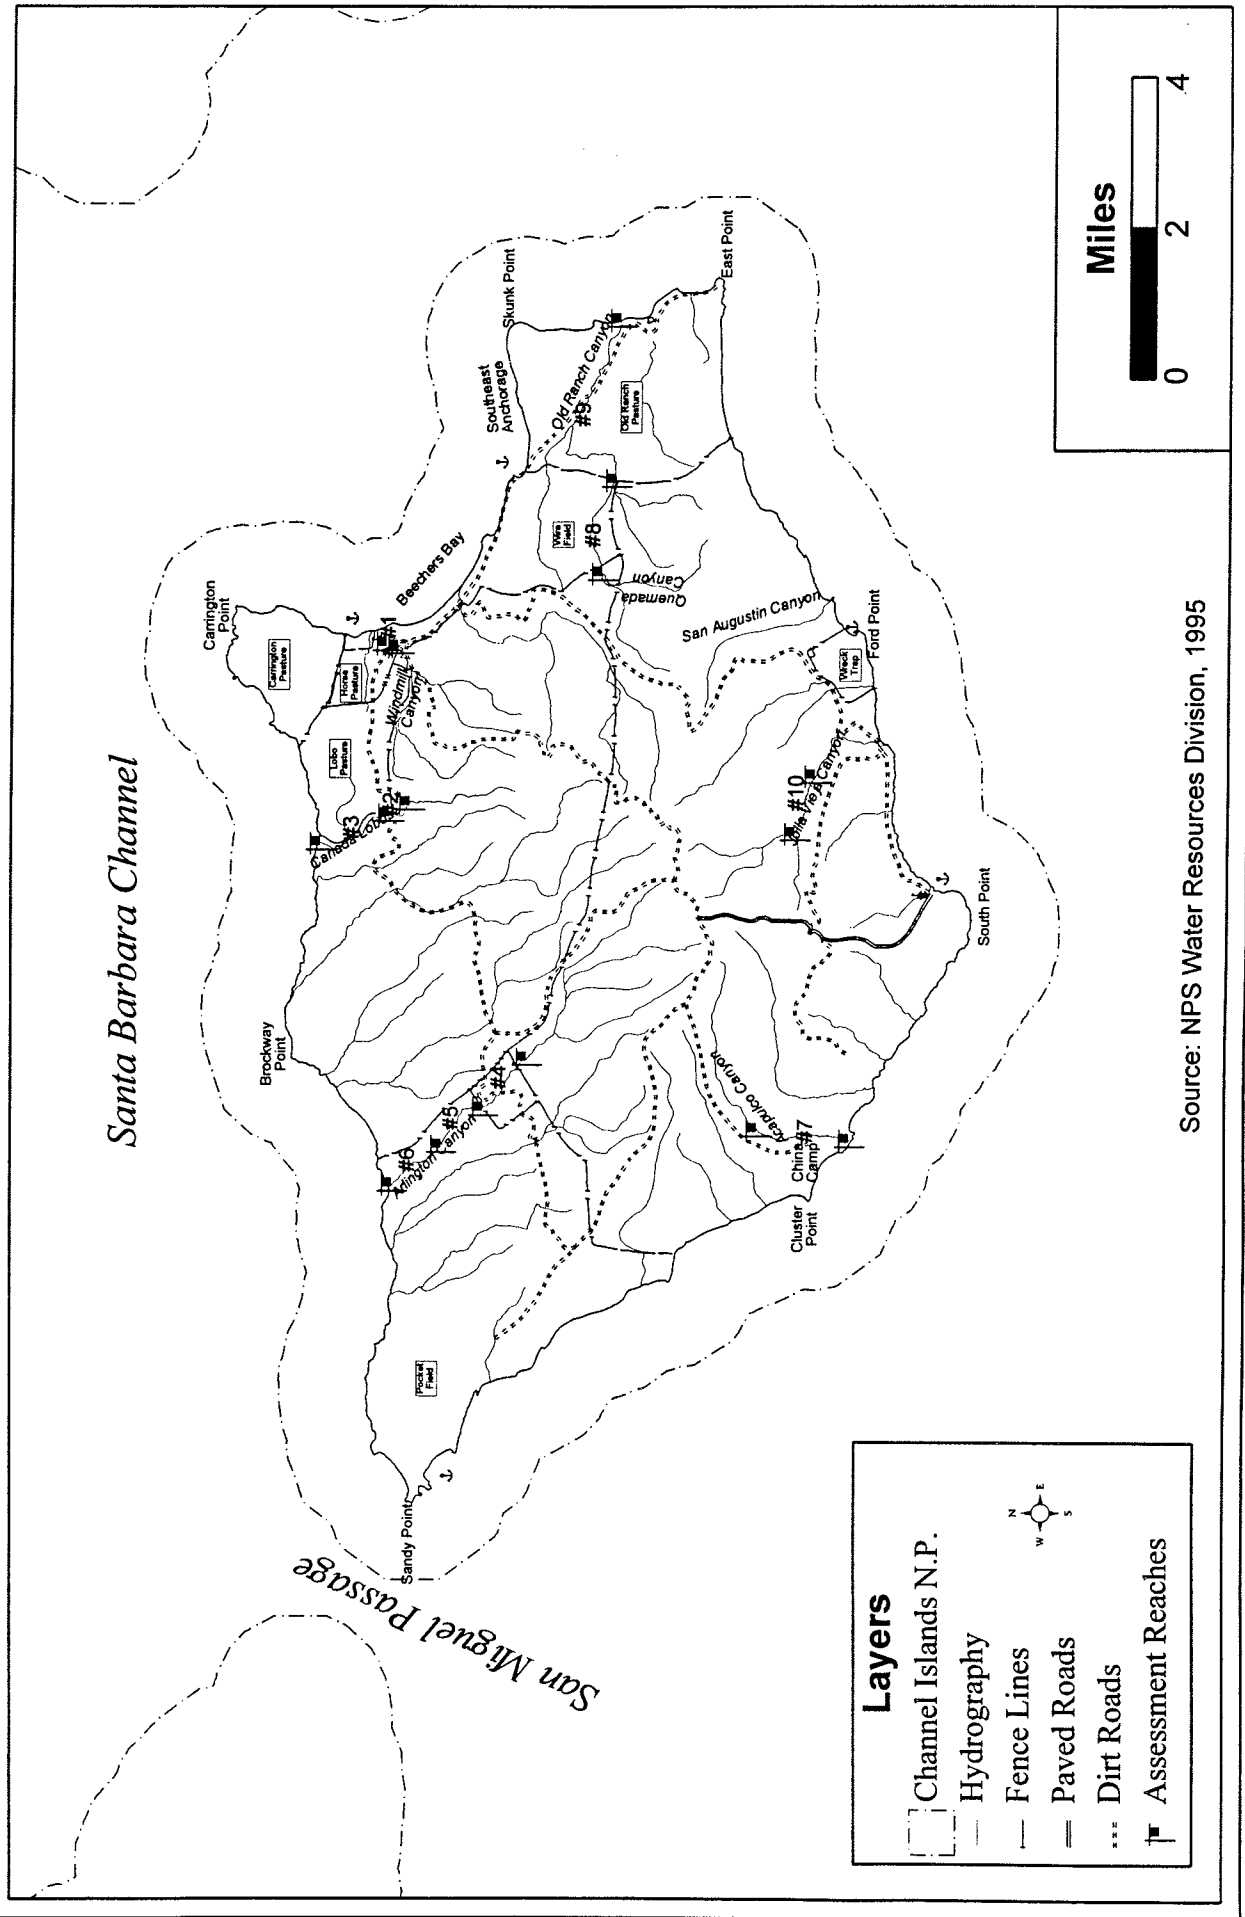
**Figure 3. Riparian Assessment Reaches  
Channel Islands National Park  
Santa Rosa Island**

Ten segments on seven streams, including two segments representative of pseudo-relic conditions, were selected to represent the range of physiographic zones and stream types on Santa Rosa Island (Figure 3). The team (or one of two split-teams) walked each of the subject stream segments and rated the various processes/attributes which contribute to riparian function.

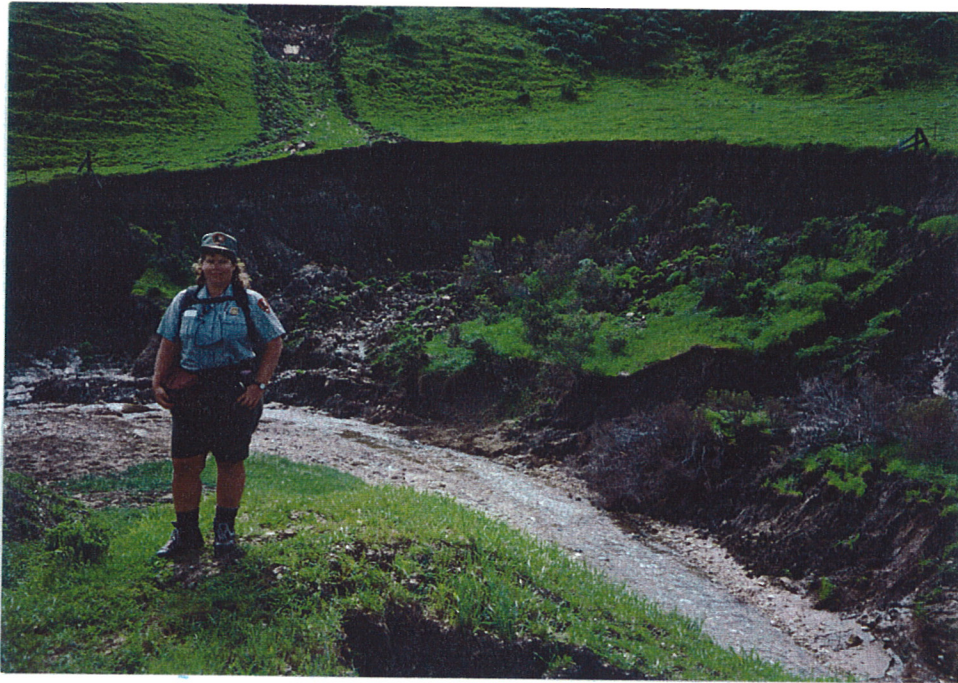
Figure 4. Incised colluvium in a reach of Quemada Canyon.

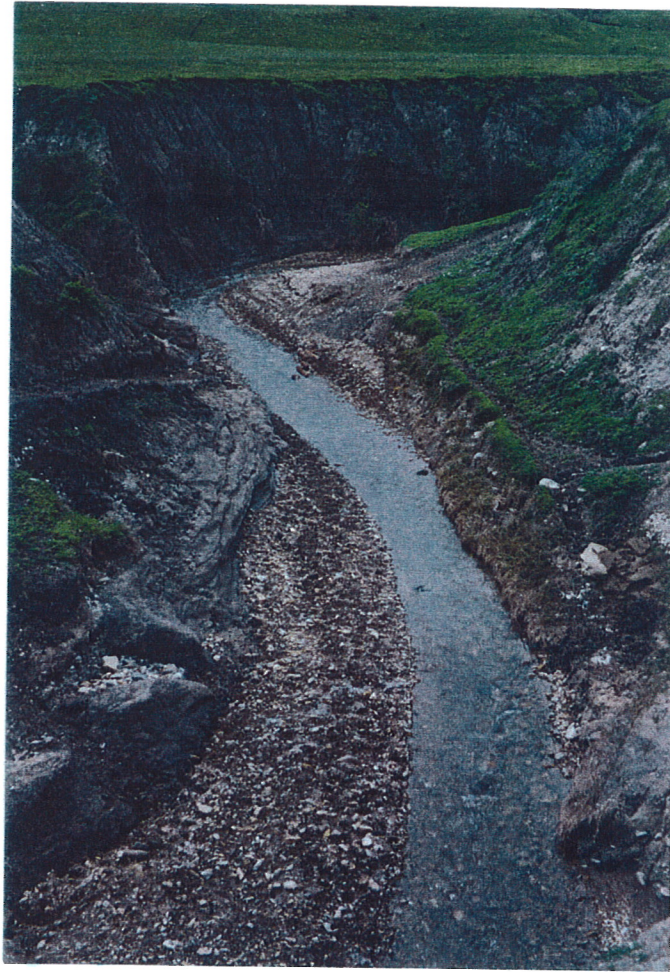
Figure 5. Incised bedrock in Quemada Canyon.

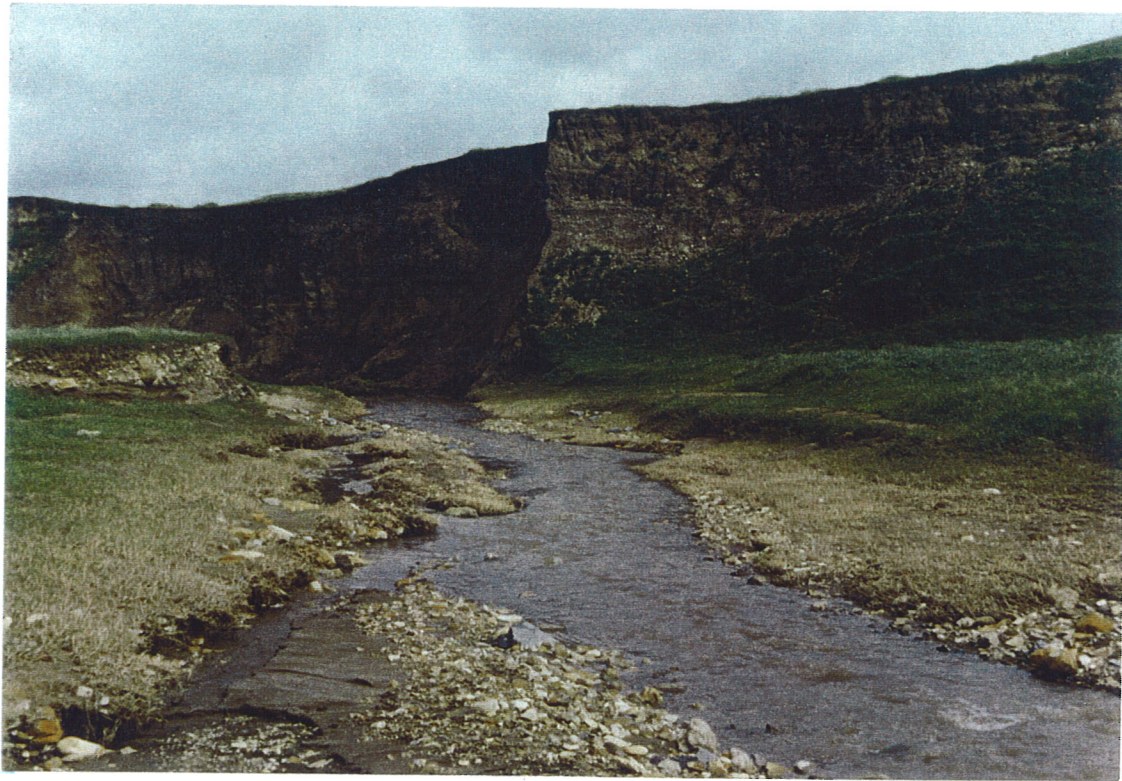
Figure 6. A reach of Arlington Canyon with terraces evident on the left and right.

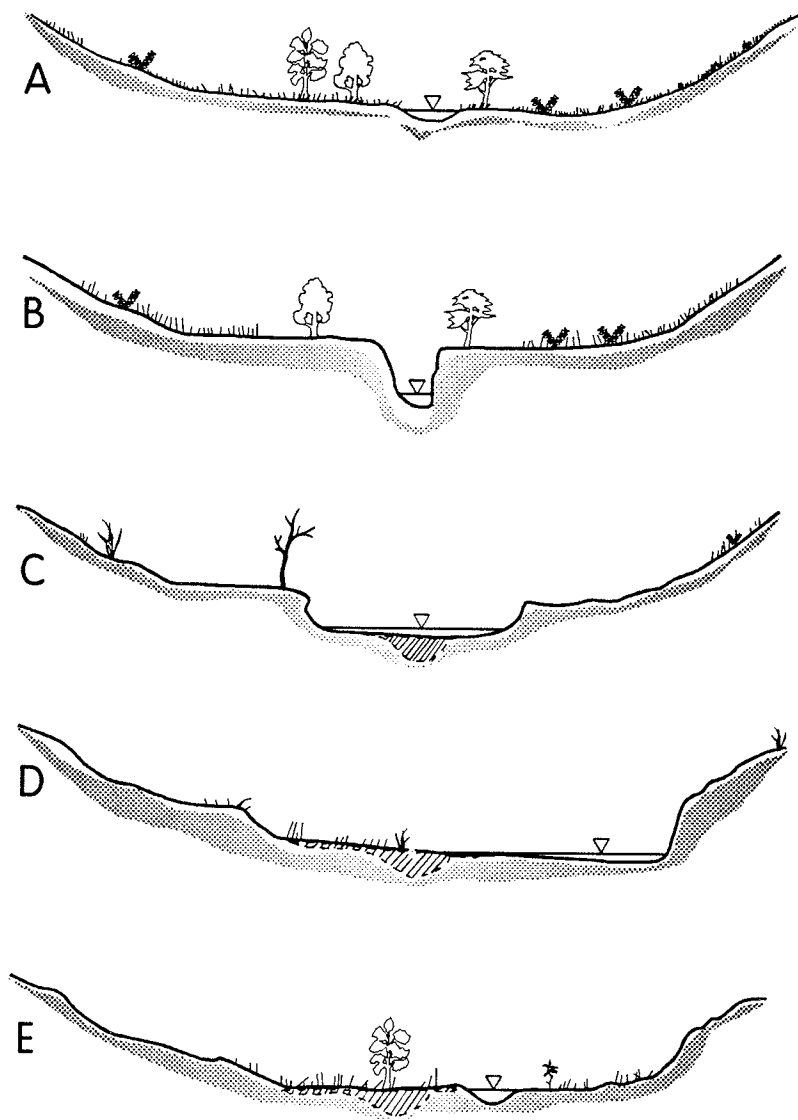
Once arroyo systems have downcut into the landscape, they typically undergo additional stages of evolution (Van Haveren and Jackson, 1986; Harvey, et al., 1985; USDI Bureau of Land Management, 1993). Arroyo evolution following initial downcutting involves lateral erosion of the main arroyo walls and consequent widening of the arroyo floor (Figure 7, Profiles A-C). A secondary "inner" channel usually forms in the floor of the widened arroyo. As the arroyo matures, the inner channel becomes sized to carry common flows (flows less than the mean annual peak flow), and the arroyo floor begins to function as a floodplain. Widening of the arroyo floor generally ceases when the inner channel floodplain has adequate width to convey large floods (Figure 7, Profiles D-E). Aggradation of the inner channel and arroyo floor may or may not occur once the arroyo has evolved an effectively functioning floodplain.

Figure 7. Evolution of an arroyo

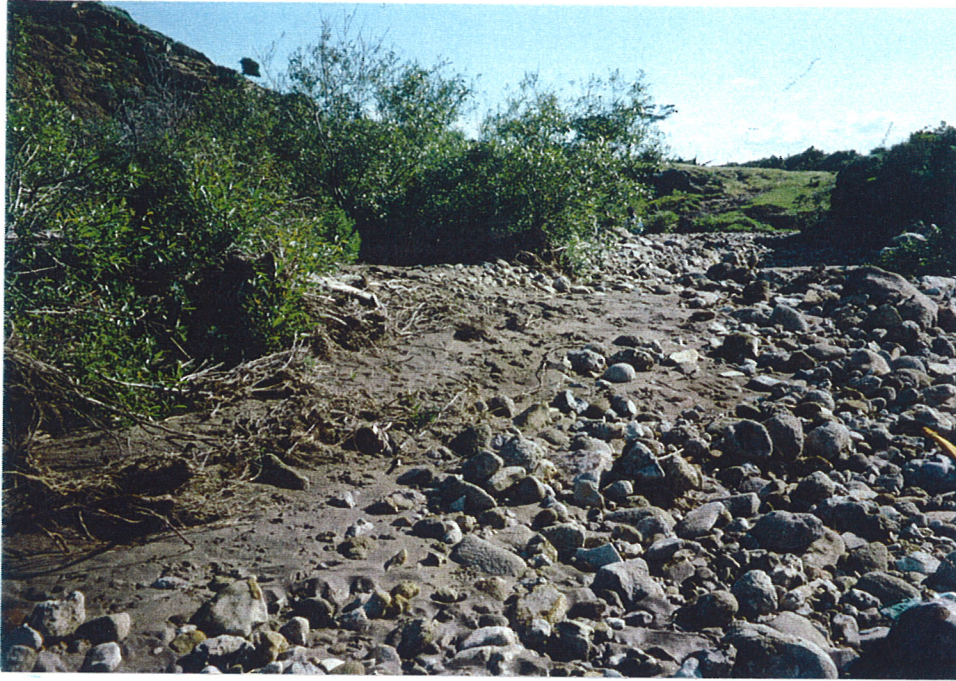
Figure 8. #1 - Windmill Canyon. The presence of bank-protecting willows gives this section of the stream functionality. But excessive bedload sediment deposition places it at high risk.

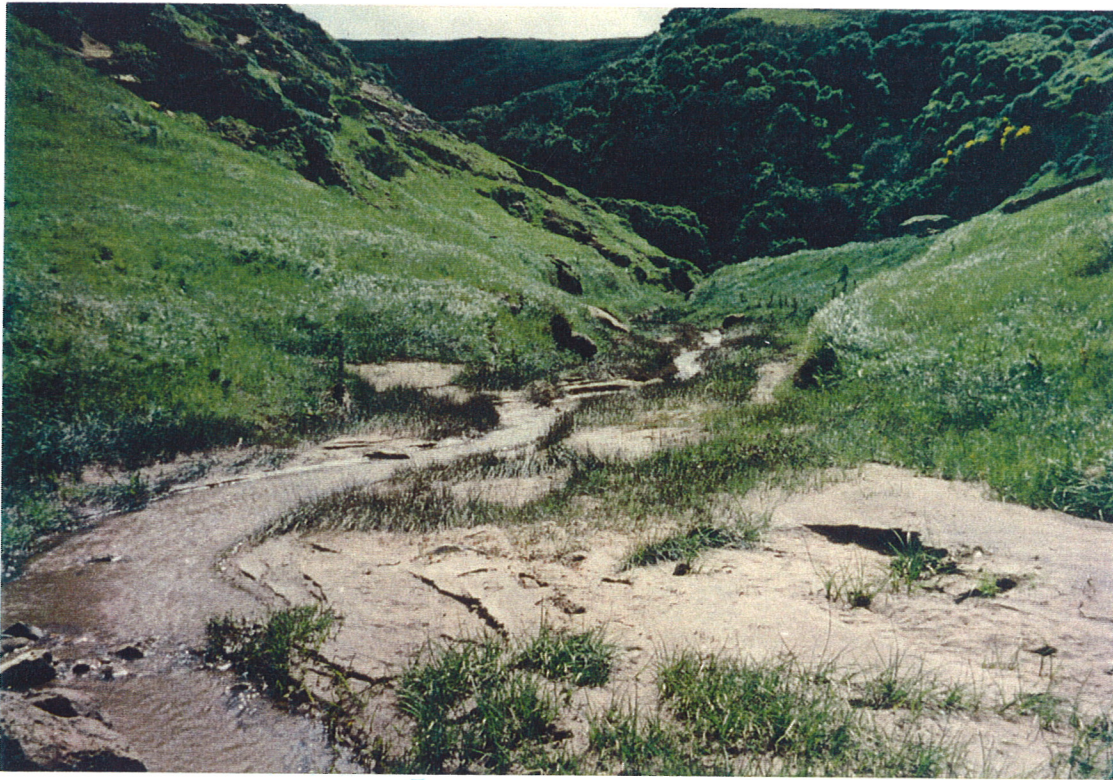
Functionality Rating: Properly Functioning Condition

Assessment: This reach of Cañada Lobos is just above the exclosure that was constructed in 1993; however, the steepness of the slopes leading into the canyon discourages livestock grazing.

The reach was judged to have the attributes of a properly functioning stream riparian area, including appropriate floodplain-bank relationship, sufficient herbaceous vegetation to dissipate stream energies and maintain bank stability during flood events, an expanding riparian area and vegetated point bars, channel characteristics that provide suitable aquatic habitats, and an appropriate (although not ideal) balance between sediment inputs into the system (Figure 9). Excessive sediment deposition on the point bars probably is derived from upland soil slips that occurred after the recent heavy rains. Although rated in properly functioning condition, this reach is probably not at its potential relative to desired plant communities.

Figure 9. #2 - Cañada Lobos. Sediment-trapping herbaceous vegetation on the banks and point bars and more ideal channel characteristics place this reach in proper functioning condition.

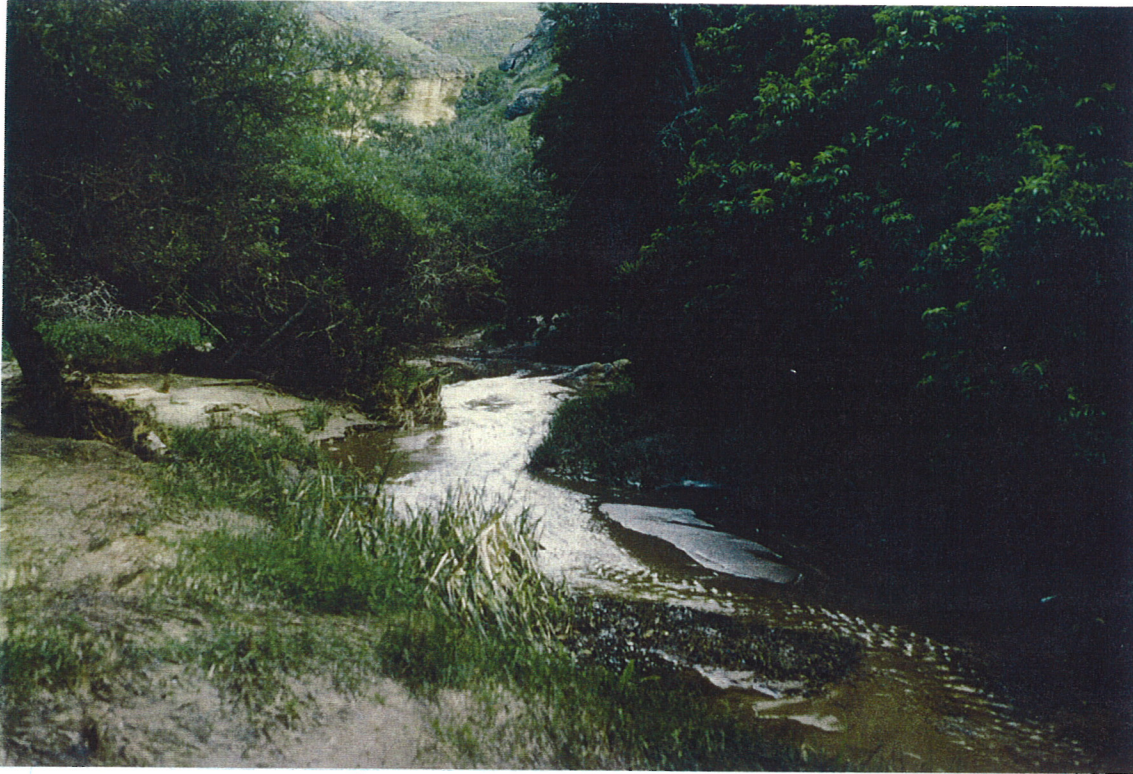
Functionality Rating: Proper Functioning Condition

Assessment: A diverse, mostly vigorous, energy-dissipating, and bank-protecting herbaceous and woody riparian vegetative community structure, consisting of arroyo willow (*Salix lasiolepis*), black cottonwood (*Populus trichocarpa*), Mexican elderberry (*Sambucus mexicana*), saltgrass (*Distichlis spicata ssp stolonifera*), and Mexican rush (*Juncus mexicanus*) present in this relic area at the very least epitomizes a proper functioning riparian area on Santa Rosa Island and perhaps is indicative of the potential natural plant community for riparian areas on Santa Rosa Island. Deer browsing is evident and affecting the vigor of the woody plants. A browseline is evident on the willows, the trees and shrubs are decadent, and reproduction is judged to be poor. Channel characteristics in this reach are near ideal with low width/depth ratios, overhanging banks have been formed), and the stream is both horizontally and vertically stable (Figure 10).

Figure 10. #3 - Cañada Lobos. Diverse riparian vegetation and ideal channel characteristics places this reach at proper functioning condition and beyond.

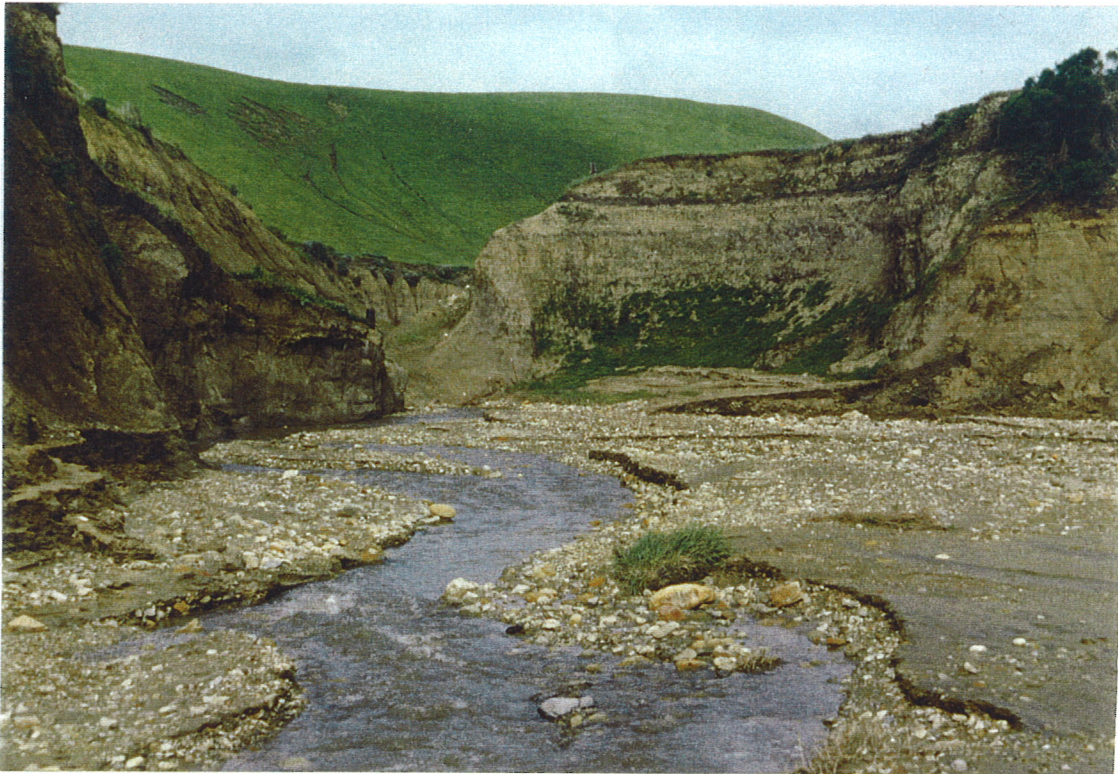
Functionality Rating: Nonfunctional

Assessment: While separate assessments were completed for three reaches on this drainage, all were rated as nonfunctional and only subtle differences exist between the attribute assessment for the reaches. The portion of the drainage assessed is absent almost all of the attributes required for a proper functioning riparian area. An oversupply of sediment from upland and channel sources has exceeded the stream transport capability. The channel is typically braided and lateral instability is high, resulting in high width/depth ratio and unnatural sinuosity. Riparian and wetland vegetation is absent and point bars are bare, exposing the banks to erosion during each flood event (Figure 11). The channel is, however, vertically stabilized by numerous bedrock controls throughout its longitudinal profile, and it appears to have high potential for natural restoration, especially in the lower reaches where gradients are low to moderate and there is the remnant of a functional floodplain.

Figure 11. Typical reach in Arlington Canyon indicating a lack of bank and point bar vegetation, excessive sediment deposition, and poor channel characteristics.

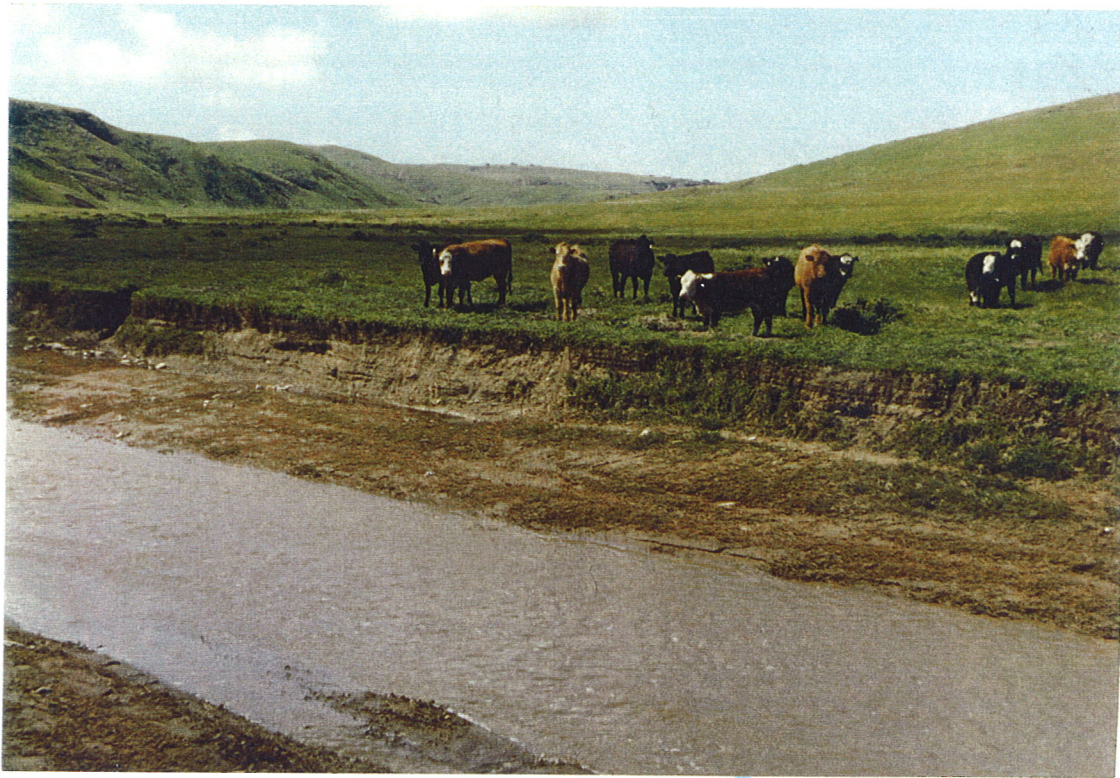
Figure 12. Old Ranch Canyon.

Assessment: While the few representatives of the vegetative species present indicate that riparian soil moisture is being maintained, the reaches lack both the herbaceous and woody species that should be represented on the floodplains in this drainage. Old Ranch Canyon (Reach #9) is especially indicative of an area that is presently judged to be nonfunctional (high width/depth ratios, exposed point bars, and poor sinuosity characteristics) but with high restoration potential (Figure 12).

The low to moderate gradients in the Old Ranch reach would naturally enhance sediment deposition, the current high sediment loads will provide ample material for bank and floodplain reconstruction, and existing loamy bank soils are an excellent substrate for the natural reestablishment of woody and herbaceous vegetation.

have high potential to achieve PFC in a timely fashion (seven to ten years). Based on the team's assessment, Old Ranch and lower reaches of Arlington Canyon are two streams that appear to have characteristics conducive for rather rapid natural restoration of functional riparian conditions. Starting with these pastures will have less economic impact on the ranch and will allow the park and the ranch to jointly develop riparian management strategies that could eventually be applied to the rest of the Island. Three options of this alternative that could be applied to Old Ranch and Pocket Field Pastures are presented below. Under all three options, resting the pastures for one or two years prior to implementing cool season grazing would allow riparian vegetation recovery at a faster rate.

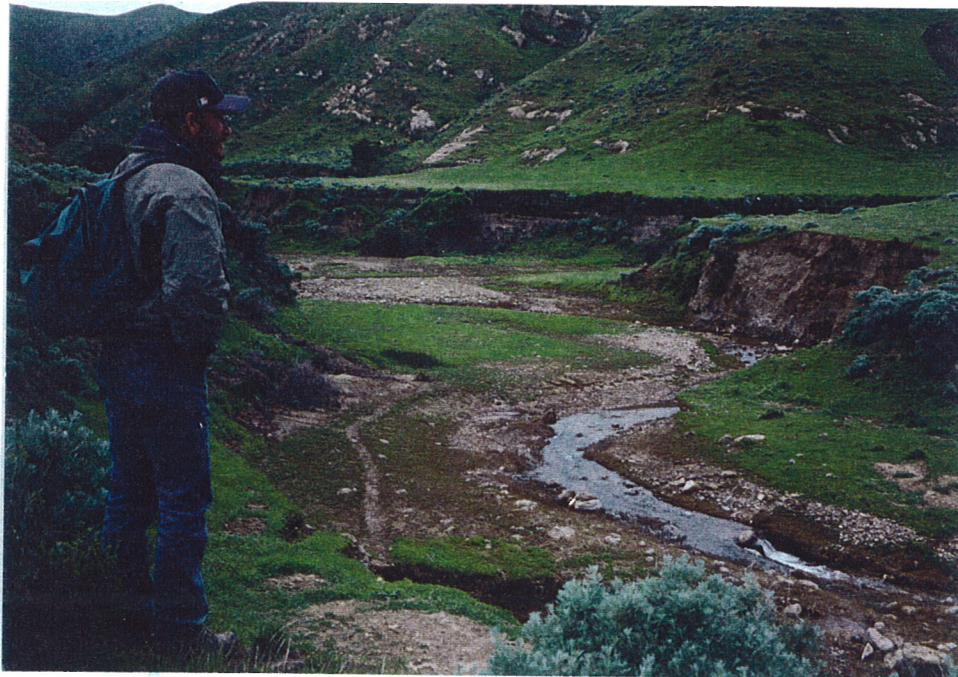
Figure 13. Jolla Vieja Canyon.

Functionality Rating: Nonfunctional

Assessment: The ratings assigned to the attributes of this reach are very similar to those assigned to Arlington Canyon. There is little floodplain development despite forced lateral migration of the channel by excessive sedimentation from upland and channel sources that exceeds the stream's power to transport it. The arroyo is widening overall, but the floodplain is seldom inundated by floodwaters (Figure 13). The riparian corridor is extremely narrow. Vegetation is largely absent from the point bars and channel area, thus exposing the channel to erosion during each flood event.
