SANTA ROSA ISLAND  
FEDERAL INTERAGENCY  
RIPARIAN ASSESSMENT AND RECOMMENDATIONS  
FOR ACHIEVING WATER QUALITY  
MANAGEMENT GOALS  
CHANNEL ISLAND NATIONAL PARK

Technical Report NPS/NRWRD/NRTR-95\*\*

June 1995

United States Department of the Interior  
National Park Service  
Washington, D.C.

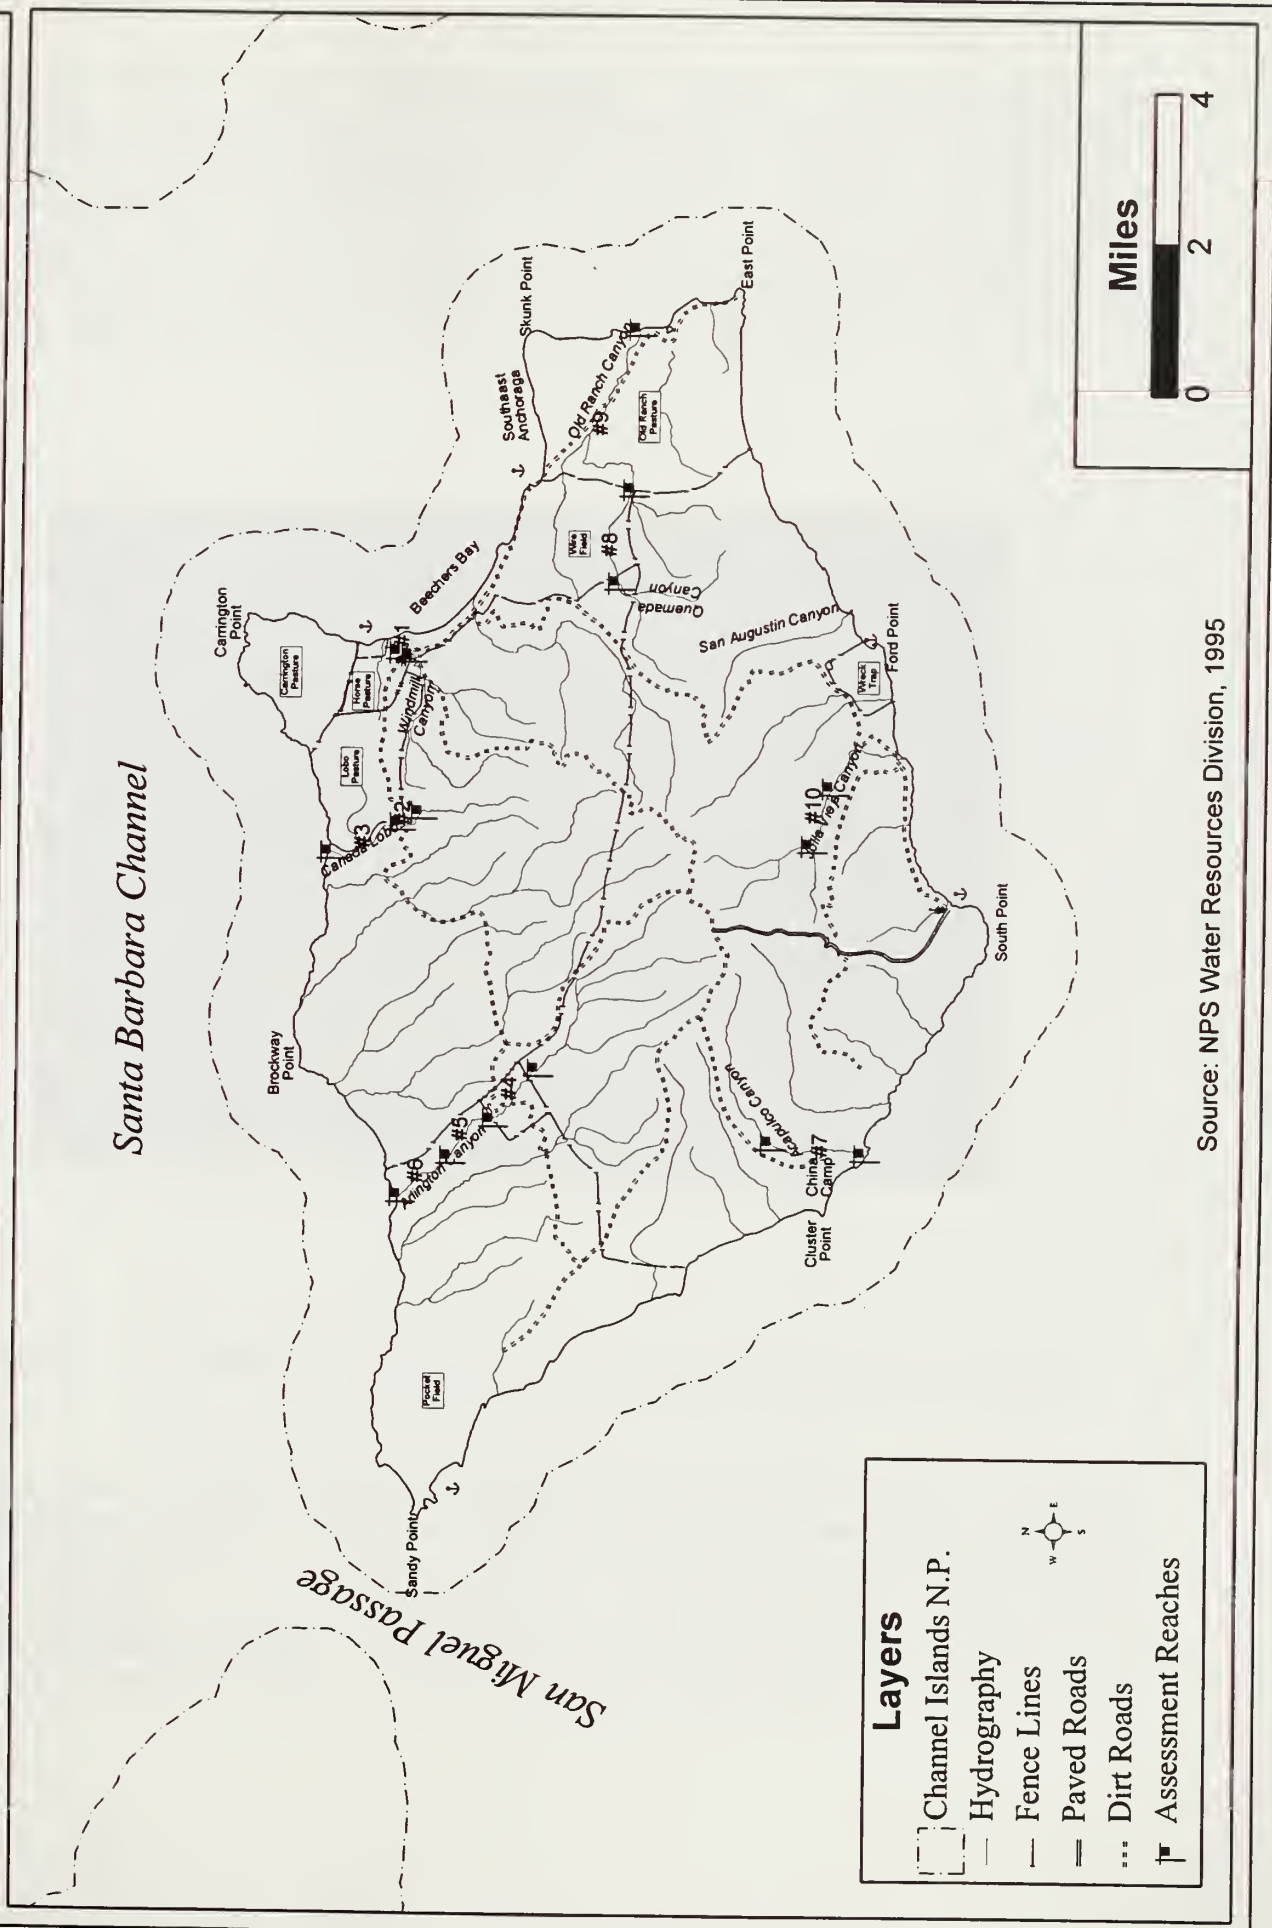
**Figure 3. Riparian Assessment Reaches  
Channel Islands National Park  
Santa Rosa Island**

Ten segments on seven streams, including two segments representative of pseudo-relic conditions, were selected to represent the range of physiographic zones and stream types on Santa Rosa Island (Figure 3). The team (or one of two split-teams) walked each of the subject stream segments and rated the various processes/attributes which contribute to riparian function. Those processes/attributes are grouped under the categories of hydrogeomorphic attributes, vegetation attributes, and erosion/deposition attributes. After ranking riparian areas as functional, functional-at risk, or non-functional the team then developed a subjective assessment of the riparian area's capability, potential and likely responsiveness to management. Use of relic areas in enclosures, examination of existing vegetation and soils, information on native vegetation and historic conditions, experience of the team in working in other similar riparian systems, and many other sources of information were used to assess capability and potential. It became apparent after the synthesis and integration of the information by the team that geomorphologic processes as well as historic land uses have played an important role in shaping the present-day landscapes of Santa Rosa Island. Therefore, a discussion of the geomorphic status and its inferences to overall riparian conditions on the island is included in the Results section.

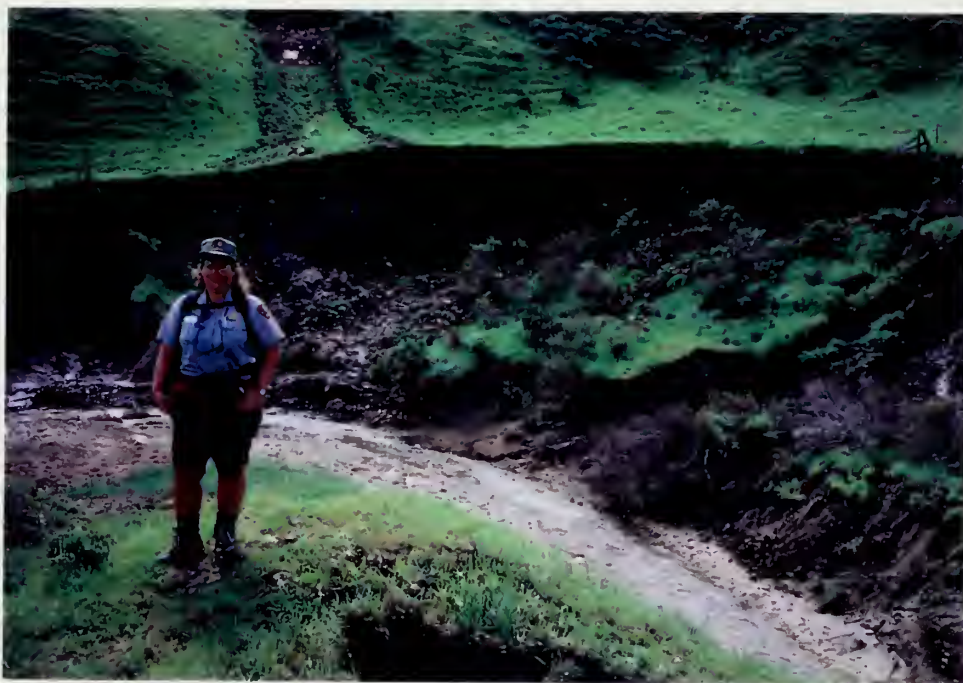
Figure 4. Incised colluvium in a reach of Quemada Canyon

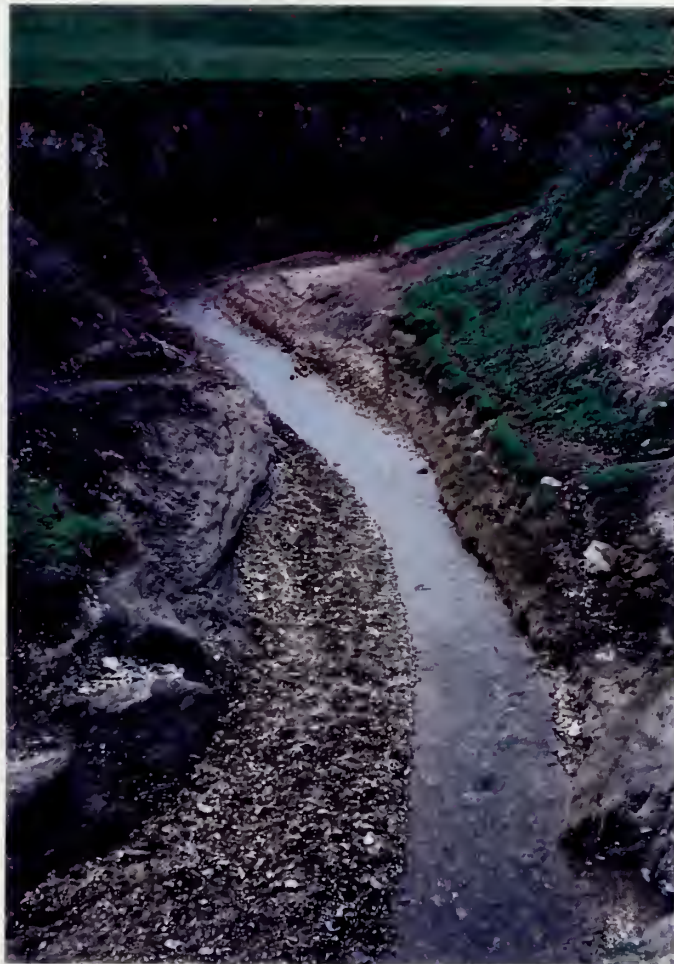
Figure 5. Incised Bedrock in Quemada Canyon

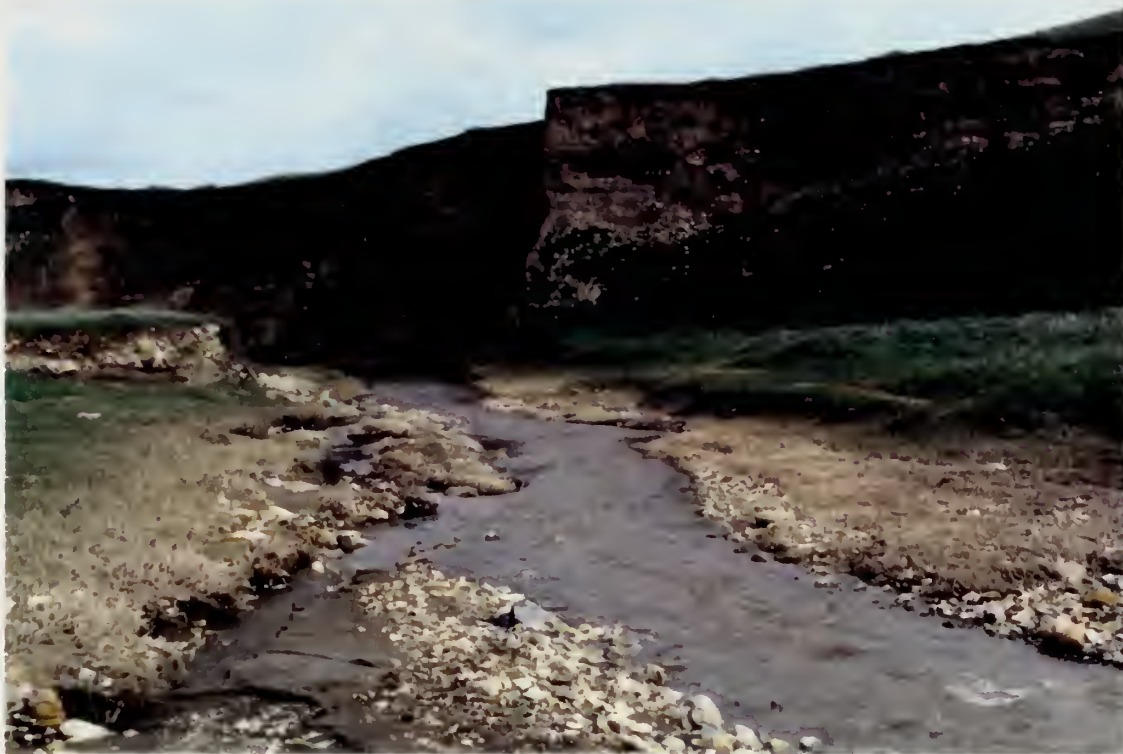
systems we visited had remnant terraces roughly half-way down the main arroyo walls (Figure 6). Episodic downcutting is not uncommon for arroyo systems and often occurs when gradual geomorphic processes (such as sedimentation or tectonic uplift) result in a net steepening of the overall slope of a river system (Schumm, 1977; Bull, 1979; Harvey, et.al., 1985). Erosion "thresholds" eventually are created and rapid downcutting can then be triggered by large runoff events, or by a combination of large discharges and impacted watershed, channel or riparian conditions.

Figure 6. A Reach of Arlington Canyon with Terraces Evident on the left and right.

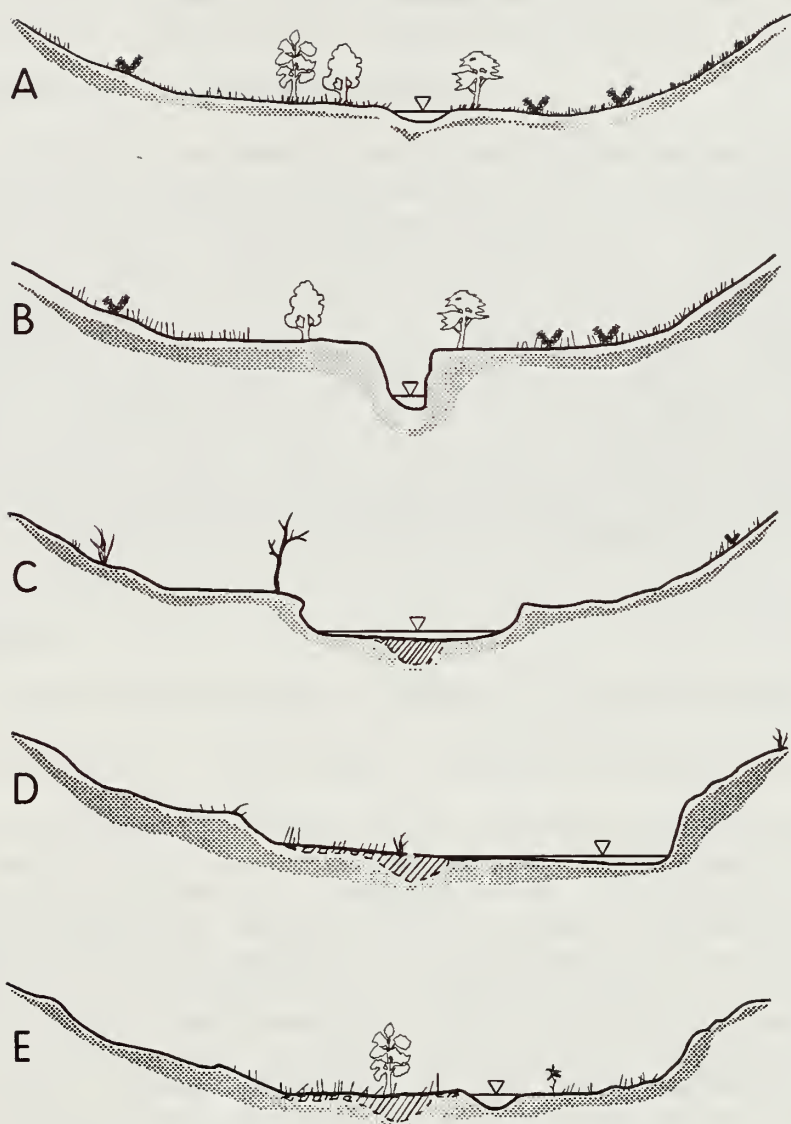
Arroyo evolution following initial downcutting involves lateral erosion of the main arroyo walls and consequent widening of the arroyo floor (Figure 7, Profiles A-C). A secondary "inner" channel usually forms in the floor of the widened arroyo. As the arroyo matures, the inner channel becomes sized to carry common flows

(flows less than the mean annual peak flow), and the arroyo floor begins to function as a floodplain. Widening of the arroyo floor generally ceases when the inner channel floodplain has adequate width to convey large floods (Figure 7, Profiles D-E). Aggradation of the inner channel and arroyo floor may or may not occur once the arroyo has evolved an effectively functioning floodplain.

Figure 7. Evolution of an arroyo.

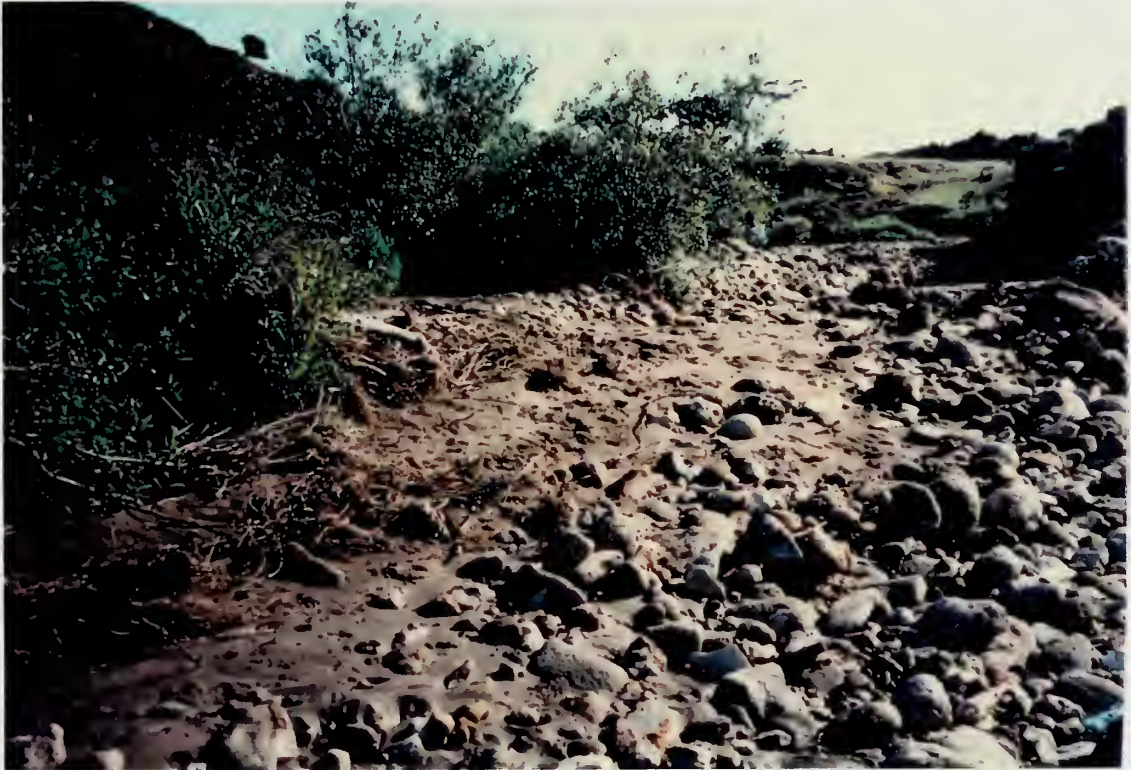
Attributes of the reach which place it at high risk include an out of balance width-depth ratio, lack of herbaceous bank vegetation which would serve to further protect banks during overbank flooding events, exposed point bars, and excessive bed and washload sediment deposition from upstream upland and channel sources. The Windmill Canyon reach above the Horse Pasture would be rated as non-

functional because it lacks energy dissipating woody bank vegetation, and generally lacks the floodplain and erosional characteristics that are required for proper functionality.

Figure 8. Windmill Canyon #1. The presence of bank-protecting Willow gives this section of the stream functionality. But excessive bedload sediment deposition places it at high risk.

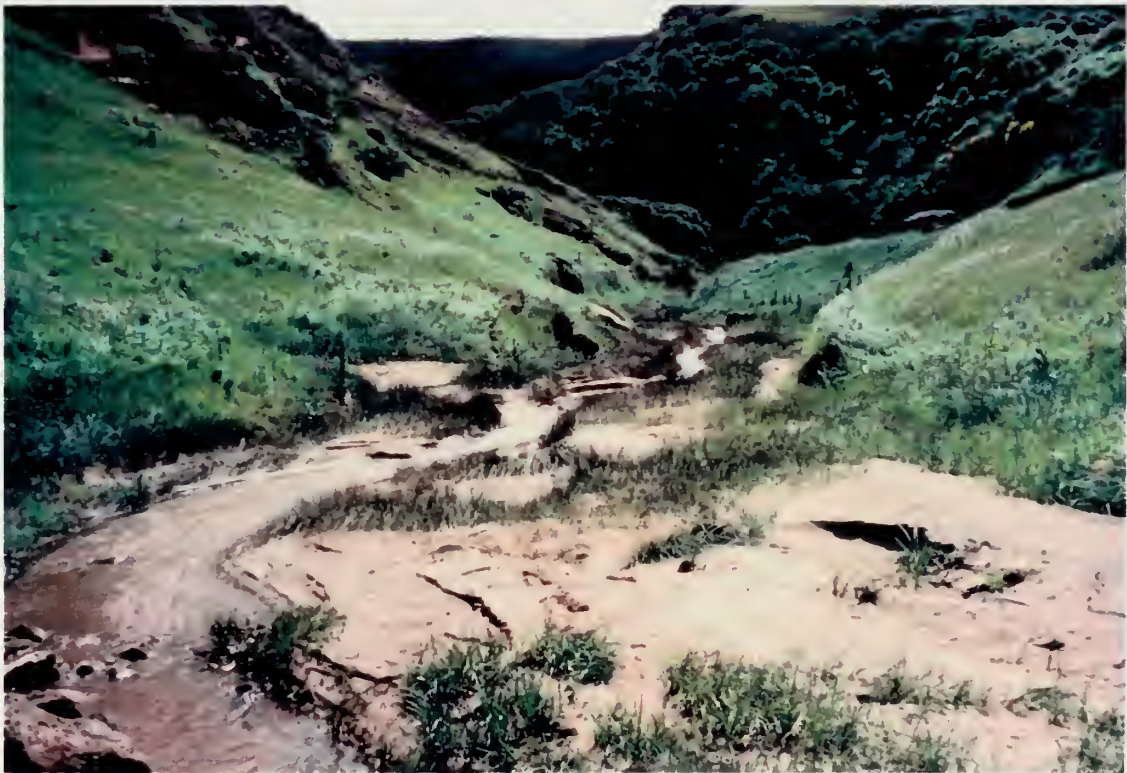
Functionality Rating: Properly Functioning Condition

Assessment: This reach of Cañada Lobos is just above the enclosure that was constructed in 1993, however, the steepness of the slopes leading into the canyon discourages livestock grazing. The reach was judged to have the attributes of a properly functioning stream

riparian area, including appropriate floodplain-bank relationship, sufficient herbaceous vegetation to dissipate stream energies and maintain bank stability during flood events, an expanding riparian area and vegetated point bars, channel characteristics that provide suitable aquatic habitats, and an appropriate, although not ideal, balance between sediment inputs into the system (Figure 9). Excessive sediment deposition on the point bars probably is derived from upland soil slips that occurred after the recent heavy rains. Although rated in Properly Functioning Condition, this reach is probably not at its potential relative to desired plant communities.

Figure 9. Cañada Lobos #2. Sediment-trapping herbaceous vegetation on the banks and point bars, and more ideal channel characteristics places this reach in Proper Functioning Condition.

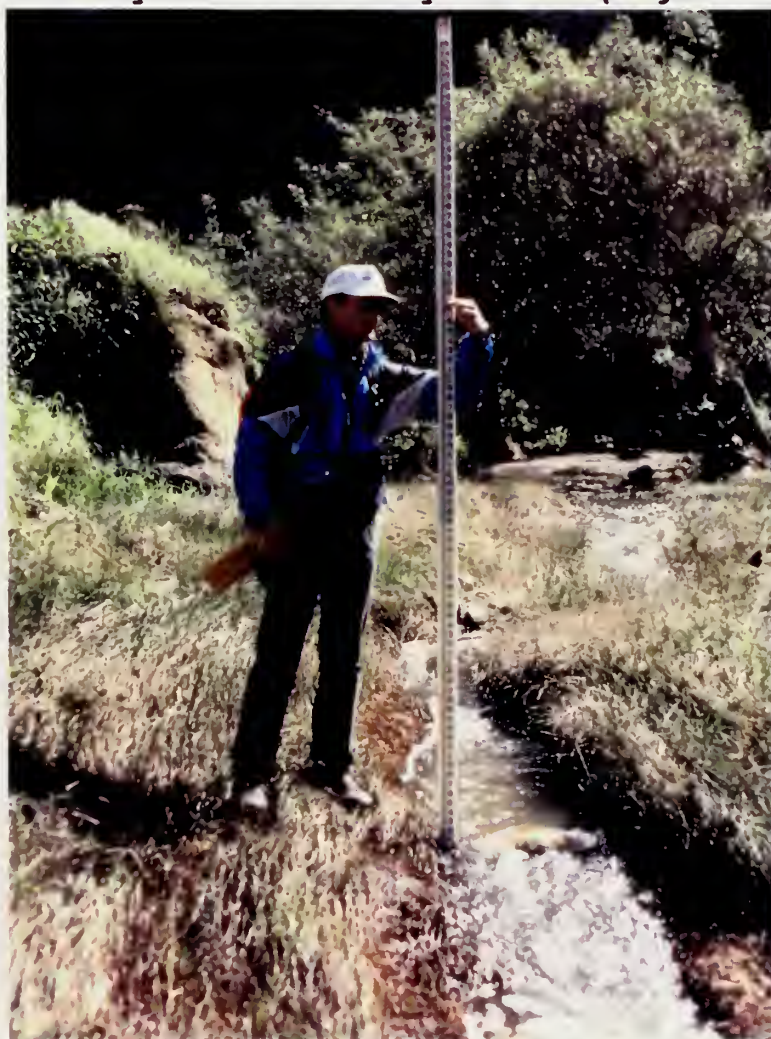
Functionality Rating: Proper Functioning Condition

Assessment: A diverse, and mostly vigorous, energy dissipating and bank-protecting herbaceous and woody riparian vegetative community structure consisting of arroyo willow (*Salix lasiolepis*) black cottonwood (*Populus trichocarpa*) and Mexican elderberry (*Sambucus mexicana*), saltgrass (*Distichlis spicata ssp stolonifera*) and Mexican rush (*Juncus mexicanus*) present in this relic area at the very least epitomizes a proper functioning riparian area on Santa Rosa Island and perhaps is indicative of the potential natural plant community for riparian areas on Santa Rosa Island. Deer browsing is evident, and effecting the vigor of the woody plants. A browseline is evident on the willows, and the trees and shrubs are decadent, and reproduction is judged to be poor. Channel characteristics in this reach are near ideal, with low width depth ratios, overhanging banks have or are being formed, and the stream is both horizontally and vertically stable (Figure 10).

Figure 10. Cañada Lobos 3#. Diverse riparian vegetation, and ideal channel characteristics places this reach at Proper Functioning Condition and beyond.

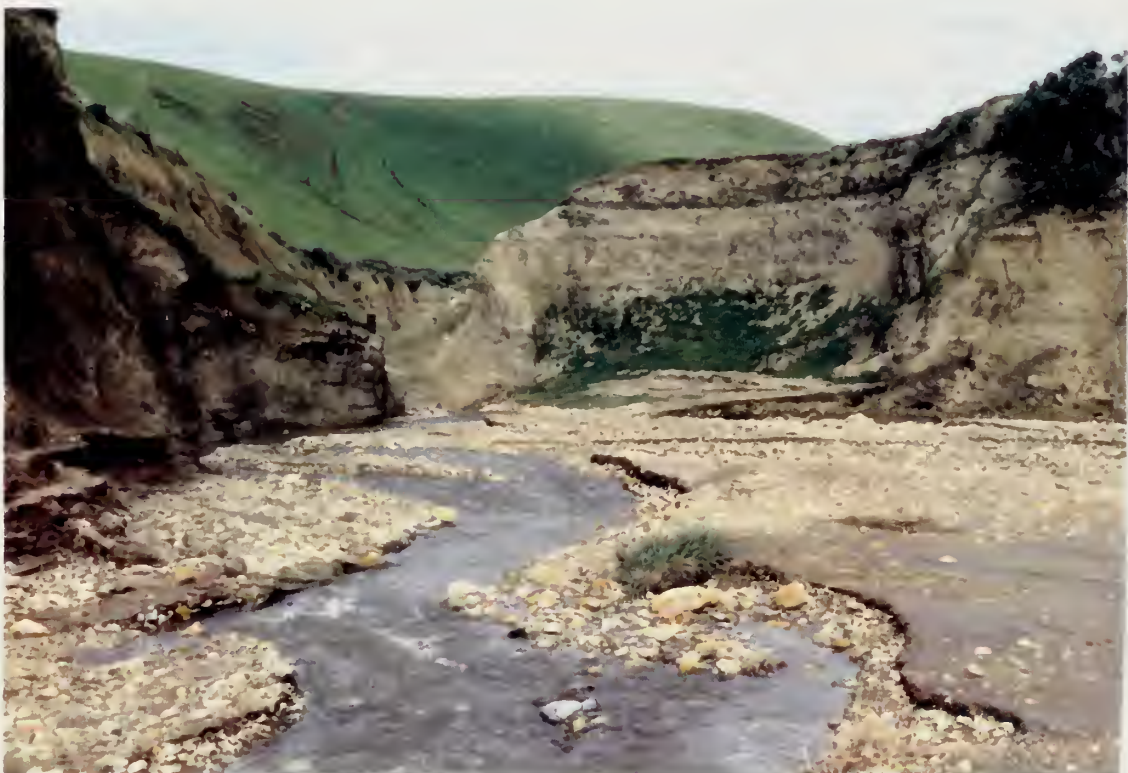
Functionality Rating: Nonfunctional

Assessment: While separate assessments were completed for three reaches on this drainage, all were rated as nonfunctional and only subtle differences exist between the attribute assessment for the reaches. The portion of the drainage assessed is absent almost all of the attributes required for a proper functioning riparian area. An oversupply of sediment from upland and channel sources has exceeded the stream transport capability. The channel is typically braided and lateral instability is high, resulting in high width/depth ratio and unnatural sinuosity. Riparian and wetland vegetation is absent and point bars are bare laying open the banks to erosion during each flood event (Figure 11). The channel is, however, vertically stabilized by numerous bedrock controls throughout its longitudinal profile, and it appears to have high potential for natural restoration, especially in the lower reaches where gradients are low to moderate, and there is the remnant of a functional floodplain.

Figure 11. Typical reach in Arlington Canyon indicating a lack of bank and point bar vegetation, excessive sediment deposition, and poor channel characteristics.

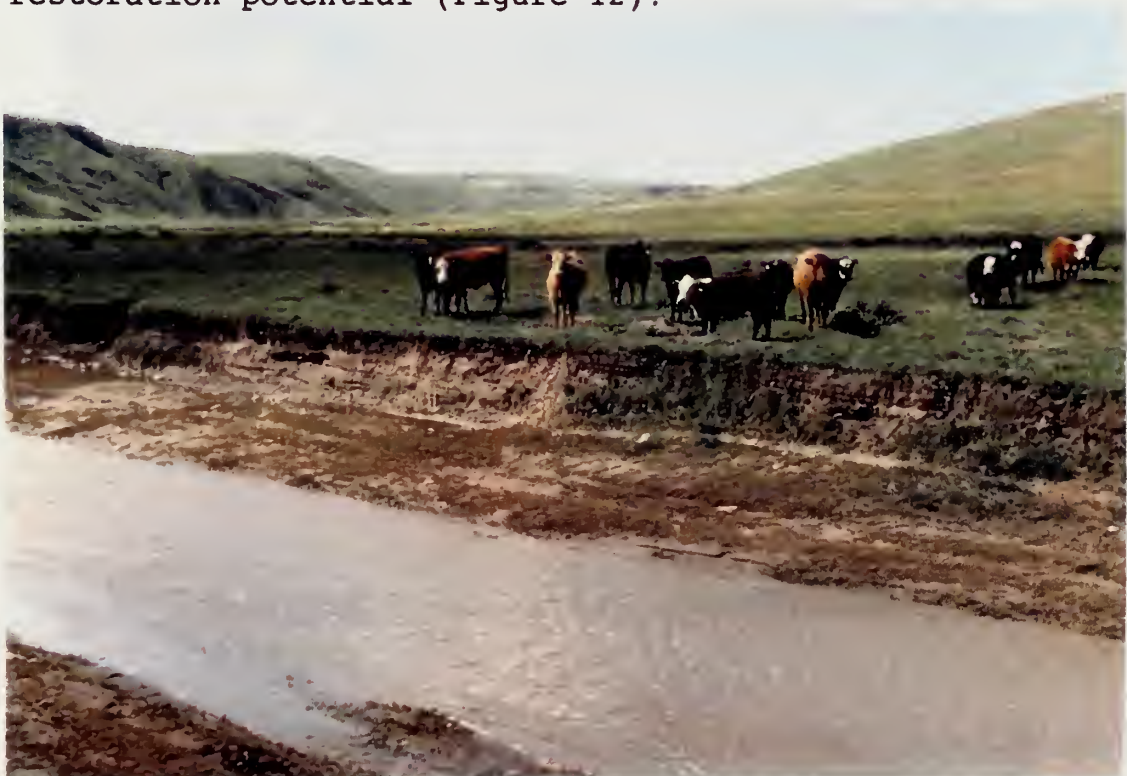
Figure 12. Old Ranch Canyon.

Assessment: While the few representatives of the vegetative species present indicate that riparian soil moisture is being maintained, it lacks both the herbaceous and woody species that should be represented on the floodplains in this drainage. Old Ranch Canyon (Reach #9) is especially indicative of an area that is presently judged to be nonfunctional (high width-depth ratios, exposed point bars, and poor sinuosity characteristics) but has high restoration potential (Figure 12).

The low to moderate gradients in the Old Ranch reach would naturally enhance sediment deposition, the current high sediment loads provide ample material for bank and floodplain reconstruction, and existing loamy bank soils are an excellent substrate for the natural reestablishment of woody and herbaceous vegetation.

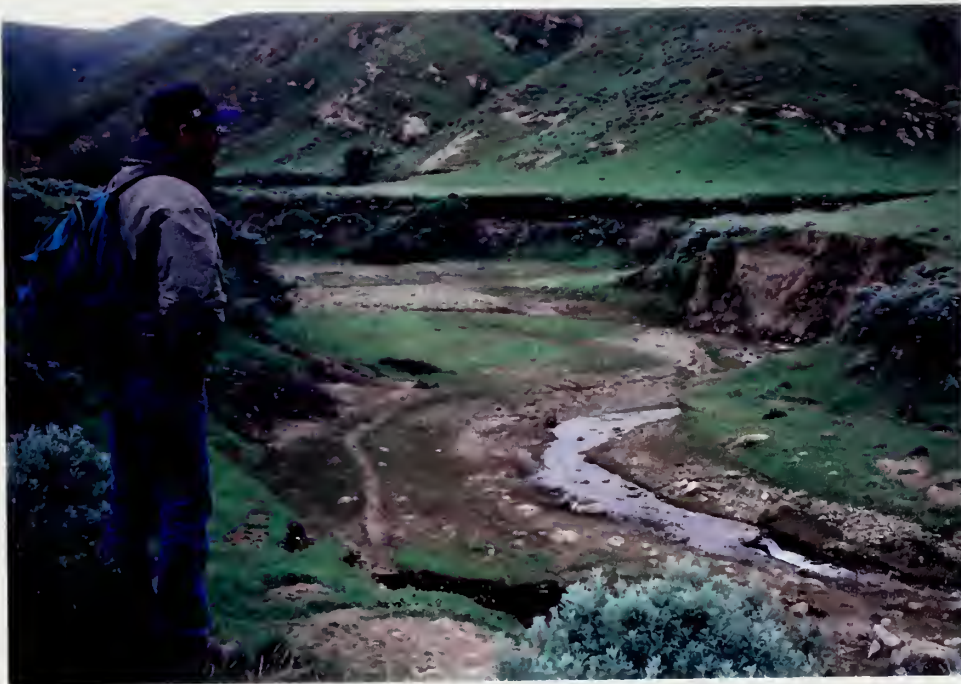
Figure 13. Jolla Vieja Canyon.

Functionality Rating: Nonfunctional

**Assessment:** The ratings assigned to the attributes of this reach are very similar to those assigned to Arlington Canyon. There is little floodplain development despite forced lateral migration of the channel by excessive sedimentation from upland and channel sources that exceeds the stream's power to transport it. The arroyo is widening overall, but the floodplain is seldom inundated by floodwaters (Figure 13). The riparian corridor is extremely narrow. Vegetation is largely absent from the point bars and channel area, thus exposing the channel to erosion during each flood event.
