# Hydrology and Geochemistry of Yucca House National Monument and Surrounding Area, Southwestern Colorado

By Winfield G. Wright  
*Certified Professional Hydrologist*

## *Hydrological Studies Report 2006-1*

*Prepared in Cooperation with the National Park Service,  
Mesa Verde National Park*

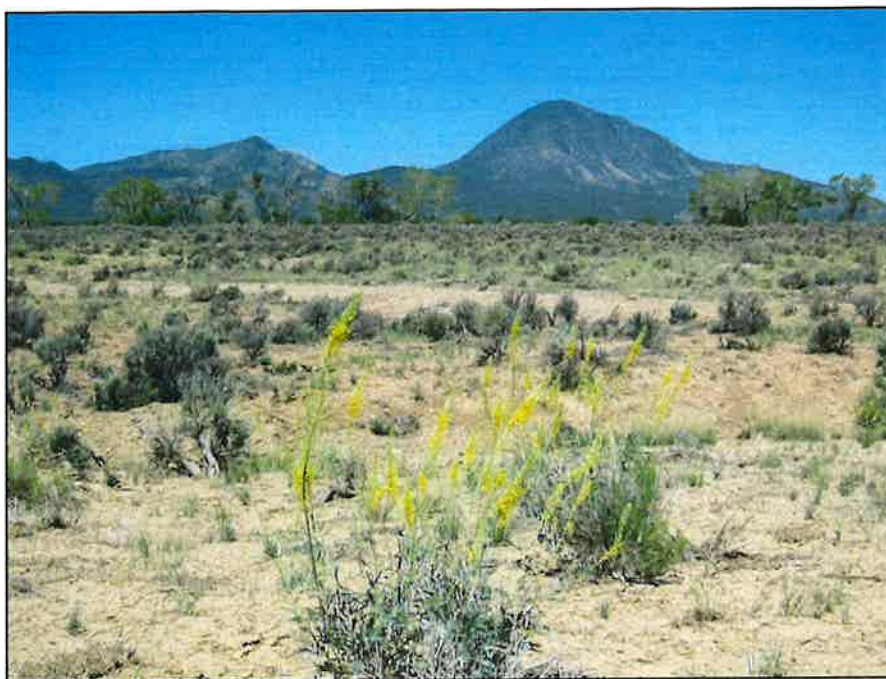
Figure 5. Photograph showing bare soil, sage, and prince's plume which is a primary indicator of high selenium concentrations in soil.

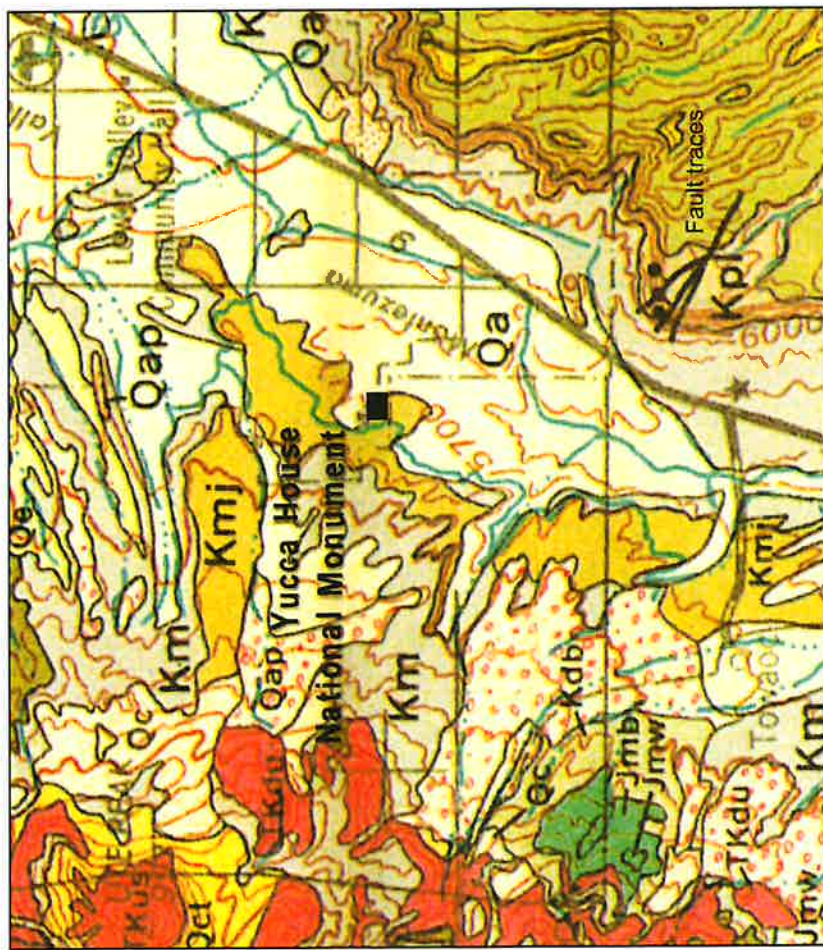
Figure 6. Geologic map of Yucca House National Monument and surrounding area (from Haynes and others, 1972).

There are no faults known in the Yucca House area; however, there are indications of faults across Montezuma Valley, southeast of Yucca House (Figure 6). Fracturing of the bedrock has likely occurred because of the uplift of the rocks caused by the intrusive Sleeping Ute Mountains. Fractures can act as conduits for the movement of ground water.

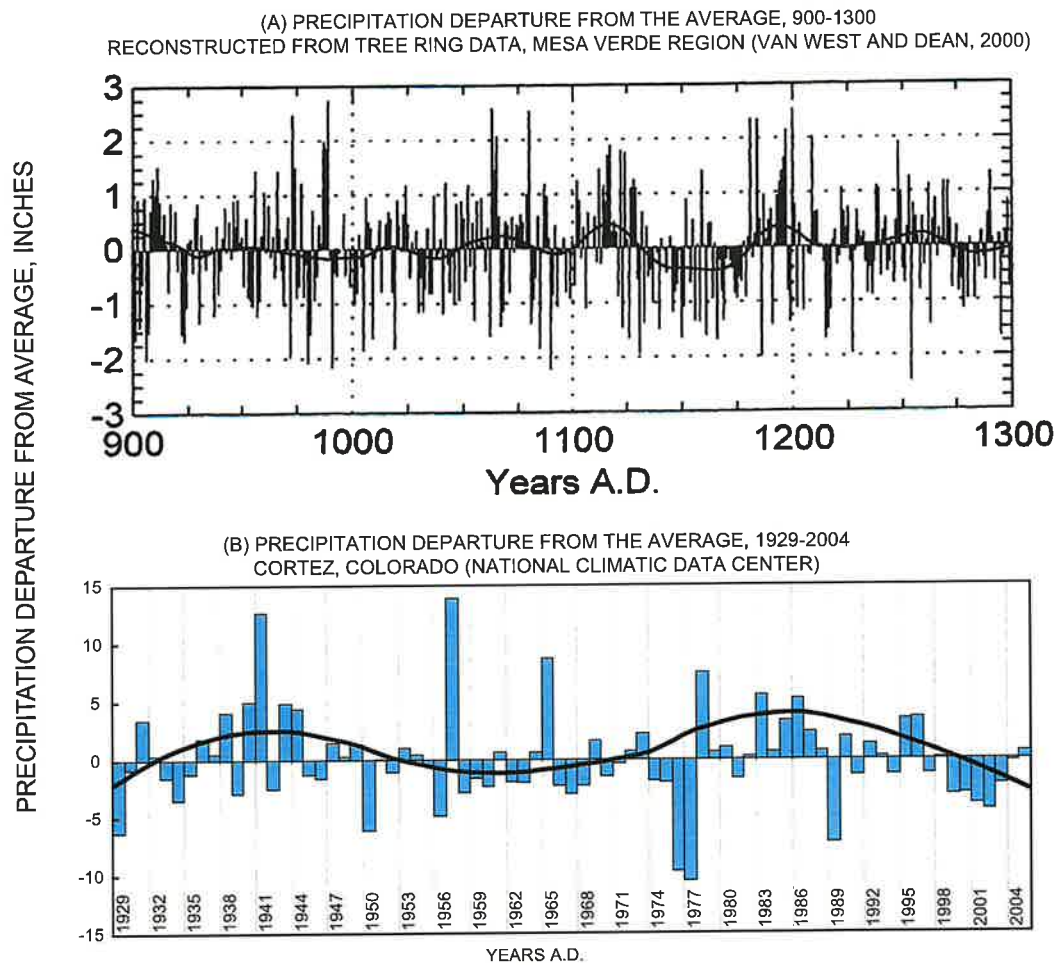
Figure 7. (A) Precipitation departure from average during A.D. 900-1300 for the Mesa Verde region from tree-ring chronology (Van West and Dean, 2000), and (B) Precipitation departure from average during A.D. 1929-2005 for the meteorological station at Cortez, Colorado.

7). The departures were both fitted with a LOWESS curve which is a data analysis technique for producing a "smooth" set of values from a time series. Both the tree-ring data and the recent Cortez data show similar frequency of fluctuation around the average; however, the values of departure from the average (amplitudes) appear to be subdued in the tree-ring data. It appears that the area experienced sustained drought conditions during A.D. 1125-1175 (50-year drought period), and the drought of A.D. 1276-1300 was, at one time, hypothesized as the reason for abandonment of the region by the Anasazi (Van West and Dean, 2000). In the recent record there appears to be only slight drought conditions sustained during A.D. 1954-1968, and the negative departures were not substantial. There is not enough data to indicate whether the current drought cycle compares with the A.D. 1125-1175 drought; however, other studies have indicated that precipitation during 2002 was as low as during the A.D. 1276-1300 drought period (Doesken and Pielke, 2004).

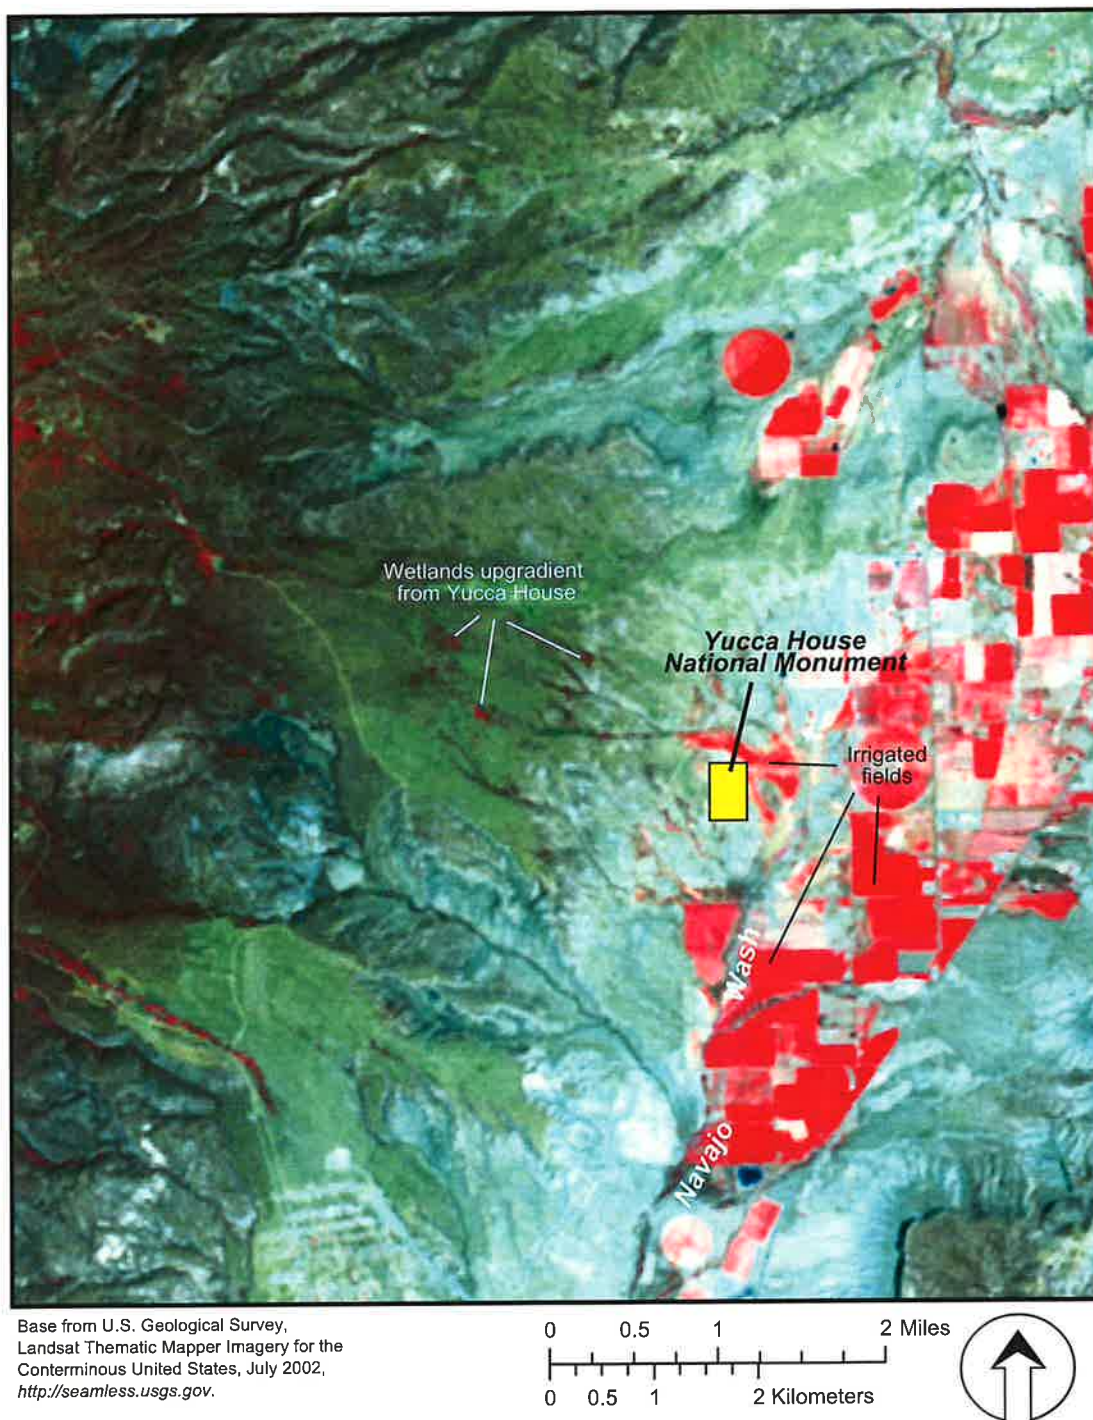
Figure 9. Color infrared imagery showing water-loving plants (phreatophytes) in bright red colors.

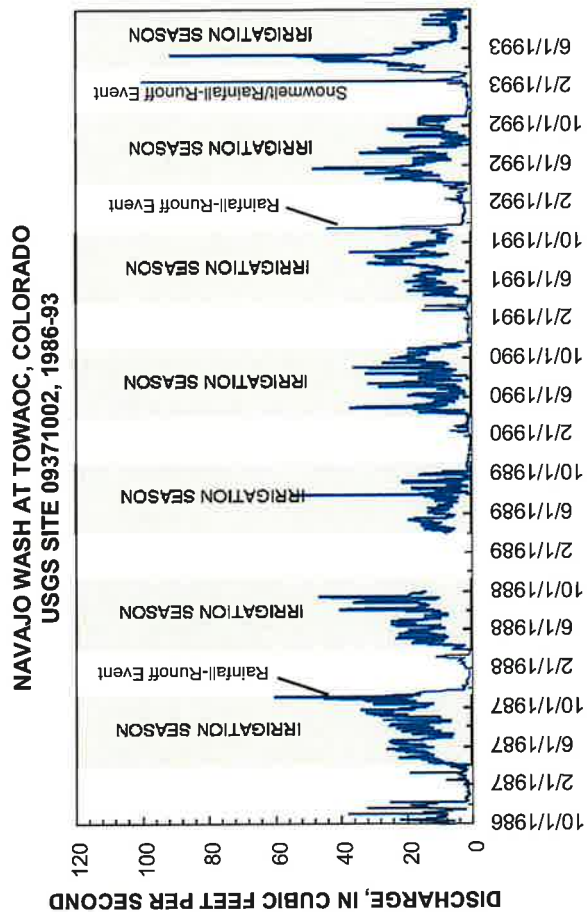
Figure 10. Hydrograph of Navajo Wash at Towaoc, Colorado, showing the influences of irrigation water on discharges in the stream.

Streamflows in the area surrounding Yucca House are influenced by imported irrigation water which is delivered to the area through canals and pipelines during April through October of each year. Streamflow discharges in Navajo Wash near Towaoc can fluctuate widely during the irrigation season (Figure 10). Some of the larger discharges that occurred during the non-irrigation season are caused by rainfall runoff from thunderstorms or snowmelt/rainfall-runoff events (Figure 10). During the non-irrigation season, discharges in Navajo Wash are sourced from seepage caused by irrigation drainage. If not for the irrigation water, Navajo Wash would probably be dry most of the time, except during periods of high precipitation and snowmelt.

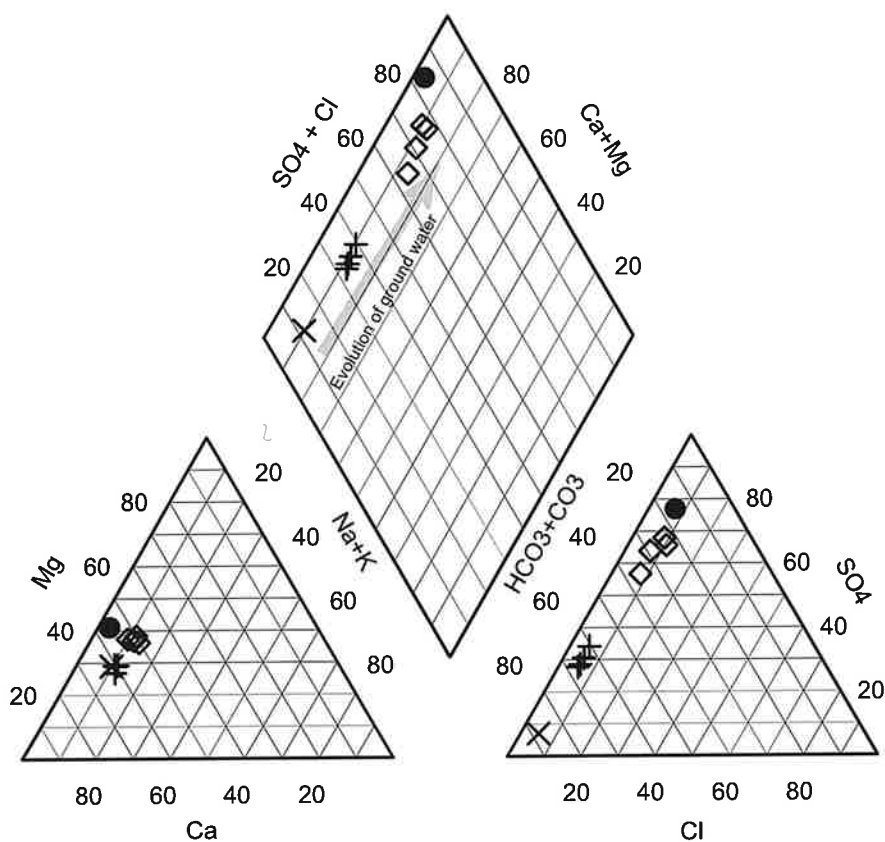
Figure 12. Water analysis diagram showing percentages of major ions in water samples from springs in the Yucca House National Monument area. On the top-central diagram, the arrow indicates evolution of ground water as it flows from the Sleeping Ute Mountains (Elbow Spring), to Ismay Spring, the Yucca House spring, and Gate Marsh Spring.

higher dissolved constituent concentrations. This is called the evolution of ground water along a flow path. In the Piper diagram (Figure 12), an example of ground-water evolution is shown, where the water at Elbow Spring is a calcium bicarbonate type water with a TDS of 206 mg/L. At Ismay Spring, the water is still a calcium bicarbonate type water with a relatively low TDS concentration of about 474 mg/L. At Yucca House Spring, the water has evolved into a calcium sulfate type water with TDS concentrations of about 1000 mg/L due to water-rock interaction with the Mancos Shale. Gate Marsh Spring also is a calcium sulfate type water with a high TDS concentration of 2000 mg/L. Yucca House and Gate Marsh Springs appear to be similar types of waters; however, there are higher dissolved-constituent concentrations in Gate Marsh Spring than in Yucca House Spring. It is possible that water in the Yucca House Spring is influenced (or diluted) by irrigation water in the field near West Pond and by seepage from West Pond.

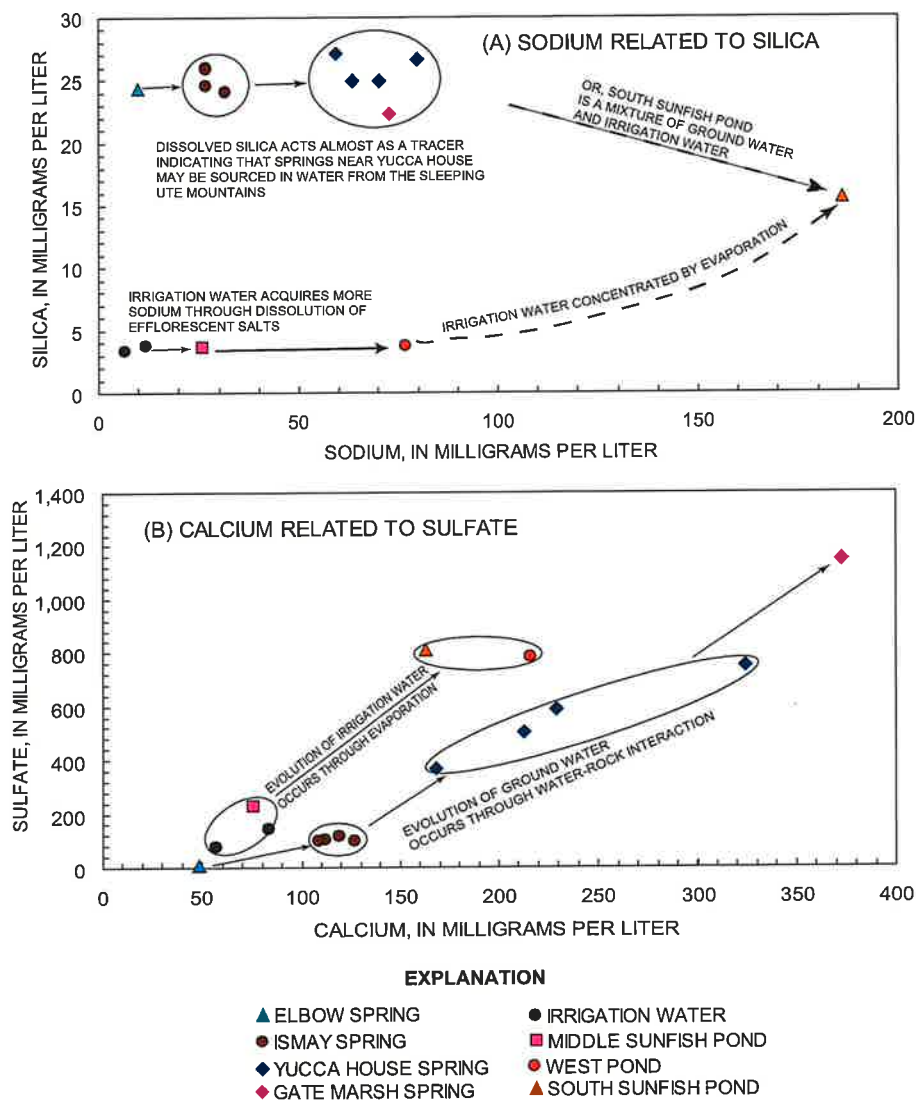
Figure 13. X-Y plots of (A) sodium related to silica, and (B) calcium related to sulfate in water from springs, irrigation ditches, and ponds in the Yucca House National Monument area.

Further evidence of the evolution of natural waters can be displayed by X-Y plots of dissolved-constituent data (Figure 13). Elbow Spring, Yucca House, and Gate Marsh Springs all had silica concentrations of about 22-25 mg/L. Waters in Elbow Spring interact with quartz diorite of the Sleeping Ute Mountains and acquire dissolved silica. As the water flows downgradient from Sleeping Ute Mountain to the Yucca House area, the dissolved silica concentrations are similar to Elbow Spring, almost acting as a tracer (Figure 13). In contrast, the irrigation water had silica concentrations of about 3 to 4 mg/L. Water in West Pond and Middle Sunfish Pond appear to be similar to the irrigation water, except

sodium was probably acquired from the dissolution of efflorescent salts (Figure 13). Water in South Sunfish Pond had higher silica and sodium concentrations, which may have been caused by evaporation from the ponds and subsequent concentrating of the dissolved solutes. It is also possible that South Sunfish Pond represents a mixture of sources--irrigation water and ground water.

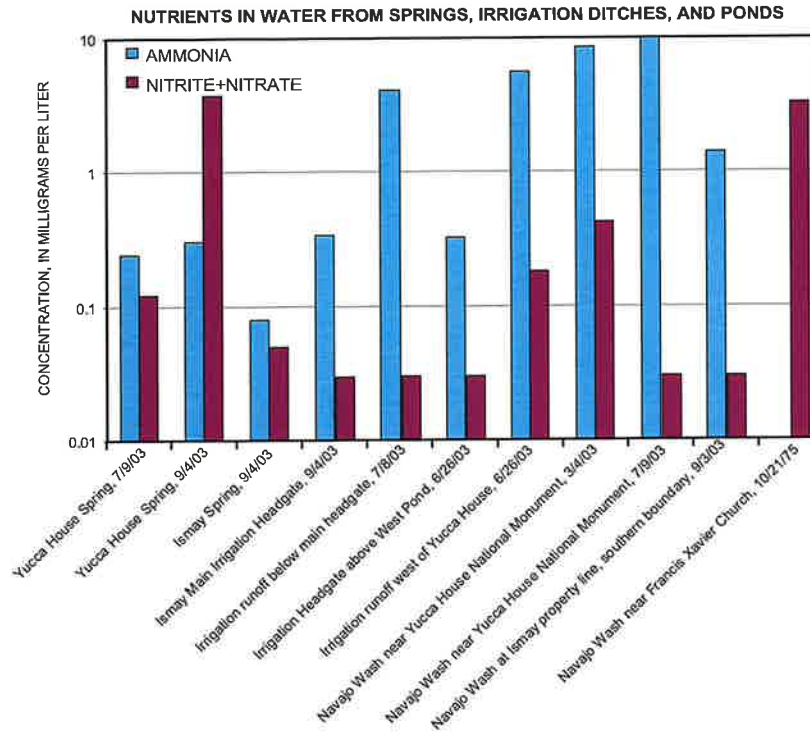
Figure 14. Concentrations of nutrients (total ammonia and dissolved nitrite plus nitrate) in water from springs, irrigation ditches, and ponds in the Yucca House National Monument area.

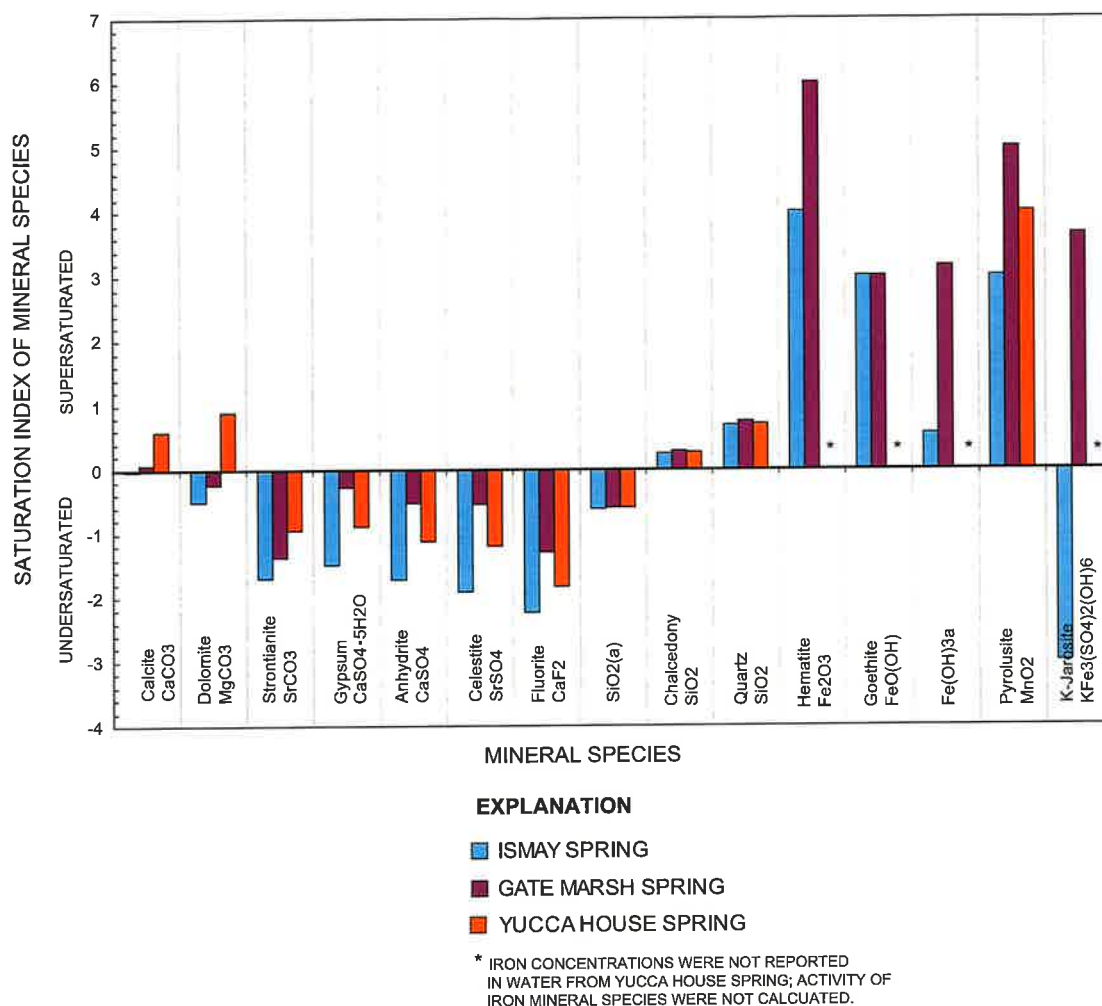
Figure 15. Saturation index of mineral species for springs in the Yucca House area. Saturation index less than zero indicates undersaturation, and the mineral species would be dissolving in a water-rock interaction environment. Saturation index greater than zero indicates saturation, and the mineral would be precipitating from the dissolved phase into the solid phase.

undersaturation, and the mineral species would be dissolving in a water-rock interaction environment. SI values greater than zero indicate supersaturation, and the mineral would be precipitating from the dissolved phase into the solid phase (Figure 15). SI values can help describe whether the geochemical system is dissolving bedrock as ground water moves through fractures in the rock (undersaturated SI values), or whether the system is precipitating minerals in the fractures in rock (supersaturated SI values), possibly filling up the fractures. Filling of fractures through chemical precipitation contributes to the migration of springs from one discharge point to another. The SI values also can be used to compare sites, and the data are useful for describing possible flow paths.

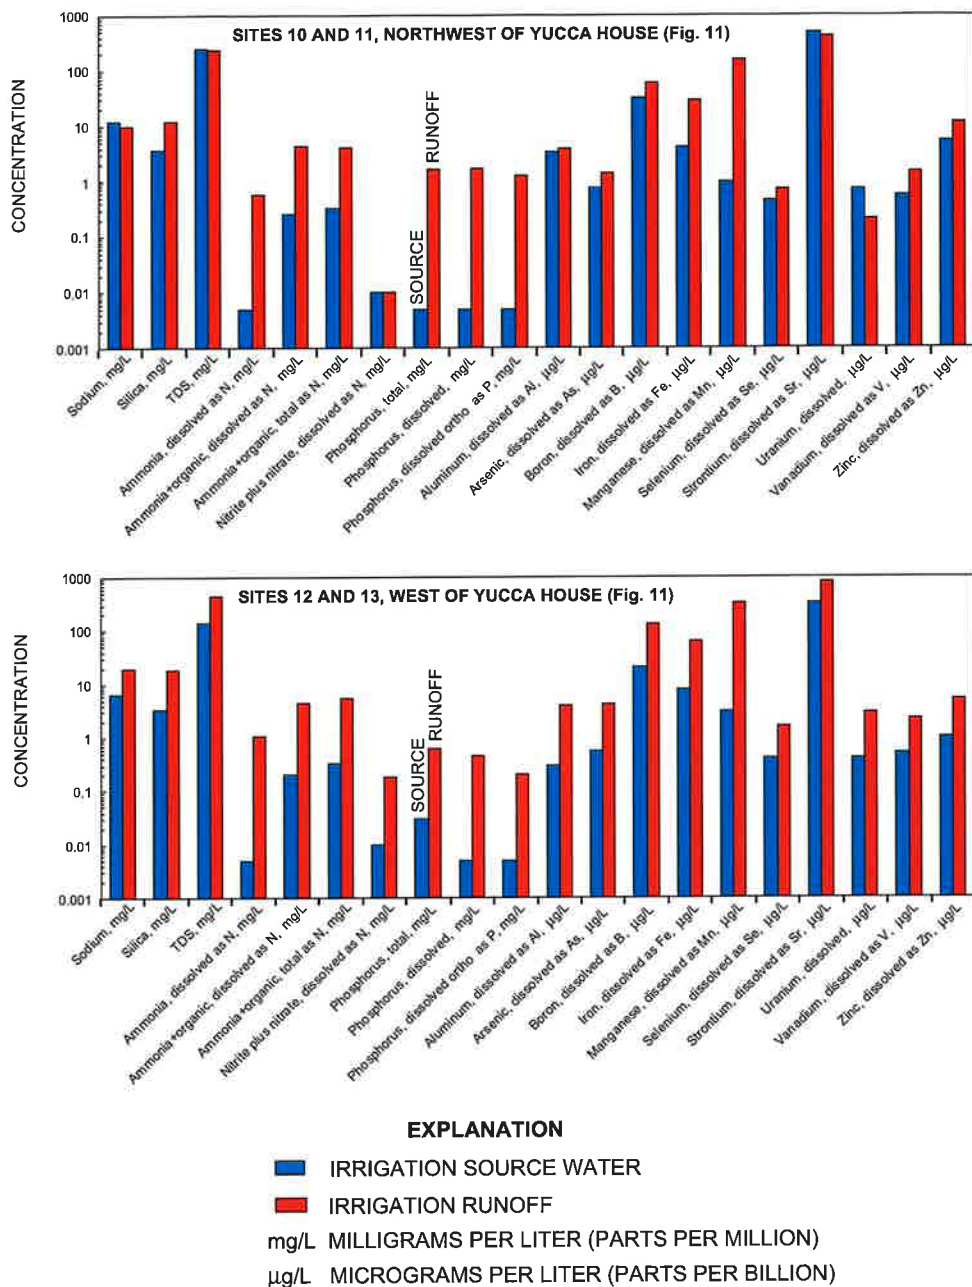
Figure 16. Effects of irrigation on water quality showing concentrations of selected constituents of source water (Ute Mountain Ditch water) and irrigation runoff water (runoff from fields), Yucca House National Monument and surrounding area.

At both sites, water-quality samples were collected of the irrigation source water, and water-quality samples were collected on the same day of the irrigation runoff downgradient from the source water. At both sites, concentrations of almost all constituents increased from the source water to the irrigation runoff water (Figure 16). Significant increases were reported for ammonia and phosphorous concentrations in the irrigation runoff (Figure 16). The irrigation source water already contains relatively high concentrations of some constituents because the Ute Mountain Ditch receives irrigation tailwater and runoff from other irrigated fields upstream from the Yucca House area.

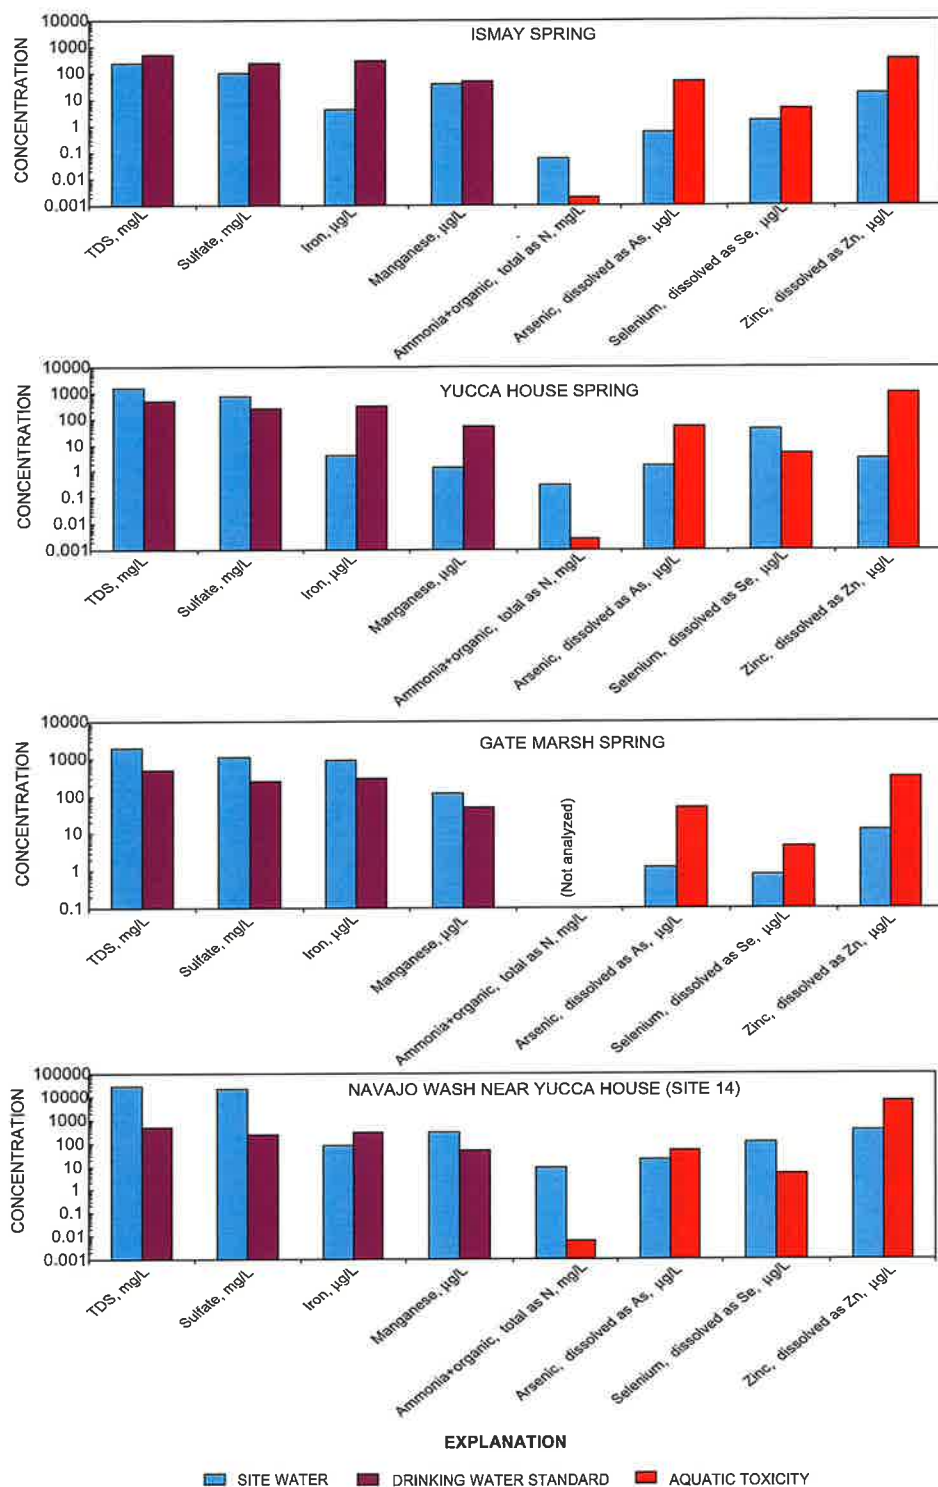
Figure 17. Concentrations of selected constituents in water from sites, drinking water standards, and toxicity threshold for survival of aquatic life.

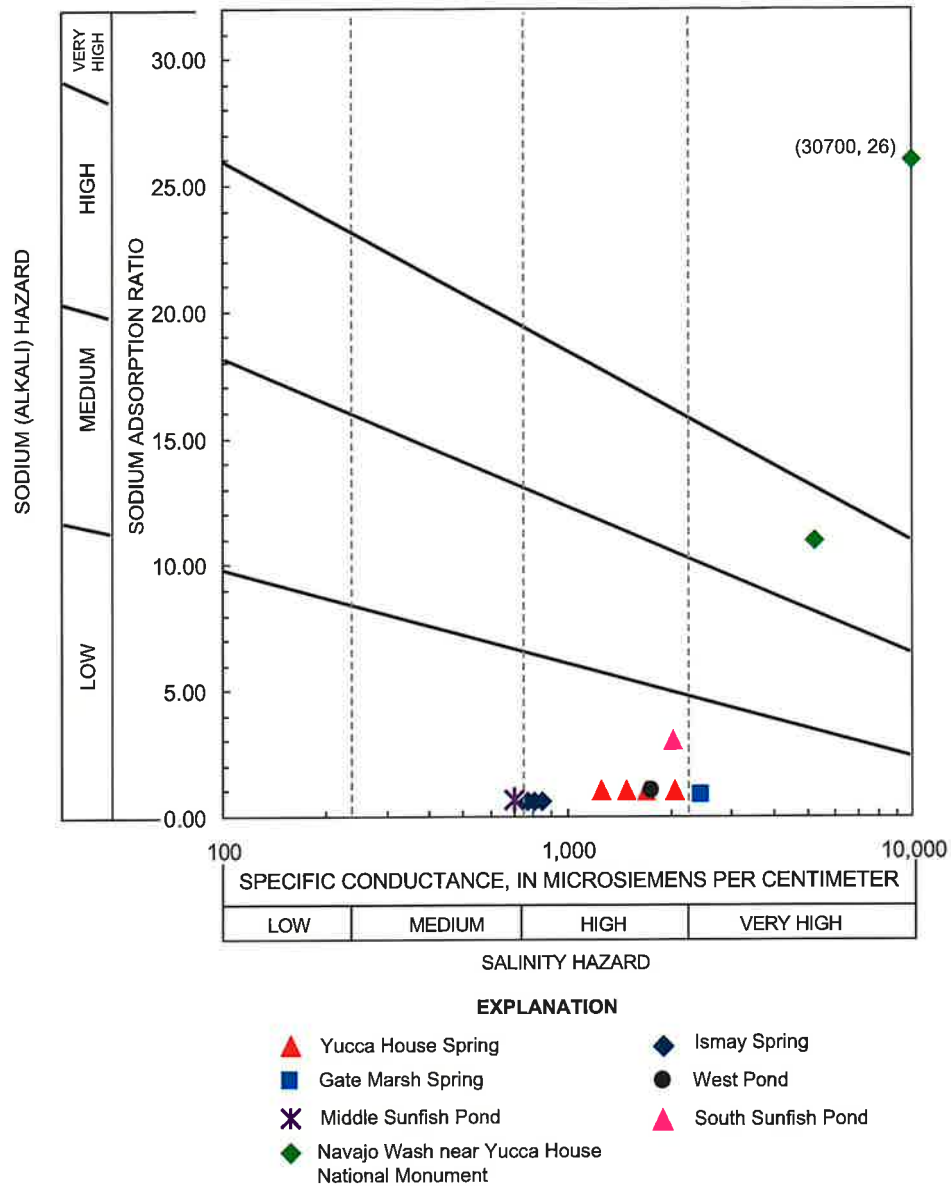
Figure 18. Salinity and sodium (alkali) crop hazard and water-quality results from Yucca House National Monument.

Specific conductance and SAR values in water from sites at Yucca House National Monument were plotted on the diagram for classification of the waters for the suitability for cultivation (Figure 18). Water-quality samples from Ismay Spring had a high salinity hazard and low sodium-alkali hazard rating. Water-

quality samples from Yucca House Spring had a high salinity hazard and a low sodium-alkali hazard rating. Water-quality samples from Navajo Wash, which resulted from irrigation of Mancos Shale, had a very high salinity hazard and a high to very high sodium-alkali hazard rating (Figure 18).

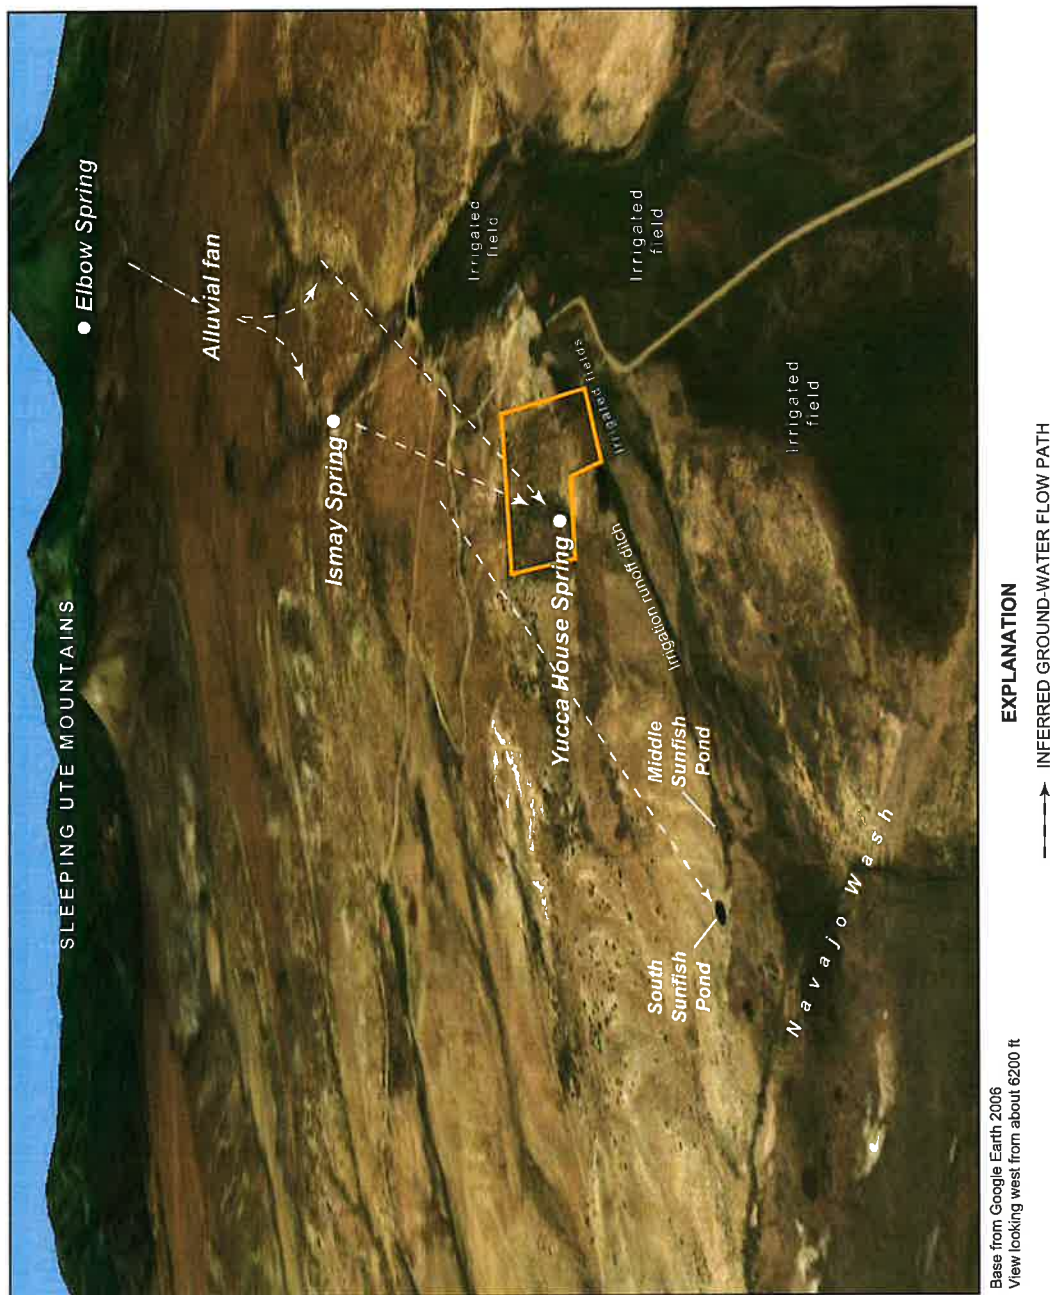
Figure 19. 3D satellite image of the Sleeping Ute Mountain area, Yucca House National Monument, springs and ponds, and inferred ground-water flow paths.

For the current conditions, the inferred ground-water flow conditions are described as follows (Figure 19):
