# Upper Columbia Basin Network Integrated Water Quality Annual Report 2009

*City of Rocks National Reserve (CIRO)*  
*Castle Rocks State Park (CRSP)*

Natural Resource Technical Report NPS/UCBN/NRTR—2010/279

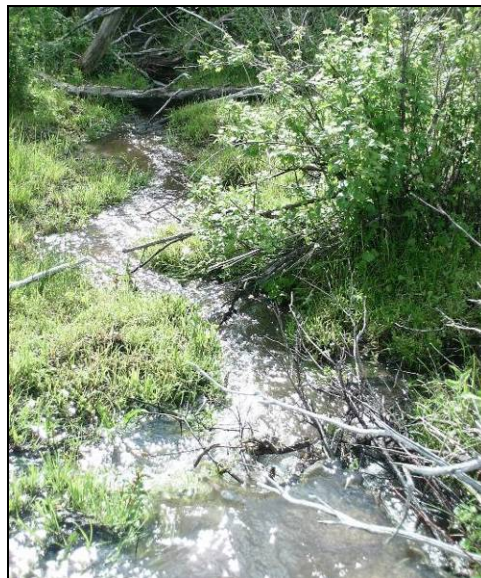
**Figure 1.** North Fork Circle Creek looking downstream from transect F, sample reach 001, during macroinvertebrate sampling on June 14th 2009.

Two macroinvertebrate sample reaches were established on the North Fork, South Fork and Main Circle Creeks (Appendix A) (Figures 1, 2, 3 and 5). The Hydrolab was deployed in locations with adequate water depth and locations that facilitated relatively easy equipment transfer from one stream to another (i.e. near trails).

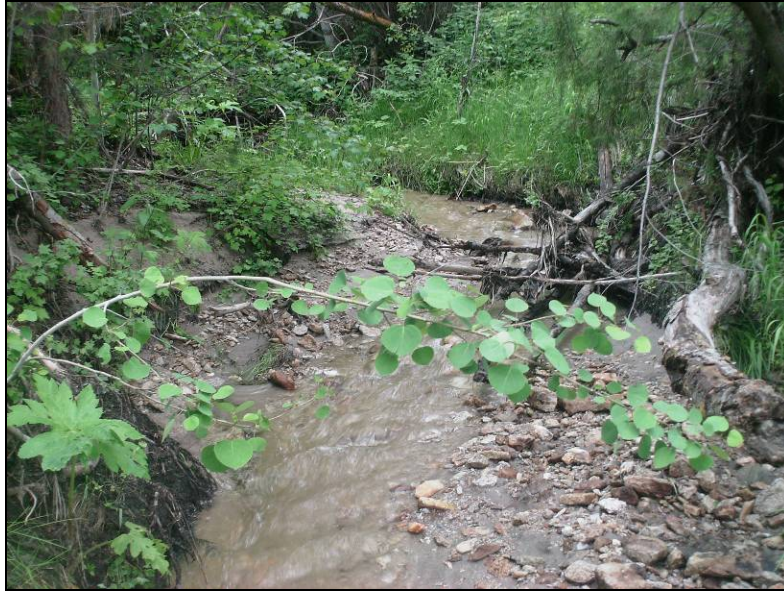
**Figure 2.** South Fork Circle Creek looking upstream from transect F, sample reach 002, during macroinvertebrate sampling on June 13<sup>th</sup> 2009.

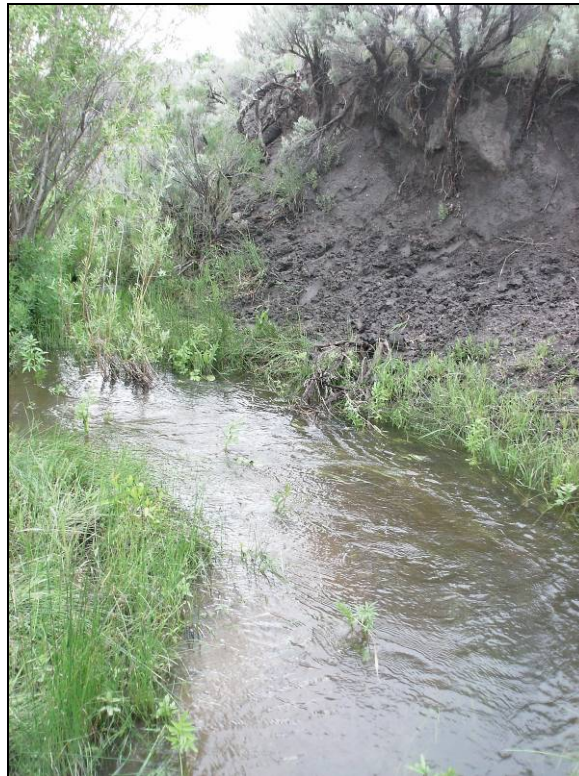
**Figure 3.** Main stem Circle Creek looking upstream from transect F, sample reach 001, during macroinvertebrate sampling on June 12<sup>th</sup> 2009.

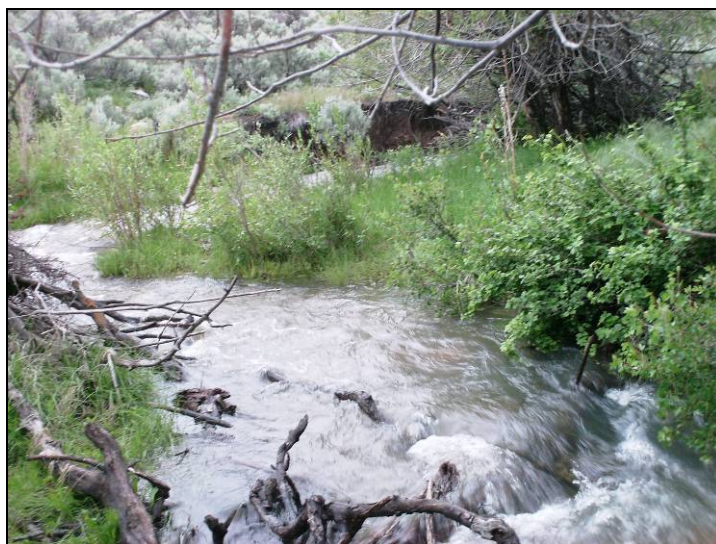
**Figure 4.** Almo Creek looking upstream from transect F, sample reach 002, during macroinvertebrate sampling on June 11<sup>th</sup> 2009.

Three macroinvertebrate sample reaches were established on Almo Creek. One of which (002) is within the lower wetland mitigation area (Figures 4 and 5). The Hydrolab was deployed just upstream of the “Ranch House” where there is adequate water depth and relatively easy access (Appendix A).

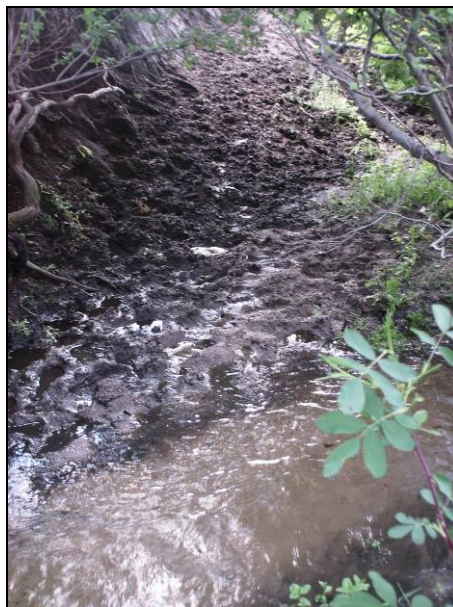
**Figure 10.** Evidence of livestock use of North Fork Circle Creek’s riparian area and stream channel.

It is unlikely that North Fork Circle Creek experiences widespread elevated turbidity except during rain events. These event based spikes in turbidity are in large part due to sediment supplied to the stream via bank erosion. Several substantial headcuts were noted along macroinvertebrate sample reach 002 (Appendix A). Bank erosion is one of the primary concerns along the North Fork of Circle Creek. The primary source of erosion is due to the use of the riparian area and stream channel by livestock (Figure 10). As noted by Belsky et al. (1999), many publications indicate the detrimental effects of cattle on stream communities.

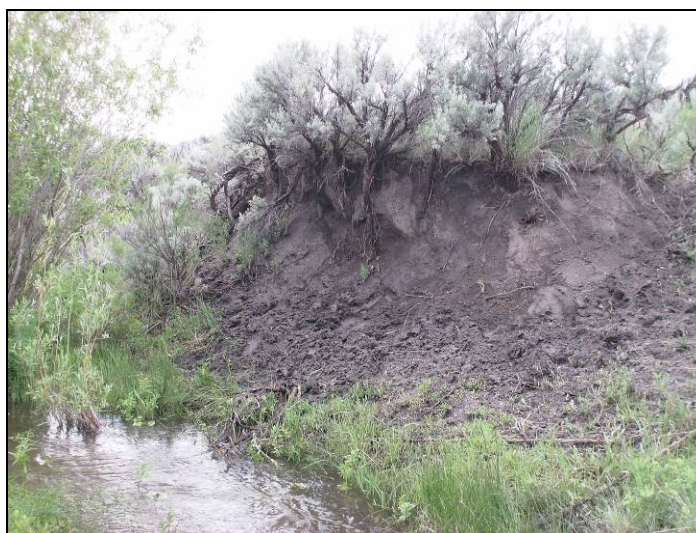
**Figure 24.** Bank erosion on the main stem of Circle Creek near macroinvertebrate reach 001 (looking upstream).

The main stem of Circle Creek had turbidity levels that far exceeded the North Fork or South Forks of Circle Creek. The primary driver of elevated turbidity is extensive bank erosion (Figure 24). Most of the stream channel is entrenched 1-2 m. Causes of bank erosion likely come from two sources. The first and primary cause of erosion is the extensive use of the riparian area and stream channel by livestock. The entire length of both macroinvertebrate reaches (300 m) had widespread cattle trails with evidence of recent erosion. The second factor is the series of small impoundments upstream on private property. These impoundments prevent bed and suspended load transport that would otherwise aggrade downstream sections of Circle Creek. Currently only one of these factors can be controlled by CIRO, thereby it is advisable to restrict livestock from the stream to minimize continued erosion. Many publications indicate the detrimental effects of cattle on stream communities. Belsky et al. (1999) provides a summary of literature related to livestock’s influence on streams.

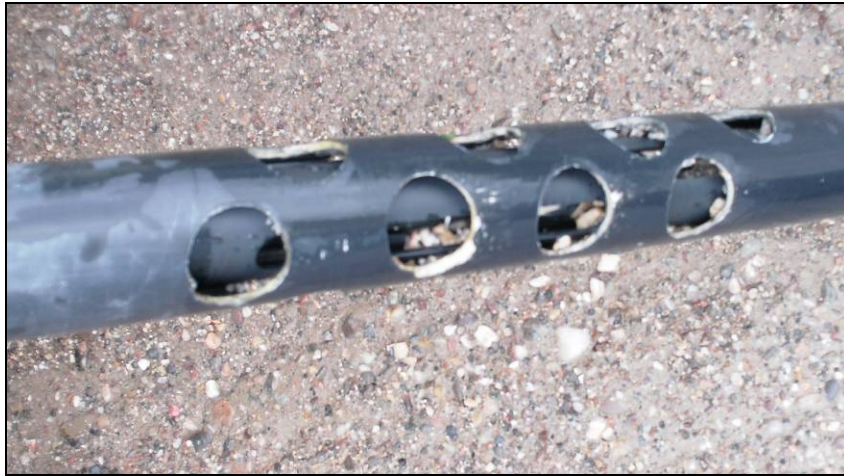
**Figure 31.** Gravel and sand deposited in the Hydrolab housing and sensor guard by high flows in Almo Creek.

When the Hydrolab was removed from the stream on June 13<sup>th</sup> gravel had become trapped in the sensor guard and caused the self cleaning wiper to “park” over the turbidity sensor (Figure 31). As a result, assessment of turbidity in Almo Creek was unsuccessful. A graph of turbidity data from Almo Creek has been included in this report to illustrate what wiper “parking” looks like when the data is graphically displayed (Figure 32).
