The M-3-1-2 Road and Slope  
Watershed Rehabilitation Project

Unit 86-5

December 1987

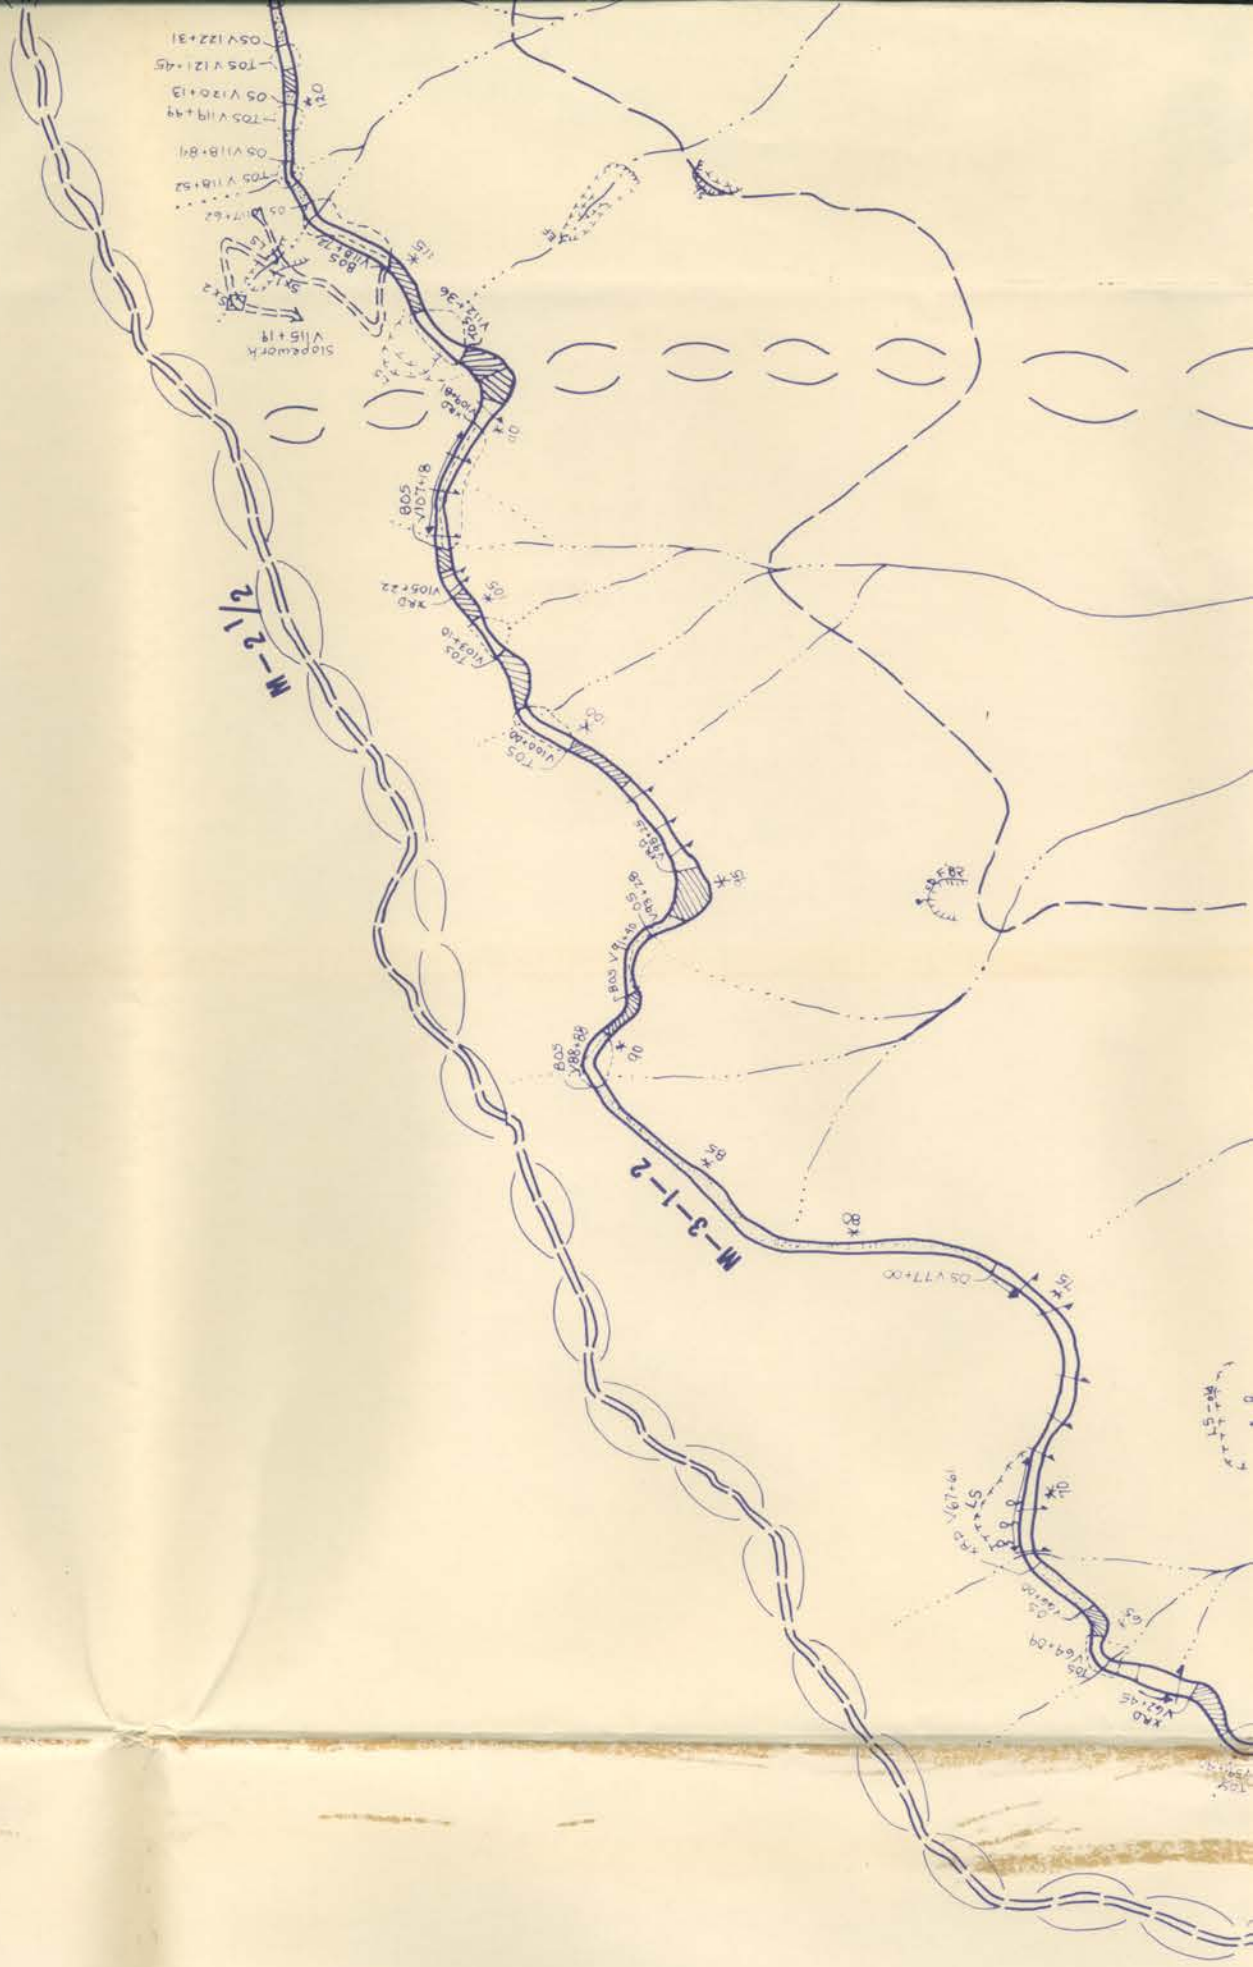
- Drainage
- Major Ridge
- Scarp, inactive
- Scarp, active
- Toe feature
- Rill (R), Gully (G)
- Spring, Seep
- EF, LS, DT Earthflow, Landslide, Debris torrent
- FF, CBF Fill failure, Cutbank failure
- Haul road
- Secondary haul road or skid trail

- XRD V 9+38 Rip and Drain (XRD)
- OS V 16+37 Outslope (OS)
- Fillsite (FS)
- TOS V 57+47 Total Outslope (TOS)
- BOS V 39+68 Bench Outslope (BOS)
- Rx V 166+04 Haul Road Stream Crossing Excavation (RX)
- Skid Trail Stream Crossing Excavation (SX) and access trail
- Photo Point Location and Number

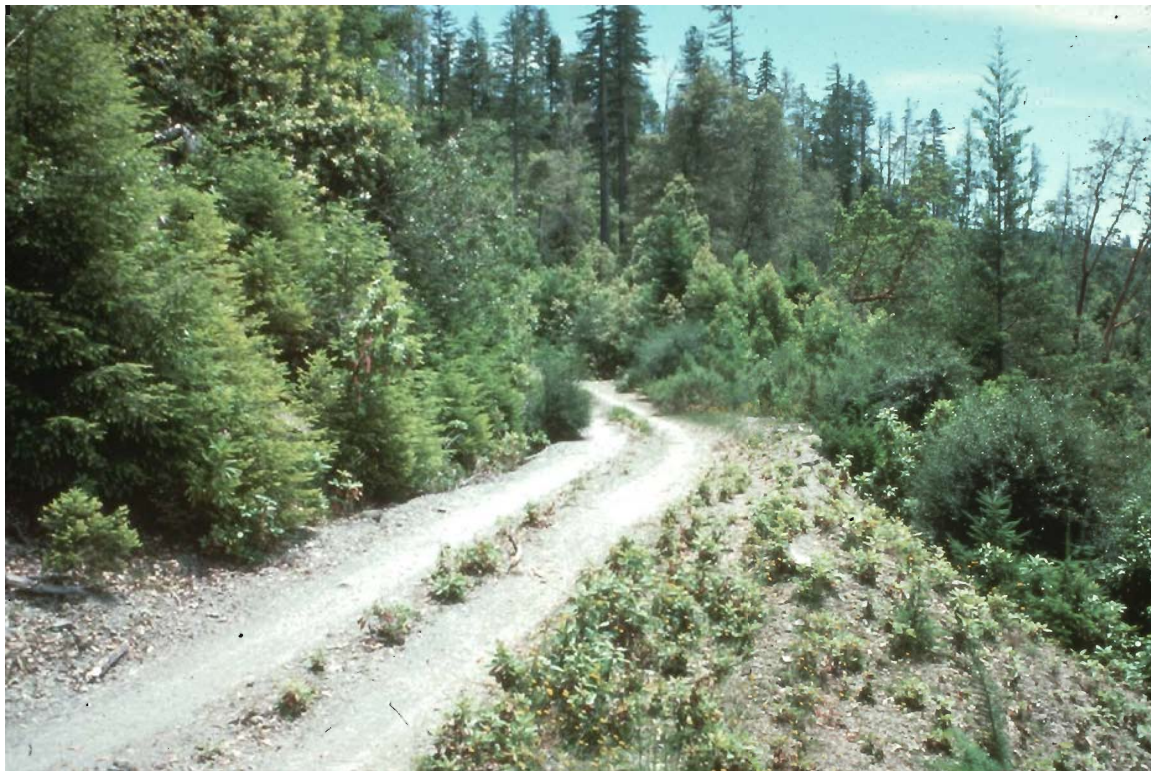
Unit: 86-5 Date: 7-2-1986, PP5B, M-3-1-2 STA 18+00 pre HE upstation outslope, 35mm, (LEJ)

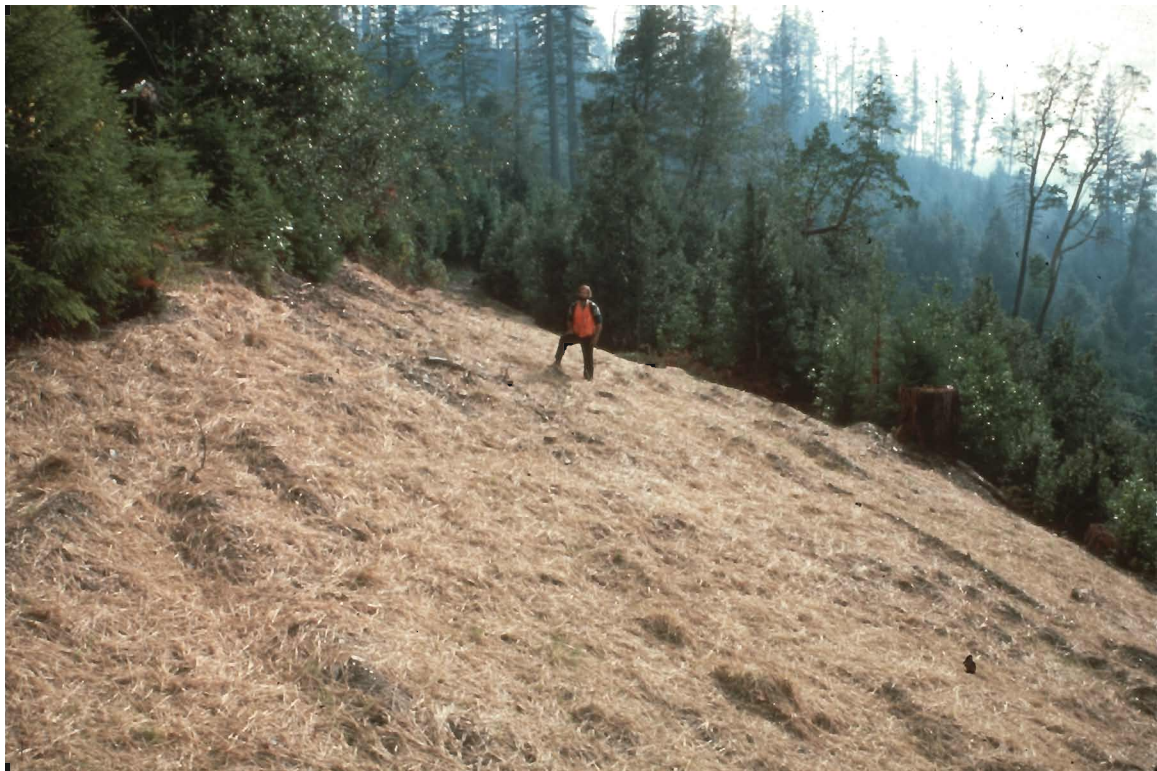
Unit: 86-5 Date: 11-12-1986, PP5B, M-3-1-2 STA 18+00 post HE, 35mm, (LEJ)

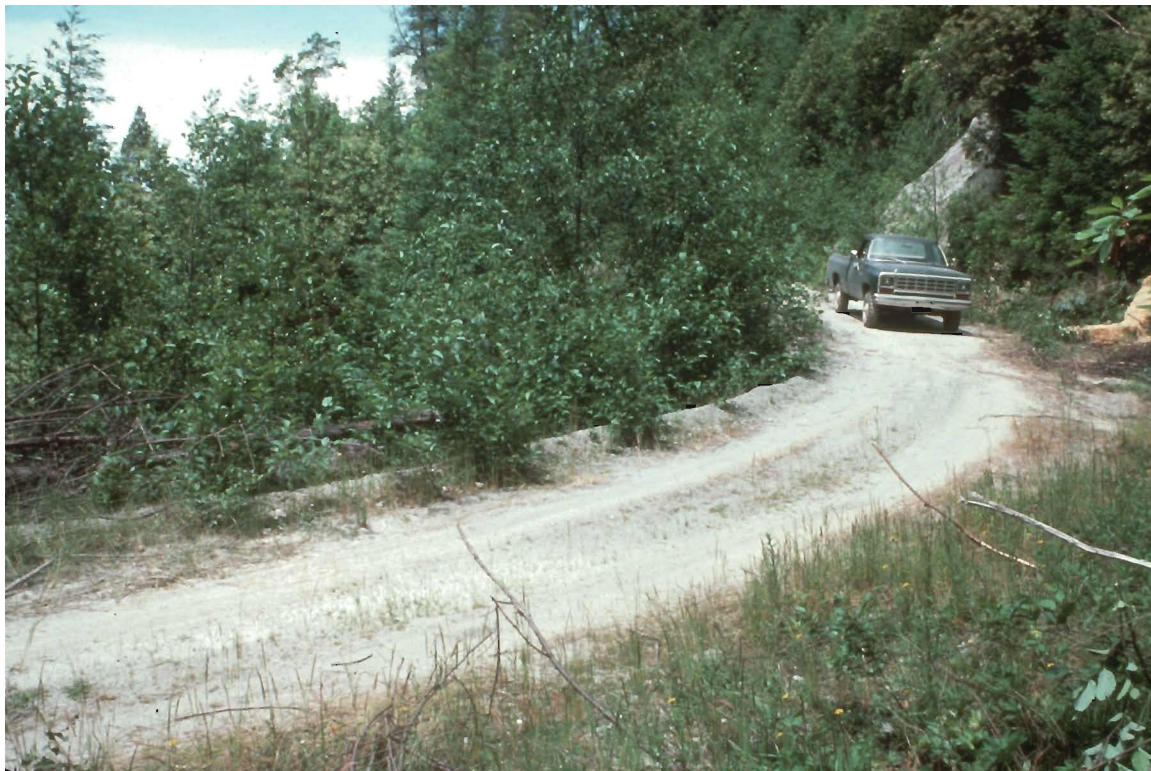
Unit: 86-5 Date: 7-2-1986, PP12, M-3-1-2 STA 60+70 TOS 59+40 pre HE, 35mm, (LEJ)

| Excavation<br>Site<br>Number | Volume<br>(cubic<br>yards) | Contract<br>Bid<br>Cost | ACTUAL EQUIPMENT HOURS: | | | HERE: | | Excavation<br>Rate<br>yd <sup>3</sup> /hour | Ave. Push<br>Dist. to<br>Fillsite<br>(ft.) | \$<br>Saved<br>(contract vs. hourly) | OR<br>vs. | \$<br>Lost |
|---|---|---|---|---|---|---|---|---|---|---|---|---|
| 59 + 40 | 1,000 | 2,354.00 | 6.5 | 6.5 | 6.5 | 1,787.50 | 1.79 | 51 | 142 | -.- | | 566.50 |

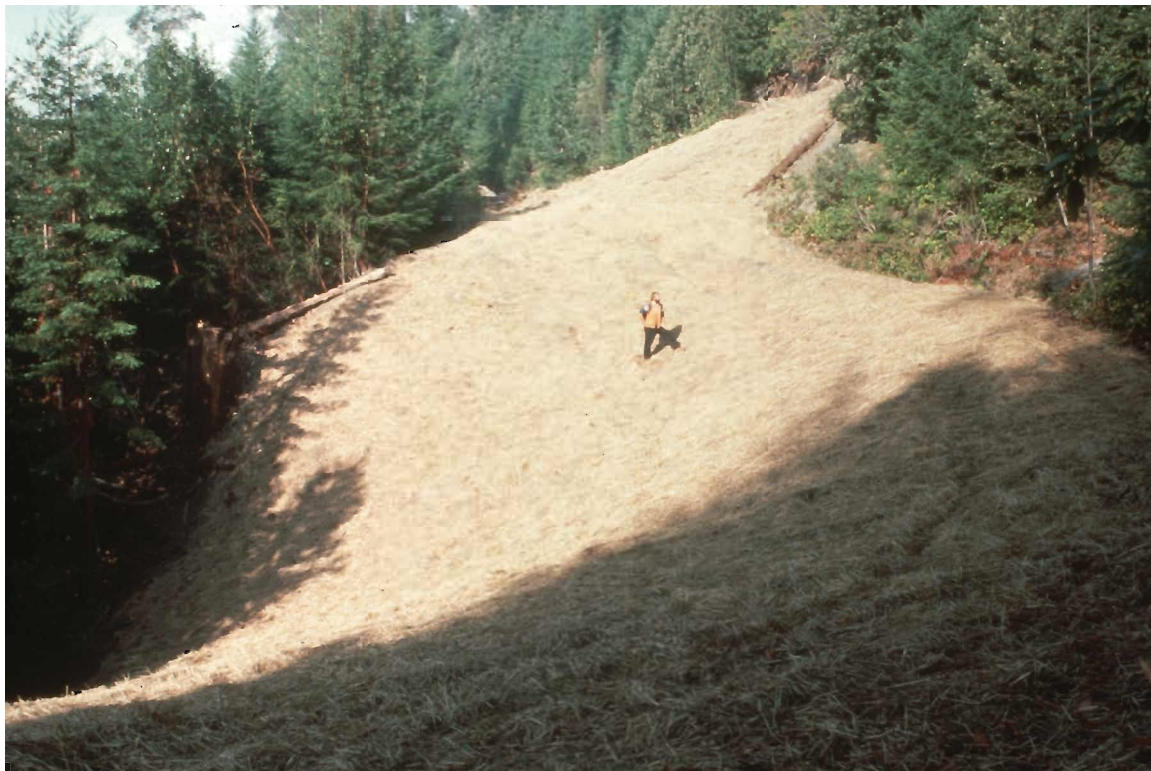
Unit: 86-5 Date: 11-12-1986, PP12, M-3-1-2 STA 60+70 TOS 59+40 post HE, 35mm, (LEJ)

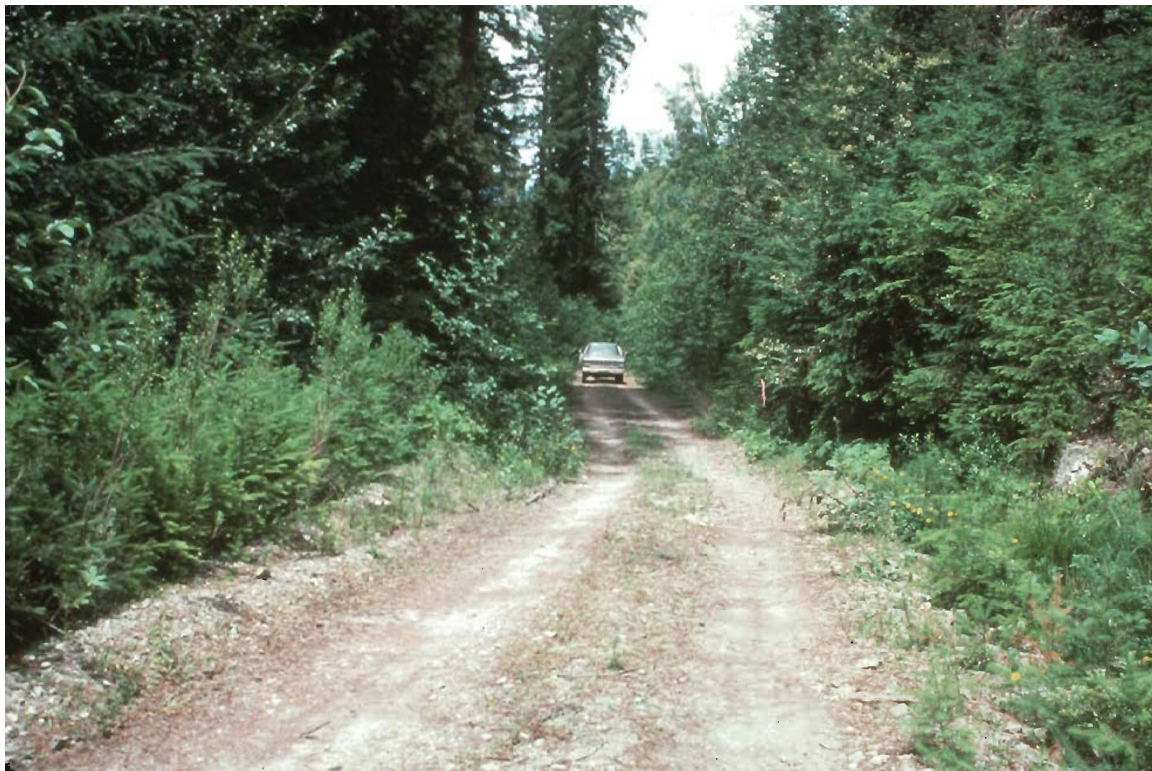
Unit: 86-5 Date: 7-2-1986, PP17, M-3-1-2 STA 88+00 pre HE outsloping, 35mm, (LEJ)

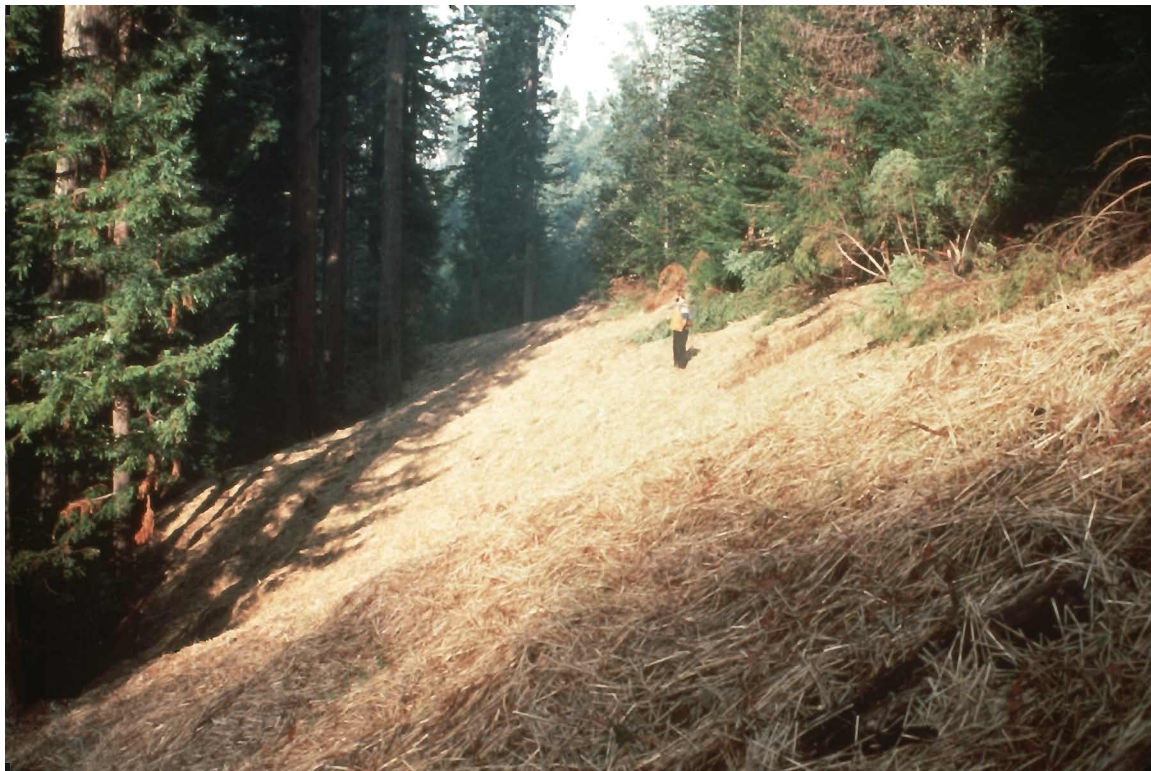
Unit: 86-5 Date: 11-12-1986, PP17, M-3-1-2 STA 88+00 post HE outsloping, 35mm, (LEJ)

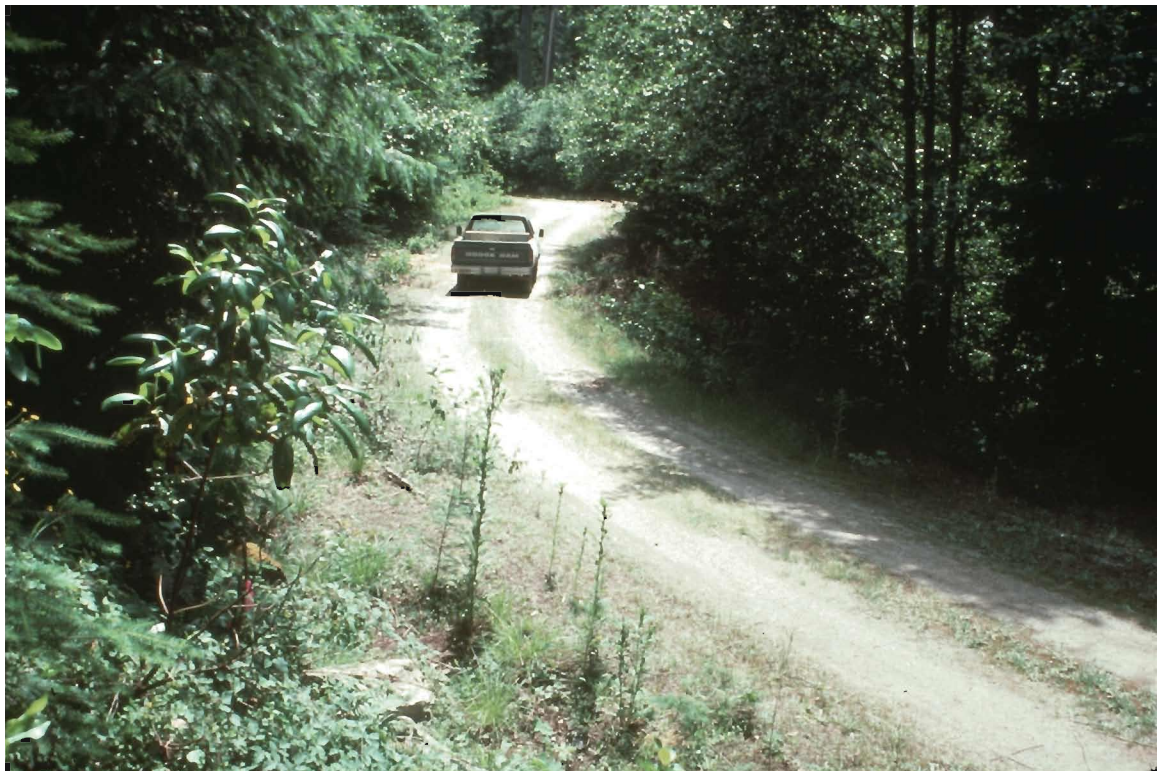
Unit: 86-5 Date: 7-2-1986, PP21, M-3-1-2 STA 112+25 TOS 112+36 pre HE, 35mm, (LEJ)

| Excavation<br>Site<br>Number | Volume<br>(cubic<br>yards) | Contract<br>Bid<br>Cost | ACTUAL EQUIPMENT HOURS: | | | HERE: | | Excavation<br>Rate<br>yd <sup>3</sup> /hour | Ave. Push<br>Dist. to<br>Fillsite<br>(ft.) | \$<br>Saved<br>(contract vs. hourly) | OR<br>vs. | \$<br>Lost |
|---|---|---|---|---|---|---|---|---|---|---|---|---|
| 112 + 36 | 860 | 1,926.00 | 5.5 | 4.5 | 4.5 | 1,337.50 | 1.56 | 59 | 301 | -.- | | 588.50 |

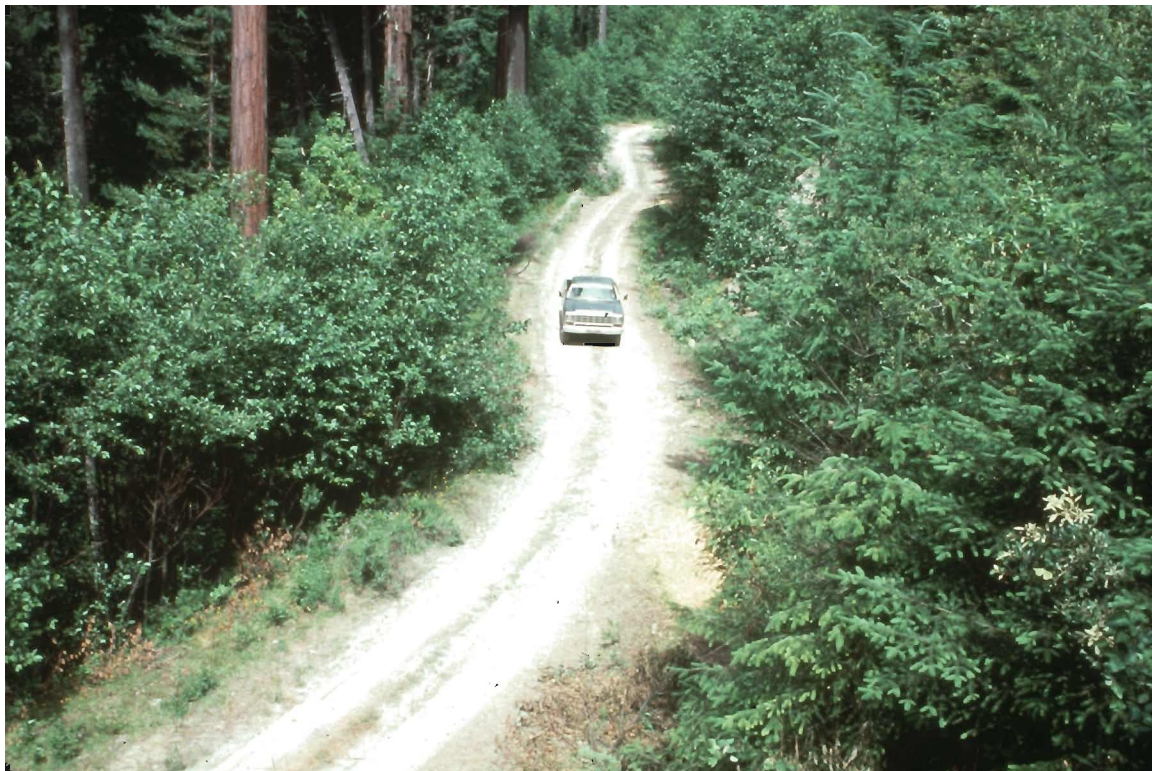
Unit: 86-5 Date: 7-2-1986, PP24, M-3-1-2 STA 124+25 OS looking down sta. pre HE, 35mm, (LEJ)

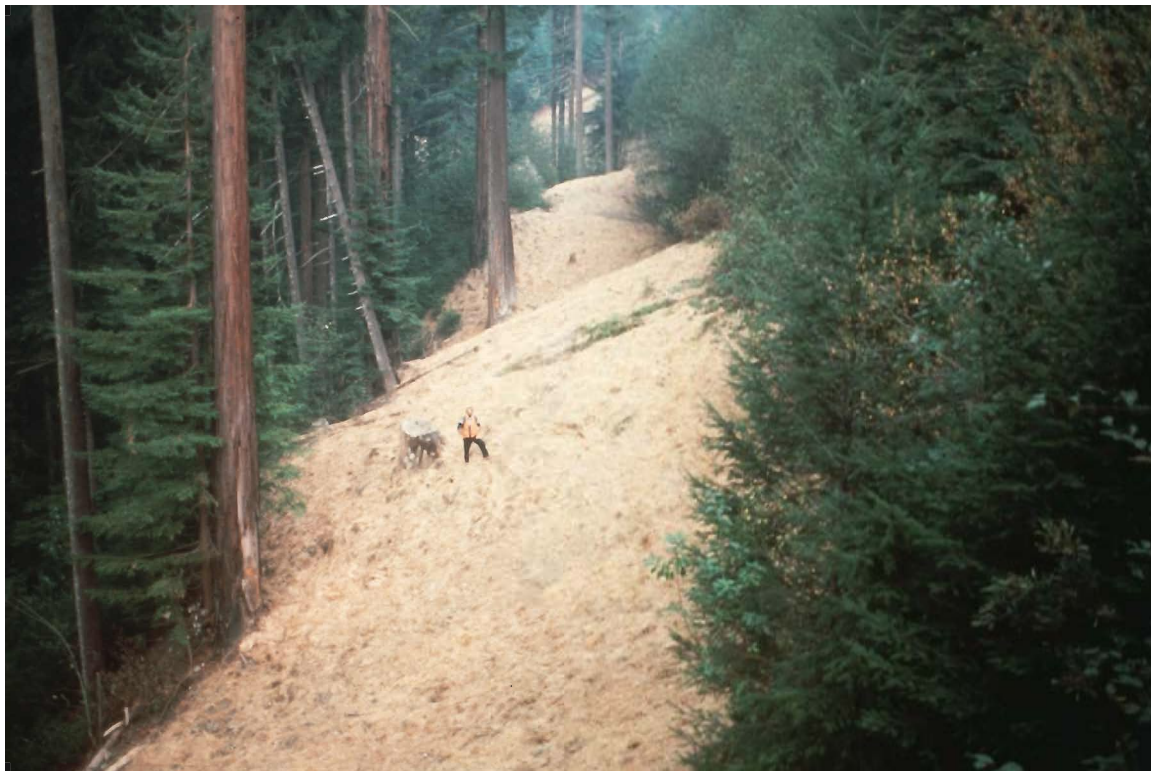
Unit: 86-5 Date: 11-5-1986, PP24, M-3-1-2 STA 124+25 OS looking down sta. post HE, 35mm, (LEJ)
