**M-3-1 ROAD AND SLOPE  
WORK AND COST SUMMARY REPORT  
WATERSHED REHABILITATION UNIT 83-2**

**December 1983**

**Terry Spreiter  
Louise Johnson**

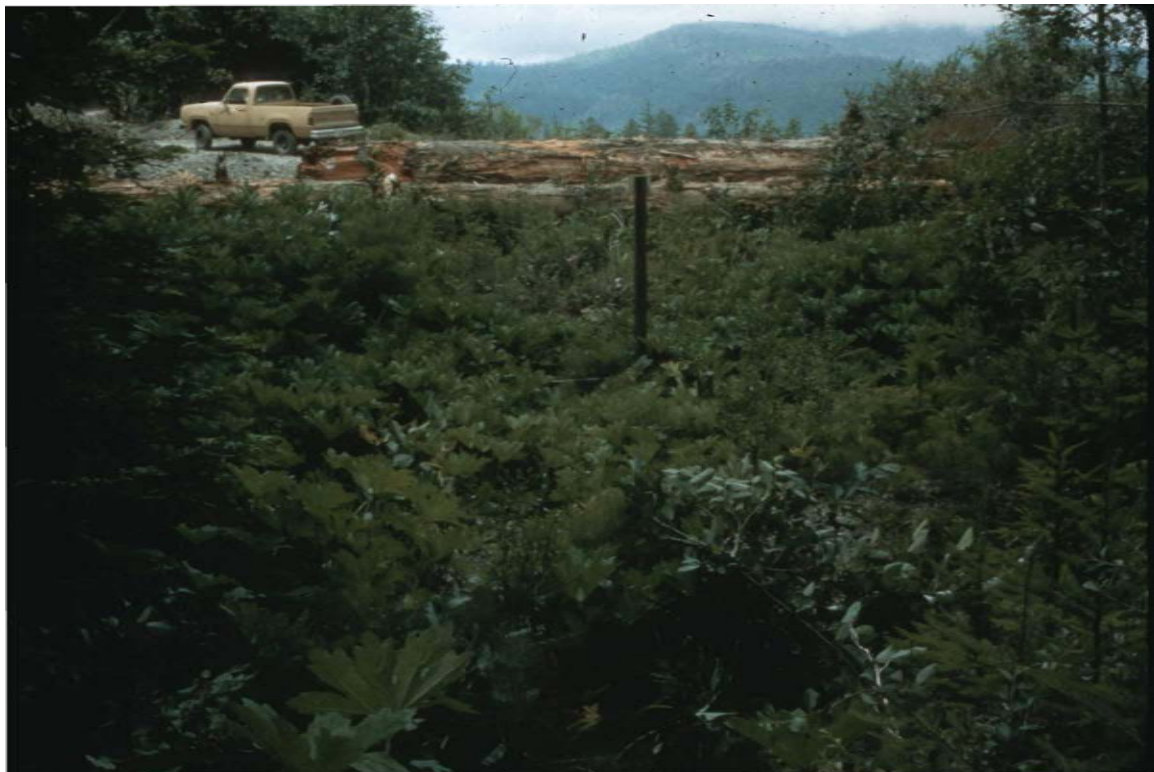
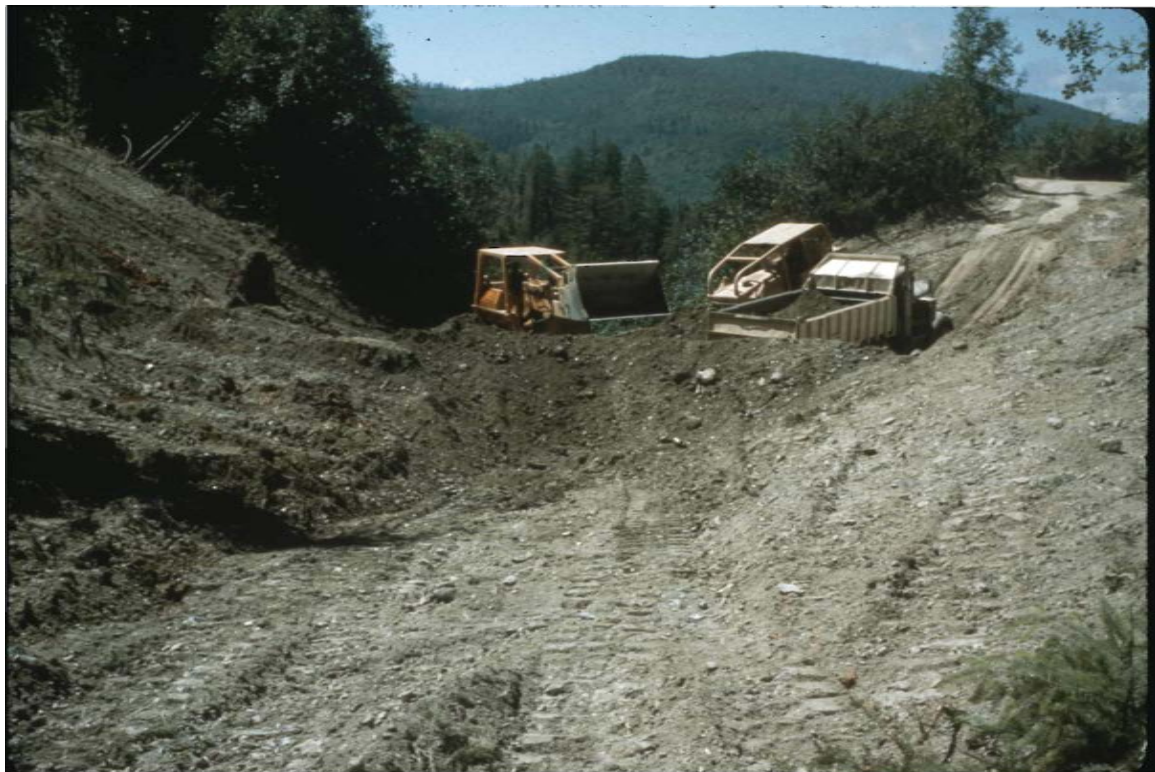
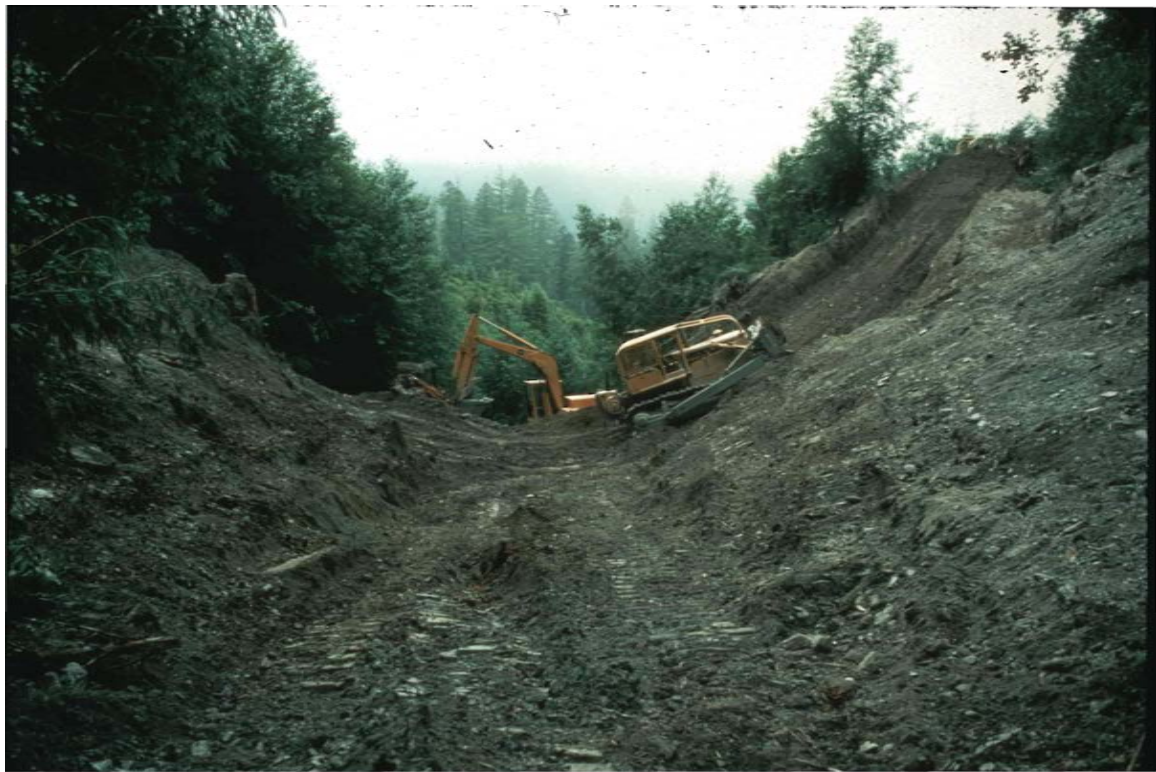
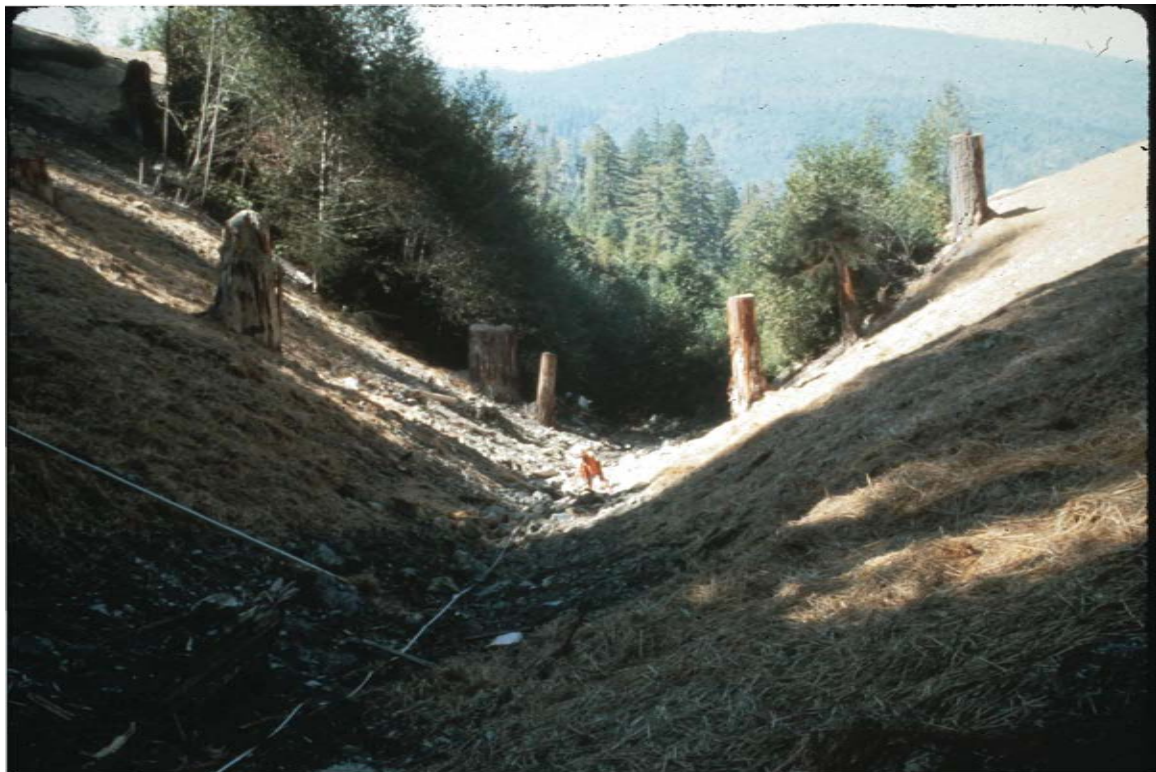
Unit: 83-2 1-A 7/19/83 PP#20 RX-5

Unit: 83-2 1-B 8/8/83 PP#20 RX-5

Unit: 83-2 1-C 8/9/83 PP#20 RX-5

Unit: 83-2 1-D 10/4/83 PP#20 RX-5

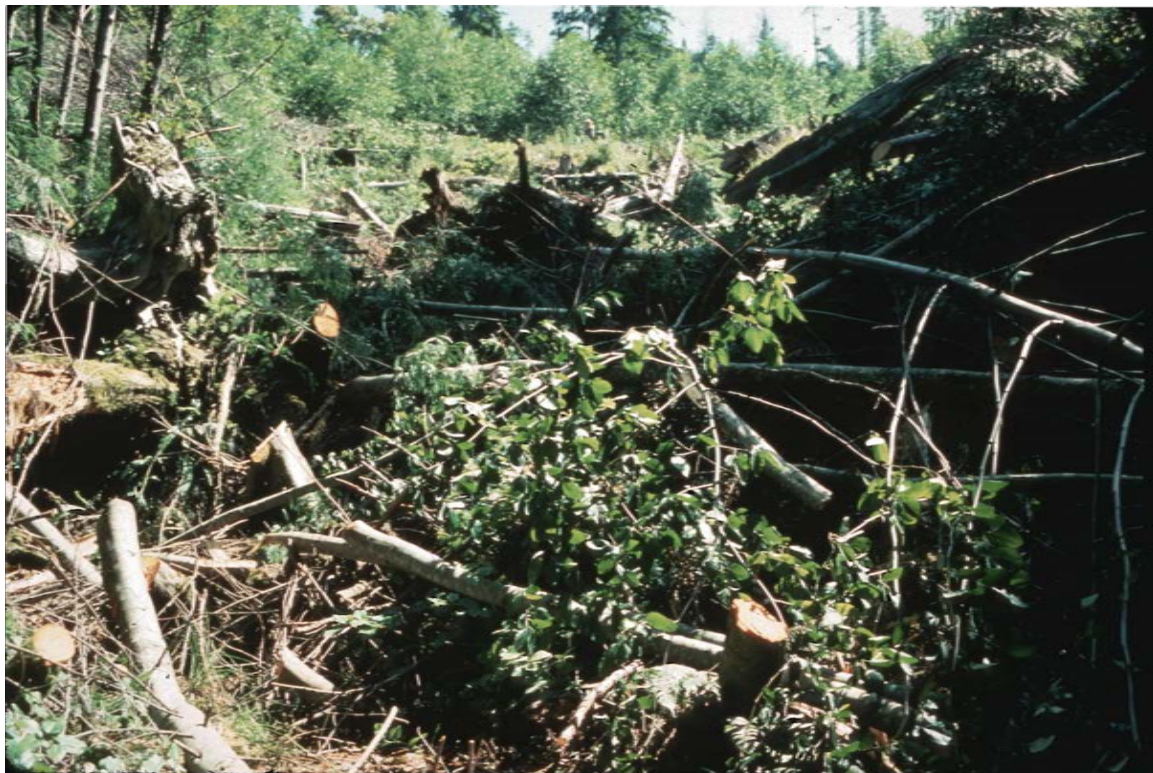
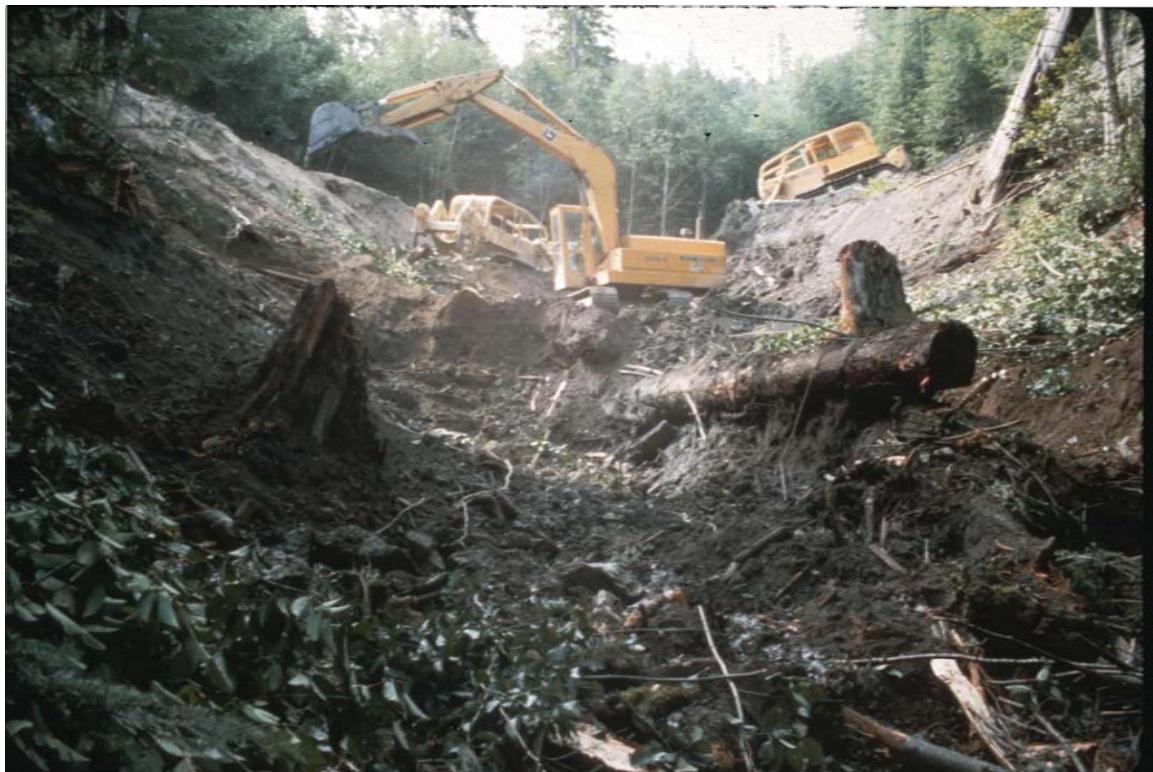
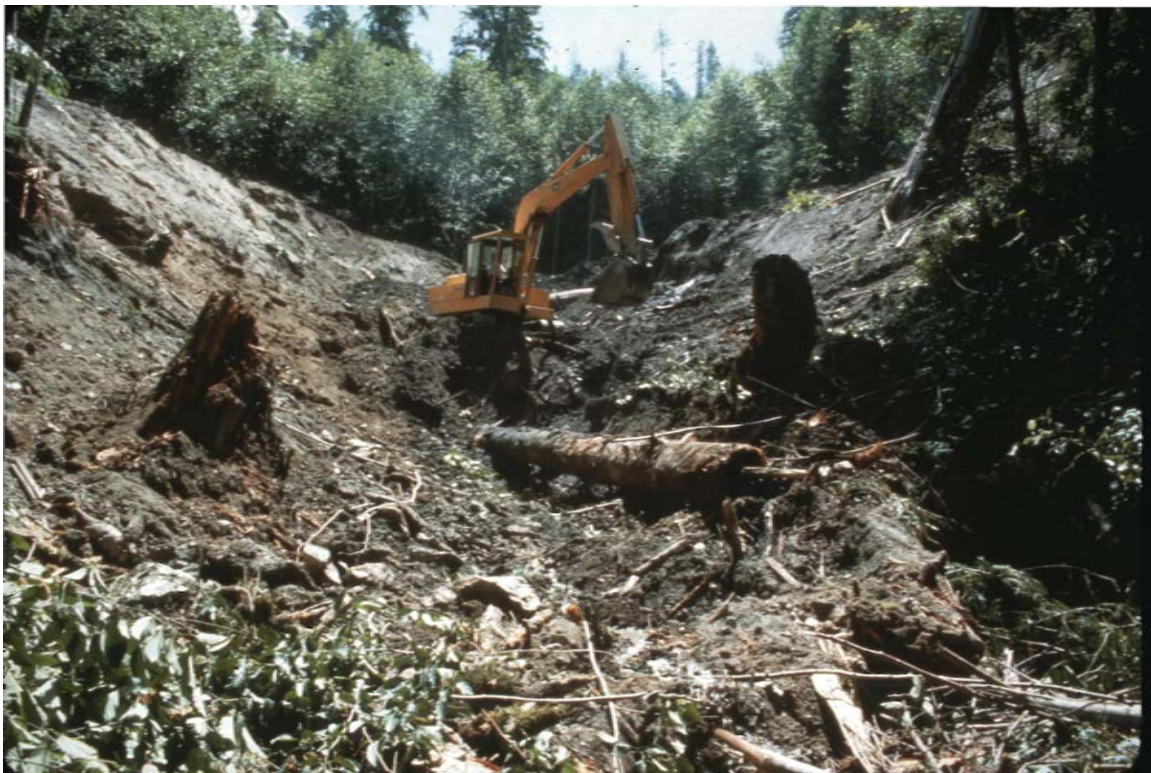
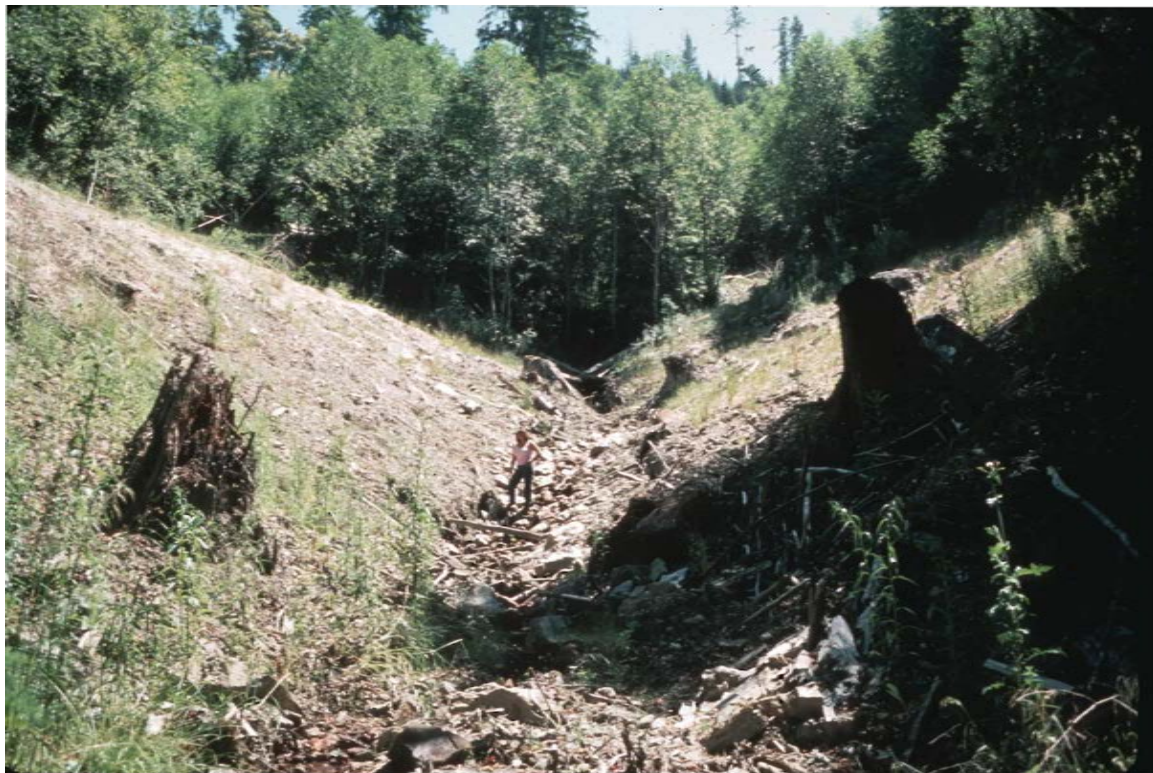
Unit: 83-2 2-A 7/12/83 PP#17 RX-4

Unit: 83-2 2-B 7/22/83 PP#17 RX-4

Unit: 83-2 2-C 7/27/83 PP#17 RX-4

Unit: 83-2 2-D 10/4/83 PP#17 RX-4

A 75' high, 100' long cutbank failure occurred on the north (left) bank of Rx-4, on March 31, 1983 following 4.59 inches of rain in 3 days (in Orick).

This area had already been mapped; no springs were present along the cutbank and there were no signs of potential failure. The slide brought down several hundred cubic yards of logs and stumps; <sup>most</sup> piled up on the road but overflowed approximately 50 yd<sup>3</sup> into the creek. Most of this debris was caught by a log jam, and was removed during channel excavation. The slide initiated on a skid trail; there was a small spring in the cutbank of the skid trail and for several days following <sup>the failure</sup> a spring was visible 3 - 4 feet below the top of the scarp. A similar failure happened in 1972 about 100 feet down the road. Both slides are in Devils Creek soil. The slide adjacent to the crossing was bench outsloped, as it seemed likely that additional, hopefully smaller slides and raveling would occur as the main feature stabilized. The older slide, further from the stream, was total outsloped.

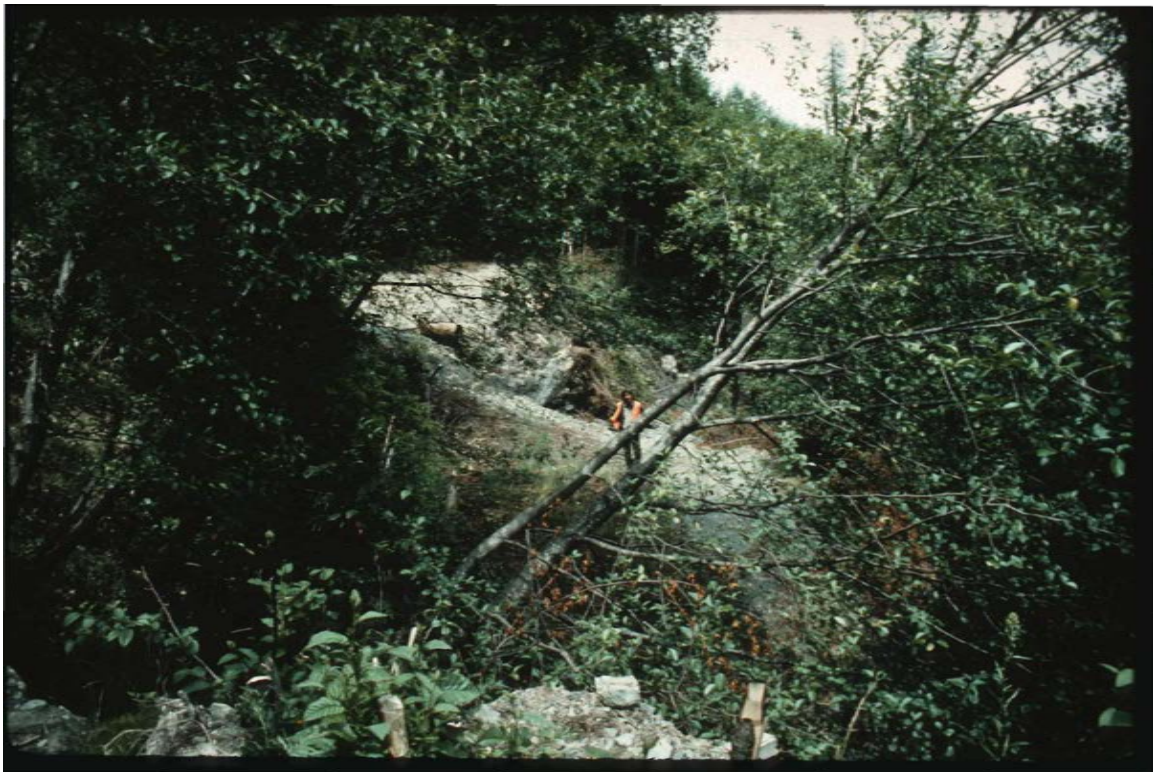
Unit: 83-2 PP#70 Landslide, Pre H.E.

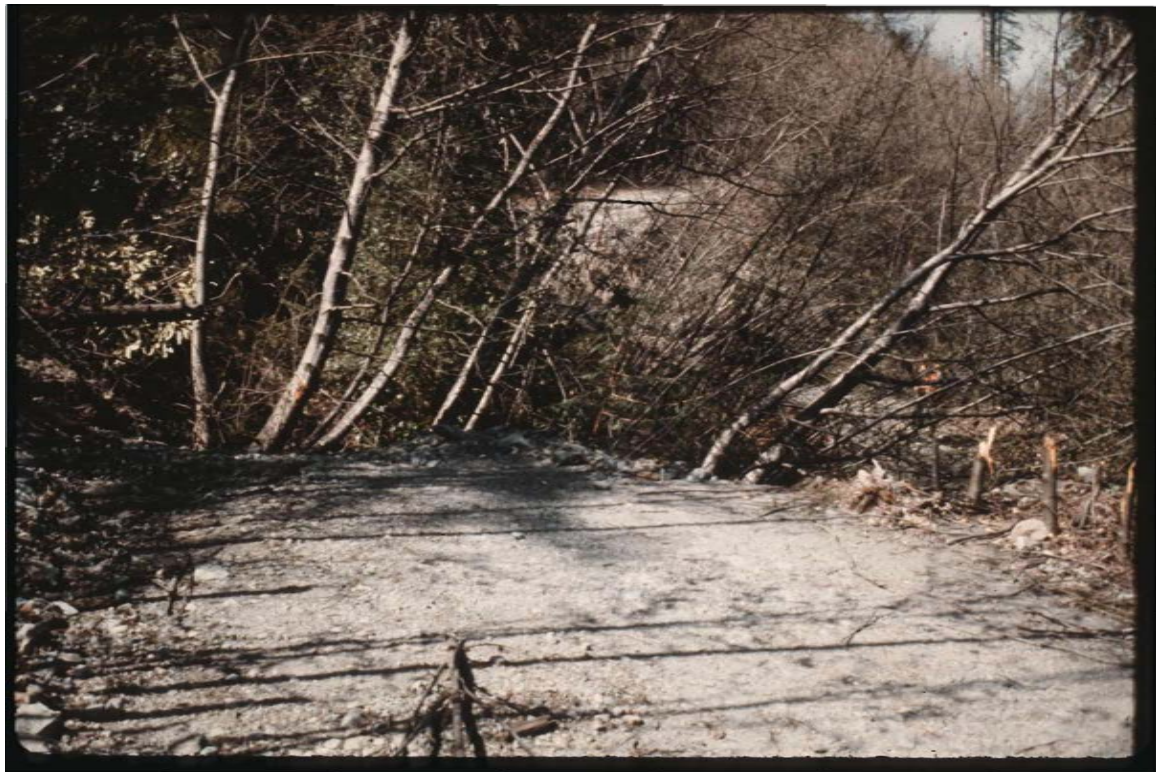
Unit: 83-2 PP#70 Landslide. 4/5/83

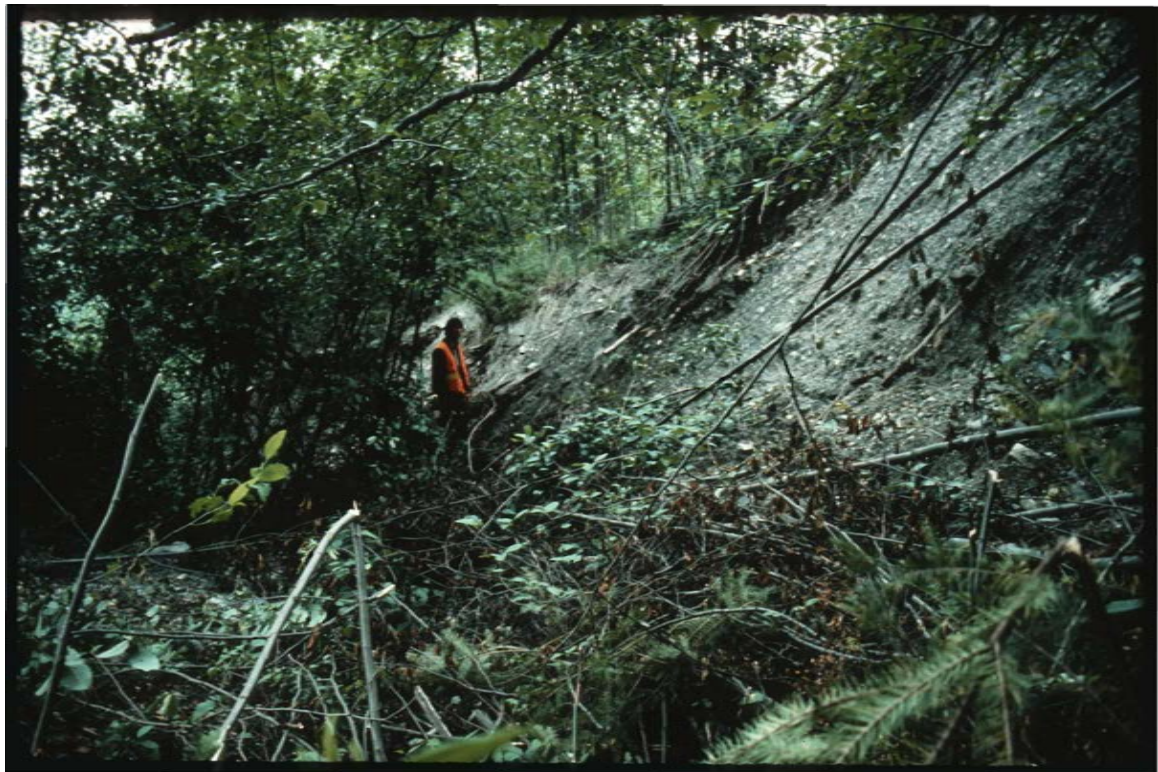
Unit: 83-2 PP#71 Landslide, headscarp.

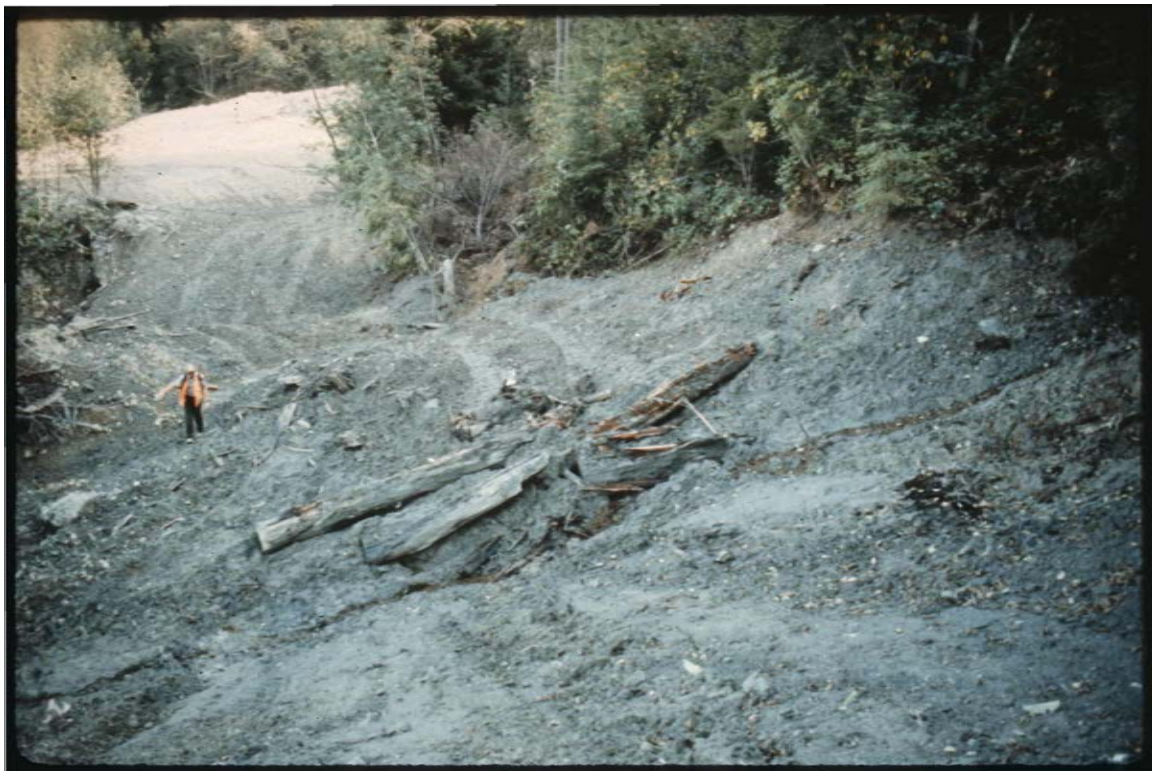
Unit: 83-2 PP#75 Active Landslide toe.
