The M-4½ and M-5 Roads and Slope  
Watershed Rehabilitation Project

Unit 86-3

Louise E. Johnson

January 1988

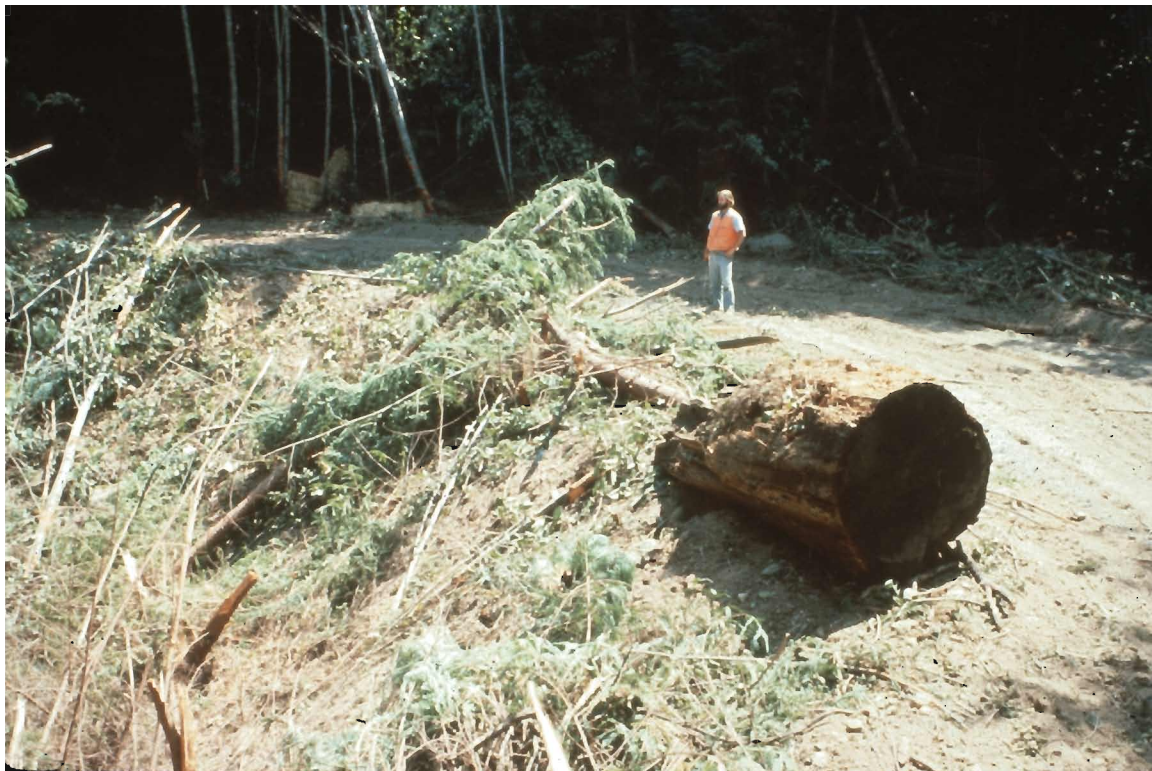
Unit: 86-3 Date: 8-6-1986, PP1 M-5 Rx-7 pre HE, 35mm, (LEJ)

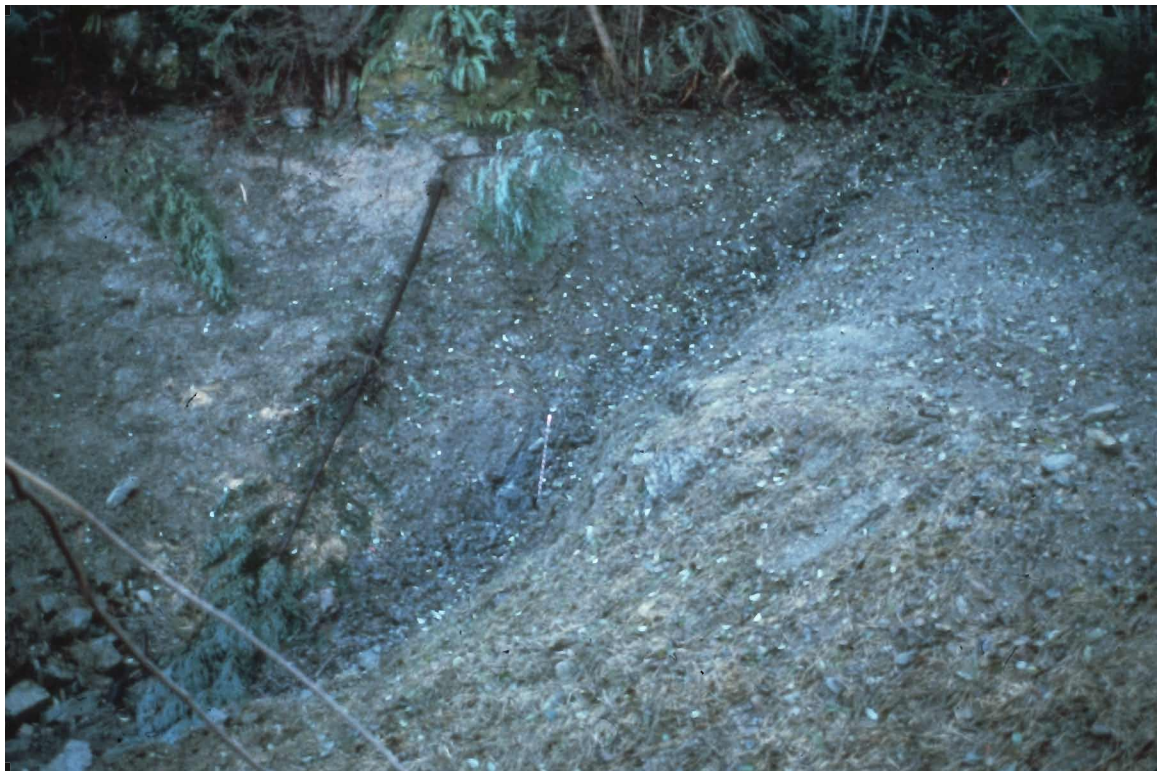
Unit: 86-3 Date: 12-1-1986, PP1 M-5 Rx-7 post HE, 35mm, (LEJ)

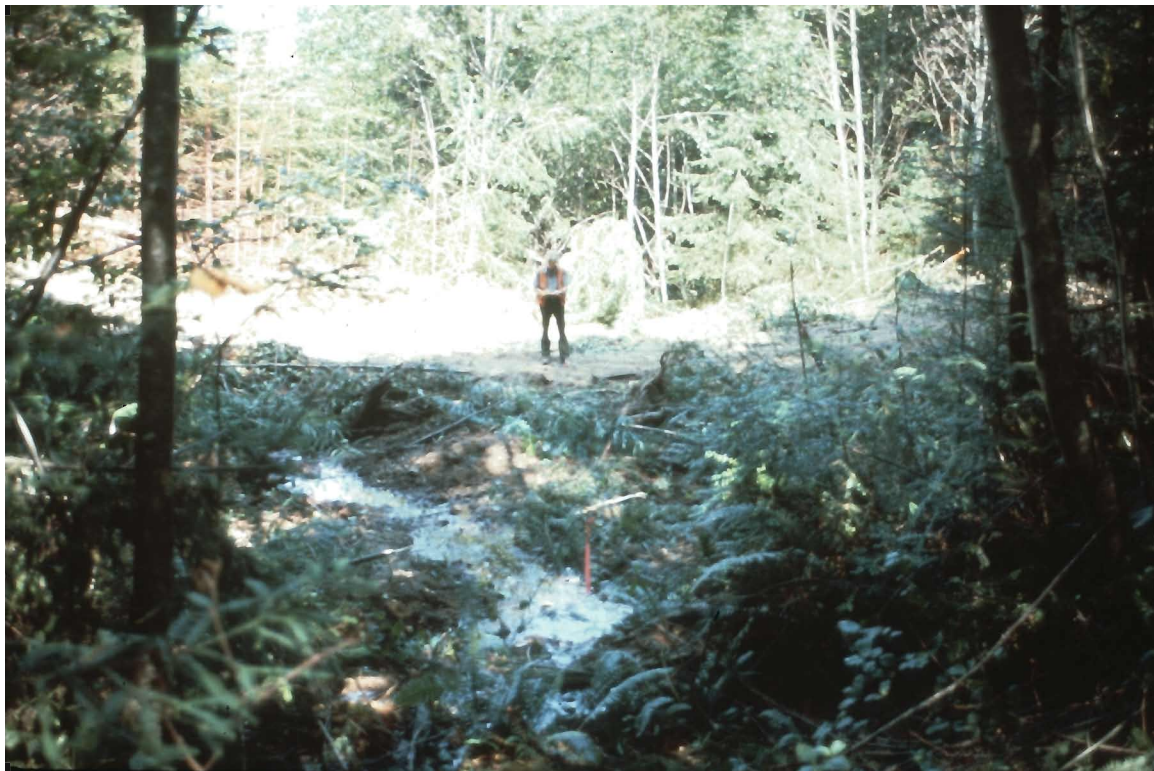
Unit: 86-3 Date: 8-6-1986, PP2 M-5 Rx-7 pre HE, 35mm, (LEJ)

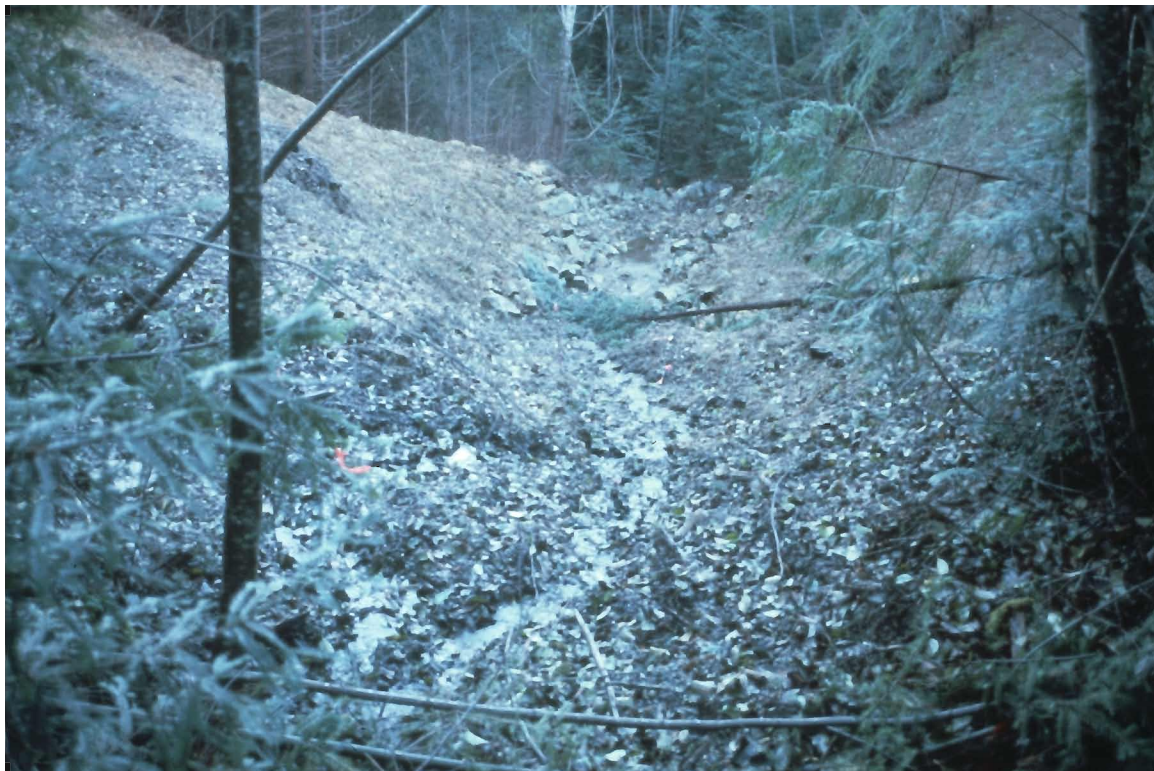
Unit: 86-3 Date: 12-1-1986, PP2 M-5 Rx-7 post HE, 35mm, (LEJ)

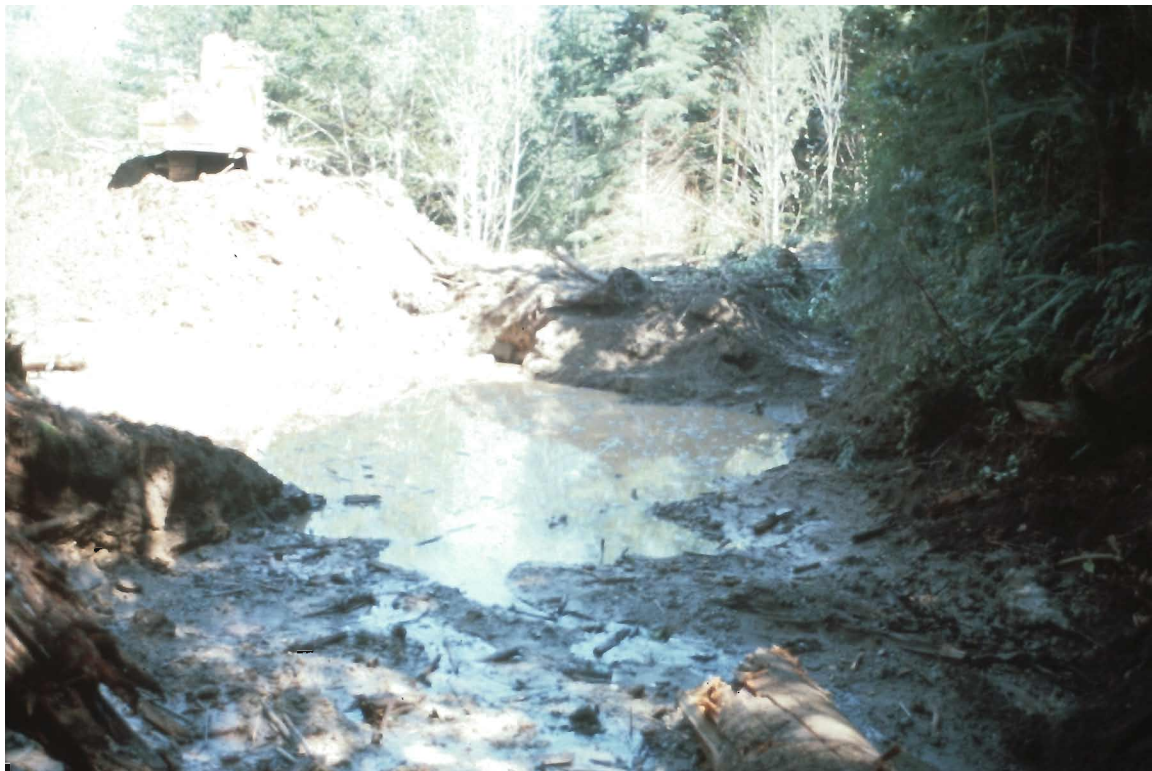
Unit: 86-3 Date: 9-8-1986, PP9 M-5 Rx-4 pre HE, 35mm, (LEJ)

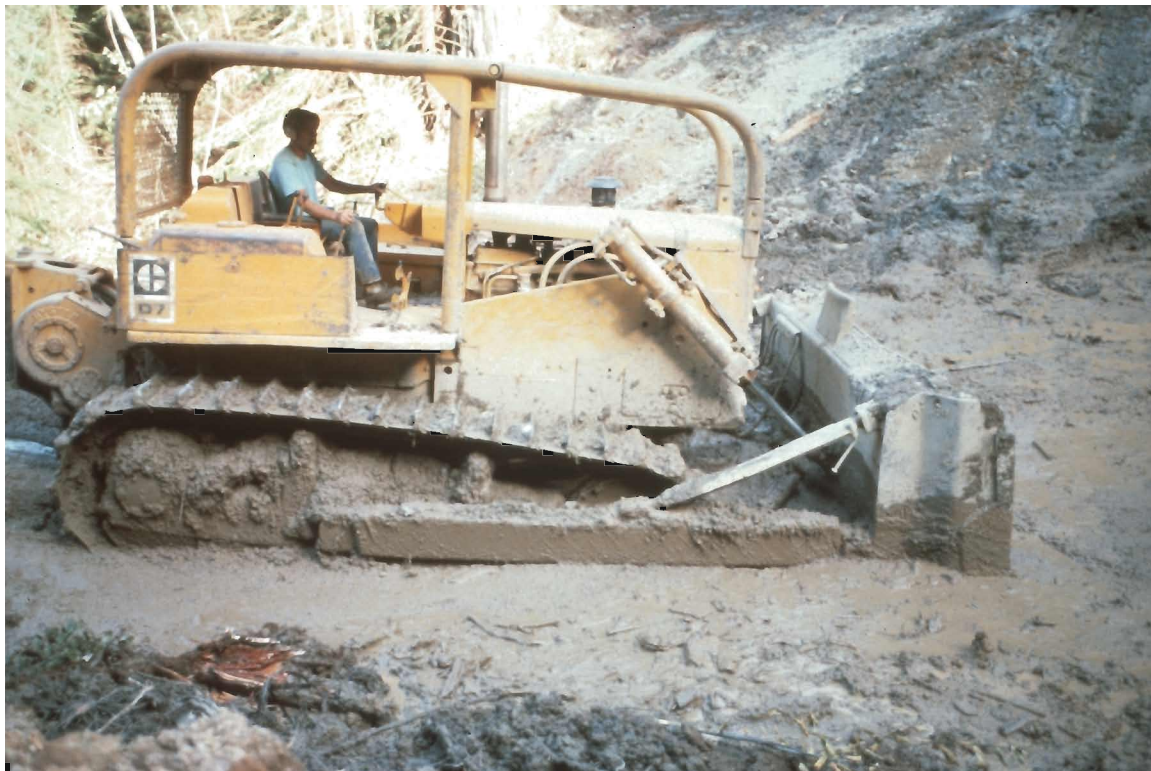
and instead "flowed" out on either side. The solution to this problem would have been a large perforated soup ladle to transport this oozing mess to the fillsite. In addition, few fillsites were located nearby or on a downhill grade. Many skid trail crossings had fillsites located up 30-50 percent skid trail grades and around tight turns. And on several large haul road crossings the fillsite push distances were greater than 250 feet. On top of all these other problems, it was not uncommon to have one to two pieces of equipment stuck in the "muck" during the course of an excavation, not once but several times. All of these factors added up to a severe reduction in the overall excavation production rates for unit 86-3, which is reflected by the substantially higher unit costs (compared to similar worksites on past rehabilitation units).

Unit: 86-3 Date: 9-5-1986, PP9 M-5 Rx-4 action HE Back-blading "soup", 35mm, (LEJ)

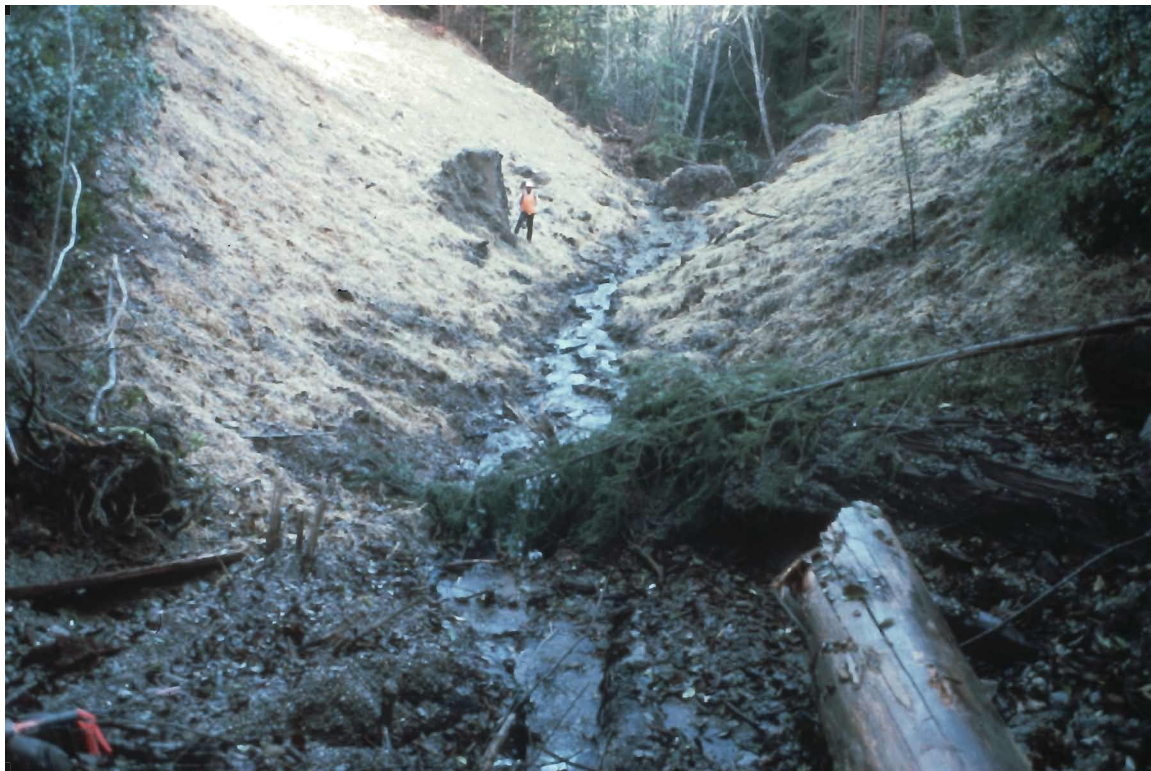
Unit: 86-3 Date: 12-2-1986, PP9 M-5 Rx-4 post HE, 35mm, (LEJ)

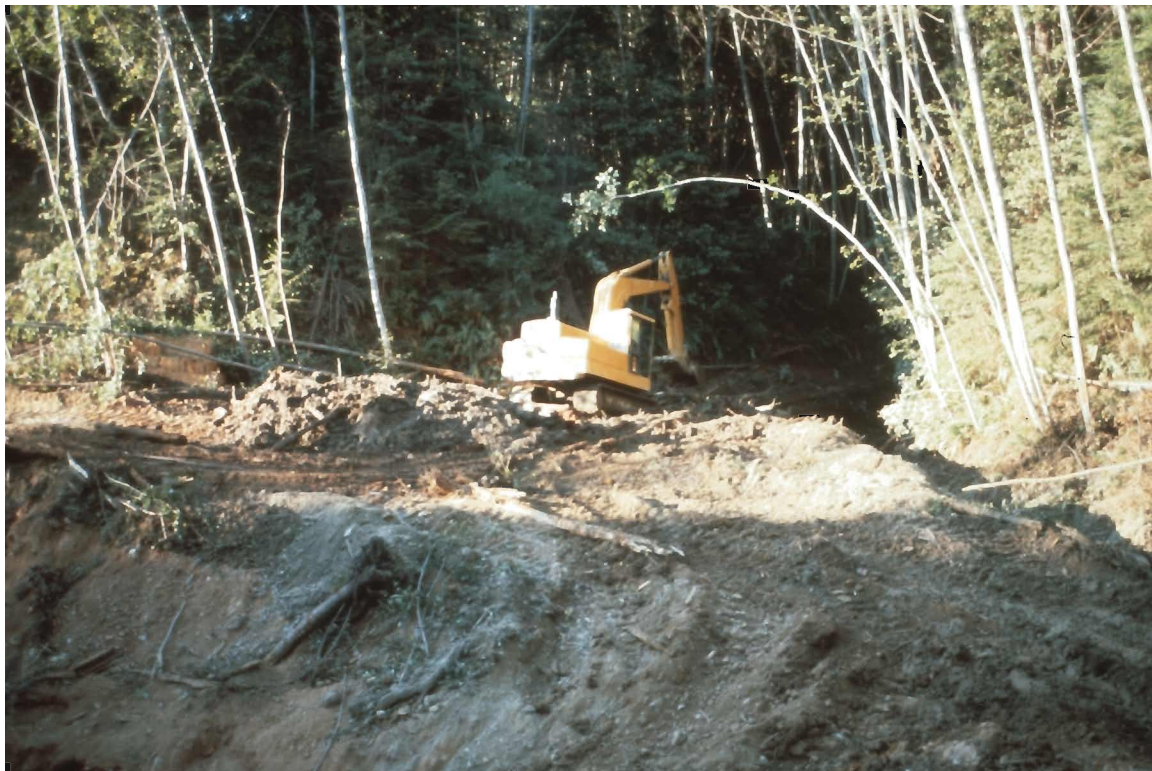
Unit: 86-3 Date: 9-8-1986, PP10A M-5 Rx-3 pre HE, 35mm, (LEJ)

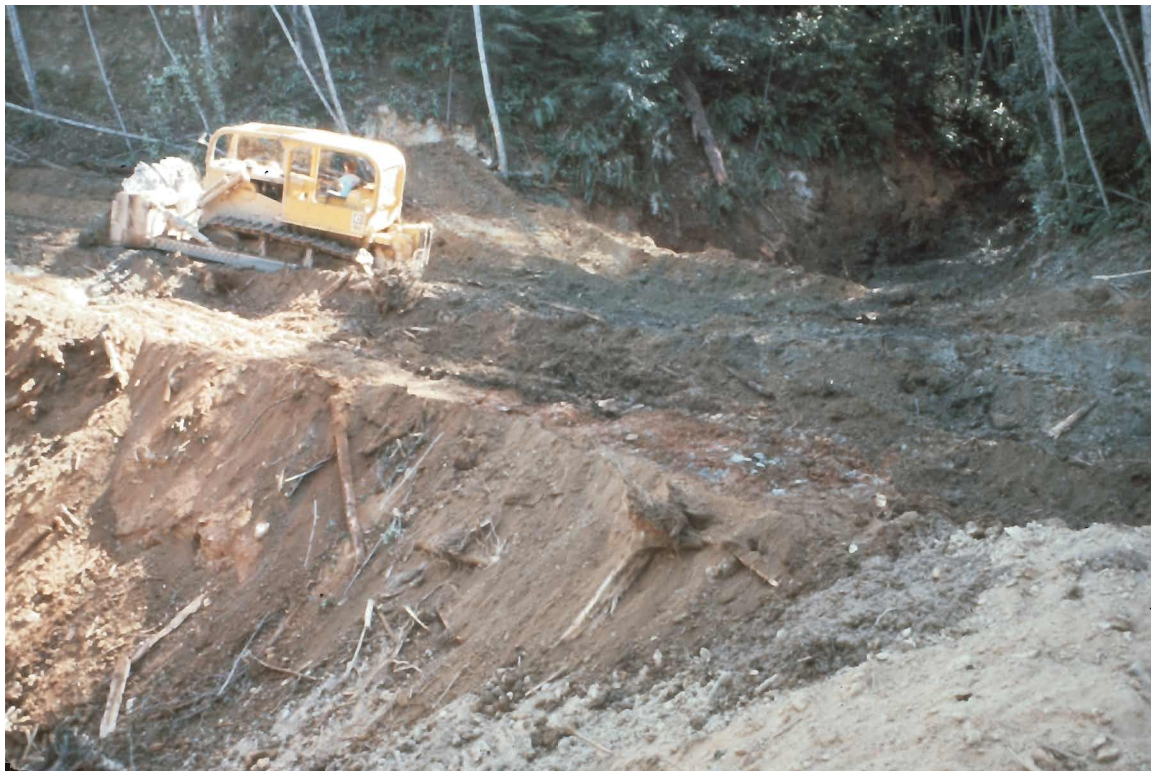
Unit: 86-3 Date: 9-1986, PP10A M-5 Rx-3 action HE, 35mm, (LEJ)

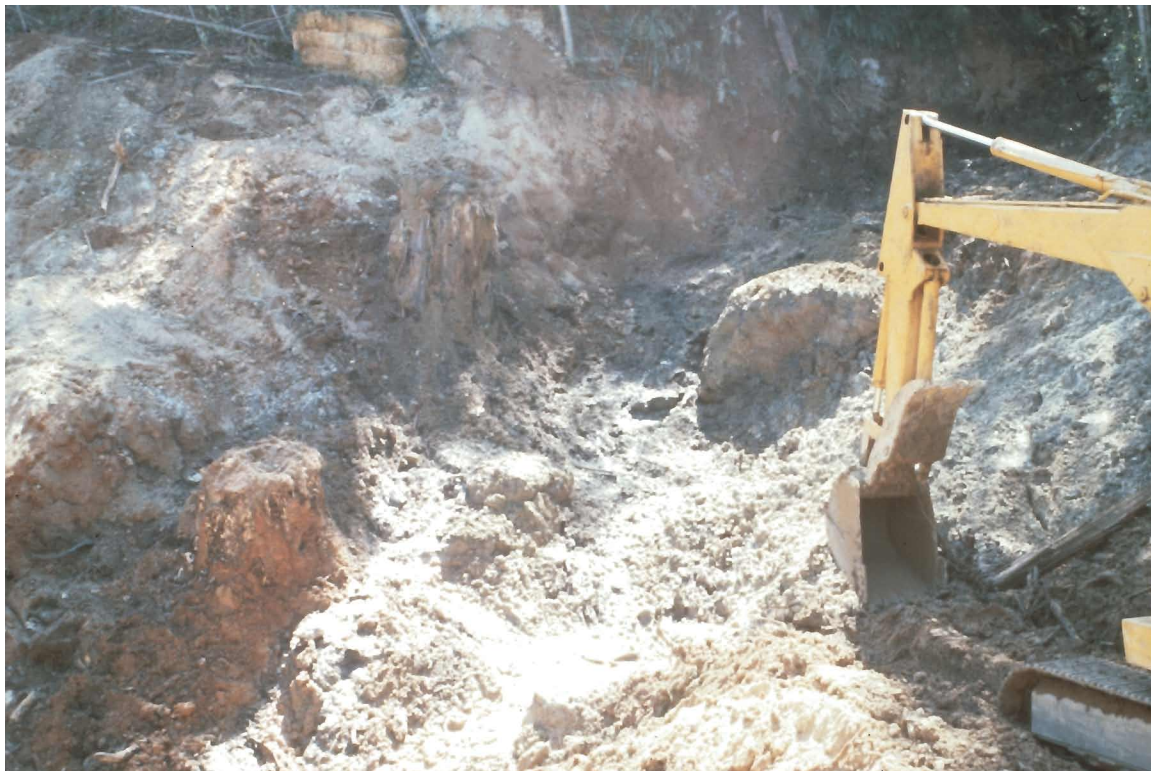
Unit: 86-3 Date: 9-1986, PP10A M-5 Rx-3 action HE, 35mm, (LEJ)

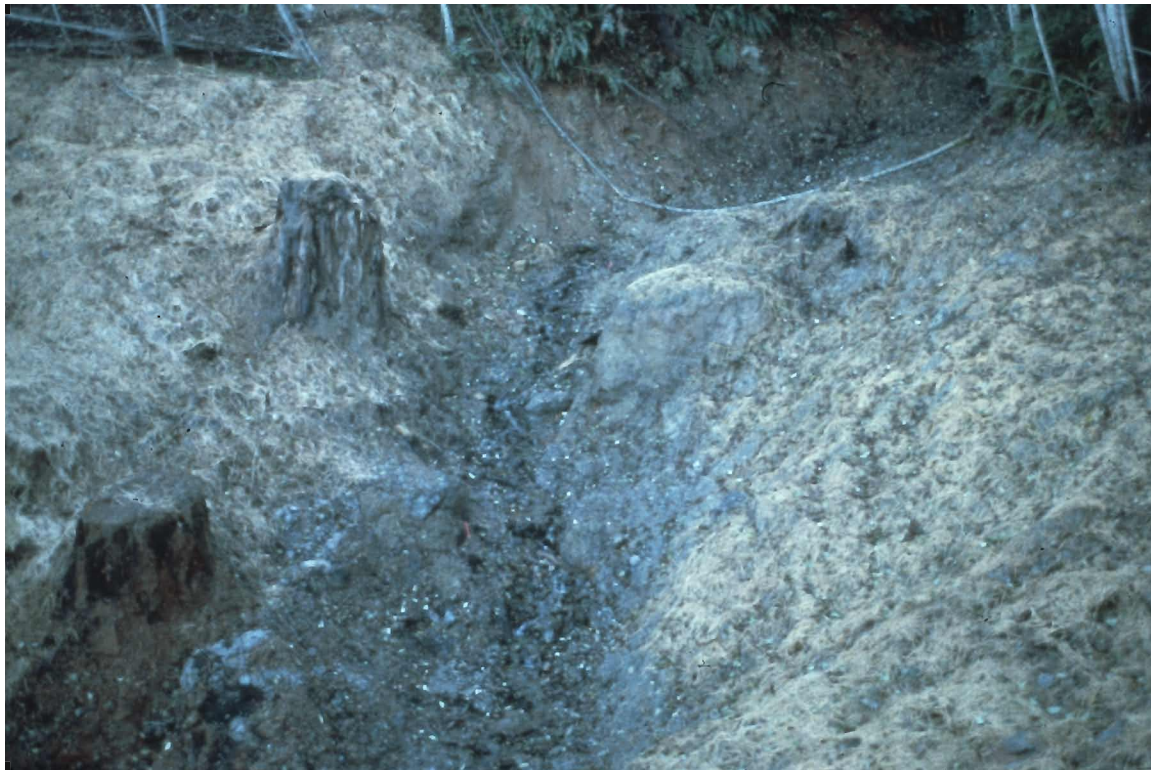
Unit: 86-3 Date: 12-1-1986, PP10A M-5 Rx-3 post HE, 35mm, (LEJ)

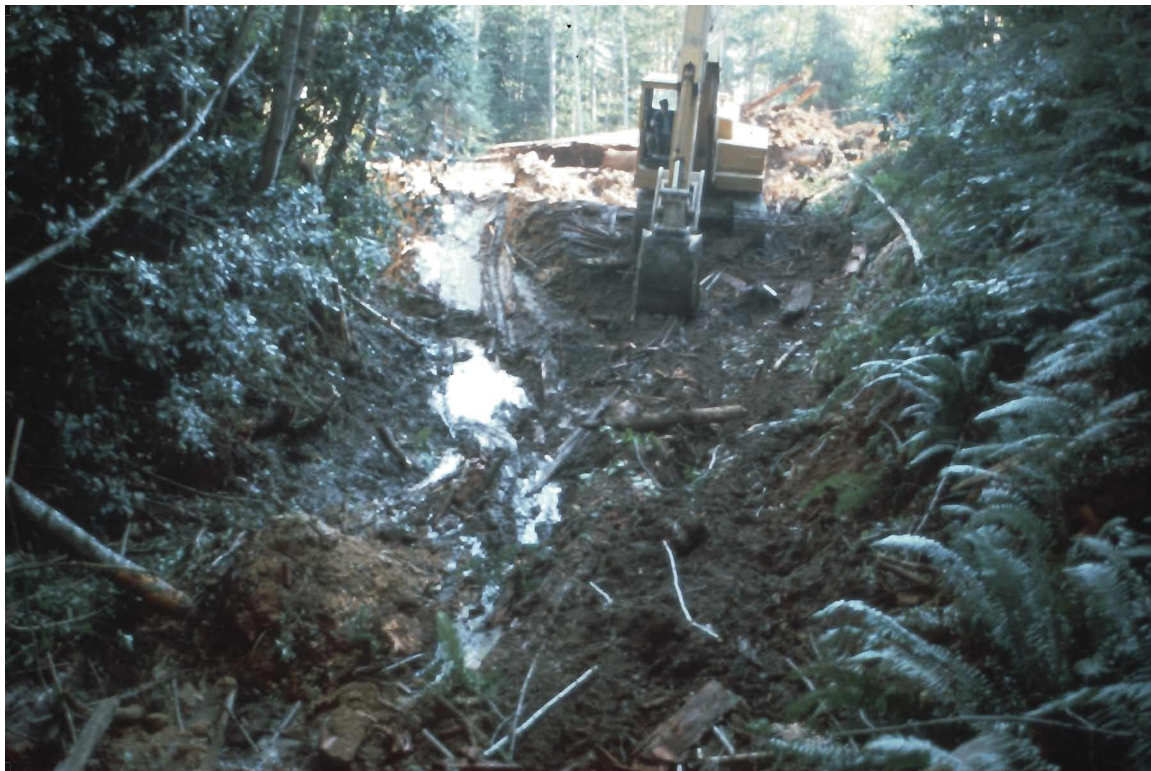
Unit: 86-3 Date: 9-8-1986, PP11 M-5 Rx-3 pre HE, 35mm, (LEJ)

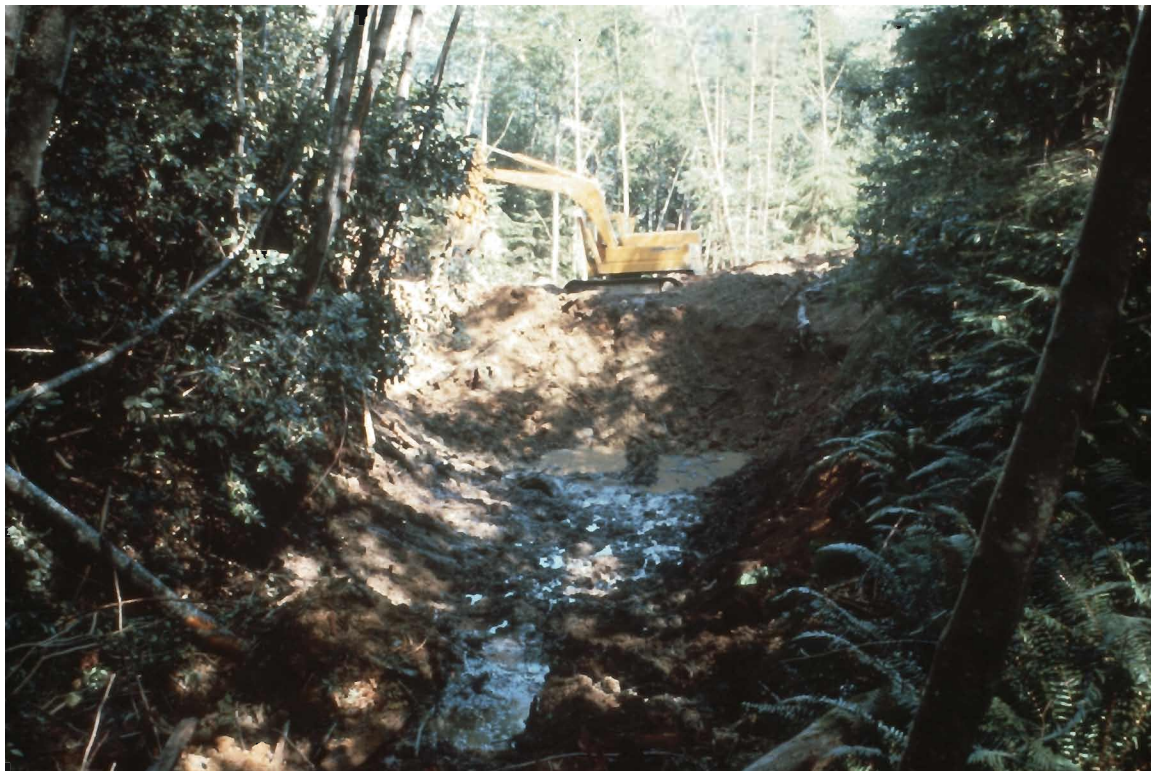
Unit: 86-3 Date: 9-1986, PP11 M-5 Rx-3 action HE, 35mm, (LEJ)

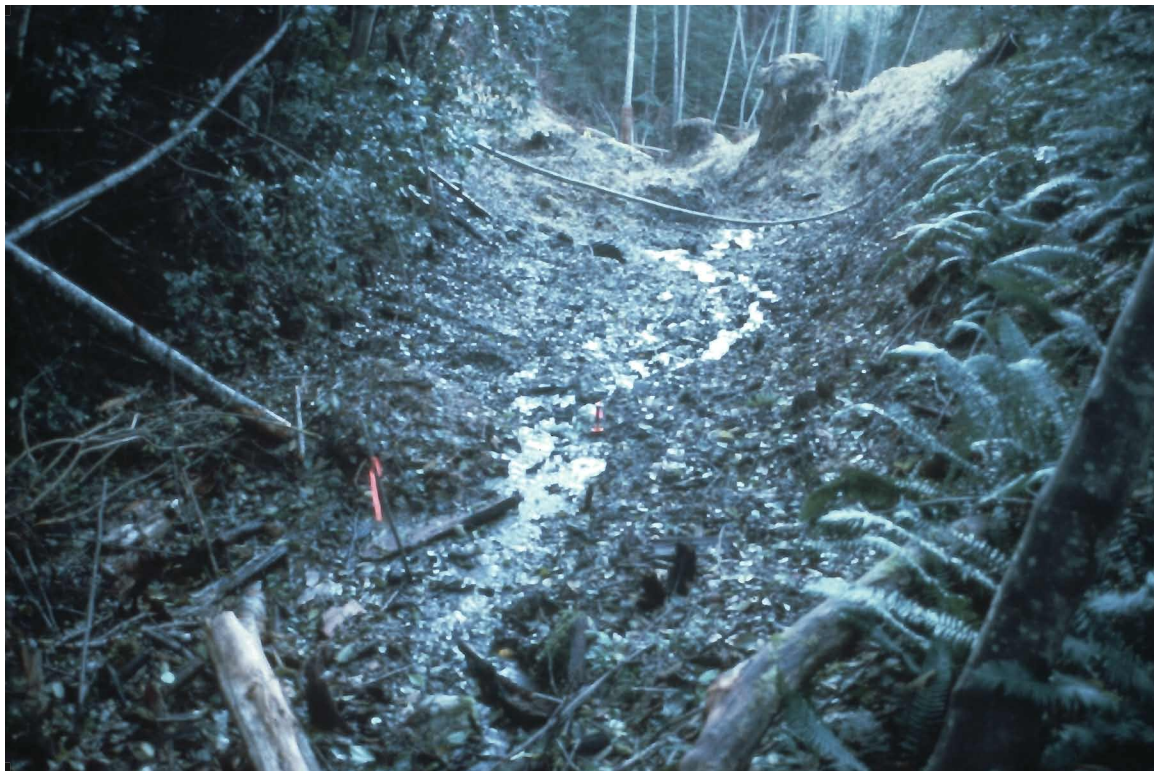
Unit: 86-3 Date: 12-1-1986, PP11 M-5 Rx-3 post HE, 35mm, (LEJ)
