**QUALITATIVE EVALUATION OF THE EFFECTS OF CHANGING WATERSHED LAND USES  
ON THE  
HYDROLOGY, CHANNEL MORPHOLOGY AND HISTORICAL USES OF VALLEY CREEK,  
VALLEY FORGE NATIONAL HISTORICAL PARK, PENNSYLVANIA**

**Technical Report NPS/NRWRD/NRTR-90/08**

**U.S. Department of Interior • National Park Service**

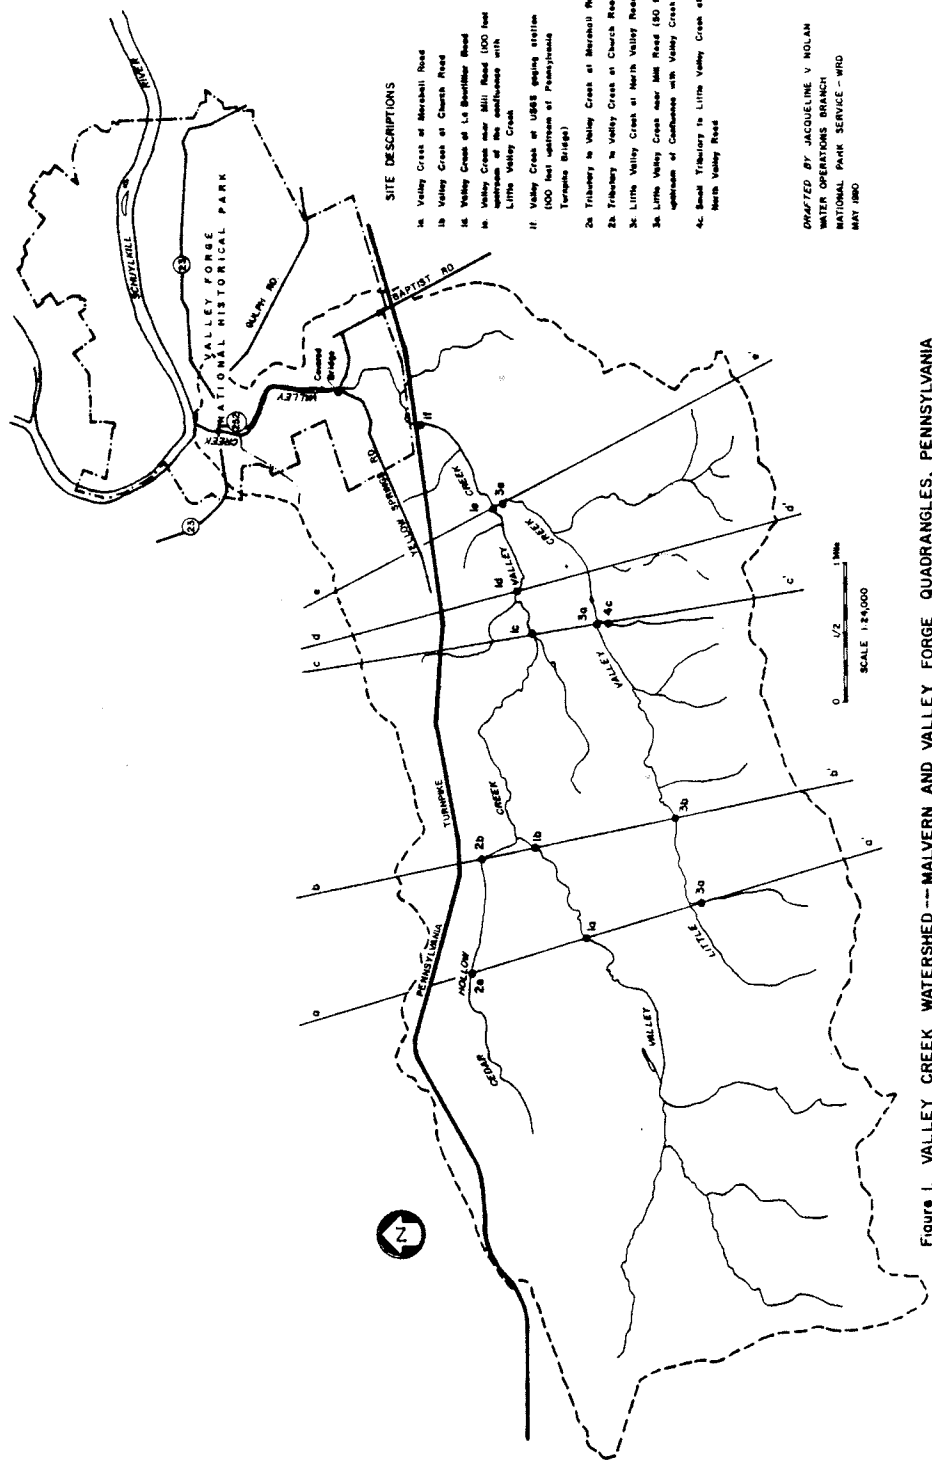
Figure 1. VALLEY CREEK WATERSHED -- MALVERN AND VALLEY FORGE QUADRANGLES, PENNSYLVANIA

**SITE DESCRIPTIONS**

- 1a Valley Creek at Marshall Road
- 1b Valley Creek at Church Road
- 1c Valley Creek at La Bontelle Road
- 1d Valley Creek near Mill Road 100 feet upstream of the confluence with Little Valley Creek
- 2a Valley Creek at USGS gauging station 100 feet upstream of Pennsylvania Turnpike Bridge
- 2b Tributary to Valley Creek at Marshall Road
- 2c Tributary to Valley Creek at Church Road
- 2d Little Valley Creek at North Valley Road
- 3a Little Valley Creek near Mill Road 150 feet upstream of confluence with Valley Creek
- 3b Small Tributary to Little Valley Creek at North Valley Road
- 4c Small Tributary to Little Valley Creek at North Valley Road

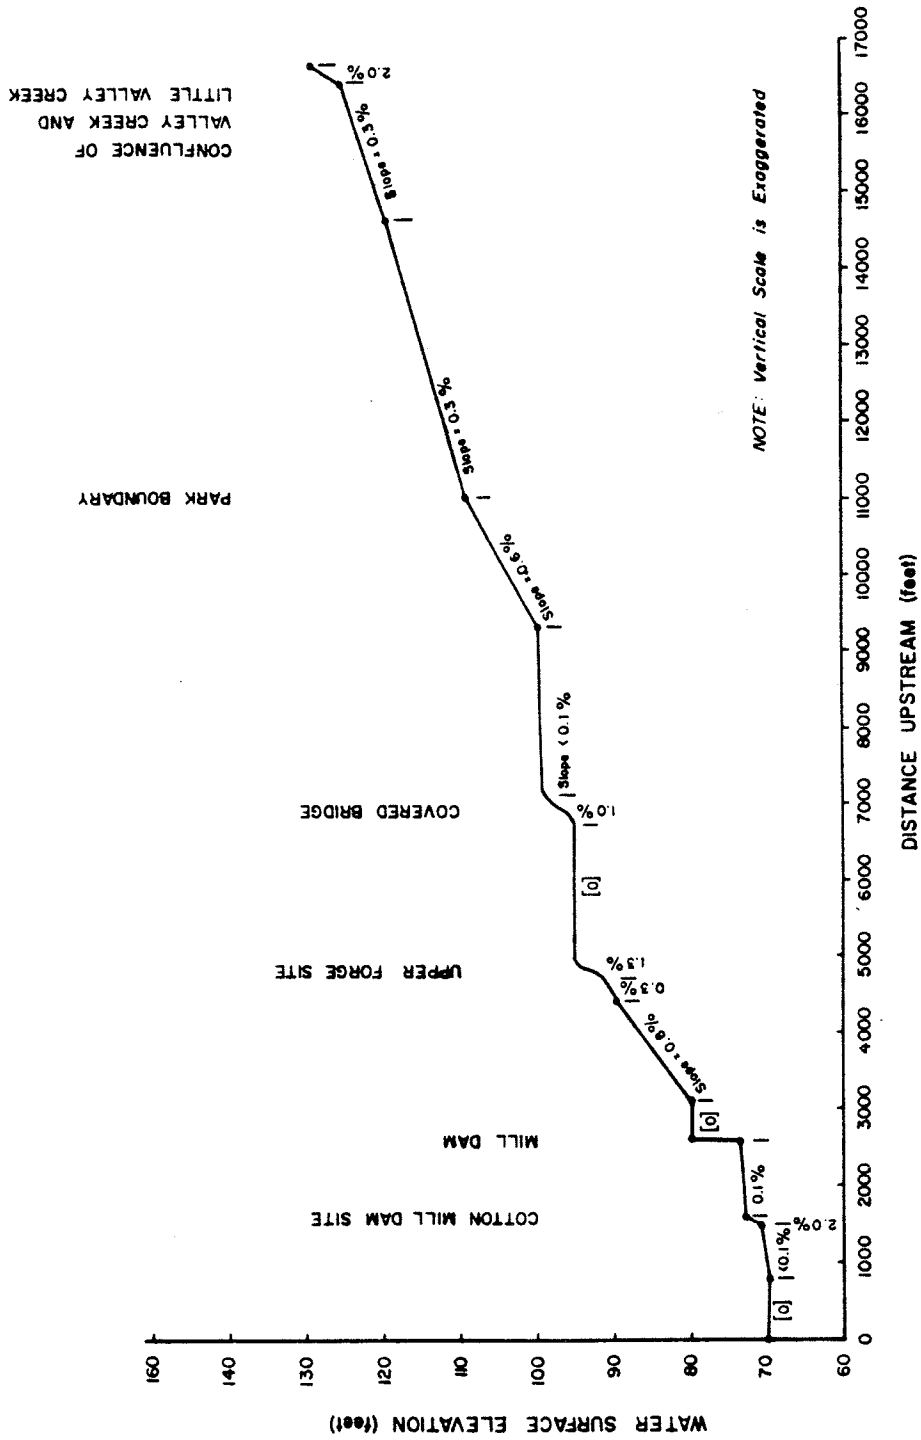
Figure 4. WATER SURFACE PROFILE--EXISTING CONDITIONS, VALLEY CREEK, VALLEY FORGE NHP

channel away from the upper forge site. Later, in 1931, the middle dam was reconstructed. This dam, although small by comparison with the former textile mill dam, does provide base control, i.e., it is a structurally controlled break in the water surface profile (Figure 4).

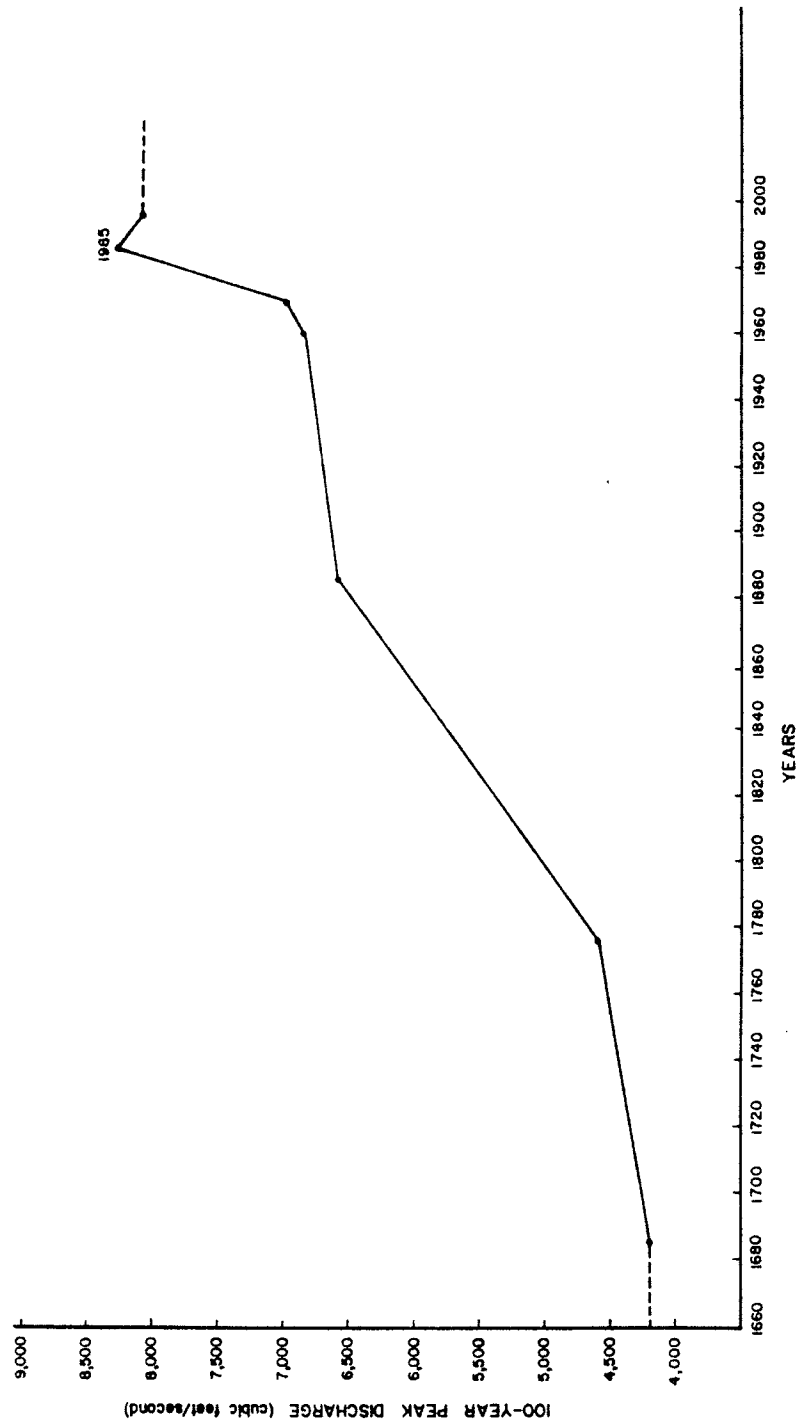
Figure 5. 100-YEAR PEAK DISCHARGES -- 1685 to 1995, VALLEY CREEK at SCHUYLKILL RIVER, VALLEY FORGE NHP

The effects of changing land uses on the flood hydrology of Valley Creek at Schuylkill River has been to increase the magnitude of floods, e.g., the magnitude of the 100-year flood increased from 4,200 cfs to 6,600 cfs over the 200-year period from 1685 to 1885. Another way to interpret this hydrologic trend, is that a given magnitude flow now has a more frequent (smaller) recurrence interval and thus, a higher probability of occurring. For example, a flow with a magnitude of 6,600 cfs would have been a flood with a recurrence interval (or return period) slightly greater than the 500-year flood in 1776, but would have been only a 100-year flood in 1885. And if a flood of this magnitude was to occur today, it would be only a 50-year flood (Appendix C). One result of this trend is that although the covered bridge may have been designed (by chance or on purpose) for the 100-year flood at the time of its construction (1851), that it now has a conveyance (below low steel) roughly equal to the 50-year flood.

In general, over the 300-year period from 1685 to 1985, the peak discharges were doubled. This is typical of changes in stream hydrology for a moderately developed watershed, i.e., increased peak discharges about 2 to 5 times higher than pre-development conditions (Schueler, 1987). Essentially, half of the increase occurred over the 100-year period from 1785 to 1885 and half occurred over the 100-year period from 1885 to 1985. Most of this latter increase has occurred since 1970. As modeled, the present trend in land use changes may actually cause a slight decrease in current (1985) peak discharges (Figure 5). This is because I assumed that in the future stormwater runoff would be better managed, i.e., I assumed that future land uses would have a lower curve number than the current land uses they replaced.
