Study of Climate Change Impacts on Cultural Landscapes in the Pacific West Region, National Park Service

Cultural Landscape Research Group
Department of Landscape Architecture
University of Oregon, Eugene, OR
2016

Study of Climate Change Impacts on Cultural Landscapes in the Pacific West Region

December 31, 2016

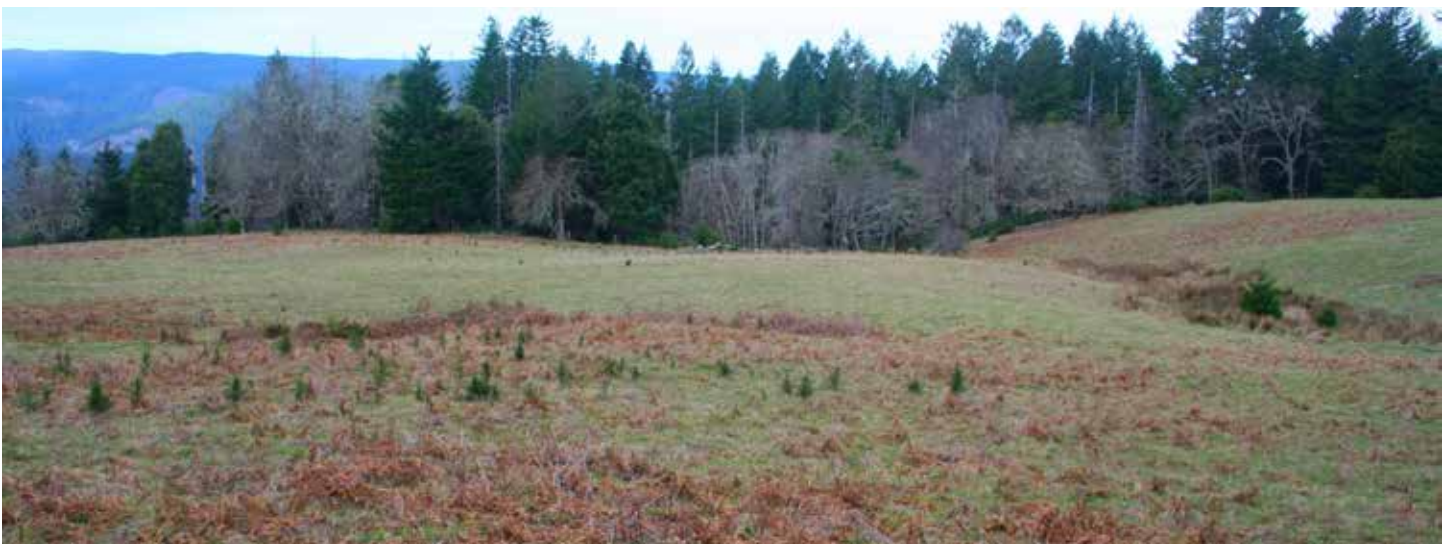
Figure REDW 1.6: Elk Prairie, view south. Encroaching woody vegetation, such as Douglas fir (*Pseudotsuga menziesii*) threatens prairie stability. (Kerr/UO CLRG, 2016)

- Stream-fed stock ponds, key resources in livestock management, continue to be affected by encroaching conifers, as within Elk Camp, and overgrowth and sedimentation, seen at Home Place (See [Figure REDW 1.9](#)). Projected change in precipitation and air temperature also threaten to foster microbiological growth in and around the perimeter; subsequent increases in water temperature could support harmful algal and plant blooms. Collectively, these conditions introduce new levels of complexity into the stewardship of prairie ecosystems, and further stress the integrity of historic features.

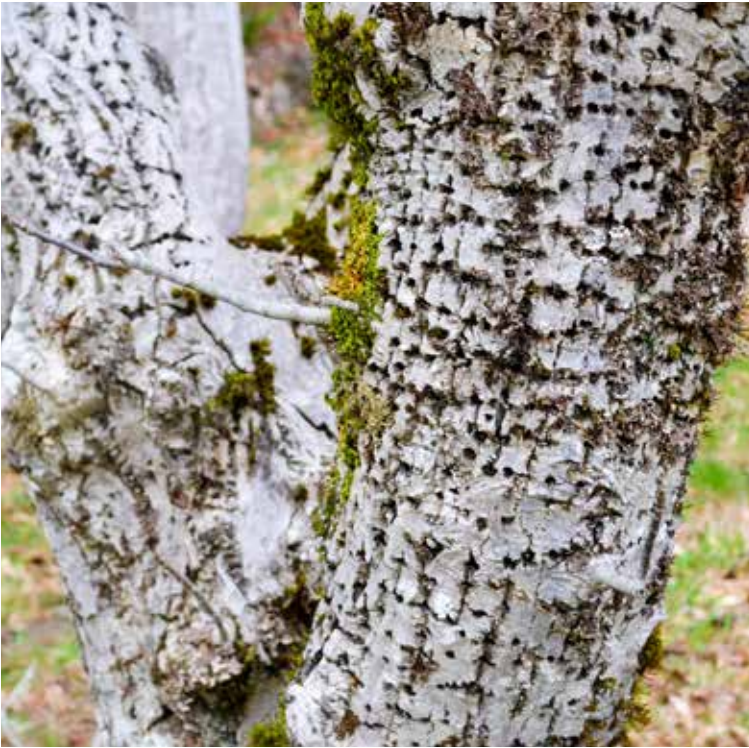
Figure REDW 1.7: Bore holes on apple tree (*Malus* sp.), detail view, caused by sapsucker woodpeckers (*Sphyrapicus* sp.) southeast of the Elk Camp residence. Similar impacts affect orchard remnants like this one across the historic district, and are symptomatic of poor tree health. (Malinay/UO CLRG, 2016)

- wildlife and insect damage (bore holes) to fruit orchard remnants (See [Figure REDW 1.7](#));
 - loss of fence lines and utility posts;
 - material degradation of water collection and diversion systems; and decline of stock ponds.

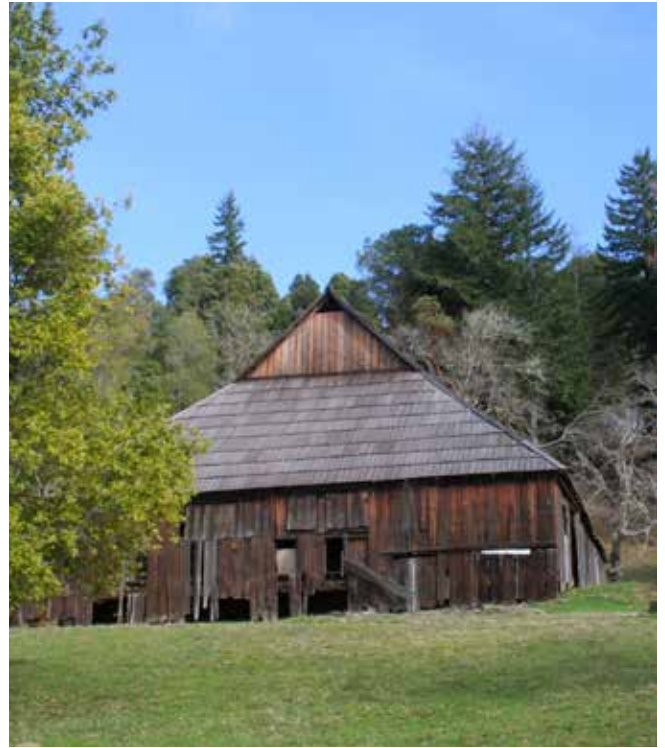
Figure REDW 1.8: Home Place Barn, view east. Changes in precipitation may alter effects of weather exposure on wood cladding and framing. (Kerr/UO CLRG, 2016)

- Historic building fabric remains susceptible to climatic shifts, particularly in the context of projected precipitation increases, possibly accelerating frequency of maintenance cycles to maintain integrity in exposed timber and frame construction (See [Figure REDW 1.8](#)). The ranch buildings at Elk Camp and Home Place all exhibit biological growth, desiccation, and deterioration of wood cladding components; these otherwise expected phenomena may be exacerbated by sustained exposure to the elements, and compounded by seasonal extremes and UV light.

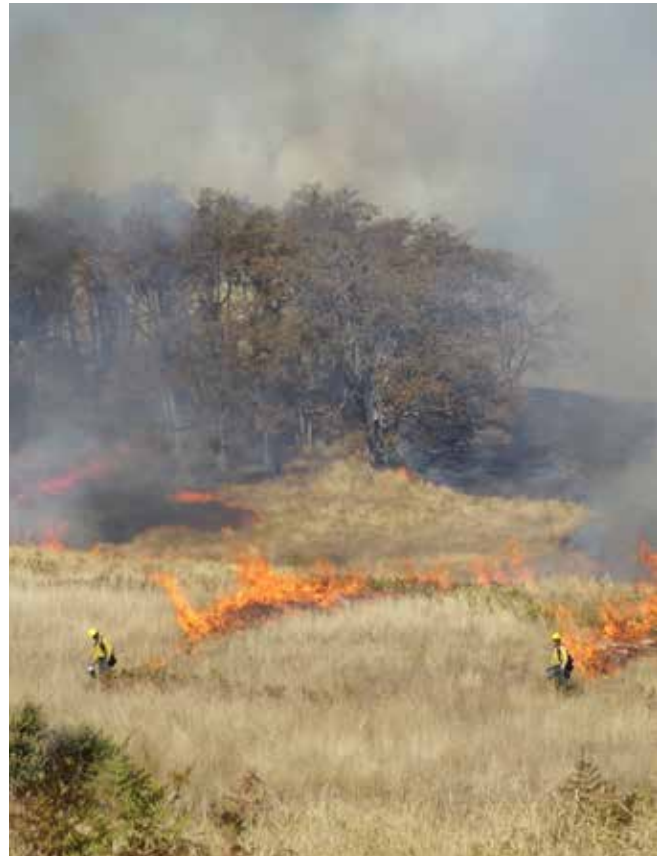
Figure REDW 1.10: Park staff currently manage the landscape and maintain the prairies with prescribed burns. (NPS Redwood National Park staff, 2016)

- Further expand efforts to preserve prairie integrity and limit succession, in order to better sustain historic spatial configuration and patterns of use. Mitigation of conifer encroachment and invasive species through expanded disturbance regimes (i.e. low-intensity/high-frequency), where possible, should utilize prescribed burns (See [Figure REDW 1.10](#)) or mechanical removal.

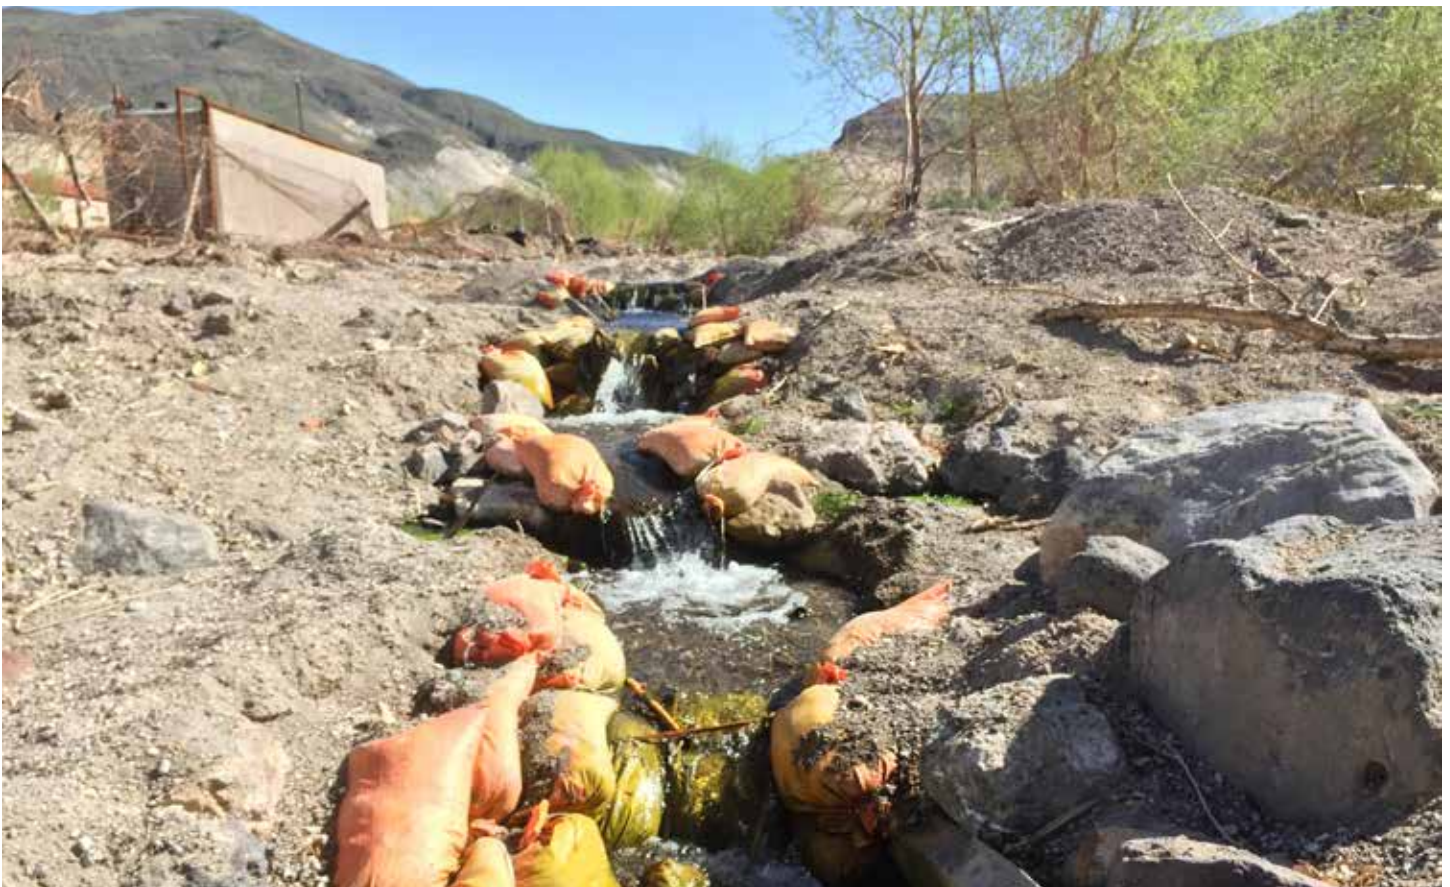
Figure DEVA 1.6: Flood stabilization efforts, view east, up Tie Canyon. The flood damaged the topography and vegetation, in addition to depositing large amounts of debris. (Kerr/UO CLRG, 2016)

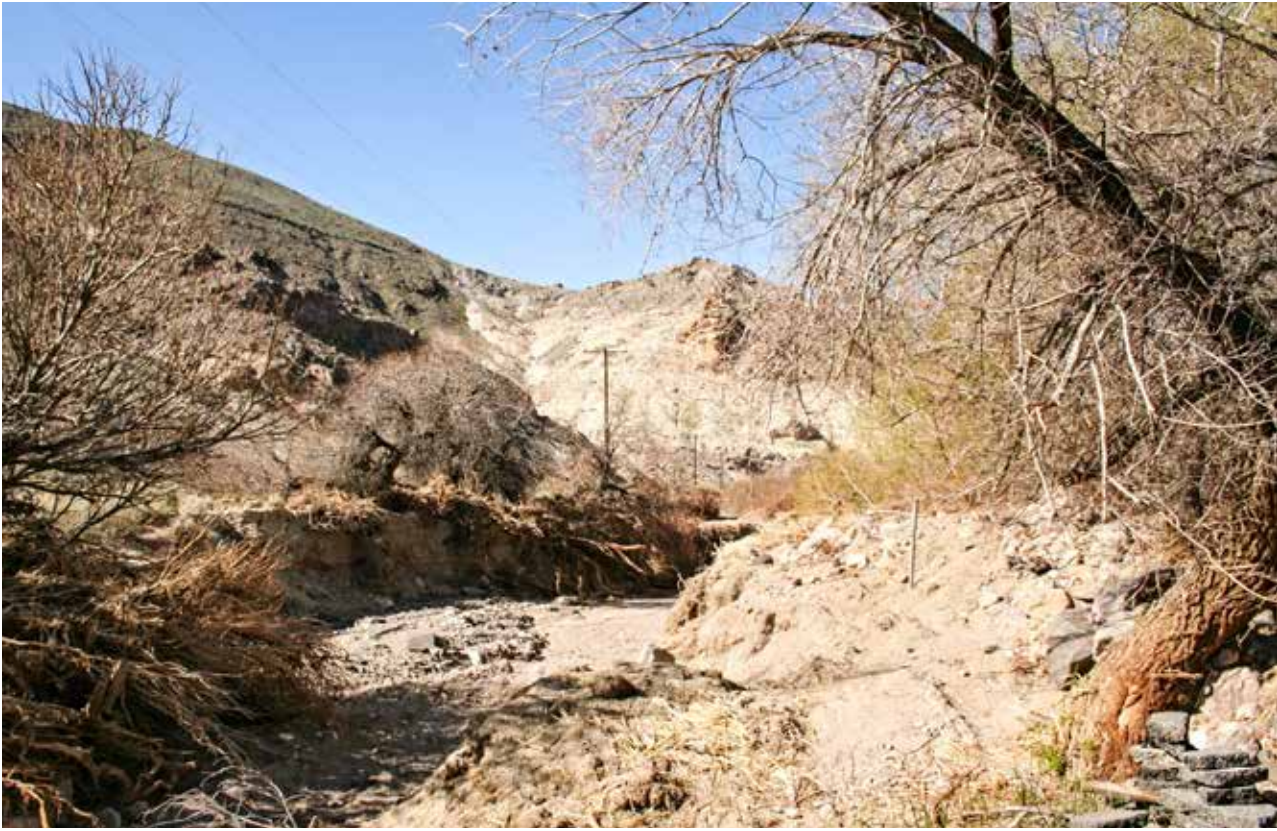
- Picnic area is washed away.
- Damage exists to the overall landscape around watercourse. Vegetation is missing in several areas.

Figure DEVA 1.7: Flood destruction. The flood damaged the topography and vegetation, in addition to depositing large amounts of debris. (Kerr/UO CLRG, 2016)

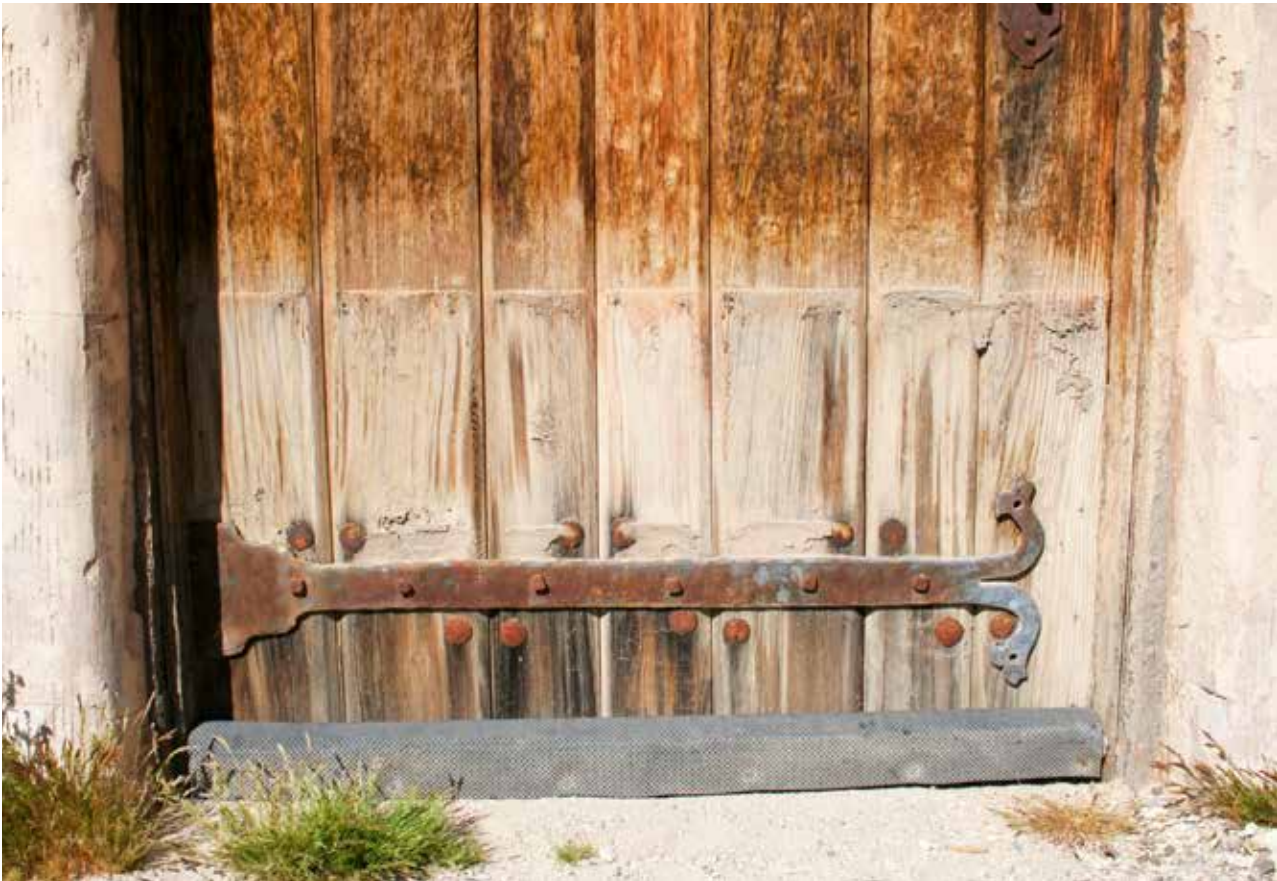
- Scotty's Castle Annex is sandbagged for flood mitigation, although there was some cracking of the exterior stucco.
- There is debris and evidence of the flood path above the stables.

Figure DEVA 1.8: Evidence of moisture staining and sediment deposits on the south stable door and hardware, detail view, seen as a flood impact in the Scotty's Castle building complex. (Kerr/UO CLRG, 2016)

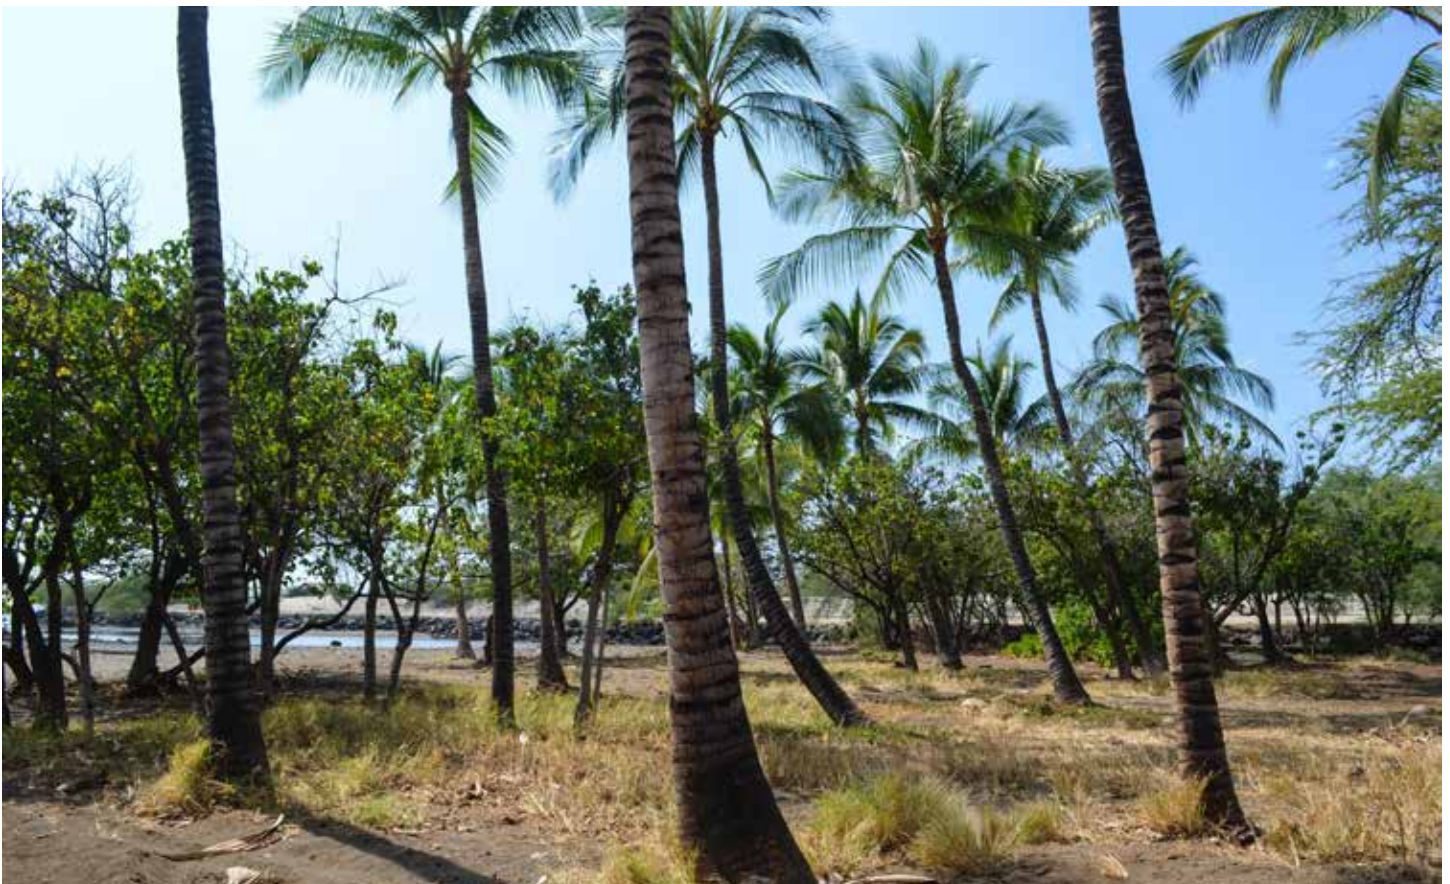
- Portions of the landscape are susceptible to sea-level rise, especially a stand of coconut trees (*cocos nucifera*), a contributing feature, on the west side of the site (See [Figure PUHE Image 1.6](#)).
- The contributing stand of coconut trees is also susceptible to the threat of the coconut rhinoceros beetle (*Oryctes rhinoceros*), and trunk and heart rot (both fungal diseases).
- Grasses encroach many of the structures at the John Young Homestead site.

Figure PUHE 1.6: Coconut Stand, view west. Given this contributing feature's adjacency to the Pacific Ocean, it is susceptible to rising sea levels. (Malinay/UO CLRG, 2016)

- Given the susceptibility of the coconut grove to sea-level rise, monitor and document changes in sea level using the coconut grove as a point of reference for measurements.
- In the case of fire, minimize damage to resources during disaster response through oversight and training of the response crew.
- Research, determine, and map areas of risk on the cultural landscape in relation to storm surges.

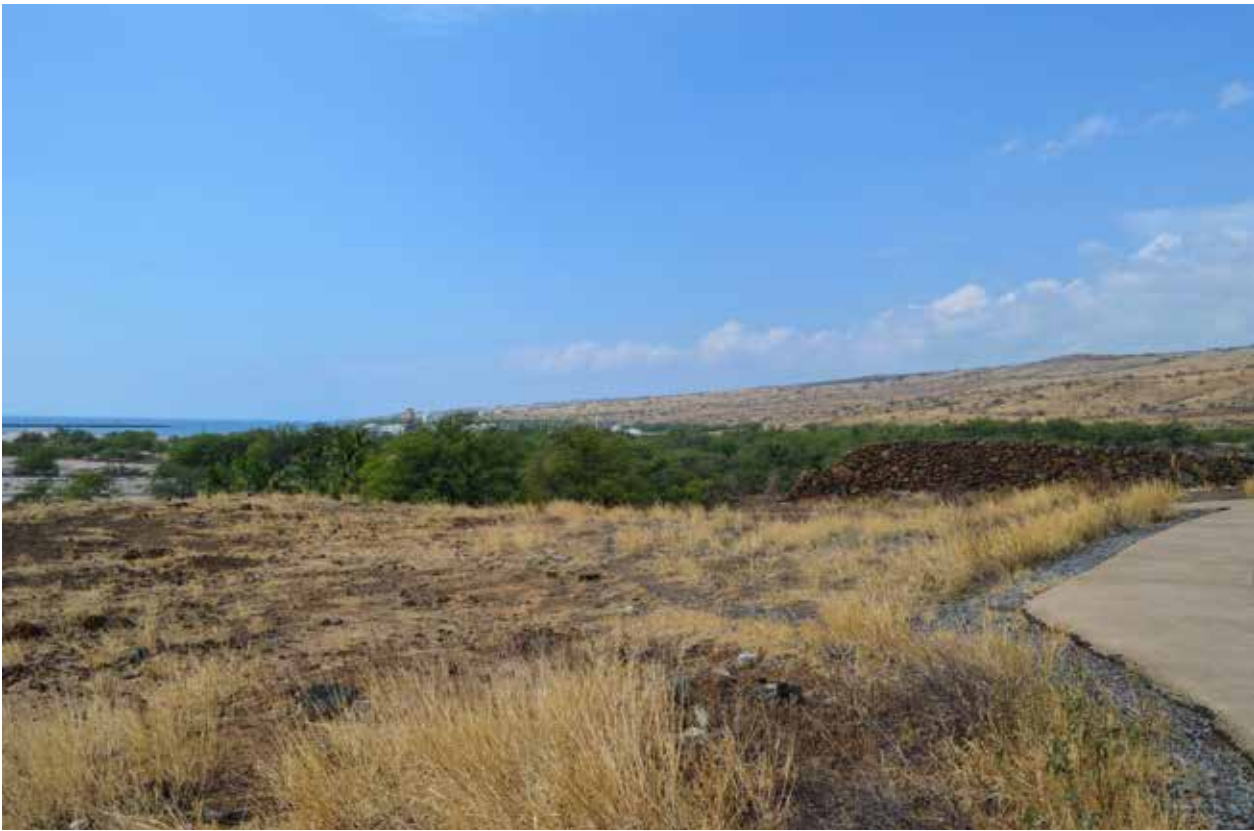
Figure PUHE 1.7: The NPS is in the process of reestablishing native pili grass community, view north. (Malinay/UO CLRG, 2016)

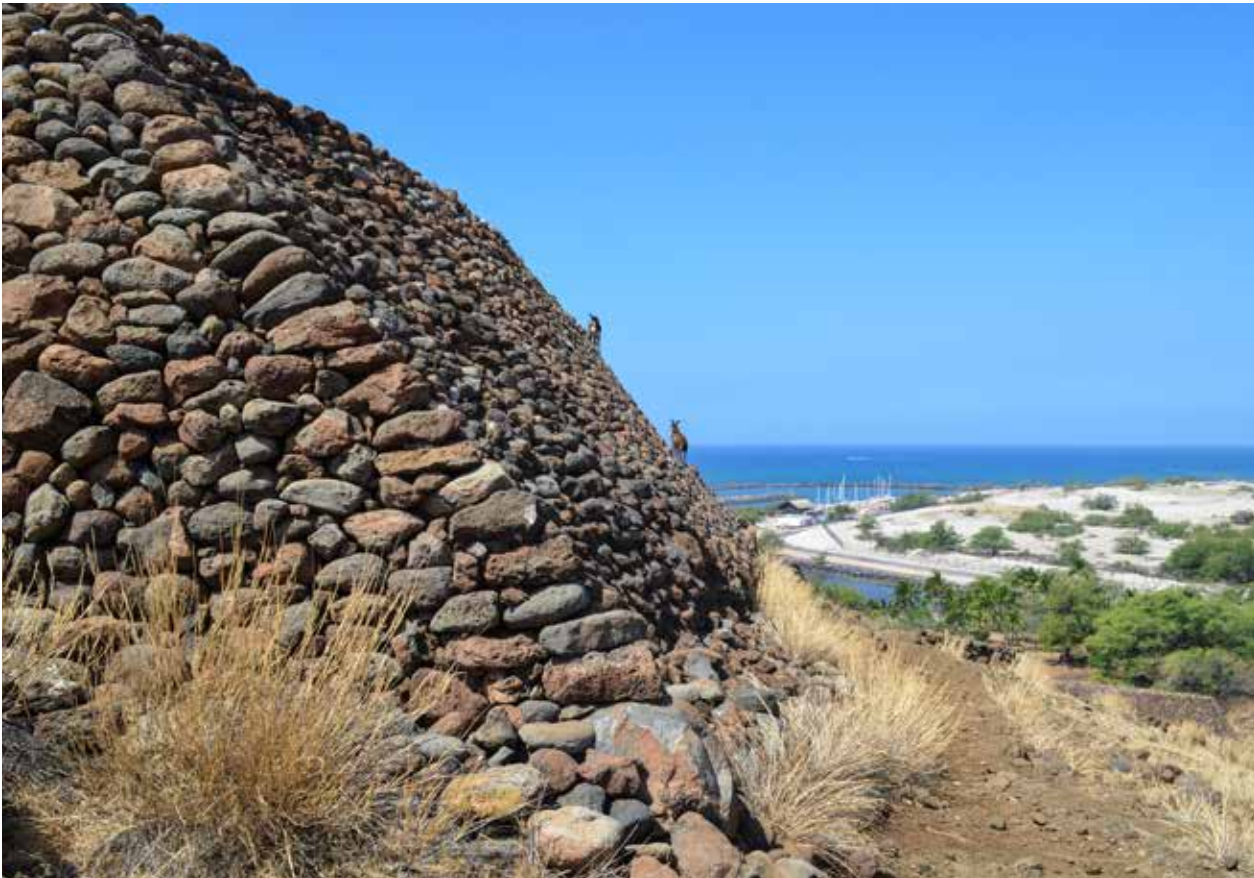
Figure PUHE 1.8: Pu'ukoholā Heiau, view west. Park staff are in the process of addressing the impacts of goats climbing on contributing features. (Malinay/UO CLRG, 2016)

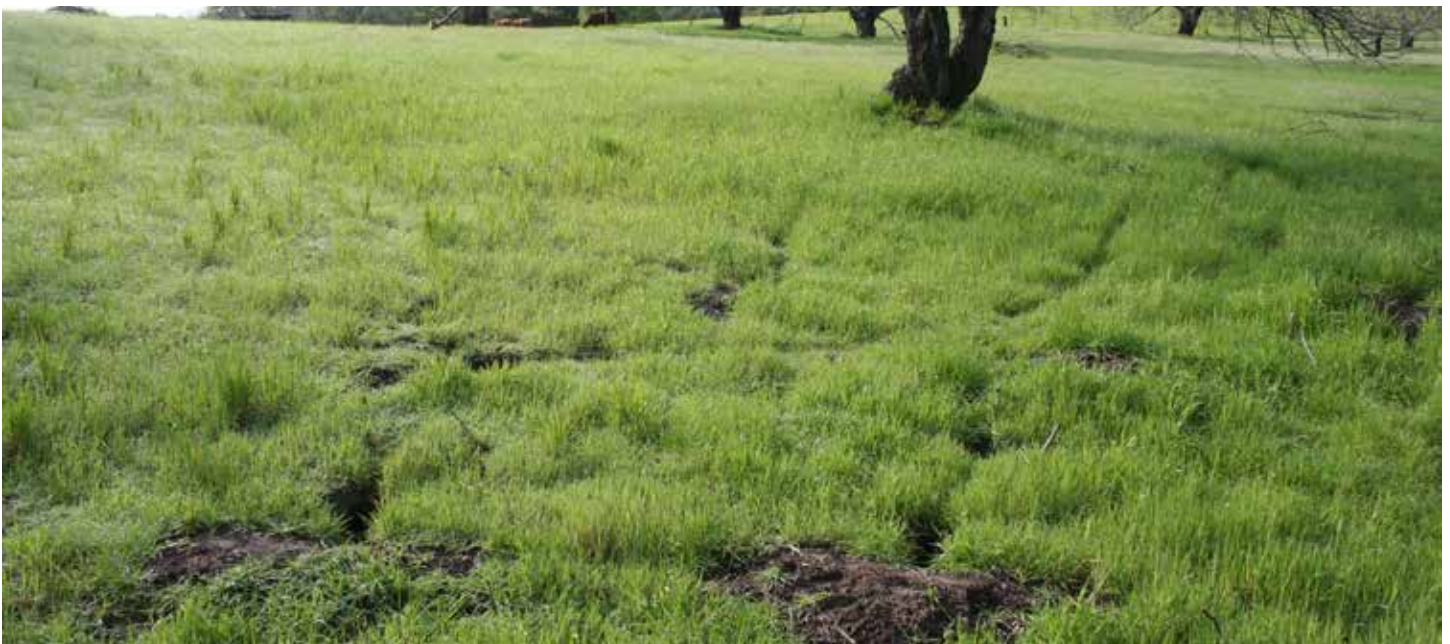
Figure EUON 1.6: Ground squirrel (*Otospermophilus beecheyi*) burrows, view south. These newer networks appear to extend through the north walnut orchard and may impact root systems. (Kerr/UO CLRG, 2016)

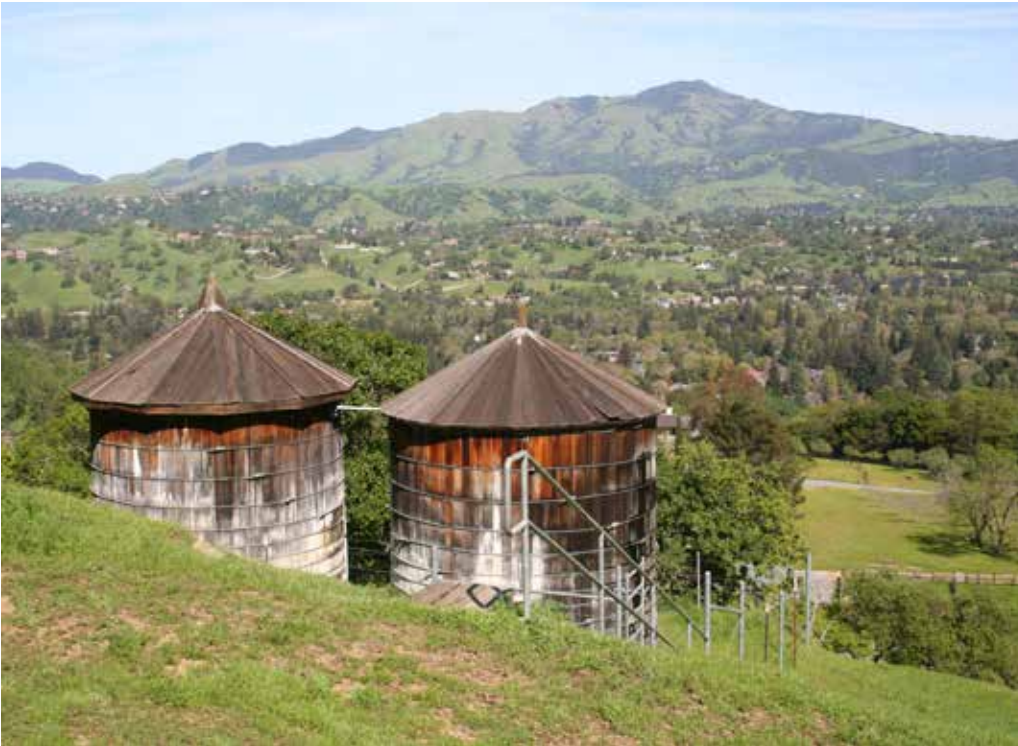
Figure EUON 1.7: Two freshwater tanks remain operational today onsite, view northeast. These serve both as historic features and wayfinding point for a contributing viewshed. (Kerr/UO CLRG, 2016)

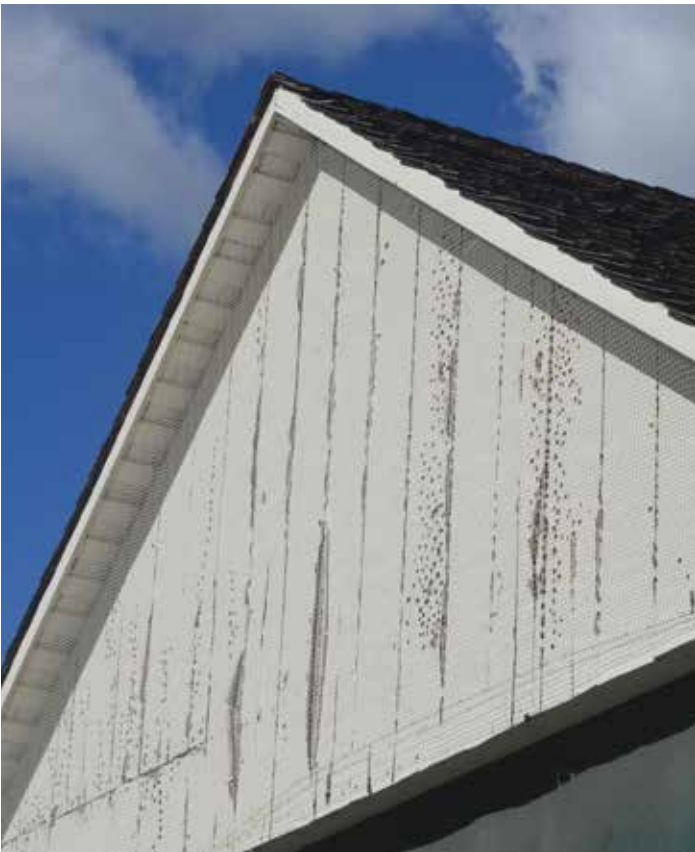
Figure EUON 1.8: Woodpecker bore-holes are evident across the west gable of the Old Barn. Note synthetic mesh netting, hung to deter further damage. (Malinay/UO CLRG, 2016)

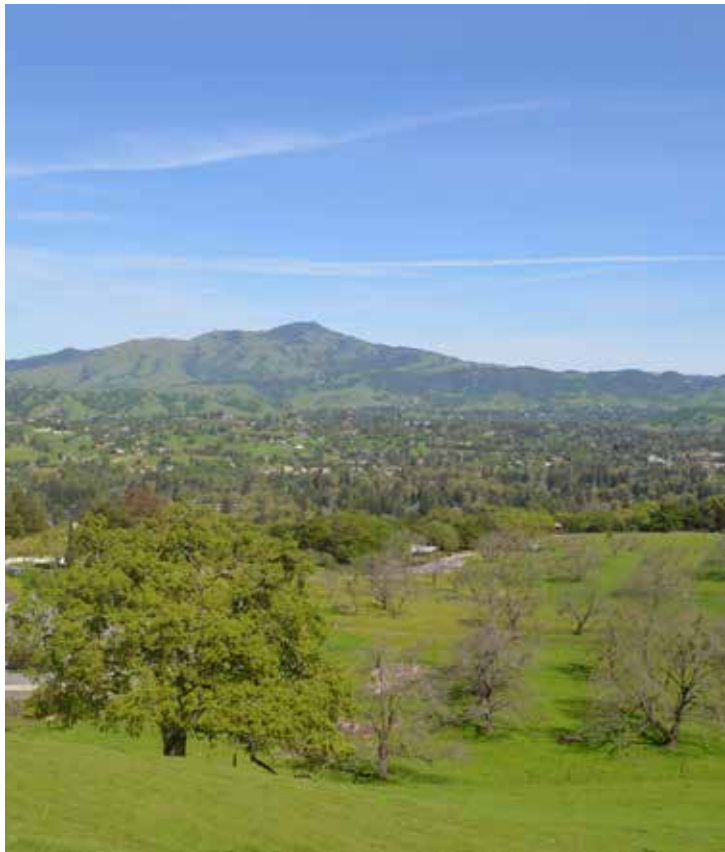
Figure EUON 1.9: Views and vistas are affected by suburban development, view east. (Malinay/UO CLRG, 2016)

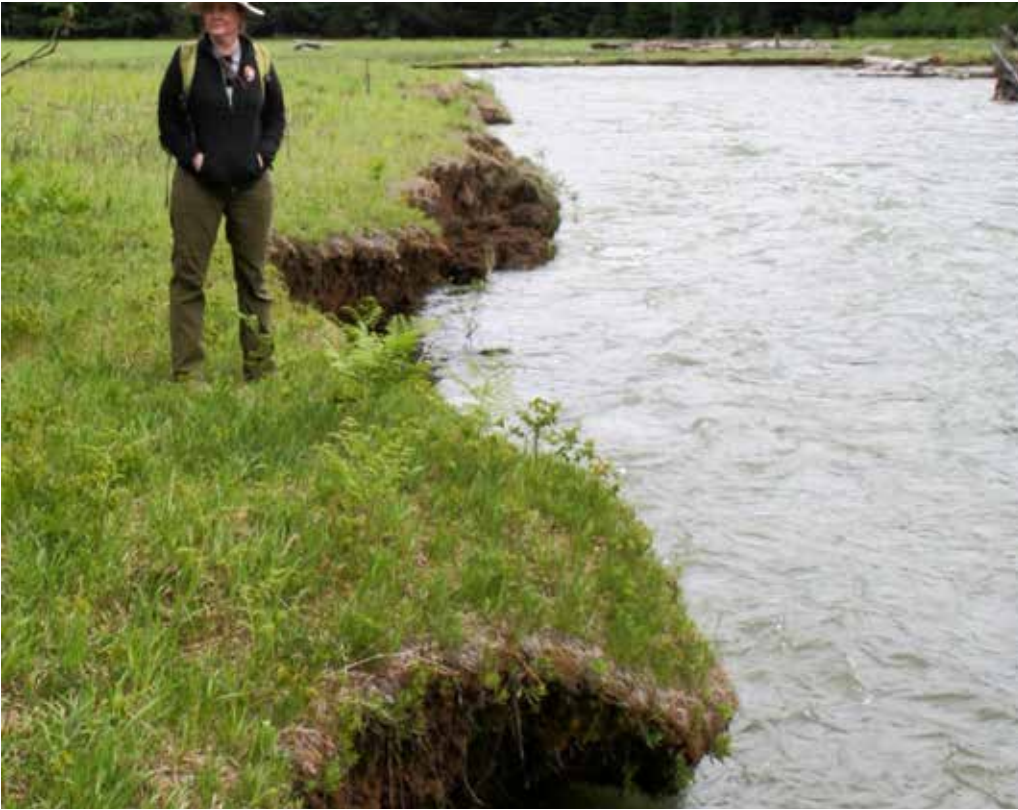
Figure NOCA 1.7: Stehekin River bank erosion impacts historic pasture features and spatial organization, view southeast. (Kerr/UO CLRG, 2016)

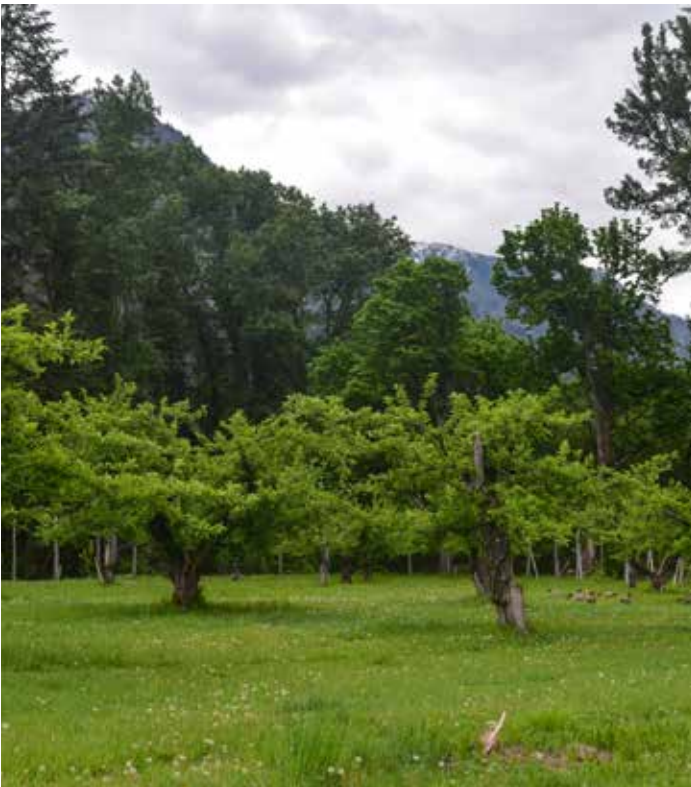
Figure NOCA 1.8: Buckner apple orchard (north block), view north. (Malinay/UO CLRG, 2016)

- Shifts in temperature and precipitation, with the potential for milder and wetter winters, raise possibilities of pest damage to orchard specimens. Traces of powdery mildew were apparent on apple leaves.

- Monitor and control continued interest by wildlife in orchard vegetation as a seasonal food source.

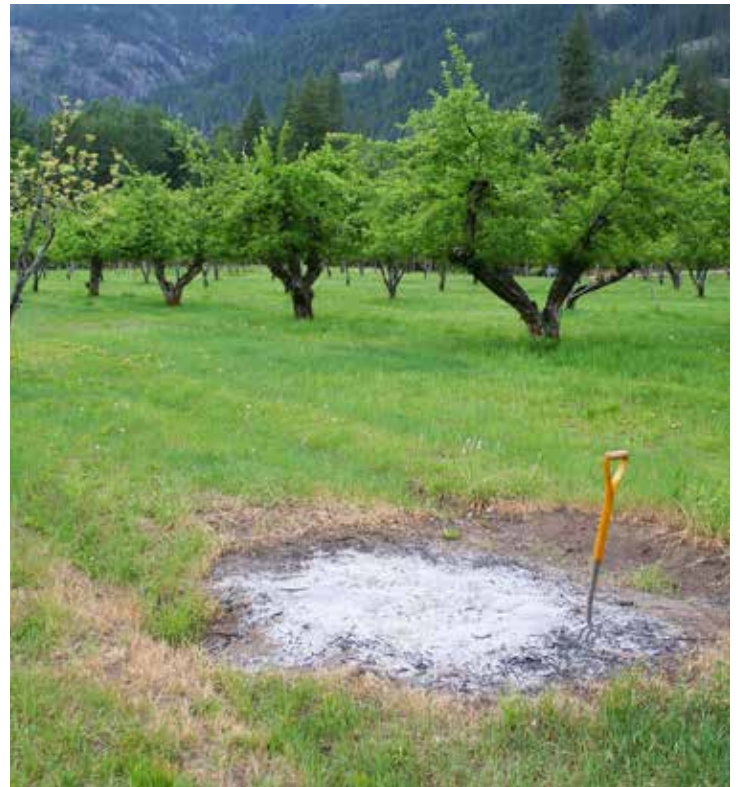
Figure NOCA 1.9: Former location of historic fruit tree within Buckner Orchard, view south. Propagation of a grafted cultivar will occur in the same place, sustaining spatial organization, after 7-10 years, to reduce risk of disease infection in the new tree. Note hand-dug irrigation ditches, immediately parallel to each row. (Kerr/UO CLRG, 2016)

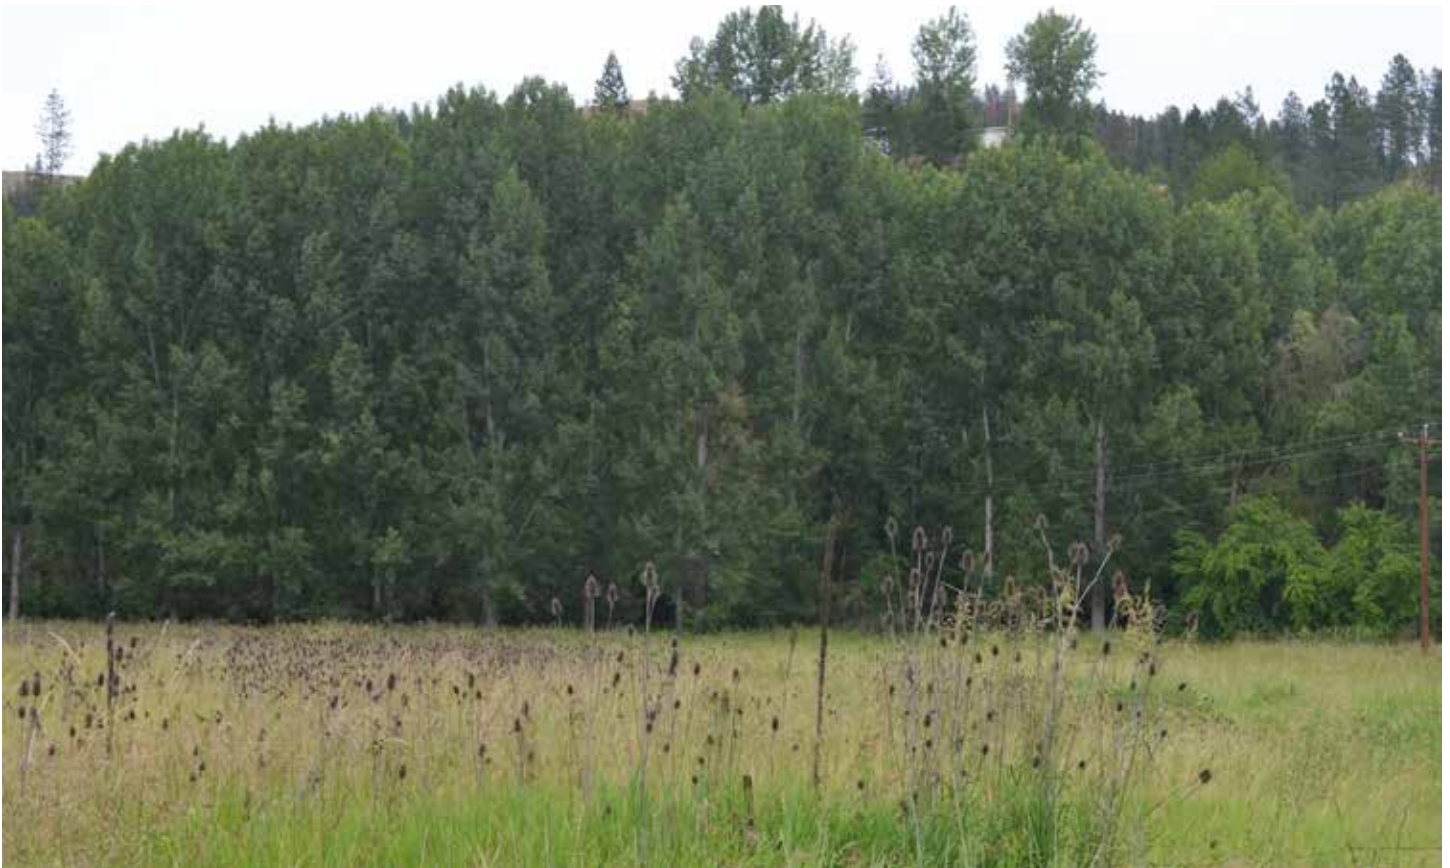
Figure NEPE 1.6: Invasive Scotch thistle (*Onopordon acanthium*) is pictured in the foreground, view east. (Malinay/UO CLRG, 2016)

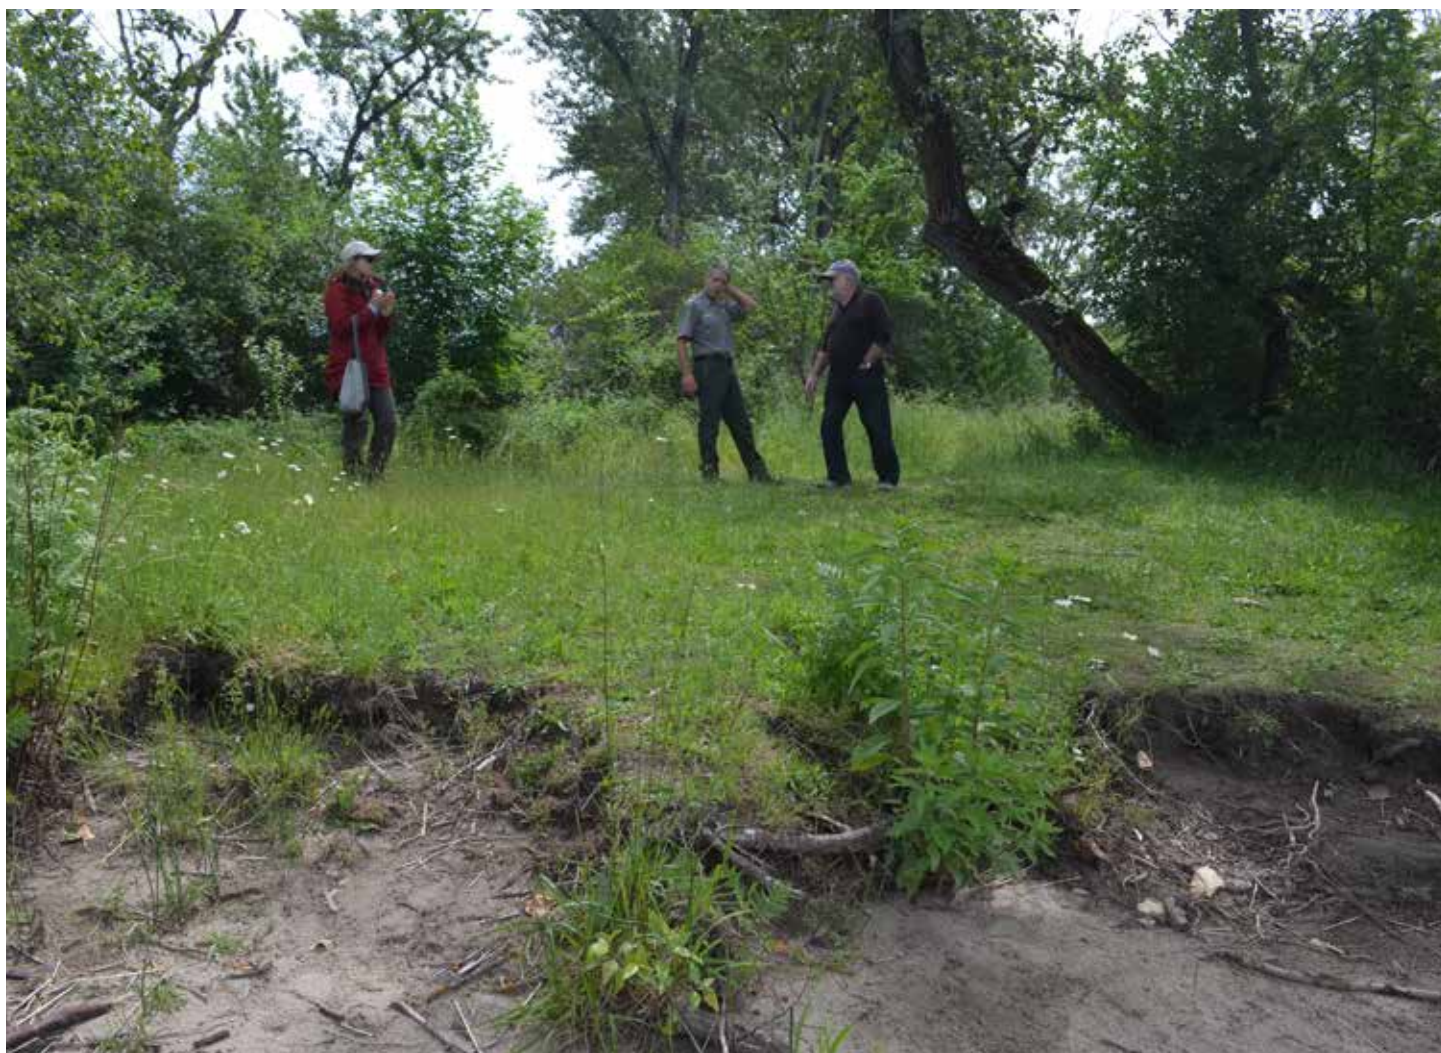
Figure NEPE 1.7: Clearwater River bank erosion. (Malinay/UO CLRG, 2016)
