## Grant-Kohrs Ranch Cultural Landscape Report, Part Two

# Treatment Recommendations

### Seven Component Landscapes

June 2017

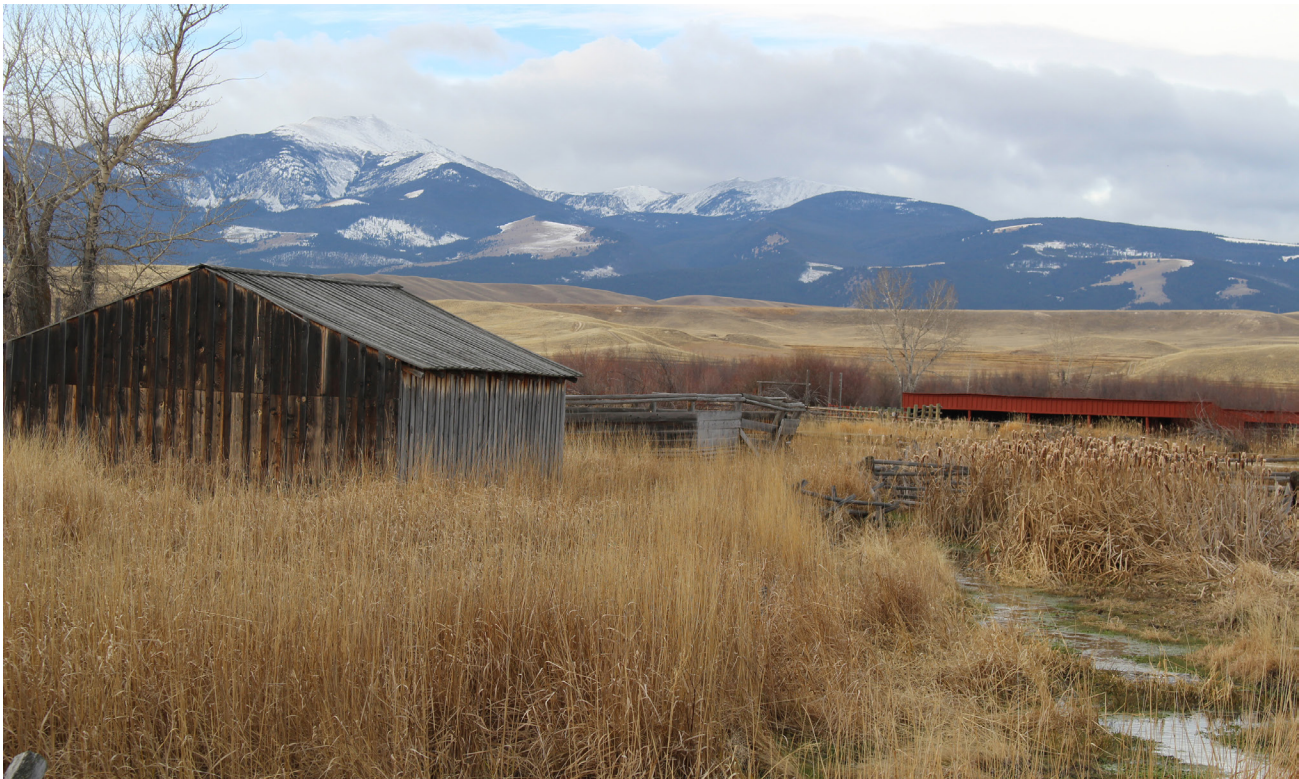
Figure 1-3. The Home Ranch Complex is the most highly developed area, and includes all landscape features associated with the core complex of the Grant-Kohrs Ranch. (Mundus Bishop, 2015)

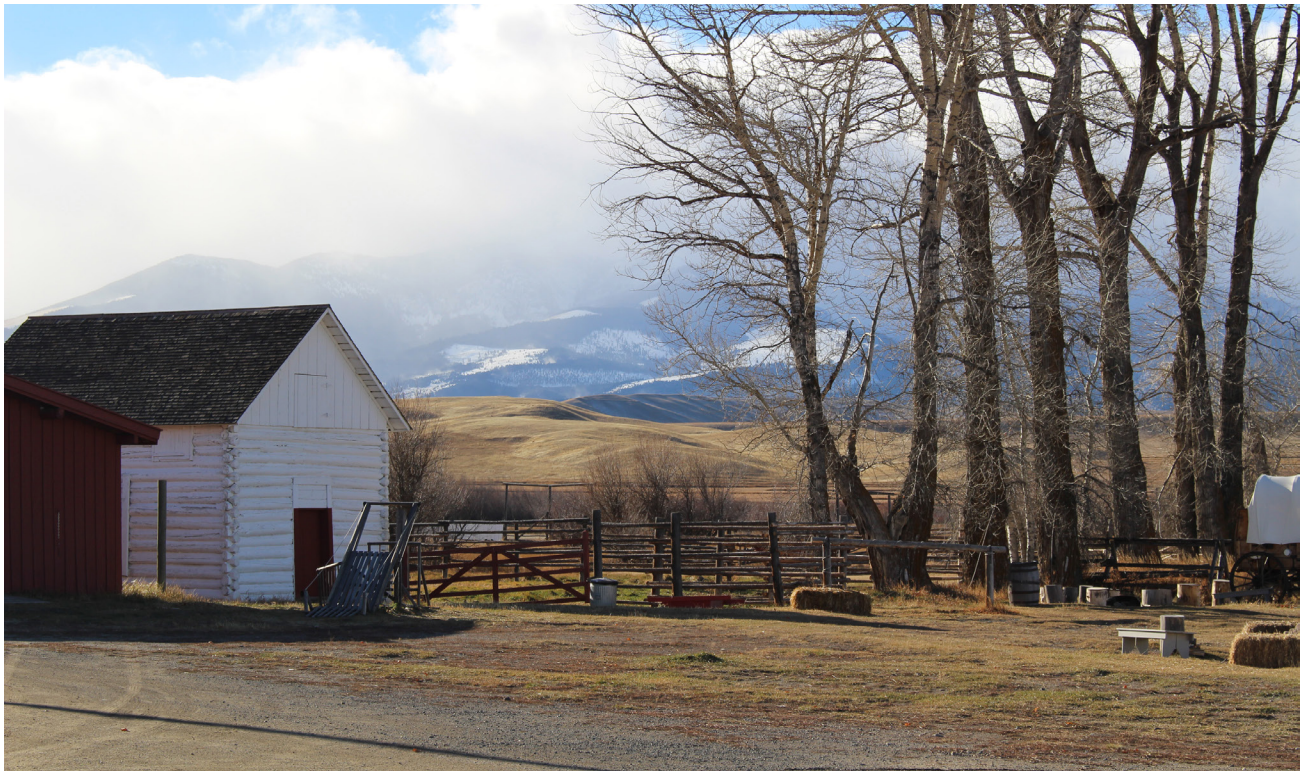
Figure 1-4. The Home Ranch Complex was the heart of the historic ranch and includes barns and outbuildings, corrals, yards and fields, narrow dirt roads, Johnson Creek and natural fresh water springs. (Mundus Bishop, 2015)

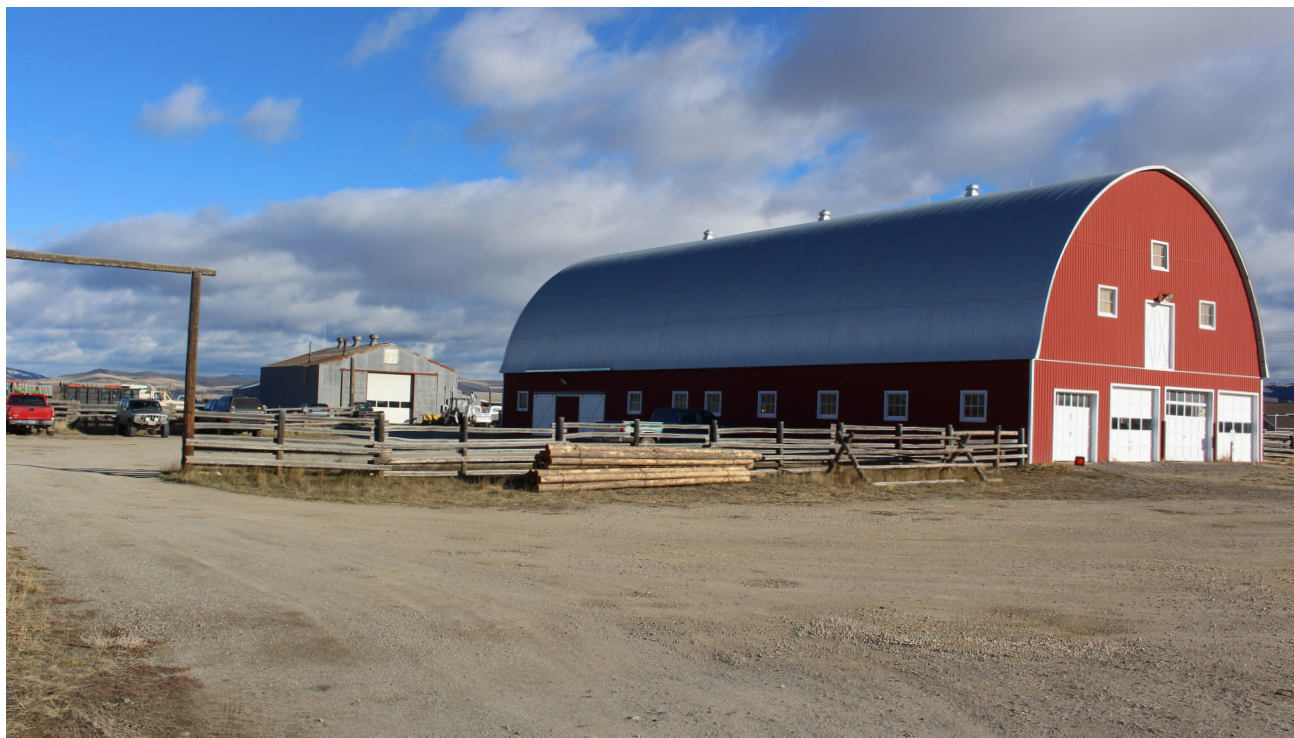
Figure 1-5. The East Feed Lot / Warren Hereford Ranch component landscape includes the Warren Barn and several outbuildings that were part of modernizing ranch operations in the 1950s. (Mundus Bishop, 2015)

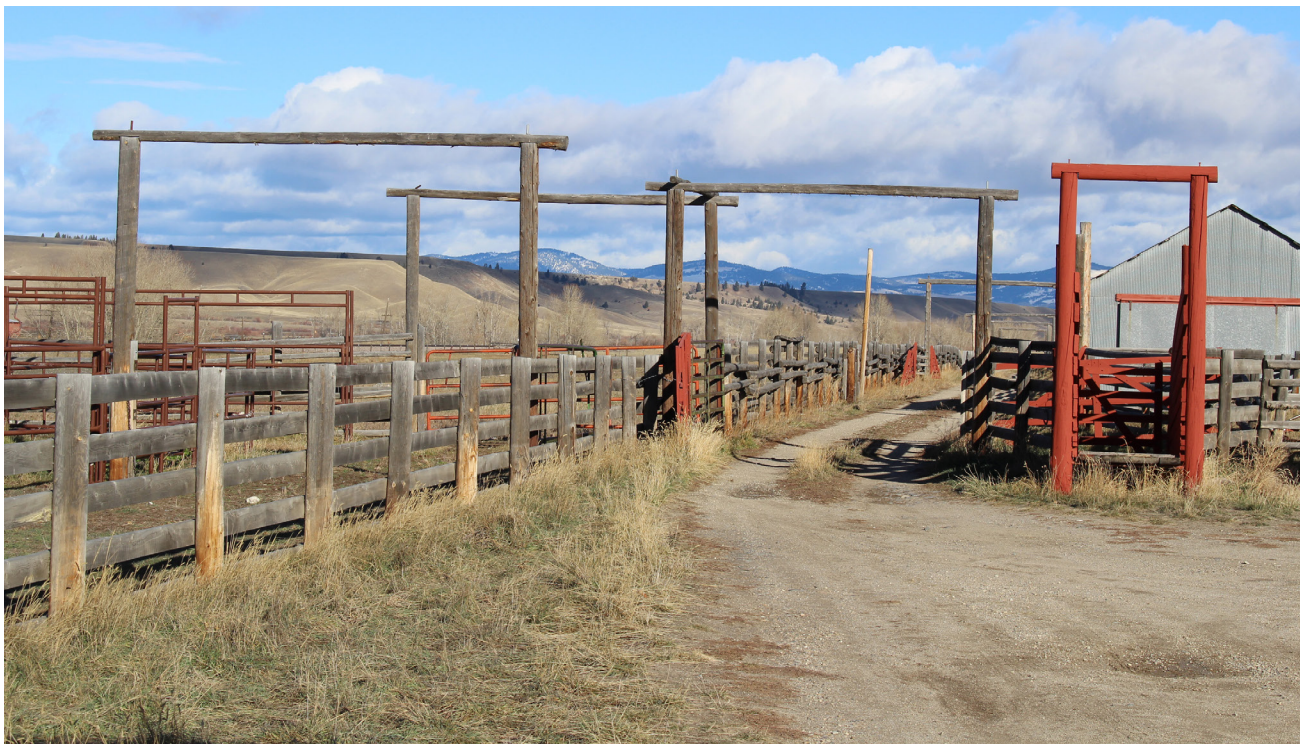
Figure 1-6. The East Feed Lot / Warren Hereford Ranch component landscape is an organized grid of feedlots, sheds, and barns, situated on the level, elevated plain east of the Clark Fork River. (Mundus Bishop, 2015)

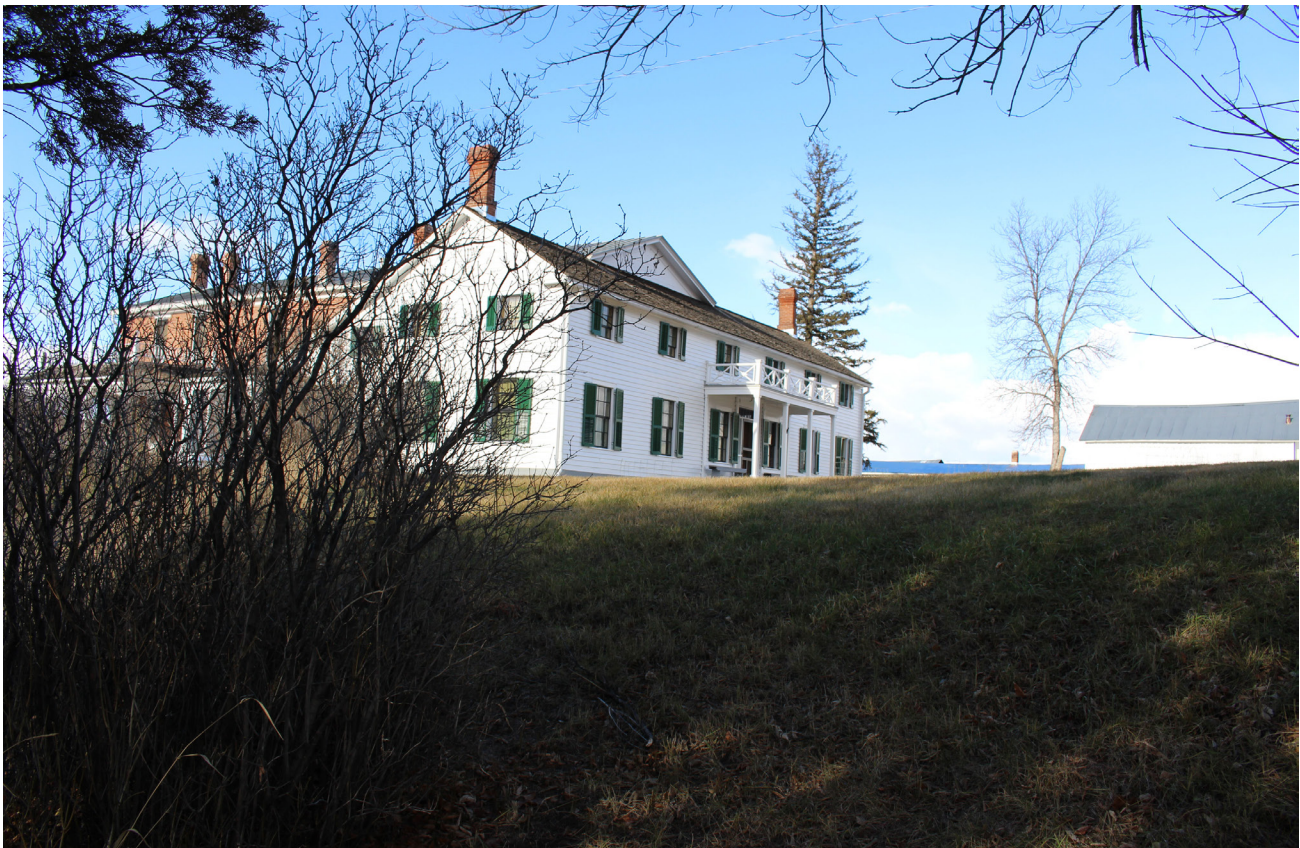
Figure 1-7. The Grant-Kohrs Residence component landscape includes the residence and immediate surroundings: lawn, shade trees, garden, walls and pathways around the building. (Mundus Bishop, 2015)

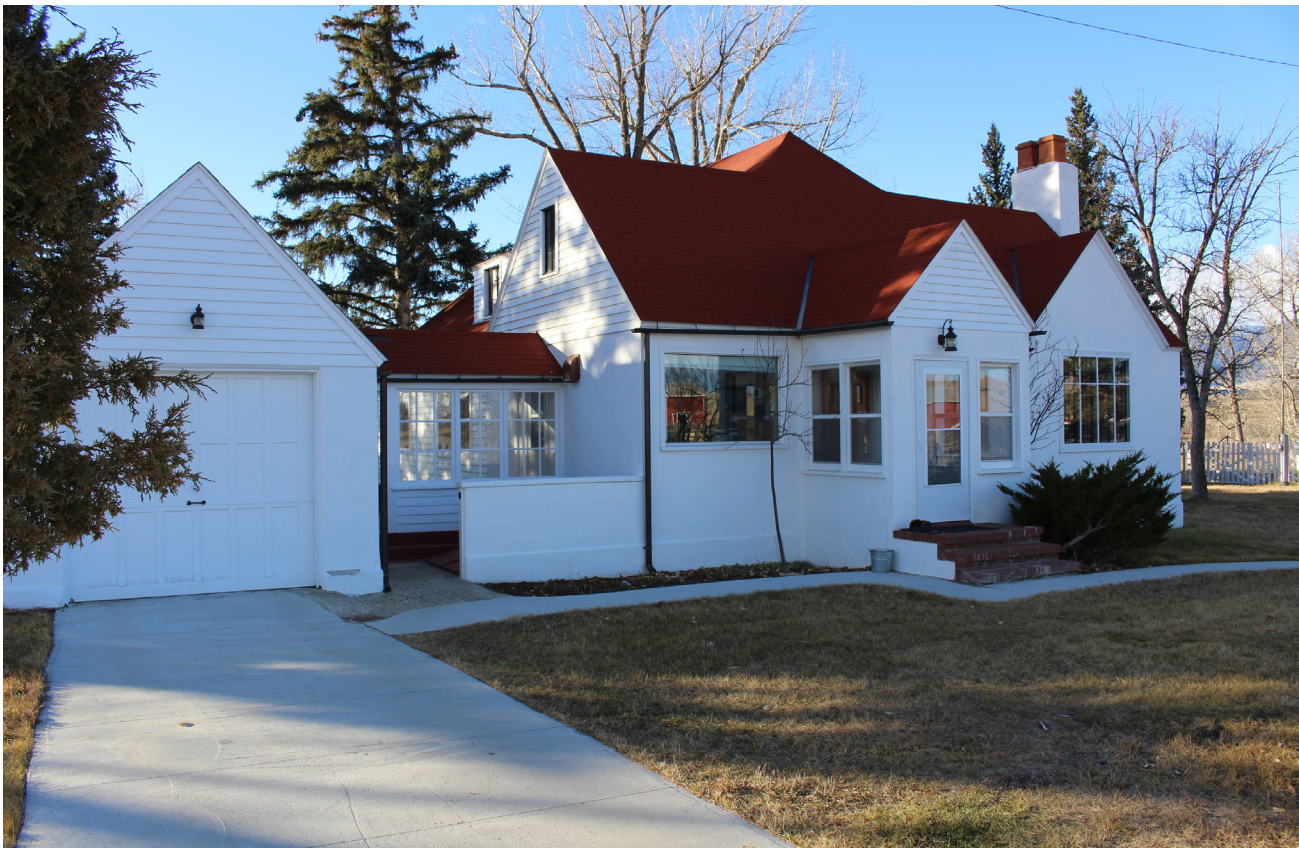
Figure 1-8. The Warren Residence component landscape includes the Warren Residence, outbuildings, vegetation, and small scale features constructed by Conrad Warren. (Mundus Bishop, 2015)

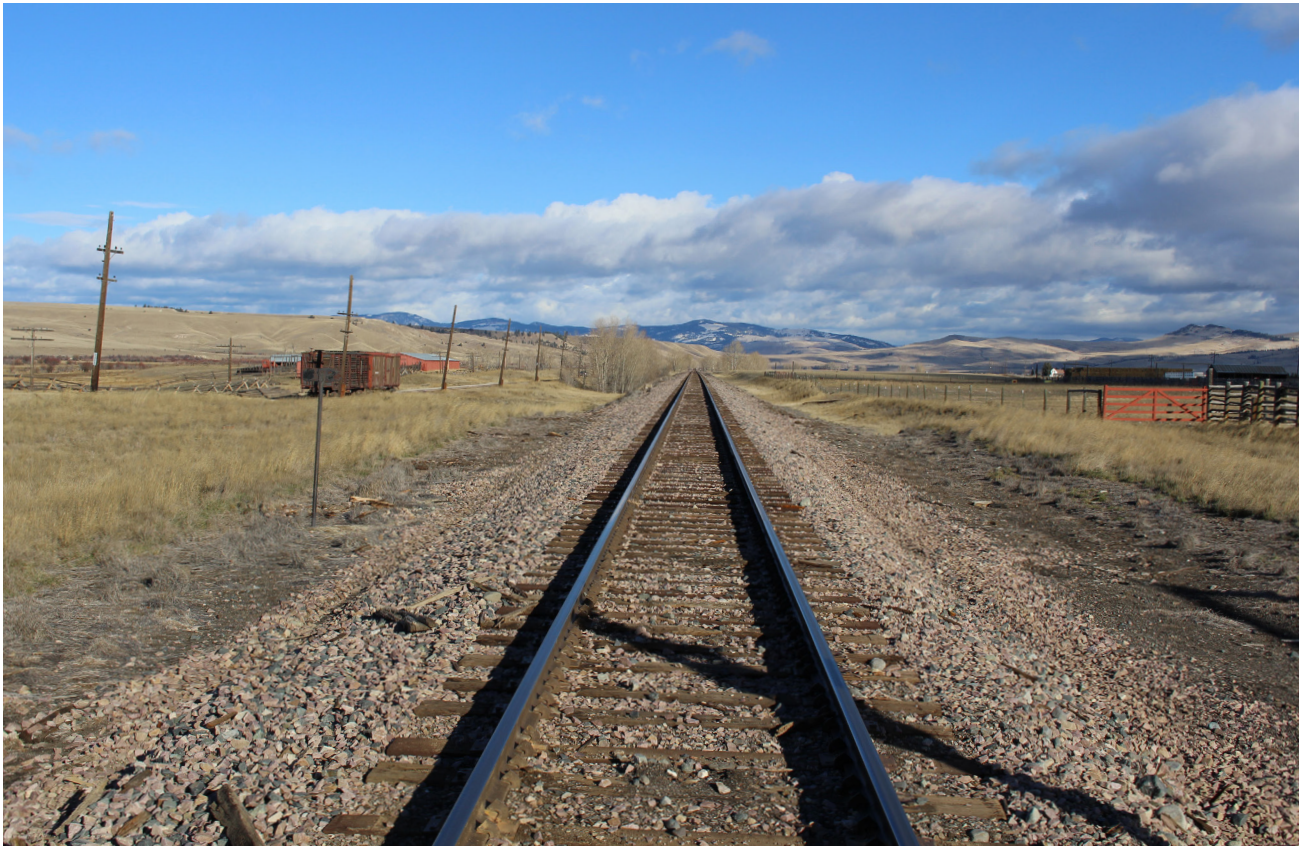
Figure 1-10. The Railroad Corridor and Barrow Pit/Wetland component landscape includes the double set of railroad tracks that traverse the ranch north - south, and the barrow pits that were created as part of the railroad grade construction. (Mundus Bishop, 2015)

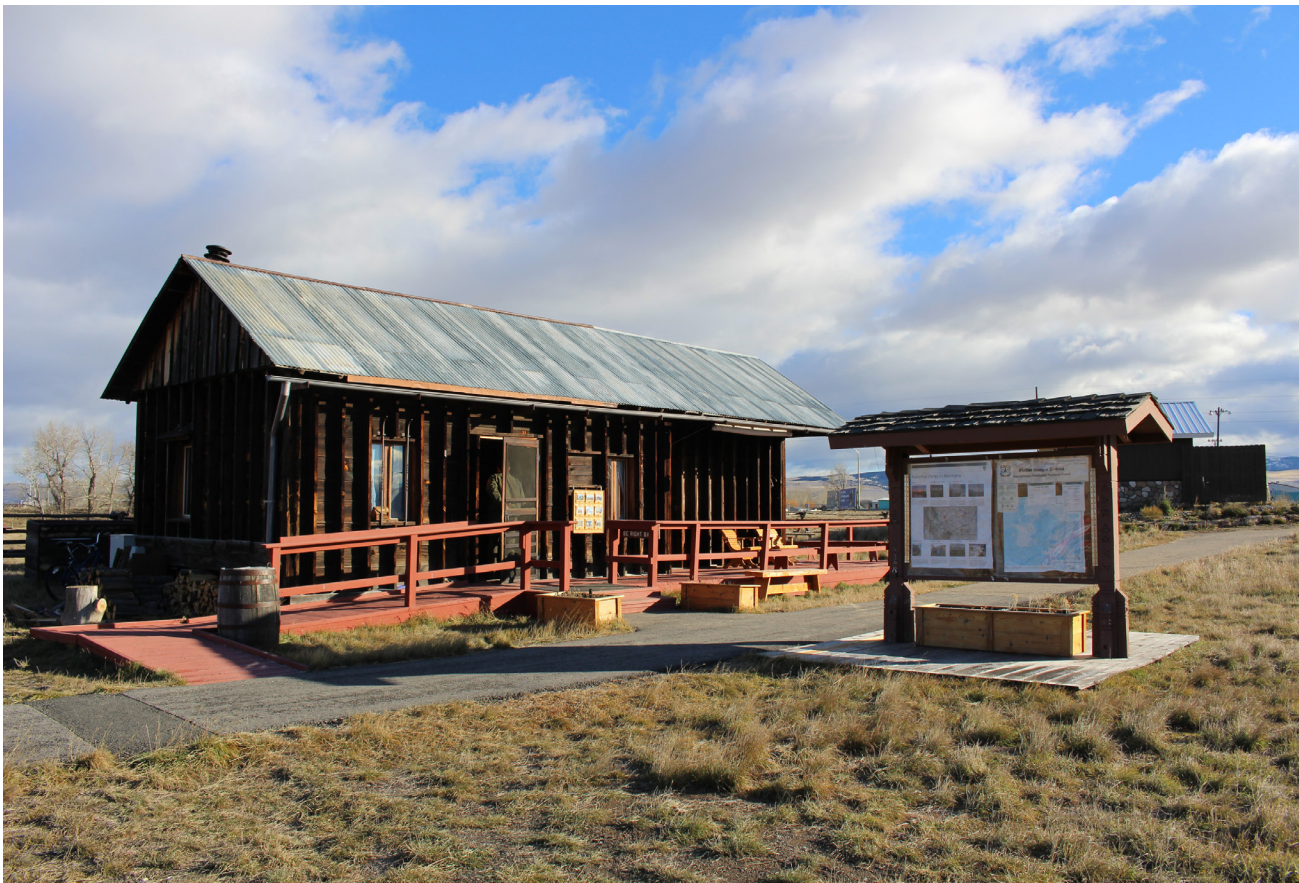
Figure 1-11. The Development Zone includes contemporary additions by the NPS, including the visitor contact station, archival storage building, and visitor parking. (Mundus Bishop, 2015)

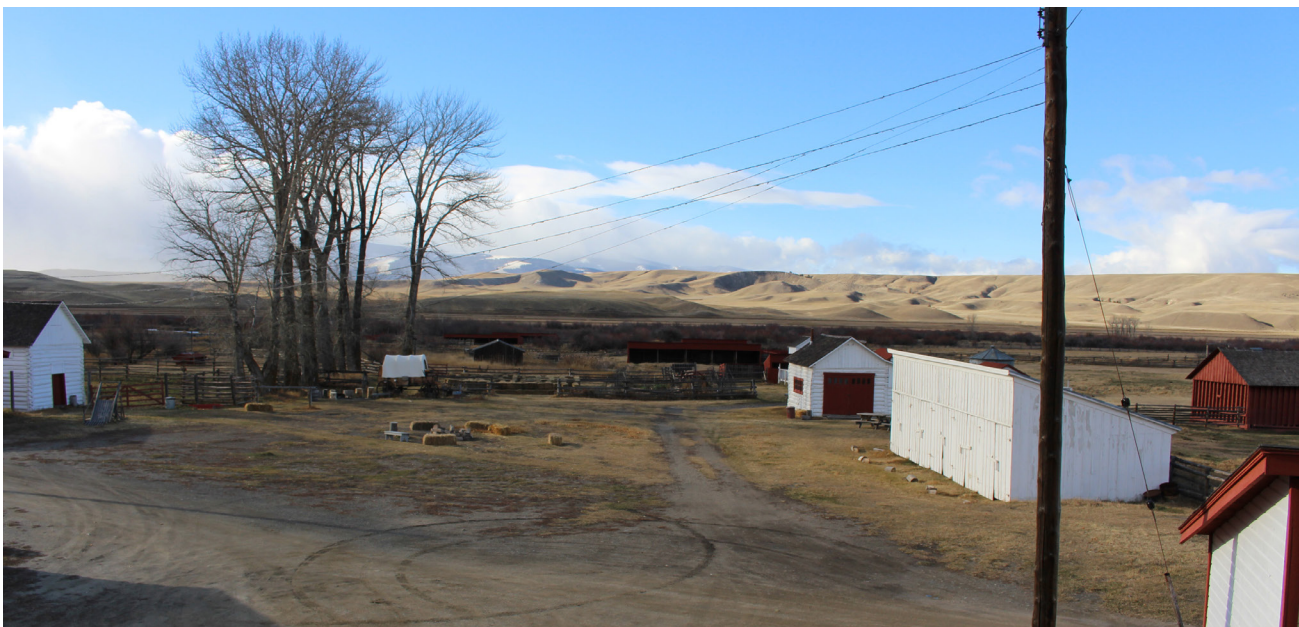
Figure 3-1. Treatment guidance for the Lower Yard of the Home Ranch Complex includes maintaining the space as an open area with a level surface that allows universal access. (Mundus Bishop, 2015)

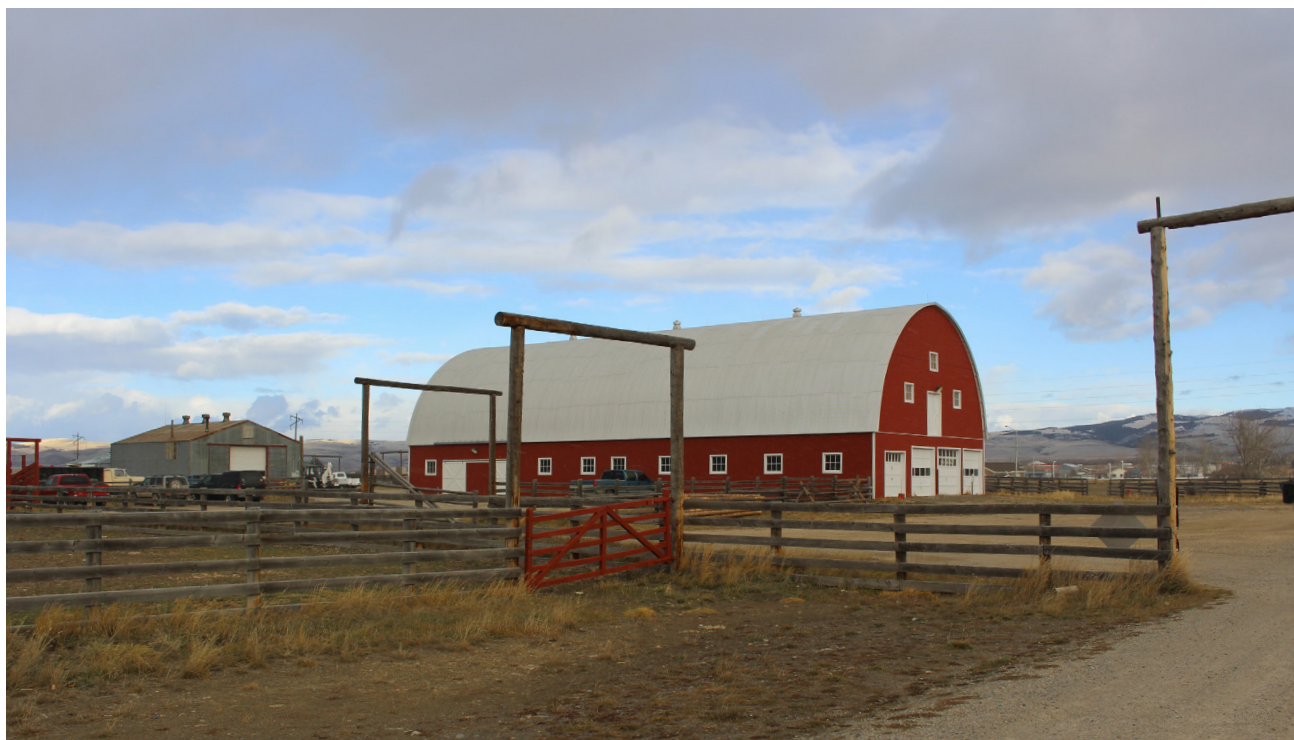
Figure 3-2. Treatment recommendations for the East Feed Lot / Warren Hereford Ranch balance preservation of contributing features with continued use of the area for NPS operations. (Mundus Bishop, 2015)

| Figure 3-2. | Treatment recommendations for the East Feed Lot / Warren Hereford Ranch balance preservation of contributing features with continued use of the area for NPS operations. (Mundus Bishop, 2015) ..... | 3-19 |

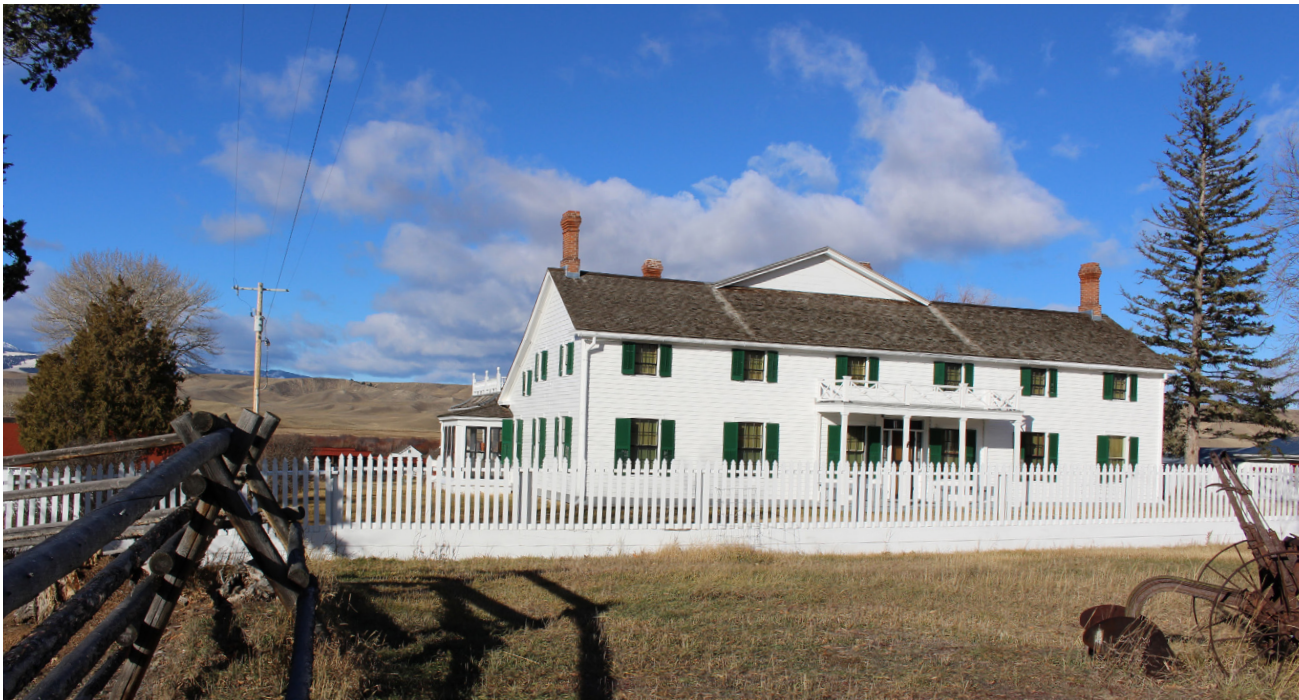
Figure 3-3. The Grant-Kohrs Residence component landscape will be reestablished as the center of domestic life on the ranch by replanting missing trees and ornamental plantings that enhance the residential quality of the setting. (Mundus Bishop, 2015)

| Figure 3-3. | The Grant-Kohrs Residence component landscape will be reestablished as the center of domestic life on the ranch by replanting missing trees and ornamental plantings that enhance the residential quality of the setting. (Mundus Bishop, 2015) ..... | 3-25 |

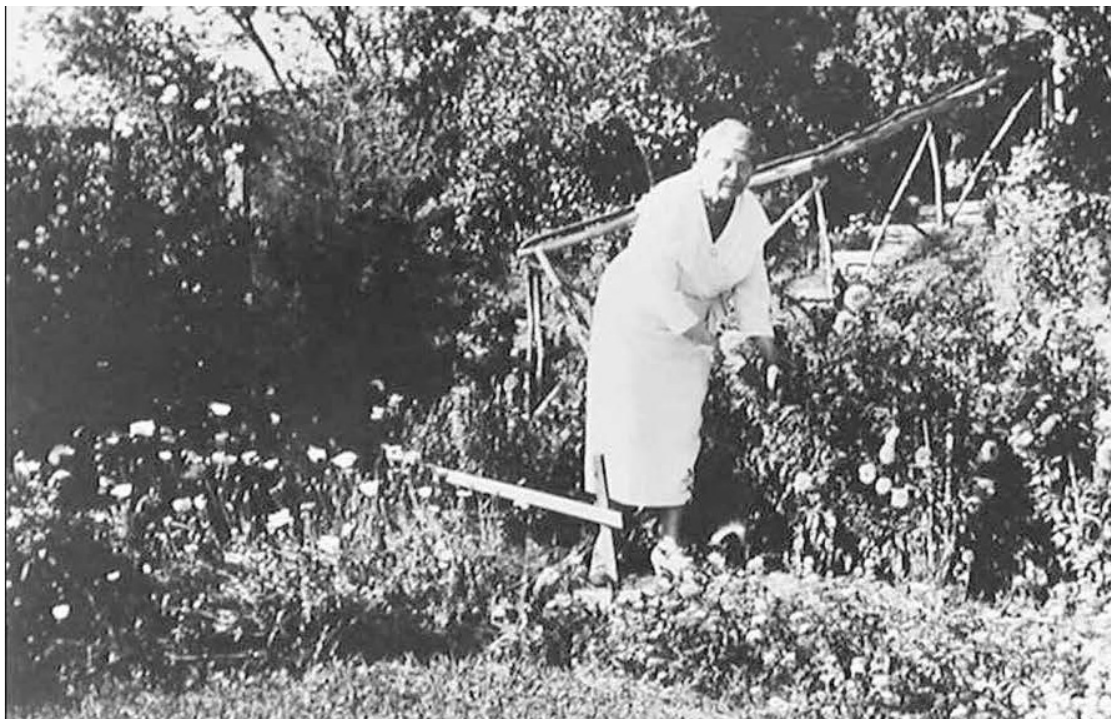
Figure 3-4. Katherine Kohrs Warren Bogard in the lower garden, circa 1930. Perennial plantings occurred both east and west of the stone staircase. (GRKO Archives)

- Repair the stone landing and steps at the west edge of the residence by resetting the steps to create a level surface. Add soil as necessary to provide a level setting bed for the stone steps.
- Remove the flagstone walk on the north side of the garden (added 1997-98) and replace with a soft-surface path (dirt or sand) to

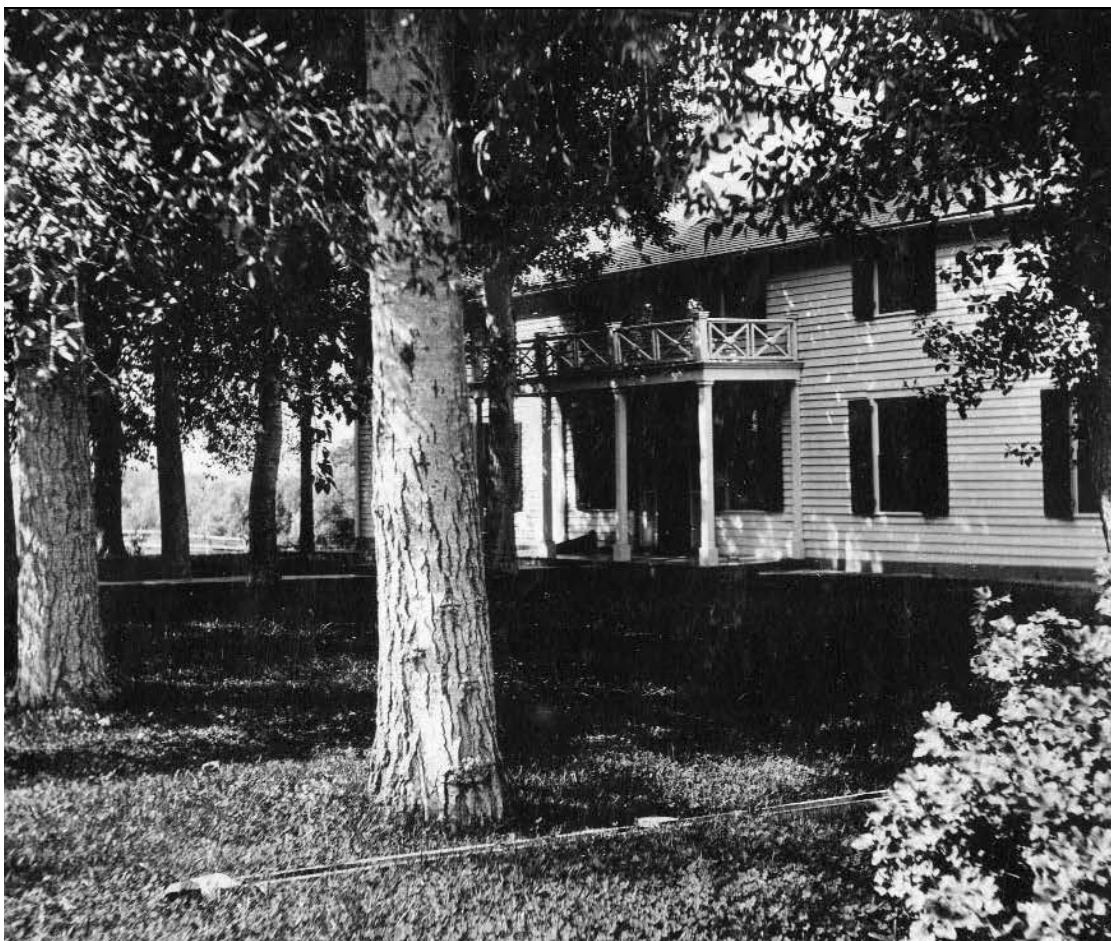
Figure 3-5. Cottonwood trees in front of the Grant-Kohrs Residence, circa 1900. The grid of trees and lawn created a formal entrance into the residence. (GRKO Archives)

- Formalize the main entrance to the residence. Resurface the drive in front of the residence, re-establish the grid of cottonwood trees, and maintain the symmetrical lawn in front of the residence. Restore carriage block and hitching posts per historic photographs.
- Repair the cobble wall adjacent to the residence and to reveal its full extents. Repair the landing and stone steps at the base (west) of the residence, and resurface paths to match the historic condition.
- Repair the stone walk between the residence and Bunkhouse.
- Maintain the perennial garden, utilizing historic plant species. Conduct further investigations into the type and arrangement of the historic garden.

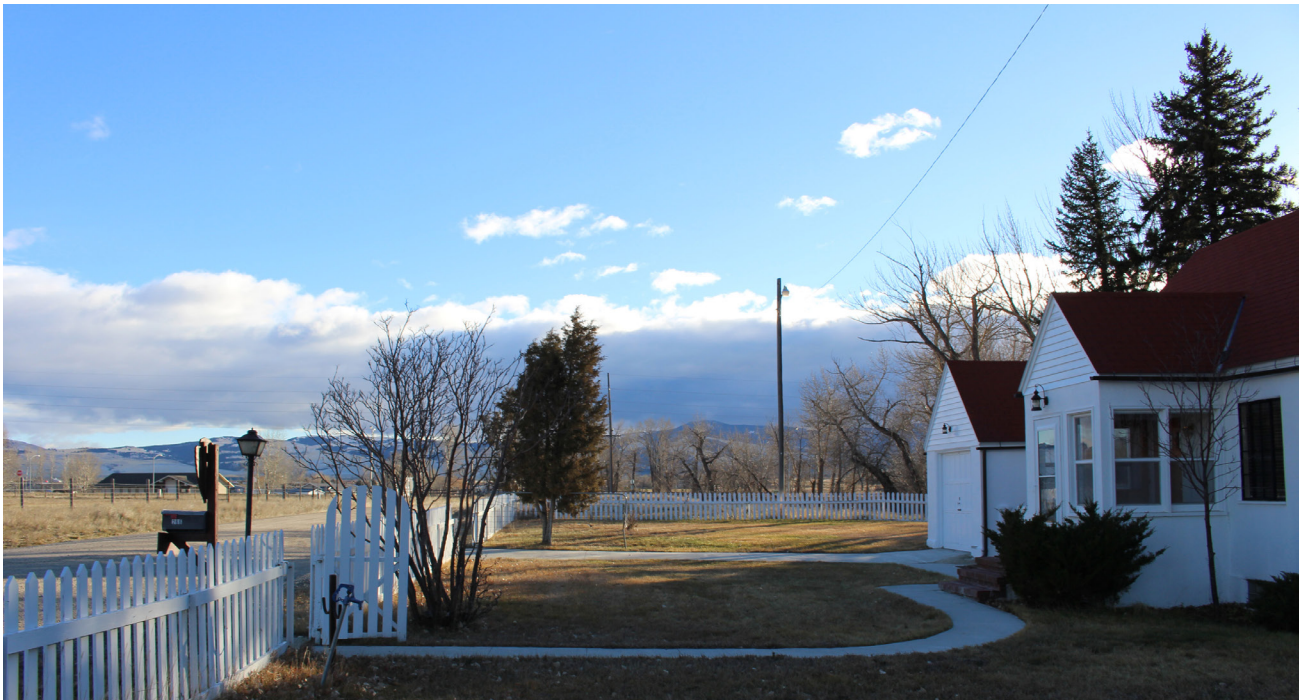
Figure 3-6. Warren Residence will continue as NPS administrative offices. Contributing features will be preserved, missing features replaced, and universal accessibility access routes will be added. (Mundus Bishop, 2015)

| Figure 3-6. | Warren Residence will continue as NPS administrative offices. Contributing features will be preserved, missing features replaced, and universal accessibility access routes will be added. (Mundus Bishop, 2015) ..... | 3-33 |

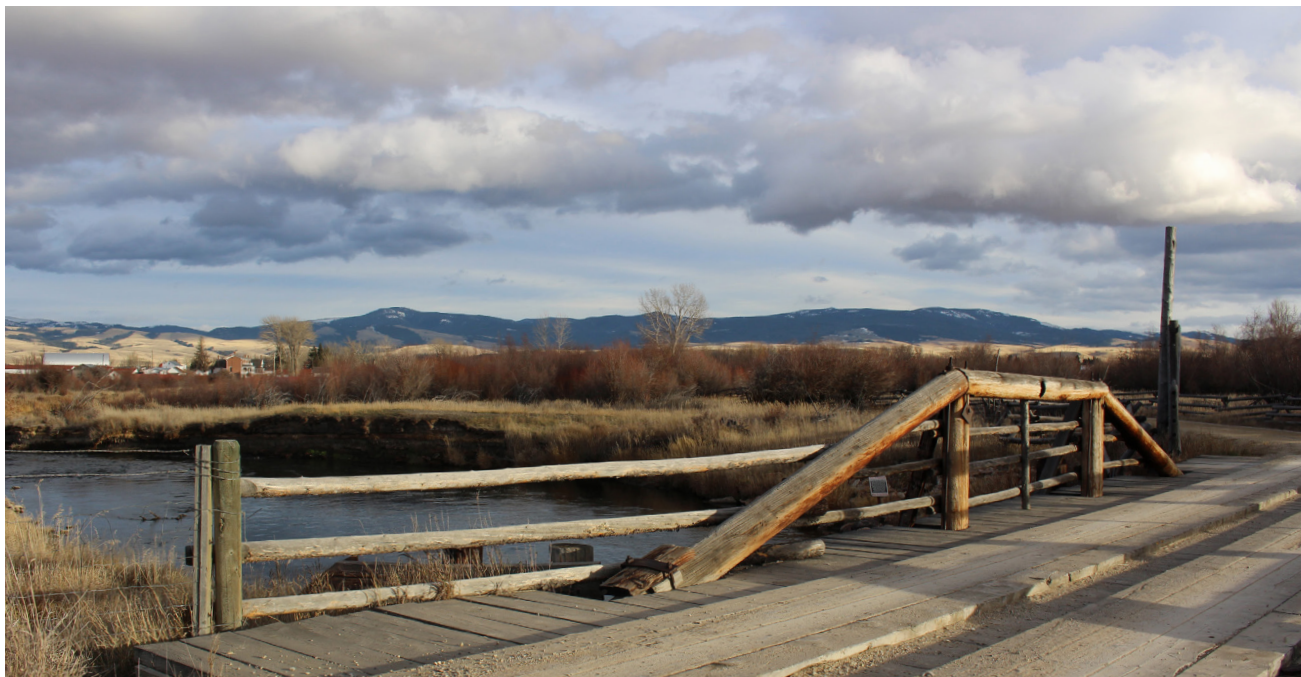
Figure 3-7. The treatment recommendations for the Riparian Woodland component landscape build upon the Superfund remediation and work already underway. Recommendations focus on the desired future condition once remediation is complete, and include recommendations to preserve existing structures, such as the Clark Fork River Bridge, above. (Mundus Bishop, 2015)

| Figure 3-7. | The treatment recommendations for the Riparian Woodland component landscape build upon the Superfund remediation and work already underway. Recommendations focus on the desired future condition once remediation is complete, and include recommendations to preserve existing structures, such as the Clark Fork River Bridge, above. (Mundus Bishop, 2015) ..... | 3-39 |

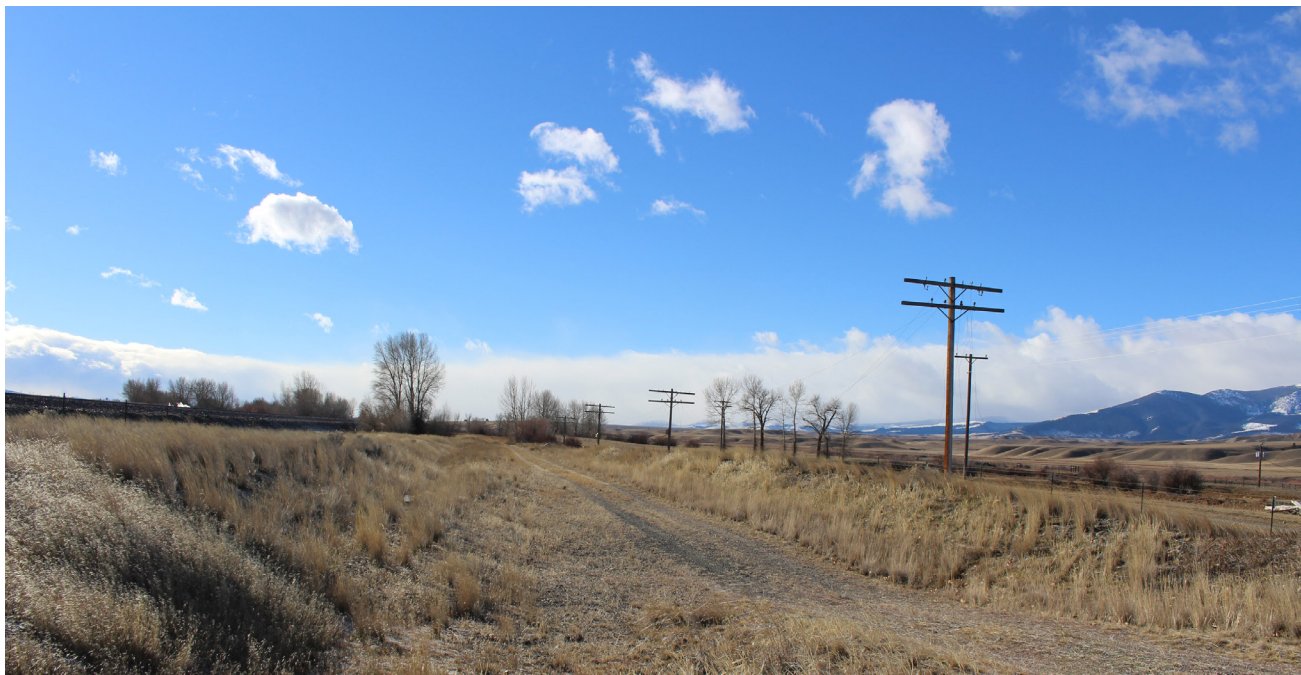
Figure 3-8. Treatment recommendations for the Railroad Corridor and Barrow Pit /Wetland component landscape include a two-part approach of preserving all features in the southern part of the ranch, and allowing for the eventual removal of hazardous features at the north end of the ranch. (Mundus Bishop, 2015)

| Figure 3-8. | Treatment recommendations for the Railroad Corridor and Barrow Pit /Wetland component landscape include a two-part approach of preserving all features in the southern part of the ranch, and allowing for the eventual removal of hazardous features at the north end of the ranch. (Mundus Bishop, 2015)..... | 3-45 |

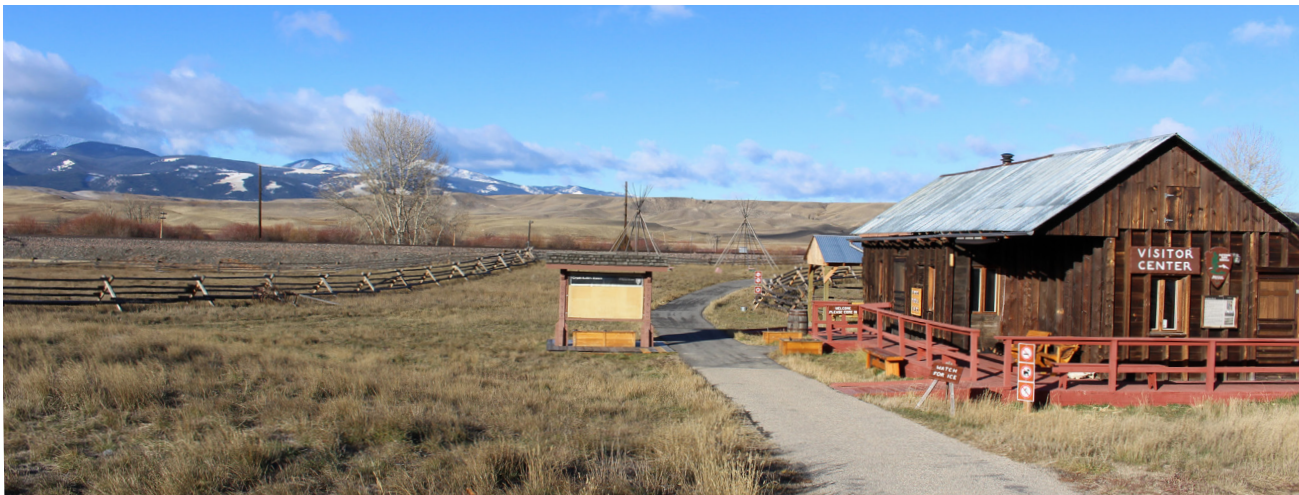
Figure 3-9. The Development Zone will be enhanced with new entrance signage and wayfinding. Future development will consider implementing a consistent NPS aesthetic, unique from the remainder of the historic ranch. (Mundus Bishop, 2015)

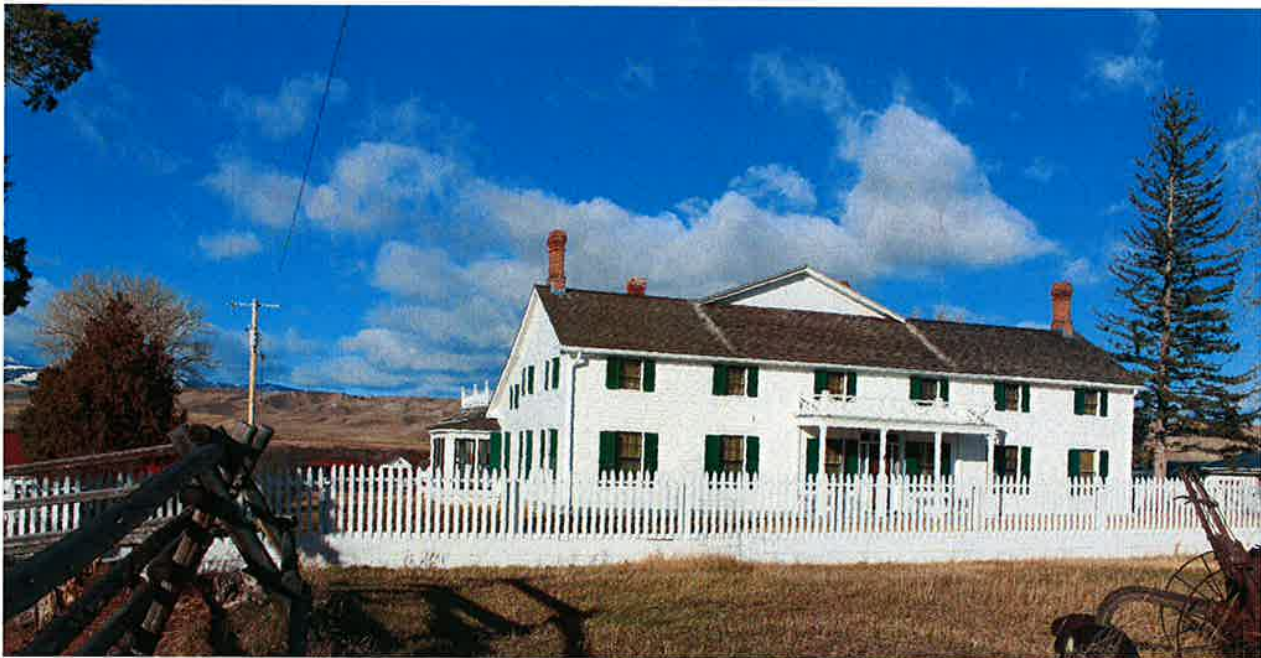
Figure 3-2. The Grant-Kohrs Residence component landscape will be reestablished as the center of domestic life on the ranch, by restoring missing trees and ornamental plantings.

- 1 -Repair grid of cottonwood trees and
- 2 regrade road and approach to house.
- 3 Remove non-contributing asphalt path from
- 4 directly in front of the residence.

- 19 ° Reestablish the front yard and entrance as a  
20 formal entrance, which existed historically.

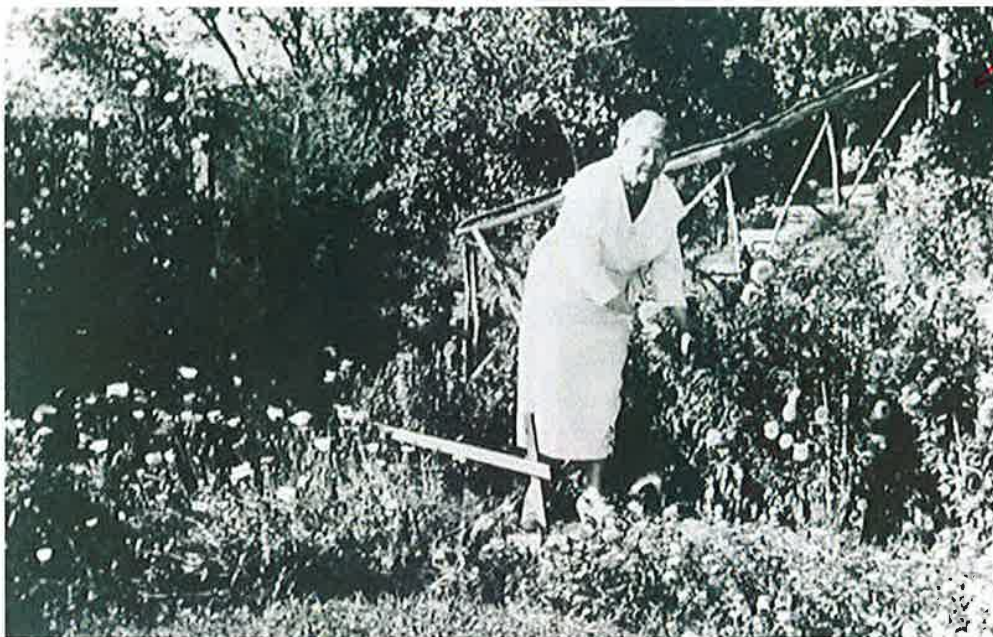
Figure 3-4. August Kohrs in the lower garden, circa 1930. Perennial plantings occurred both east and west of the stone staircase. Maps drawn of the garden based on interviews with Pat Warren, suggest that the sweet pea trellis divided the lower garden in two; to the east were the ornamental plantings and to the west were rows of vegetables

*The sweet pea trellis was not located at present spot.*

NOT  
August  
Anna or  
Katharine

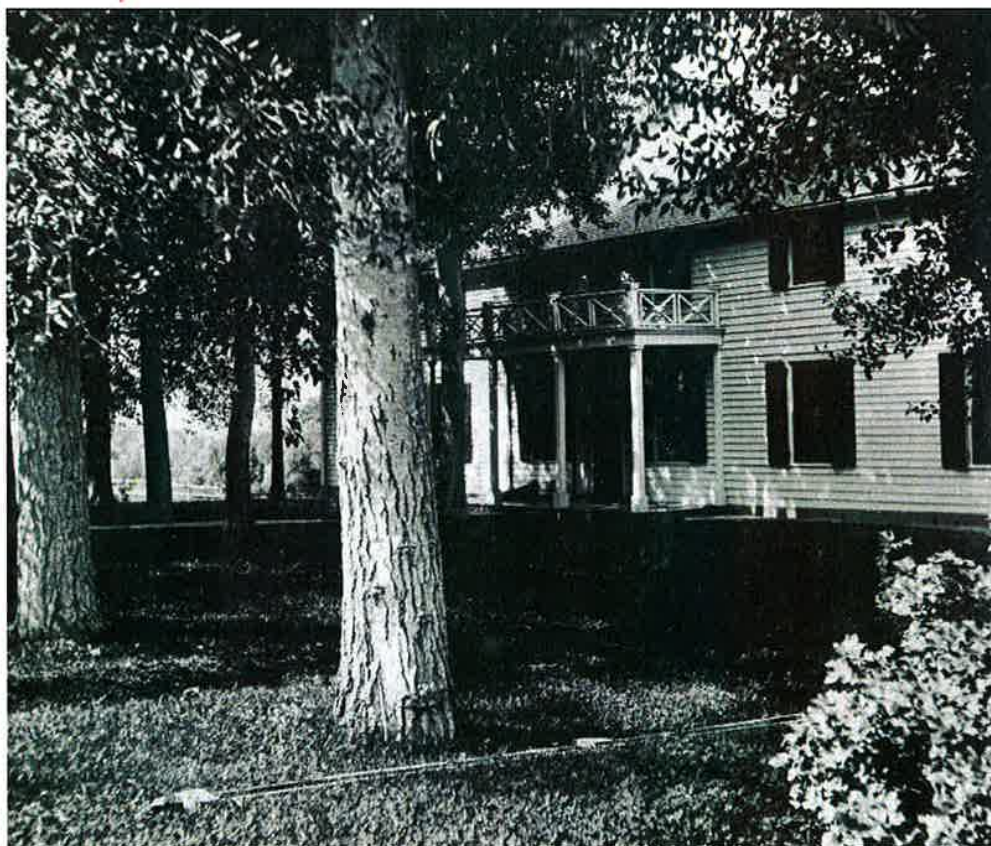
Figure 3-5. View of cottonwood trees in front of the Grant-Kohrs Residence, circa 1900. The grid of trees and lawn created a formal entrance into the ranch house.
