CONDITION ASSESSMENT REPORT:

BAKER ISLAND LIGHTKEEPER'S QUARTERS, ACADIA NATIONAL PARK

Frank Briscoe
Building Conservation Branch, CRC
North Atlantic Region, National Park Service
U.S. Department of the Interior
Boston, Massachusetts
1990

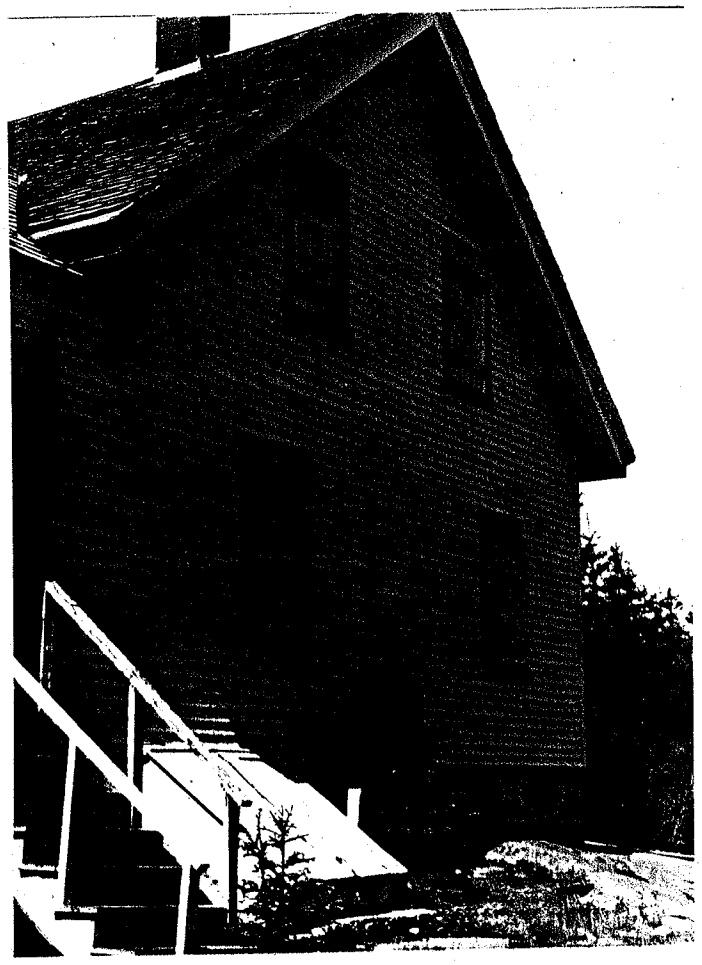
Figure 1. East gable of original structure. (BCB)

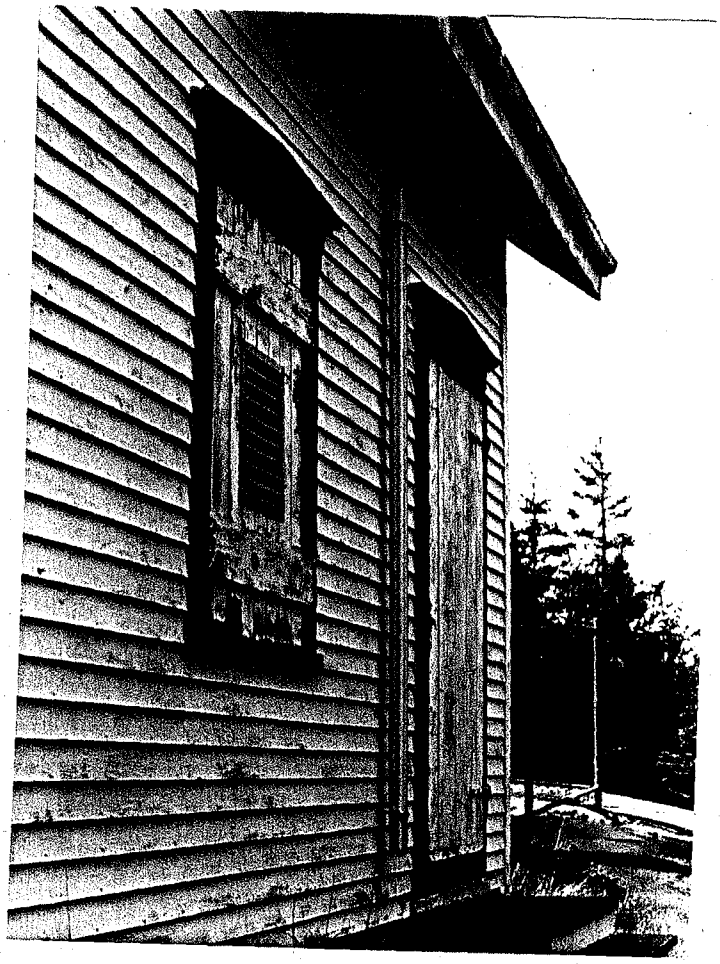
Figure 2. West corner of north facade. (BCB)

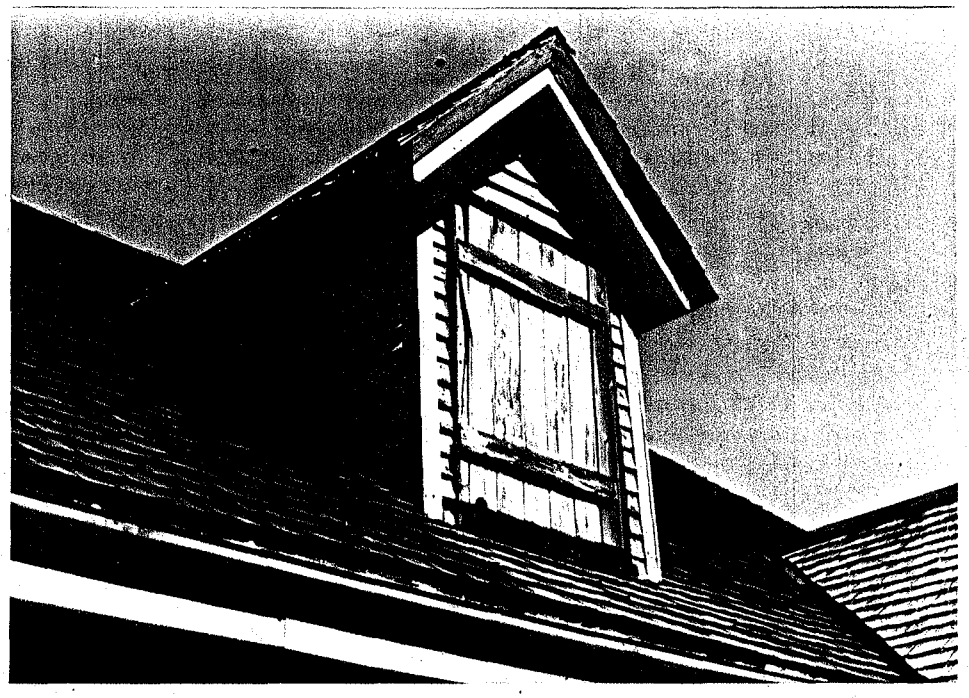
Figure 3. Dormer of south facade.
(BCB)

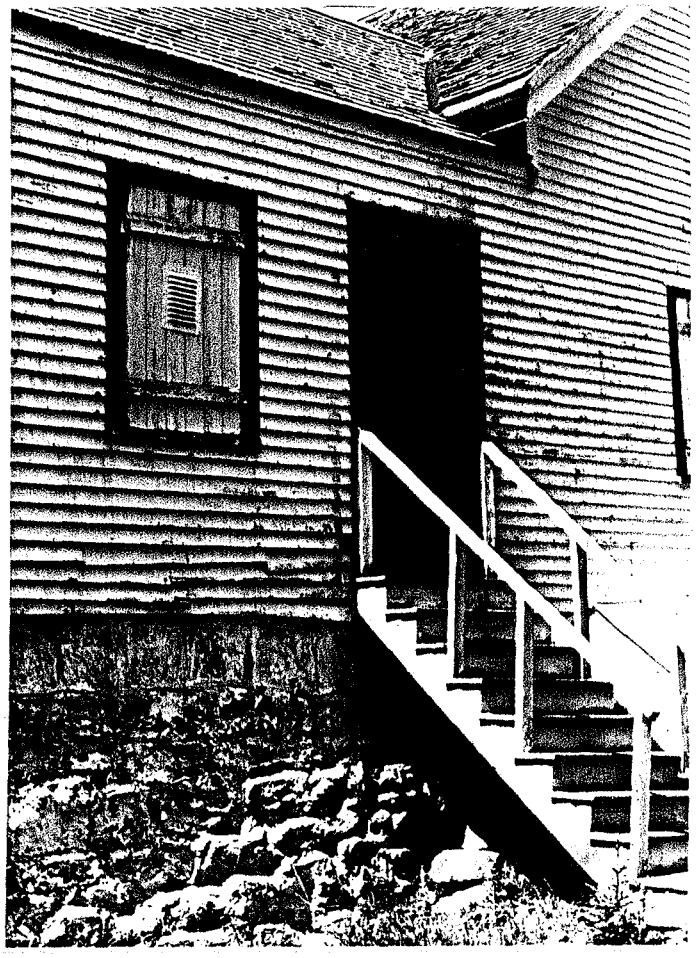
Figure 4. Intersection of wing with original structure. (BCB)

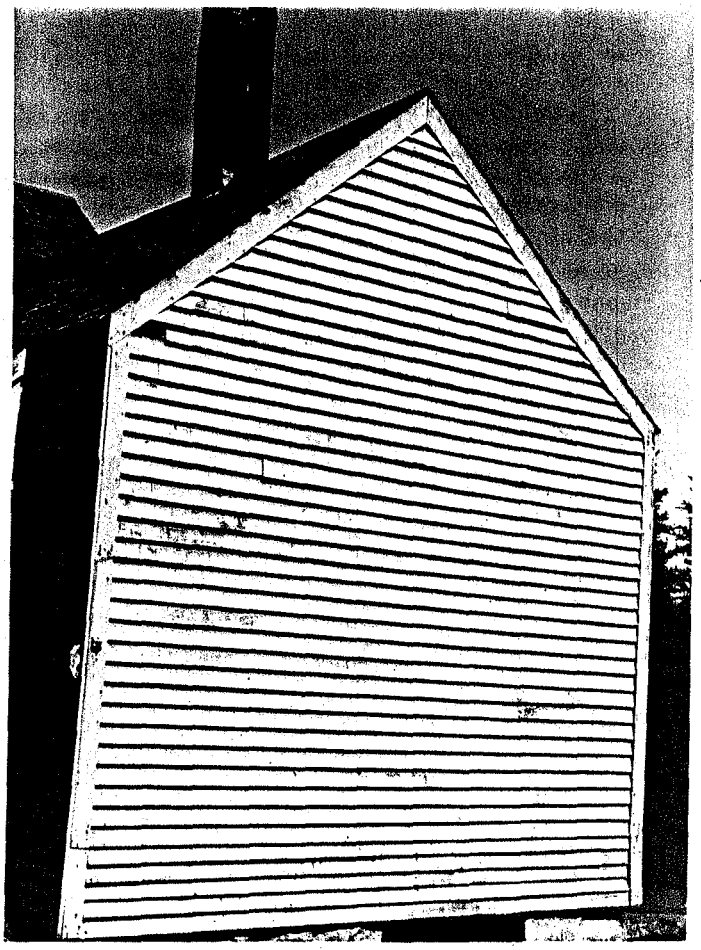
Figure 5. South facade of wing.
(BCB)

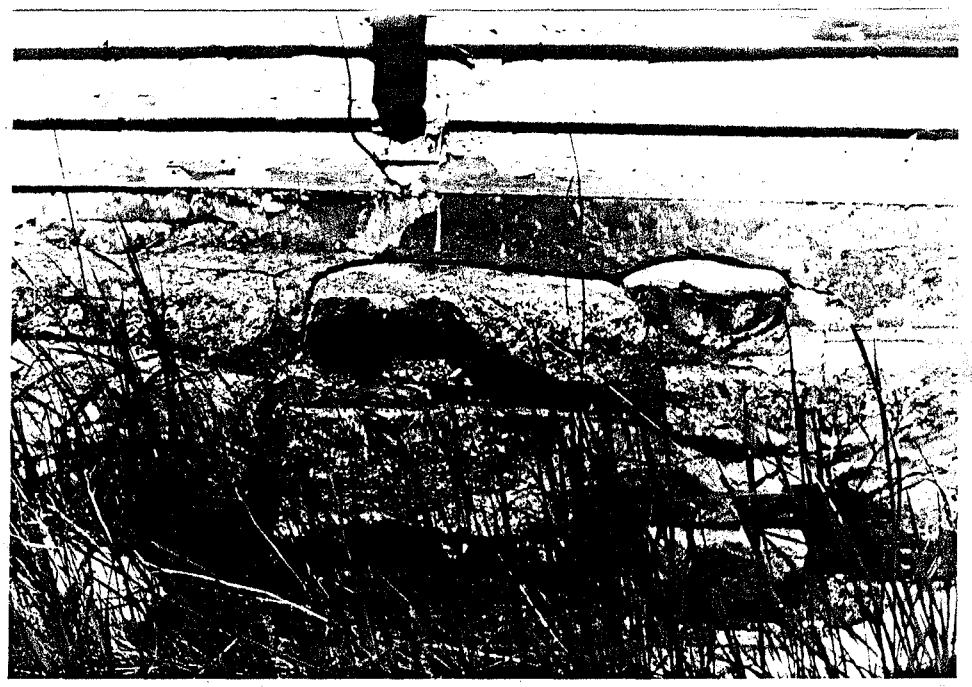
Of these moisture sources, the drainage from the roof is probably the most destructive. This is because roof run-off is generally deposited in a more concentrated way - beneath valleys and failed gutter systems. Some of the problems related to building drainage are visible in the foundation near the intersection of the wing and one and one-half story section on the west side. A valley draining a large area of the roof (Fig. 7.) and a disconnected gutter leader empty run-off along the foundation at this point. Several relatively small cracks and numerous patches in the pointing can be seen along the south facade of the original building in this area (Fig. 8.). Some of the most conspicuous evidence of movement in the foundation is visible along this section of the wing.

Damage from run-off deposited by the leader of the north roof gutter just east of the front door is also evident, but less of a threat. Some loss of material from the stone foundation and some spalling and loss of pointing from the brick can be seen (Fig. 9.). Areas where the brick skirt is in close proximity to ground level, such as at this point, are prone to the effects of rising damp. This damage is most apparent at the north side of where the hyphen to the lighthouse used to join the original building (Fig. 10.).

Figure 8. Damage to foundation below south gutter leader from roof drainage. (BCB)

Figure 9. Damage to brick skirt below north gutter leader.

The wooden gutters of the north and south facades should be made functional, even if these repairs are only temporary. Holes in the gutter troughs can be patched with asphalt building paper embedded in asphalt roofing cement. Particular care should be taken in sealing the joints where the downspouts join the troughs. Leaders should be checked for obstructions. An elbow should be added to lower end of the north leader and this leader extended to carry run-off away from the perimeter of the building (toward the north). If feasible, the leader of the south gutter should be added to and routed around the building to a point where runoff will not further damage this vulnerable corner.

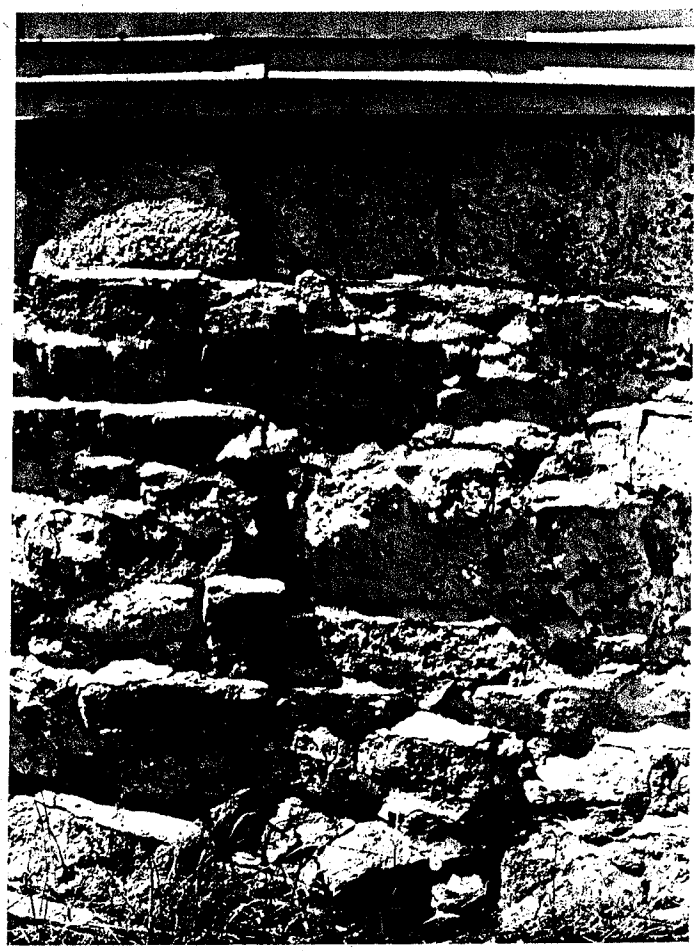
the east facade. The northern half of the building's perimeter is relatively well-drained. Foundation problems from poor site drainage are most visible along the south facade and on the east facade near the southeast corner of the building (Figs. 11., 12.). At the southwest corner foundation settlement has removed all visible means of support from the enclosed entrance here (Fig. 13.).

Figure 11. Cracks in stone foundation on east facade near south corner. (BCB)

Figure 12. Cracks in foundation on east facade near south corner. (BCB)

Figure 13. Foundation settlement at southwest corner. (BCB)

Installation of temporary gutters along the east and west eaves of the wing would significantly slow damage to the foundation. Leaders from these gutters should carry precipitation away from locations lacking adequate drainage (especially the southwest corner).

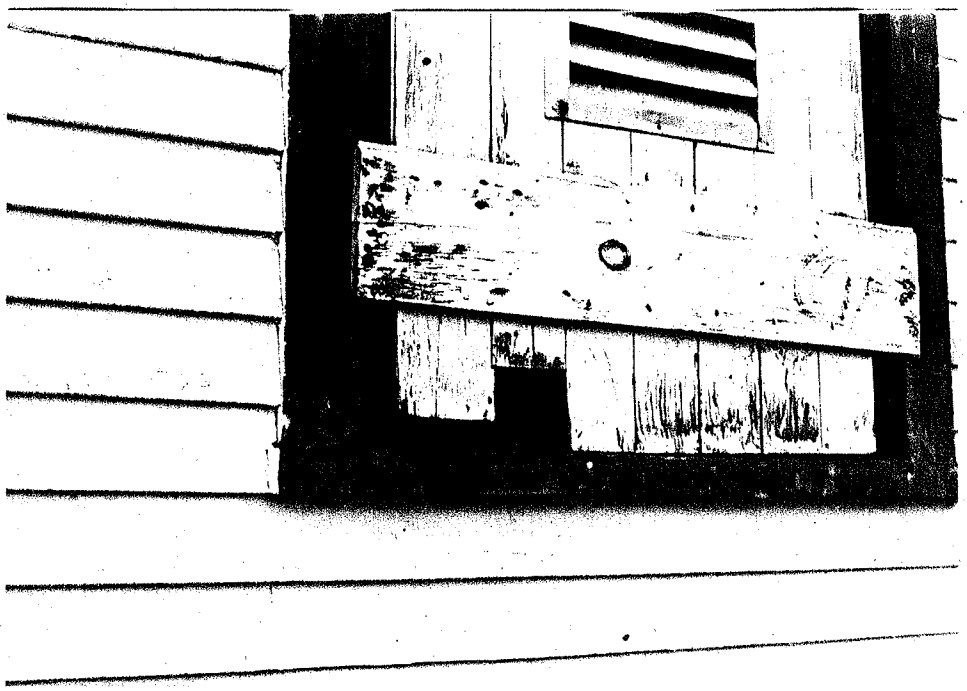
Other problems related to the building envelope include openings or loss of fabric allowing pests to enter the structure and making the building vulnerable to vandalism. The most serious threat by building pests is from birds. Several bird nests were found between window sash and window coverings (Figs. 16., 17.) (believed to be starlings) and in corners of the first floor interior, and between the floor joists over the south basement (swallows). Besides the debris of their nests, birds introduce dirt into structures which can encourage infestations by beetles, particularly wood-boring Longhorn beetles.[2] The excrement of birds is both acid and alkaline and causes decay in a variety of materials. It is also difficult to satisfactorily remove.

Figure 16. Openings in the window covers allow birds to nest in building. (BCB)

The existing window coverings discourage unauthorized entry to the building and provide important ventilation. However, for better security, more effective ventilation, and to protect the interior from building pests without damaging historic fabric, these coverings should be replaced with alternative enclosures described below.

The enclosures we recommend are similar to those the park used in some of the window openings at the Gilley house. The upper sash is lowered half-way, the lower sash is raised half-way, a piece of 3/4" exterior grade plywood is cut to fit snugly over the outside of exterior window stop (inside the trim) and bolted with carriage bolts to "strong-backs" (usually 2 by 4s) set flat overlapping the interior window opening (Figs. 30., 31.).

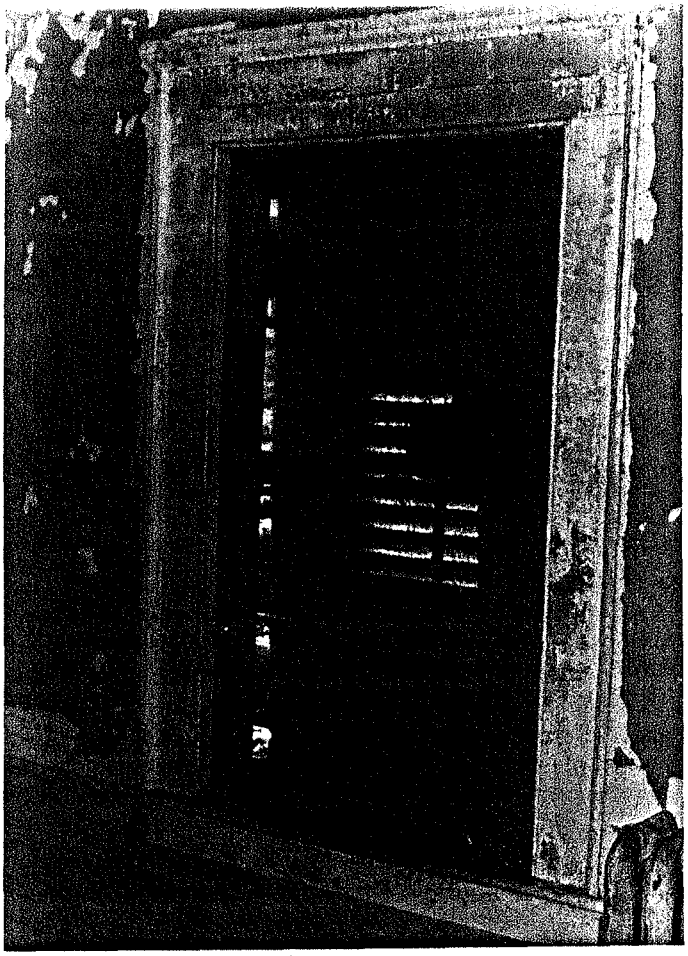
Figure 17. Bird nests in the west window of north facade. (BCB)

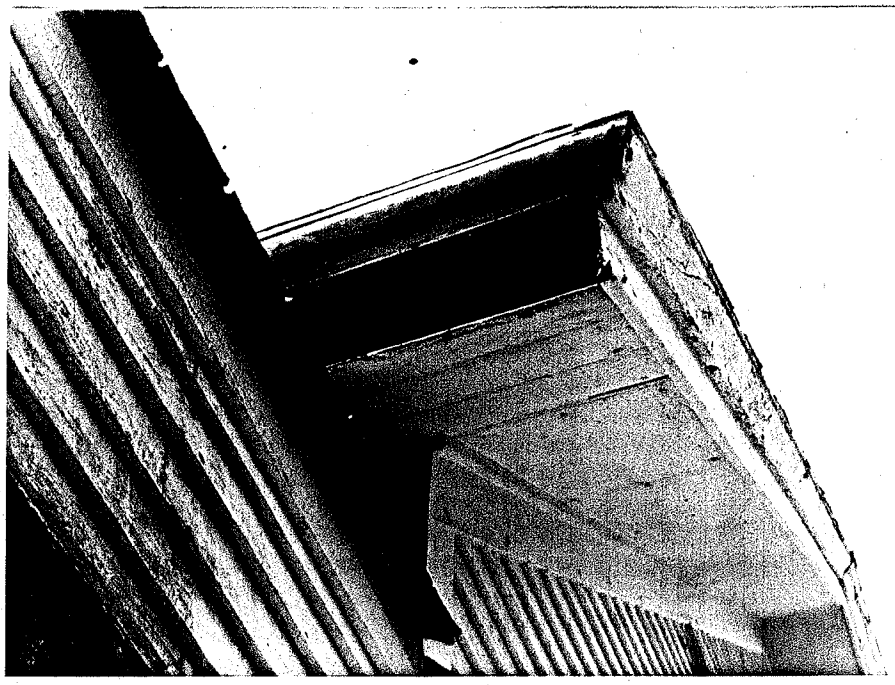
Surprisingly little decay was found in exterior wooden elements. Most of the decay is in areas where roof drainage is concentrated, such as in the wooden gutter troughs, eaves and below the valleys of the east and west facades. On the east side a facia member is lost from the south side of cornice (Fig. 18.). Minor decay is visible in the cornice molding at this corner of the roof and at the corresponding corner on the west side. Decay is also apparent where the leader comes through the eaves on the west side (Fig. 19.) and in about two and a half feet of the lower eaves member of the north facade at the west corner.

Figure 18. Missing facia member from eave below east valley. (BCB)

All repairs of wall cladding and eaves elements necessary to prevent access by birds should be made. Screen should be applied over the holes where the leaders once entered the

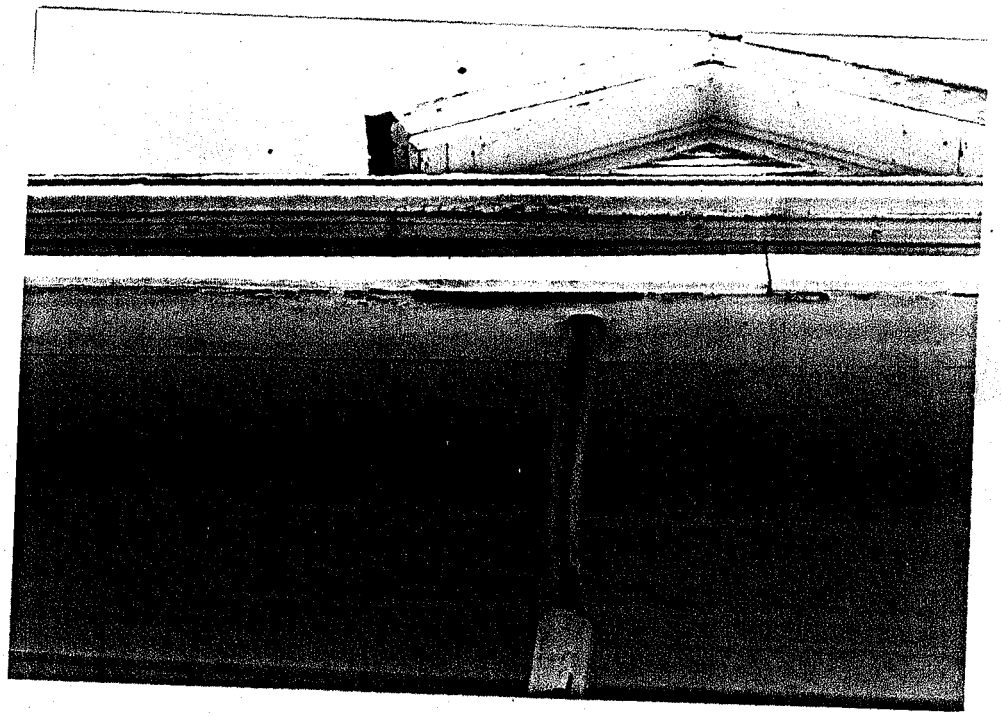
Clapboard is damaged or missing in several areas of the exterior walls. About ten feet of clapboard is loose in the lower four courses on the east facade south of the door (Fig. 20.). Small pieces of clapboard are missing at the north end of west facade (Figs. 21., 22.) and on the south facade of the wing at cornice level.

Figure 19. Decay in eaves below south gutter. (BCB)

Figure 20. Loose clapboard on east facade of wing. (BCB)

Figures 21., 22. Clapboard missing from north window of west facade. (BCB)

When feasible, loose and missing clapboard should be re-affixed.

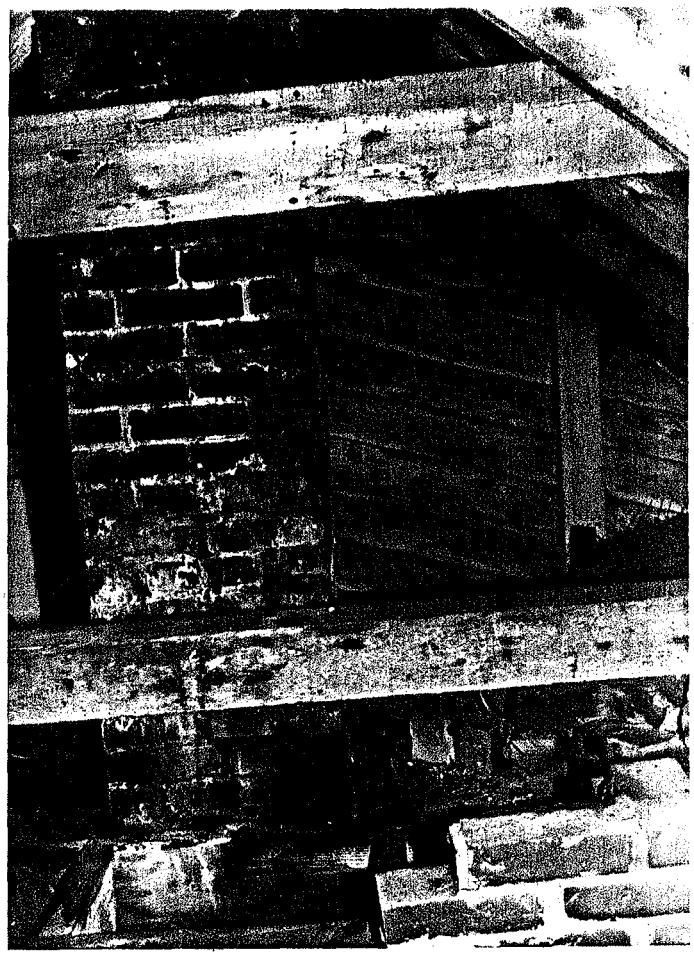
Rain and snow also penetrate the building envelope through the uncapped chimneys. Efflorescence is visible on the south chimney in the attic (Fig. 23.) and on the north

Figure 23. Efflorescence on the south chimney visible from the attic. (BCB)

chimney in the attic of the original structure. This is caused by the deposit of soluble salts as moisture migrates through porous masonry. The resulting crystals can grow and damage the masonry units. Excessive moisture migration through the chimney walls is probably also responsible for the failing pointing of both chimneys.

Chimney caps are highly recommended for both chimneys. These will reduce the amount of moisture on the interior surfaces of these features and greatly slow their deterioration. The caps must allow ventilation of the chimneys. (Removing some of the debris from the stove pipes would probably improve air circulation and further reduce condensation.) The material of choice for the caps would be sheet metal, but wooden caps would be serviceable.

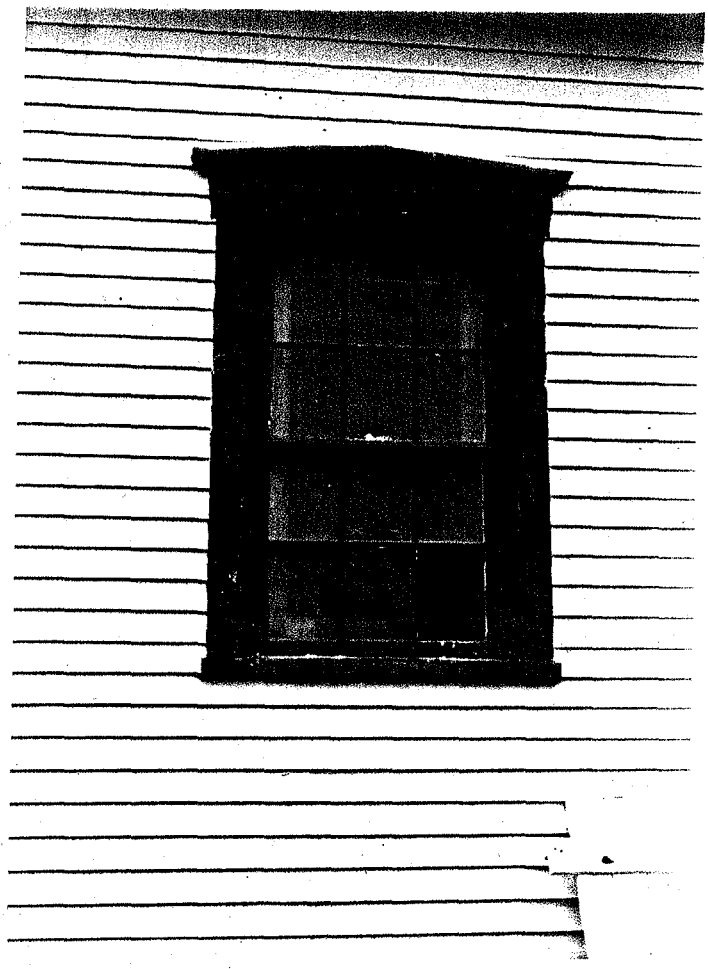
defining features such as door and window treatments (Fig. 24.), exterior wall treatment (clapboard) and cornice details (Fig. 25.), interior wall treatment (Fig. 26.) (mostly wood wanescote below and plaster above) and interior moldings and hardware.

Figure 24. Typical window treatment of original structure. (BCB)

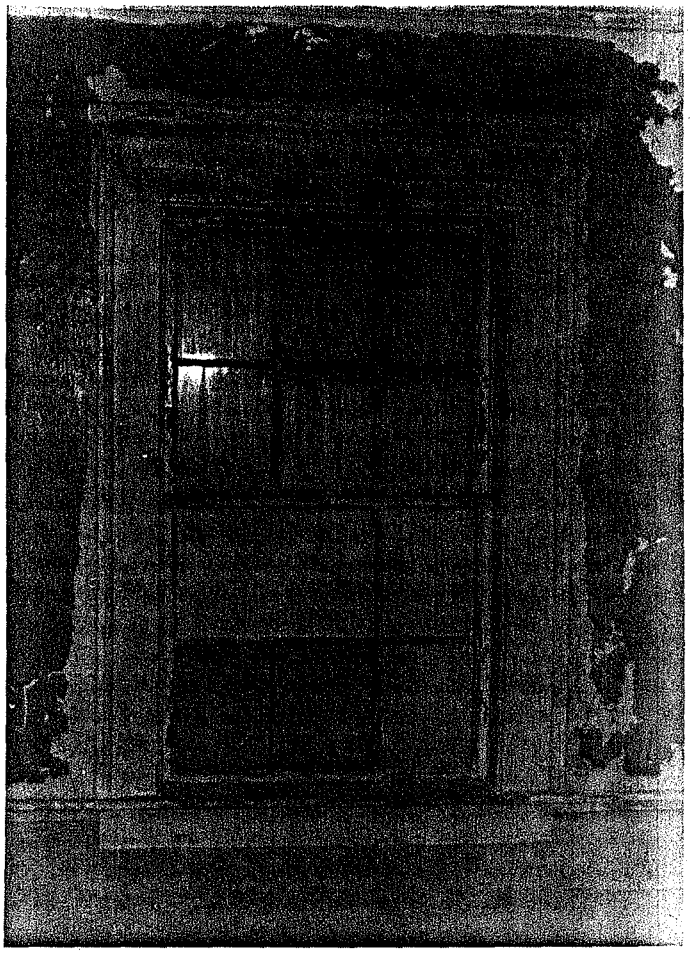
Historic fabric of the building is in generally good condition, with a few exceptions. The historic front door has been extensively battered with a hammer along the upper left exterior side. Several window units have broken sash or muntins (Fig. 27.), and a few muntin elements were found on the floor of the building. Exterior window trim and sills show some damage from the present method of nailing the window coverings into these features (Figs. 28., 29.).

Figure 27. Several windows have broken or missing muntins. (BCB)

Figure 28. Present method of securing window coverings results in damage to historic trim. (BCB)

Figure 29. Window covering nailed to historic trim. (BCB)
