HISTORIC STRUCTURES REPORT

BATES WELL RANCH
ORGAN PIPE CACTUS NATIONAL MONUMENT

A Service Learning Project of the
Preservation Studies Program
College of Architecture and Landscape Architecture
The University of Arizona

June 2007

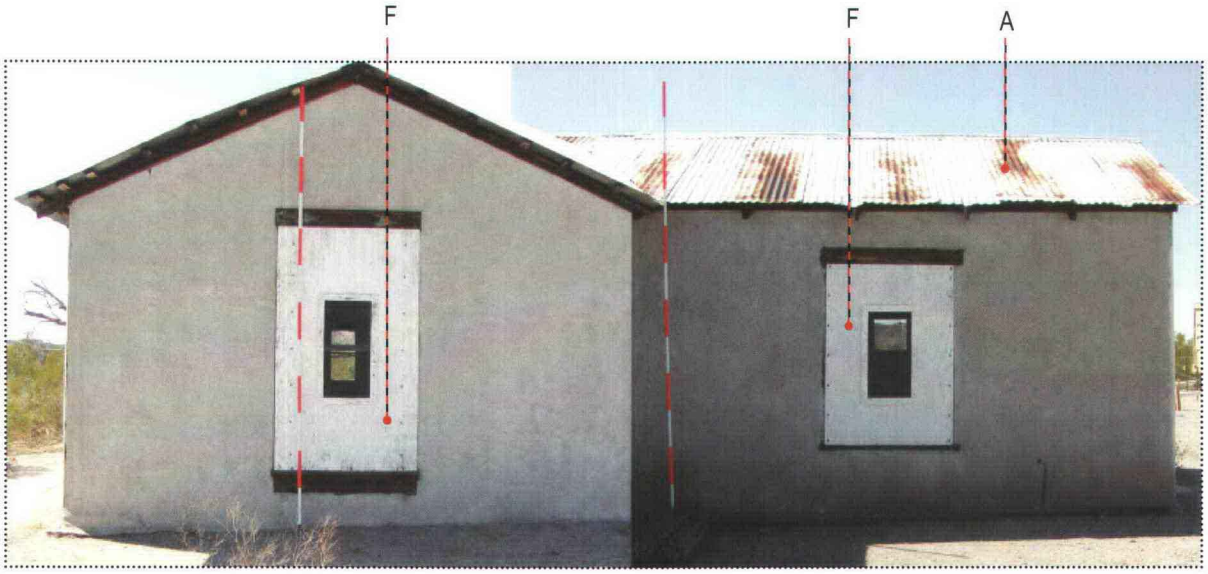
North elevation of the Main Residence (letters refer to notes in condition assessment table below)

Of all the buildings that comprise the Bates Well Ranch, the Main Ranch House possesses the greatest level of integrity. The exterior is in good condition with small cracks in the stucco surface. The corrugated metal roof is in need of attention with many holes from previous nails and rusting from age. In order to deter vandalism, the window openings were boarded up in the 1990s by NPS staff from the outside with plywood, with smaller 1 foot by 2 foot openings cut into the plywood and screened with quarter inch steel mesh. The glazing is gone and many of the frames are missing as well. The ceiling material is missing in all but a few areas and there are several pieces of the wall material missing as well. The kitchen cabinets and the stove are intact. The linoleum flooring is peeling back to reveal the wood floor below from the leaking roof but there is no evidence of mold.

Deficiencies	Recommended Treatments	Priority
A	Corrugated metel roof contains nail holes and severe rust damage.	Replace roof with like material	Serious
B	Rotted/termite infested Wood	Application of biocides where severe damage.	Critical
C	Missing Components	Replace lost components with like material	Serious
D	Water Damage	Replace roof and repair or replace damaged material.	Serious
E	Broken Window Framing/glazing	Replace and repair as needed	Serious
F	Window inserts added after period of significance	Remove and return to original state	Critical

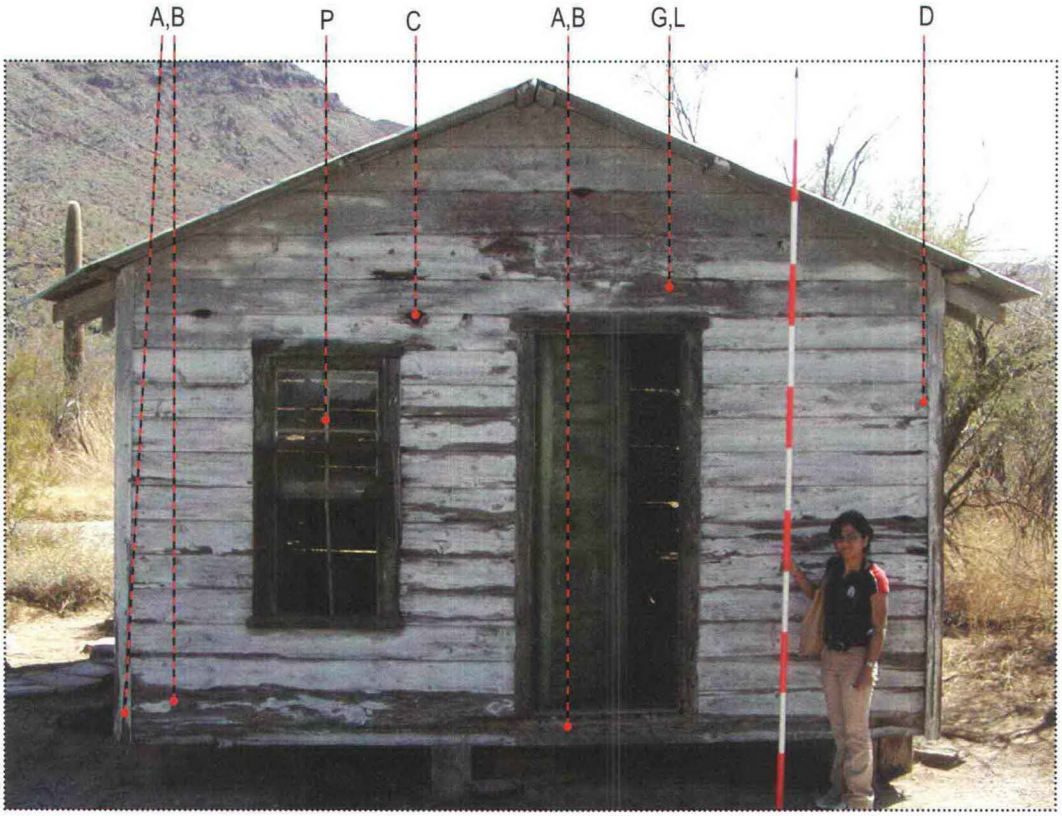
The Bunkhouse has a gable roof supported by a series of nine trusses spanning in the E-W direction. These trusses support secondary 2 x 4 rafters running in the N-S direction. The covering is done with corrugated tin sheets which appears relatively new. The interior of the Bunkhouse displays remnants of linoleum flooring and gypsum board panelling on the wall surfaces. While the interior board panels are completely missing from the south wall, they are present with missing parts and defects on the remaining walls. The gypsum board also appears to have been used for providing a ceiling and covering for the trusses from inside, although at present it is intact in only a few places.

At present, the condition of the Bunkhouse has been assessed as fair relative to the condition of the other ranch structures on site. However, there are many pressing problems which need to be addressed. The structure is tilting towards the rear west corner probably due to settling of the corner pier. In addition, the floor is sagging; this can be clearly noticed on the eastern side. The wooden planks on the facades are also deteriorating due to the combined effects of the harsh climate and the impact of microorganisms. The roof sheathing is relatively new, although it displays signs of detaching itself at the rear. The interior of the building is also in a state of disrepair. The gypsum board paneling on the walls and ceiling is completely missing in parts and also suffers from damage due to water seepage. Only remnants of the original linoleum flooring are left behind.

The recommended treatment for the Bunkhouse is *Restoration* as defined by the Secretary of the Interior's Standards for the Treatment of Historic Properties. For more specific treatment recommendations, see the *Ultimate Treatments* section.

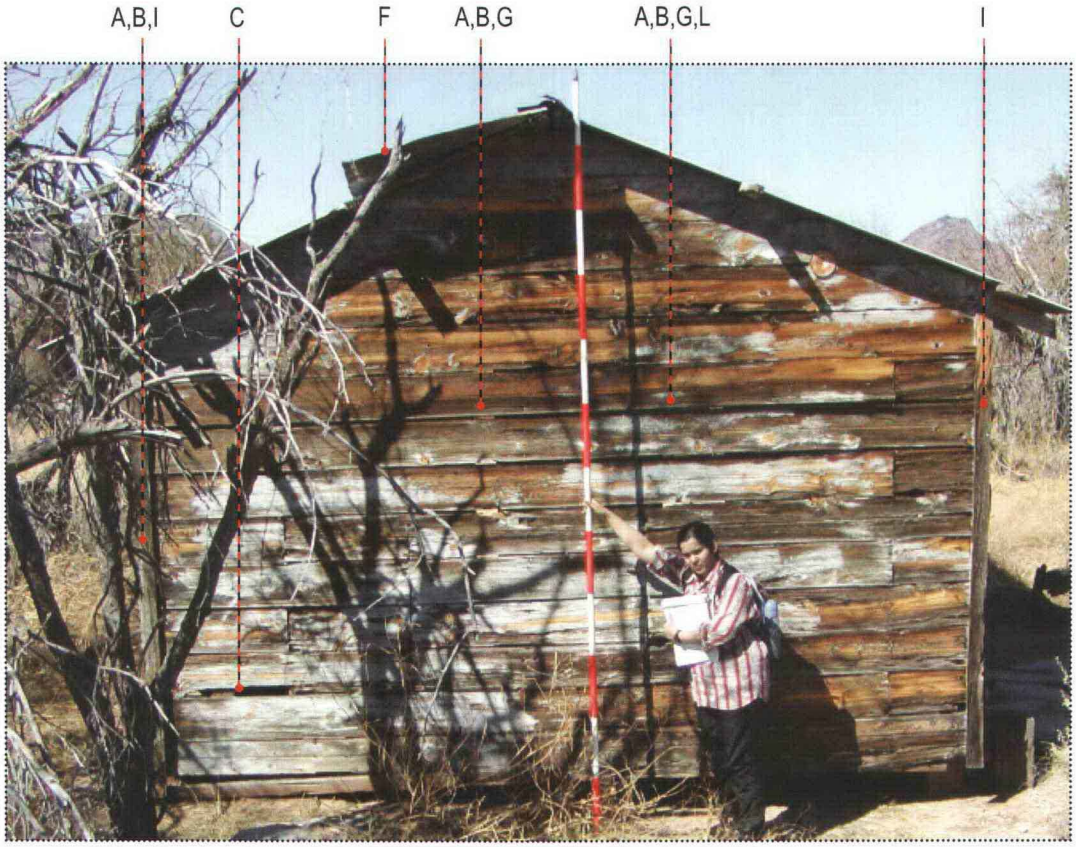
East elevation of the Bunkhouse (Letters refer to notes in condition assessment table below)

Deficiencies	Recommended Treatments	Priority
A	Water damage to wood paneling and facia including warping and splintering.	Remove source of water, replace wooden planks where severely damaged with like material	Serious
B	Rotting of wood due to microorganisms/ pests (also termite) infestation.	Application of biocides where damage is sever	Serious
C	Missing portions of wood planks	Replace entire plank where substantial portions are missing or structural stability is endangered.	Critical
D	Corrosion and deterioration of wood around nails.	Apply anti-rust coating on nails before replacement planks are installed.	Serious
F	Delamination of sheet metal roof	Replace/reattach portions delaminating. If pieces are missing replace with like material	Critical
G	Staining of wood due to water damage.	Remove source of water, which may be due to roof leaks or holes in the cladding.	Serious
I	Leaning of the structural wooden posts leading to instability & leaning of the shed.	Stabilize the structure by realigning the main structural posts. If necessary reassess the condition of the tie-beam and strengthen to bind the structure	Critical

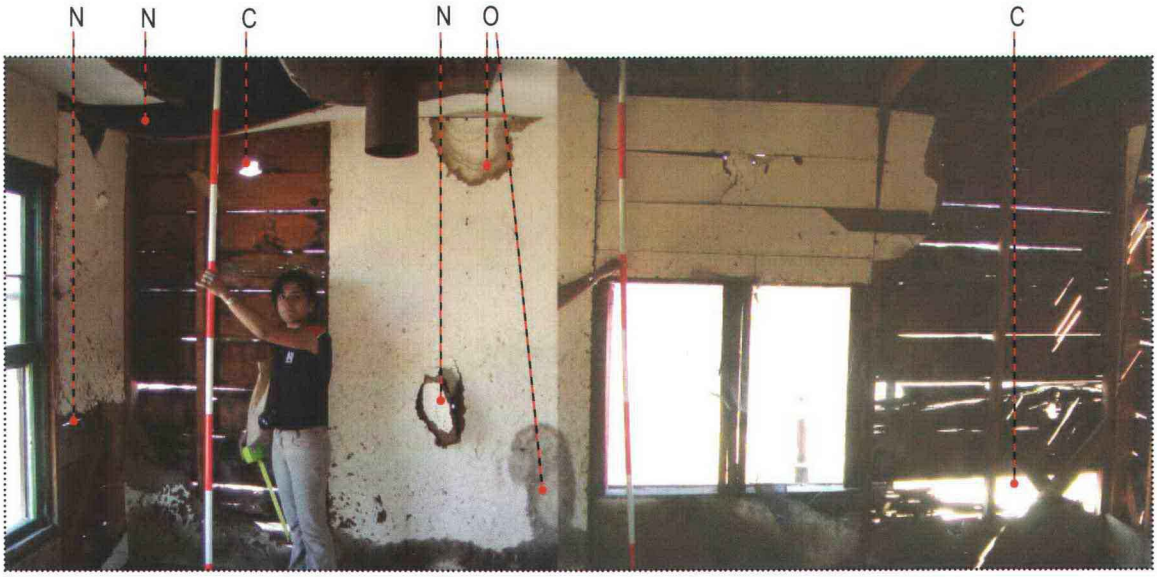
South elevation of the Bunkhouse (Letters refer to notes in condition assessment table below)

J	Deterioration of planks near the base of the structure.	Missing pieces should be replaced with like material.	Critical
K	Sagging floor.	The cause of the problem should be addressed then entire floor repaired.	Critical
L	Paint cracked and peeling	Reapply paint on facades. New paint should match exactly previous in appearance & texture.	Serious
M	New screen frames nailed onto original facade	New parts should be removed after being documented	Serious
N	Missing pieces from the Gypsum-board paneling & ceiling in the interior	The paneling should be replaced if severely damaged or missing	Serious
O	Water damaged Gypsum-board	Address source of seepage & replace if extensively damaged	Serious
P	Broken window mullions	Repair or replace with like materials	Serious

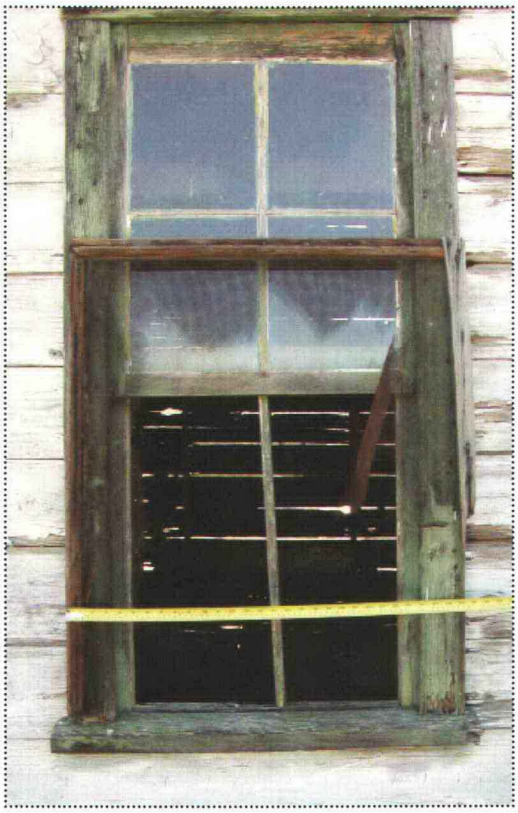
M, A, B. Detail view of window on west elevation. Note the wire mesh screen coming off & new board above opening

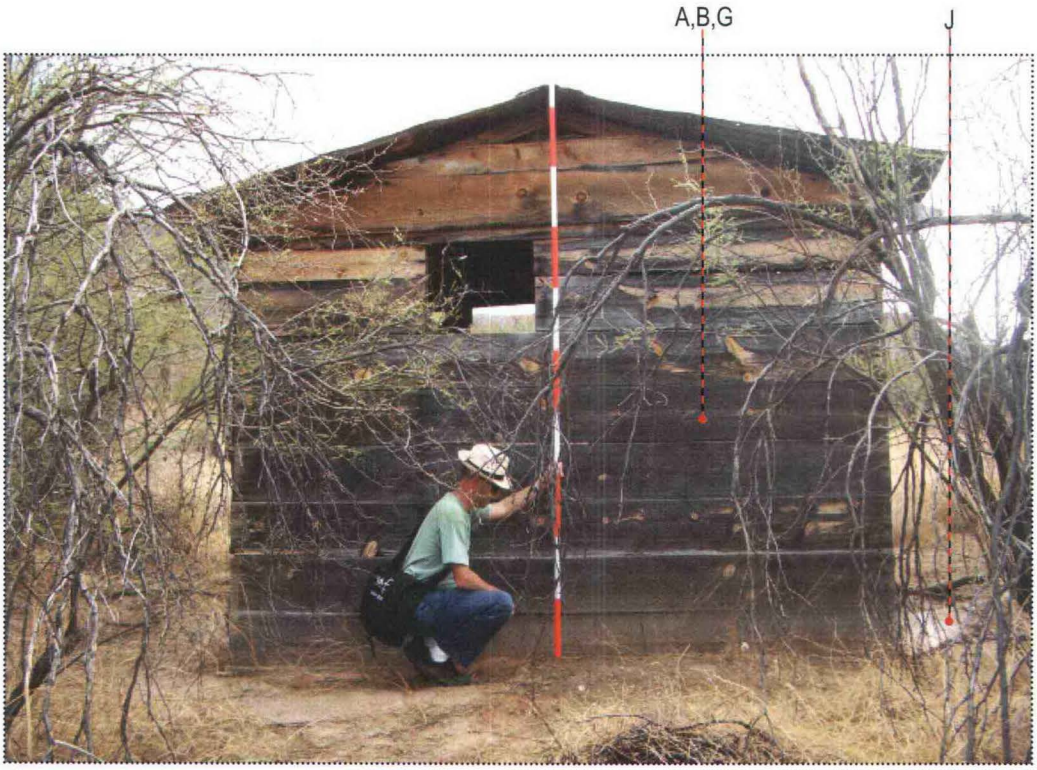
At present, the condition of the Tack House has been assessed as fair relative to the condition of the other ranch structures on site. However, there are many pressing problems to be addressed. The shed is leaning to the east and suffers from bowing of the wooden support posts, leading to instability. The wooden planks suffer from extensive rotting and staining. The major causes are animals / pests and termite infestation. The other major cause is moisture damage. As a result there is rusting at the juncture of wood & iron nails, leading to eventual corrosion of the surrounding wood. Thus either entire planks become disjointed or rotten pieces detach, causing gaping holes in the exterior facade. The corrugated sheet metal roof displays rust damage. Also, several mesquite trees in close proximity to the Tack House may pose a fire hazard.

South elevation of the Tack House (letters refer to notes in condition assessment table below)

Deficiencies	Recommended Treatments	Priority
A	Water damage to wood paneling and facia including warping and splintering.	Correction of the source of water Replace the wooden planks where severely damaged; match the size & type of wood to existing.	Serious
B	Rotting of wood due to microorganisms/ pests (also termite) infestation.	Application of biocides where severe damage.	Critical
C	Missing parts from wood planks	Replace entire plank where substantial parts missing or structural stability is endangered.	Serious
D	Corrosion and deterioration of wood around iron nails on edges.	Apply anti-rust coating on nails before replacement planks are installed.	Serious
E	Rusting of the corrugated metal roof due to water damage	Replace the sheets which are severely rusted.	Serious
F	Falling apart of the metal sheets on the roof esp. the central ridge	Replace/reattach the portions that are coming apart. Use identical sheeting for replacement	Critical

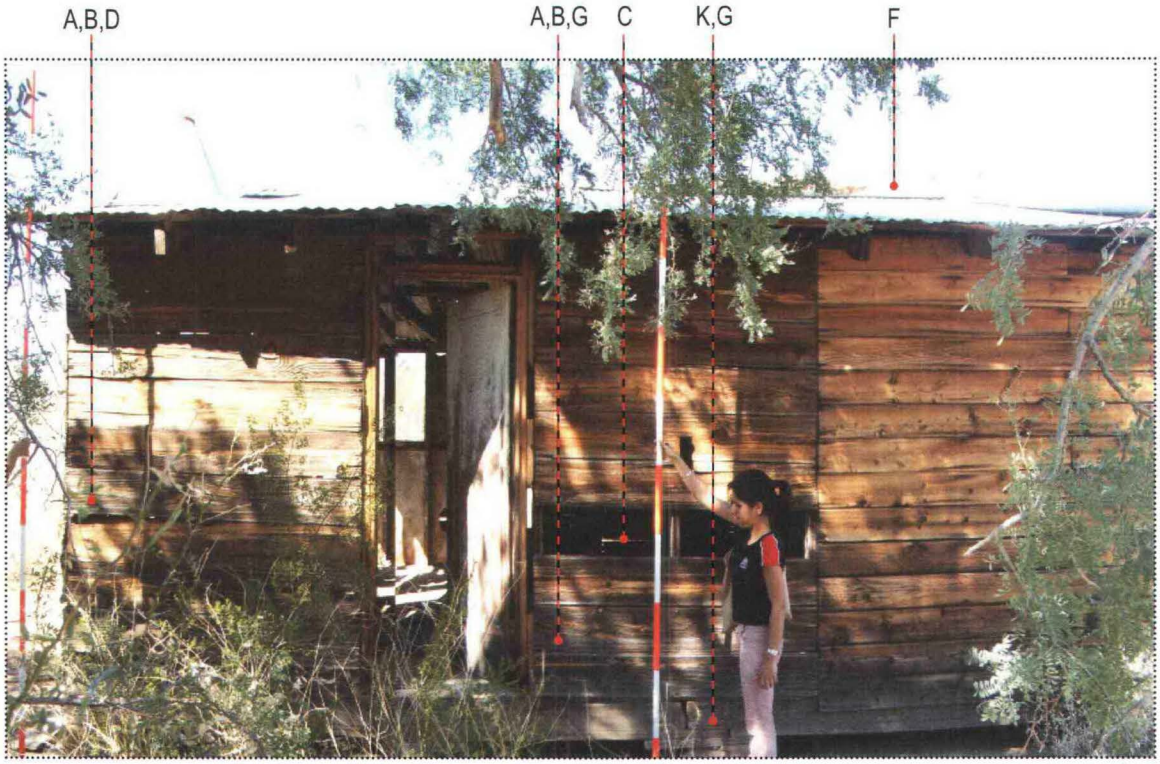
The Hay Barn has a gable roof supported by a series of ten trusses spanning in the N-S direction. The trusses support 2 x 4 purlins running in the E-W direction. The roof is clad with corrugated sheet metal which appears relatively new. There is a conical sheet metal aperture in the northwest corner. The interior of the Hay Barn displays wooden plank flooring and the walls display remnants of gypsum board panelling.

At present, the condition of the Hay Barn has been assessed as fair relative to the condition of the other ranch structures on site. However, there are many pressing problems which must be addressed. Similar to the Bunkhouse, the Hay Barn is raised off the ground. In this case, concrete blocks have been used for this purpose. The floor of the Hay barn is sagging, leading to structural instability. Another pressing problem is the extensive weathering damage that has occurred to the horizontal plank siding. Planks are missing in many places leading to instability and water infiltration. The corrugated sheet metal roof is riddled with holes, suffers rust damage and is detaching in several places.

The recommended treatment for the Hay Barn / Bunkhouse No. 2 is *Restoration* as defined by the Secretary of the Interior's Standards for the Treatment of Historic Properties. For more specific treatment recommendations, see the *Ultimate Treatments* section.

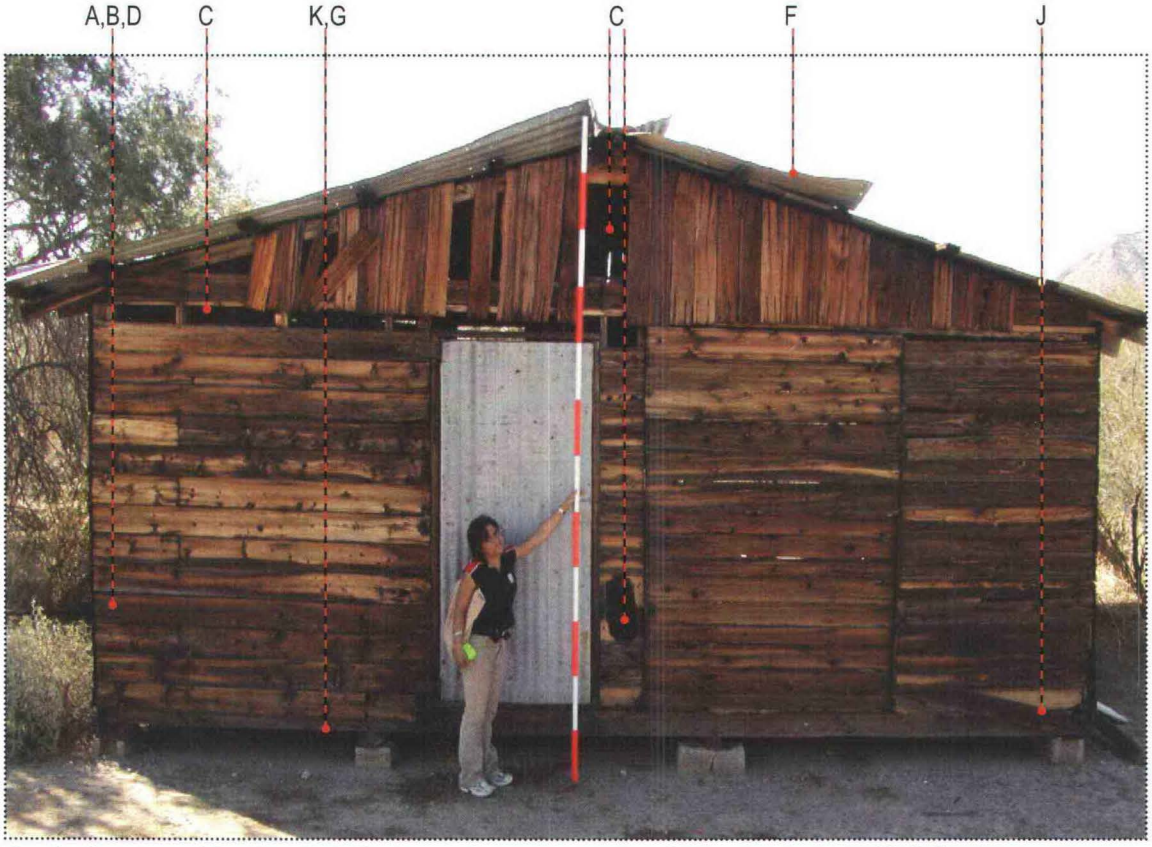
West elevation of the Hay Barn (Letters refer to notes in condition assessment table below)

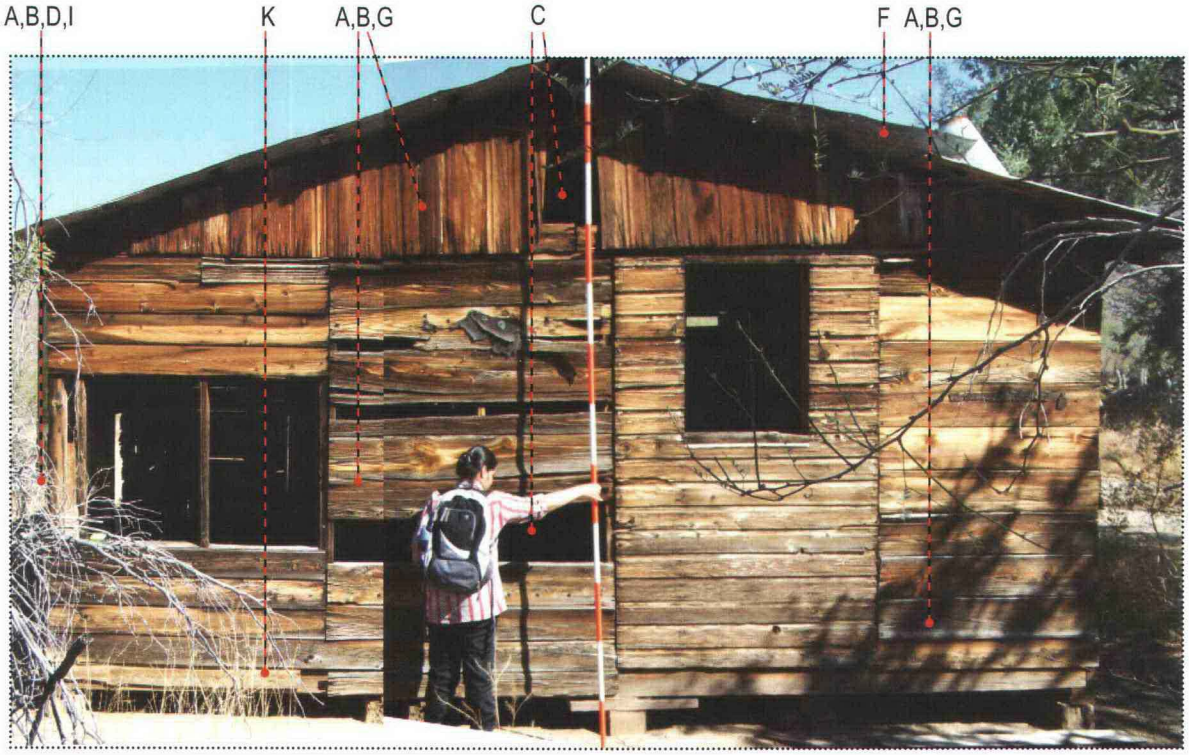
South elevation of the Hay Barn (Letters refer to notes in condition assessment table below)

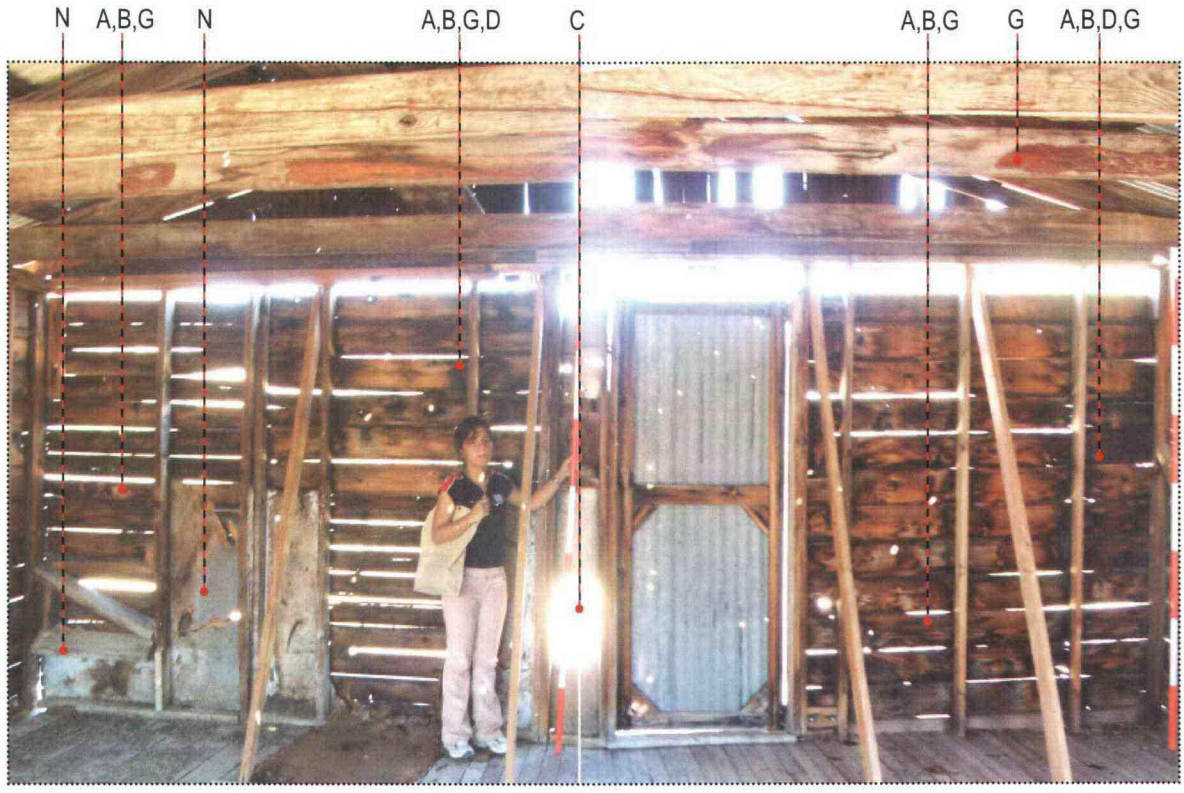
North elevation of the Hay Barn (Letters refer to notes in condition assessment table below)

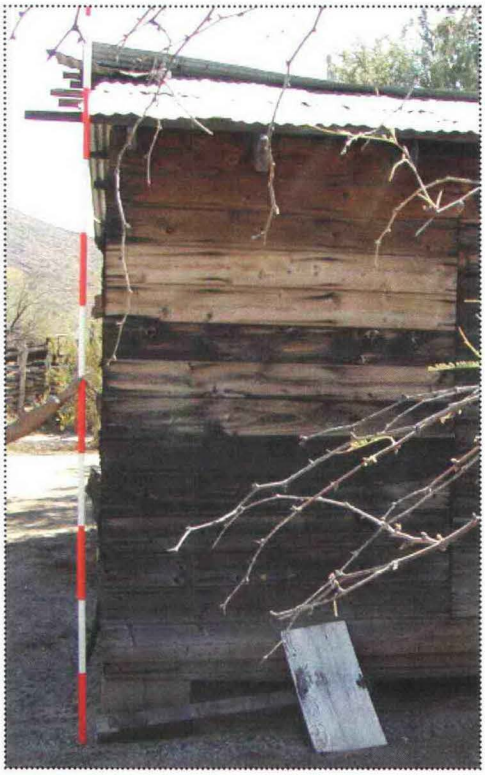
Interior elevation of South wall of the Hay Barn (Letters refer to notes in condition assessment table below)

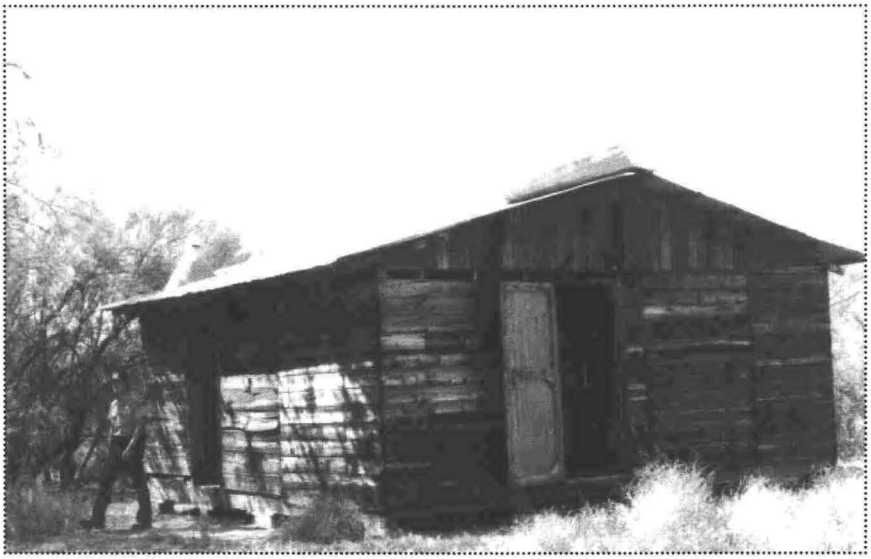
E. Detail view of metal roofing from the interior. Notice the rusting of sheets.

Deficiencies	Recommended Treatments	Priority
A	Water damage to wood paneling and facia including warping and splintering.	Correction of the source of water Replace the wooden planks where severely damaged; match the size & type of wood to existing.	Serious
B	Rotting of wood due to microorganisms/ pests (also termite) infestation.	Application of biocides where severe damage.	Serious
C	Missing parts from wood planks	Replace entire plank where substantial parts missing or structural stability is endangered.	Critical
D	Corrosion and deterioration of wood around iron nails on edges.	Apply anti-rust coating on nails before replacement planks are installed.	Serious
E	Rusting of the corrugated metal roof due to water damage	Replace the sheets which are severely rusted.	Serious
F	Falling apart of the metal sheets on the roof	Replace/reattach the portions that are coming apart. Use identical sheeting for replacement	Critical

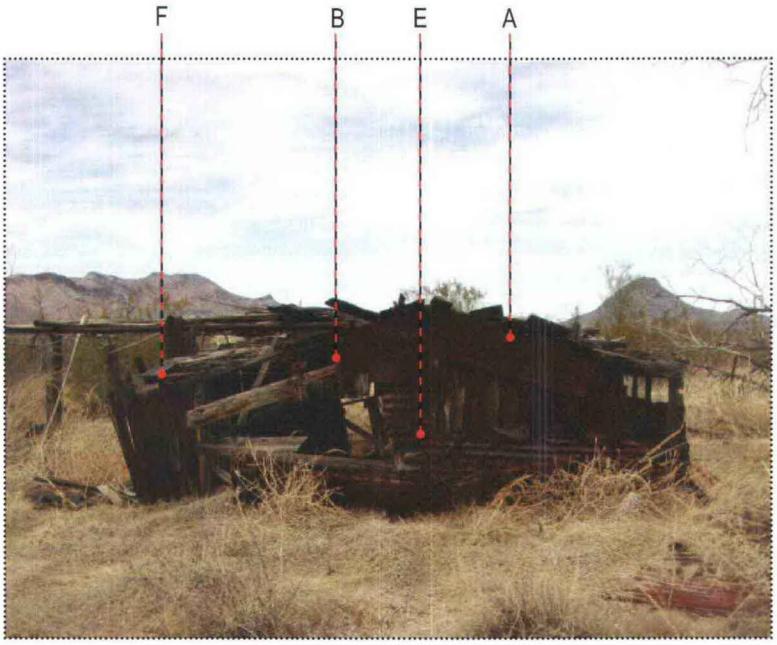
North elevation of Blacksmith Shop. (letters refer to notes in condition assessment table below)

Deficiencies	Recommended Treatments	Priority
A	Corrugated metel contains severe rust damage.	Replace roof with like material	Serious
B	Rotted/termite infested Wood	Application of biocides where damage is severe.	Critical
C	Missing Components	Replace lost components	Serious
D	Water Damage	Replace roof and repair or replace damaged material.	Serious
E	Broken Window Framing/glazing	Replace and repair as needed	Serious
F	Structural Failure	Repair structural damage	Critical

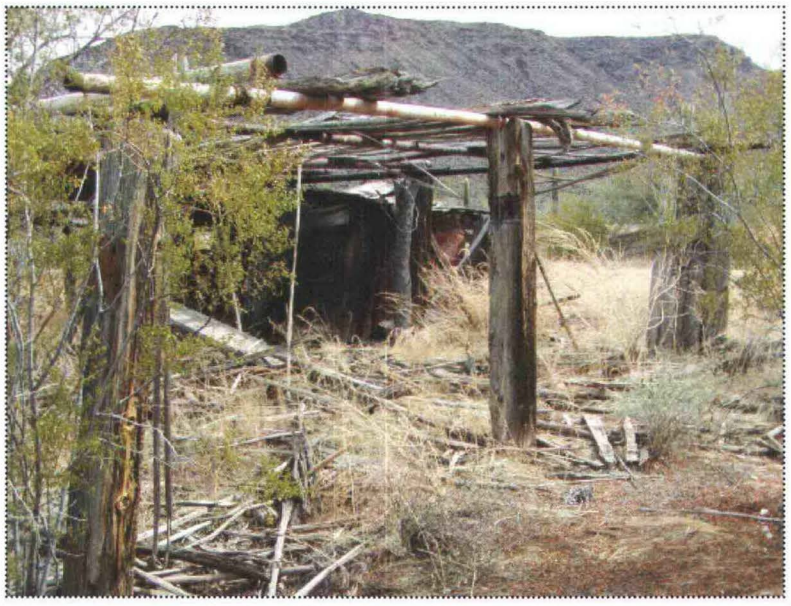
East elevation of Blacksmith Shop (letters refer to notes in condition assessment table below)

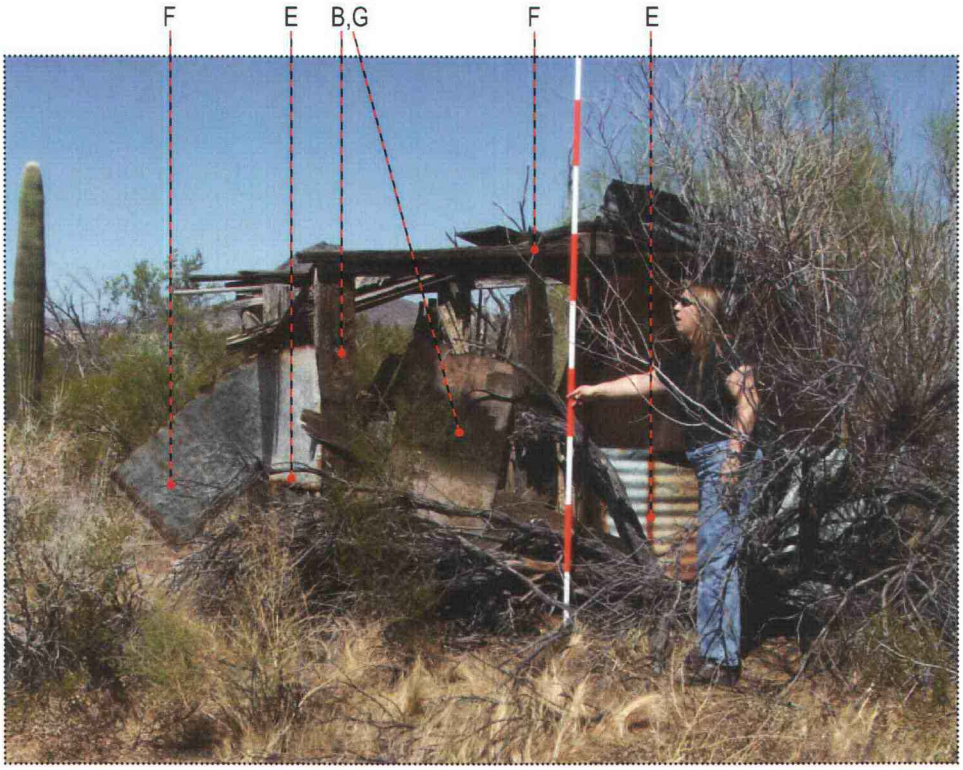
North elevation of the Ocotillo Shed (Letters refer to notes in condition assessment table ahead)

Deficiencies	Recommended Treatments	Priority
B	Rotting of wood due to microorganisms/ pests (also termite) infestation.	Application of biocides where severe damage.	Serious
C	Missing parts from wood planks	Replace entire plank where substantial parts missing or structural stability is endangered.	Critical
D	Corrosion and deterioration of wood around iron nails on edges.	Apply anti-rust coating on nails before replacement planks are installed.	Serious
E	Rusting of the corrugated metal roof due to water damage	Replace the sheets which are severely rusted.	Serious
F	Falling apart of the metal sheets on the roof and walls	Replace/reattach the portions that are coming apart. Use identical sheeting for replacement	Critical
G	Staining of wood due to water damage.	Correction of the source of water; pay attention to roof leaks & holes in wall panels.	Serious
I	Tilting of the structural wooden posts leading to de-stability & bending of the shed sideways.	Stabilise the structure by realigning the main structural posts. If necessary reassess the condition of the tie-beam and strengthen it to bind the structure	Critical

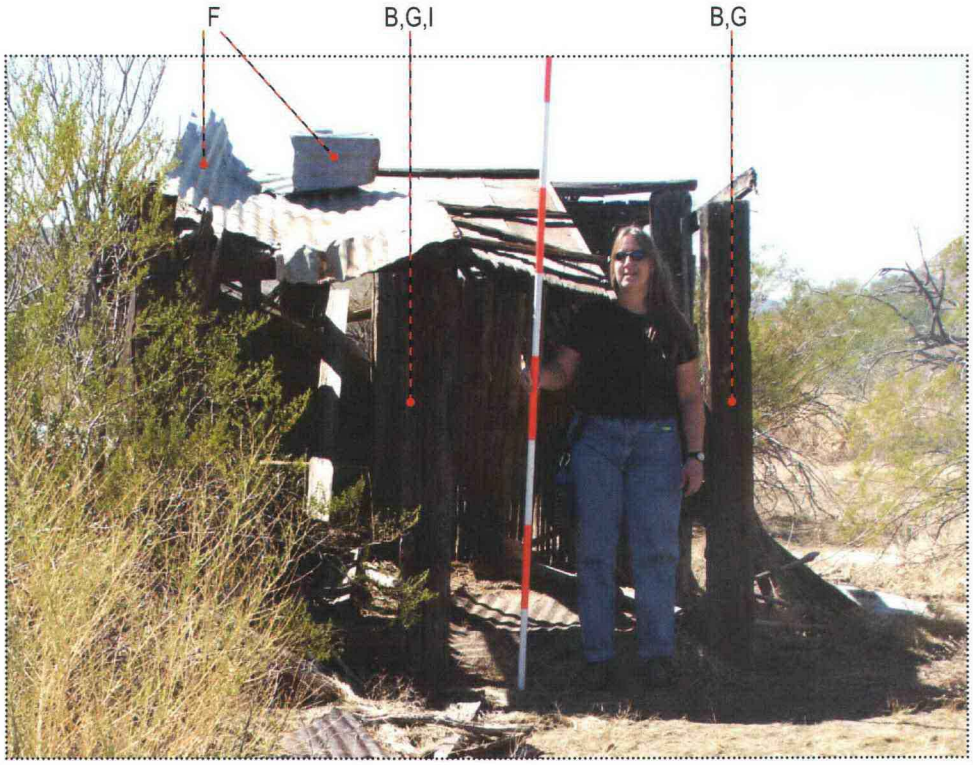
West elevation of the Ocotillo Shed (Letters refer to notes in condition assessment table ahead)

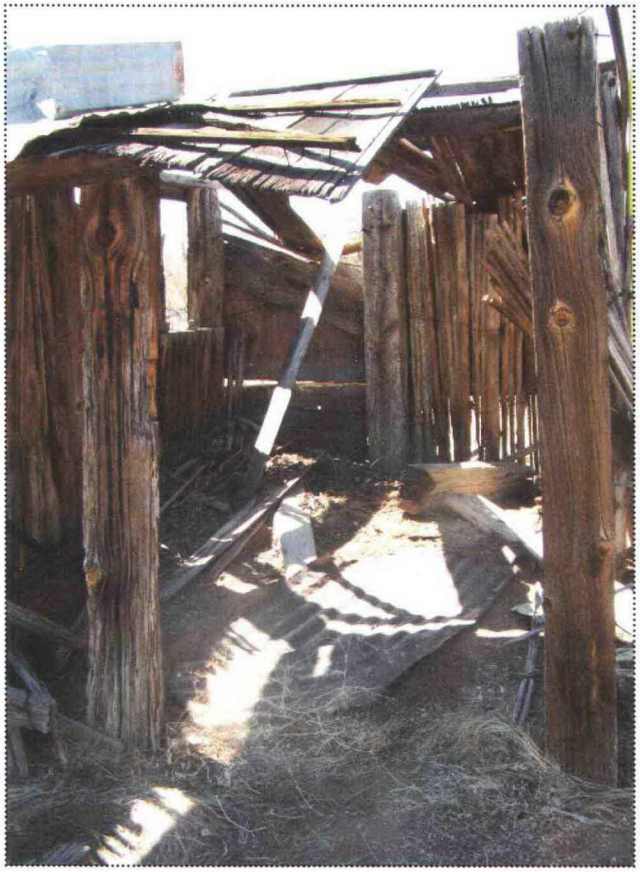
South elevation of the Ocotillo Shed (Letters refer to notes in condition assessment table ahead)

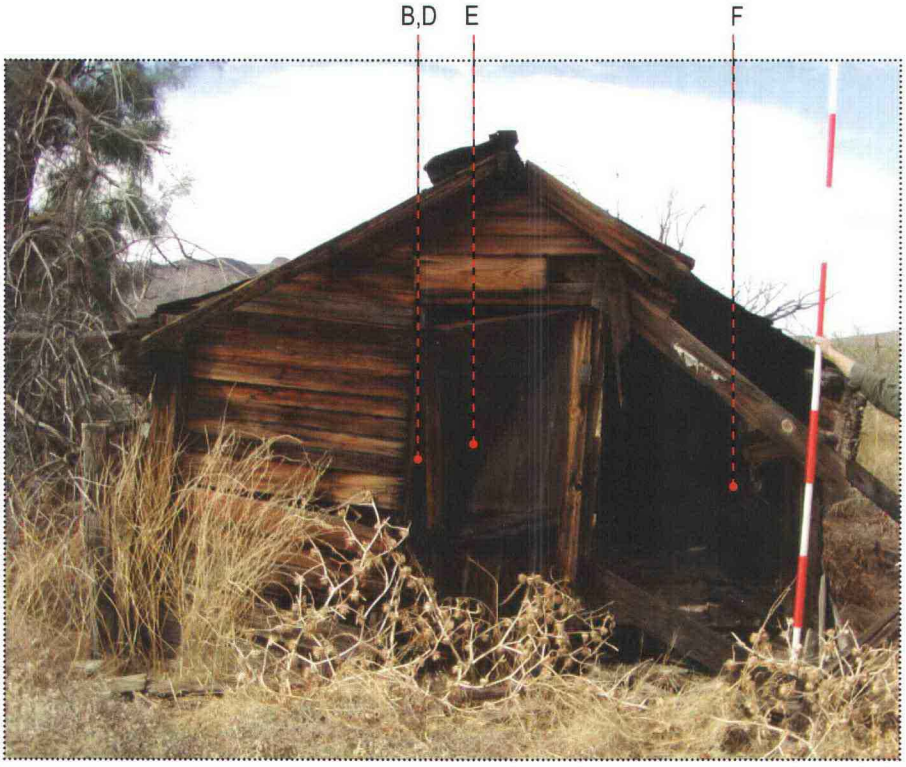
The building was in poor condition in 1986 when the National Register of Historic Places nomination was completed and has continued to deteriorate. The southeast corner of the building has failed and the building is leaning in this direction. It is only a matter of time before the balance of the building fails as well.

North elevation of the Small Residence (letters refer to notes in condition assessment table below)

Deficiencies	Recommended Treatments	Priority
A	Corrugated metel roof contains severe rust damage.	Replace roof with like material	Serious
B	Rotted/termite infested Wood	Application of biocides where severe damage.	Critical
C	Missing Components	Replace lost components with like material	Serious
D	Water Damage	Replace roof and repair or replace damaged material.	Serious
E	Broken Window Framing/glazing	Replace and repair as needed	Serious
F	Structural Failure	Repair structural damage	Critical

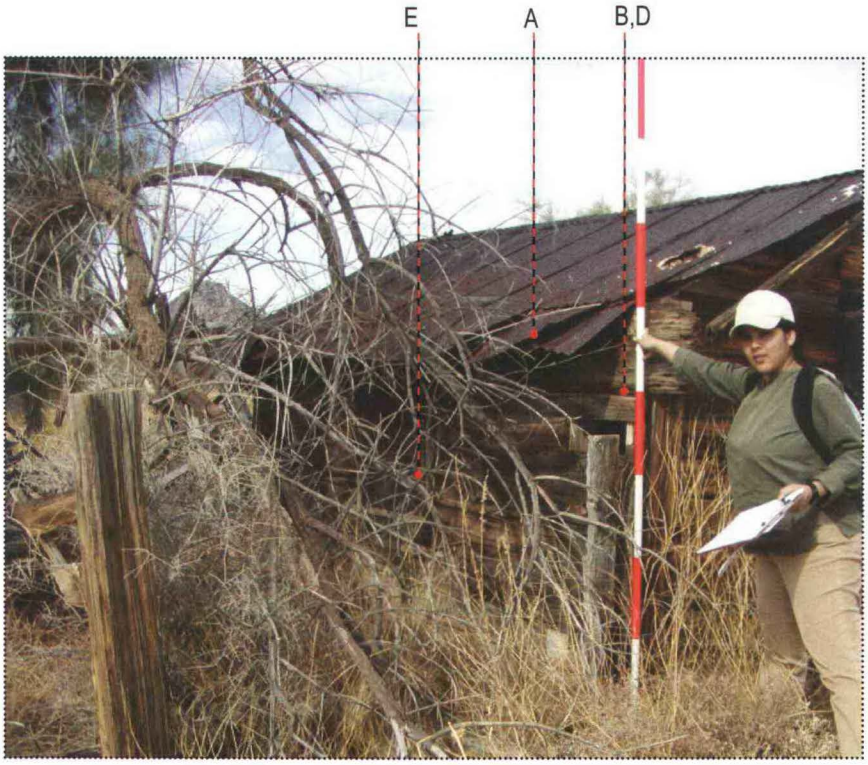
South elevation of the Small Residence (letters refer to notes in condition assessment table below)

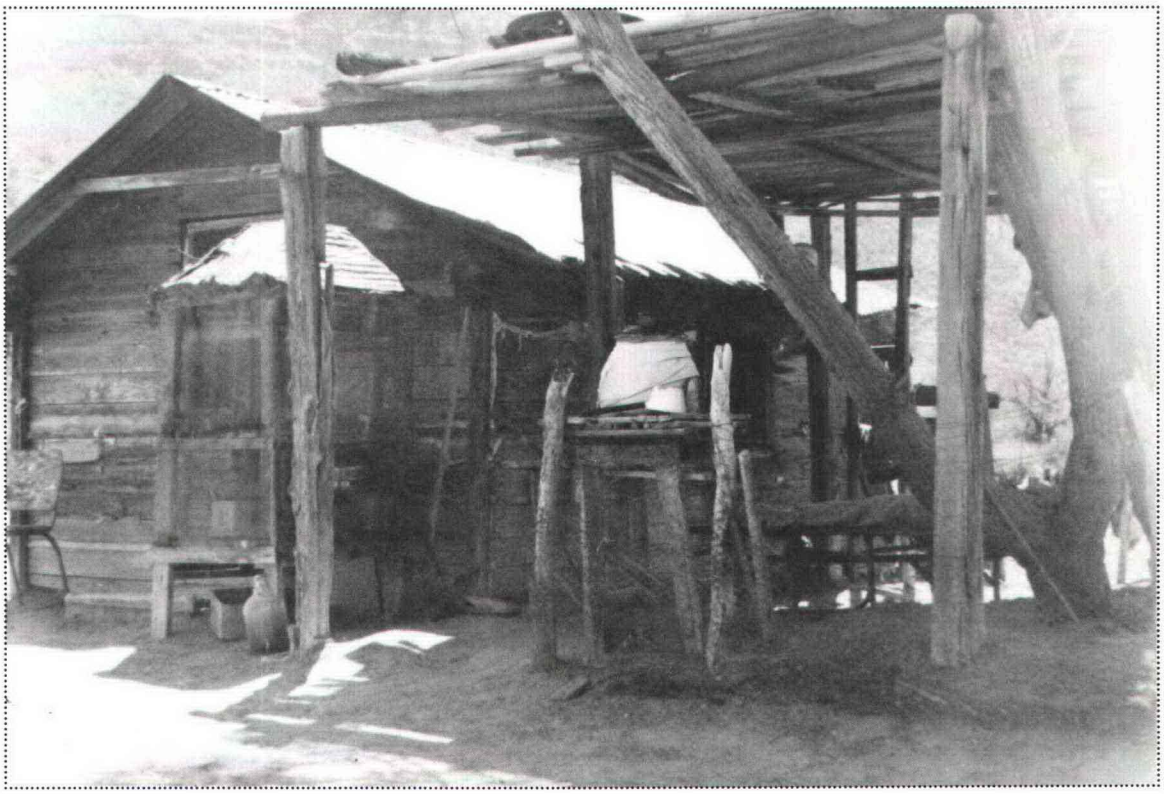
Interior elevation of the Small Residence (letters refer to notes in condition assessment table below)

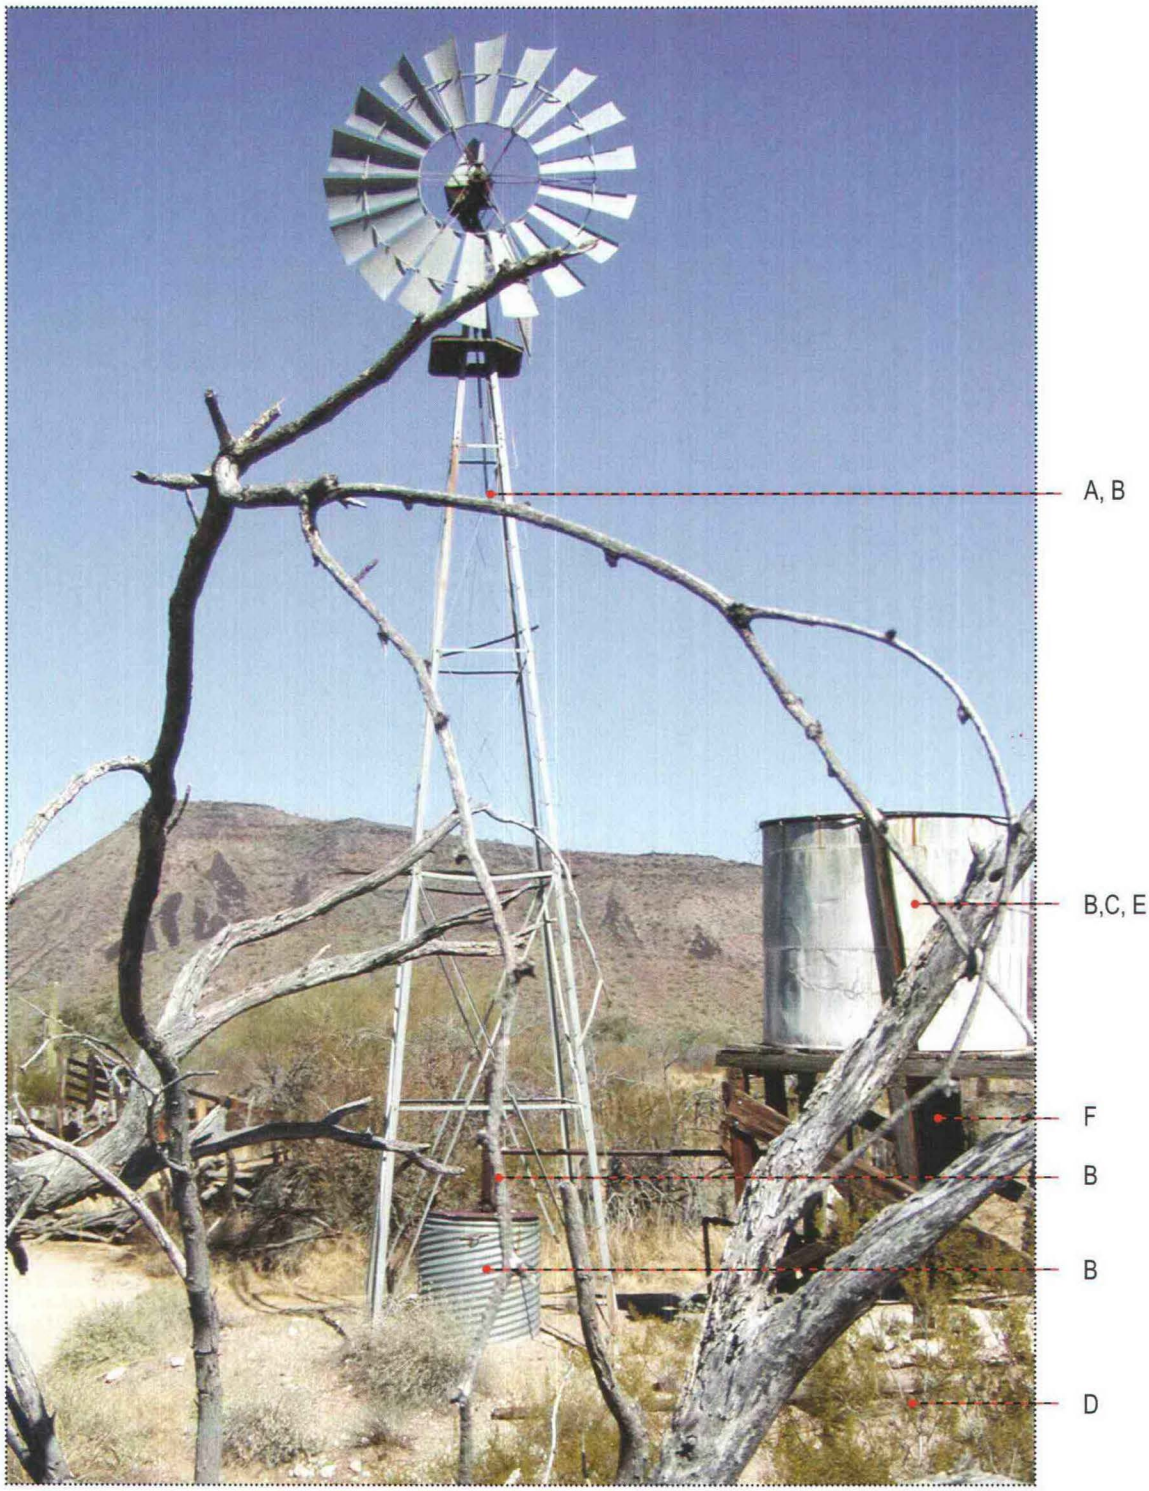
Windmill 2 is in best condition among the three windmills on site, with its blades and vane intact and the capacity for rotation when a breeze is present. Its frame is in good condition, with none of the members missing or badly deteriorated. There is not a significant amount of rust damage. The connection between the rotor and the pump is broken and hence the windmill does not function properly. Both the windmill and the adjacent water tank have suffered deterioration due to weathering. There is some rusting seen in the body of the water tank, as well as in the cylindrical corrugated metal casing for the pump. The platform of the water tank, constructed out of railroad ties, needs stabilization as some of the wooden members, as well as the connections that keep them together are deteriorating. The ladder to the tank platform is missing.

View of Windmill 2 from the west side showing existing damages and deficiencies. (letters refer to notes in condition assessment table below)

Deficiencies	Recommended Treatments	Priority
A	Detached, Deformed and/or missing components: Connector between rotor and well pump detached. Horizontal members on windmill A frame bent.	Repair and reattachment of existing members if possible. Replacement of damaged/missing members.	Critical
B	Rusting of metal parts: well cap, pipe	Chemically treat or replace elements whose integrity has been damaged by corrosion	Critical
C	Warping of Water Tank metal sheet	Re-form appropriately and affix in place.	Serious
D	Vegetation overgrowth around Structure	Trim or remove vegetation that obscures visibility	Serious
E	Staining of material due to water	Allow to occur naturally	Low
F	Rotting and Warping of wooden members in water tank platform	Chemically treat or replace members whose integrity has been compromised.	Serious

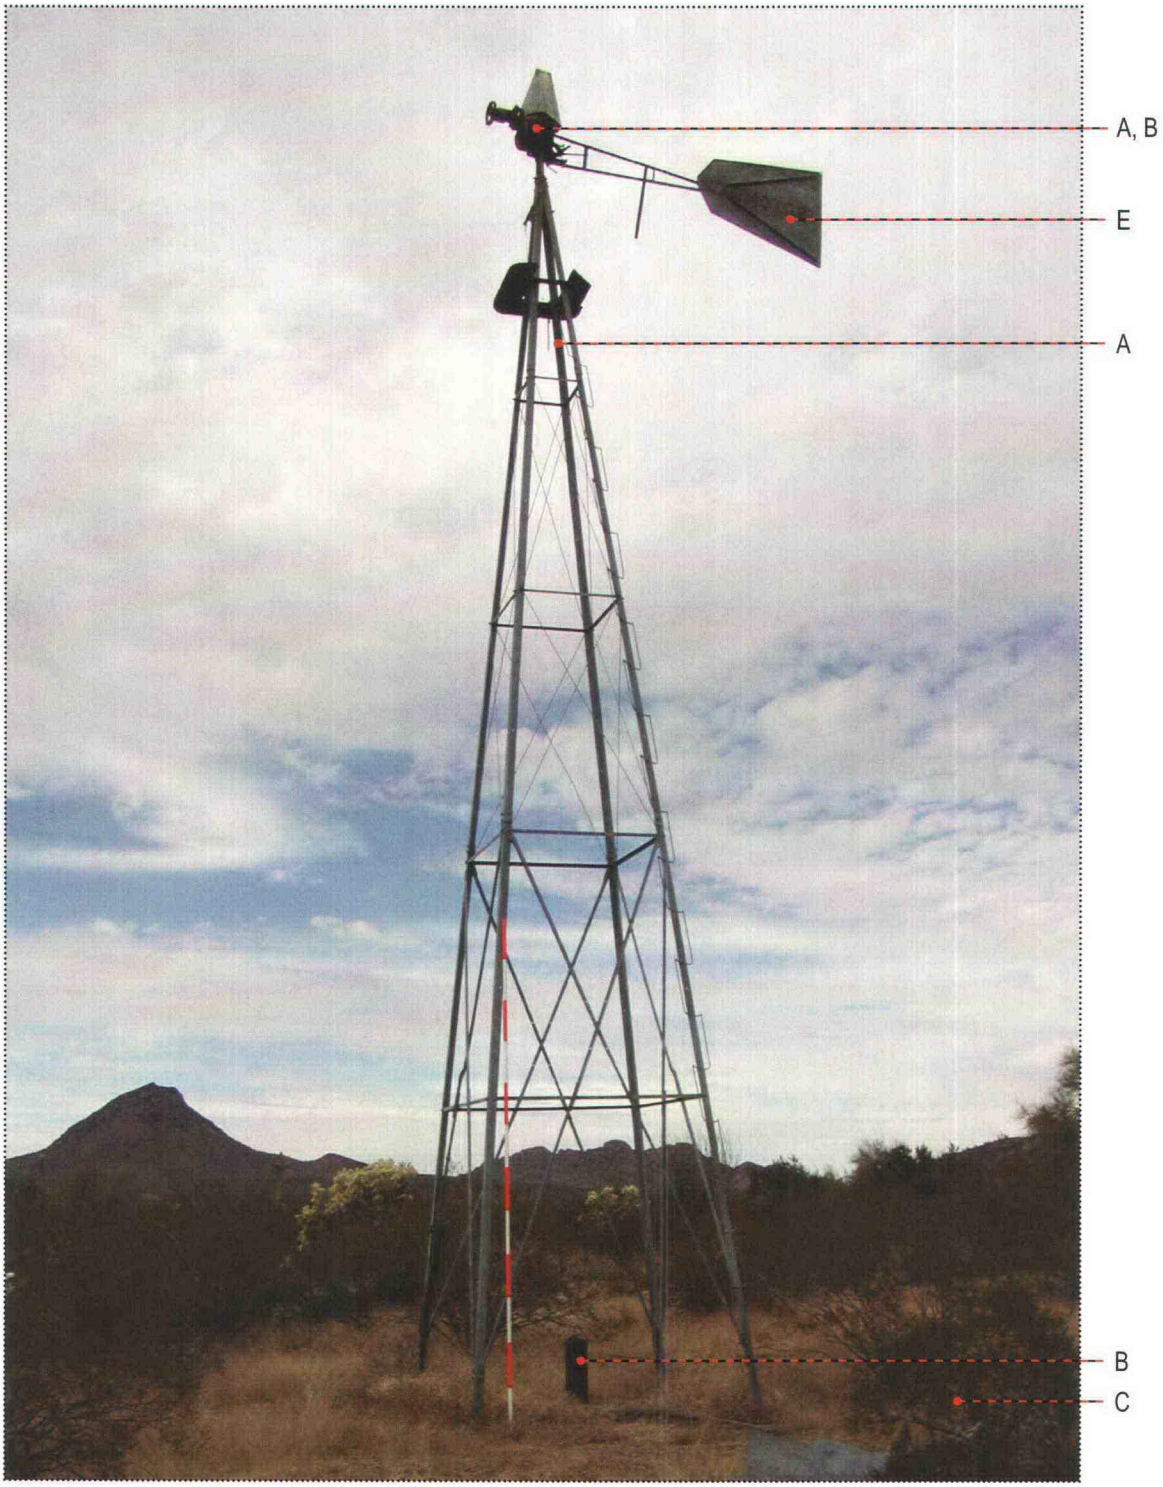
The blades of Windmill 3 have fallen to the ground, and lie near the base of the windmill. They are in a somewhat less damaged state than those of Windmill 1. The connection between the rotor and the pump is broken. The windmill has suffered deterioration due to weathering.

View of Windmill #3 from the south-west side showing existing damage and deficiencies. (letters refer to notes in condition assessment table below)

Deficiencies	Recommended Treatments	Priority
A	Detached, Deformed and/or missing components: Blades detached, lying on ground nearby. Connector between rotor and well pump detached.	Repair and reattachment of existing members if possible. Replacement of damaged/missing members.	Critical
B	Rusting of metal parts: well cap, windmill vane	Chemically treat or replace elements whose integrity has been damaged by corrosion	Critical
C	Vegetation overgrowth around Structure	Trim or remove vegetation that obscures visibility	Serious
D	Staining of material due to water	Allow to occur naturally	Low

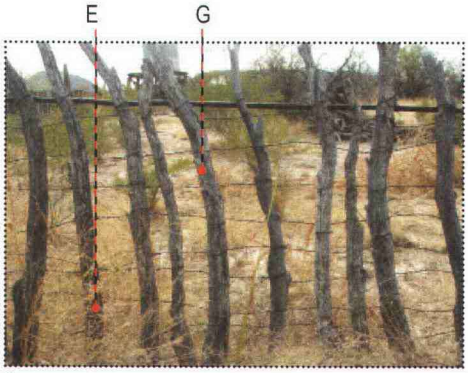
2 *Horizontally stacked mesquite logs & regularly spaced vertical mesquite posts, collapsed*
