HISTORIC STRUCTURES REPORT

BATES WELL RANCH
ORGAN PIPE CACTUS NATIONAL MONUMENT

A Service Learning Project of the
Preservation Studies Program
College of Architecture and Landscape Architecture
The University of Arizona

June 2007

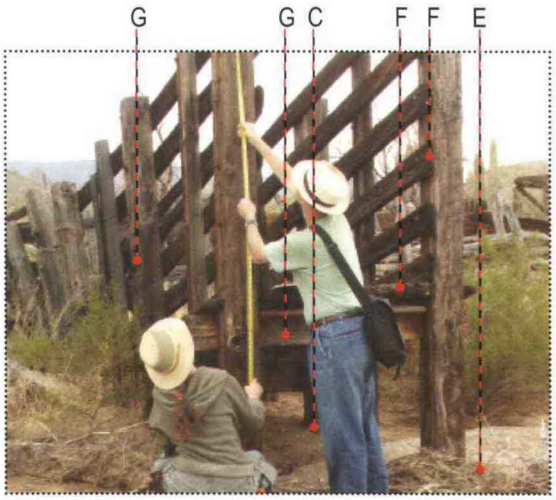
8 *Vertical railroad ties & dimensional lumber*

North elevation of the larger cattle chute (letters refer to notes in condition assessment table)

Deficiencies	Recommended Treatments	Priority
A	Complete structural collapse	Reconstruct collapsed portions using original material where possible; if original material is missing like elements should be used in the reconstruction	Critical
B	Partial structural collapse	Stabilize the structure where possible, any collapsed portions should be reassembled	Critical
C	Structural undermining attributed to water	Correction of the water source; replacement of earth where water has caused undercutting	Critical
D	Material displacement	Reinsertion of material where ever possible; if material is cracked or severely damaged replacement with a similar element is suggested	Serious
E	Vegetable overgrowth	Trim or remove vegetation within the corral	Serious
F	Cracking of wood from lack of moisture	Replace only when threatens the stability of the member	Low
G	Staining of wood due to water	Allow to occur naturally	Low

H	Missing material due to vandalism	Replace material with similar element	Serious
I	Addition of contemporary elements	Where possible remove anachronistic material	Low

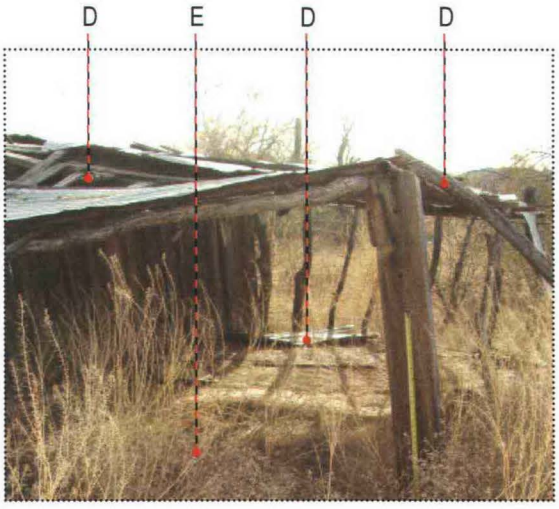
Northeast elevation of the smaller chute (letters refer to notes in condition assessment table)

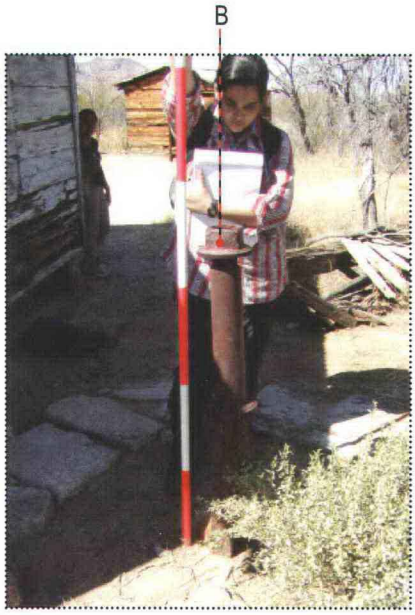
The Arrastra is in fair condition, although there is some minimal sheetwash erosion and disturbance from vegetation growth.

View of Arrastra from the south (letters refer to notes in condition assessment table below)

Deficiencies	Recommended Treatments	Priority
A	Missing Granite Stones	Replace with same	Medium
B	Missing arm and grinding wheel	Replace if period becomes part of significance.	low

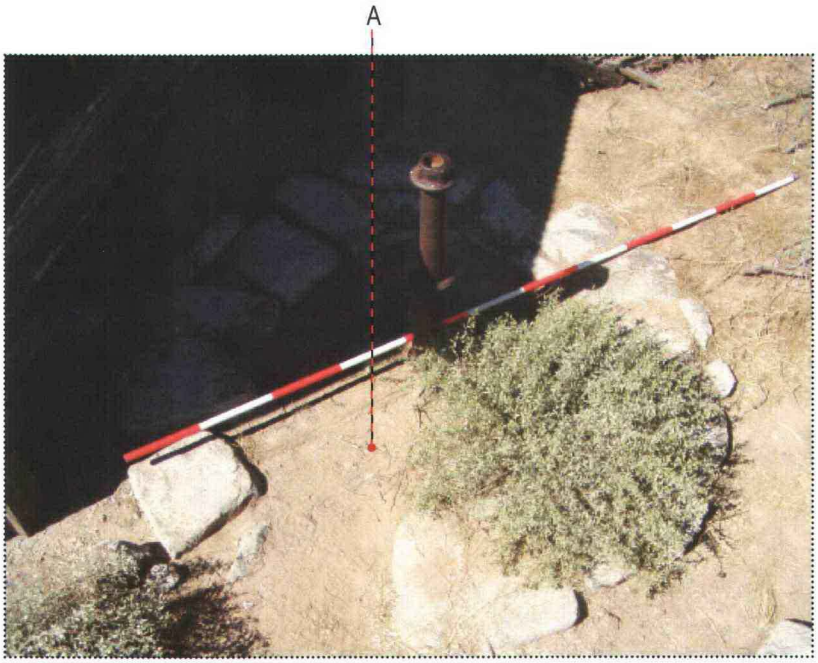
Center axle of Arrastra (letters refer to notes in condition assessment table below)

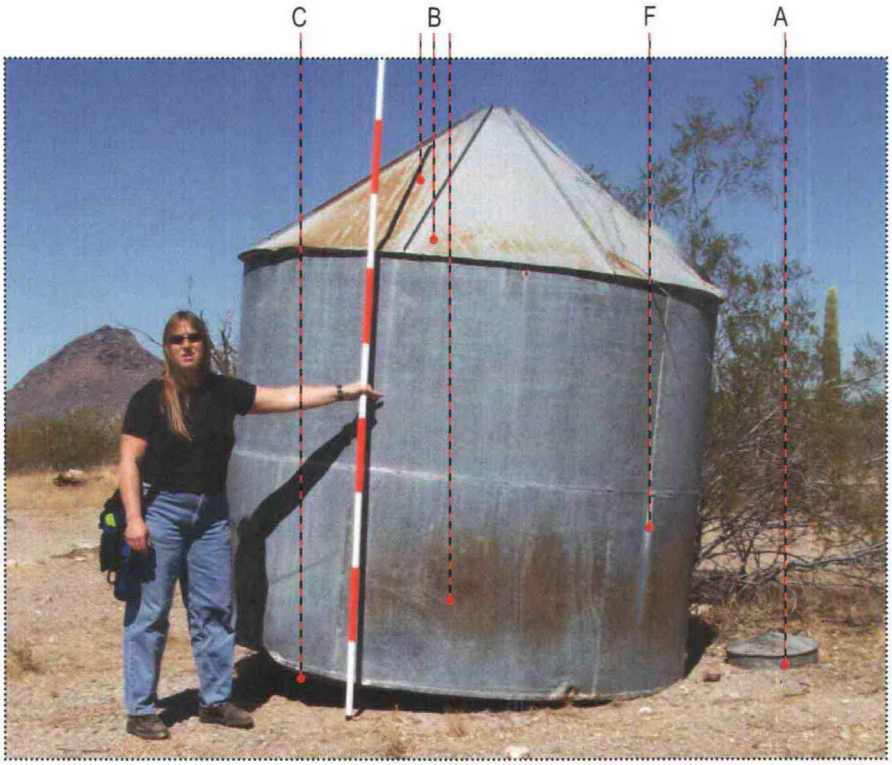
East elevation of the water tank (letters refer to notes in condition assessment table)

Deficiencies	Recommended Treatments	Priority
A	Material displacement	Reorganize elements into historic configuration	Serious
B	Corrosion of iron due to water	Replace elements whose integrity is damaged by corrosion	Serious
C	Convexity caused by structural damage	Re-form tank bottom	Serious
D	Concavity in metallic sheeting	Reform the tank sides	Serious
E	Vegetation overgrowth	Trim or remove vegetation that obscures visibility of well elements	Serious
F	Staining of material due to water	Allow to occur naturally	Low

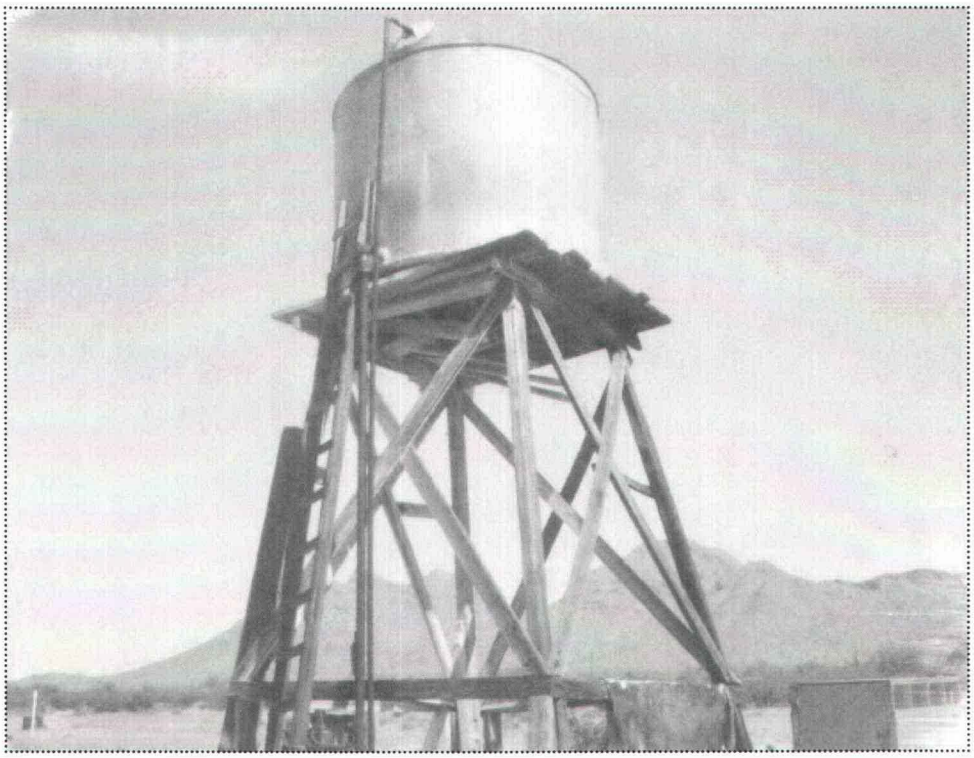
South elevation of the water tank (letters refer to notes in condition assessment table)

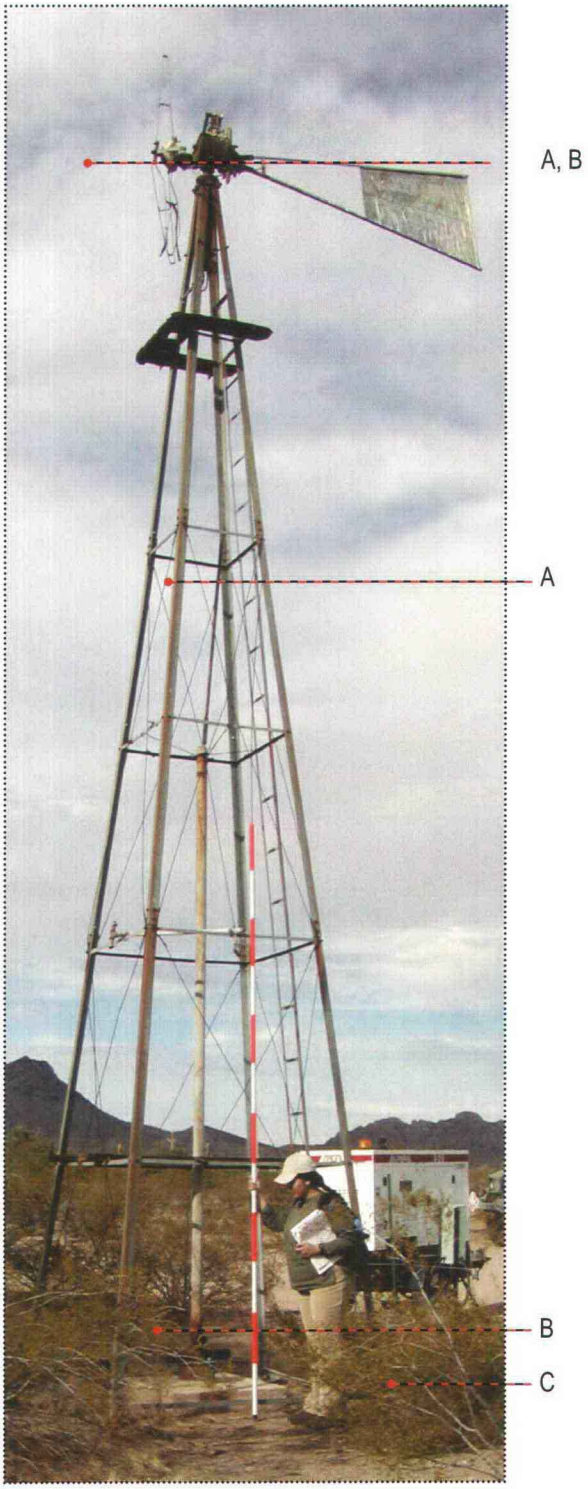
Windmill 1 is the most recent of all windmills on site, and is nearest to the Main Ranch House. Its frame is in good shape, with none of the members missing or badly deteriorated. There is not a significant amount of rust damage. The motor and rudder on the windmill are intact, but the blades have fallen to the ground, and lie near the base of the windmill. Some of these may be missing, and certainly many are damaged. The rod that connects the windmill to the well in order to pump the water is broken, and hence the pumping mechanism is

dysfunctional. The pipes that brought water from the well to the Southern Corral are disconnected and broken and pieces lie around the base of the structure. The concrete pad is in good shape

View of Windmill 1 from the south side showing existing damages and deficiencies. (letters refer to notes in condition assessment table below)

Deficiencies	Recommended Treatments	Priority
A	Detached and/or missing components: Windmill Blades missing, Connector between rotor and well pump detached. Horizontal member detached at base of windmill frame. Pipes to Southern Corral detached, missing and rusted	Repair and Reattachment of existing members if possible. Replacement of damaged/missing members with like material.	Critical
B	Rusting of metal parts: well cap, pipe, diagonal bracing of windmill frame	Chemically treat or replace elements whose integrity has been damaged by corrosion	Critical
C	Vegetation overgrowth around structure	Trim or remove vegetation that obscures visibility	Serious
D	Staining of material due to water	Allow to occur naturally	Low
E	Cracking in Concrete Pad	Stitch crack or replace pad	Low

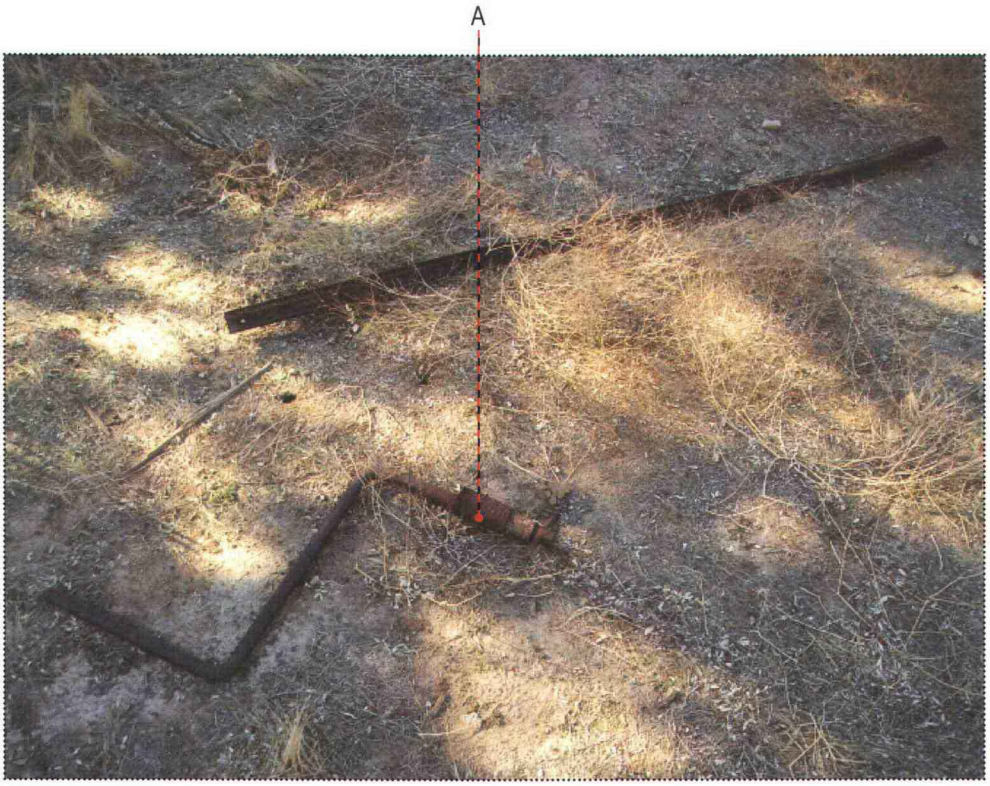
Base of Windmill 1 with associated debris (letters refer to notes in condition assessment table below)

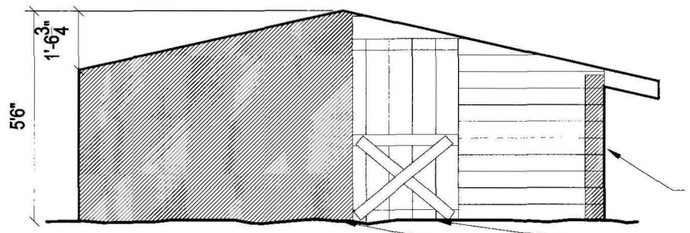
NORTH ELEVATION

FAILURE OF CORNER POST CAUSING BUILDING TO LIST TO THE RIGHT (WEST)

DOOR OFF HINGES

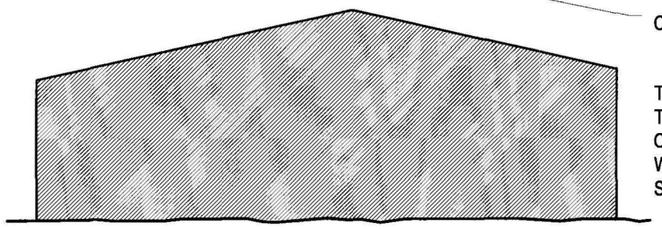
CORRUGATED STEEL DELAMINATION

THE SOUTH ELEVATION IS SO DETERIORATED THAT IT IS DIFFICULT TO DETERMINE ITS COMPOSITION. IT APPEARS THAT IT WAS CLAD WITH A COMBINATION OF BOARD AND BATTEN SIDING AND CORRUGATED STEEL.

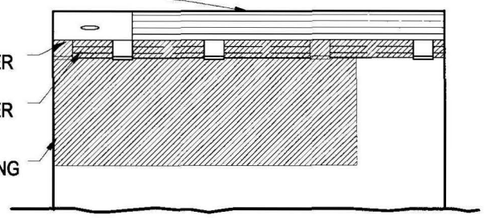
EAST ELEVATION

CEDAR SHAKE ROOF IN ADVANCE STATE OF FAILURE

ROTTEN OR MISSING 2 X 6 LUMBER

MISSING 1 X 6 LUMBER

CORRUGATED STEEL DELAMINATING

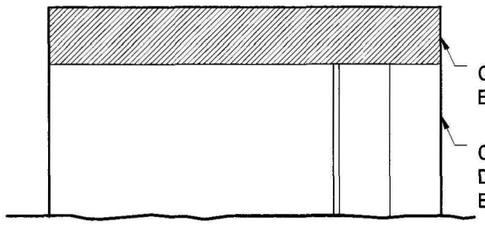
WEST ELEVATION

COMPLETE FAILURE OF ROOF - SEE EAST ELEVATION FOR DETAILS OF CONSTRUCTION

CORNER HAS ROTTED OUT AT BASE. DIMENSIONAL LUMBER 2 X 16s STANDING UP ON END AND THROUGH BOLTED FOR CONNECTION
