National Park Service
U.S. Department of the Interior

Olmsted Center
for Landscape Preservation

Cultural Landscape Report for the Historic Motor Road System Acadia National Park

Site History, Existing Conditions, Analysis, and Treatment

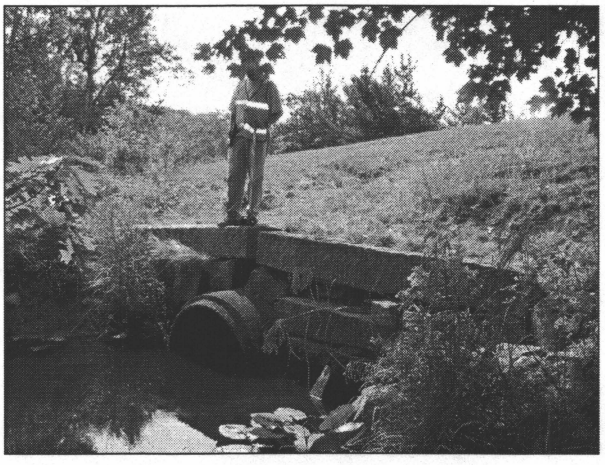
Figure 2.18. Outlet of the 48-inch diameter reinforced concrete pipe culvert along Cromwell Brook that drains Great Meadows and The Tarn. Note the poor condition of the headwall. (Acad0300_2.159_Out(2), OCLP 2005)

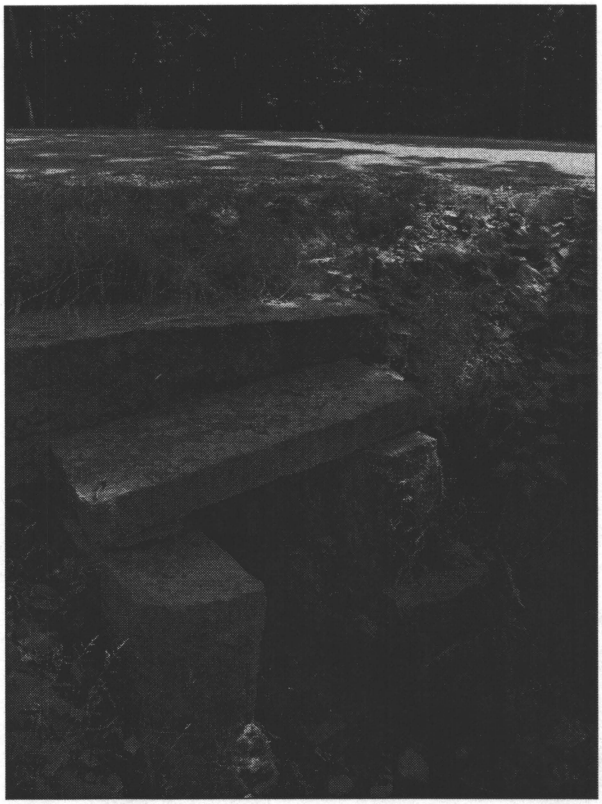
Figure 2.19. One of two dry-laid stone box culverts along the Kebo Mountain Road Extension. (Acad0300_2.306_Out, OCLP 2005)

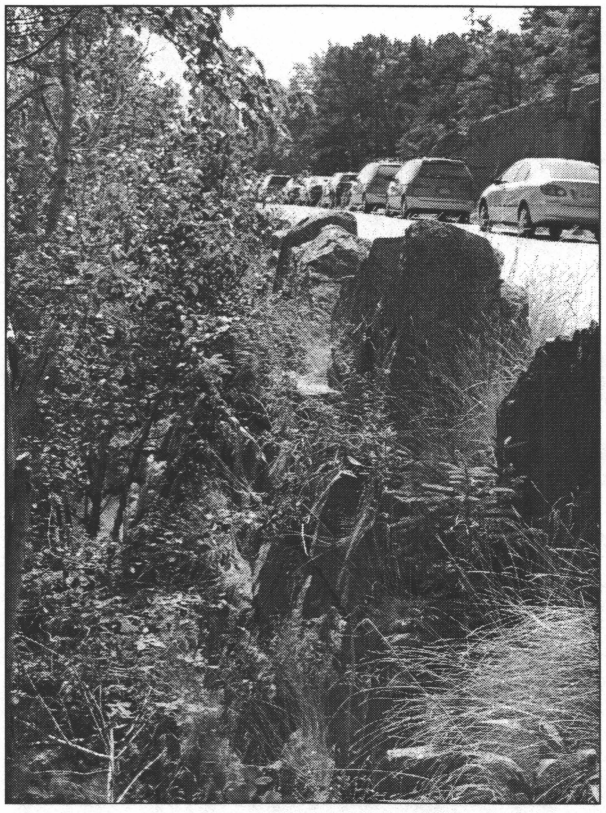
Figure 2.34. This massive guardwall/retaining wall separates the motor road from the old Ocean Drive roadbed below, which is now are parking area. (Acad0300_6.004(2), OCLP 2005)

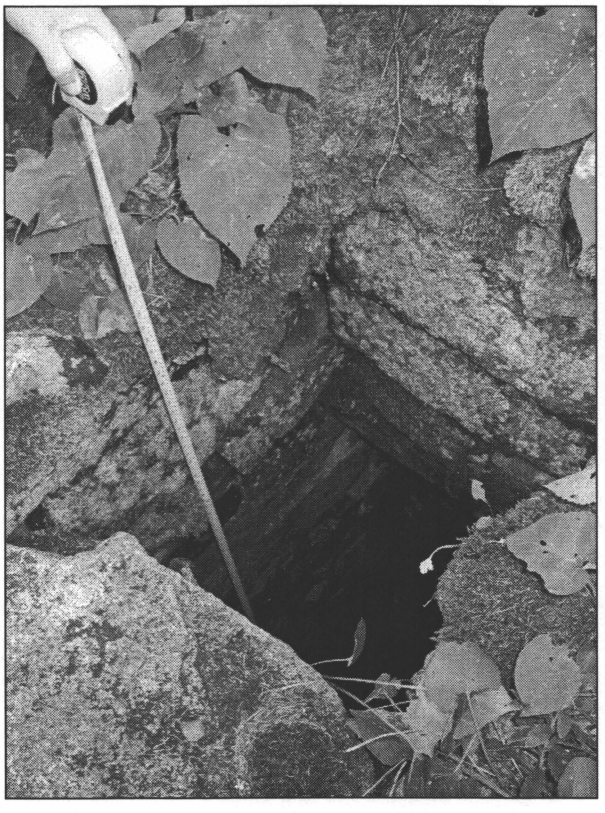
Figure 2.44. This dry-laid stone drop-inlet near the former Naval Station is over eight feet deep. (Acad0300_8.130_In(3), OCLP 2005)

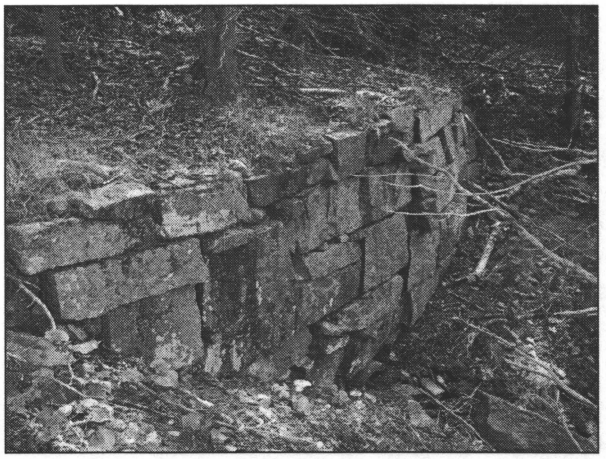
Figure 2.45. The dry-laid stone outlet headwall of the culvert shown in Figure 8.2 is in poor condition because of a severe lean. (Acad0300_8.310_Out(2), OCLP 2005)

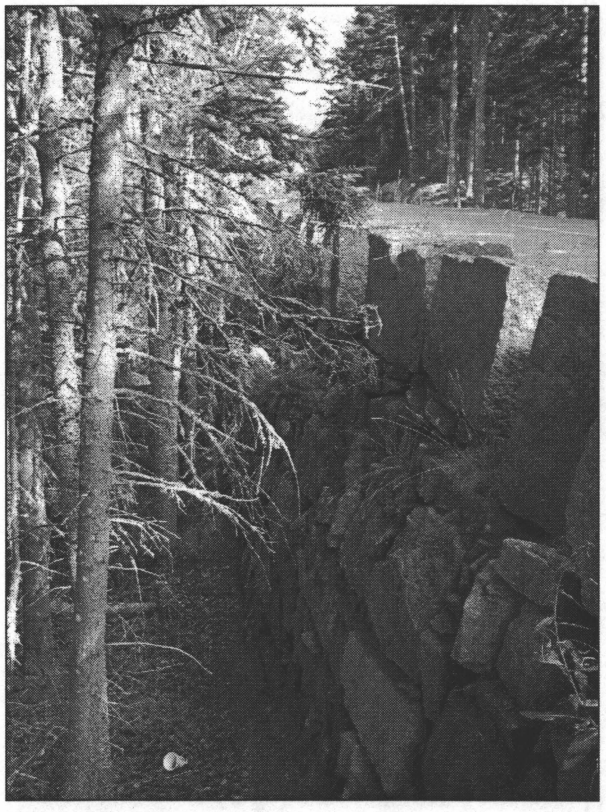
Figure 2.46. Topographic conditions in the Otter Cliff area warranted the construction of numerous guardwalls/retaining walls like this one. (Acad0300_7.301, OCLP 2005)

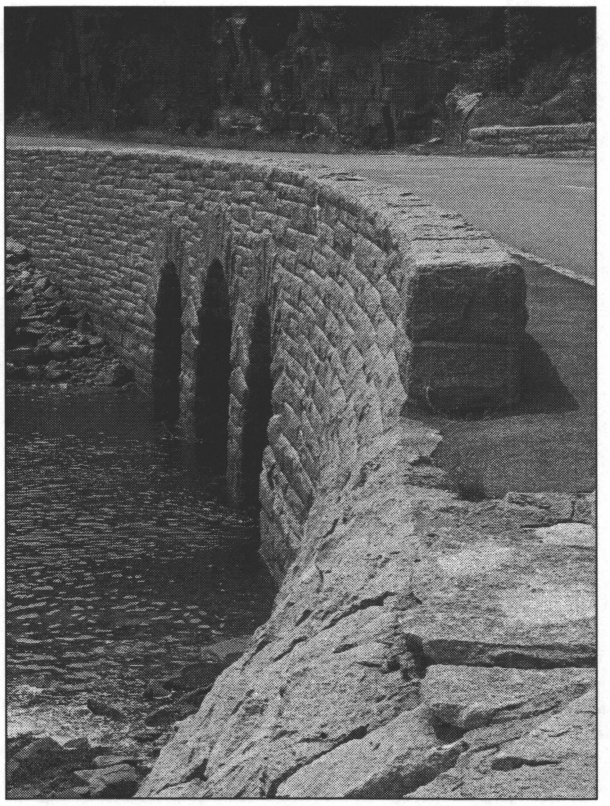
Figure 2.56. The handsome curved bridge is part of the Otter Creek causeway and was recently rehabilitated. (Acad0300_ 8.618(5), OCLP 2005)

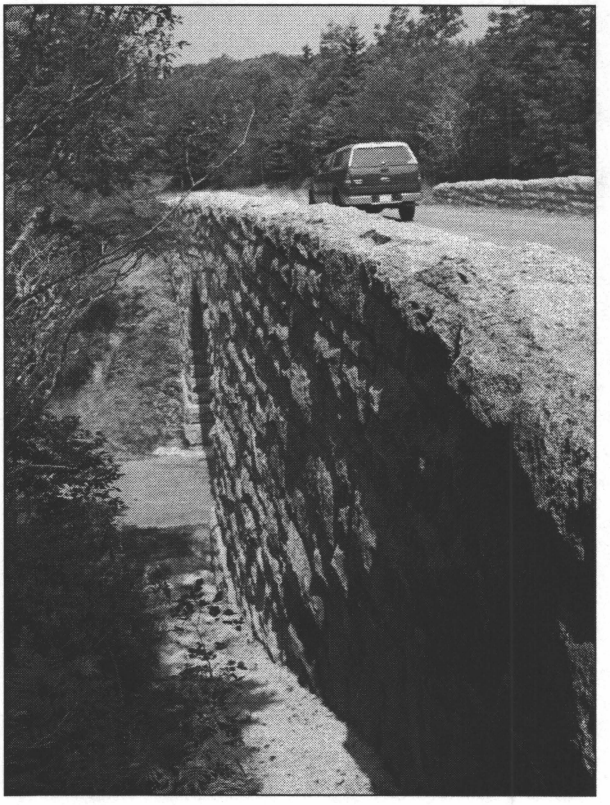
Figure 2.57. The Fishhouse Road Bridge is another example of grade separation. The bridge was recently rehabilitated. (Acad0300_8.469(4), OCLP 2005)

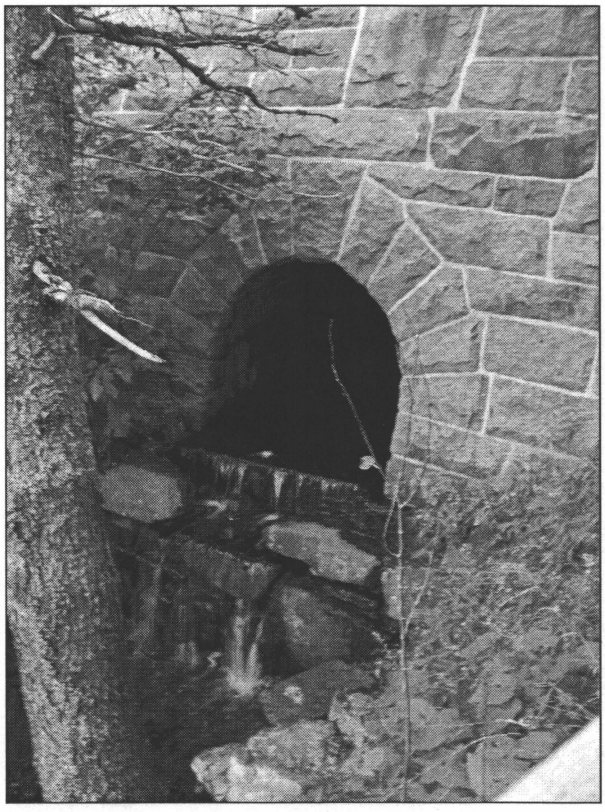
Figure 2.58. View of the Little Hunters Brook Bridge and Little Hunters Beach. (Acad0300_10.324(6), OCLP 2005)

Figure 2.59. The outlet headwall of this concrete box culvert is impressive but is failing. (Acad0300_11.356_Out(2), OCLP 2005)

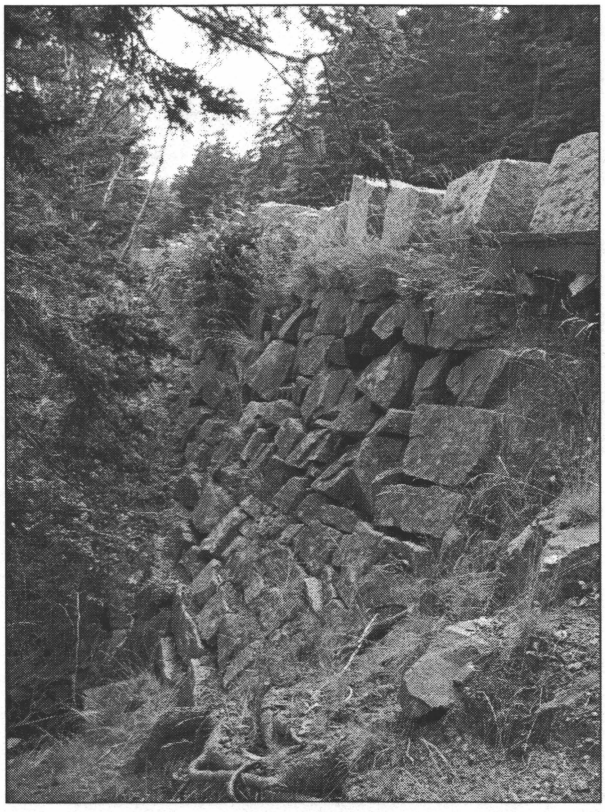
Figure 2.60. Guardwall/retaining wall along Blackwoods Road using dry-laid stones. (Acad0300_9.511(2), OCLP 2005)

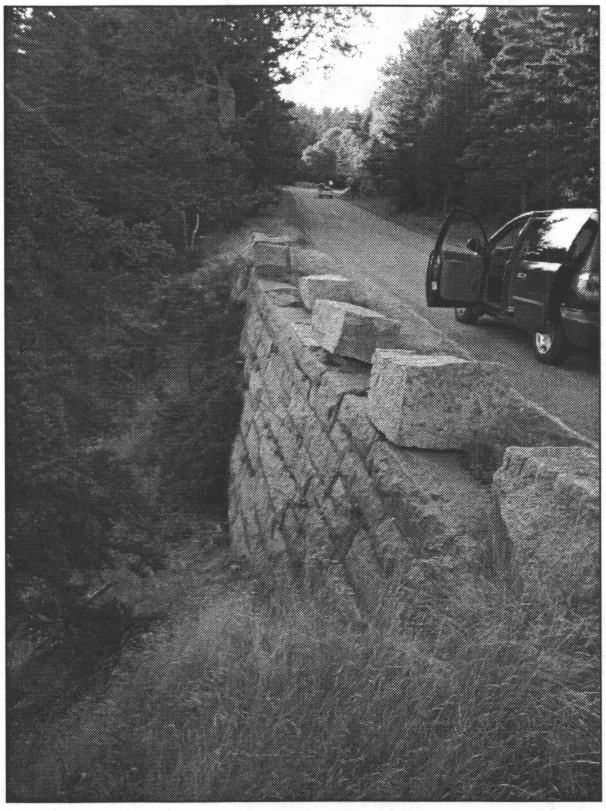
Figure 2.61. Guardwall/retaining wall employing mortared stonework. Note the skewed and missing blocks on top. (Acad0300_10.203(2), OCLP 2005)

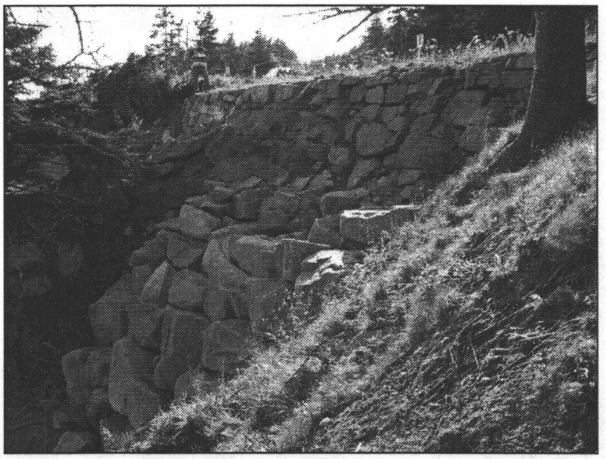
Figure 2.62. Several of the riprap embankments at Western Point have carefully been rebuilt. Note the longer retaining wall above it. (Acad0300_9.799, OCLP 2005)

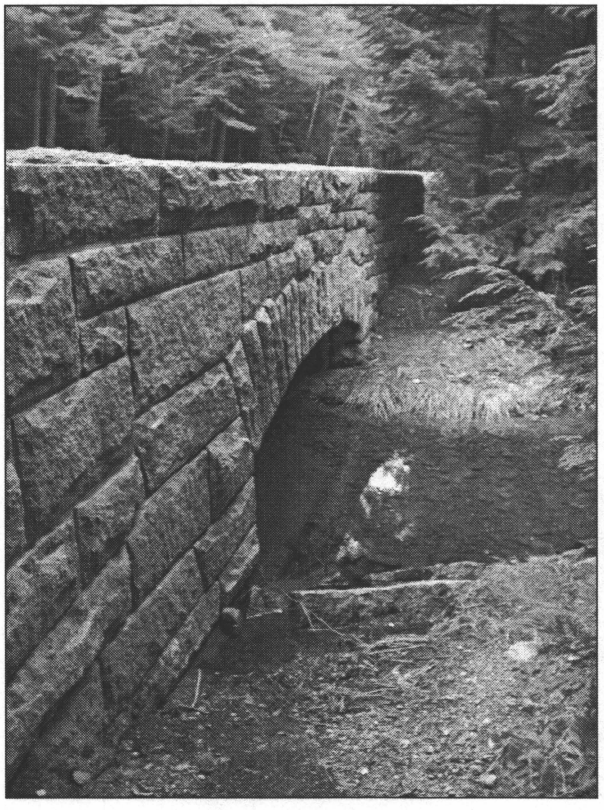
Figure 2.67. This small mortared and stone bridge spans Hunters Brook. (Acad0300_11.500(2), OCLP 2005)

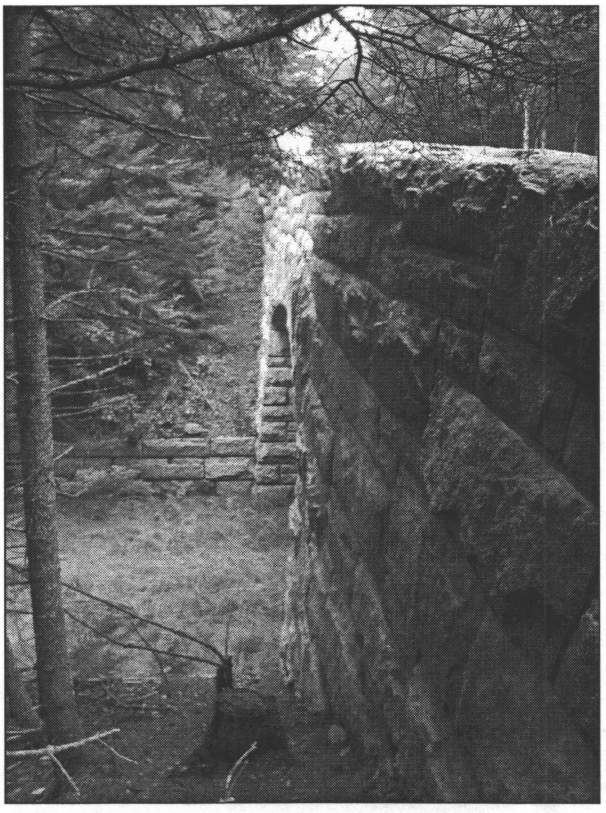
Figure 2.68. View of the single-arched bridge over the now abandoned Wildwood Stables entrance road. (Acad0300_13.049(2), OCLP 2005)

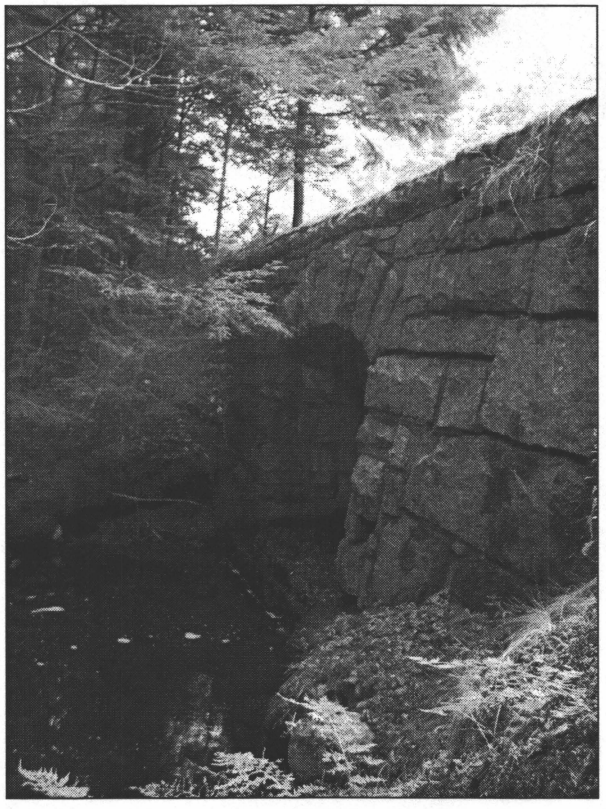
Figure 2.69. Impressive mortared stone outlet headwall of a concrete box culvert on Day Mountain Road. (Acad0300_13.227_Out(2), OCLP 2005)

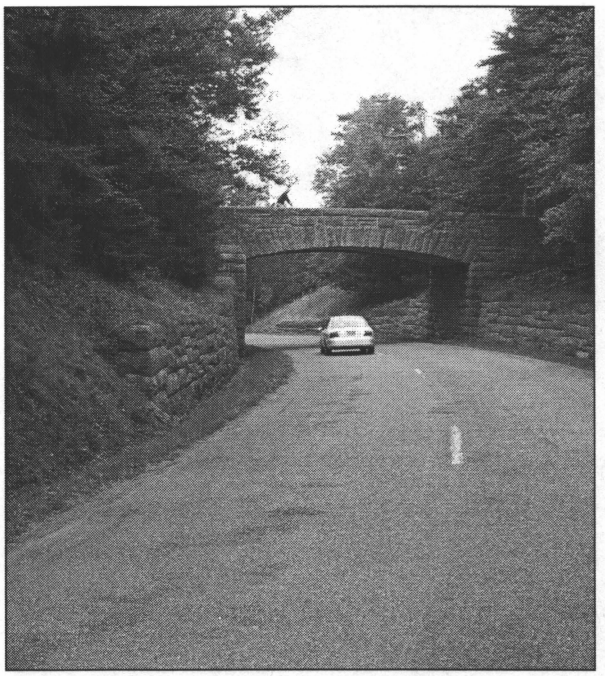
Figure 2.70. Mortared stone retaining walls segue to the carriage road bridge over Day Mountain Road. (Acad0300_12.448, OCLP 2005)

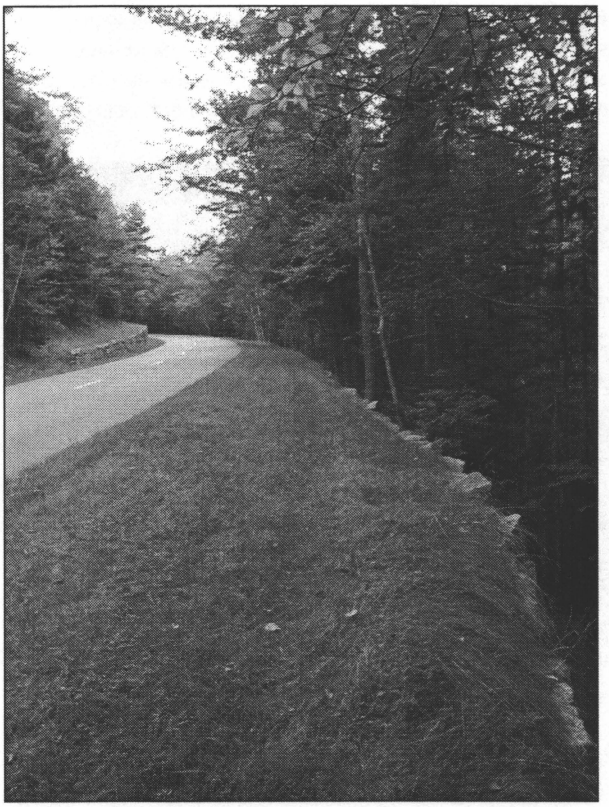
Figure 2.71. The last half of Day Mountain Road features retaining walls on both sides of the road. (Acad0300_11.642(2), OCLP 2005)

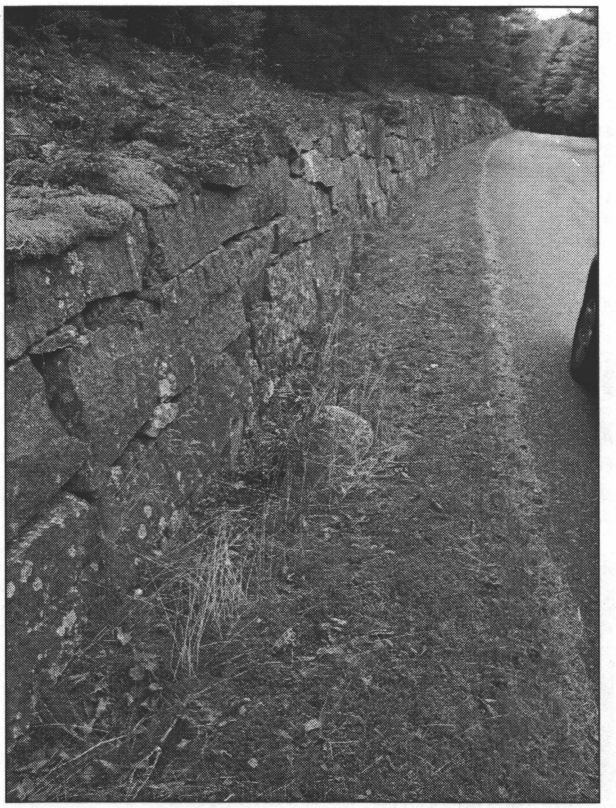
Figure 2.72. Most of the retaining walls along the road are built with dry-laid stones. (Acad0300_12.349_In, OCLP 2005)

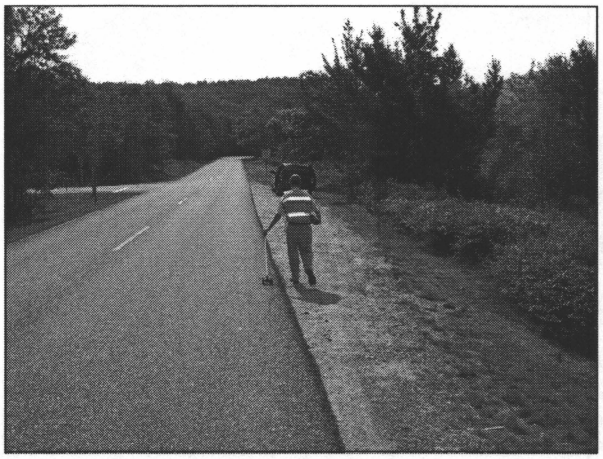
There have also been many visitor requests to open additional views, which have created some unforeseen management issues. For example, the clearing and pruning of trees along the Kebo Mountain Road Extension for a new vista of Great Meadow has allowed more sunlight to penetrate to the road shoulder and has encouraged the growth of non-native lupine plants. The spectacular display of blooms at the roadside has resulted in motorists pulling off the motor road, damaging the vegetated shoulder, and creating a new unpaved pullout (Figure 4.1).

Figure 4.1. This unpaved pullout on Kebo Mountain Road developed after the view to Great Meadow, which had overgrown, was opened up. (Acad0300_2.167, OCLP 2005)

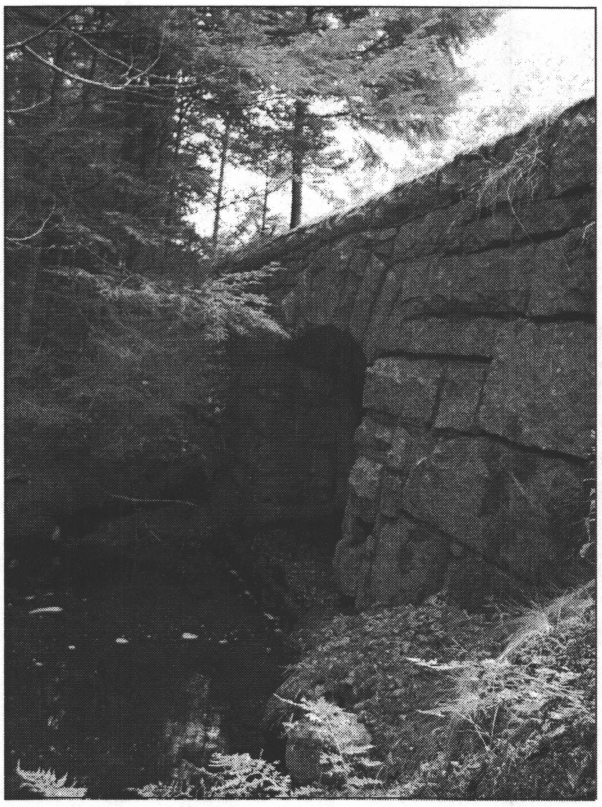
Figure 4.3. The culvert that conveys a perennial stream near the junction of Day Mountain Road Extension, Jordan Pond/Eagle Lake Road, and Stanley Brook Road has been identified by park staff as a possible impediment to fish. (Acad0300_13.227_Out(2), OCLP 2005)

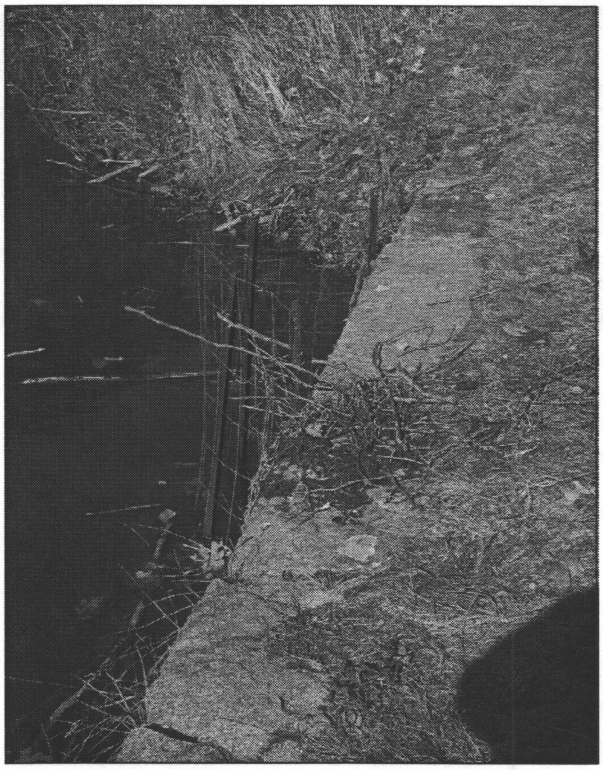
Figure 4.4. View of a new "beaver fooler" along Bureau of Public Roads Project 4A2, after the Precipice parking area. (IMG 0028, OCLP 2006)

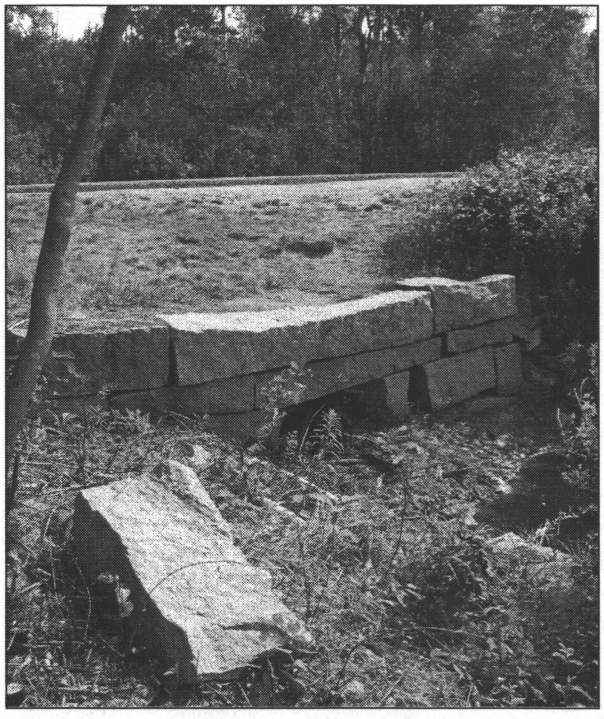
Regarding the historic culvert assemblies, in some cases, culvert pipes appear to be undersized such as the structure that drains Great Meadow (Figure 4.5). In other instances, some culvert pipes, inlet structures, and outlet structures are in poor condition due to failing or blocked pipes and deteriorating headwalls. These problems combine to alter or impede the flow of water and are a potential threat to the structural integrity of the motor roads. Inventory work completed for this cultural landscape report includes general condition assessments of culverts, and will serve as a useful first step in repairing or replacing these structures.

Figure 4.5. The culvert that drains Great Meadow is undersized and often blocked by debris from beaver dams. (Acad0300_2.159_In, OCLP 2005)

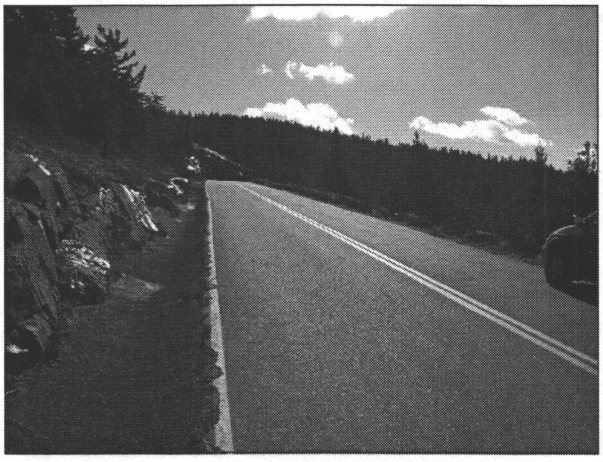
Figure 4.6. A wider cross-section, caused by paved shoulders or by paved waterways, as shown here on Cadillac Mountain Road, is a psychological cue for motorists to drive faster. (Acad0013_2.290, OCLP 2005)

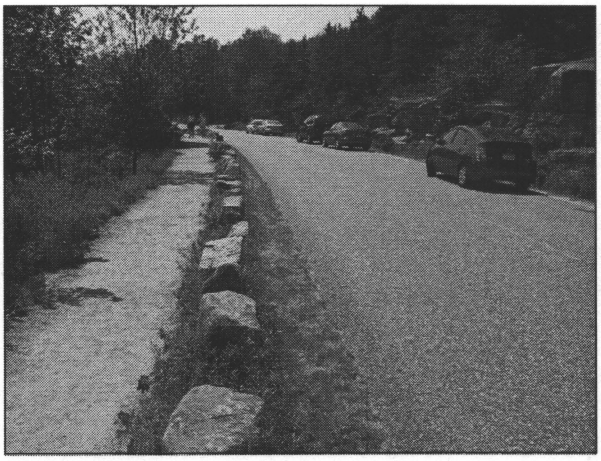
Figure 4.8. On-road parking along Ocean Drive and other major developed areas negatively effects the motor road experience. (Acad0300_6.023(1), OCLP 2005)

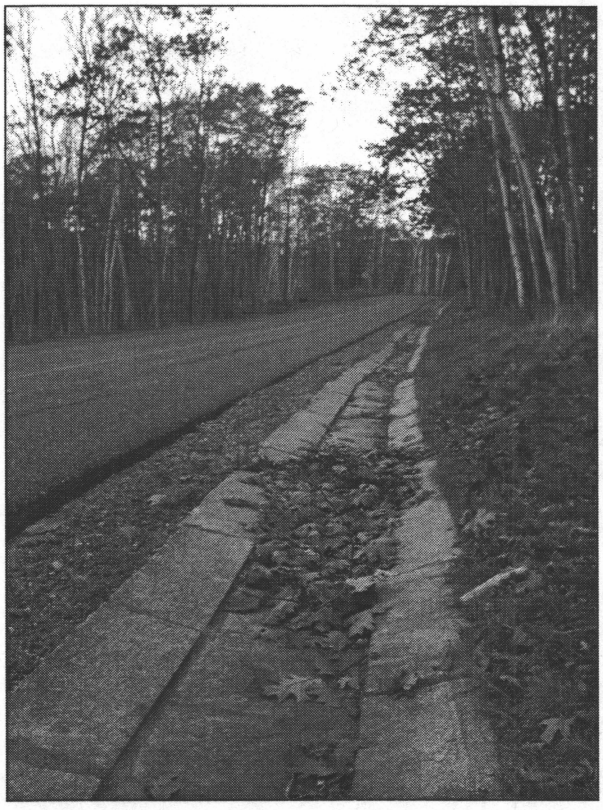
Figure 4.10. A demonstration section of a new mortared rubble waterway was installed off of Schooner Head Overlook Access Road in the mid-1990s. (IMG 0237, OCLP 2005)

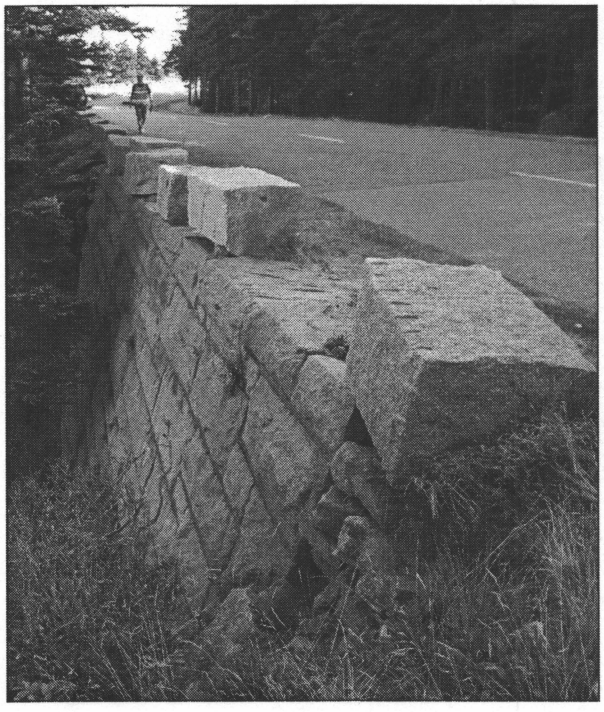
Figure 4.11. Some of the guardwall stones have fallen down the embankments or have become skewed, as seen in this photograph near Western Point on the Otter Cove Causeway and Blackwoods Road. (Acad0300_9.701(2), OCLP 2006)

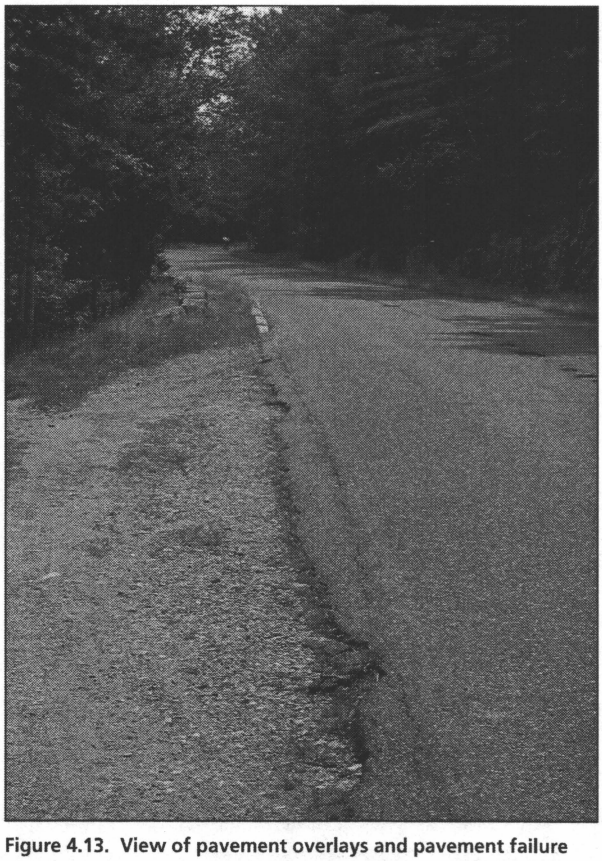
Figure 4.13. View of pavement overlays and pavement failure caused by poor drainage along the often shady section of Otter Cove Causeway and Blackwoods Road, just after the causeway. (Acad0300_8.931, OCLP 2005)

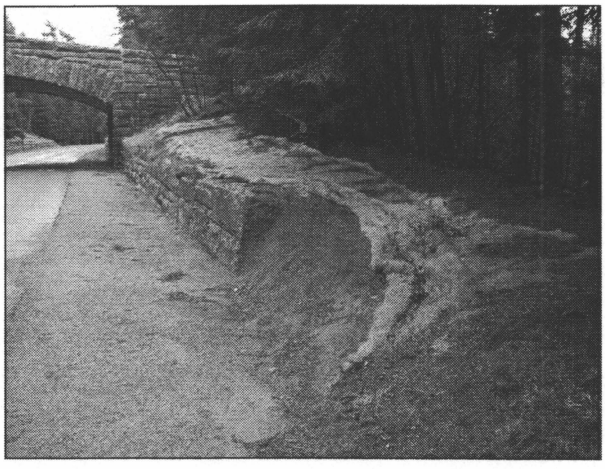
Figure 4.14. View on Day Mountain Road, looking back at Blackwoods Bridge and a section of raw gravel shoulder. (IMG_001, OCLP 2006)

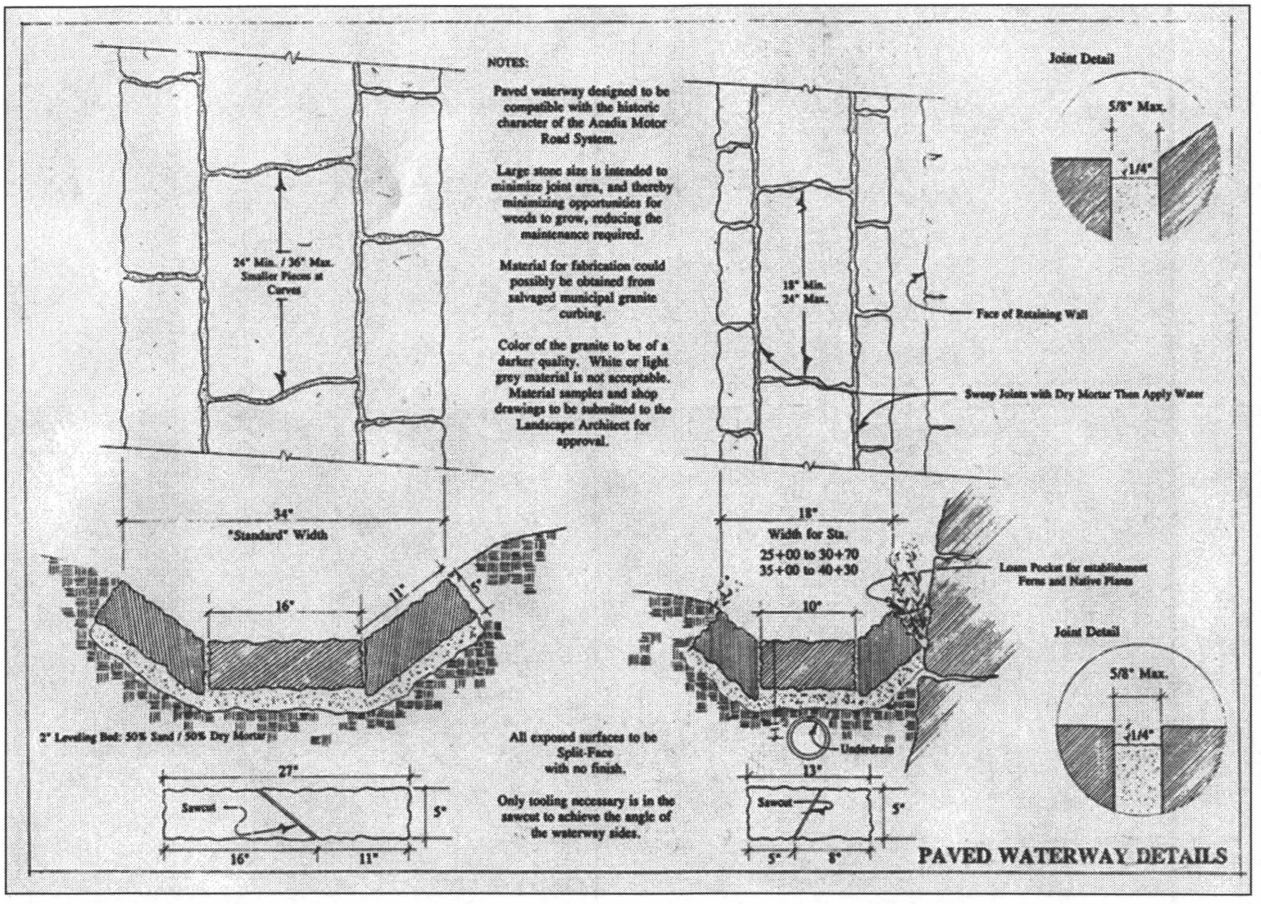
The 1991 General Management Plan/Environmental Assessment recommended removal of the bituminous waterways. A new detail for a hardened waterway was developed soon after and was installed in two test sections on the historic motor road system as a possible replacement.[23] Large flat rectangular-shaped stones were selected to reduce the overall joint area of the waterway's construction in hopes of minimizing future weed removal, and the stones themselves featured a rustic split surface. Park staff reports that the waterways function well, but the shape and color of the stones appear as too engineered and should be reconsidered and refined further (Figure 4.15).

Figure 4.15. Mortared rubble waterway detail installed near Schooner Head Overlook Access Road. (OCLP 1993)

Construction of new mortared rubble waterways:
New waterways should be constructed according to the historic waterway details illustrated in Chapter 3 and the new waterway detail developed in 1993 (see Figure 4.15). The date of construction should be included in the structure to aid future park resource and maintenance managers.

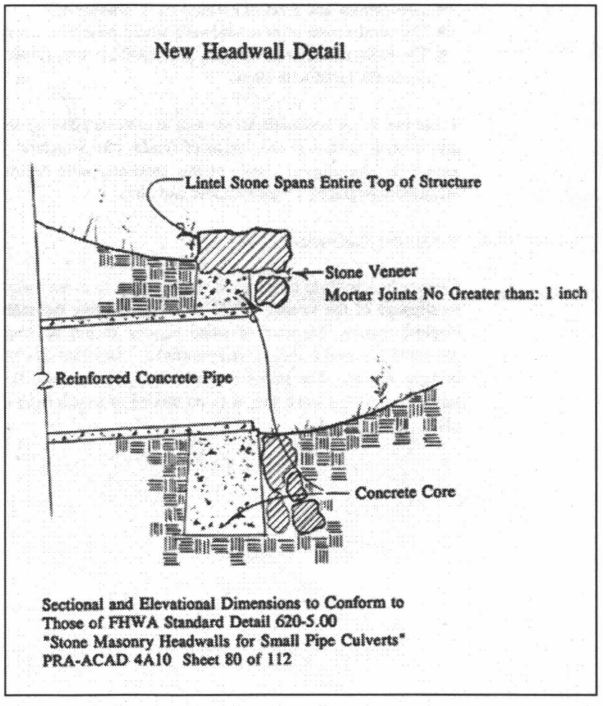
Figure 4.16. Detail for a culvert headwall that is compatible with the rustic character of the historic motor road system and distinguishable from the historic culverts. (OCLP 1993)

> Repair of existing headwalls:
> Existing headwalls removed and reset due to culvert work, or merely reset due to slippage of the stones, shall be replaced using the same stones found in the original feature. Experienced stone masons shall be employed for this work. Mortared headwalls shall be remortared, and dry-laid headwalls shall be re-laid without mortar. The stones removed from the headwall shall be laid out on a tarpaulin near the work site, with no mixing of stones from other headwalls taking place.
>
> Construction of new stone headwalls:
> Where headwalls have been found to be necessary where none has existed previously, these headwalls should be constructed according to the historic culvert details illustrated in Chapter 3 and a the new headwall detail from 1993 (Figure 4.16). The date of construction should be included in the structure to aid future park resource managers.
>
> Stabilization of areas adjacent to culverts:

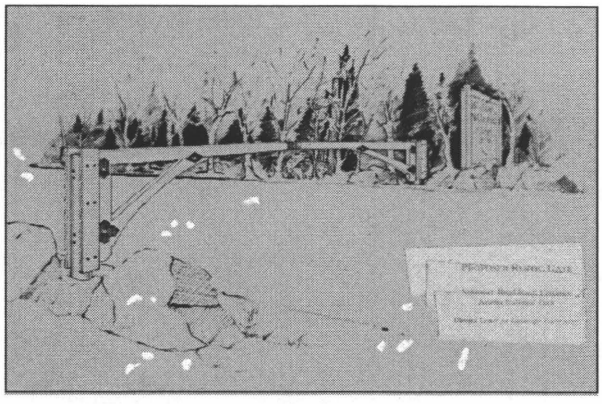
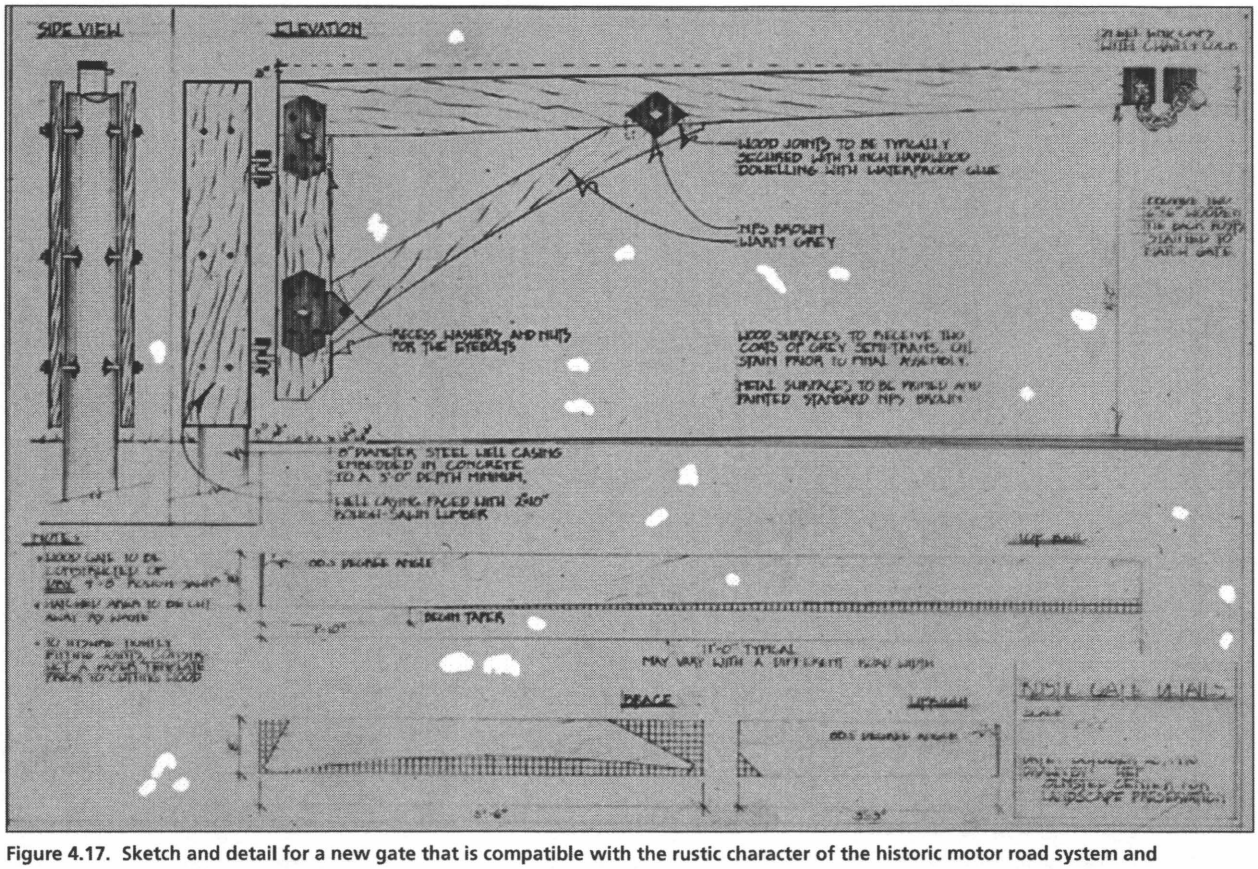
Figure 4.17. Sketch and detail for a new gate that is compatible with the rustic character of the historic motor road system and distinguishable from the historic gates. (OCLP 1993)

Recommendations:
Though desirable, the replacement of all existing galvanized steel pipe gates with the historic gate detail is impractical due to considerations of funding and maintenance. However, the new gate detail would be appropriately installed in highly visible locations and major intersections to reinforce the intended gateway effect as well as the rustic character and the historic motor road system (Figure 4.17).
