historic structure report

architectural data section

SPRINGFIELD ARMORY

NATIONAL HISTORIC SITE/MASSACHUSETTS

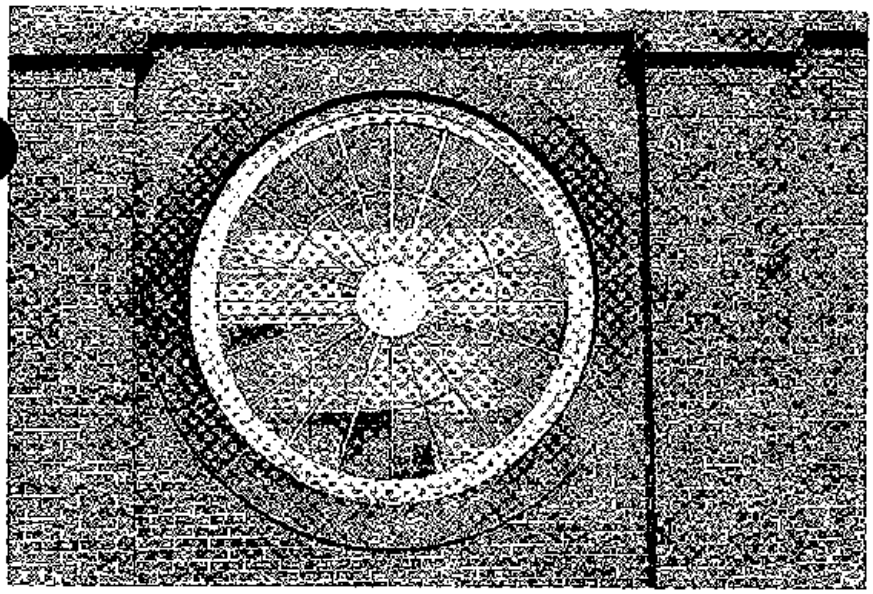
21 - Arsenal, Circular Tower Window, Note Wood Deterioration, NPS Photo, DSC

Illustration 21 **1977**
Arsenal
Circular Tower Window
Note Wood Deterioration

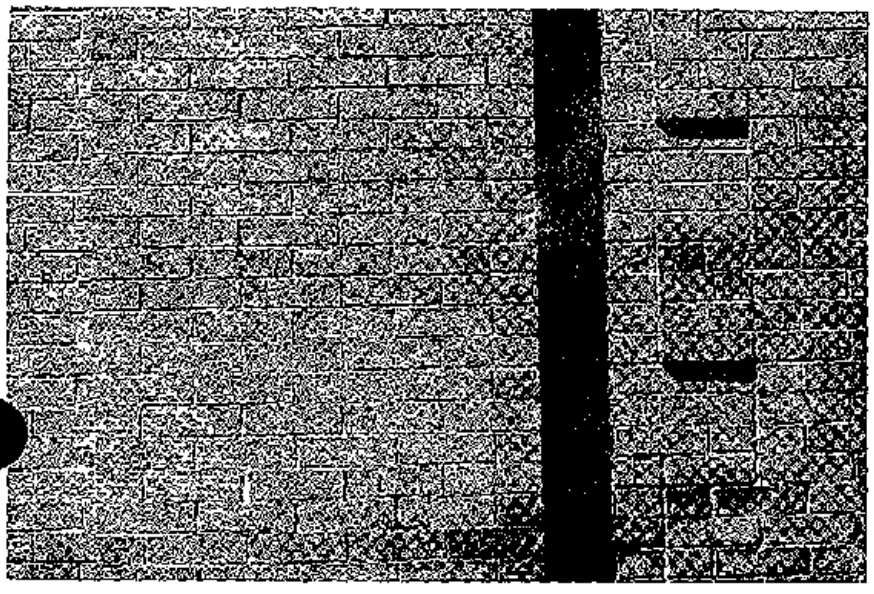
Illustration 23 **1976**
Arsenal, Tower
East Side
Sandblasted Brick Surface

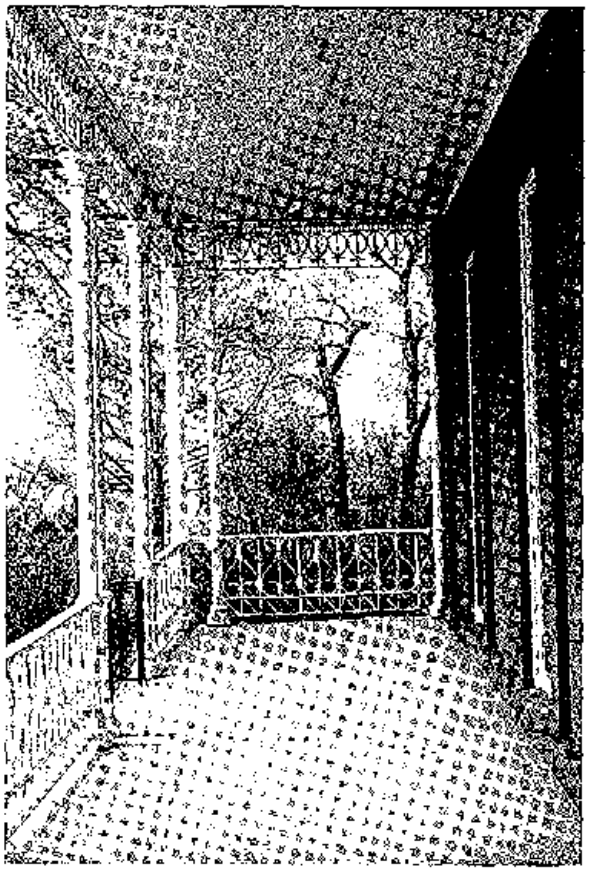
Illustration 69 **1978**
C. O.'s House
West Porch

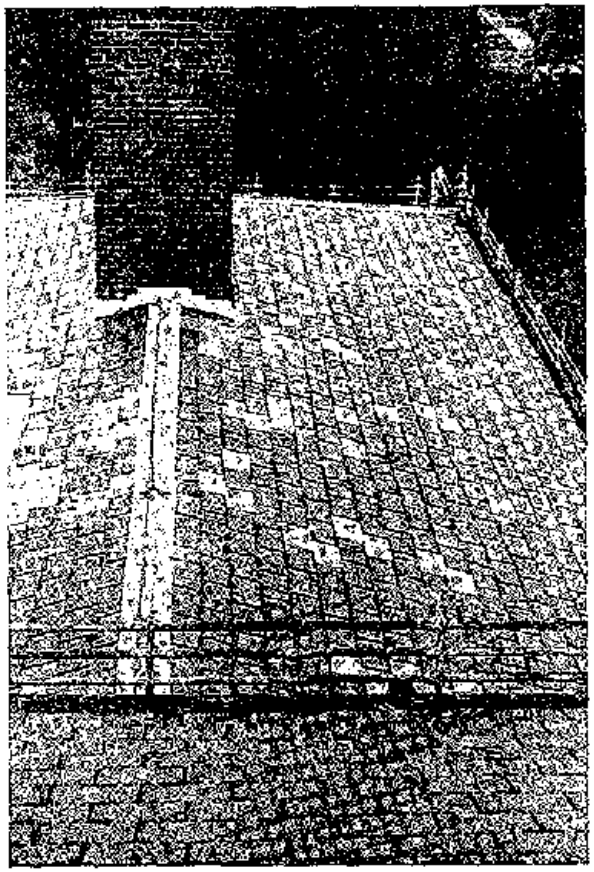
73 - C. O.'s House, Wing Roof from Main House, Note: Light-colored slates indicate repairs, NPS Photo, DSC

Illustration 73 **1977**
C. O.'s House
Wing Roof from Main House
Note: Light-colored slates
indicate repairs

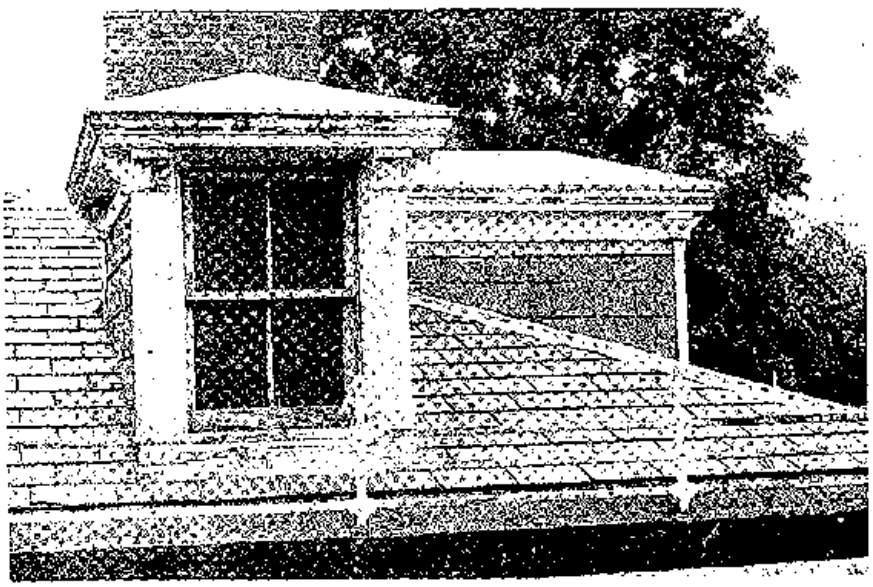
Illustration 79 **1977**
C. O.'s House
Dormer, Northeast Corner of
Main House

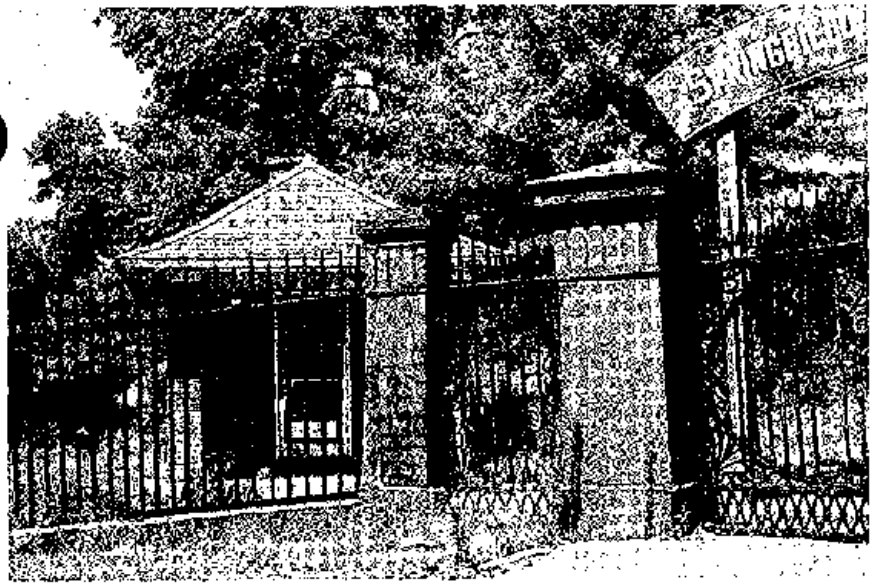
Illustration 118 **1976**
Fence
South Gate and Gatehouse

Also, one complete section of fence was missing.

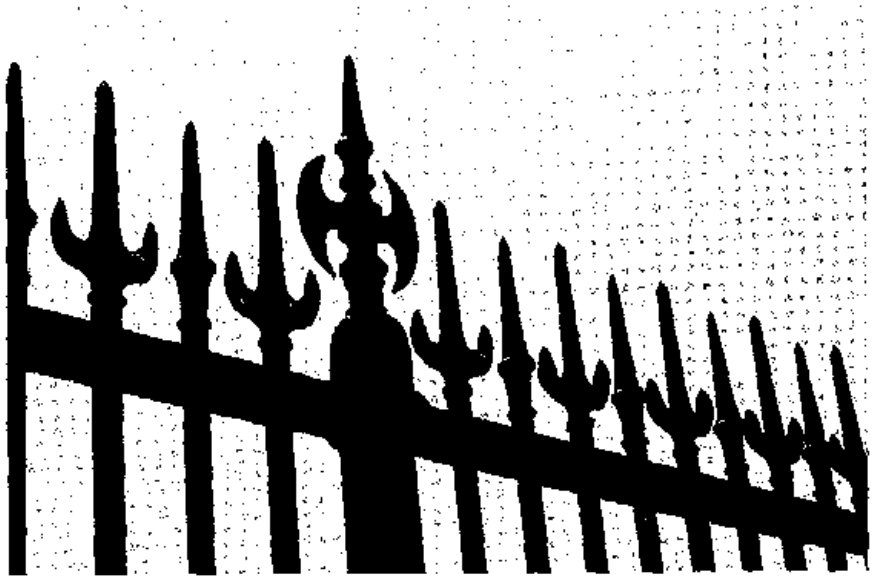
Illustration 119 **1976**
Fence
Detail of Pales

Existing deterioration of some of the foundation stone is due to weather and damage resulting from the relocation of the fence along Pearl Street. In addition to repairs and replacement of broken and missing elements, the entire fence needs refinishing. The black paint is cracked and peeling, exposing the iron to the weather. Due to the intricacy of the elements, this work will be time consuming. An advantage, however, is that molds for the paling heads are available. Repair and preservation treatment of this historic fence is required to maintain the integrity of the site.

3. Repair and replace iron elements as required. Replacement elements are recommended to be cast of mild steel to reduce galvanic action which would occur between dissimilar metals.

4. Remove loose and scaling paint. Treat bare metal with metal conditioner and rust remover. Prime bare metal with metal prime coat paint. Refinish all of fence with exterior black paint for metal.

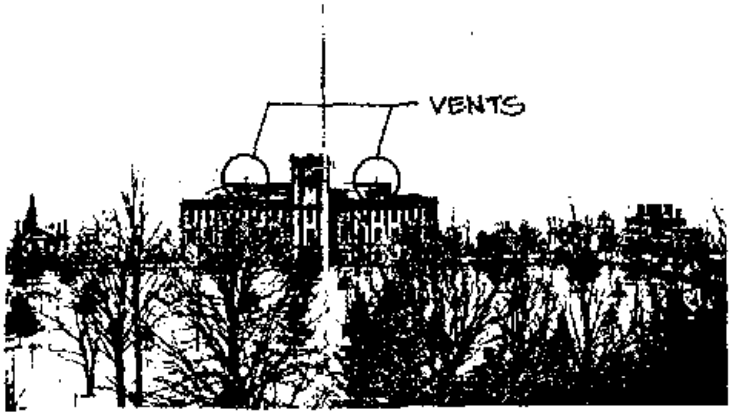
Figure 9: Main Arsenal, ca. 1880. Note location of roof vents. (Photo from the Historic Structure Report, historical data/base map, p. 69, courtesy of the Springfield City Library.)

exterior historic appearance, accomodation of a chimney or vent presents a design problem. Roof vents could be located as shown in the 1880 photo (Figure 9). Combustion air supply would be obtained through louvers installed in an existing basement window.

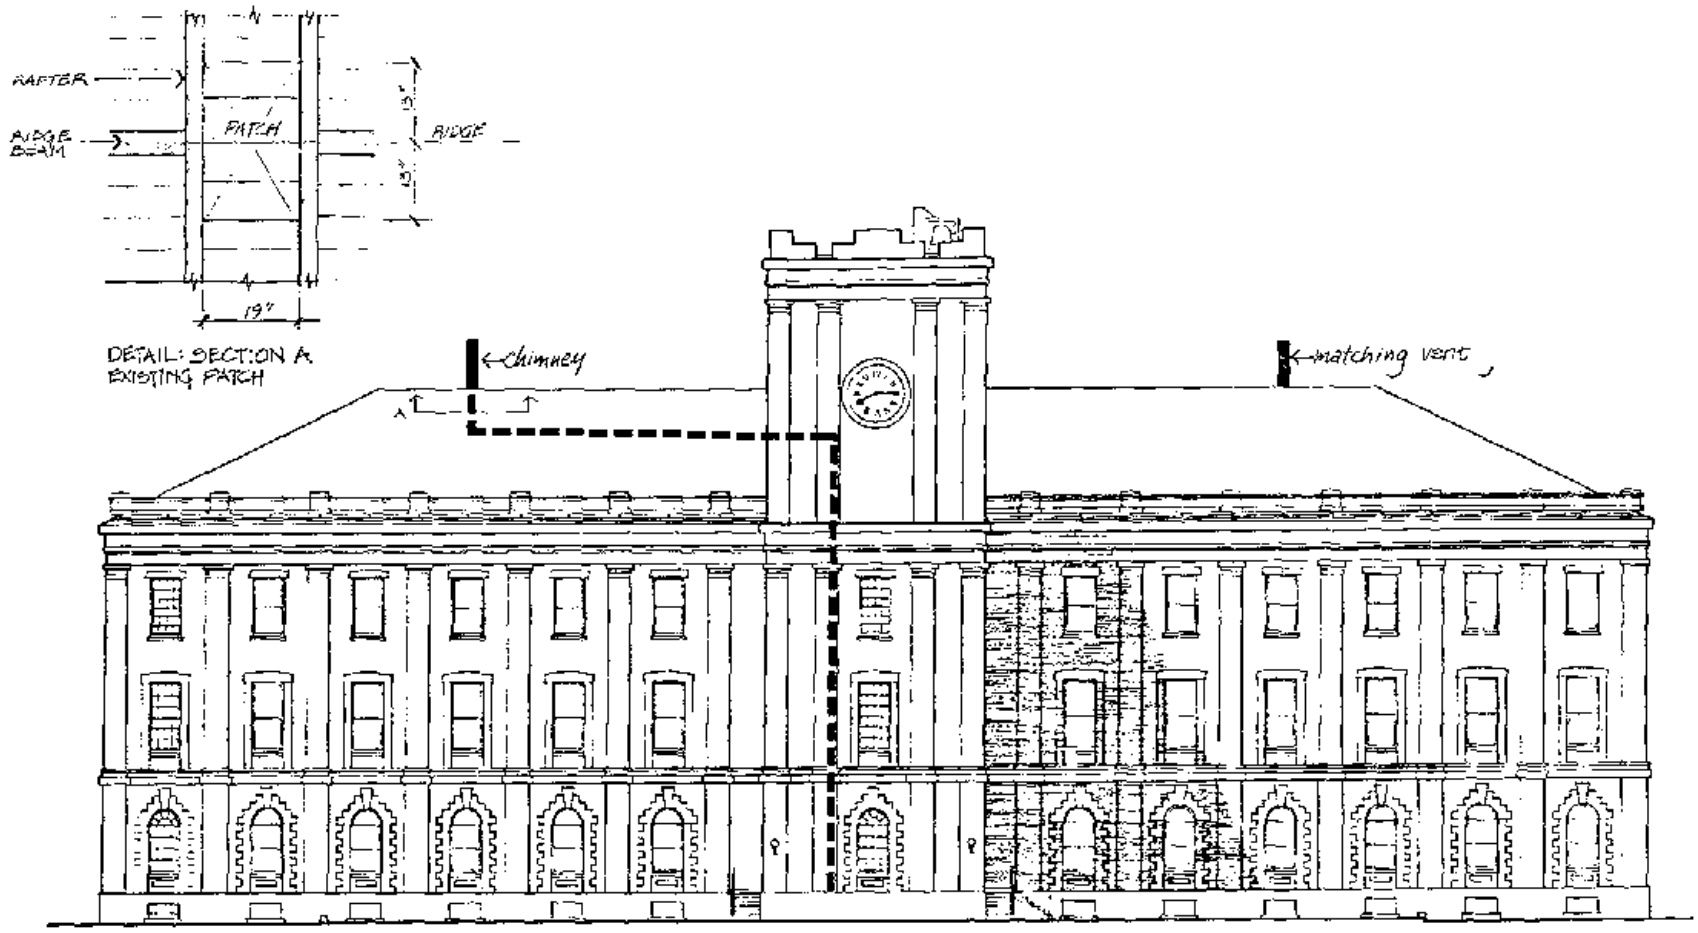
FIGURE 10

With any of the three options, a hole would have to be made in the roof to pass the flue vent; flashing and roof repairs would be required. The tower roof, which is metal, is probably the easiest to reclose; option 1 penetrating a slate roof is slightly more difficult; option 2 penetrates a formed copper ridge cap and may require more painstaking restoration. The estimated cost for cutting and patching holes in floor and roof and encasing the flue on floors one and two is $6000-$8000.

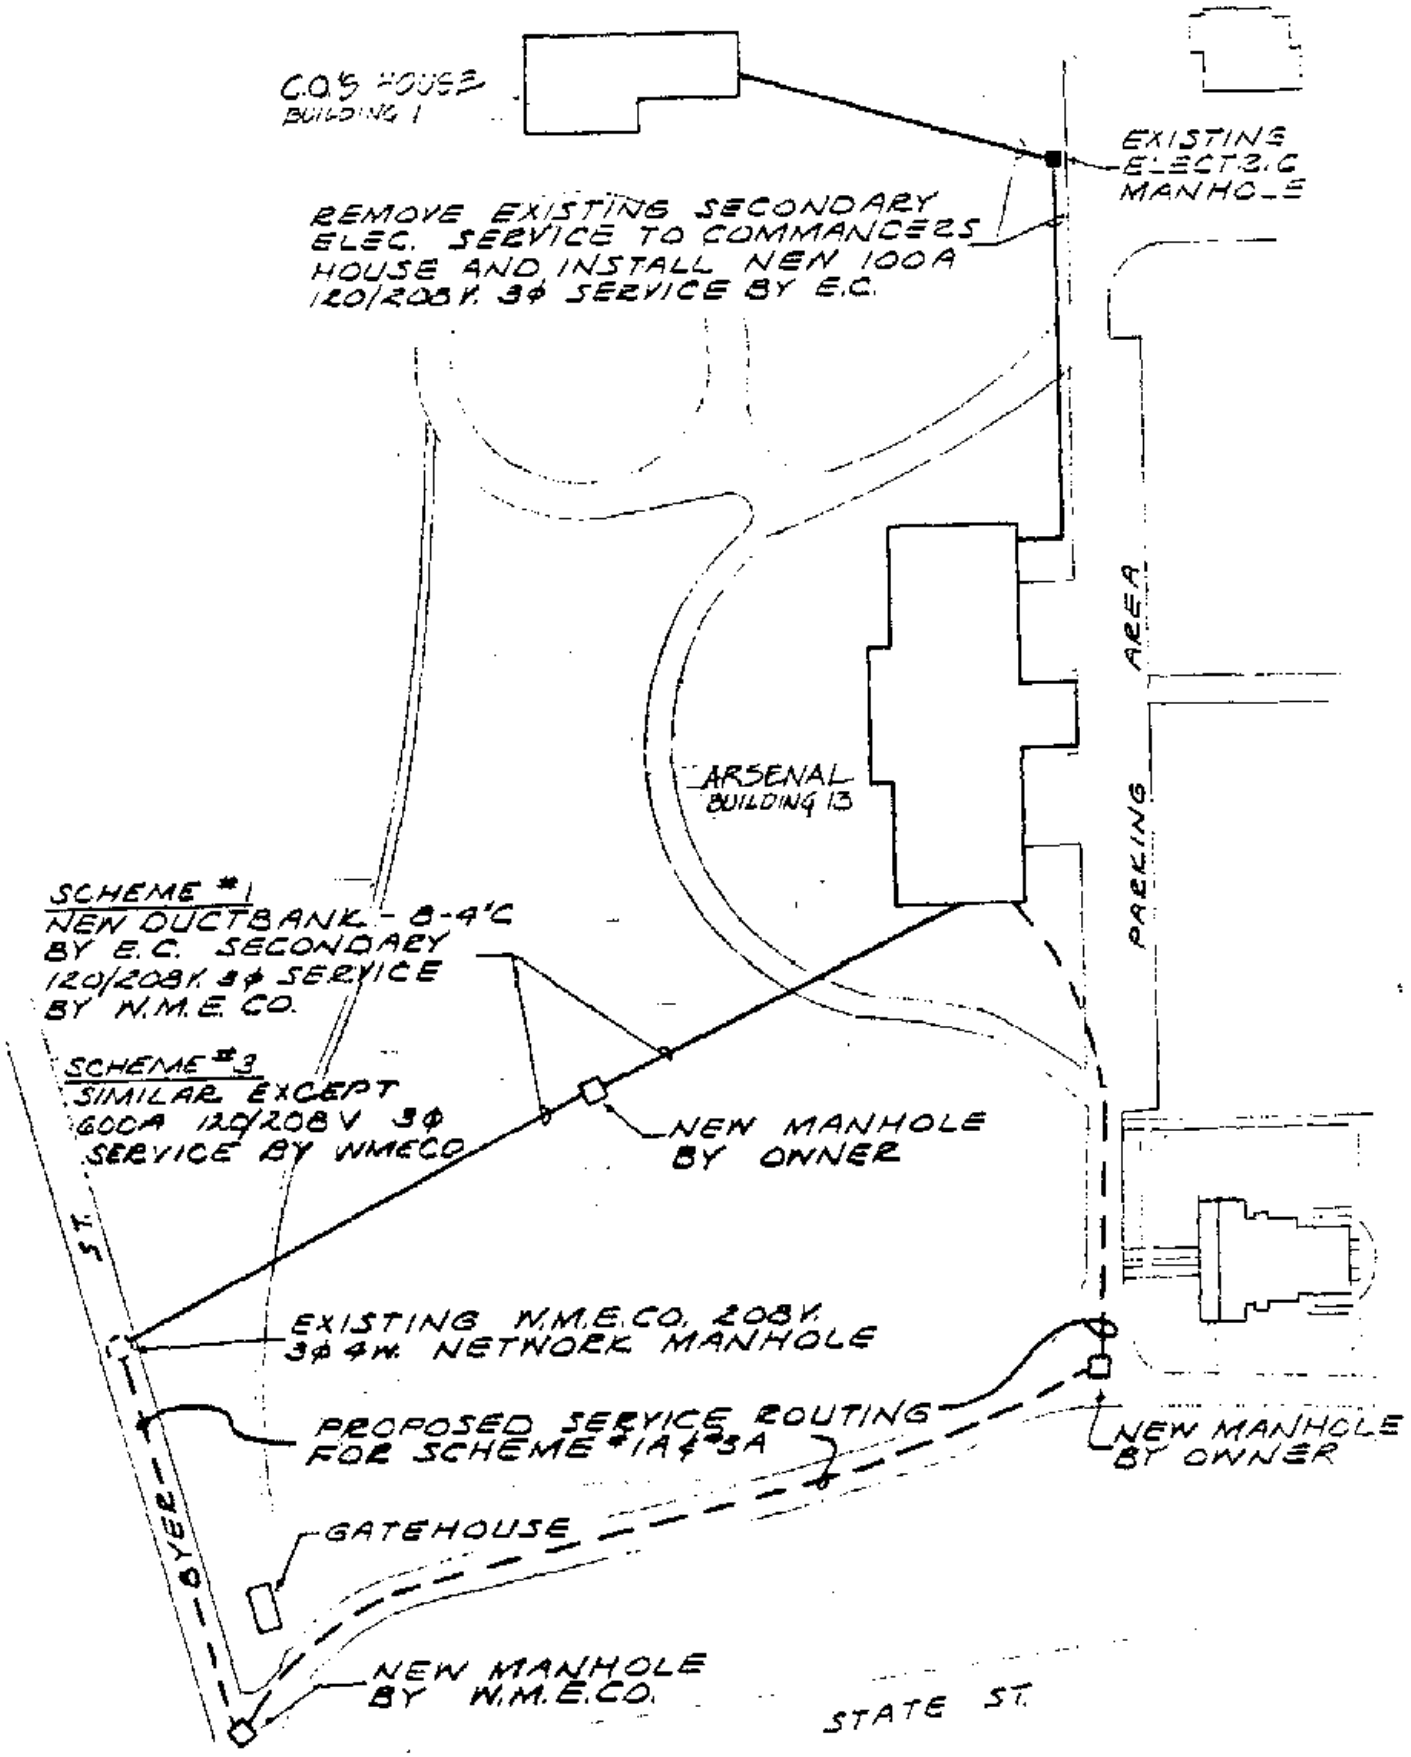
FIGURE 13: NEW ELECTRIC SERVICE, SCHEMES #1, 1A, 3, & 3A.

New electric service 2500A, 120/208V. 3Ø secondary from Byers St. would provide power to the Arsenal, including the new heating system and air conditioning, and to the Commanding Officer's House (Fig. 13). Work involved includes changing utility company's (Western Massachusetts Electric Company - WMECO) network transformers, trenching from Byers St. to the Arsenal, installing manholes and concrete encased conduit to contain new WMECO secondary service conductors. Interior work includes a new electric room in the Arsenal, (100-150 sq. ft.) cable duct box, new fused main switch and metering compartment, and new main distributing panel which will feed the Arsenal and the C.O.'s House after both of the existing electrical services have been removed. Total estimated cost for installation of this is $165,000.

New electric service 600A, 120/208V. 3Ø secondary from an existing manhole on Byers St. would provide an electric service to the Arsenal and Commanding Officer's House independent of Springfield Technical Community College and with enough capacity for new lighting and air conditioning (Fig. 13).

Service provided would be the same as Scheme #3, except that the routing would be under the walkway to avoid disturbing new portions of the site (Fig. 13). This would require longer cable runs and an additional manhole. Total estimated cost for this service is $109,000.

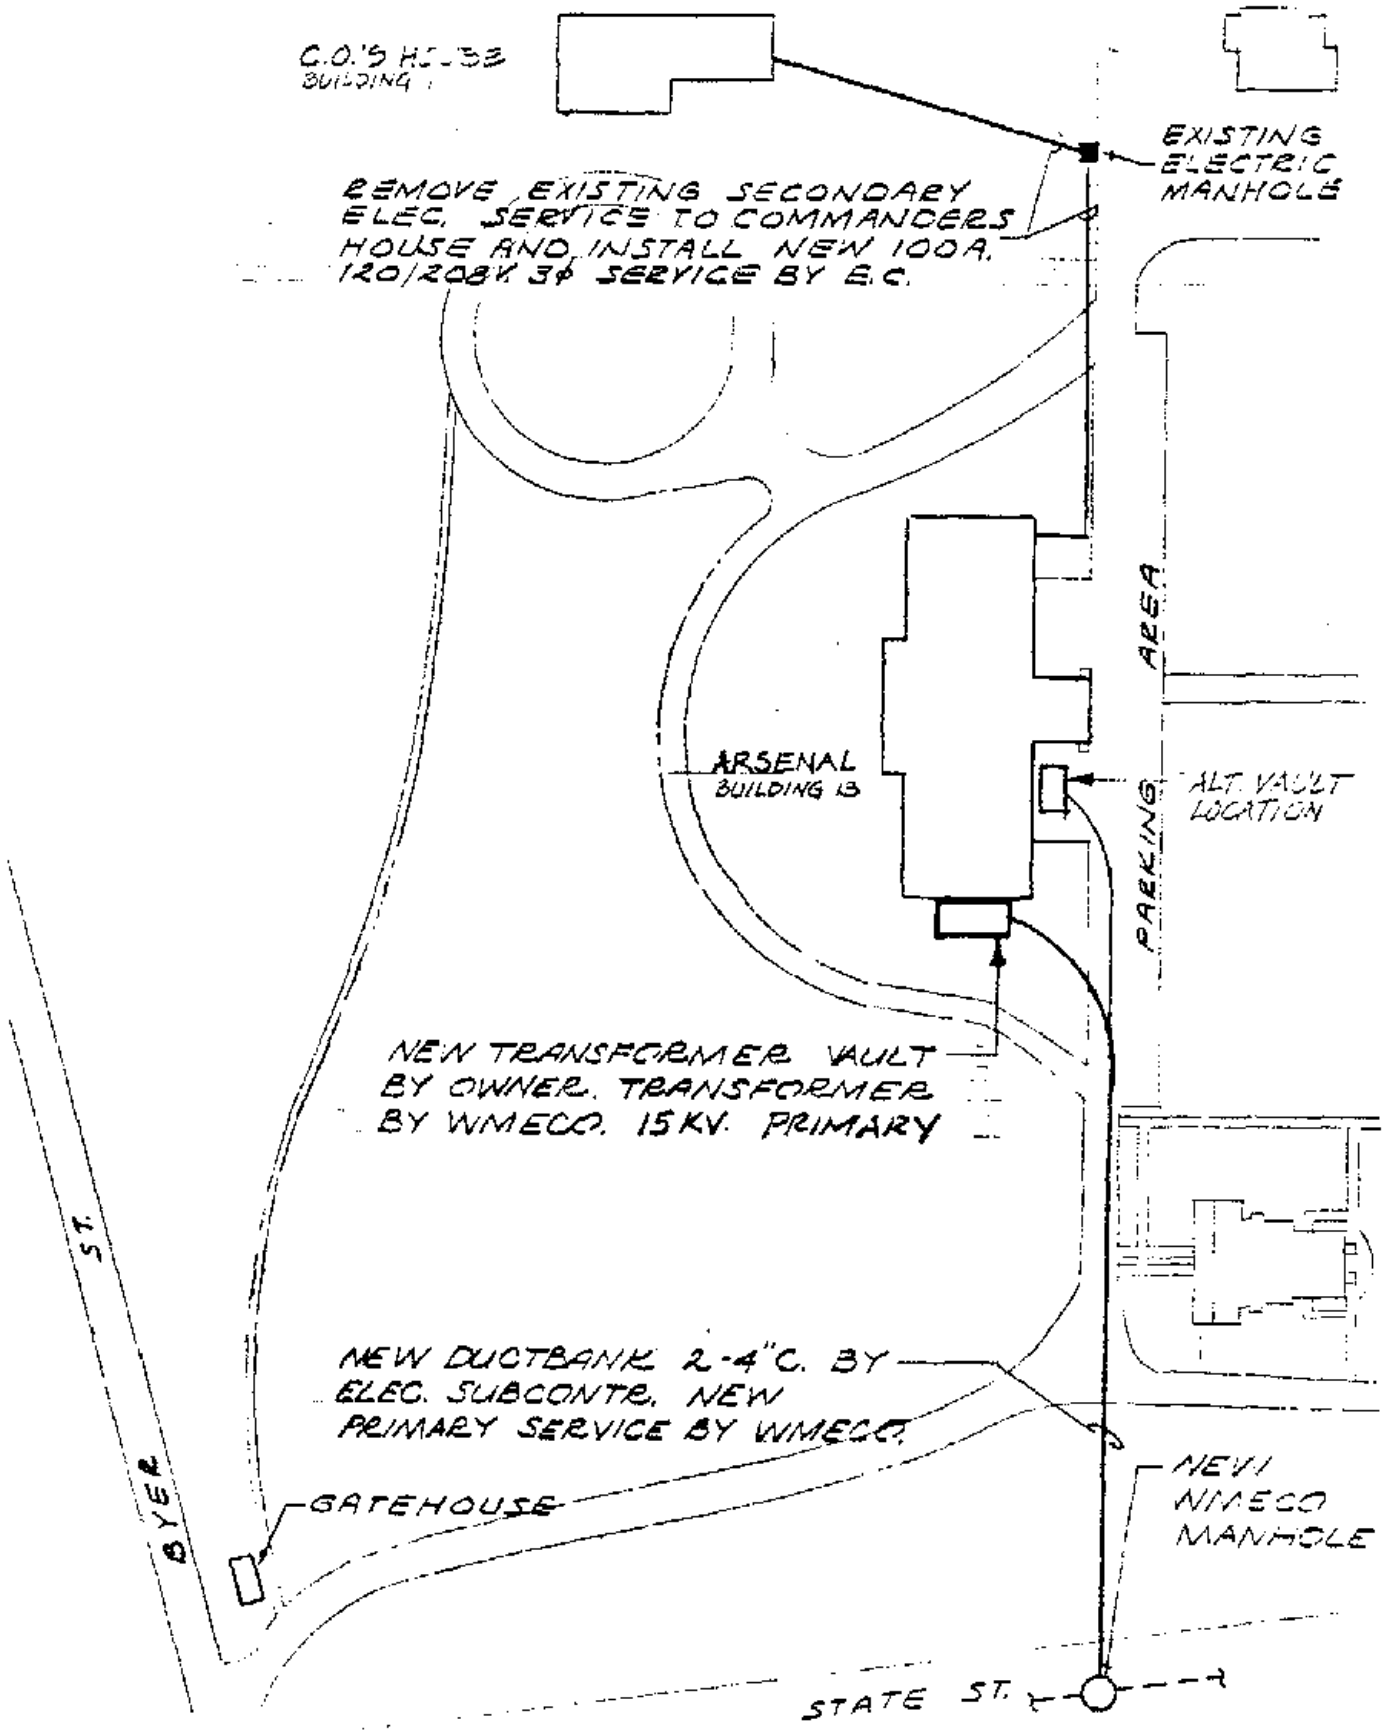
FIGURE 14: NEW ELECTRIC SERVICE, SCHEME #2.

This scheme is an alternative to Scheme #1. The service to the Arsenal would be 13,800 volts 3Ø from a new manhole on State St. via concrete encased conduit to an underground vault and transformer installed near the Arsenal (Fig. 14). The transformer would provide 480V., 3Ø 4W, 1200A service to a new fused main switch/meter cubicle which would feed a 480V. main distribution panel. The main distribution panel would provide power to the Arsenal, including the new heating system and proposed air conditioning equipment, and to a 120/208V. 3Ø 4W. dry type indoor transformer which would provide service to the Commanding Officer's House. Estimated cost for installation of this service is $124,300.

Clearly, for heating the Arsenal, scheme 2 is to be preferred over scheme 1. It is more economical by

30% and site disturbance appears to be about equal, excavation for the transformer vault (2) being balanced against the need to dig a new trench in an area previously undisturbed by site utilities (1).

The most significant decision NPS will have to make regarding electrical service is whether or not to use electrically heated boilers. If electric heat is chosen, service will be run up from State Street and a transformer will have to be buried beside the Arsenal in a vault, as shown in Scheme 2 (Fig. 14). If electric heat is not chosen, service will be brought from Byers Street as in Scheme 3 (Fig. 13). The required trench will be somewhat larger and there will be a manhole on site (to facilitate pulling of cable), but there will be no transformer. All three duct bank routes avoid the old site of the Paymaster's Quarters, but Scheme 3A, no electric heat, passes through unexplored hillside and will require archeological investigation.

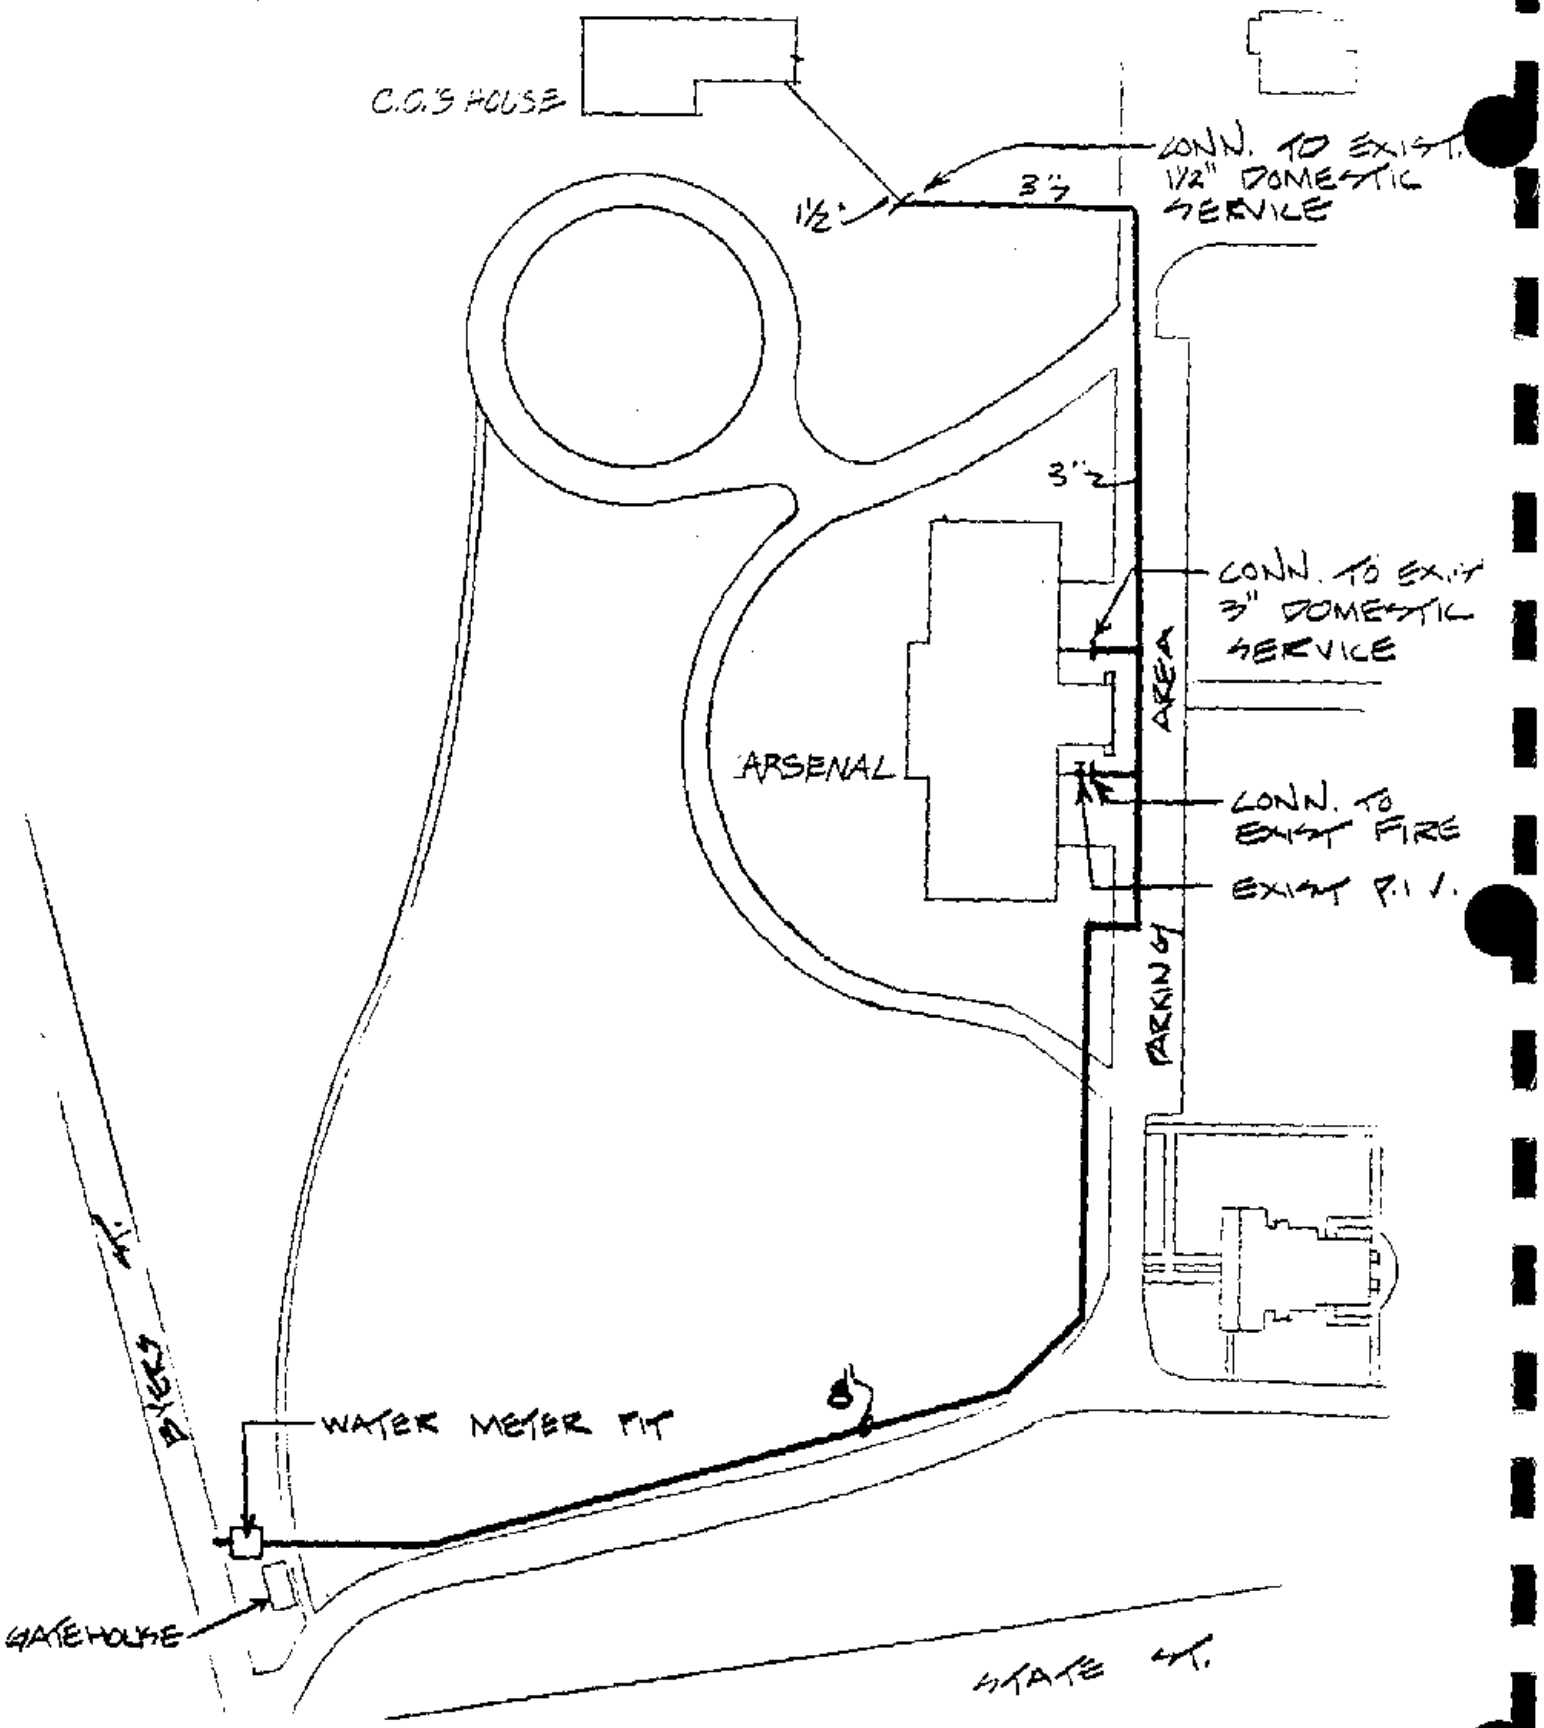
FIGURE 15: WATER SUPPLY OPTION A

A new 8" combined fire and domestic service would originate from an existing 10" main under Byers St. at a point near the gatehouse. Piping would run in a trench beside the existing path and be tied into the existing water services just outside the Arsenal and the C.O.'s House (Fig. 15).

If the existing sprinkler service cannot be retained, we recommend a two-way supply system, Option D. The choice among routing options A, B, and C, may be tied to the choice of routing for the electric cable duct bank. If option A is combined with electric scheme 1a or 3a, B with 1 or 3, or C with 2, a single trench could contain both services.

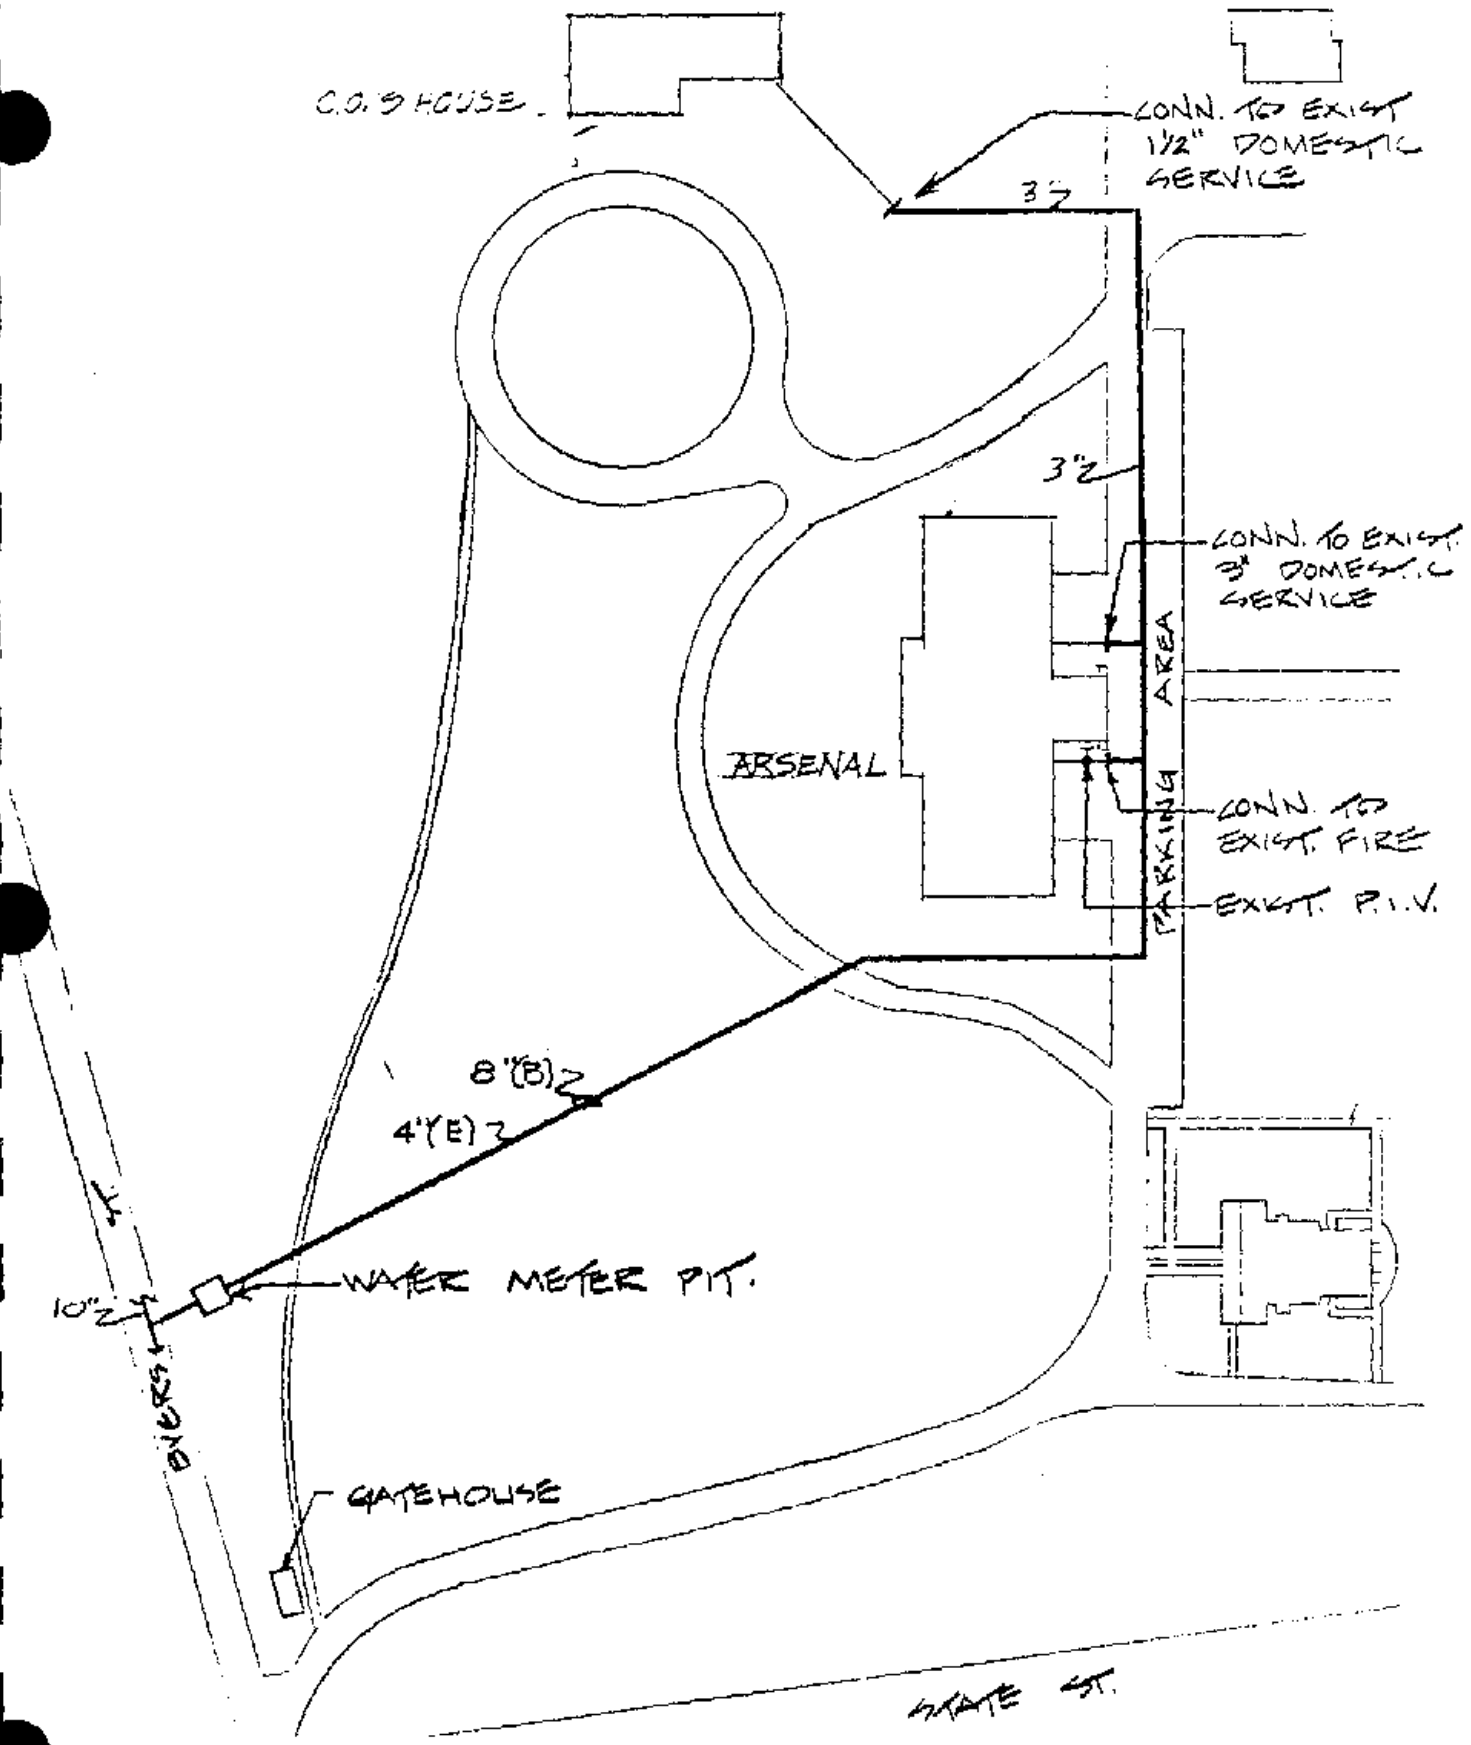
FIGURE 16: WATER SUPPLY OPTION B

A new 8" combined fire and domestic service would originate from the existing 10" main under Byers St. at a point about 320 feet north of State. Piping would run up the hillside and be tied into existing water services as for A. (Fig. 16).

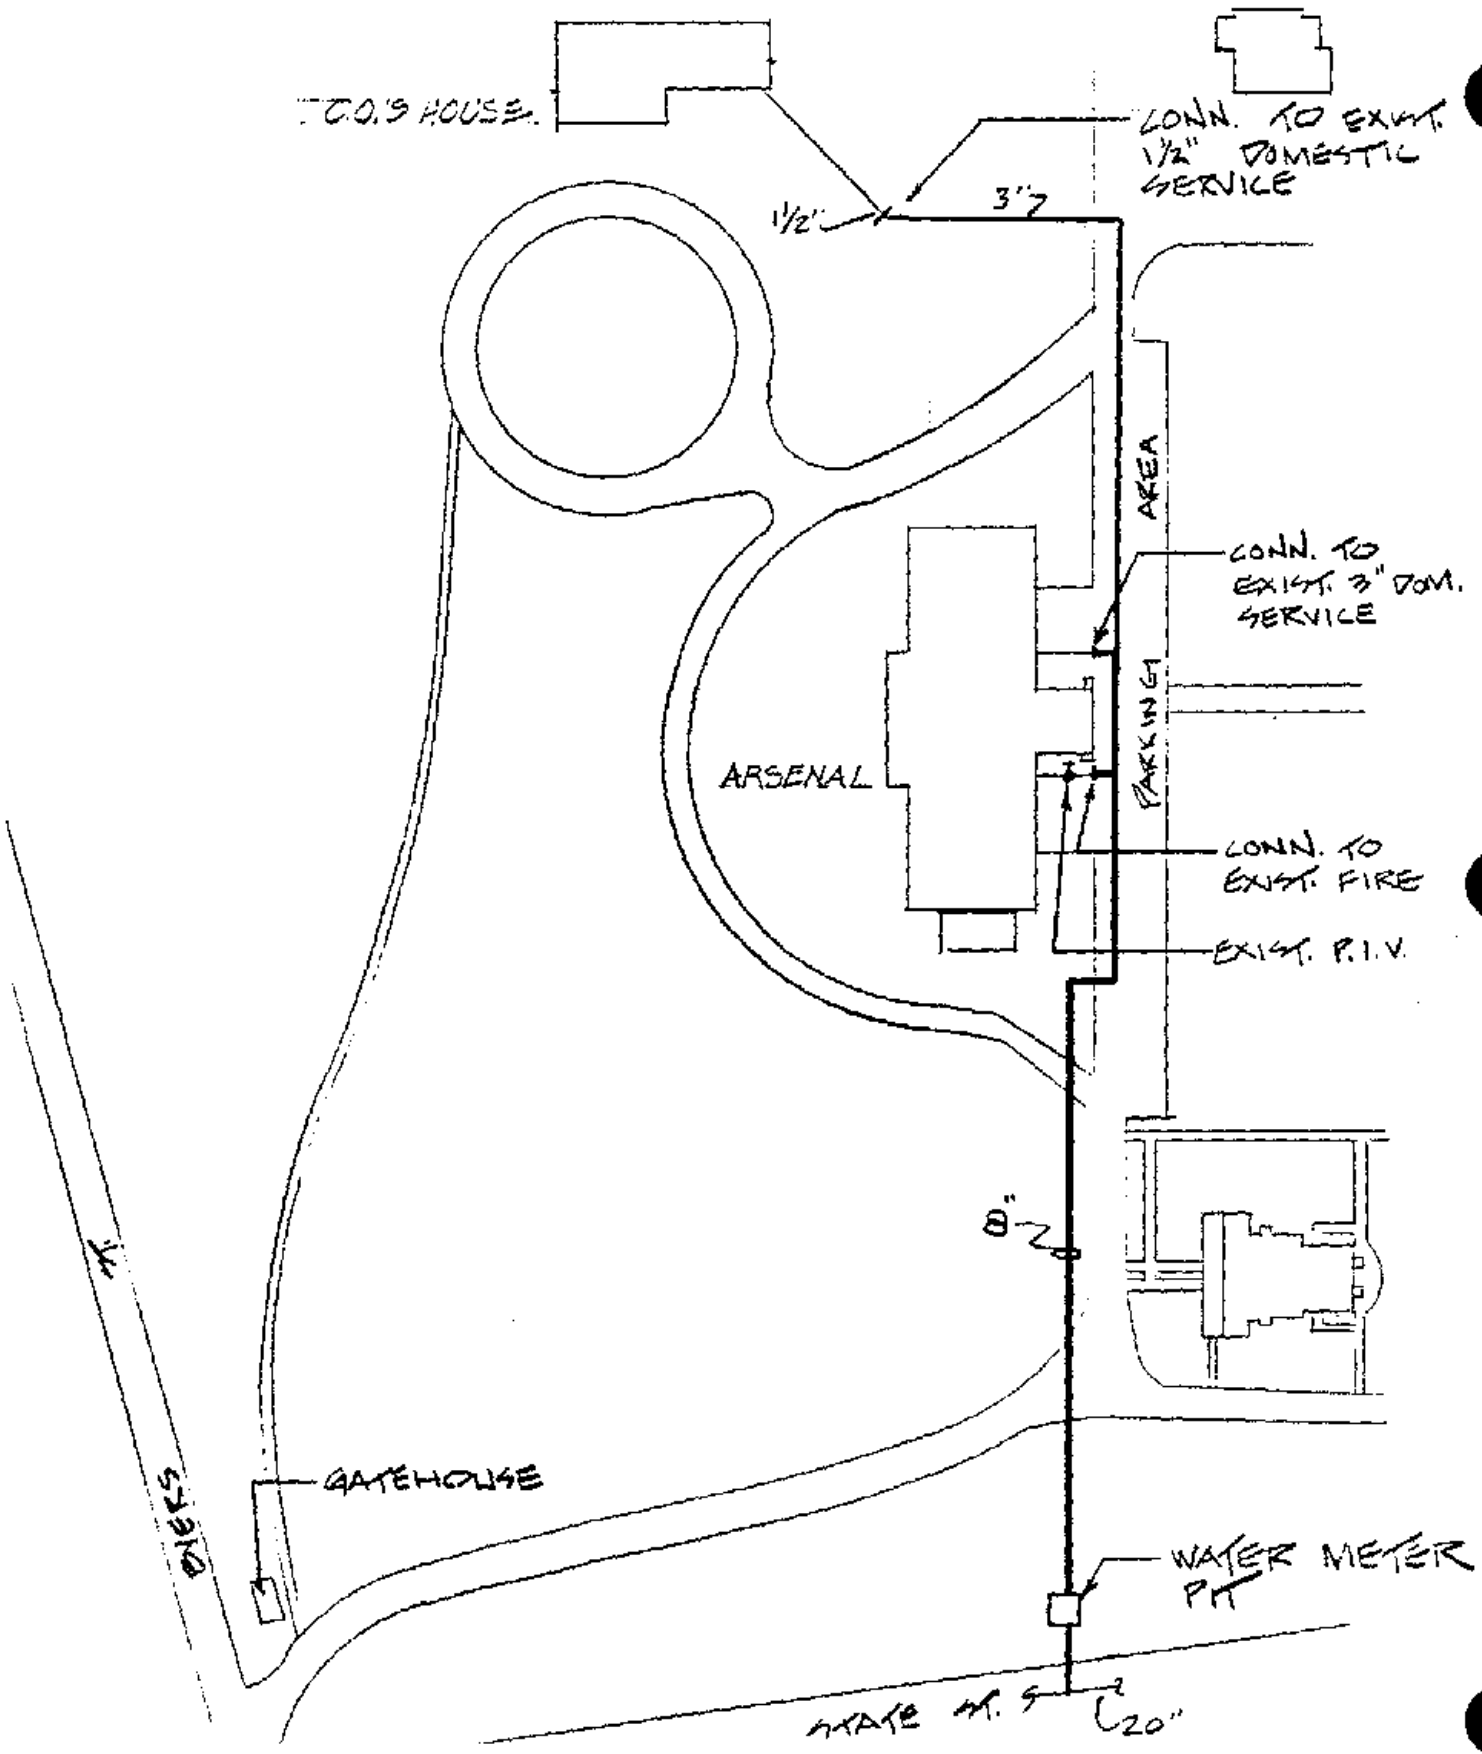
FIGURE 17: WATER SUPPLY OPTION C

A new 8" combined fire and domestic service would originate from an existing 20" main in State St. The piping trench would follow the route of the existing water main, and be tied into existing water services as for A (Fig. 17).

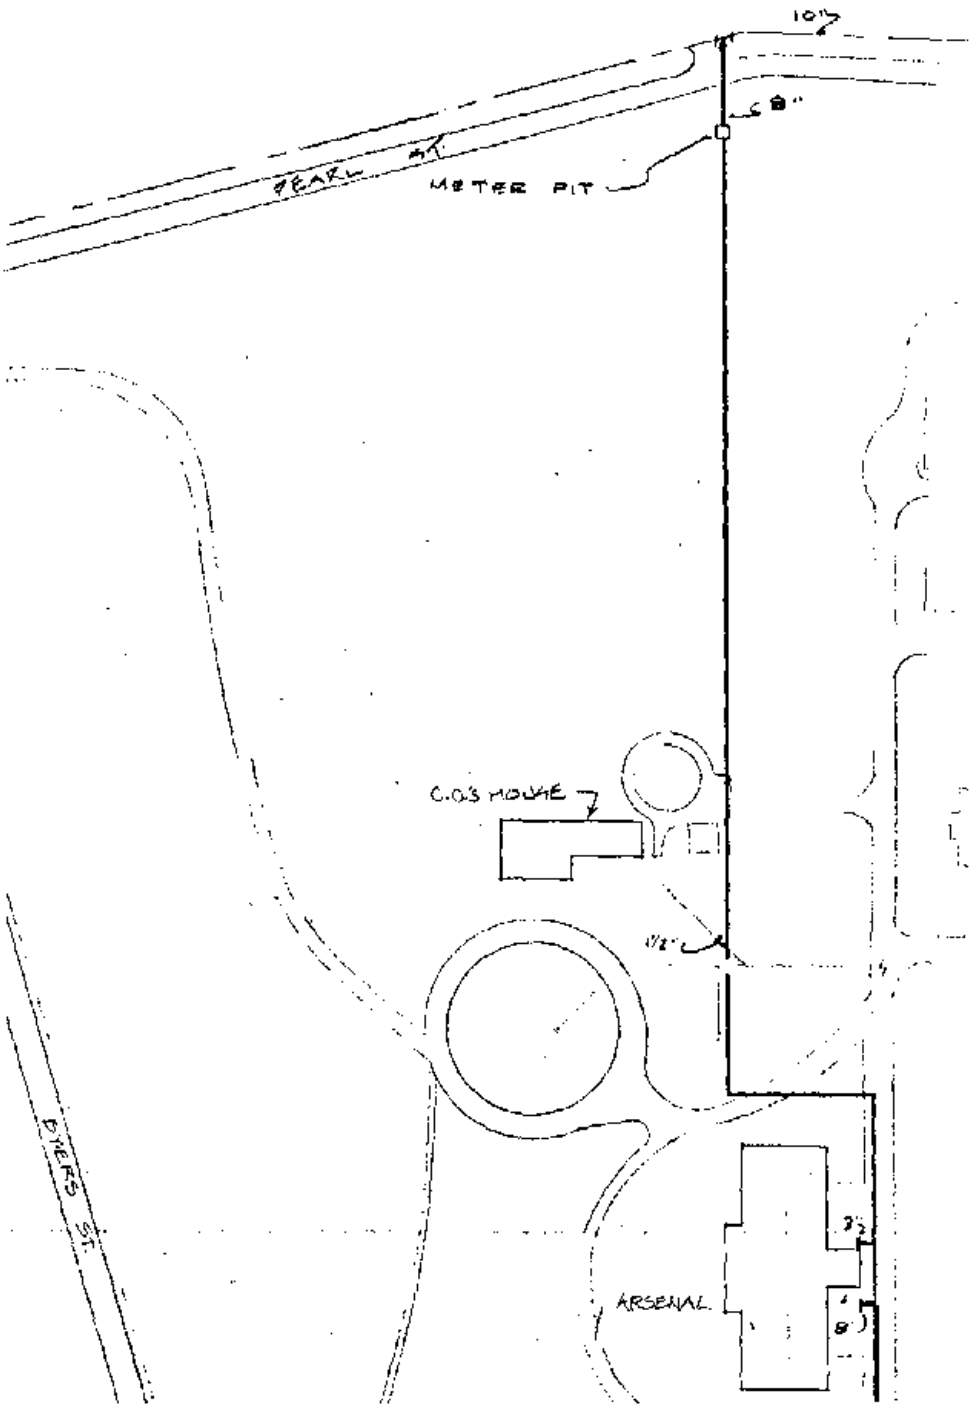
FIGURE 18: WATER SUPPLY OPTION D, SECOND SUPPLY.

In addition to any of the options above, a second (backup) 8" water service would originate from an existing 10" main in Pearl Street. The two supplies would be interconnected, before connecting with the existing services at a point outside the Arsenal and C.O.'s House (Fig. 18).
