BISCAYNE NATIONAL PARK
Historic Resource Study

Jennifer Brown Leynes
David Cullison

January 1998

Southeast Regional Office
National Park Service
U.S. Department of the Interior
Atlanta, Georgia

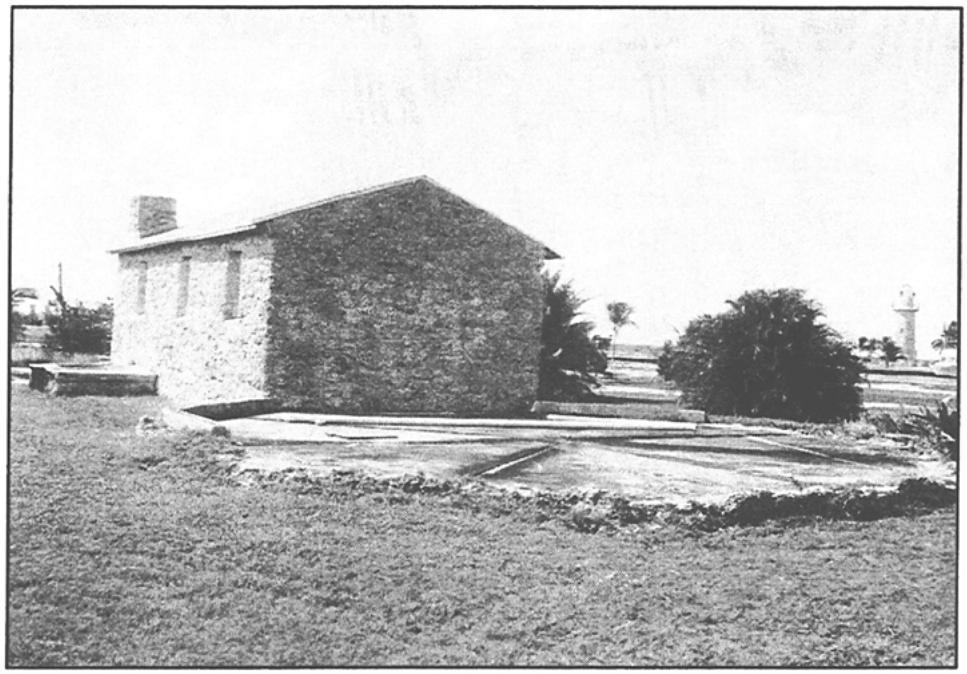
Figure A- 1. Engine House, 1997

Boca Chita Engine House and Cistern (IDLCS 90194; HS-5): Also known as the generator building, this concrete block structure with concrete slab foundation measures 15½ feet by 32½ feet. The rear third of the structure is built of a different type of concrete block than the front, although no corresponding variation can be discerned on the exterior. The exterior walls are of uncoursed oolitic limestone. The front-gabled roof has been re-covered with asphalt/fiberglass shingles, replacing the old roof damaged by Hurricane Andrew. The narrow building front has a door and window. The door appears to be original. The rear wall has no openings. Originally, the rear was gabled, but it is now hipped as a result of repairs undertaken after Hurricane Andrew. An octagonal concrete cistern, 15 feet on each side, is attached to the rear (east) of the building. A shed porch on the south side of the building was demolished by the hurricane and will not be rebuilt.

Problems and Recommended Treatments– At the time of the site visit the windows were covered with plywood. The original windows should be repaired or replaced to match the originals. Staining beneath the windows should be poulticed.

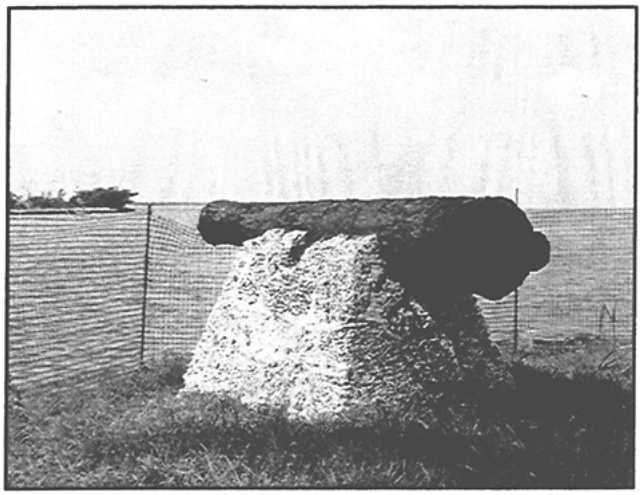
Figure A- 2. Cannon, 1995

parts, with the inner section and outer of two different alloys. Where the inner material is exposed near the muzzle it does not appear corroded.

Problems and Recommended Treatments– The surface of the cannon needs to be protected from both rain and saltwater. The surface will need to be prepared by the removal of rust, which in this case will be difficult because of the extent of the corrosion. Only manual methods should be used to remove the corrosion; a wire brush should probably be used, but chemical application might also be a possibility. The metal should then be stabilized by painting with primer and a black finish coat appropriate to the salt environment. The joints where metal rests against stone should be carefully examined for openings where water could pool against the gun or flow under it and the openings sealed. The mouth of the gun should be plugged to prevent water infiltration.

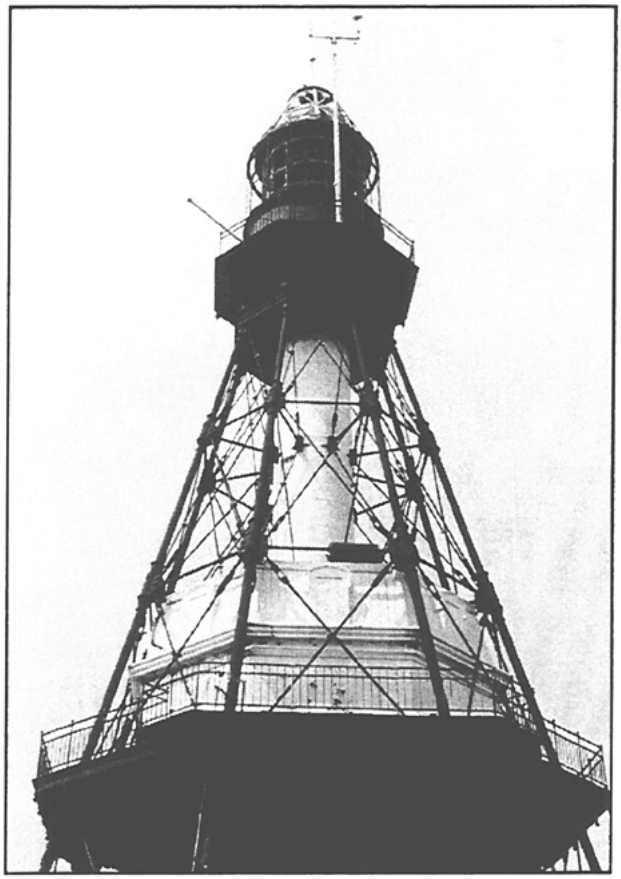
Figure D-1. Fowey Rocks Lighthouse, 1995

The United States Coast Guard owns the Fowey Rocks Lighthouse, although the structure is located within the boundary of Biscayne National Park. The surveyor could not obtain access to the lighthouse but examined the structure from the deck of a boat. The lighthouse appears eligible for listing in the National Register.
