Cultural Landscape Report for the Sandy Hook Coastal Defense Batteries

Gateway National Recreation Area

EXISTING CONDITIONS

Olmsted Center for Landscape Preservation
National Park Service, Boston, Massachusetts, 2010

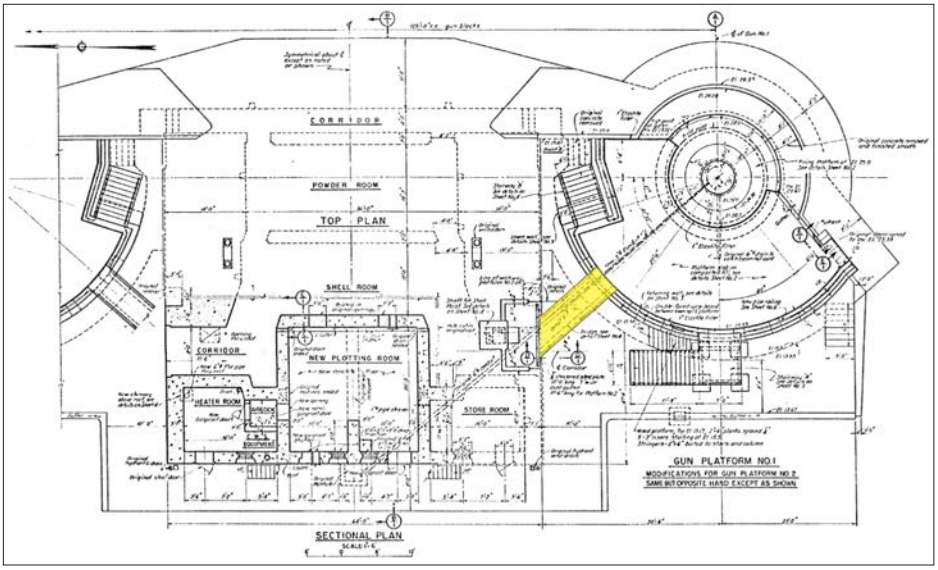
Although the General Management Plan called for greater interpretation of the coastal defense batteries and improving access for the public, efforts in the last three decades have focused on safety issues, stabilization, and research. In order to warn visitors of potentially hazardous conditions at Battery Peck, Battery Granger, and Nine Gun Battery, the park erected chain-link fencing and signage between pedestrian routes and the structures. At Battery Gunnison, the park demolished a concrete bridge in 2001 to eliminate hazards created by the deteriorating concrete. The bridge spanned between the south gun platform and the shell hoist (Figure 2.122).[176]

Figure 2.122. Detail of Harbor Defenses of New York, Battery Gunnison, Alterations and Additions, Fort Hancock, New Jersey, 1943. In 2001, the park demolished a concrete bridge (highlighted in yellow) at Battery Gunnison in order to eliminate hazards created by the deteriorating concrete. The bridge spanned between the south gun platform and the shell hoist (GATE 10689).

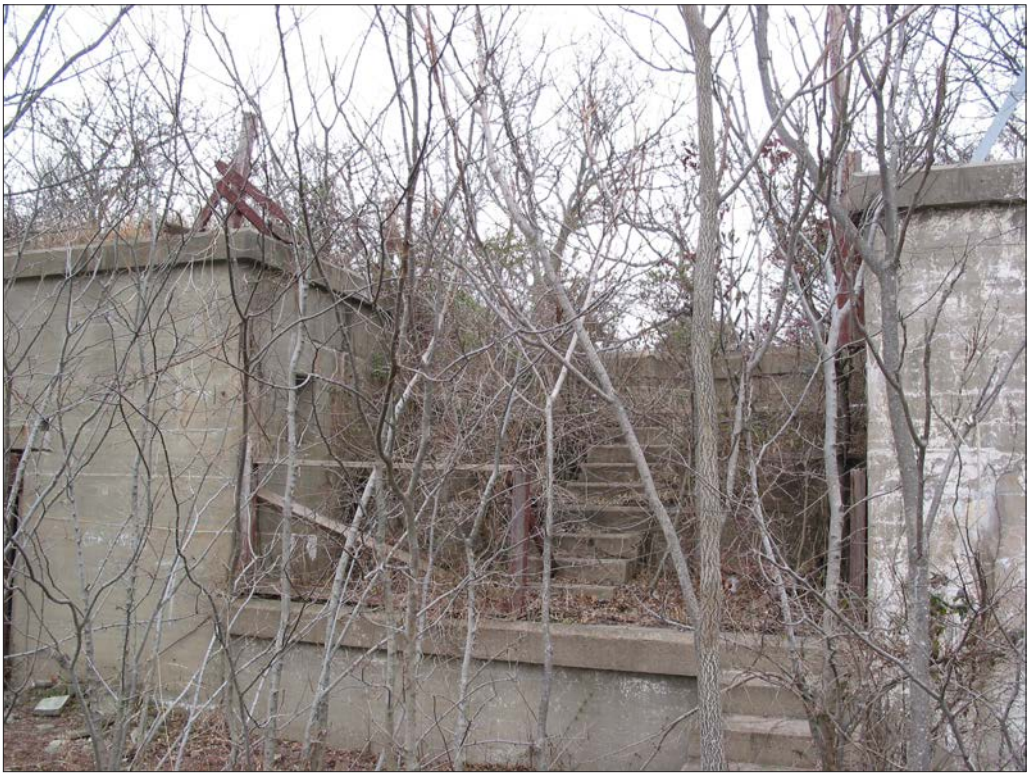
Figure 3.6. View looking north at emplacement #2, Battery Morris. Woody vegetation is growing in and around the stairs to the point where they are difficult to ascend and reach the gun platforms (Olmsted Center, January 2009).

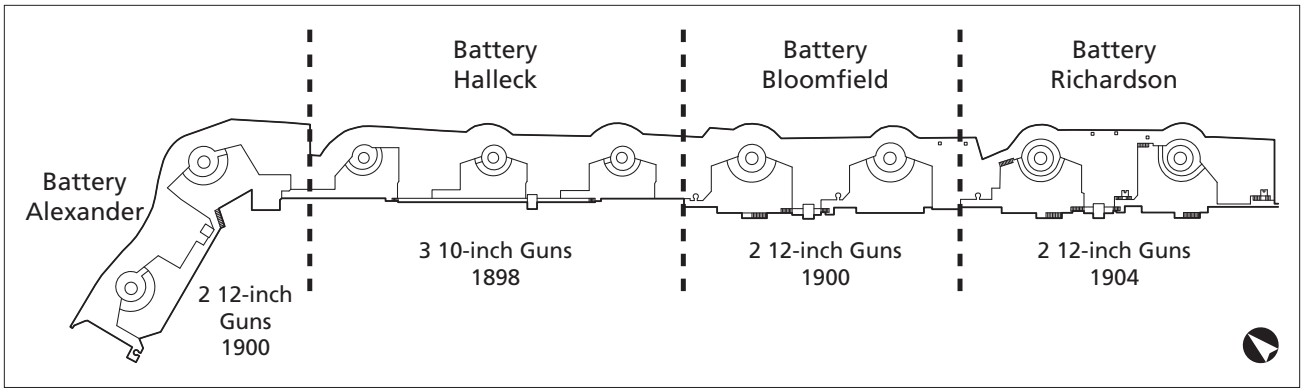
Nine Gun Battery was constructed in phases between 1898 and 1904 and designated as four batteries. From north to south, the four batteries are Battery Alexander, Battery Halleck, Battery Bloomfield, and Battery Richardson (Figure 3.15). In order to show a similar level of detail for Nine Gun Battery and the other coastal defense batteries, Nine Gun Battery is shown on two drawings that divide the structure into a northern and southern half (Drawing 3.6).

Figure 3.15. Diagram of Nine Gun Battery's individual names and construction dates. The emplacements at Nine Gun Battery were constructed in phases and divided into four separate batteries. The first three emplacements were designated Battery Halleck, south of Halleck was Battery Bloomfield and south of Bloomfield was Battery Richardson. The northernmost guns were designated Battery Alexander (Olmsted Center, 2009).

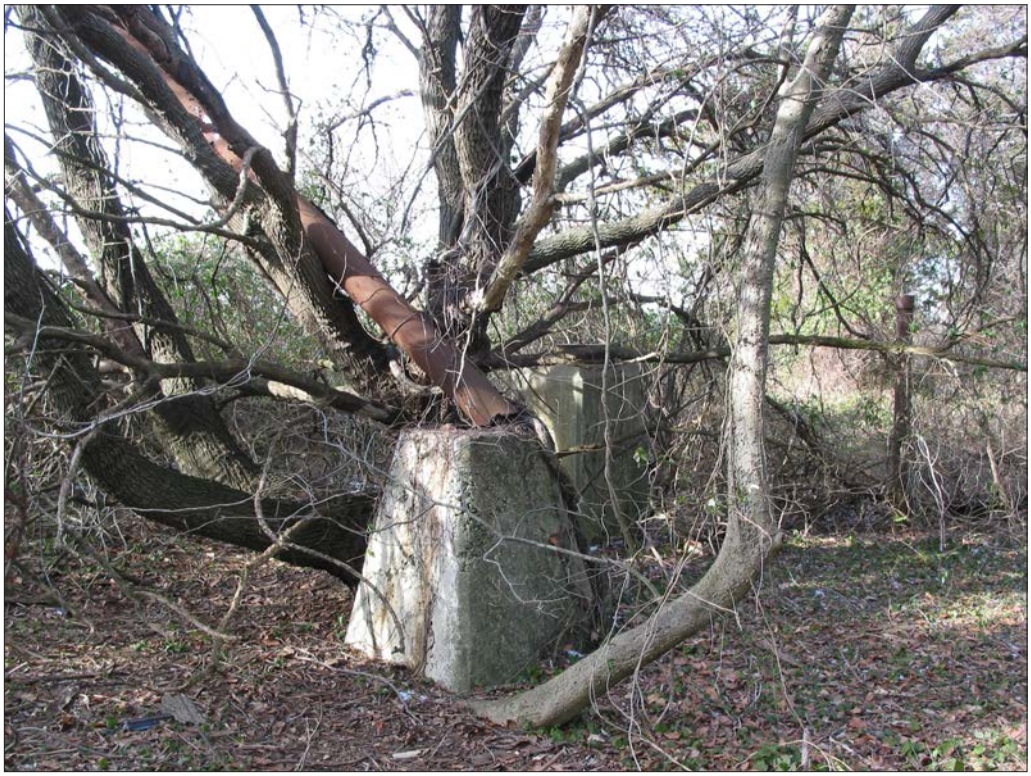
Figure 3.52. View looking northwest from the top of Battery Mills. A tapered concrete box and metal pipe are located near the center top of the engineered earthwork. These structures are most likely associated with ventilation or served as flues for furnaces (Olmsted Center, January 2009).

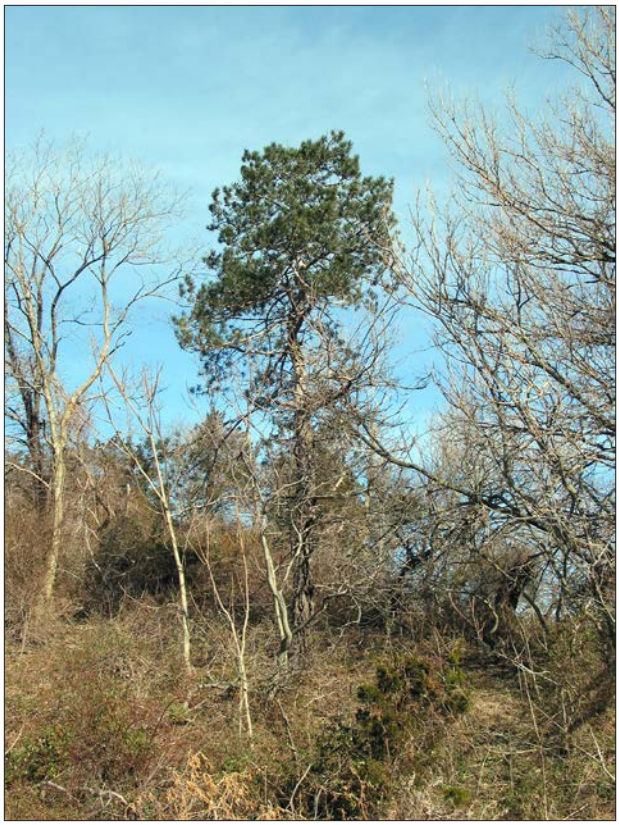
Figure 3.55. Scrub pine south of emplacement #1, Battery Mills. A few scrub pine (*Pinus virginiana*) were observed on the engineered earthwork that primarily contained mature eastern red cedar (*Juniperus virginiana*), hackberry (*Celtis occidentalis*), and ailanthus (*Ailanthus altissima*) (Olmsted Center, January 2009).

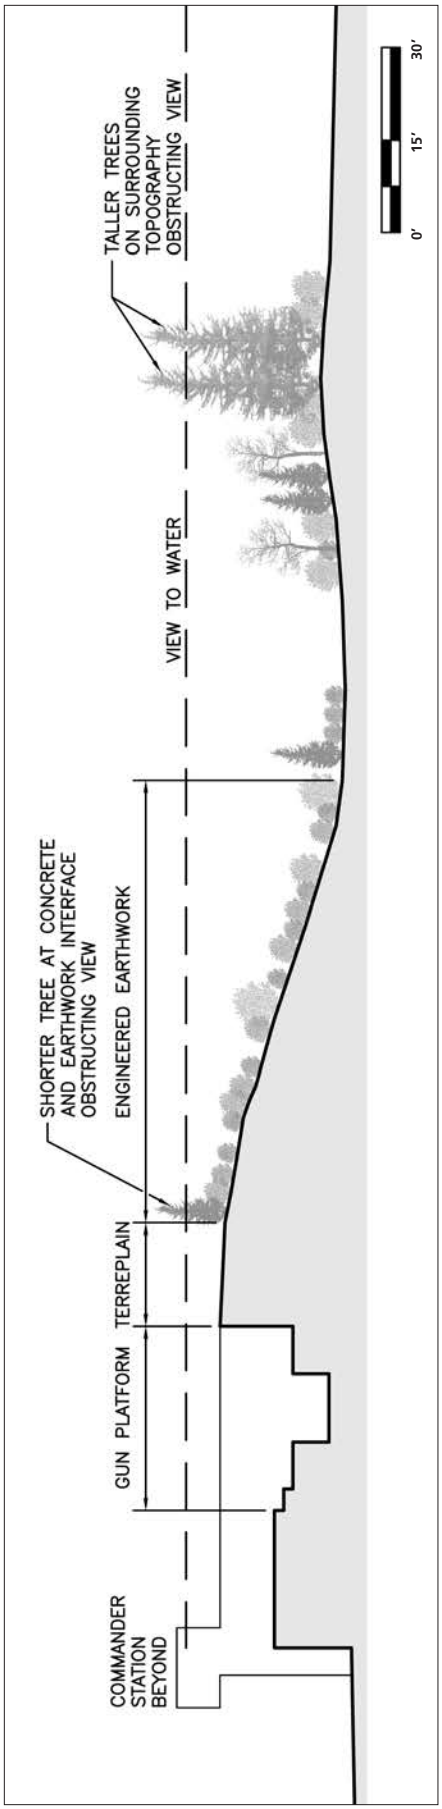
Figure 4.5. Conceptual section through a disappearing gun battery. The section is drawn through a gun emplacement for a concrete battery such as Battery Granger or Nine Gun Battery. Tactical views from the emplacements, battery commander's stations, and fire control stations to the water are primarily impeded by woody vegetation growing at the interface of the engineered earthwork and concrete battery structure (Olmsted Center, 2009).

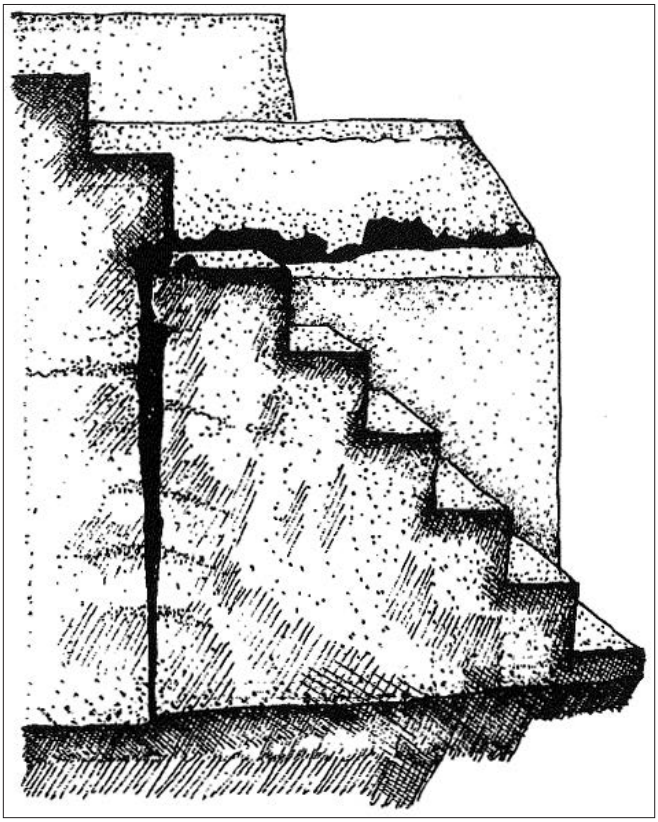
Figure 5.10. Concrete separation at unreinforced steps. Separation between individually cast concrete elements provides another opportunity for woody vegetation to emerge. The voids can also be exacerbated by growing woody material (Joe C. Freeman et al., *Seacoast Fortifications Preservation Manual, Golden Gate National Recreation Area, San Francisco, California*, United States Department of the Interior, National Park Service and KEA Environmental, July 1999, 148).

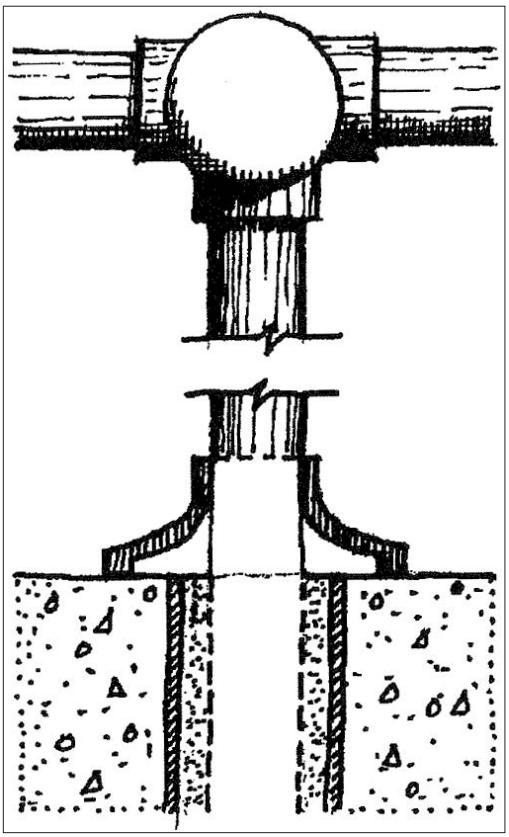
Figure 5.14. Cross-section, new railing installation. New guardrails and handrails should be attached by core drilling into the existing concrete and setting the rail in non-shrink epoxy grout. An escutcheon plate matching the historic plates should be fitted around the vertical member before the rail is set and lowered into position to cover the epoxy interface (Freeman et al., *Seacoast Fortifications Preservation Manual*, 160).

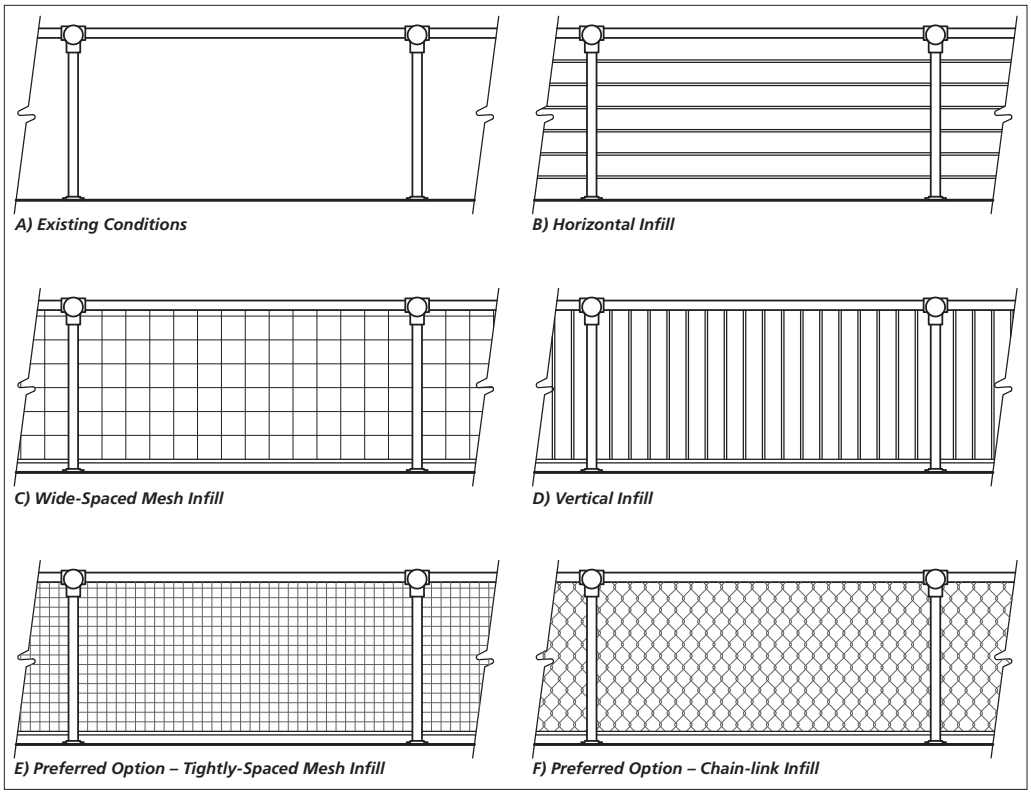
Figure 5.15. Safety railing infill elevations. Horizontal members and wide-spaced meshes (*options B and C*) create a ladder effect that potentially encourages climbing. Adding vertical members (*option D*) creates a balustrade appearance that detracts from the historic form of the simple pipe rail guards. The preferred option (*E or F*) for visitor safety and to retain the historic form is to add tightly-spaced mesh panels (Olmsted Center, 2009).

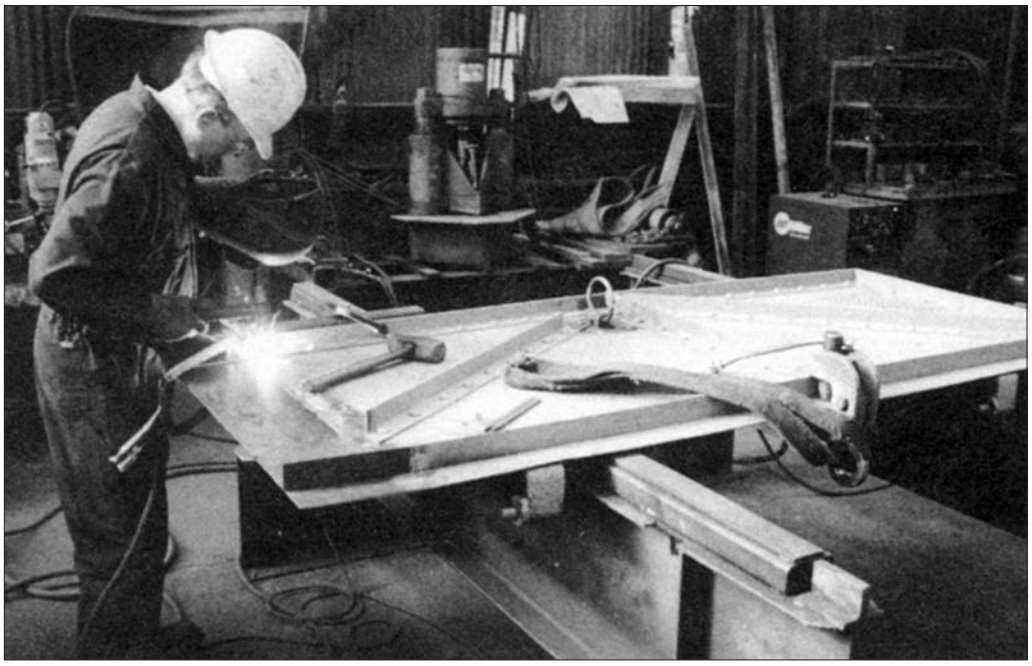
Figure 5.16. Off-site repair of historic metal door for Battery Worth, Fort Casey, Washington. Standing water resulted in the bottom portion of this door being severely deteriorated. The door was removed and is shown being repaired with a new steel plate and angles (From, David M. Hansen, Kimberly Keagle, and Deborah Rehn, *Historic Fortification Preservation Handbook*, Olympia, WA: Washington State Parks and Recreation Commission, 2003, 3.102).

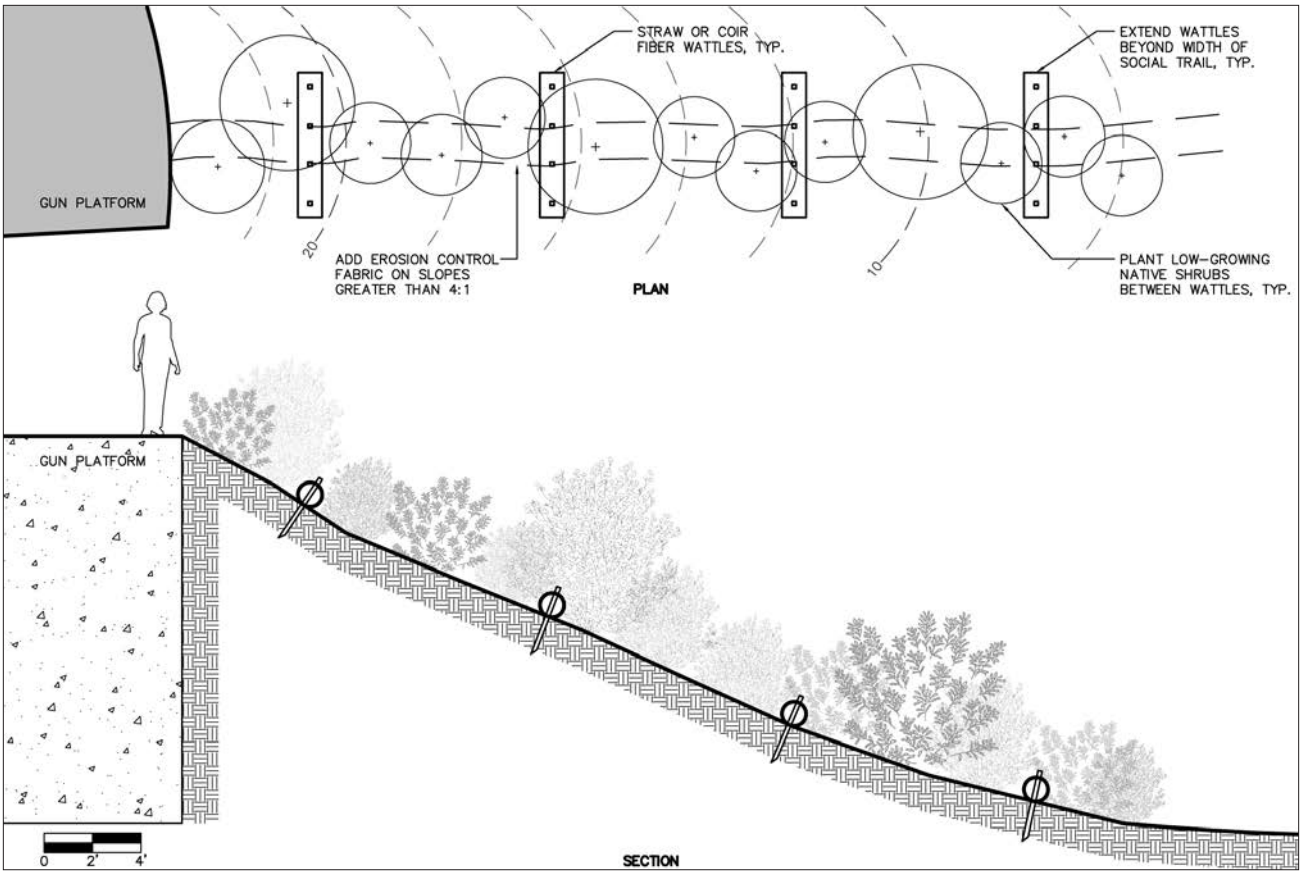
Figure 5.17. Typical revegetation detail to close an existing social trail. To manage erosion on closed social trails, straw or coir fiber wattles should be installed at approximately ten-foot intervals. Low-growing native shrubs should be planted between the wattles to discourage future use (Olmsted Center, 2009).

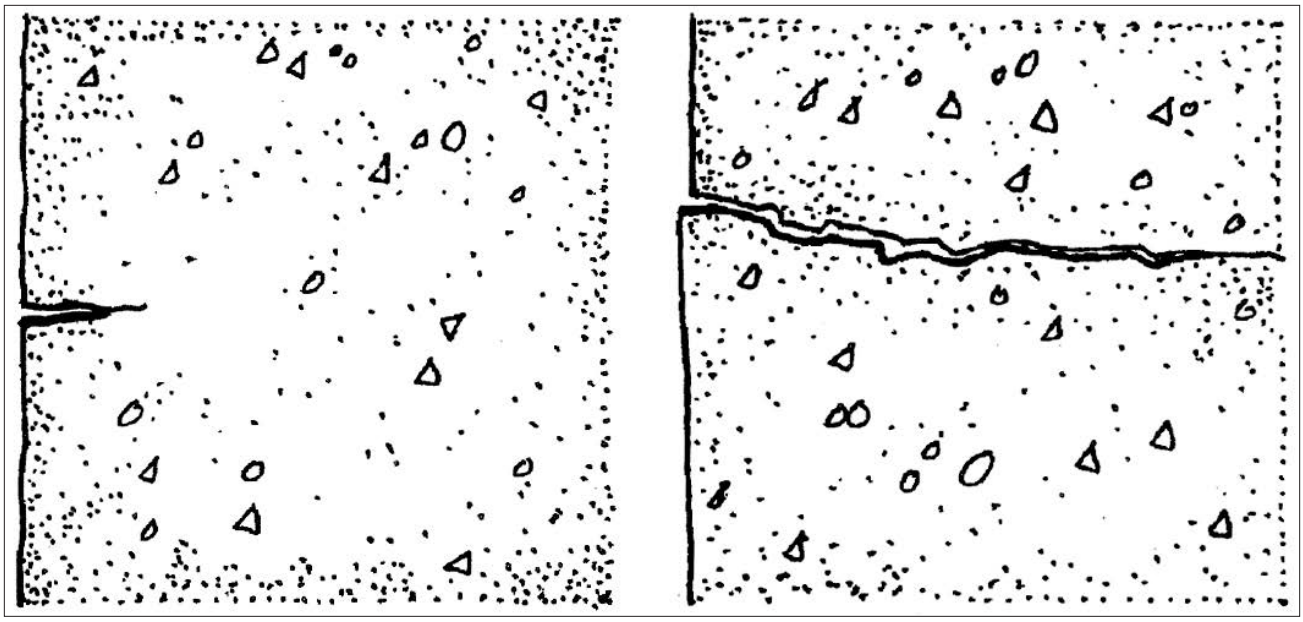
Figure 5.19. Typical concrete cracks. The image on the left illustrates a small, surface crack that can be repaired by grouting and sealing. The image on the right illustrates a large, structural crack that will require extensive repairs. Consultation with a structural engineer is recommended to determine a preferred method of repair (Freeman et al., *Seacoast Fortifications Preservation Manual*, 147).

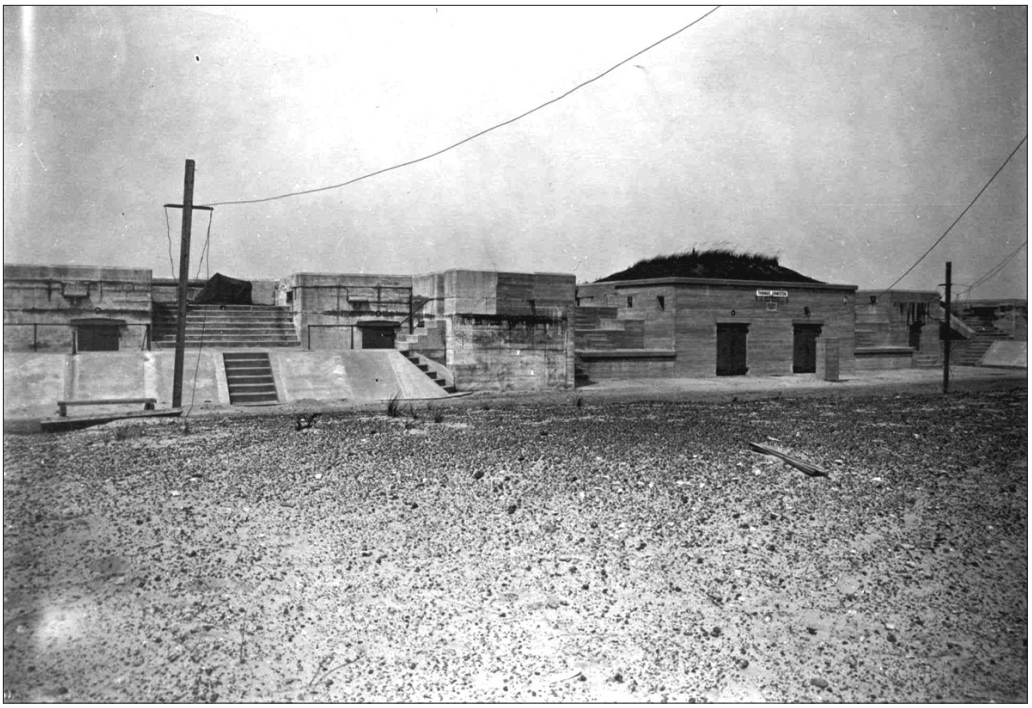
Figure 5.21. View looking northeast at Battery Urmston, circa 1900. In contrast to its appearance today, the south side of Battery Urmston contained no woody vegetation (GATE 7882).

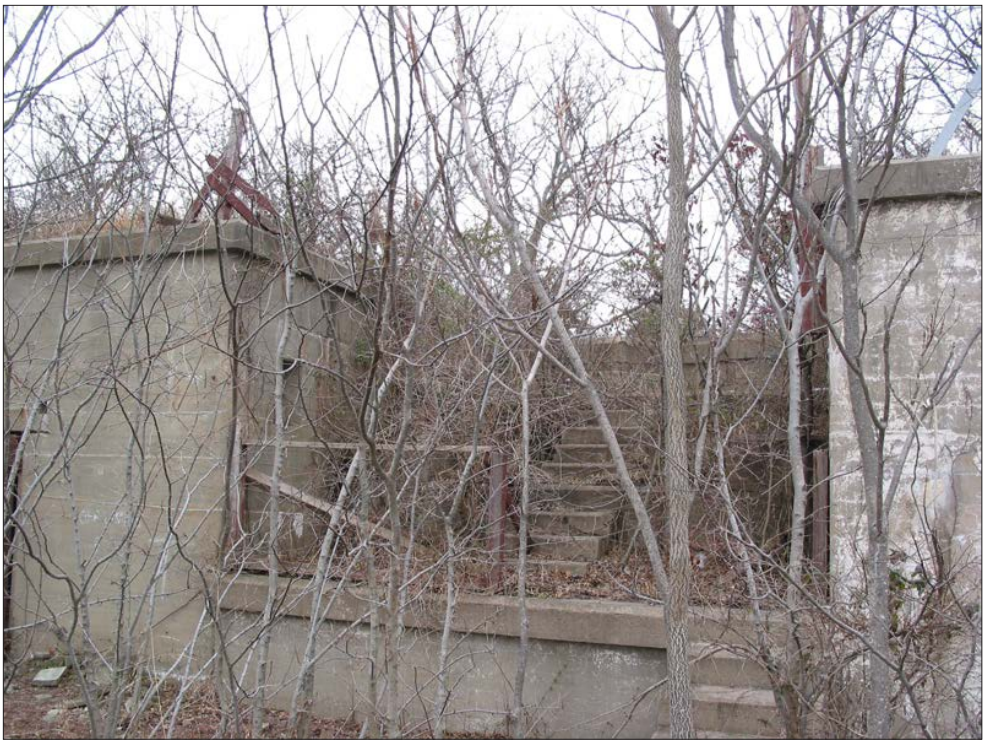
Figure 5.33. Wood guard panels at Battery Morris. The wood panels are not a historic feature and do not comply with safety codes due to the excessive space between the rails and cross brace. The wood guard panels should be removed and great care should be exercised not to damage the historic concrete structures removing fasteners that secured the wood to the concrete (Olmsted Center, January 2009).

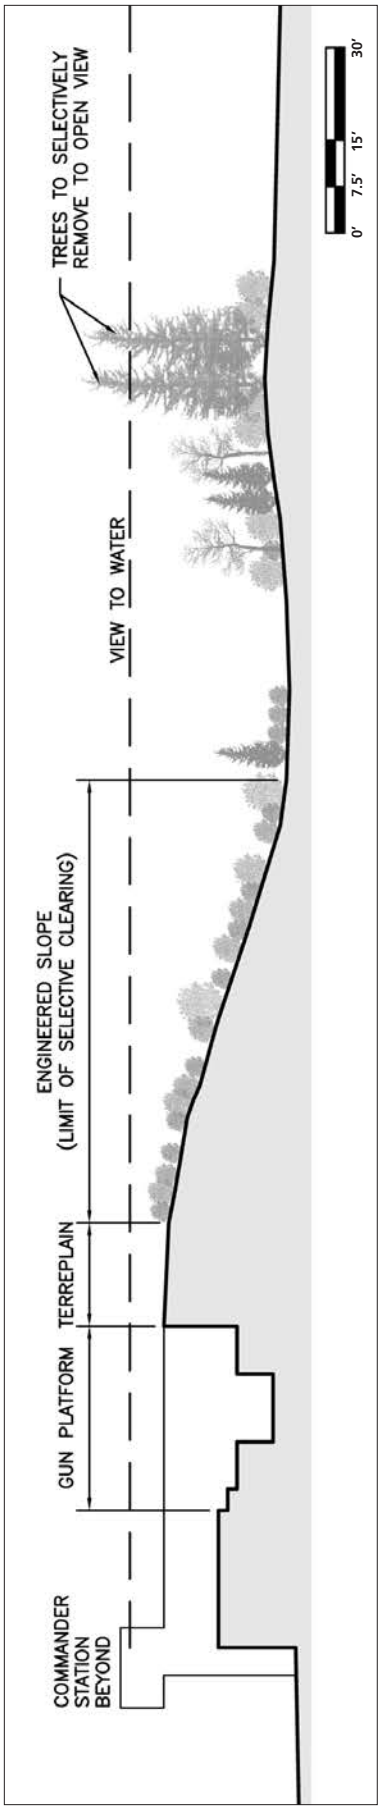
Unobstructed views were necessary from the artillery and battery commander's stations at Nine Gun Battery in order to have a clear field of fire and to locate and acquire the range of potential targets (Figure 5.45). After removing woody vegetation growing on the engineered earthwork and from the battery structure itself, the resulting downrange views to the water must be evaluated. In some instances tall, individual woody vegetation that blocks the view shed should be identified and removed. Further information on managing vegetation for downrange views can be found in the treatment tasks common to all battery sites.

Figure 5.45. Conceptual section through Nine Gun Battery. After vegetation is selectively removed from concrete structures and from engineered slopes, the historic downrange views from the battery commander's station should be evaluated. The batteries could not defend New York Harbor if they did not have an unobstructed view to the water. Restoring the view and visual connection to the water is important in communicating the history and mission of these defenses to the public (Olmsted Center, 2009).

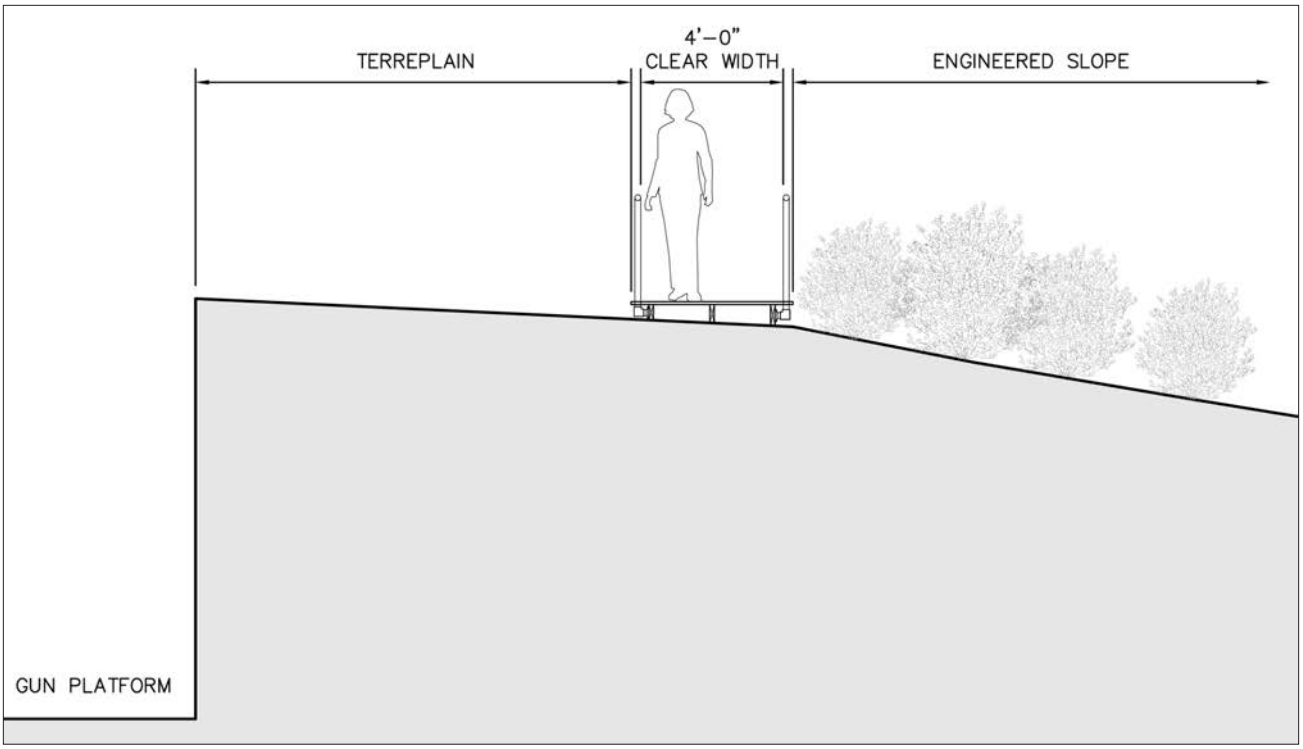
Figure 5.50. Conceptual section through Nine Gun Battery and boardwalk. In order to provide greater visitor safety and protect the historic earthwork, a boardwalk should be installed for visitor access across the terreplein (Olmsted Center, 2009).

In order to provide greater visitor safety and protect the historic earthwork, a boardwalk should be installed with simple pipe rail guards. The guards will indicate to visitors not to deviate from the boardwalk route and will be compatible with historic pipe railings currently in place (Figures 5.50 and 5.51).

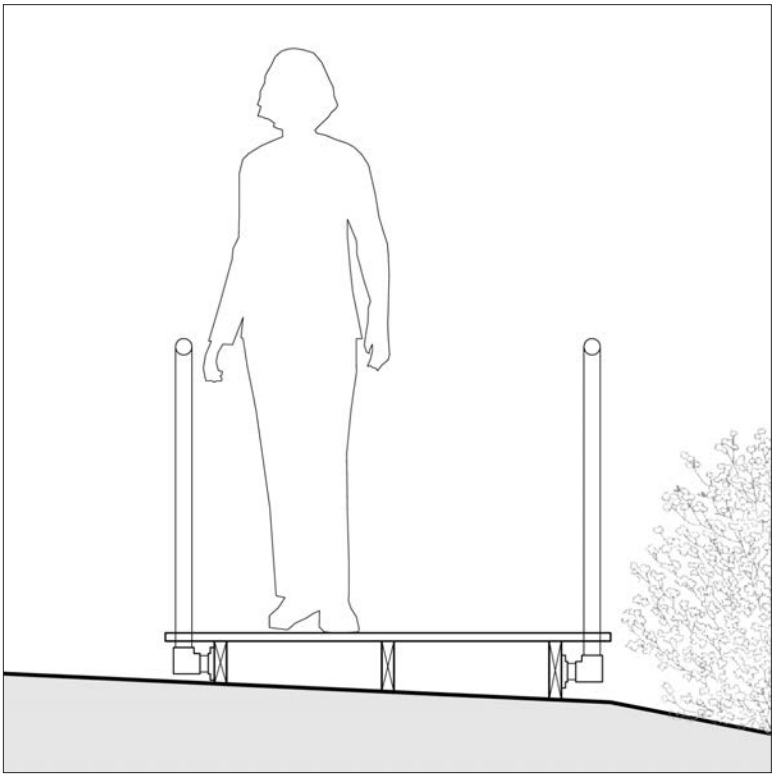
Figure 5.51. Detail section of decking and handrails, Nine Gun Battery. The handrails will indicate to visitors not to deviate from the boardwalk route and will be compatible with the historic pipe railings currently in place (Olmsted Center, 2009).

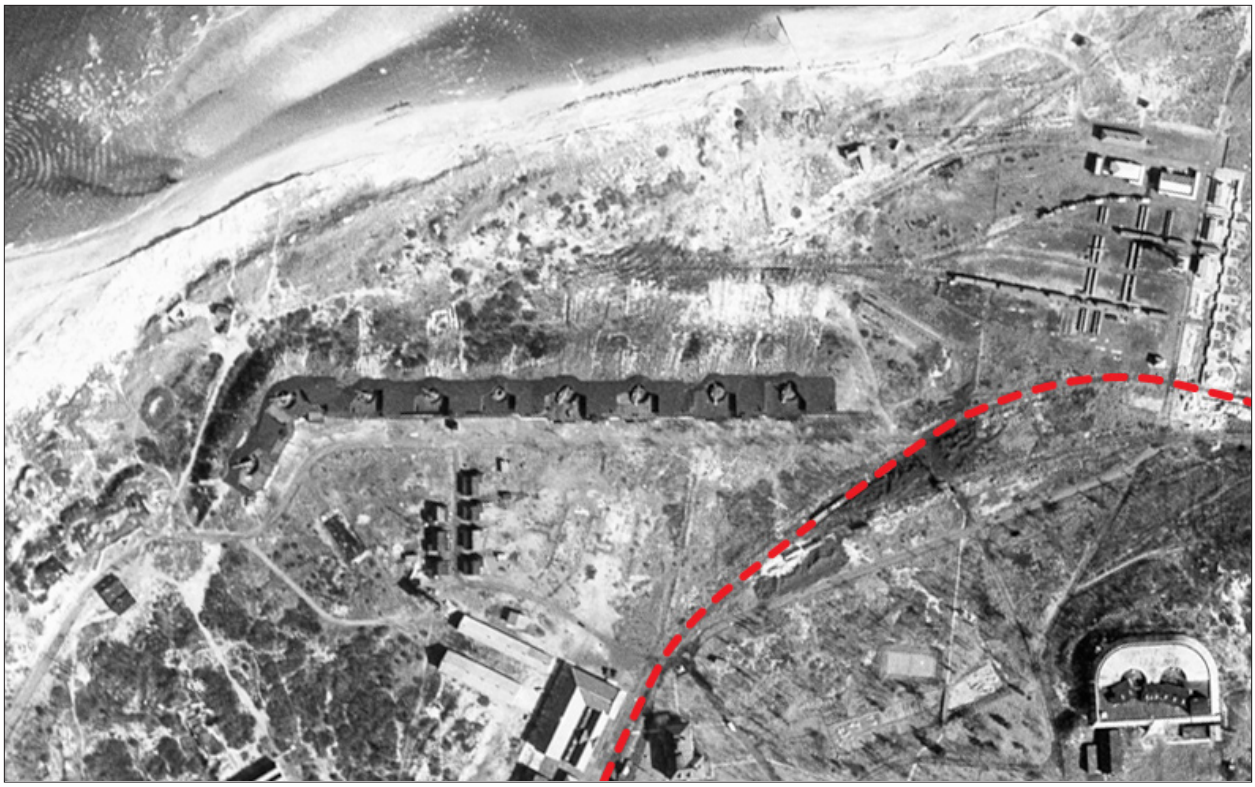
Figure 5.52. Aerial photograph of Nine Gun Battery, January 1933. The red dashed line has been added to highlight the rail line from the docks to the proving ground. Two rail cars can be seen in the image. A section of track near Nine Gun should be restored and a flatcar located there to interpret the handling of heavy ordnance and munitions (Coastal and Hydraulics Laboratory, Engineer Research and Development Center).

Figure 5.53. View of extant railroad track, Nine Gun Battery. From this location, the tracks should be extended roughly eighty-feet east to meet parking lot J and west into the field for a sufficient length to locate a flatcar for interpretive purposes (Olmsted Center, January 2009).

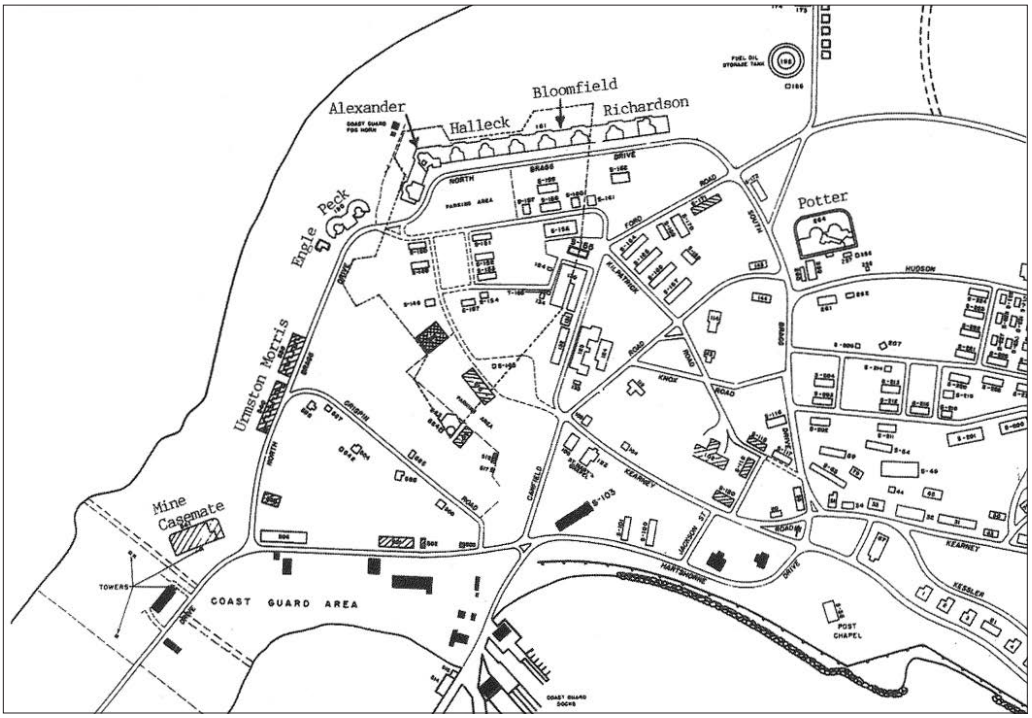
Figure 5.54. Construction of Nine Gun Battery, 1897. The concrete battery structure was built over a Civil War-era granite block fort. The fort's bastions can be seen in the image as the forming of the battery occurs over the fort's eastern wall (GATE 7880).

Figure 5.55. Site plan of Fort Hancock, 1967. This plan shows the location of the mid-19th century granite fortress (*dashed outline*) in relation to Nine Gun Battery. A portion of the northeast curtain wall and bastion is visible above the ground surface, though greatly obscured by vegetation (Thomas Hoffman, *Fort Hancock*, Charleston, SC: Arcadia Publishing, 2007).

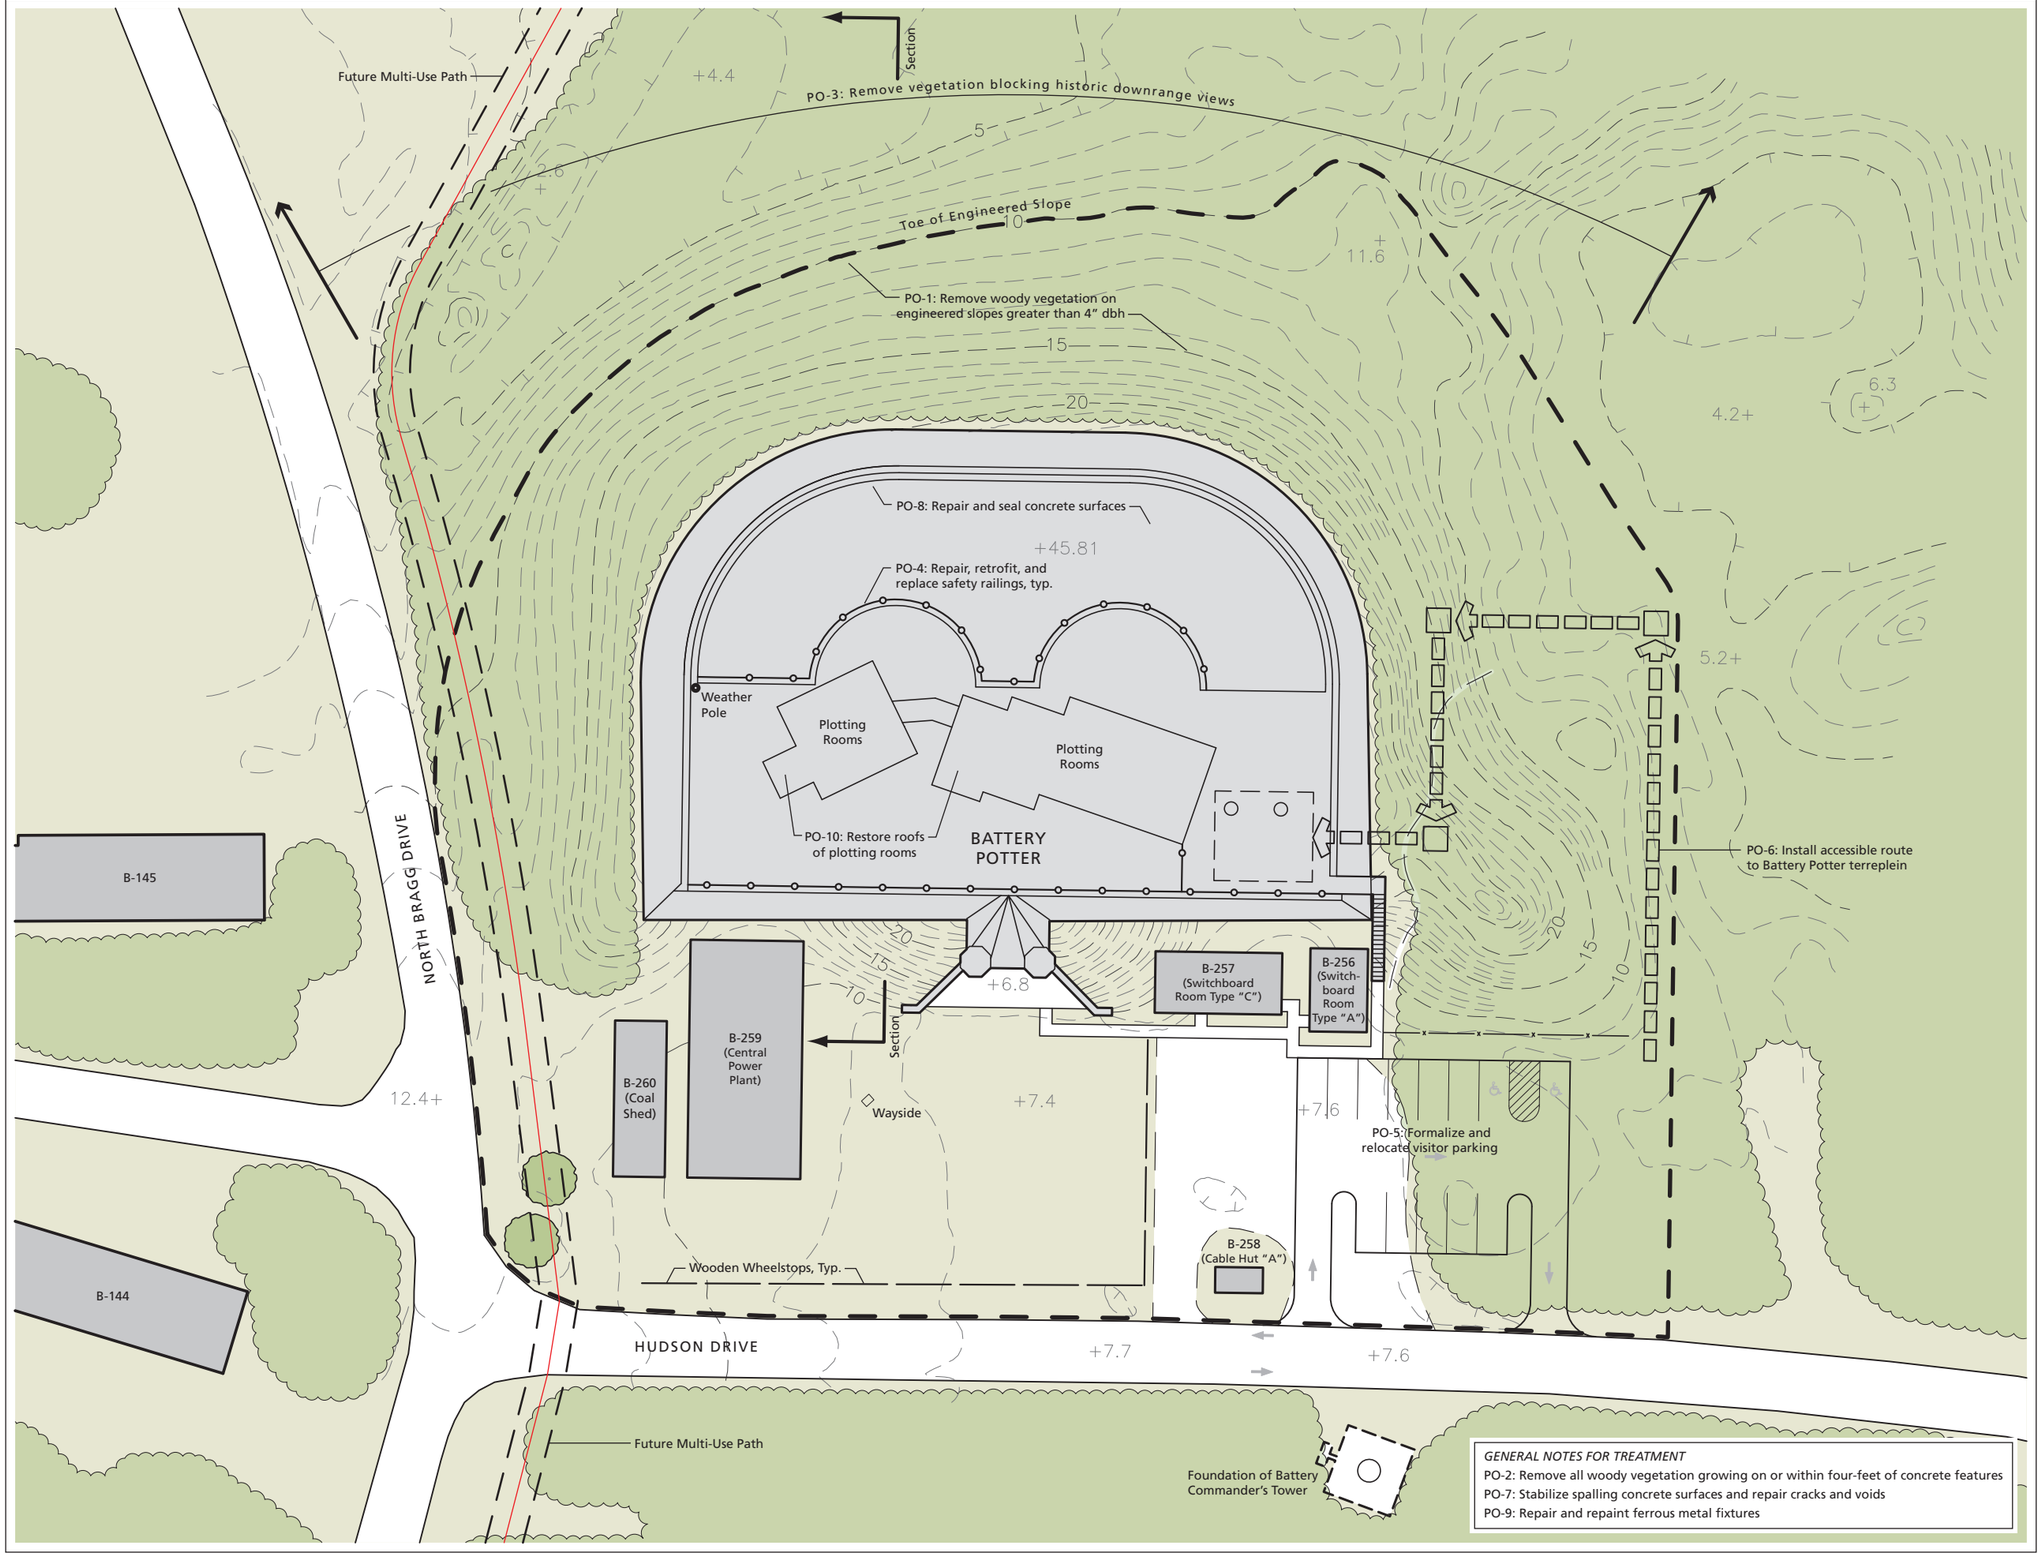
At Battery Potter, metal guardrails are installed between the superior slope and the terreplein where the guns were emplaced and along open sides of elevated areas (Figure 5.61). Metal railings in fair condition with visible rust should be chemically treated, primed, and painted to match the historic finish. Damaged or severely deteriorated railings should be removed and replaced with new components that match the original as close as possible. Additional information on metal treatments and adding infill or applied materials to comply with life safety codes can be found in the treatment tasks common to all battery sites.

Figure 5.61. Recently installed contemporary safety railing, Battery Potter. Woven-wire may be either installed as infill panel, or the mesh applied with clamps to satisfy life-safety codes (Olmsted Center, January 2009).

Figure 5.62. Plotting rooms, Battery Potter. In improving physical access to the upper level of Battery Potter for use as an elevated prospect, rehabilitating the deteriorated plotting rooms shown here may be of some value for interpretive purposes. Once the roofs of these buildings are replaced, the interiors may be used to house durable exhibitry. Enamelled interpretive wayside panels may effectively substitute for missing window frames, offering detailed graphic interpretation of Battery Potter and the entire coastal defense system (Olmsted Center, January 2009).
