Cultural Landscape Report for the Sandy Hook Coastal Defense Batteries

Gateway National Recreation Area

EXISTING CONDITIONS

Olmsted Center for Landscape Preservation
National Park Service, Boston, Massachusetts, 2010

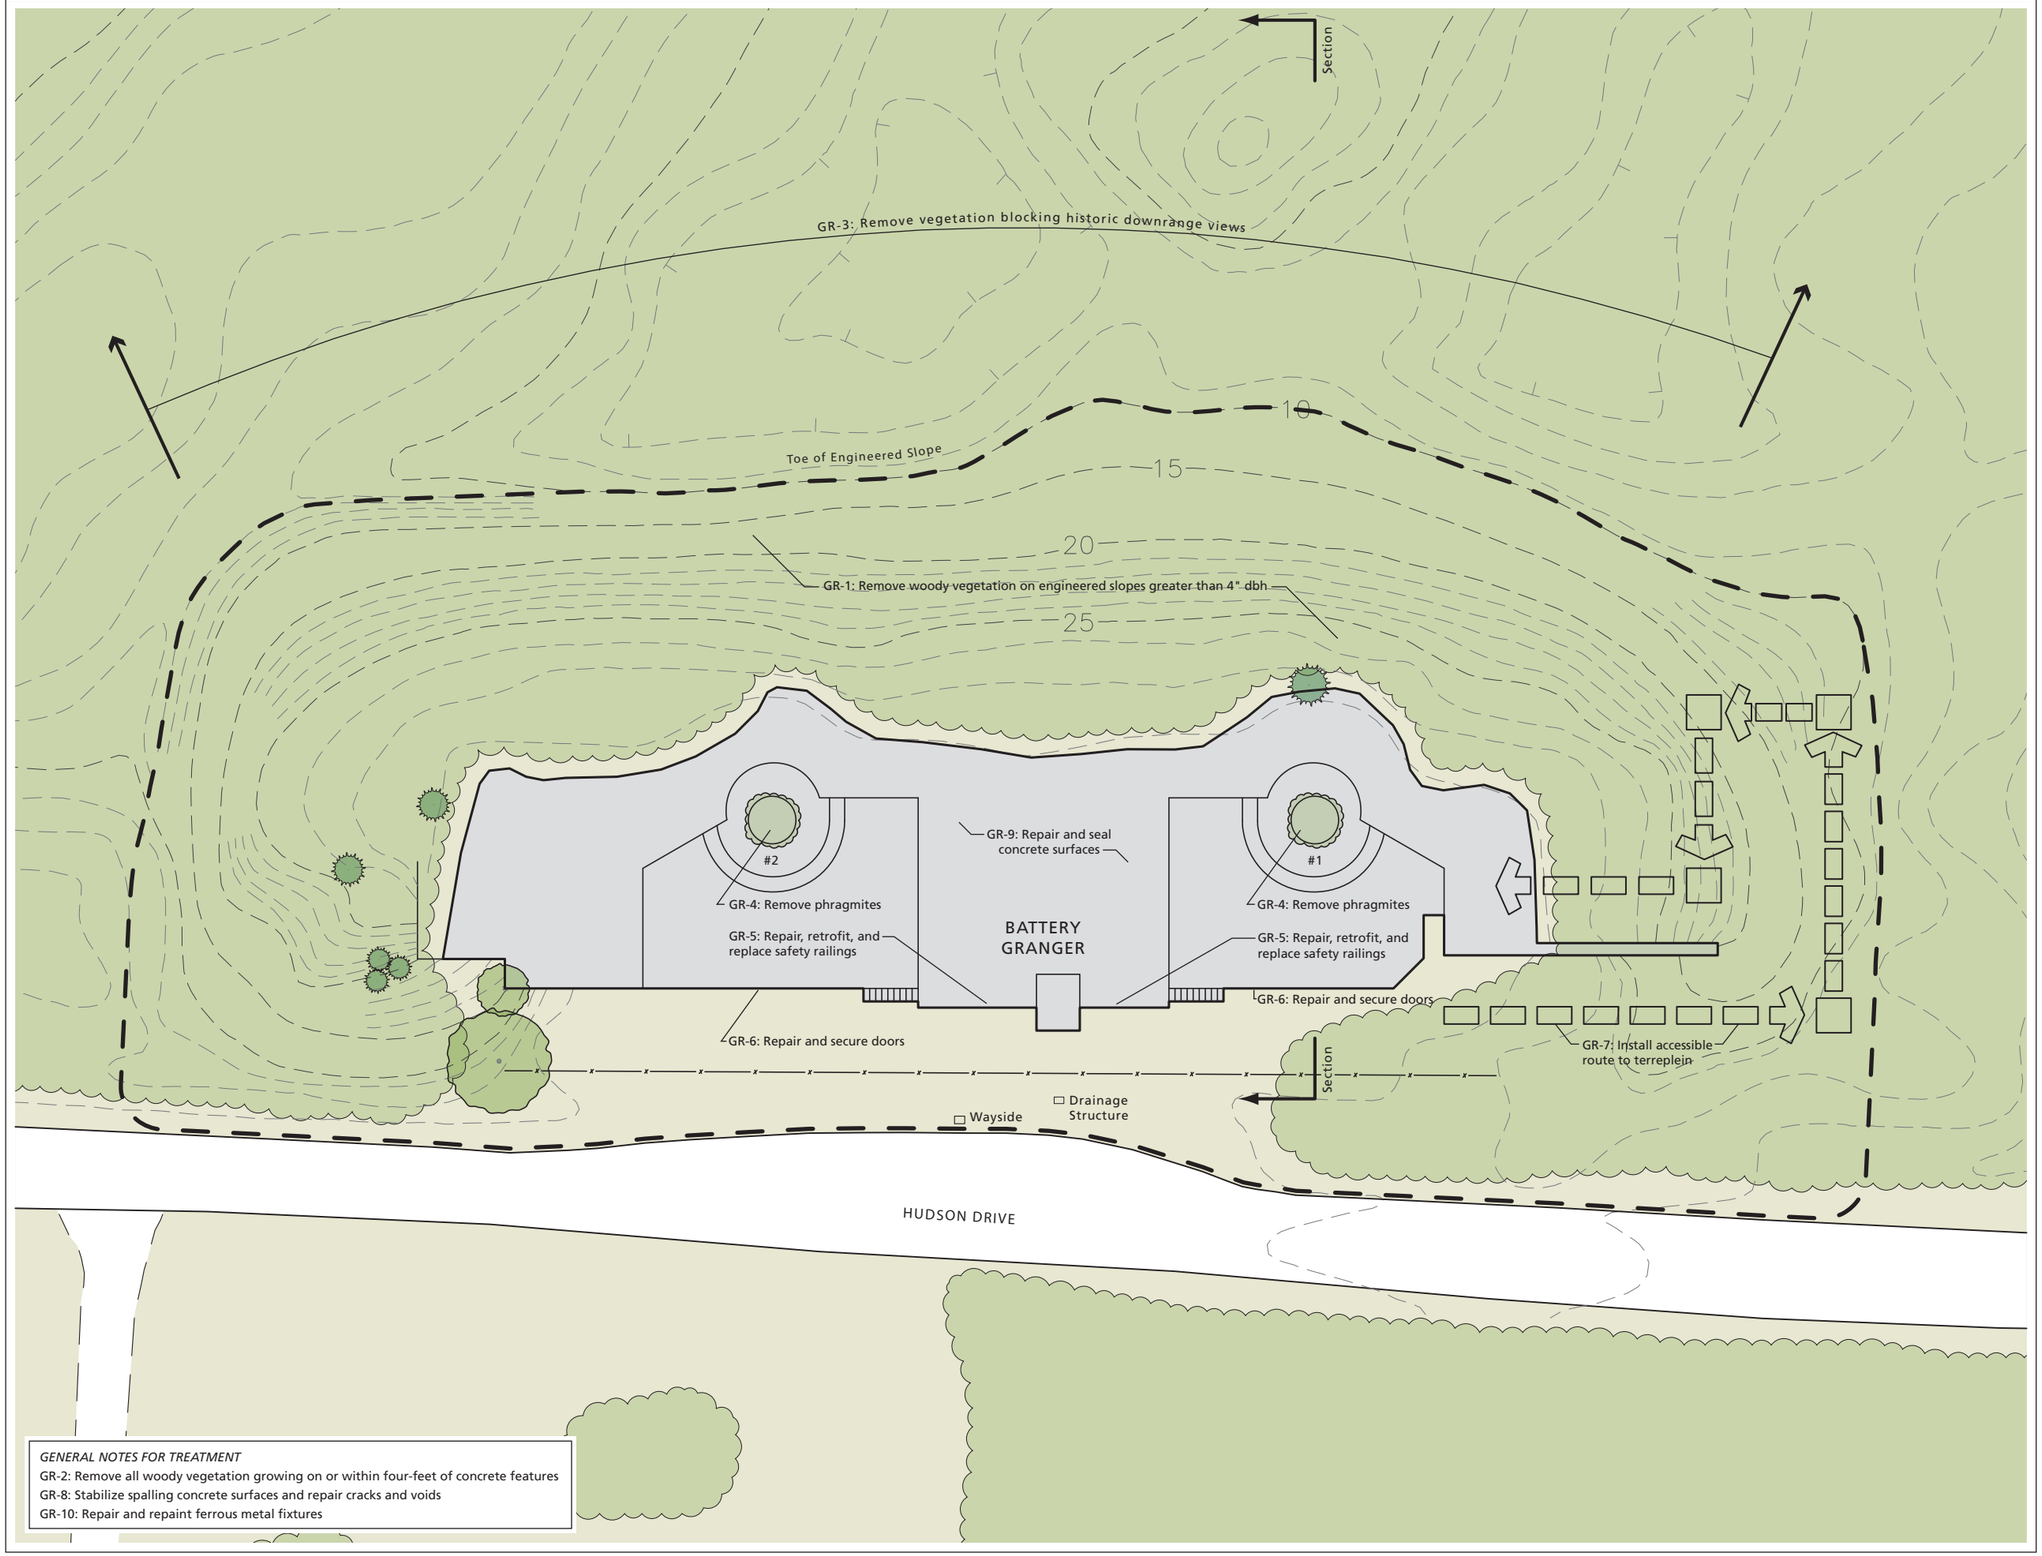
At Battery Granger, metal guardrails are installed near the open sides of the gun platforms (Figure 5.69). Metal railings in fair condition with visible rust should be chemically treated, primed, and painted to match the historic finish. Damaged or severely deteriorated railings should be removed and replaced with new components that match the original as close as possible. Additional information on metal treatments and adding infill or applied materials to comply with life safety codes can be found in the treatment tasks common to all battery sites.

Figure 5.69. Existing safety railings, Battery Granger. At this location and elsewhere throughout Sandy Hook's coastal defense sites, one can see the tangible history of maintenance and repair. This simple railing may be retrofitted with either infill mesh panels or otherwise with woven wire mesh applied with clamps and hardware to satisfy life-safety codes (Olmsted Center, January 2009).

Figure 5.70. Close-up view of existing concrete terreplein, Battery Granger. Existing conditions indicate that joints between concrete panels were once sealed with bituminous material. With the passage of time, this sealant material requires maintenance (Olmsted Center, January 2009).

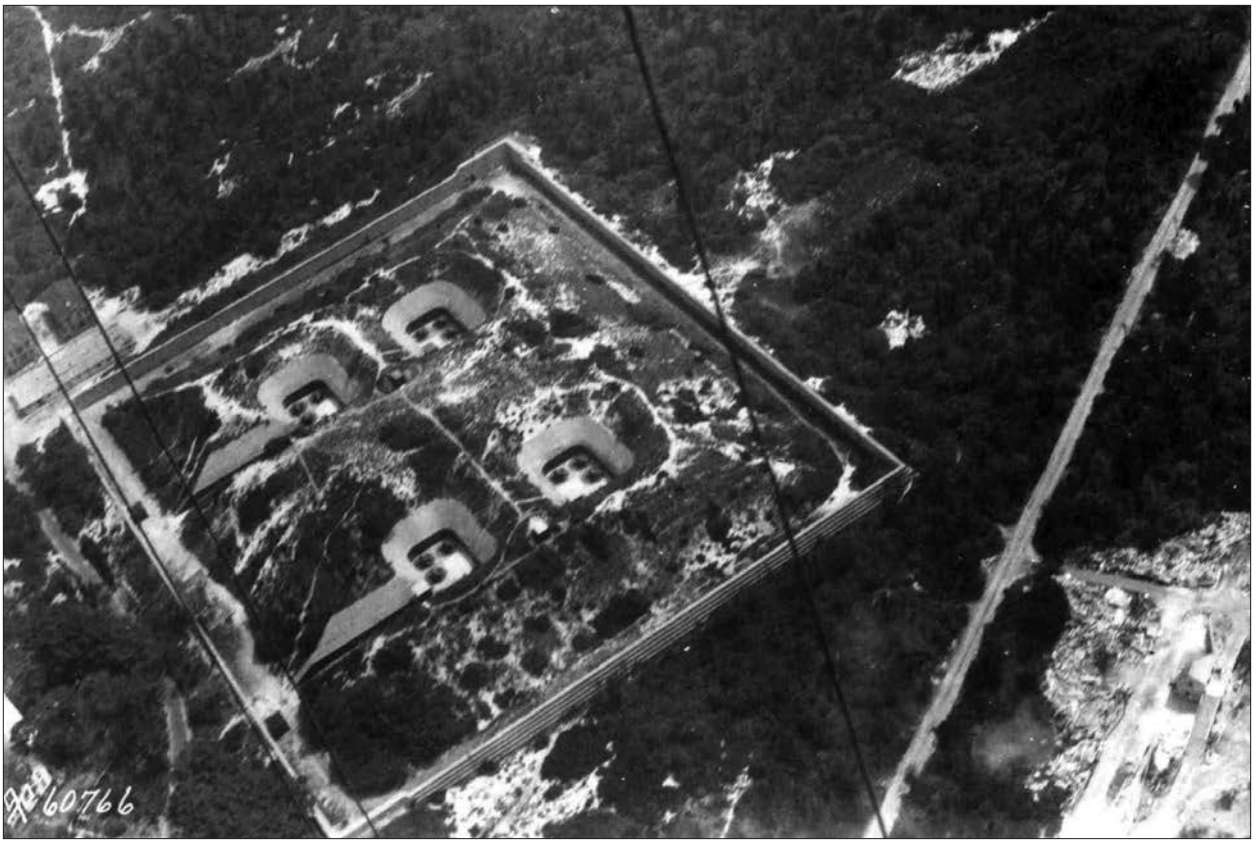
Figure 5.71. Oblique aerial photograph of the Mortar Battery, circa 1917, taken from an Army Signal Corps balloon. Note the low, scrub vegetation growing on the Mortar Battery's engineered landform (GATE 7870).

Figure 5.72. View looking northwest above mortar pit, the Mortar Battery. Woody vegetation greater than four-inches diameter should be removed from engineered slopes, and all woody trees and shrubs must not be allowed to grow upon, or within four-feet of a concrete structure or feature (Olmsted Center, January 2009).

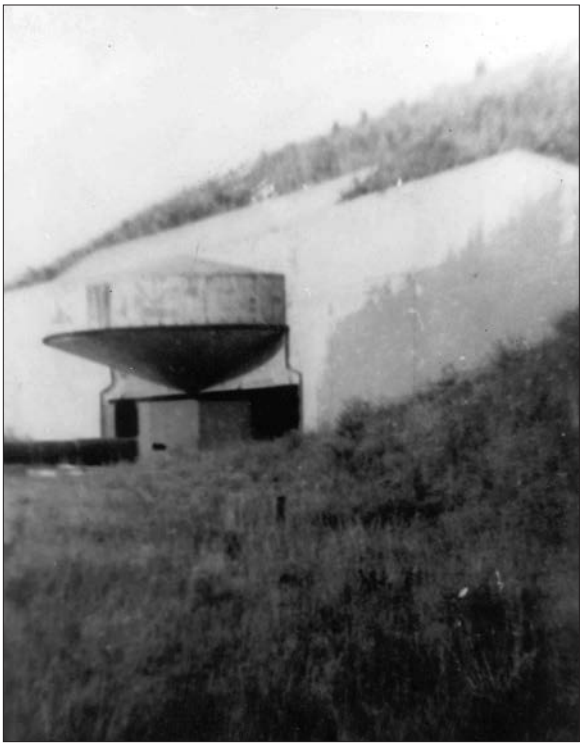
Figure 5.80. View looking southwest at gun emplacement, Battery Kingman, circa 1940s. During World War II, the vegetation immediately in front of and directly above the casemate was maintained at a low height (GATE 8084).

Figure 5.81. View looking northeast at the Battery Kingman engineered landform. This photograph shows the size and quantity of woody vegetation growing on Battery Kingman's engineered slope. All woody vegetation greater than four-inches diameter at breast height should be selectively removed to preserve the historic structure and its sheltering earthwork (Olmsted Center, January 2009).

Figure 5.82. View looking south atop of the engineered slope, Battery Kingman. Here, a large tree is seen growing near an exposed concrete feature seen at the left foreground. Woody vegetation should not be permitted to grow on, or within four-feet of concrete battery structures and features (Olmsted Center, January 2009).

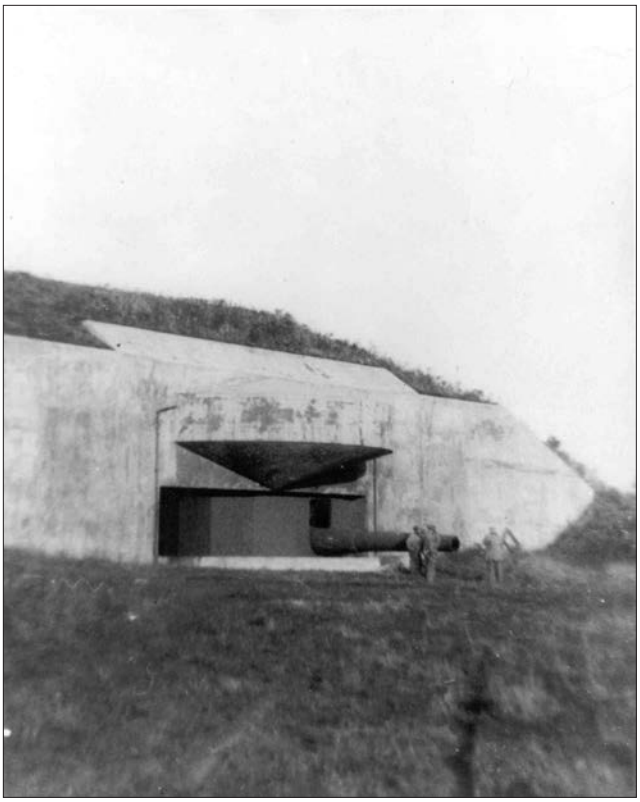
Figure 5.83. North gun emplacement, Battery Kingman, circa 1940s. This photograph shows the vegetation immediately around the gun emplacement and on the earthen casemate above was a low growing turf mixture ensuring the field of fire would not be obstructed (GATE 8085).

Figure 5.84. View looking northwest at the south gun emplacement, Battery Kingman. Vegetation removal to restore the historic field of fire should focus on the slopes against the battery's concrete facades as the level area in front of the guns is relatively free of tree and shrub vegetation (Olmsted Center, January 2009).

Figure 5.85. View looking southwest at north gun emplacement, Battery Kingman. Although visitors are warned of the hazards of accessing the summit of these batteries, existing chain-link fencing located above the concrete casemate canopies should be maintained for added safety at both Battery Kingman and Battery Mills (Olmsted Center, January 2009).

Figure 5.86. Concrete pipe on north slope of Battery Kingman. The concrete pipe should be capped to prevent possible injury and reduce water entering into or around the underground structures (Olmsted Center, January 2009).

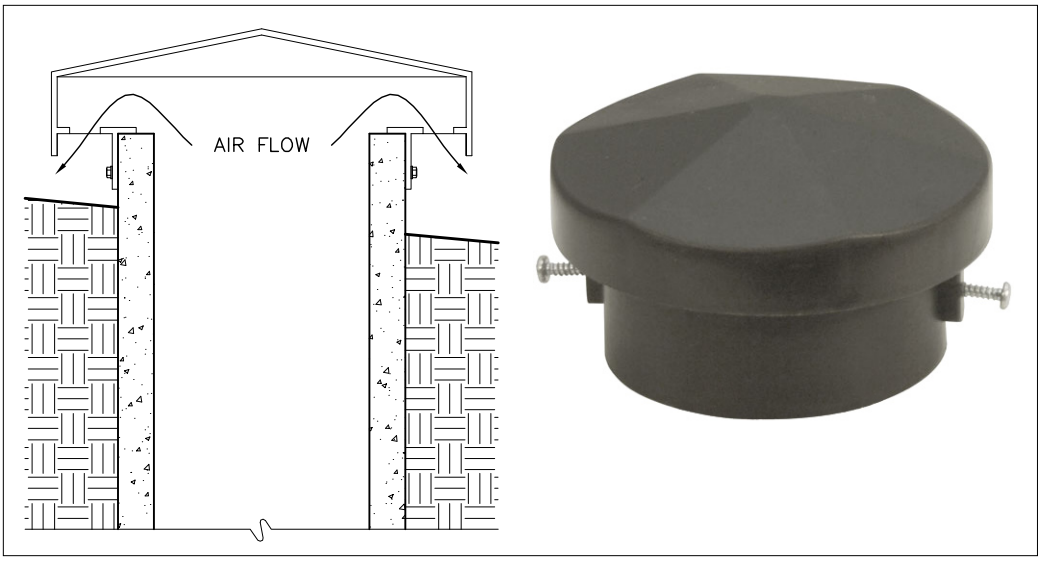
Figure 5.87. Installation of cap over concrete pipe and ABS plastic ventilation cap. The top of the cap should be pitched to prevent water and ice from building up. It should also be vented to allow air flow (Olmsted Center and http://www.toolstation.com/images/library/stock/webbig/22205.jpg).

Figure 5.88. Animal burrow on north slope of Battery Kingman. The preferred management recommendation for burrowing animals is to humanely trap the animal and relocate it to an area away from the historic earthwork. The burrow should be filled with soil from a sterile source that does not have the potential to damage archaeological information (Olmsted Center, January 2009).

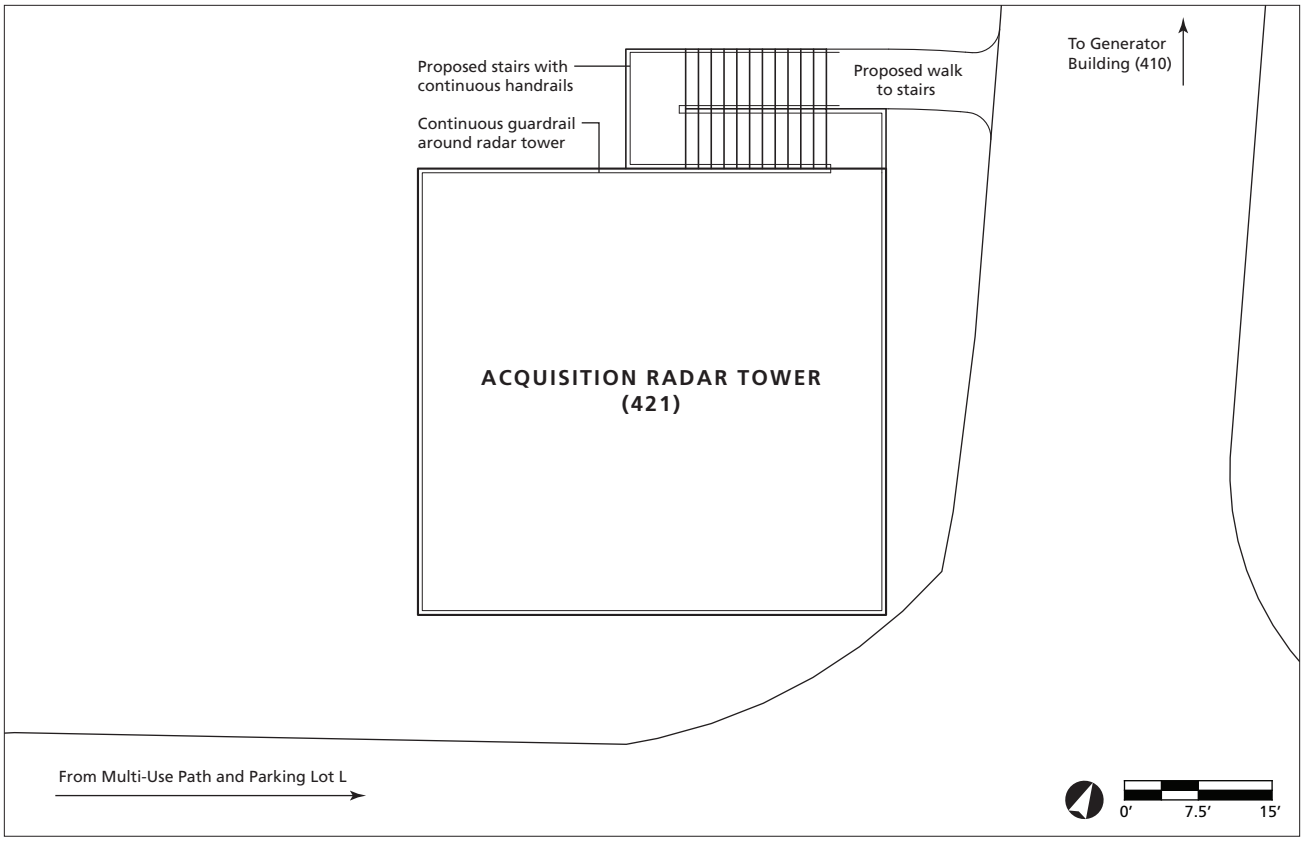
To provide a higher level of protection, expanded metal mesh should cover the existing guardrail openings. On other radar platforms, expanded metal mesh is present at the lower level of the guardrail (Figure 5.107). The metal gauge and mesh spacing should match the existing sample. The new infill material should cover lower and upper guardrail openings and be attached to the inside of the rails with non-corrosive hardware. The clamps would permit easy replacement or removal and minimize damage to the guardrails.

Figure 5.106. Plan of proposed access stairs to acquisition radar tower (Building 421), NIKE radar site. The proposed stairs should be located on the north side of the platform where they will be less conspicuous for visitors viewing the site from the parking lot and multi-use path to the west (Olmsted Center, 2009).

Figure 5.107. Existing expanded metal mesh on guardrails at radar tower, NIKE radar site. New expanded metal mesh should match the existing in this photograph and be applied to the lower and upper openings of the existing guardrails for added safety (Olmsted Center, January 2009).

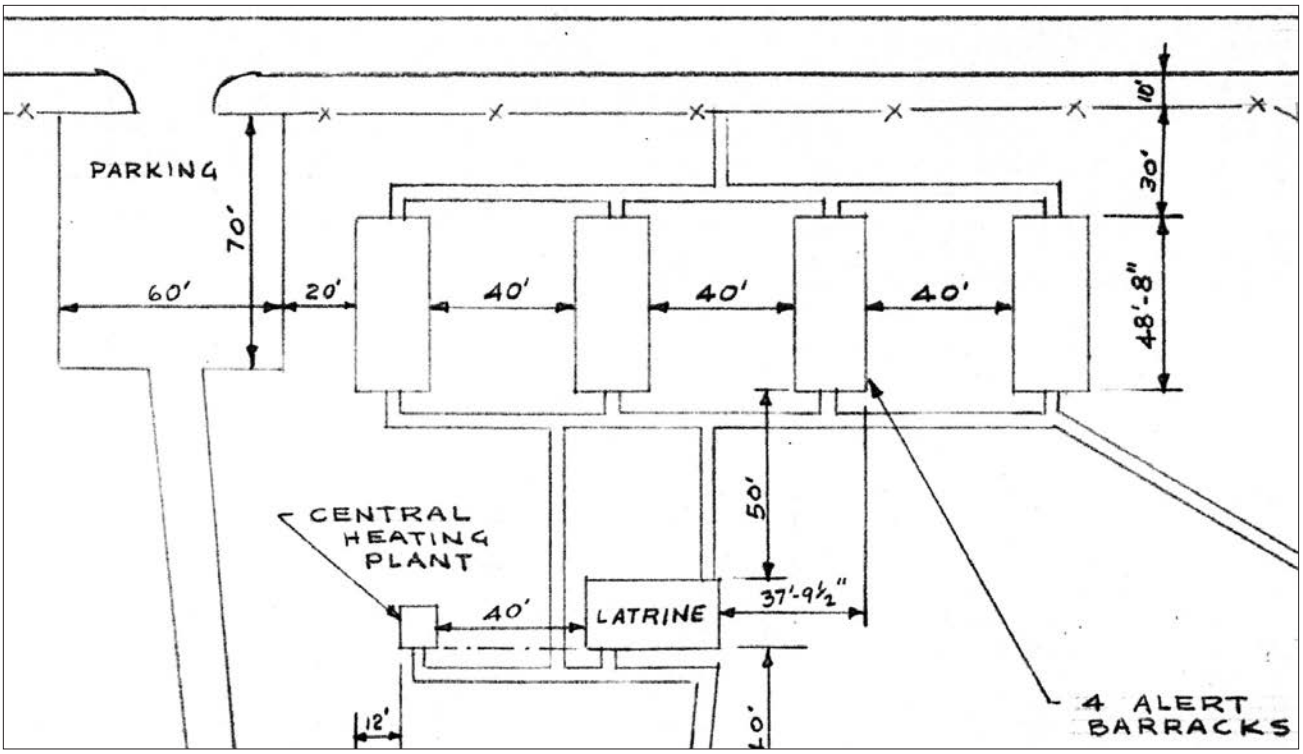
Figure 5.108. Plan of the Ready Barracks, NIKE radar site, 1962. The plan shows a parking lot layout west of the barracks that currently holds a stockpile of yellow brick for Fort Hancock buildings. The brick should be stacked on to palettes and moved to the maintenance yard at Fort Hancock (GATE 11057).

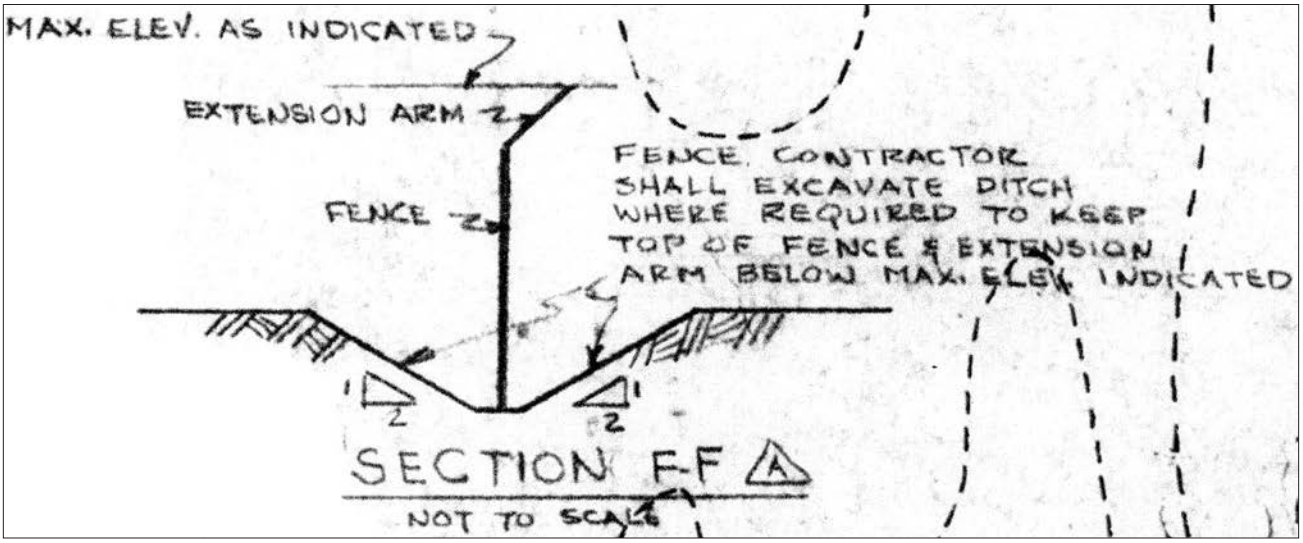
A site plan from 1954 indicates the perimeter fence was type FE-6—a designation for chain-link with barbed wire on a single extension arm. The plan further illustrates that the fence was installed at roughly ten-feet in height with minor variations to account for existing grades and to maintain unobstructed lines of sight. The contractor was to excavate either side of the fence at a 2:1 slope in order to maintain the specified height (Figure 5.109). When replacing sections of the deteriorated fencing system, new line posts should match the existing H-beam posts. The wire gauge and mesh opening should match the existing chain-link and all material and hardware should be galvanized.

Two sidewalks provided pedestrian access from the Ready Barracks to Control Area #1 and #2. Along these walks simple light fixtures—comprised of a tubular pole and metal reflector—were installed. The majority of light fixtures are in good to fair condition and should be periodically assessed (Figure 5.110).

Figure 5.109. Section of the perimeter fence, NIKE radar site, 1954. The perimeter fence was called out as type FE-6—a designation for chain-link with barbed wire on a single extension arm. The contractor was to excavate either side of the fence at a 2:1 slope in order to maintain the specified height (GATE 11052).

Figure 5.110. Existing light fixture, NIKE radar site. The historic light fixtures should be periodically inspected, have components repaired or replaced as needed, and receive corrosion treatment, priming, and painting to match the historic finish. The eastern red cedar in the foreground should be removed as part of vegetation management along the circulation systems (Olmsted Center, January 2009).

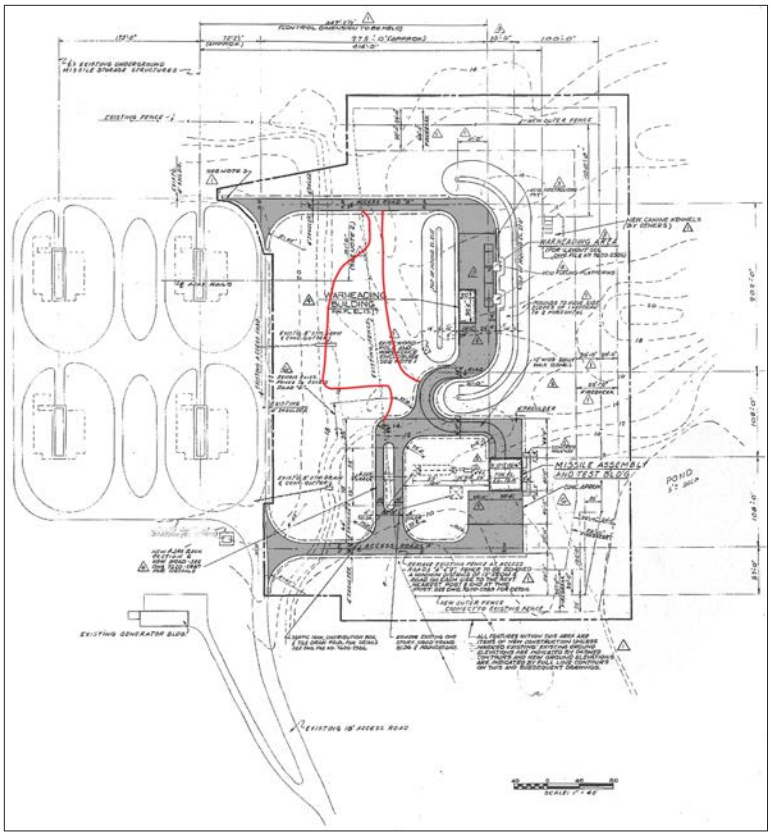
When the NIKE launch site was operational prior to 1974, there was no circulation route between the northern end of the Missile Maintenance Area and the southern perimeter of the missile magazines (Figure 5.118). During the past decade, a New Jersey state beach cleaning program has established a convenient

Figure 5.118. Site plan for Missile Maintenance Area, 1958. The gray tone has been added to show vehicular circulation. The current location for beach cleaning equipment (*red outline*) should be relocated to restore an area that was never intended for vehicular use (GATE 7620-2983 and Olmsted Center).

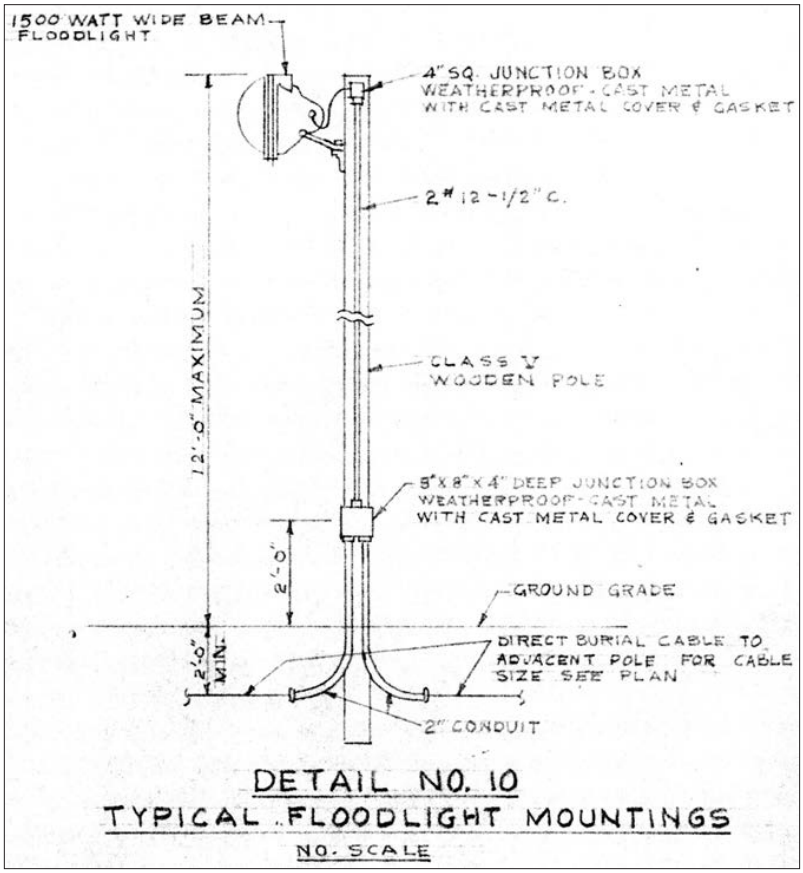
Floodlight and spotlight fixtures at the NIKE launch site are character-defining features of this Cold War defense installation. Each floodlight fixture is comprised of a twenty-four inch diameter light housing attached to a metal bracket and mounted to a pole (Figure 5.123). At the Missile Magazines, the lights are mounted on wood poles and at the Missile Maintenance Area they are mounted on metal poles. Within the Missile Magazine area, four spotlights were erected by the end of the historic period. From ground level, the first eight to ten feet of the poles were painted yellow and a red letter was added to the yellow field to denote the magazine section. Spotlights were mounted at the top of each pole. Three of the poles were removed following transfer to the National Park Service and presently, only the pole and lights at the Section B magazine (427) are extant.

Figure 5.123. Elevation of floodlight, NIKE launch site, 1958. The poles, mounting hardware, light fixtures, and glass lenses should be routinely inspected. Any deficiencies should be corrected and damage components should be replaced to match the existing (GATE 11056).

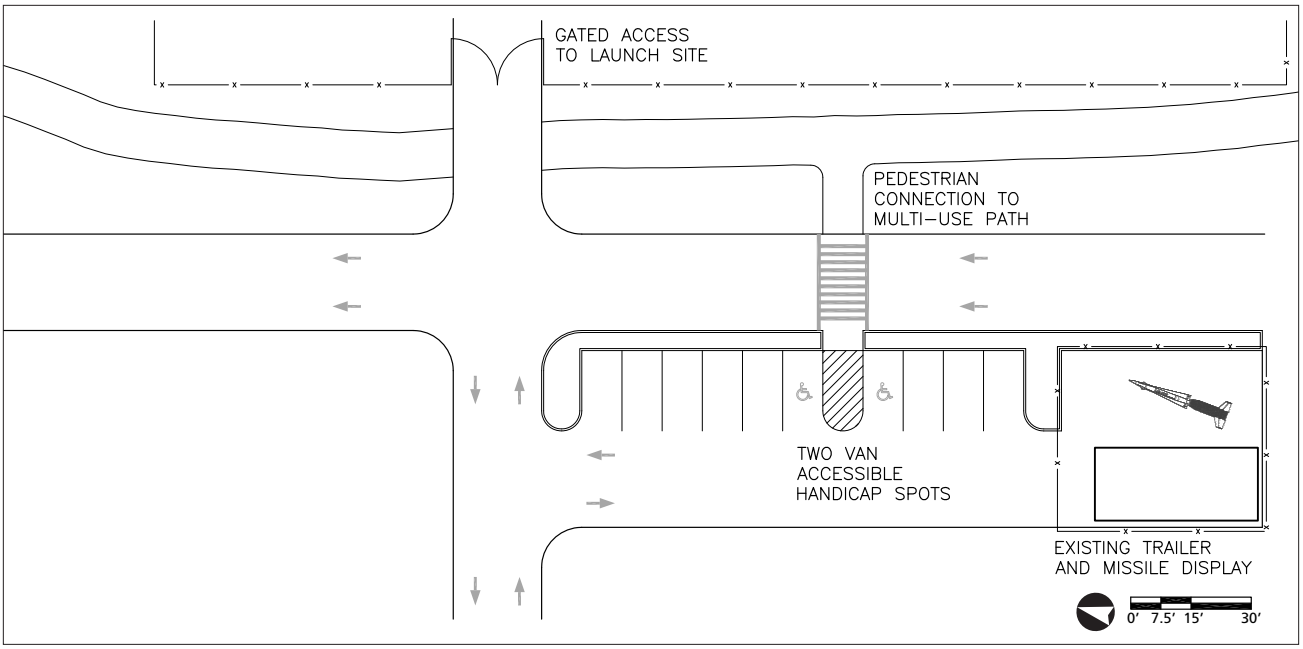
One of the items in the *Fort Hancock NIKE Launch Area Visitor Access Plan* indicates new handicap accessible parking inside the launch site near the Ready Barracks. Instead of creating separate locations for handicap and standard parking, both can be provided in the same location with a reconfiguration of the existing visitor lot off of Hartshorne Drive (Figure 5.124).

In addition to providing handicap accessible parking at the current NIKE launch area visitor parking lot, a modest reconfiguration of the existing parking lot would include adding a pedestrian crosswalk from the lot to the multi-use path on the other side of Hartshorne Drive. New Jersey Department of Transportation required signage would also be installed with the crosswalk (see Figure 5.124).

Figure 5.124. Plan for reconfigured visitor parking lot, NIKE launch site. The existing parking lot should be reconfigured to provide handicap accessible parking, a pedestrian crosswalk across Hartshorne Drive, and access to the site via the existing multi-use path (Olmsted Center, 2009).
