Inventory of Coastal Engineering Projects in Fort Matanzas National Monument

Natural Resource Technical Report NPS/NRSS/GRD/NRTR—2013/703

Kate Dallas

March 2013

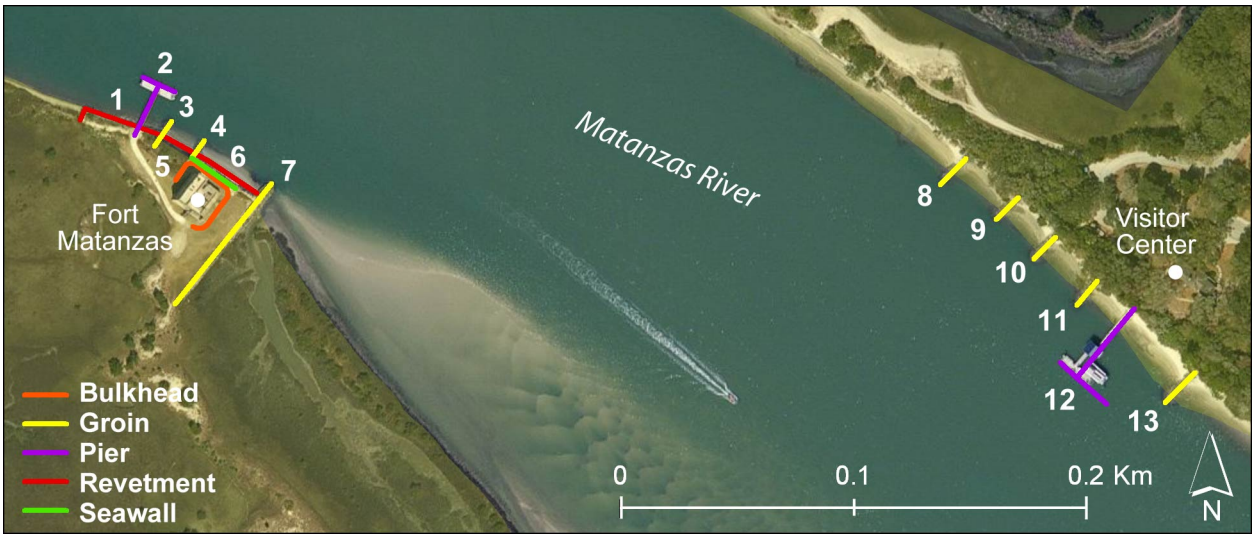
impacts of the Matanzas River (Figure 8 & #5 Figure 9) (NPS 1980, USACE 1987). The area behind the bulkhead was backfilled and revetment was placed in front (NPS 1980). In 1948–1949 parts of the bulkhead were cleaned and treated and the void between the bulkhead and fort was filled following storms in 1944 and 1947 (NPS 1980). Additional steel sheet pilings were placed approximately 0.3 m (1 ft) in front of the bulkhead by the NPS in 2007 (NPS 2006b).

Figure 9. Structure map for the area around Fort Matanzas and the Visitor Center. Yellow shading shows park property (image from ESRI Bing Maps basemap layer 2012).

In 1940 a coquina seawall was constructed along the northeast side of the fort (#6 Figure 9) and two groins were built (#3, 4 Figure 9) on the shoreline (NPS 1980). The seawall is not currently visible because a coquina revetment covers it. The groin at the southeast corner of the fort was built in 1948–1949 (#7 Figure 9) (NPS 1980) and lengthened and reinforced with timber sheet

The original ferry dock on Rattlesnake Island was built in 1935 (Kurt Foote, Natural Resource Management Specialist FOMA, email, 27 August 2012) and rebuilt in 1956, 1978–1979 (NPS 1980), and in 2007 when the NPS replaced it with the current concrete floating dock (Figure 8 and #2 Figure 9) (NPS 2006b). In 2007 the NPS also upgraded and stabilized the coquina seawall and groins, placed additional revetment (#1 Figure 9), and repaired the steel bulkhead (NPS 2006b).

In 1934–1935 eleven rock groins were constructed near the present day Visitor Center to stabilize the shoreline (Mehta and Jones 1977). The Youth Conservation Corps repaired the groins in 1976 (NPS 1980). Only five groins were visible during our site visit in 2012 (#8–11, 13 Figure 9 and Figure 10), all of which were repaired by the NPS in 2007 (NPS 2006b). The ferry dock on Anastasia Island was originally built in 1935 (Kurt Foote, Natural Resource Management Specialist FOMA, email, 27 August 2012) and replaced in 2000 by the NPS with a floating concrete dock (#12 Figure 9) (NPS 2006b).
