Fords Theatre National Historic Site
Washington, District of Columbia

William A. Petersen House
House Where Lincoln Died

Historic Structure Report

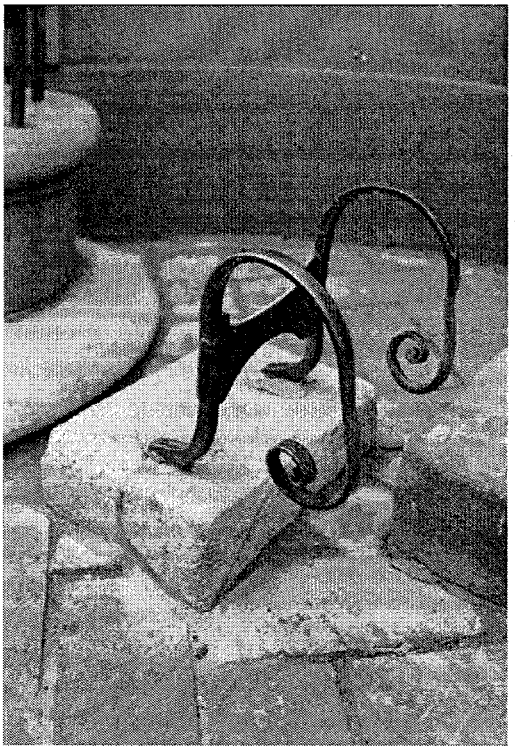
D Cast iron railing has several missing spindles and footscraper is totally missing from granite base.

Figure 40 1968 HABS photograph of foot scraper (now missing from its granite base) (Library of Congress, Prints & Photographs Division, HABS, DC-165).

R Replicate missing elements from historic documentation and replace.

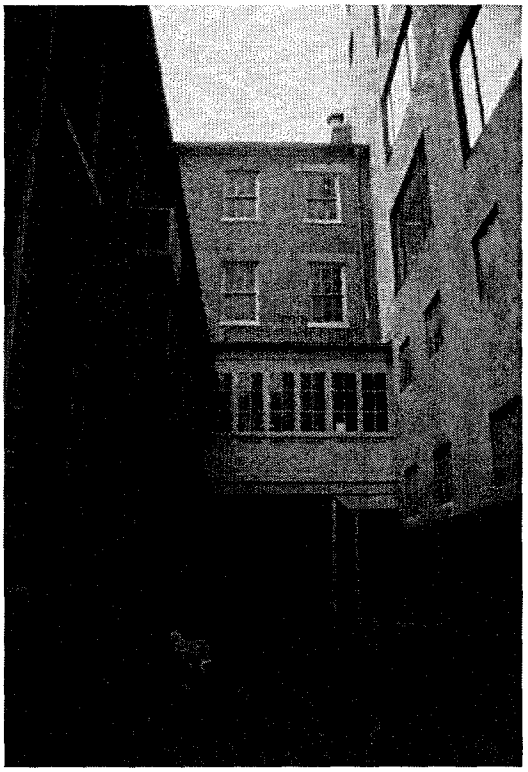
Photo AR-4; architrave p.c., architects 1/31/02

Photo AR-4:
West Elevation of Petersen House taken from Yard/Garden. Enclosed porch (First Floor level) extends from facade and connects with Rear Ell (on left).

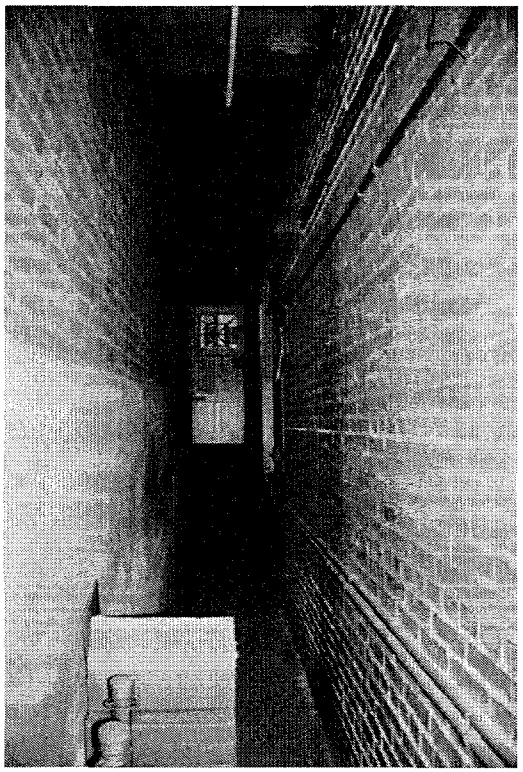
Photo AR-7; architrave p.c., architects 1/31/02

Photo AR-7:
Easement Passageway looking East towards Tenth Street.

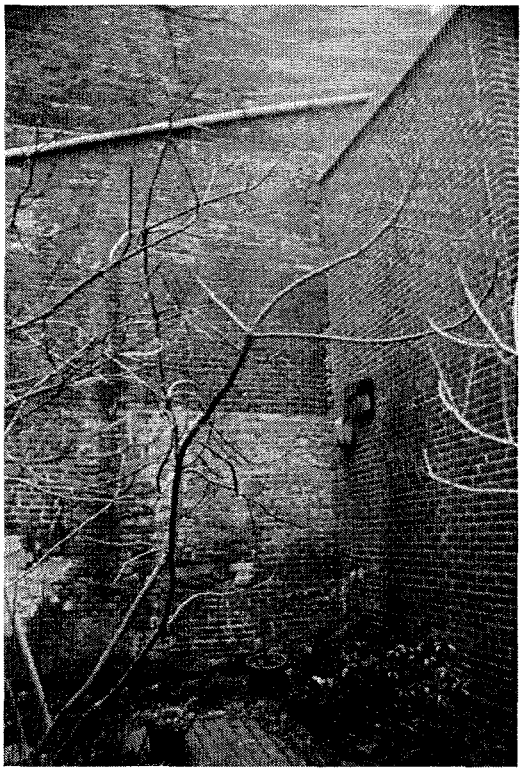
Photo AR-10; architrave p.c., architects 1/31/02

Photo AR-10:
West Elevation of Rear Ell (2) dating to 1870s-patches in brick are evident where former openings to 1899-1900 addition were filled. North wall of adjacent building (and south wall of opposite building) show shadows of former profile of demolished coalshed/ storage building, later library.

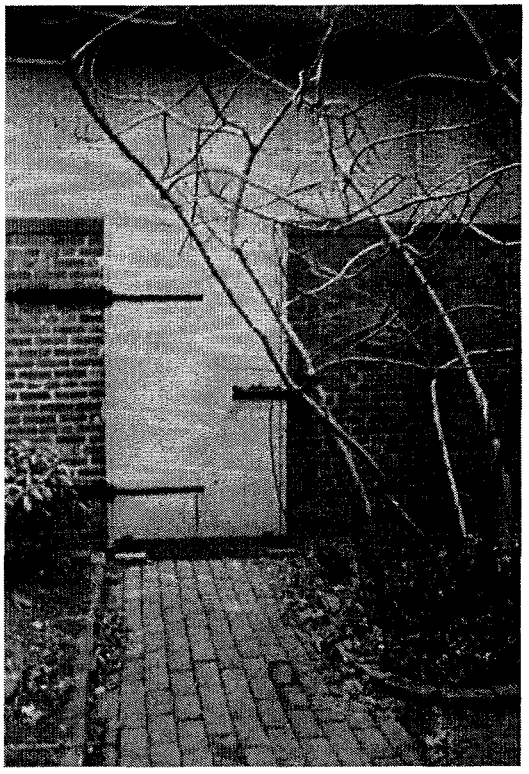
Photo AR-11; architrave p.c., architects 1/31/02

Photo AR-11:
Reconstructed wall at alley, capped with sandstone. Wood gate is also recent replacement.

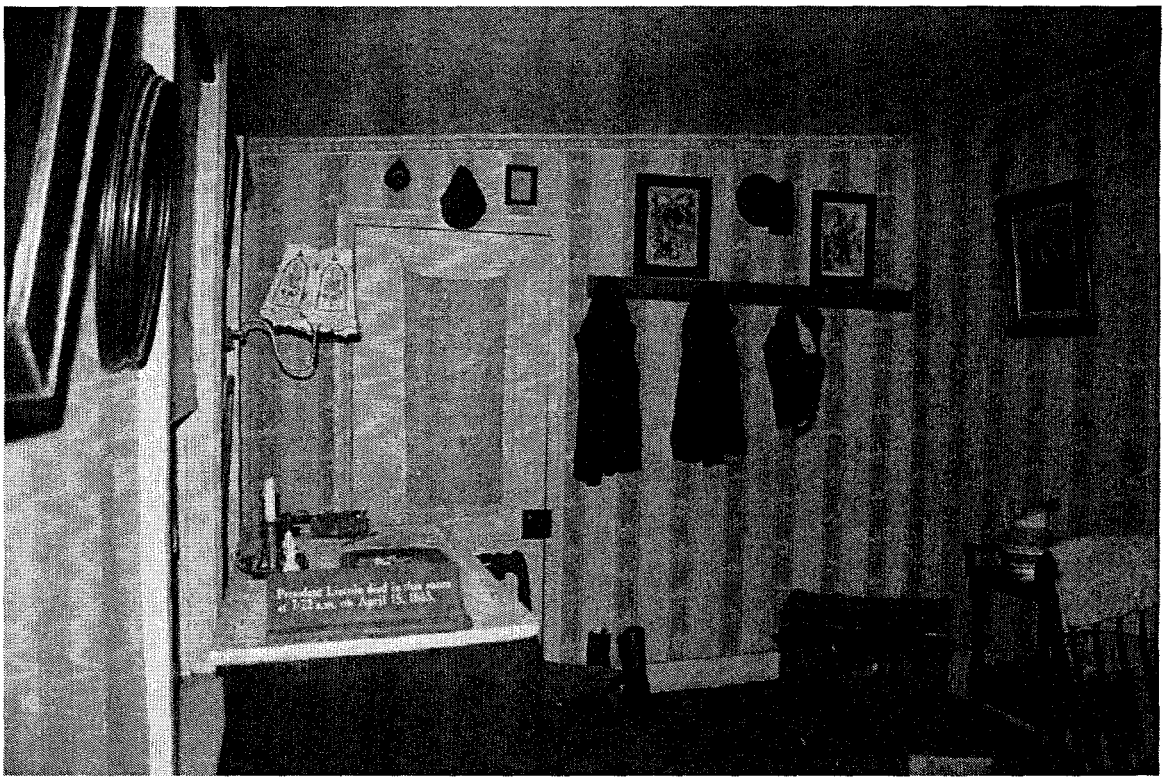
Photo AR-16; architrave p.c., architects 2/15/02

Photo AR-16:
The rear wall as it appears today, after the 1979 correction of the door placement and swing. All efforts were made during this last restoration effort to depict the room as it appeared in the Waud sketch.

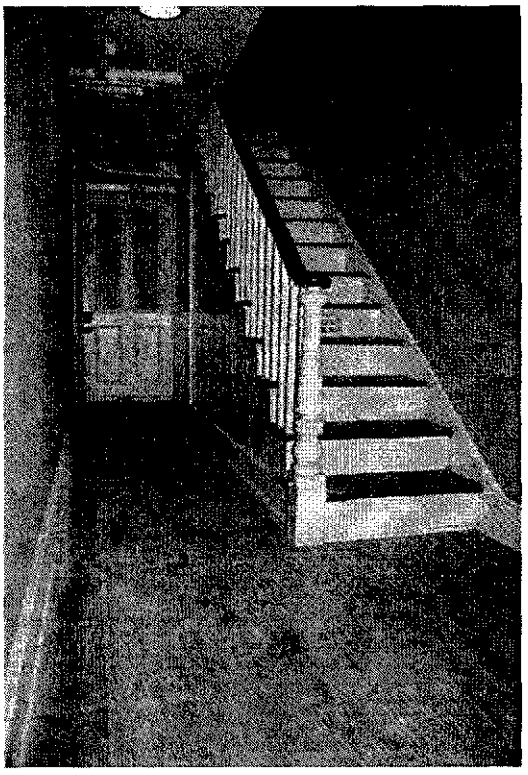
Photo AR-18; architrave p.c., architects 2/15/02

Photo AR-18:
Hall and Stairway at the Basement level. Beaded board partition fills the area beneath the stairs, with a door leading to a small closet. All stair elements are painted.

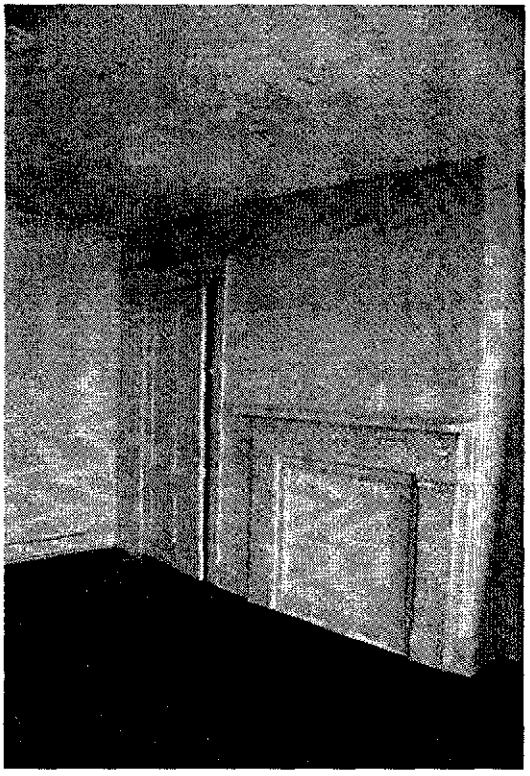
Photo AR-21; architrave p.c., architects 2/15/02

Photo AR-21:
Room 302 on back of house with mantel intact (chimney filled) and adjacent closet. The 4 paneled door and simple wood trim in the Greek Revival style are all original. Plaster exhibits previous water damage.

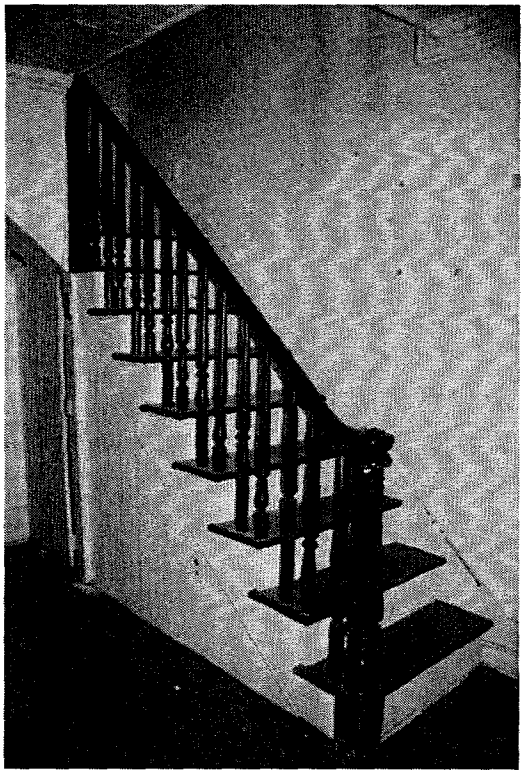
Photo AR-24; architrave p.c., architects 1/31/02

Photo AR-24:
Stairway within the former kitchen of the Rear Ell that was likely used by caregivers the night of Lincoln's assassination.

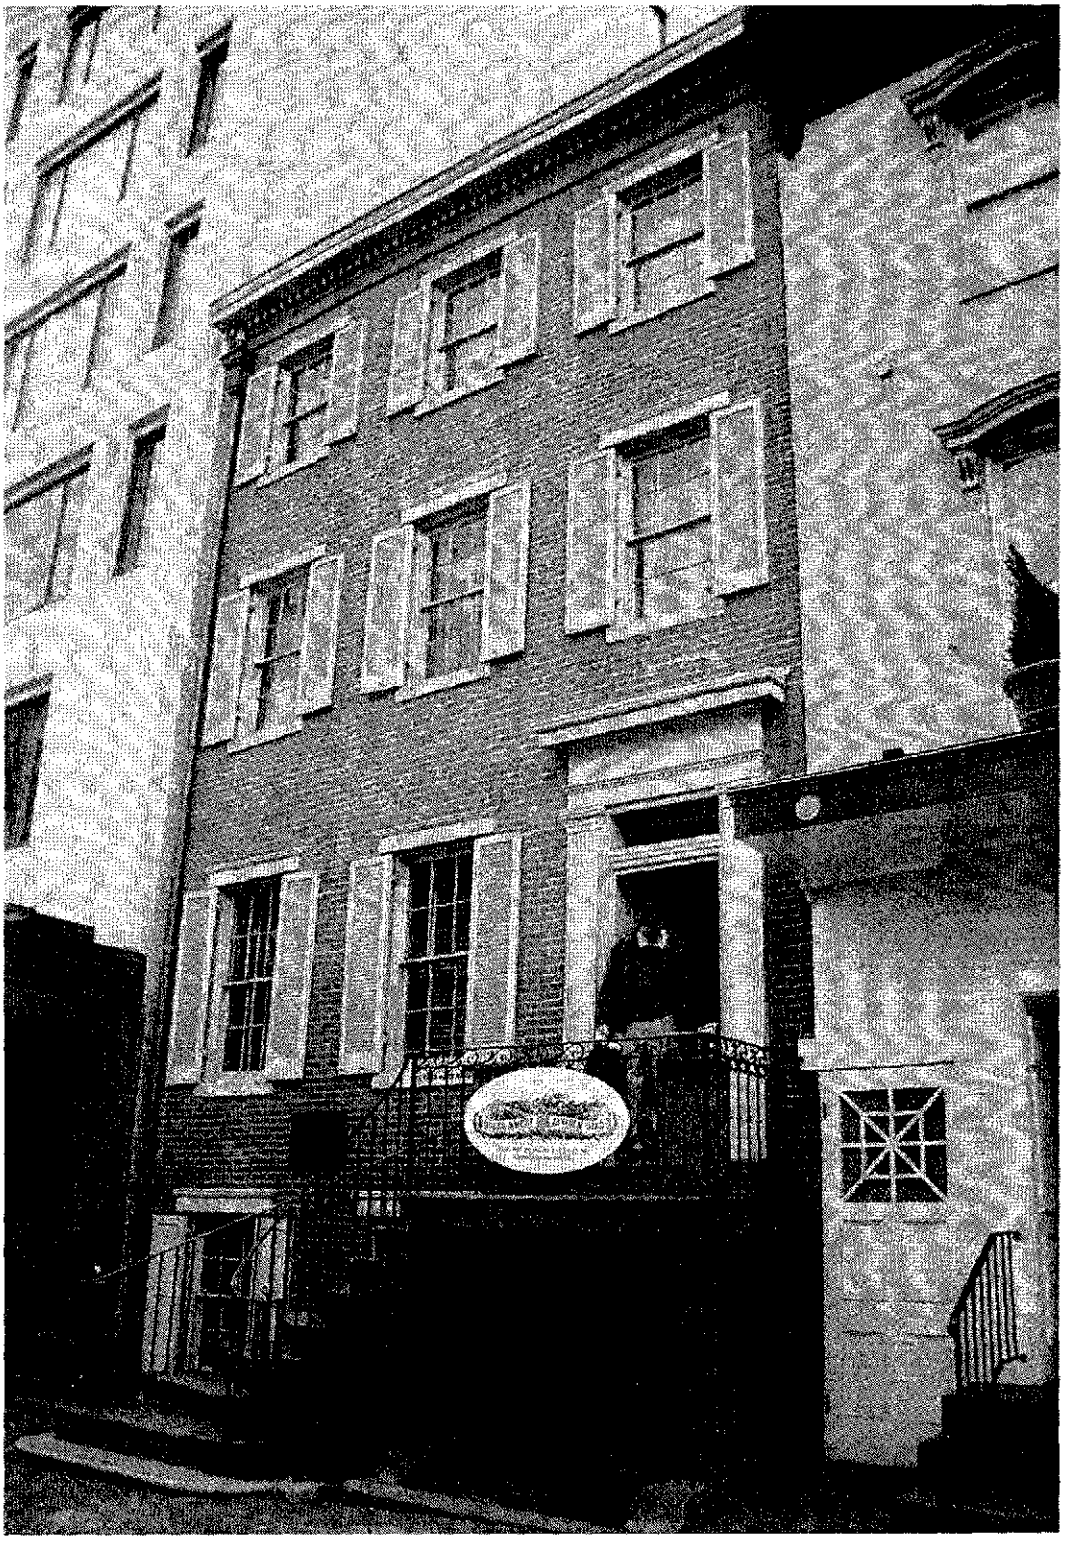
Original wood windows, hoods, sills, and paneled shutters at Basement Level windows require full, immediate repair and restoration. Visitors are unfortunately allowed to view interior clutter of store room and visually unattractive security grilles applied to interior of window openings.
Photo AR-27 architrave p.c., architects 2/26/02

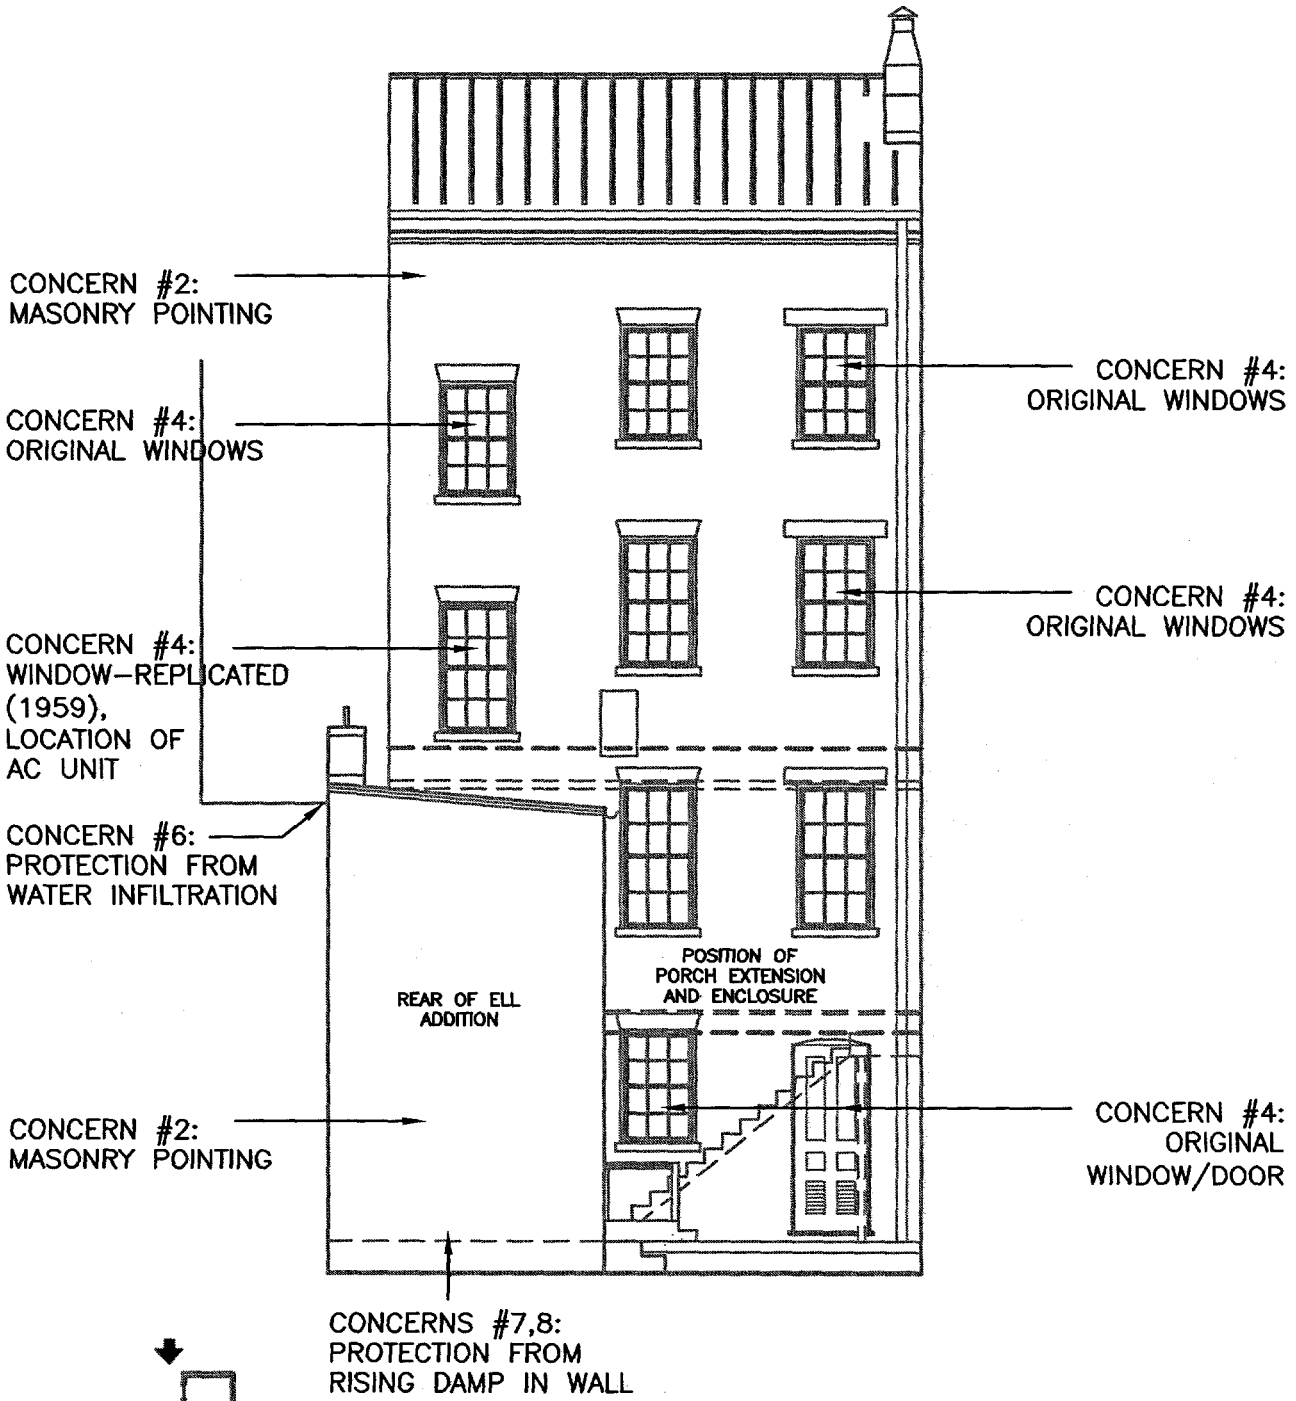
West (Rear) Elevation and Garden (former yard) of Petersen House – House Where Lincoln Died
Photo AR-31 architrave p.c., architects 1/31/02

As on the front elevation of the house, wholesale door and window repair and repainting is essential to save the original building features, even though this side of the house is not currently seen by visitors. The ground floor areaway, under the rear porch, is frequently used as a storage zone, which is an inappropriate location to stockpile items from Ford's Theatre. Under the proposed upgrade project, this area will be enclosed to better control passive air conditioning of the interior. Visitors would then exit the Death Room through the rear porch and down the steps, to be directed back to the street, via the easement walkway (former alleyway). This pattern of circulation improves current visitor flow through the house and emergency egress, but does not meet ADA accessibility guidelines.

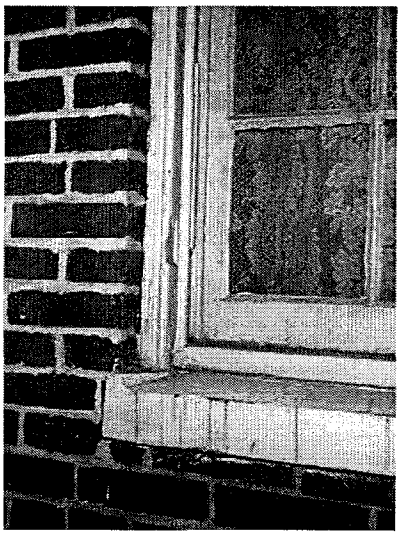
Intersection of original Rear Ell (rebuilt 1863) and 1870s extension, post Lincoln's death. Lattice treatment is inappropriate to period.

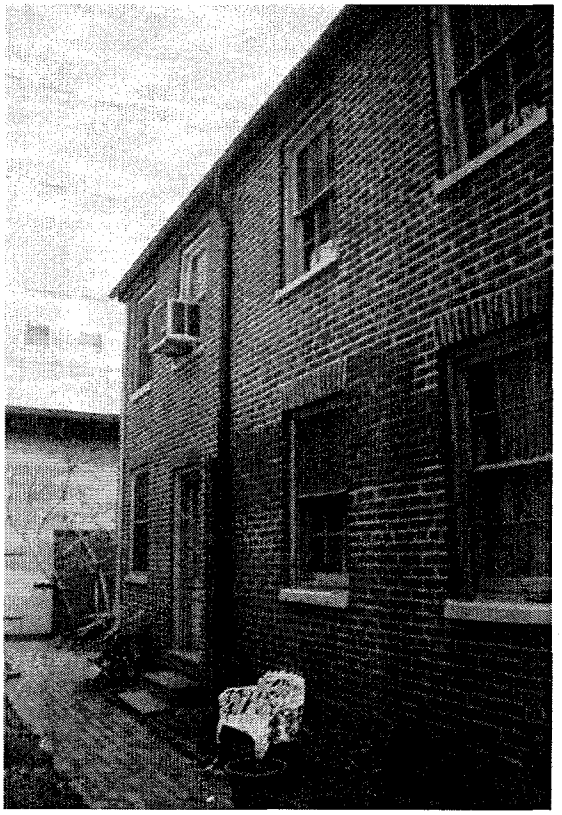
Photos AR-33 and AR-34 architrave p.c., architects 1/31/02

Condition of windows in Rear Ell are poor with broken panes, cracked paint and missing shutters.

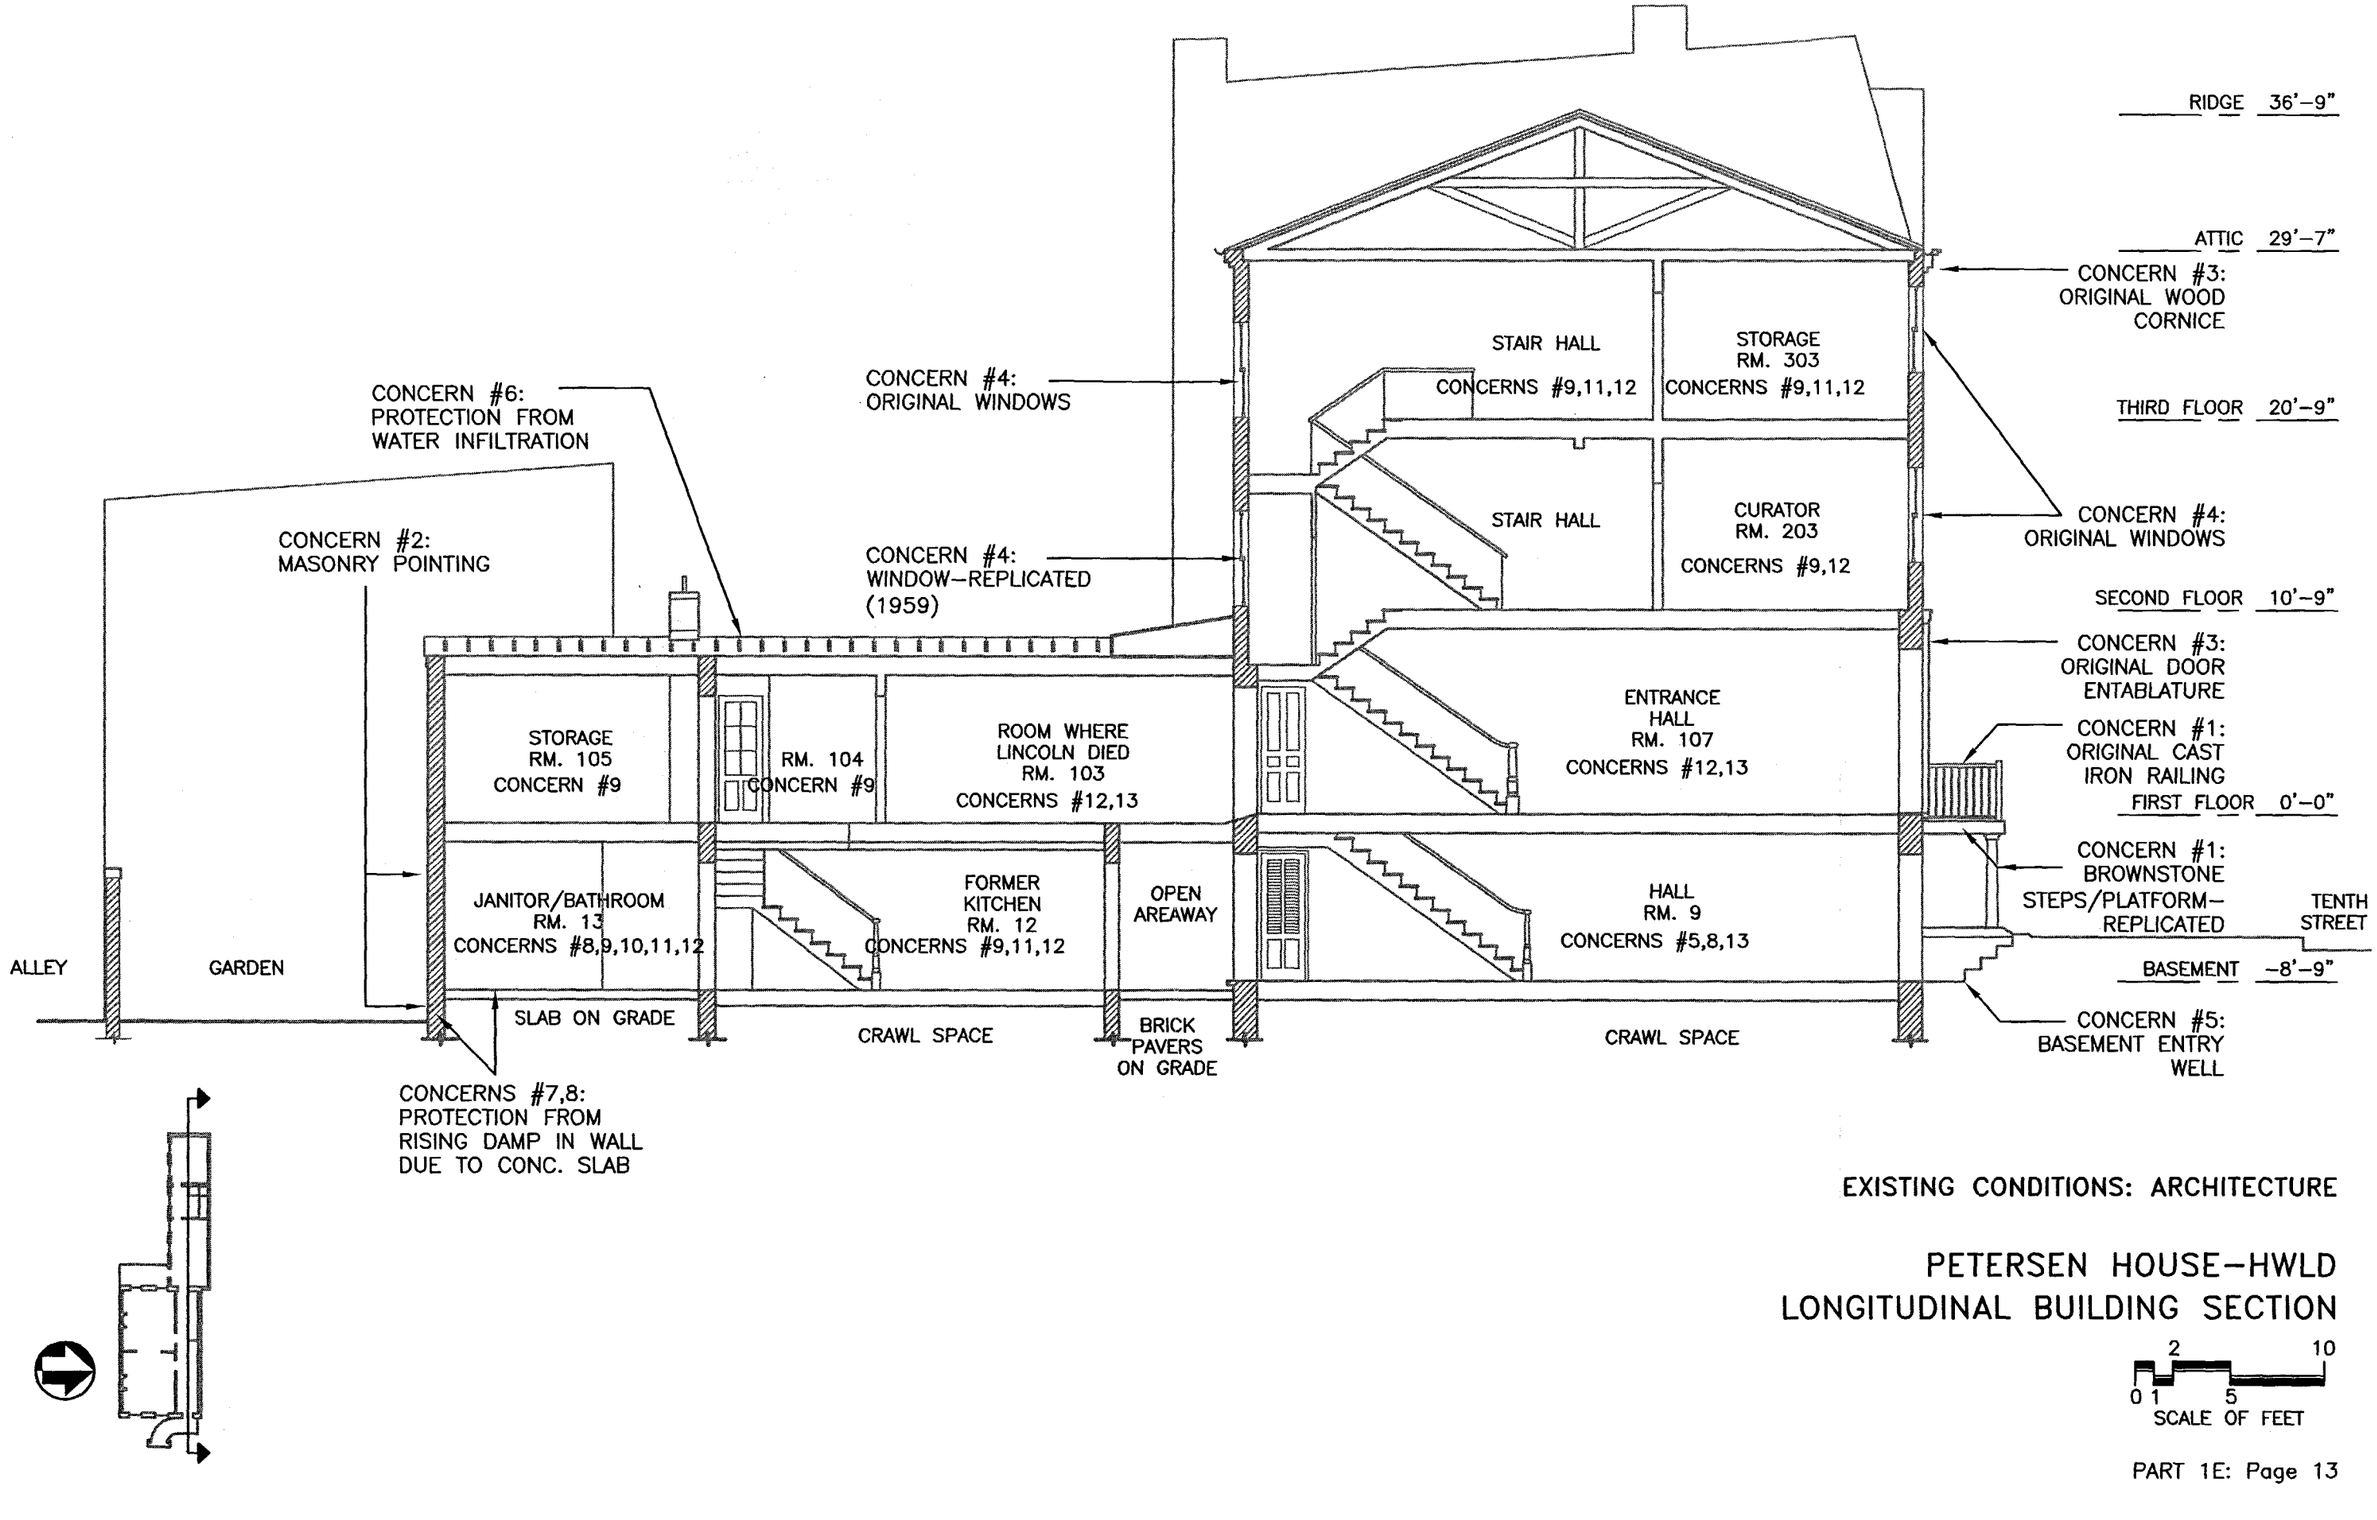
South Elevation (Rear Ell) of Petersen House – House Where Lincoln Died
Photo AR-35 architrave p.c., architects 1/31/02

This rear section of the house (exterior) is not generally exposed to public view, because of the controlled circulation patterns of visitors through the main house, and has evidently received little attention to building maintenance issues. Although a supporting structure, the rear ell is historically significant as it contains the Death Room and the former kitchen below. This building section requires immediate repairs of building elements to alleviate the serious concerns listed above.

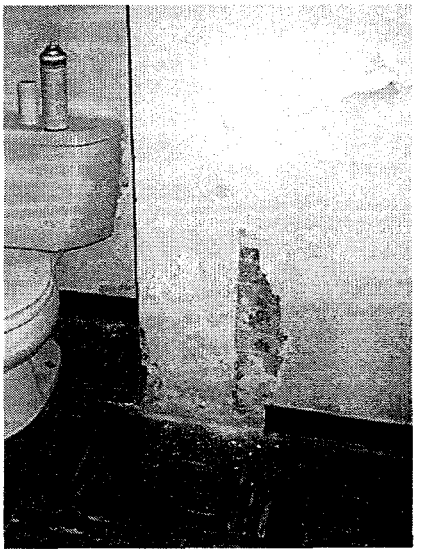
Main House Block
Hall (Room 9) – Condition Assessed as FAIR. Plaster was removed from a large section of wall due to probable rising damp condition or water intrusion (predicated by problematic drainage of stormwater from lowered entrance well) and/or structural settlement from heavy foot traffic above. Many visually obtrusive conduits and various pipes extend below the ceiling level, as this is not a restoration zone.
Storage (Room 10) – Condition Assessed as FAIR. The use of this space by the Museum Bookstore and security grilles for such, create a visual distraction from the sidewalk, inappropriate for a restored historic property.
Boiler Room (Room 11) – Condition Assessed as FAIR. The addition of a concrete slab floor and the parging treatment of the base of the brick masonry wall (interior to room) typically advance the probability of rising damp; however, no evidence was observed in the exterior face of the plaster finish.

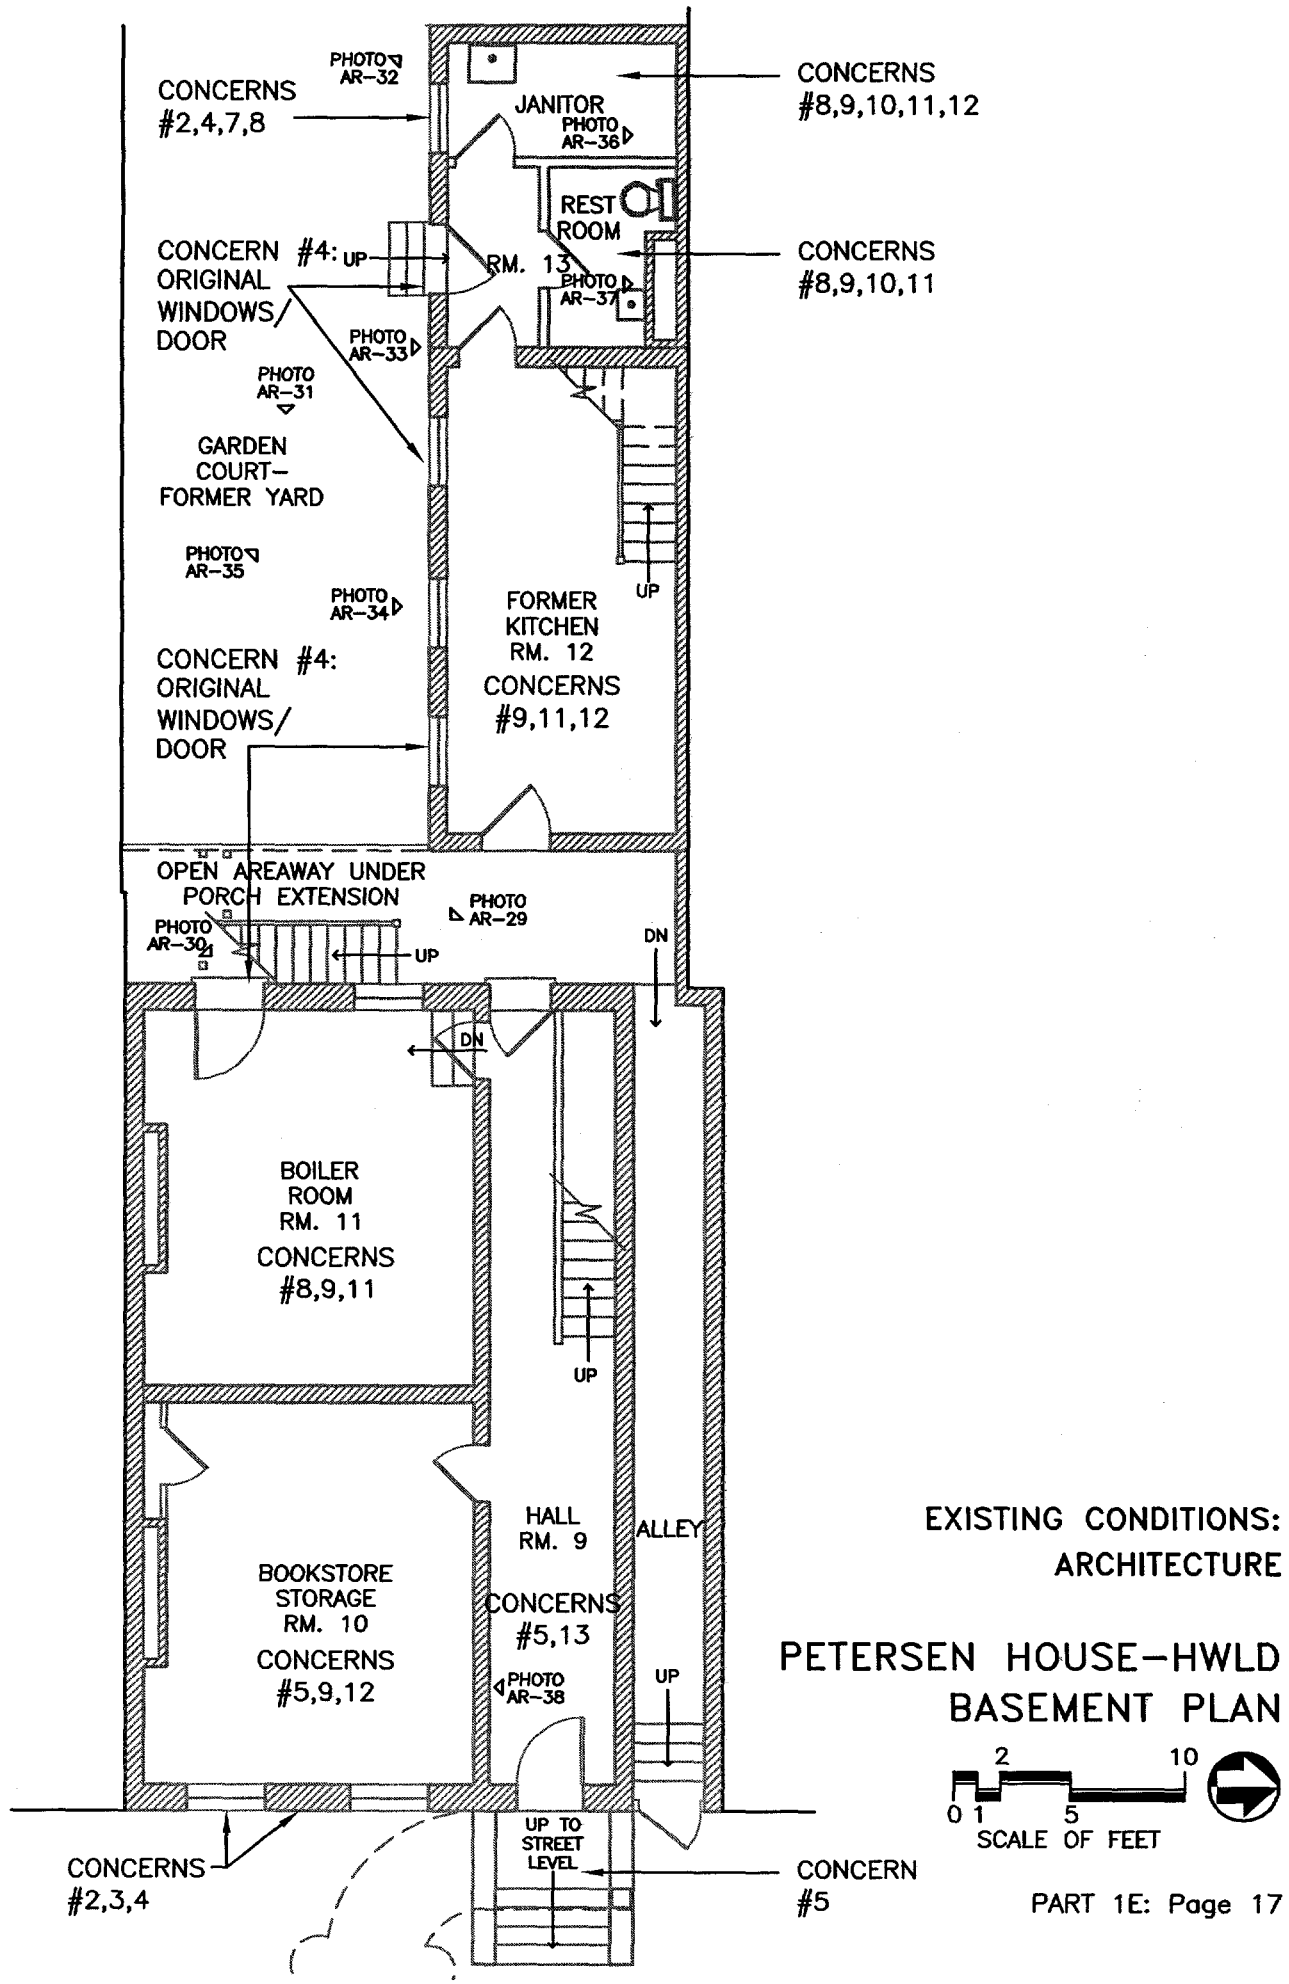
Basement Hall near Front Entrance Door where rising damp and structural weakness have combined to cause deterioration of historic plaster (removed prior to failure).
Photo AR-38 architrave p.c., architects 2/15/02

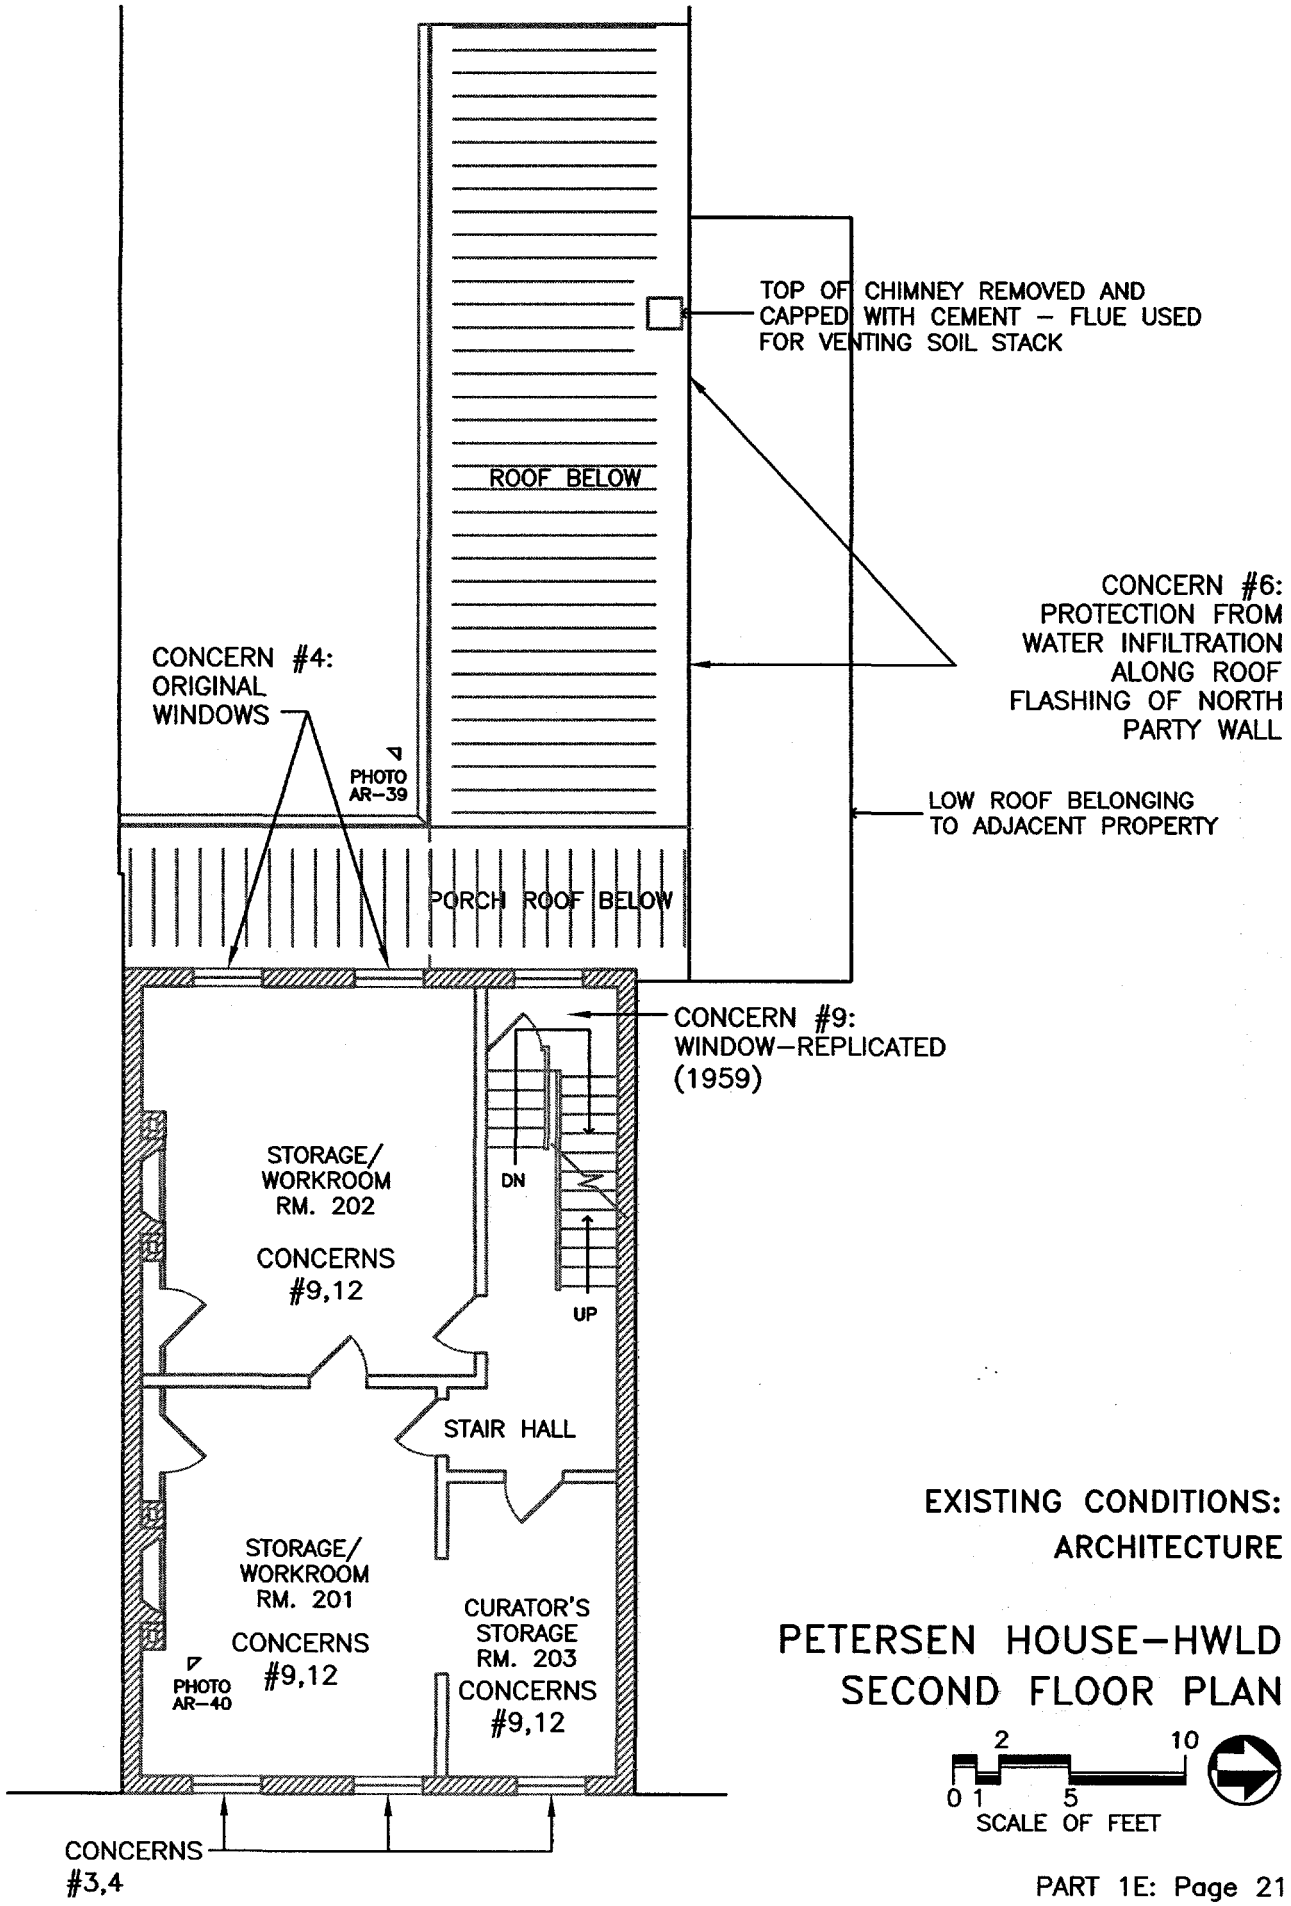
Sloping Rear Ell Roof with view of flat-roofed extension to adjacent building to North with potential for trapped stormwater; drainage of upper roof of adjacent building also poses a concern with long gutter run to rear alley.
Photo AR-39 architrave p.c., architects 2/15/02

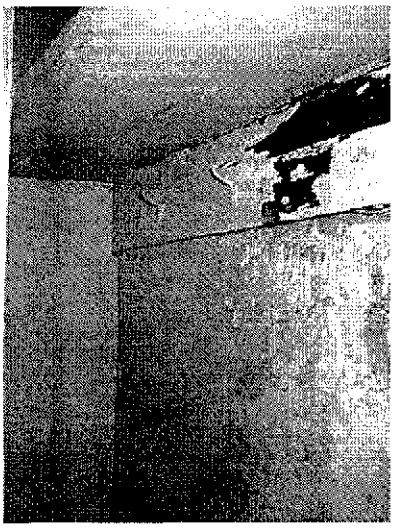
Decorative cast iron grille at Second Floor Fireplace, Room 201, likely late 19th c. addition.

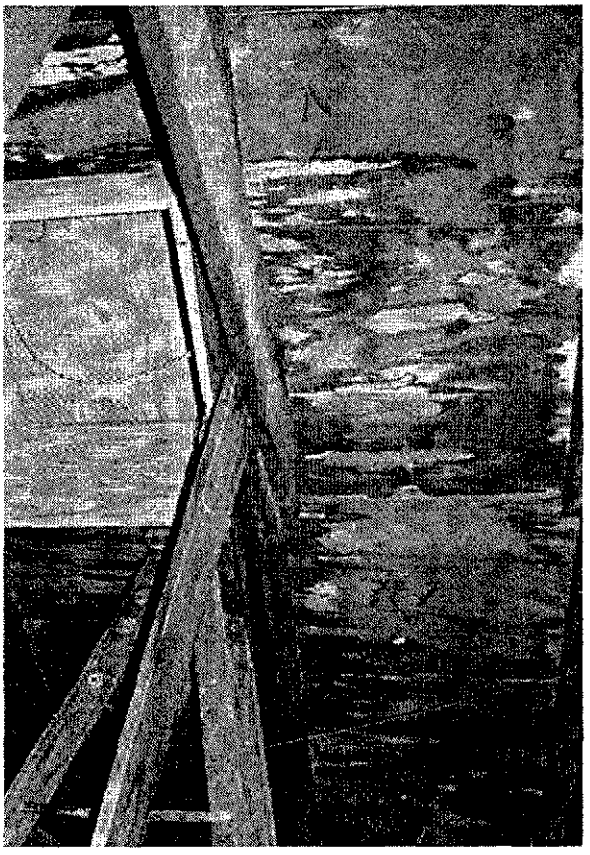
Water damage at original wide board sheathing, visible within Attic.
Photo AR-43 architrave p.c., architects 2/05/02

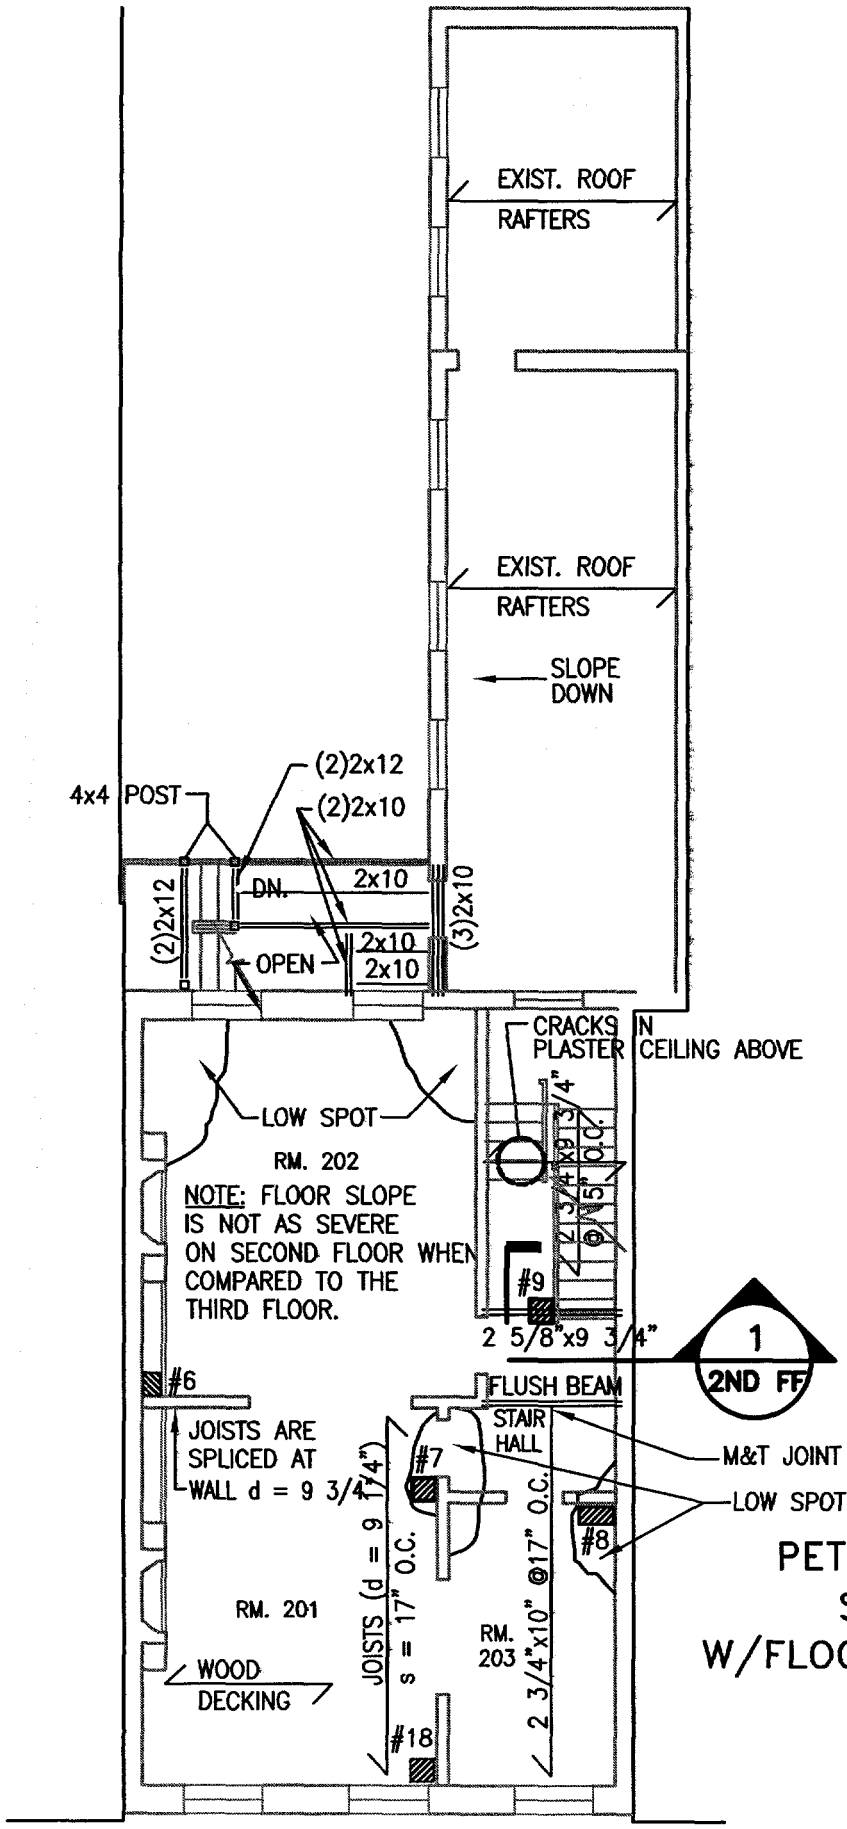
PETERSEN HOUSE–STRUCTURAL DETAIL
SECTION 1 @ 2ND FL. FRAMING

As observed at the third floor, the floor slopes toward the east/west partition wall and to the southwest fireplace. It appears that the slope of the floor adjacent to the wall may have been exacerbated by the presence of heavy storage cabinets placed against the wall. This use has caused permanent defection in the decking. It would be necessary to jack the floors in order to remove the deflection, an action that could cause significant damage to the existing plaster on the surface of the walls. For this reason, no remedial work is recommended for this condition, beyond immediate removal of all heavy objects. Note that the floor slopes observed on the second floor are slightly less severe than the slope observed at the third floor.
