Fords Theatre National Historic Site
Washington, District of Columbia

William A. Petersen House
House Where Lincoln Died

Historic Structure Report

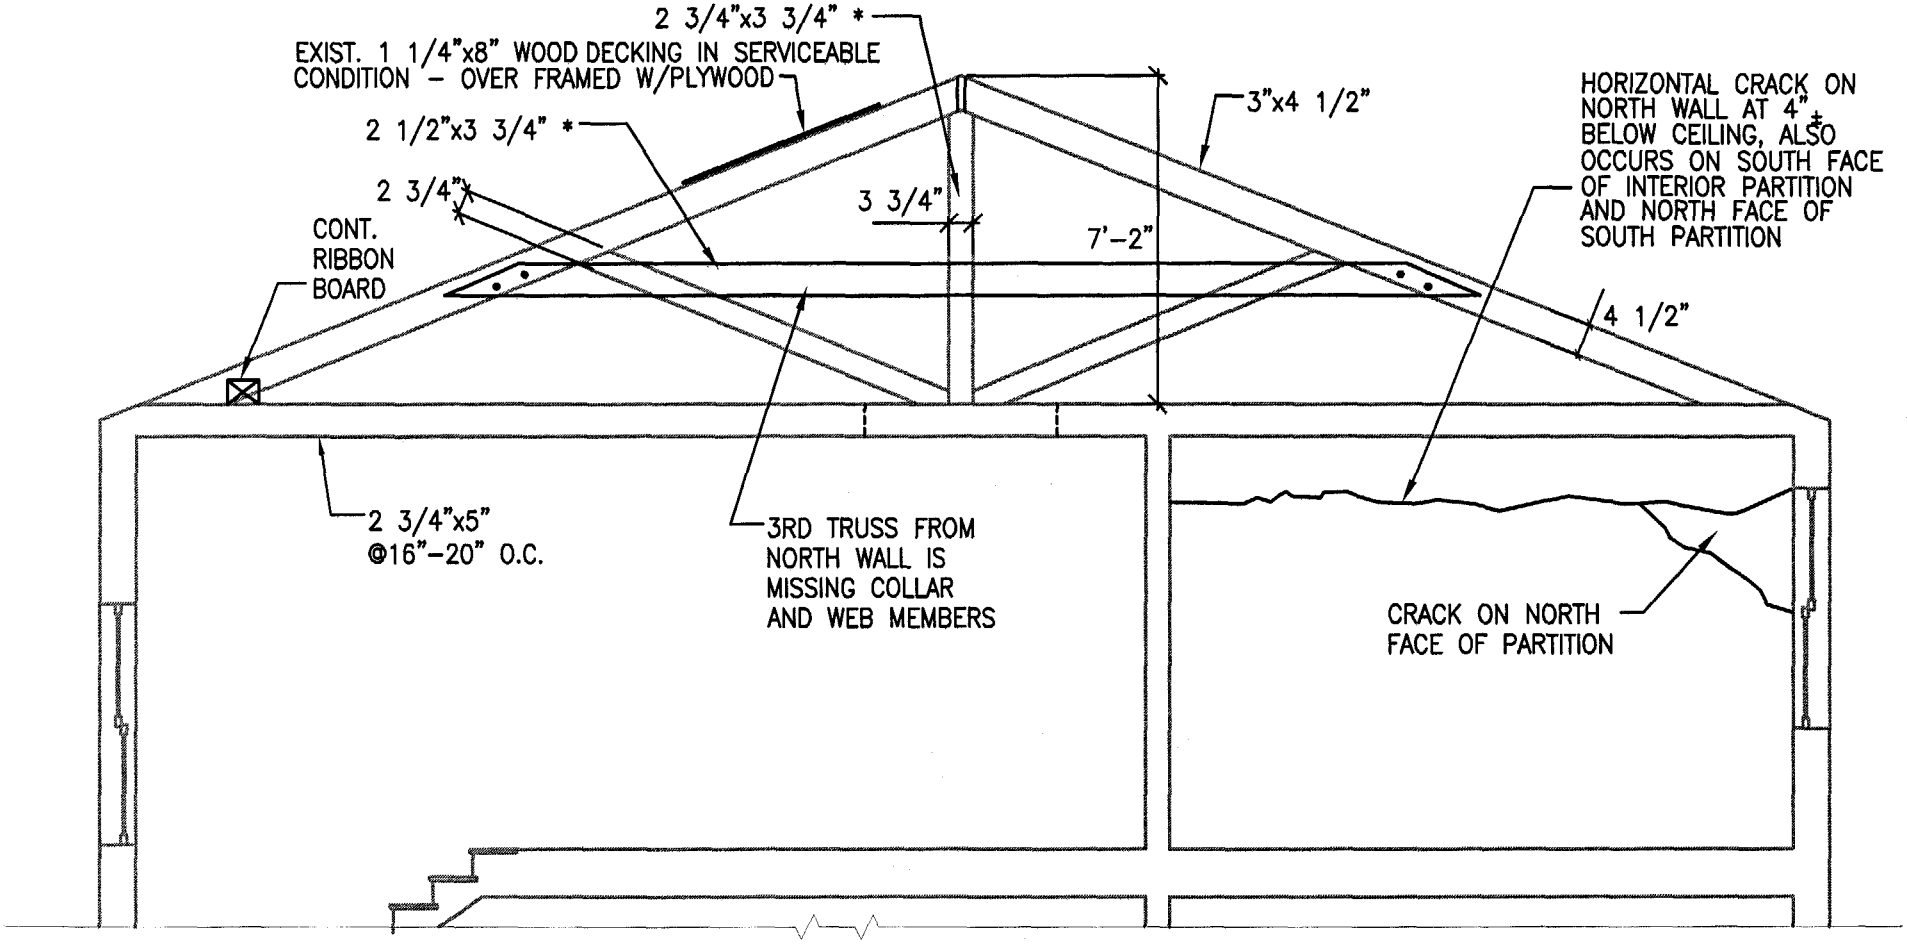
PETERSEN HOUSE–HWLD
ROOF FRAMING PLAN

2. MANY RAFTERS ARE WATER STAINED BUT NO SERIOUS SIGNS OF ROT OR DETERIORATION WERE EVIDENT.

The roof truss framing appears to be performing satisfactorily; however, the truss nearest the hatch is missing all of its web members. This condition significantly decreases the structural capacity of the truss. The missing members should be reattached identical to the adjacent trusses in order to restore the structural capacity of the truss and the roof system.

- Existing roof truss located immediately to the south of the attic hatch is missing all web members. – *The members must be reinstalled to match the existing trusses and to restore the structural capacity of the truss.*

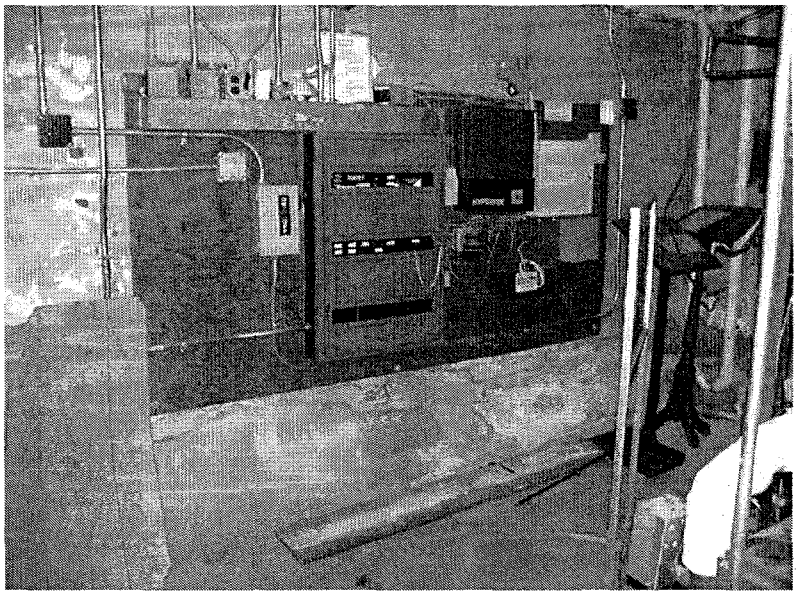
Main electrical panelboard in easement/alley, scheduled for relocation.
Photo MEP-5 JVP Engineers, P.C. 1/8/02

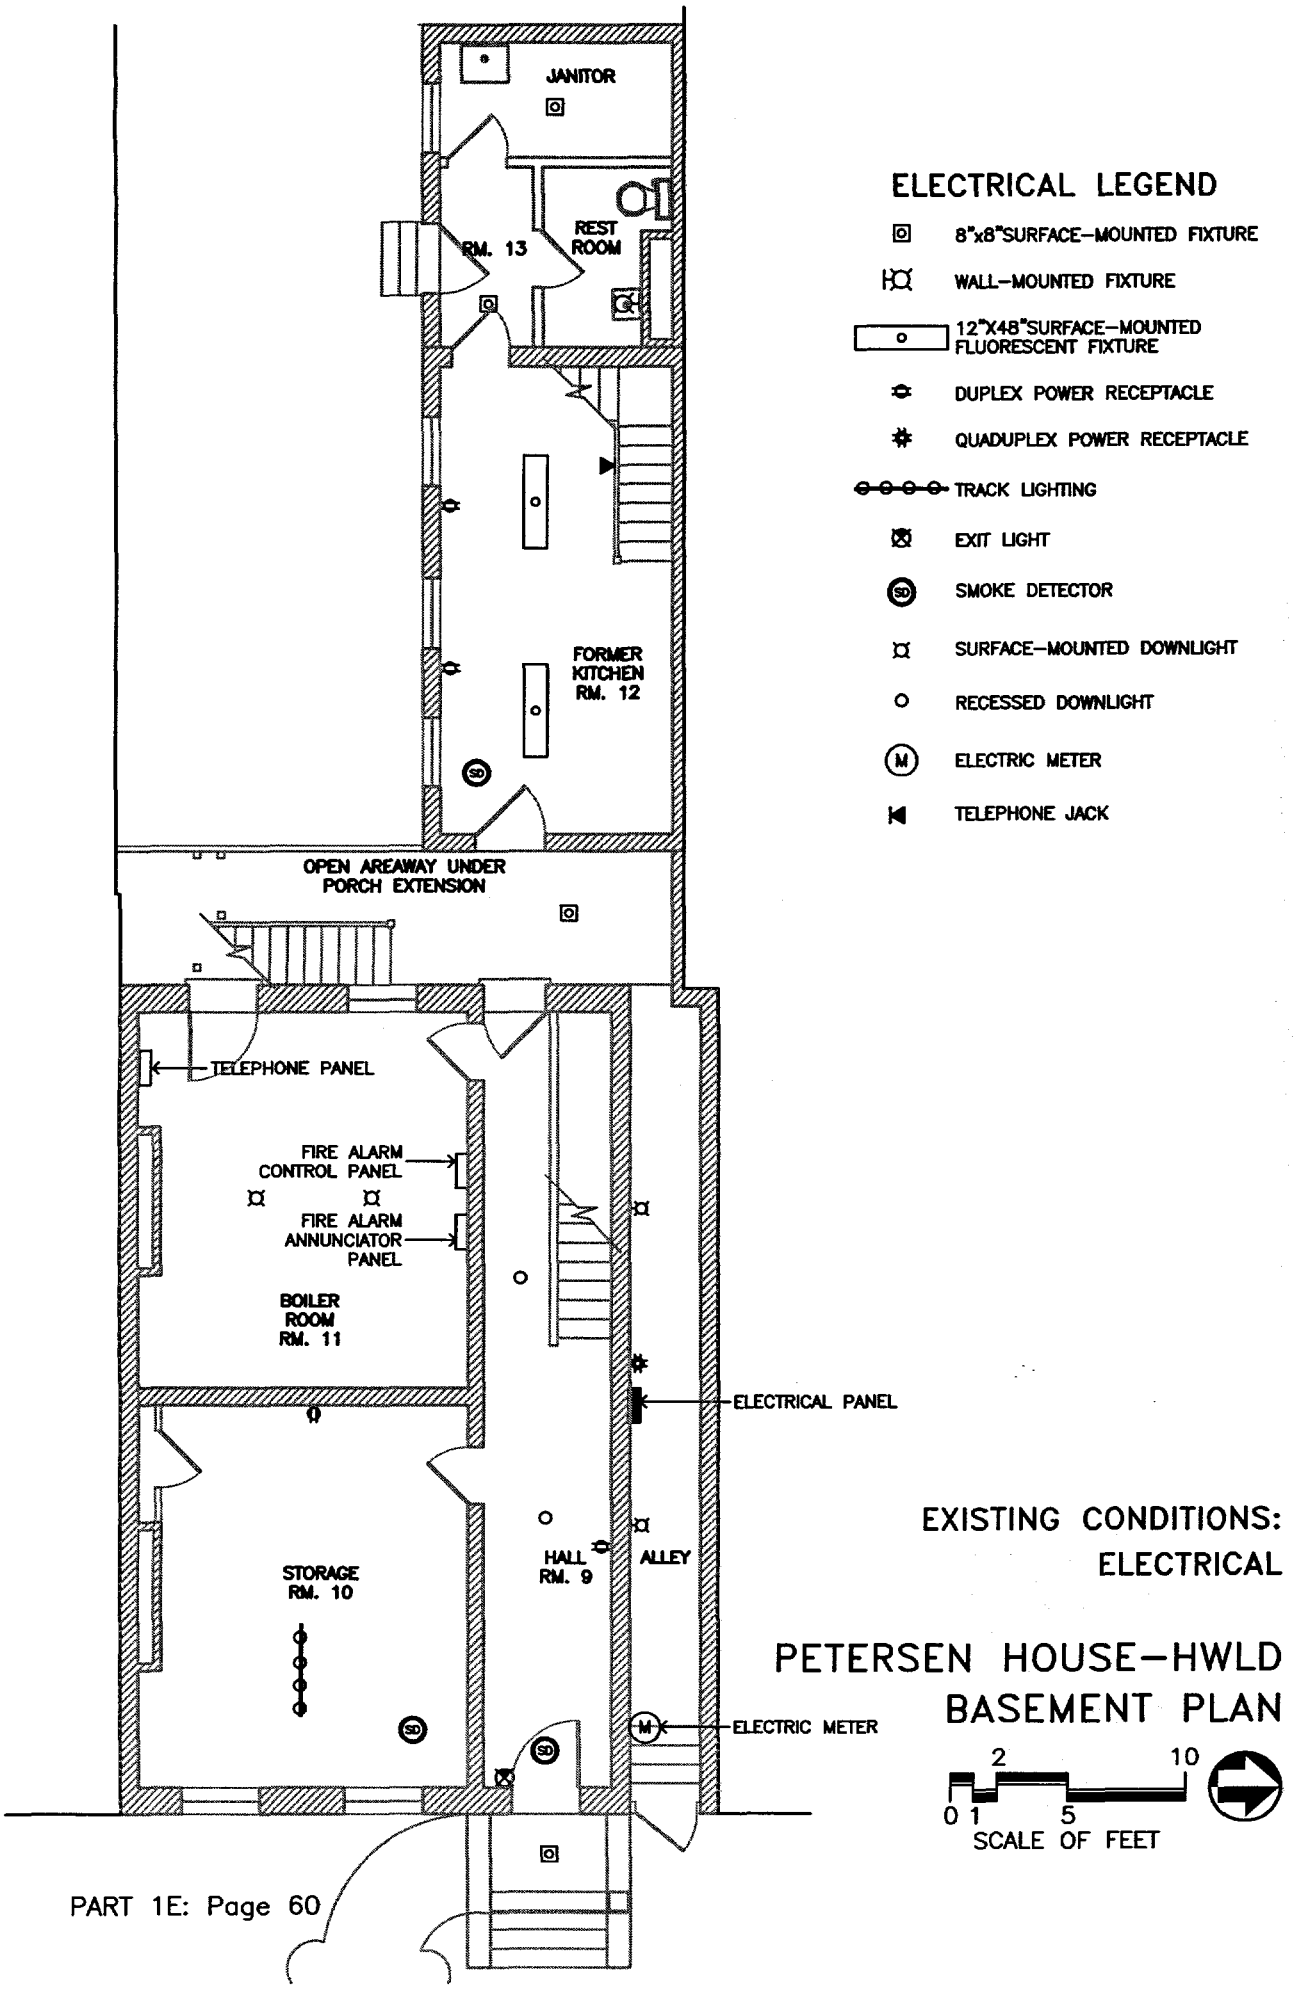
Fire alarm control panel in boiler room in basement.
Photo MEP-6 JVP Engineers, P.C. 1/8/02

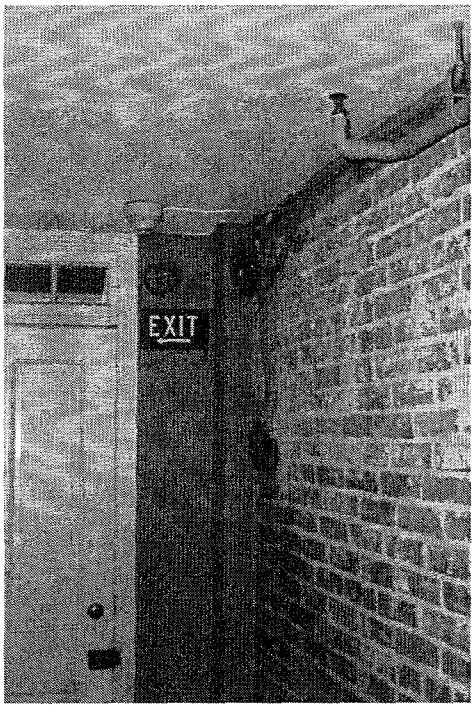
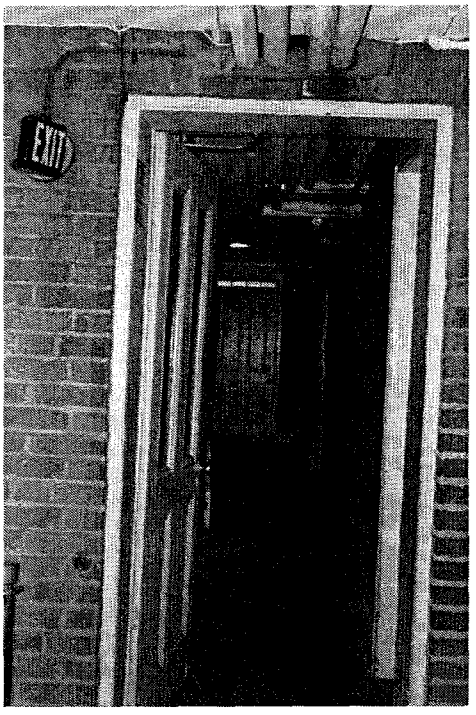
Current storage in the easement/side alley, identified as a future means of emergency egress.
Photo LS-1 Gage-Babcock & Associates

The path of egress must be kept free of obstructions, such as furniture, storage or equipment, at all times. Removing obstructions from the path of egress will not affect the historic fabric, as the obstructions are not part of the structure nor historically significant.

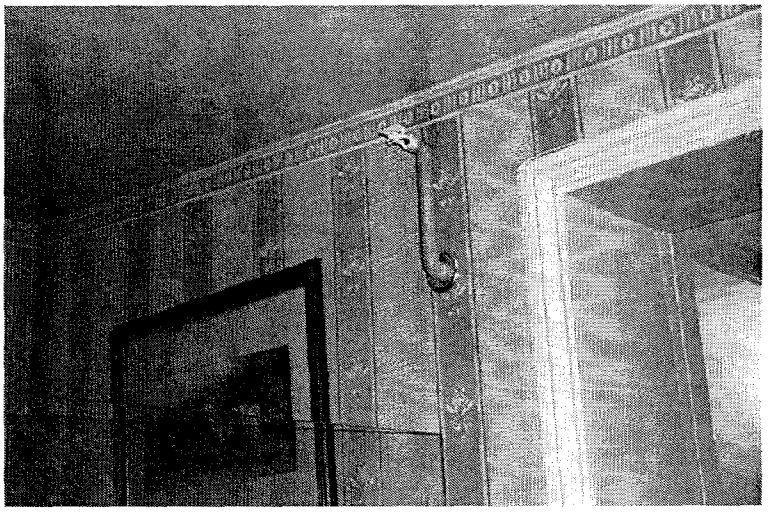
Non-illuminated exit signs at basement doors. Also shown are examples of typical fire alarm devices. Note exposed smoke detector wiring.
Photos LS-2 and LS-3 Gage-Babcock & Associates

The building has an assortment of lit and unlit exit signage. Exit signs are required to be internally or externally illuminated while the building is occupied. The unlit exit signs should be replaced with illuminated signs as shown on the drawings. Replacing exit signs in existing locations should not affect the historical fabric of the building. All exit signs may be replaced with decorative signs that still meet code requirements.

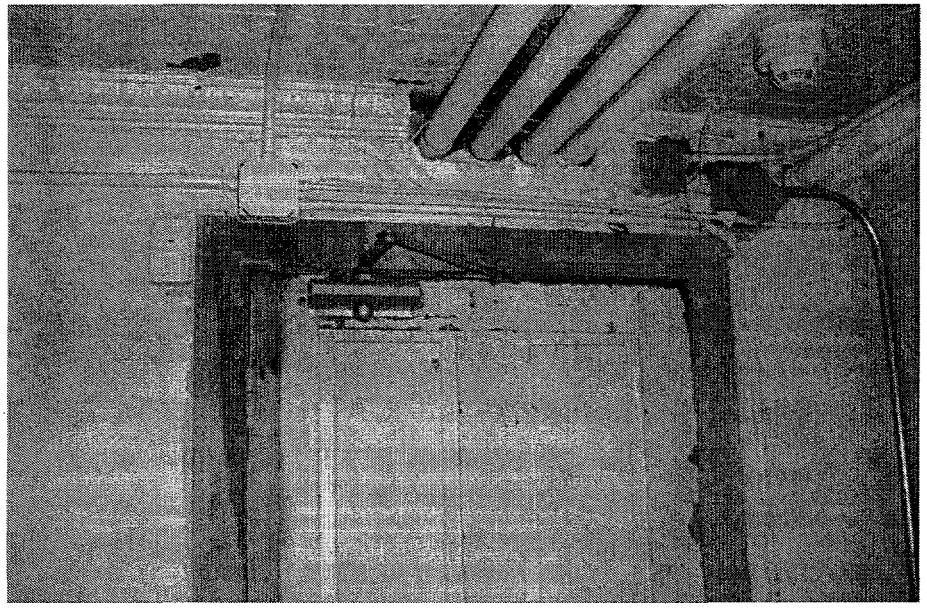
Both abandoned in place wiring and current security wiring are clearly visible.
Photo LS-6 Gage-Babcock & Associates 8/13/02

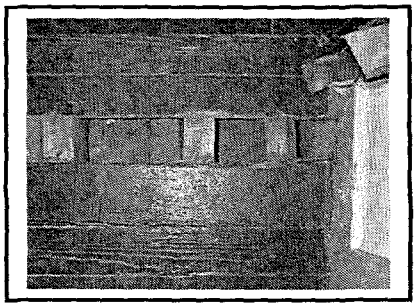
#2 - Photo at interior wall

Reason for Opening/Findings:
- To observe potential joist bearing location.
- To determine framing size, span direction and spacing of members.
- Framing information for floor and ceiling was documented. Low beam was observed.
- At north wall, steel strap was found extending from joists into brick wall. Strap serves as a lateral brace.

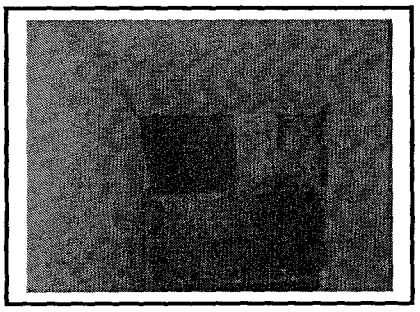
- To observe assumed bearing wall/beam bearing condition.
- Found that the low beam runs continuous across the width of the house.

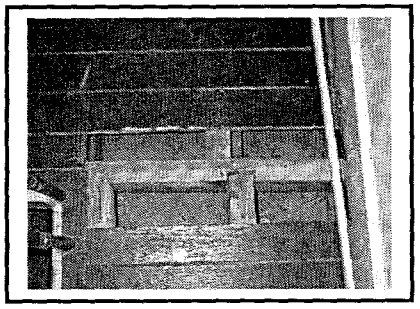
- To observe stair/floor connection.
- Determined stair header size and landing joist sizes.

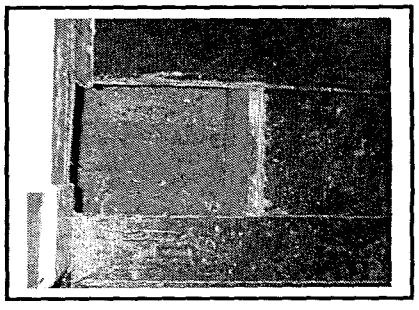
- To observe assumed bearing wall/beam bearing condition.
- Found that no low beam occurs at this location. Wall studs extend to face of existing brick wall.

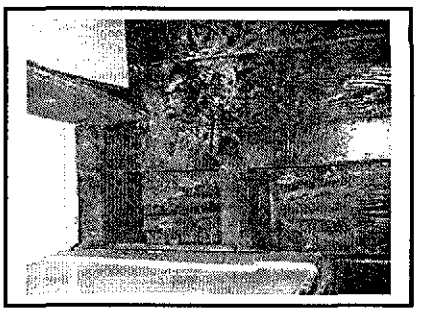
- To observe bearing condition at area of severe floor deflection.
- Confirmed that partition is non-loadbearing and that wall studs are discontinuous. Steel strap, bracing wall into wood floor, was observed.

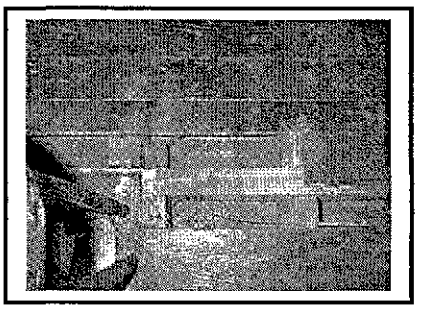
- To observe stair/floor connection.
- Determined stair header size and landing joist sizes.

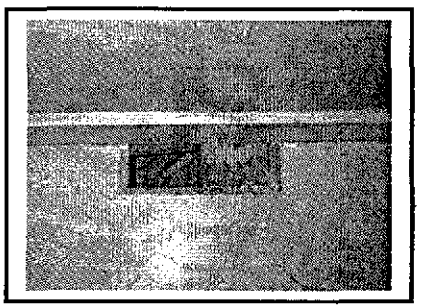
- Floor at base of partition near death room (partition likely removed and rebuilt)

- To observe framing size, spacing and span direction in original portion of ell (in location out of the restoration area).
- Framing information was measured and documented.

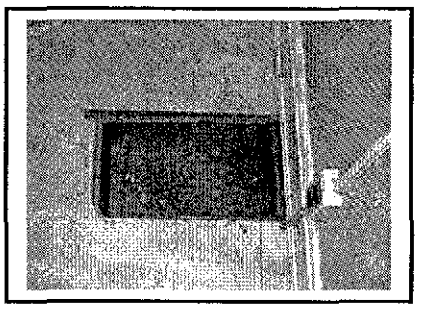
Opening #11

- Floor at base of interior masonry wall (rear exterior wall in 1865)

- To observe framing size, spacing and span direction in 1870s portion of ell.
- Framing information was measured and documented.

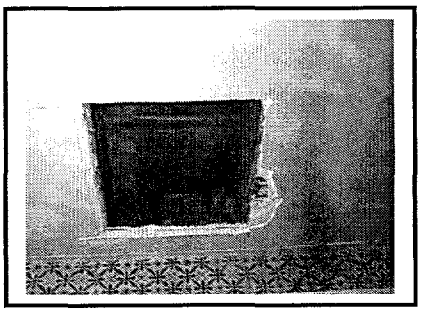
Opening #12

Location: Basement Floor – Room 10

- Ceiling at interior partition, below Front Parlor

- To observe framing size, spacing and span direction at assumed bearing wall (in location out of the restoration area).
- Framing information was measured and documented.

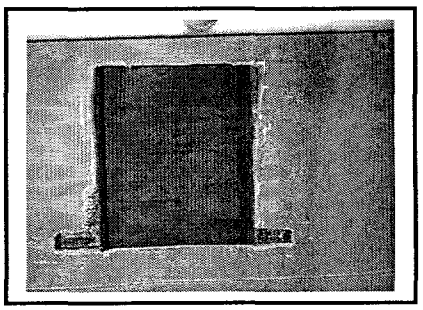
Opening #13

Location: Basement Floor – Room 11

- To observe framing size, spacing and span direction (in location out of the restoration area).
- Framing information was measured and documented.

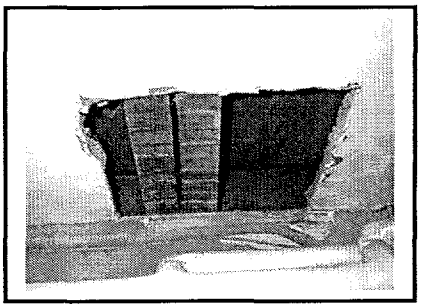
Opening #14

Location: Basement Floor – Stair Hall

- To observe potential joist bearing location.
- To determine framing size, span direction and spacing of members.
- Framing information for floor and ceiling was documented. Low beam was observed.

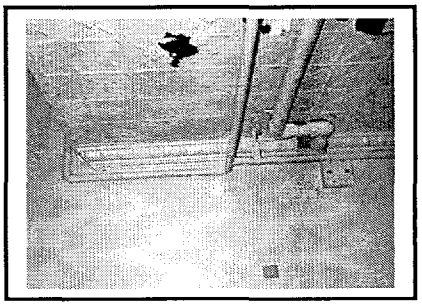
Opening #15

Location: Basement Floor – Room 12

- To observe existing framing condition where water damage may have occurred.
- Framing, size and spacing, was confirmed. No structural damage was apparent at joist ends.

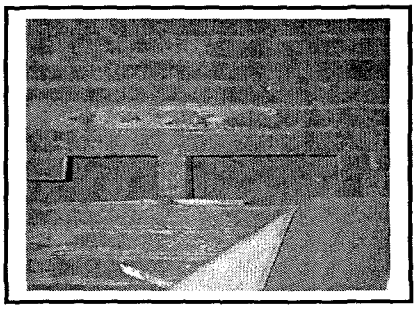
Opening #16
Location: Basement Floor – Stair Hall
- Floor of hallway near north exterior masonry wall

Reason for Opening/Findings:
- To confirm joist bearing condition at exterior brick wall (east)
- Joists were observed to pocket into existing brick. Framing, size and spacing, was measured and documented.
