MARTIN VAN BUREN

HISTORIC STRUCTURE REPORT

Architectural Data Section

LINDENWALD

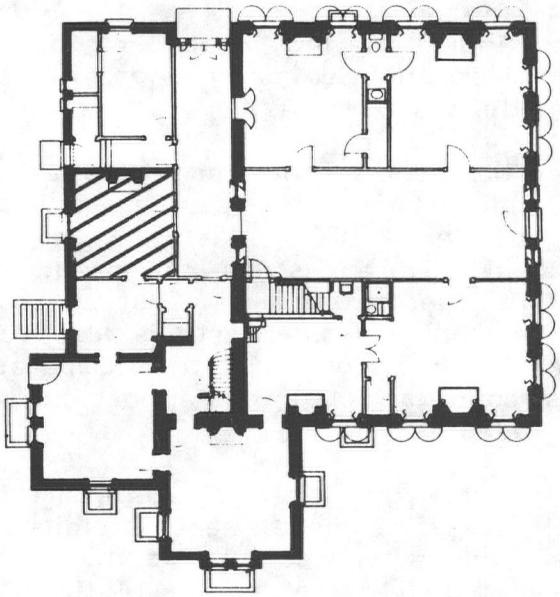
The original finish of the plaster walls and ceiling was the unpainted white-coat plaster. Lower portions of the walls are now painted gray and white. More than half of the ceiling has been patched and, most likely, totally replastered. Cracks on the west wall indicate a downward movement of a short portion north of the board

partition. One very visible, vertical crack occurs at the point where the wall meets the masonry arch. It was caused by deflection of the floor joists that support the frame west wall.

Replace the plaster ceiling patch with a closer match in texture and evenness.

Remove the board partition and door.

Remove the folding door and replace with the original door.

Restore the unpainted plaster wall and ceiling finish.

Restore all painted wood finishes to a tan color (Munsell 10YR 8/2, Benjamin Moore CB-35).

Check the floor joists in relation to downward movement, and monitor cracks.

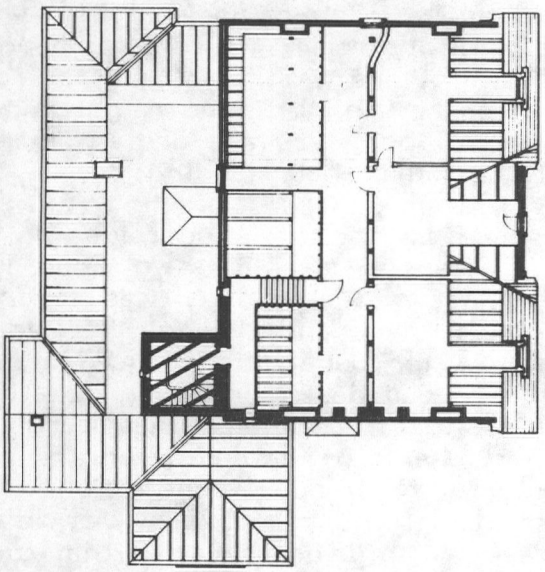
There is no discernible evidence of any mechanical equipment in the room.

The preservation and restoration work recommended for room 401 includes the following items:

Repair or replace all damaged or missing plaster and lath.

Replace missing balusters, repair the railing, and tighten loose joints to make the rail assembly more secure.

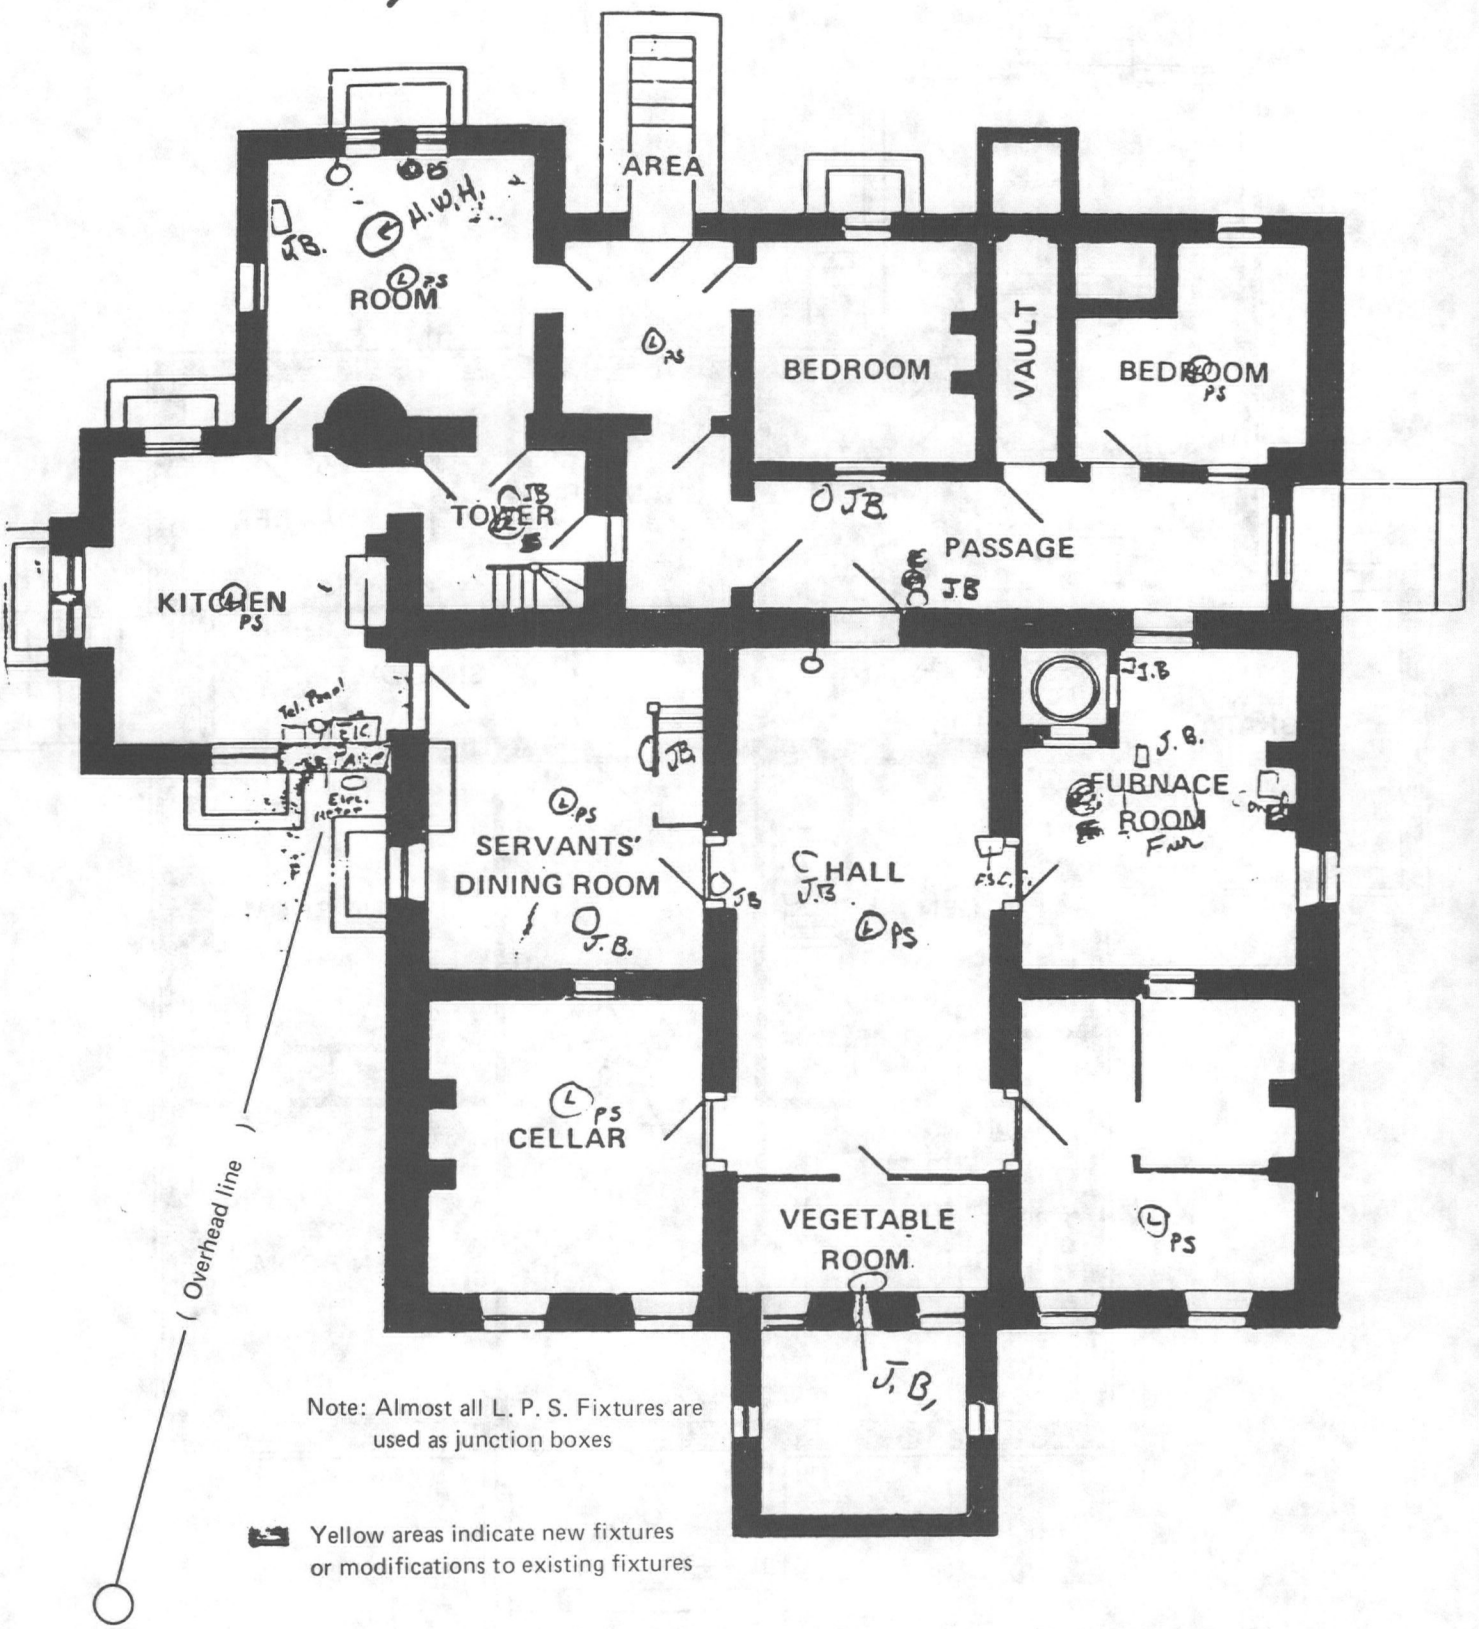
In order to restore the house to its appearance during Van Buren's residence, it will be necessary to remove or conceal all evidence of electrical equipment. The first and most important part of this process will be to conceal the electrical supply lines that bring power into the house by burying them. The location of the buried lines is affected by three factors--the archeological resources that might be disturbed by the trenching operations, the site of existing or future power supply lines, and the future placement of the main disconnect and/or panel box on the interior. Any location that would create the possibility of disturbance to subsurface resources would require monitoring of the excavation work by a qualified archeologist. It is recommended that any planned subsurface disturbance around windows 007 and 009 or the north entrance be preceded by controlled archeological excavation.

The existing overhead electrical line approaches the house from the east and continues past the south side of the house to serve the garage, trailers, and farmhouse beyond. The present service entrance and panel box is in the northeast corner of room 006.

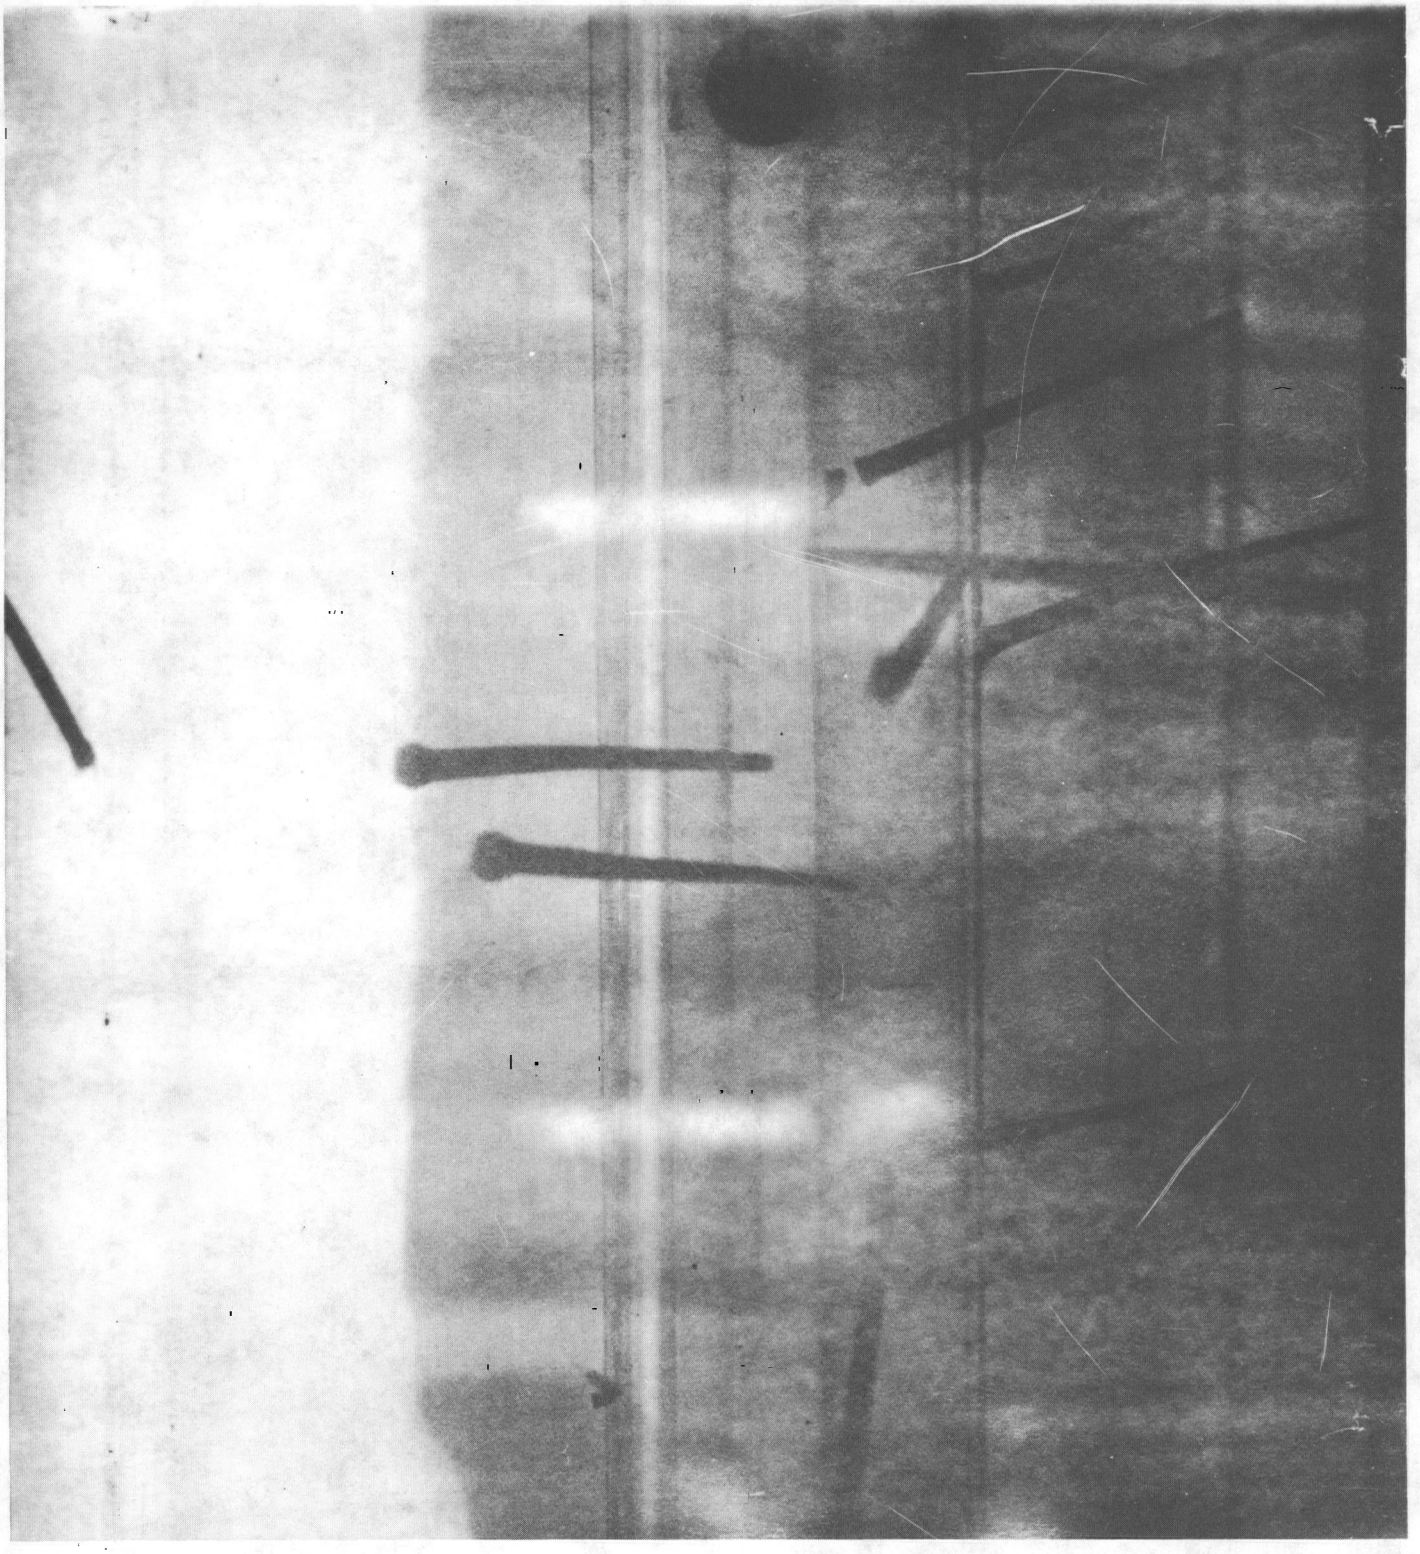
The X-ray taken at the floor level shows the wood pin securing a stud tenon to the plate. This information supports the existing physical evidence of change in the location of the door opening (see MAVA 01 X018-019).
