National Park Service
Cultural Landscapes Inventory
2012

Roose's Homestead
Olympic National Park

CONDITION ASSESSMENT: **Poor**

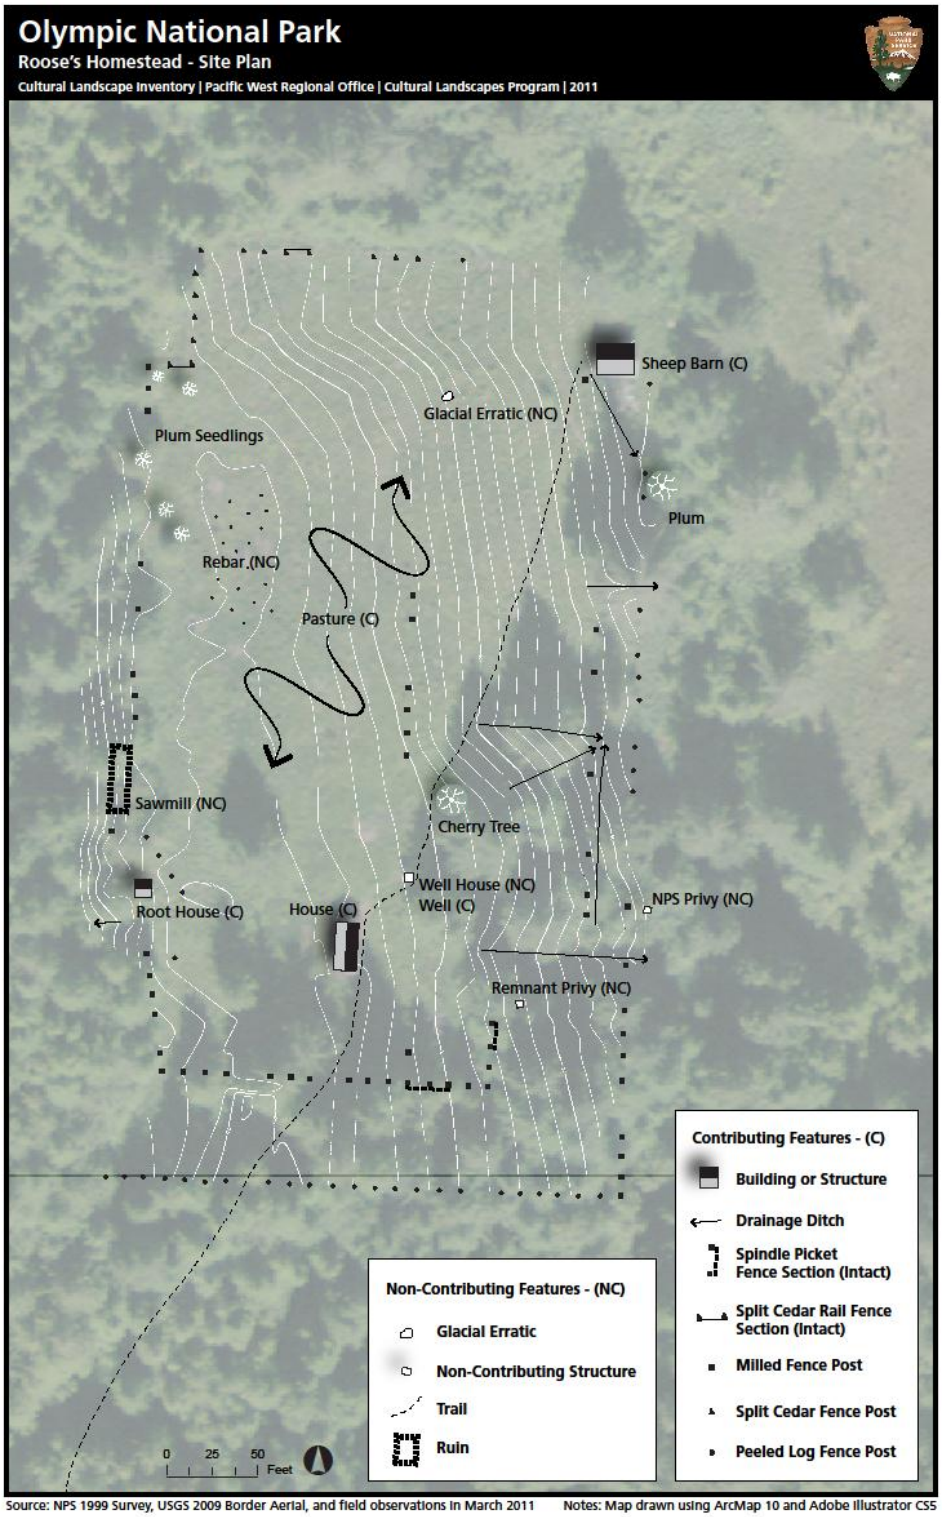
Site Plan #2: Map showing existing conditions at Roose's Homestead. See the supplemental information section for a full 11 x 17-inch version of the site plan (Pavlik, PWR 2011).

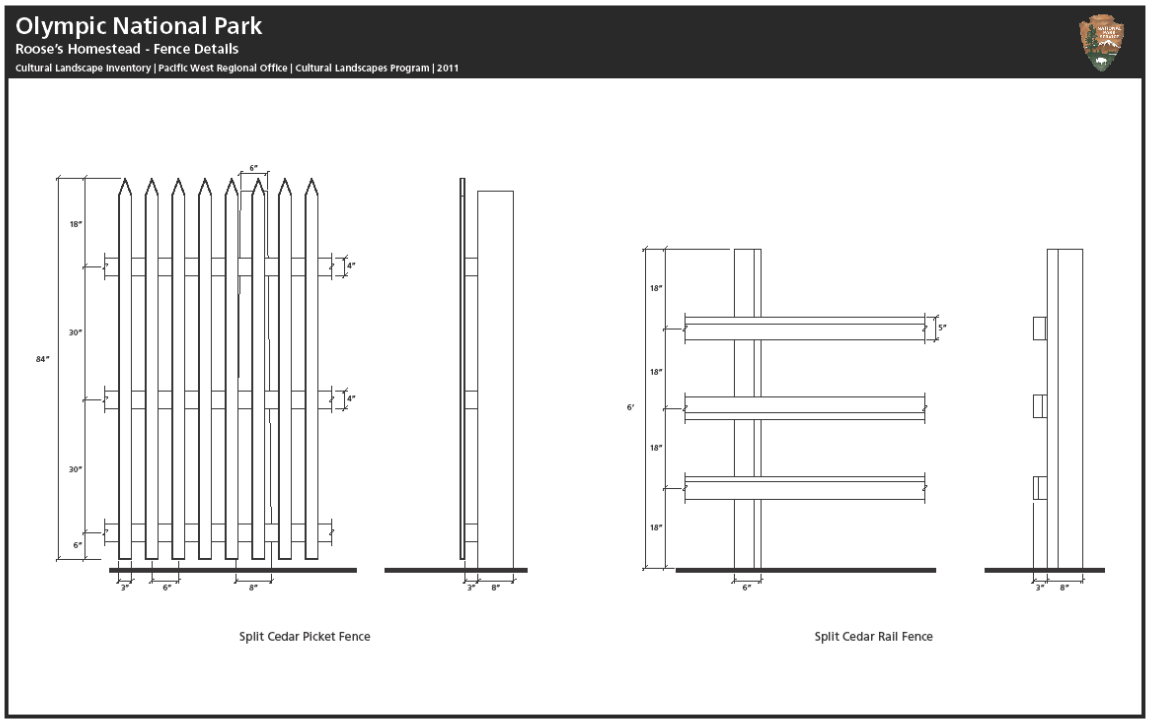
Structures #5: Graphic showing three different fence types found in the core developed area at Roose's Homestead. For a larger version of each illustration, see the supplemental information section at the end of the CLI (Pavlik, PWR 2011).
