LANDSCAPE PRESERVATION MAINTENANCE PLAN

DUMBARTON OAKS PARK

Olmsted Center for
Landscape Preservation

April 1997

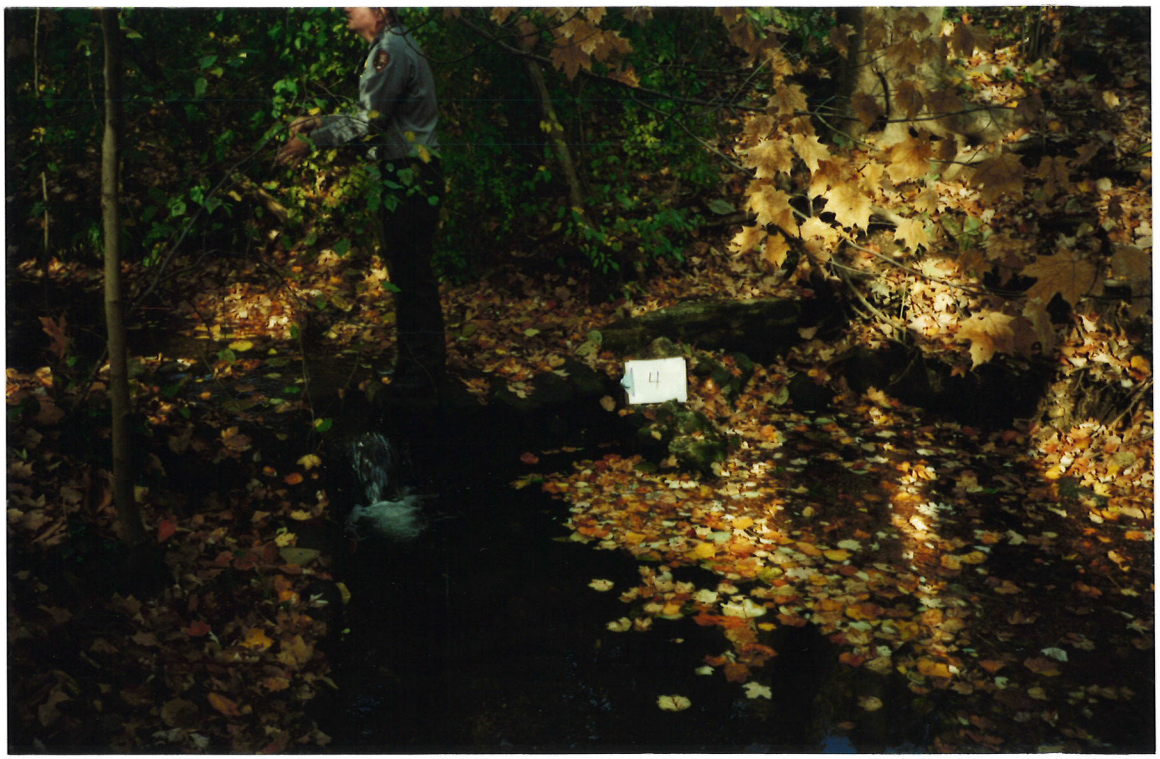
Figure 4: Three Bridge Falls (3 of 3), 1996.

Historic Significance: The third of the Three Bridge Falls provides one of the rare glimpses of the formal gardens and just beyond provides an advantage point to see Forsythia Hill. It was designed with a more casual appearance and prepares one for a more natural section of the stream path. All three falls intentionally interrupt the curving stream path and mark vantage points of unique garden features.

Descriptive Characteristics: The upper falls is approximately 64 feet above the middle falls. It is constructed of stone spill rocks with adjacent concrete and stone retaining walls.

Dam #4: Three Bridge Falls (3 of 3)
Emergency Stabilization: Sandbag behind left wingwall, as well as to fill voids on right bank adjacent to dam.
Repair: Replace dam "lip" stones permanently; remove left sapling closest to dam and hand-excavate to find wall above dam; leave larger sapling whose roots are "holding" the bank. Remove siltation.
Note: Use as a model project to be completed cooperatively by Friends and Park
