Gordon Hall

Rehabilitation Master Plan

Gordon Hall Local Historic District

August 2011

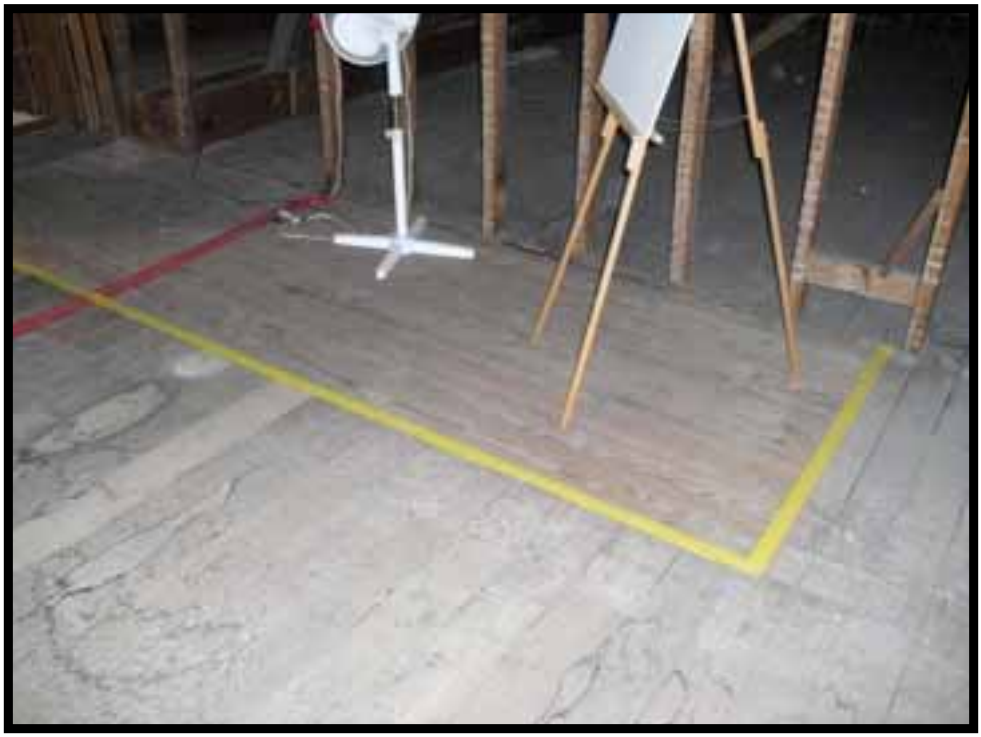
23. OPENING FOR ORIGINAL ATTIC STAIR HAS BEEN FILLED IN AND FLOORED OVER.
