HIGHLAND LIGHTHOUSE AND KEEPER'S DWELLING

HISTORIC STRUCTURE REPORT

North Truro, Massachusetts

May 1994

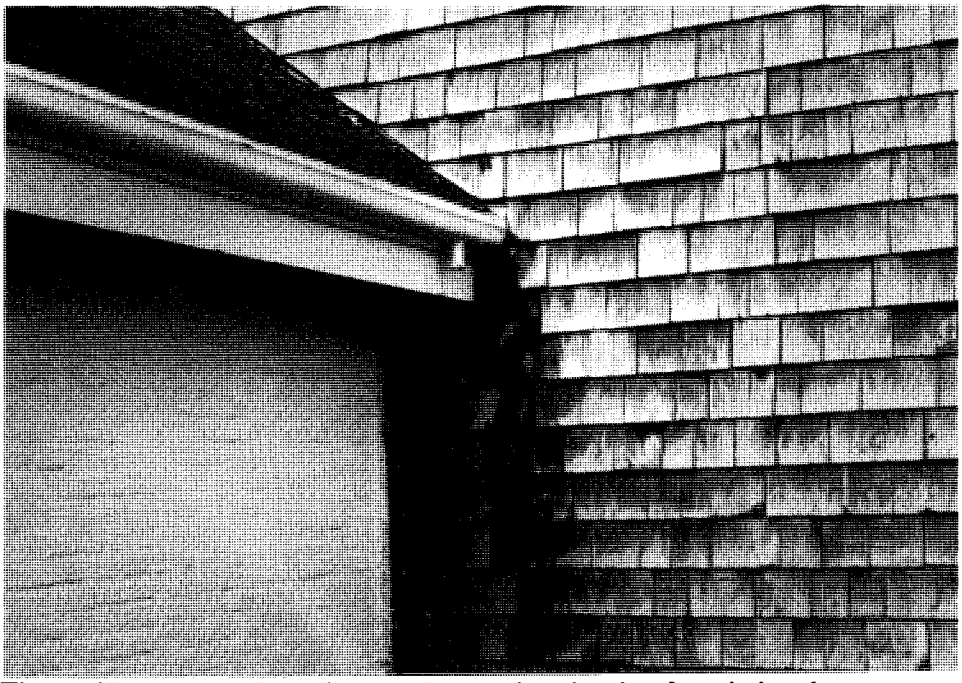
Figure 49. Keeper's Dwelling, south elevation, bracket for missing downspout.

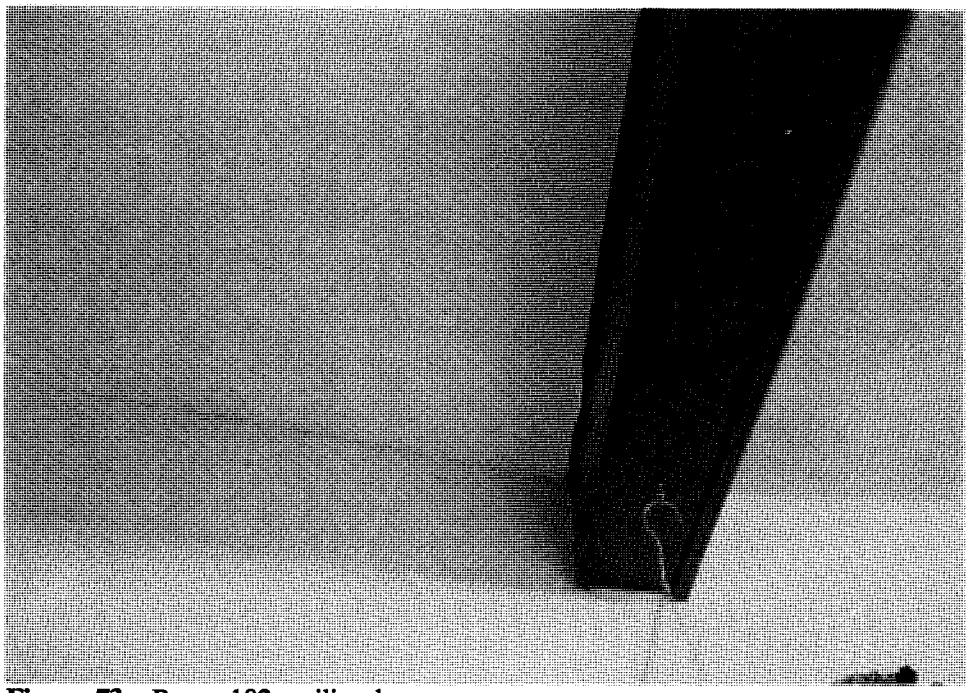
Ceiling. A single encased beam runs east to west near the doorway to the southeast room (fig. 73). It is darkly stained and does not appear to be original. The ceiling is otherwise typical.

Figure 73. Room 102, ceiling beam.

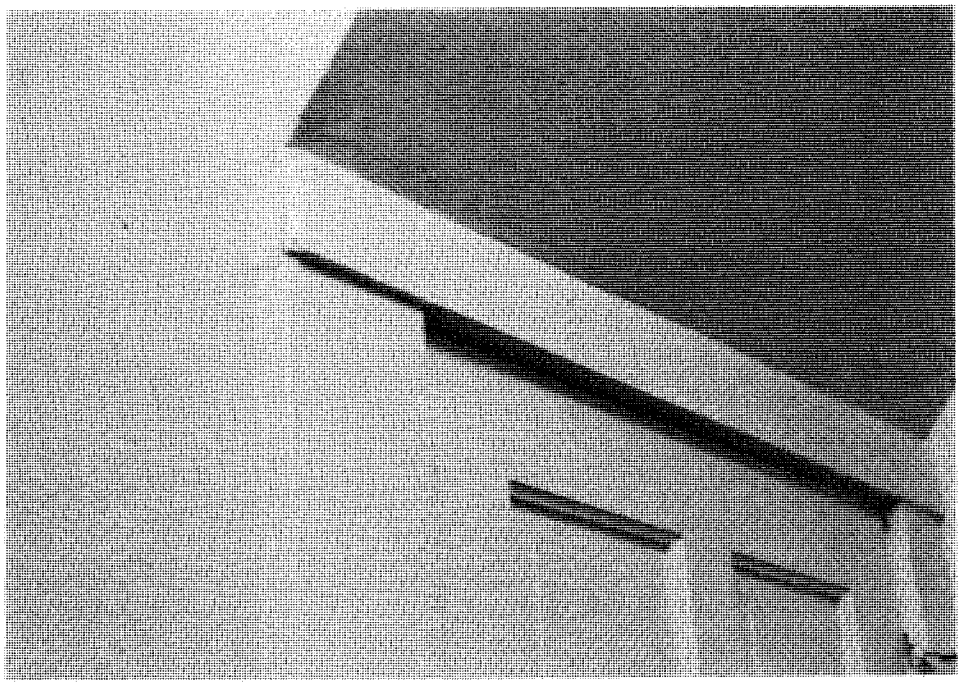
Doorways and Doors. There is a doorway on the west wall of the stair hall leading to the basement. The doorway surround may date to circa 1900 (fig. 76). Its south side is 5 3/8 inches wide, while its north side is 4 1/4 inches wide. The door is typical and painted off-white.

Figure 76. Room 104, trim of doorway to basement.

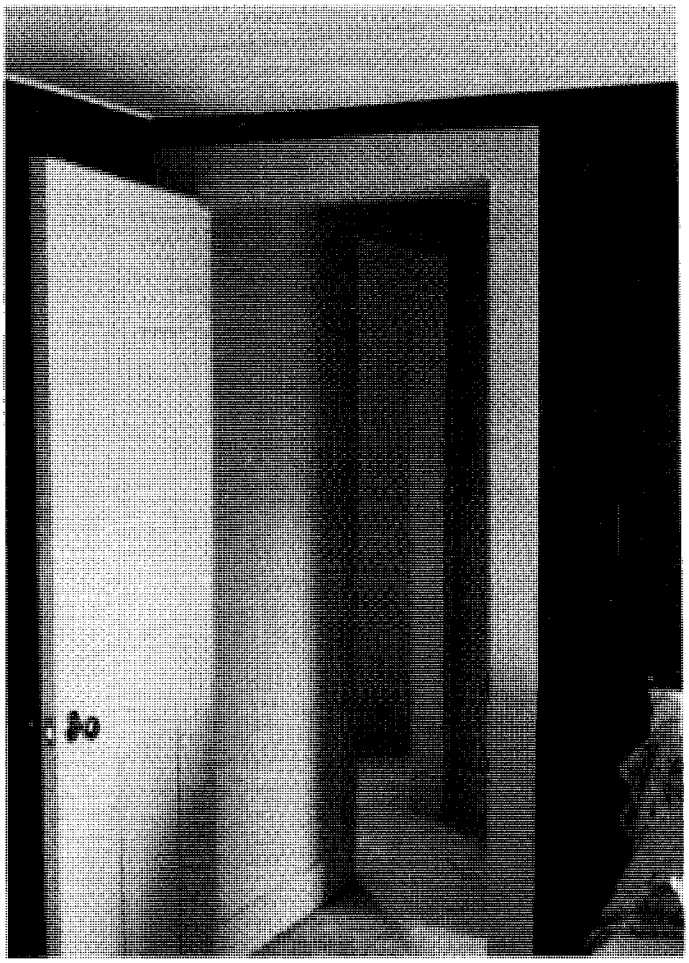
Doorways and Doors. The entrance doorway, at the west end of the north wall, and the west-wall closet doorway are typical. The trim around both doorways (figs. 83 and 84), painted off-white, does not match the trim found typically. It dates to the 1900 renovation.

Figure 83. Room 204, trim of north doorway (may date to 1900 renovation).

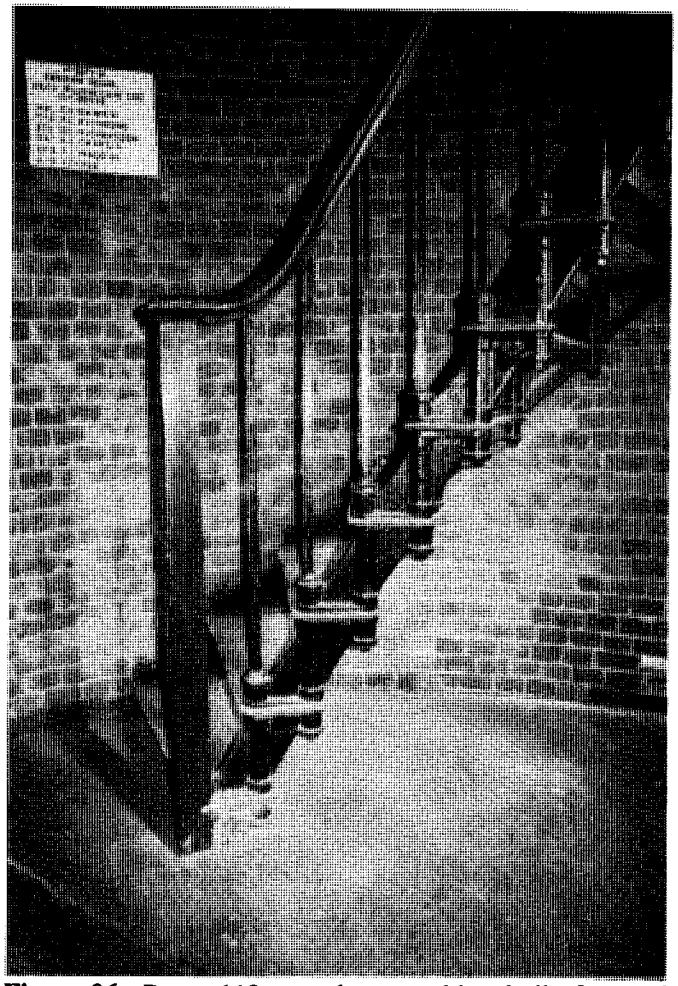
The stair balustrade has a wooden handrail and newel post, and wrought-iron balusters square in section. The handrail and newel (fig. 96) are unpainted; the balusters are painted black. The handrail shows signs of possible alteration. Its grooved underside has round holes where round balusters may have previously been fitted; the baluster spacing does not correspond to the existing spacing (fig. 97). The end of the rail near the newel post may have been cut.

Figure 96. Room 112, newel post and handrail of curved stair, First Level of Tower.

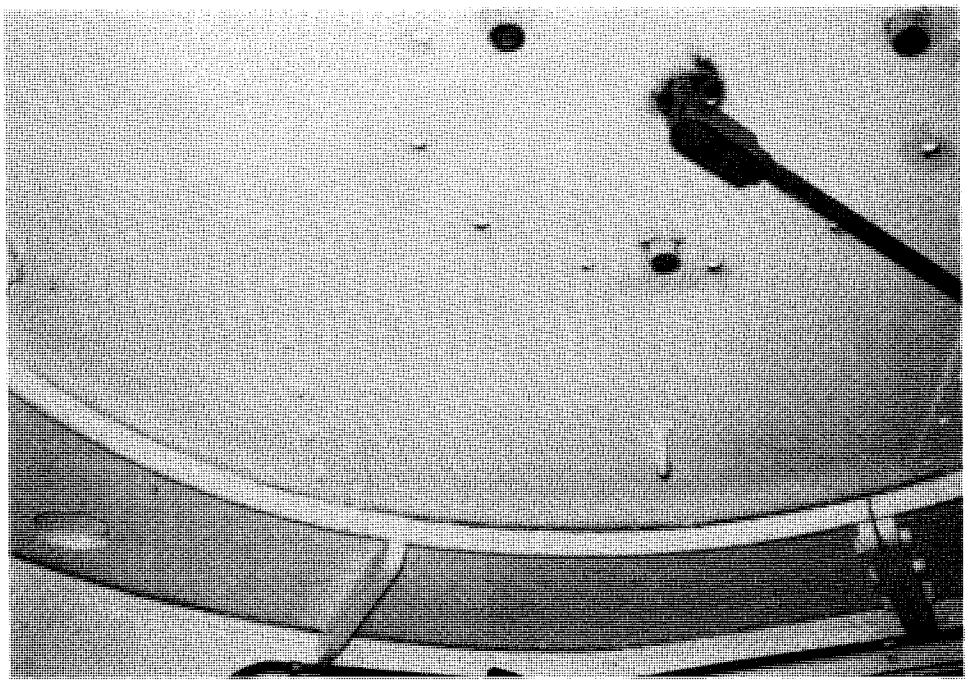
Figure 107. Room 112, Watch Deck ceiling (underside of Lantern Deck), showing original floor and later circular floor added to support 1946 beacon.

The floor of the Lantern Deck is covered with a circular steel floor in three sections. The original perimeter floor was presumably installed in 1857, and is visible from the Watch Deck below. It is composed of four sections of flanged steel plate, with intermediate stiffening webs, bolted together at the flanges (see fig. 107). A wood quarter-round base molding covers the junction of the floor and wall. The floor has a circular pattern of evenly spaced holes (fig. 113) near the center from previous equipment before the lantern was changed to a beacon in 1946. The floor is painted red. The opening in the floor for the stair down to the Watch Deck has been made narrower by the addition of a plywood section, 3 1/4 inches wide and painted yellow, along the inner side of the opening (fig. 114). On the opposite, outer edge of the opening, the top of the furred-out wall of the Watch Deck is painted bright yellow. A stock iron handrail protects the opening.

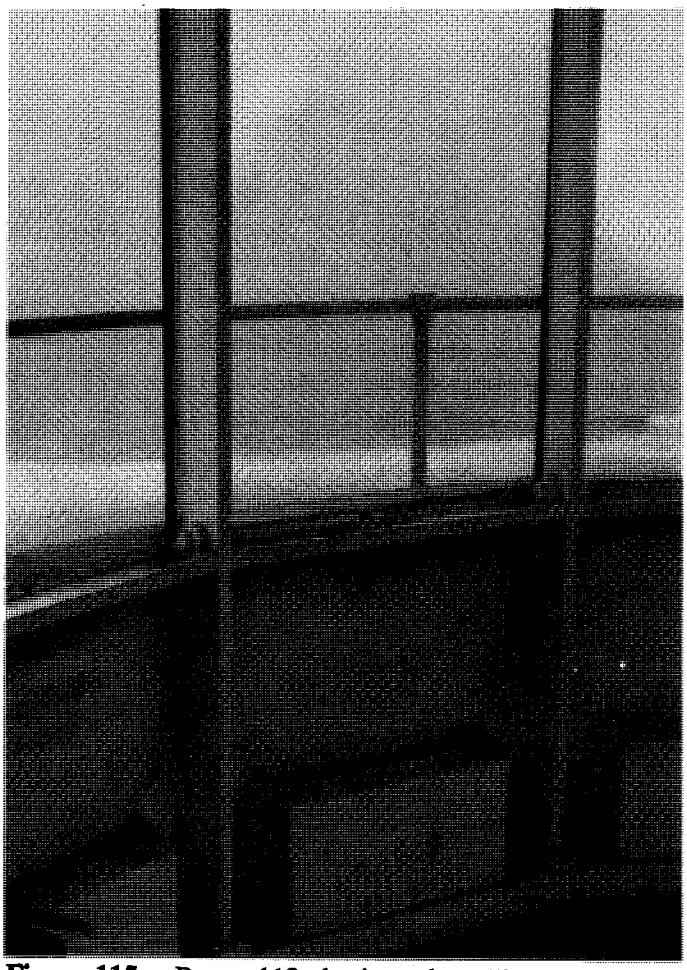
The "walls" of the Lantern consist of 16 panels of equal size rising from floor to ceiling. Each panel is divided into three horizontal sections. The sill of each panel is bolted to the floor, and intermediate horizontal mullions are bolted to the vertical members (fig. 115). The bottom sections of the panels measure 2 feet 7 1/2 inches high by 2 feet 1/2 inches wide, and consist of painted aluminum. Sheet-metal vent covers with filters are located at the base of each panel (fig. 116). The top two sections of each panel are filled with plexiglass; each measures 3 feet 4 3/8 inches high by 2 feet 1/2 inches wide. The tops of the panels form a continuous iron ring (fig. 117). A vent is centered above each panel. Iron pegs (fig. 118) pin the vertical mullions to the perimeter lintel. Attached to these blocks are eye hooks and eye bolts that may have been used for curtains. All of the metal is painted white.

Figure 115. Room 112, horizontal mullion of Lantern Deck window wall.

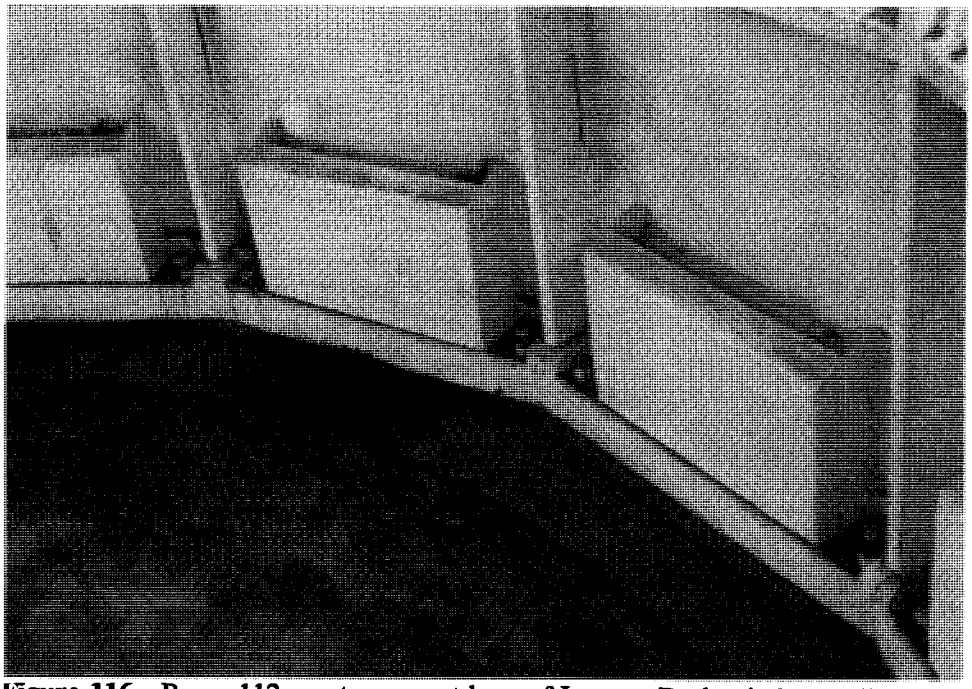
Figure 116. Room 112, vent covers at base of Lantern Deck window wall.

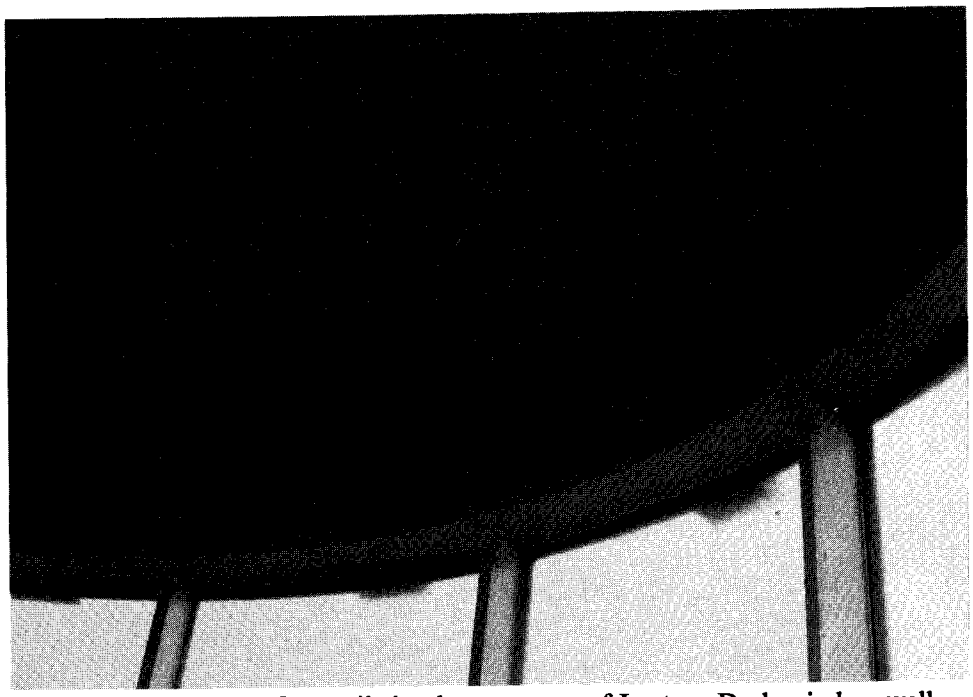
Figure 117. Room 112, ventilation boxes at top of Lantern Deck window wall.

Figure 118. Room 112, iron pegs that pin vertical mullions of Lantern Deck windows to continuous perimeter lintel. (Note curtain hooks.)

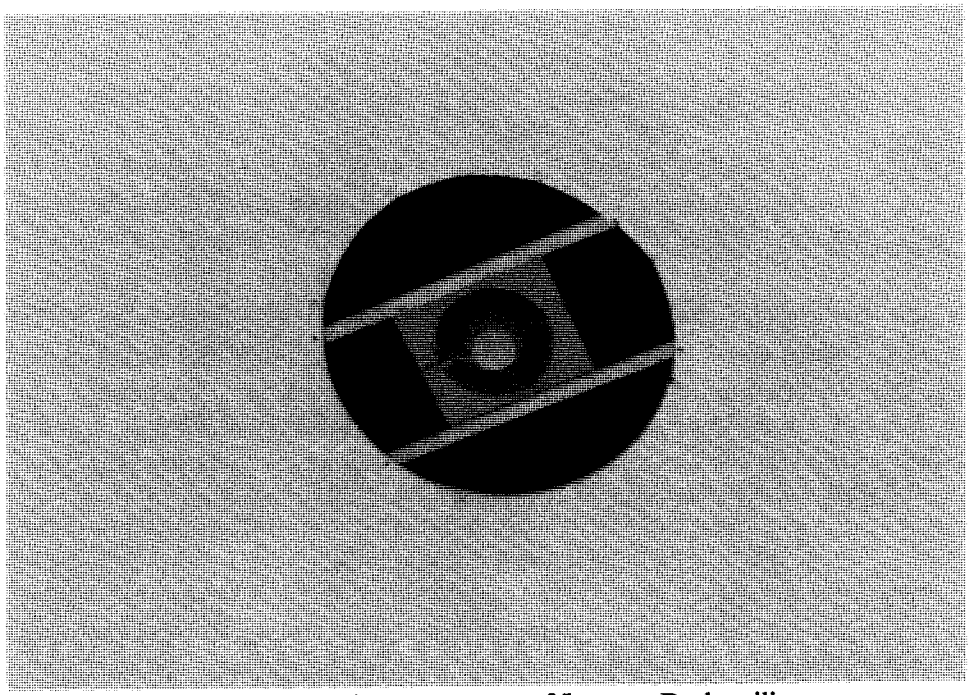
The ceiling is covered with sections of sheet metal that are painted white, the underside of the truncated cone spaced several inches below the underside of the roof. The lantern lining was replaced in 1906. The sheet metal is secured with bolts of alternating size. At the center of the ceiling, a circle is cut out for a ventilator (fig. 119).

Figure 119. Room 112, ventilator at center of Lantern Deck ceiling.

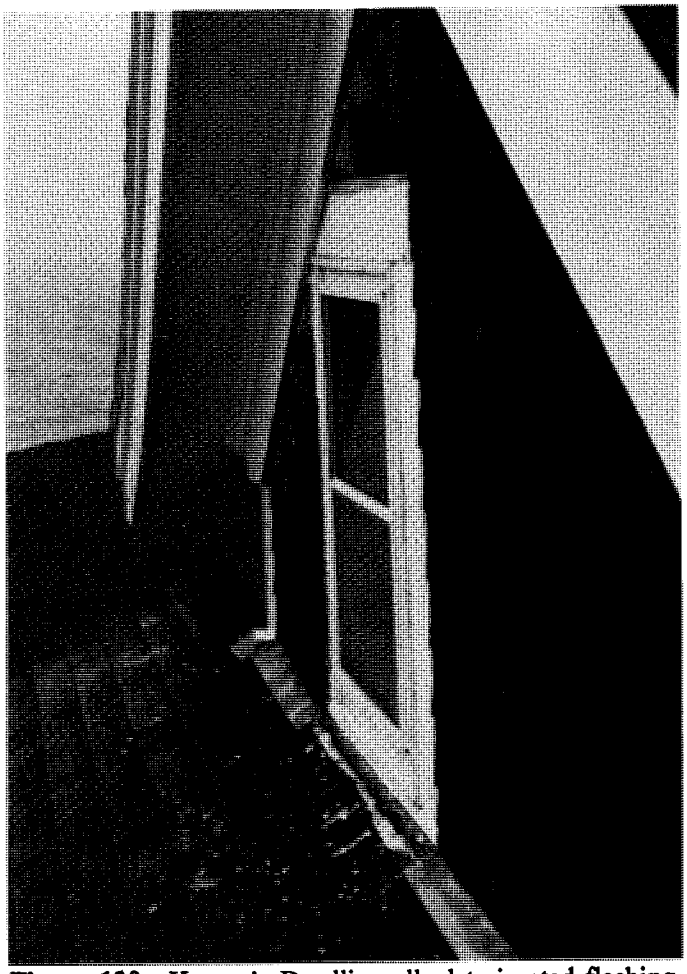
Figure 120. Keeper's Dwelling ell, deteriorated flashing at north elevation.

- Install leaders, downspouts, elbows, and splash blocks at both gutter sections.
- Verify the condition of the flashing at the termination of the built-in gutters.
- Scrape and paint the metal vent stack.
- Regrade surrounding soil to a minimum of 6 inches below the bottom of the wood siding, where possible, sloping away from the building.
- Regrade soil to a level below the basement window sill.
- Install a proper scupper at the valley of the interconnected dormer roofs.
- Reset the sill of the entry door sill in a level condition.
- Replace all step flashing.
- Repair/replace deteriorated wood trim.

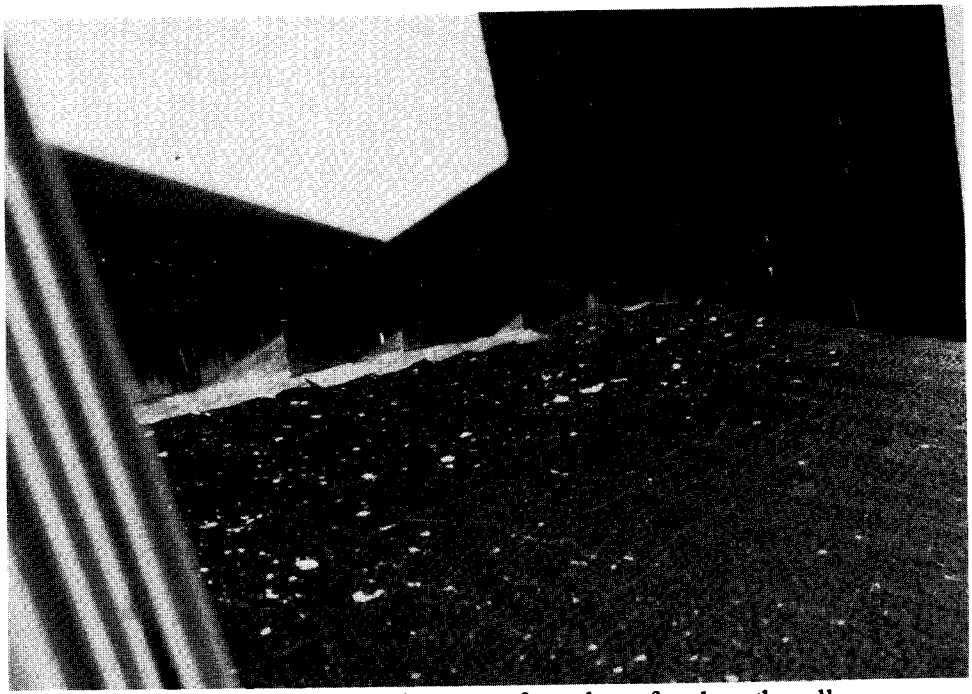
Figure 121. Keeper's Dwelling, juncture of porch roof and north wall.

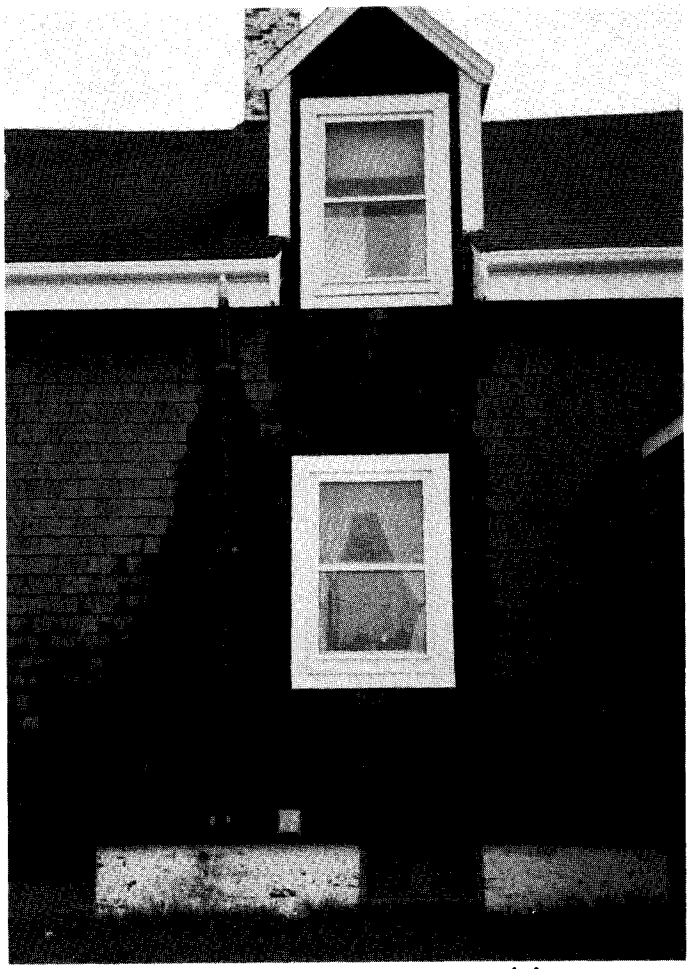
Figure 124. Keeper's Dwelling, water staining at west elevation.

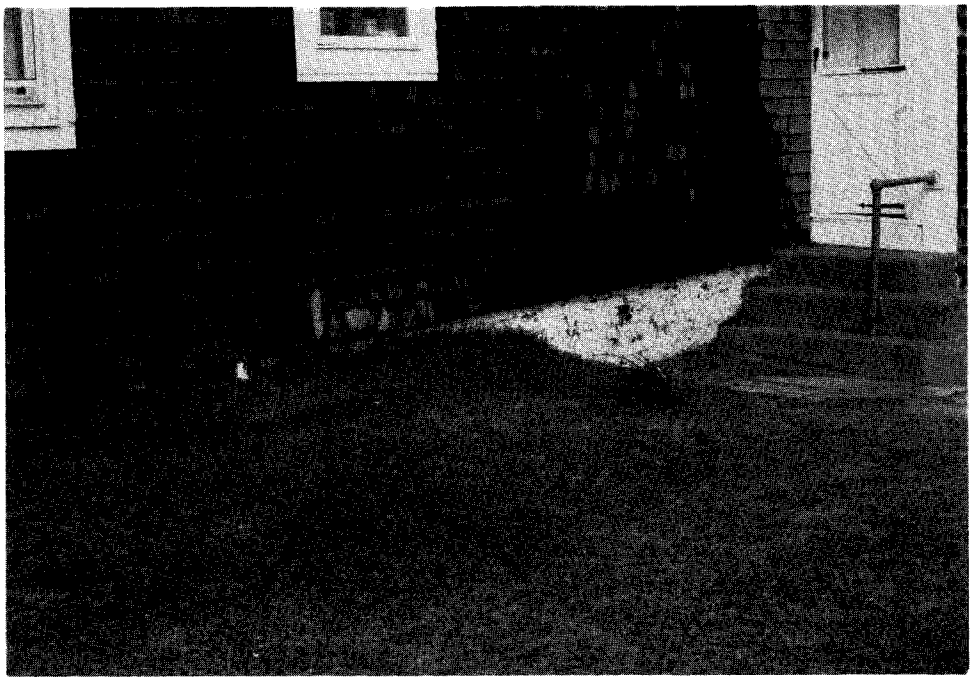
Figure 126. Keeper's Dwelling, built-up grade against wood siding of east elevation.

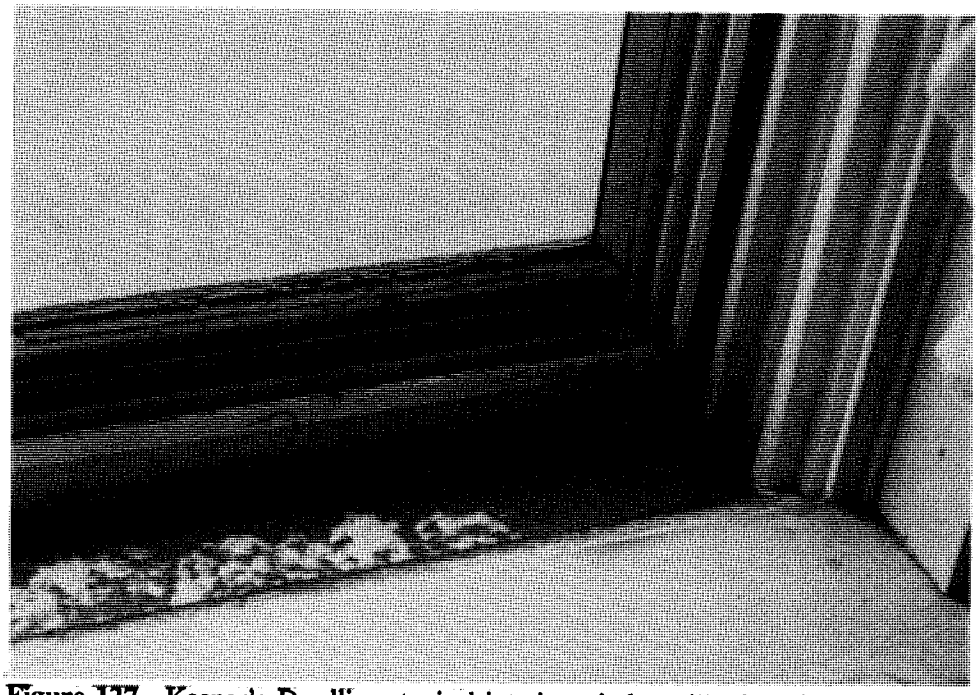
Figure 127. Keeper's Dwelling, typical interior window sill with wind-blown sand.

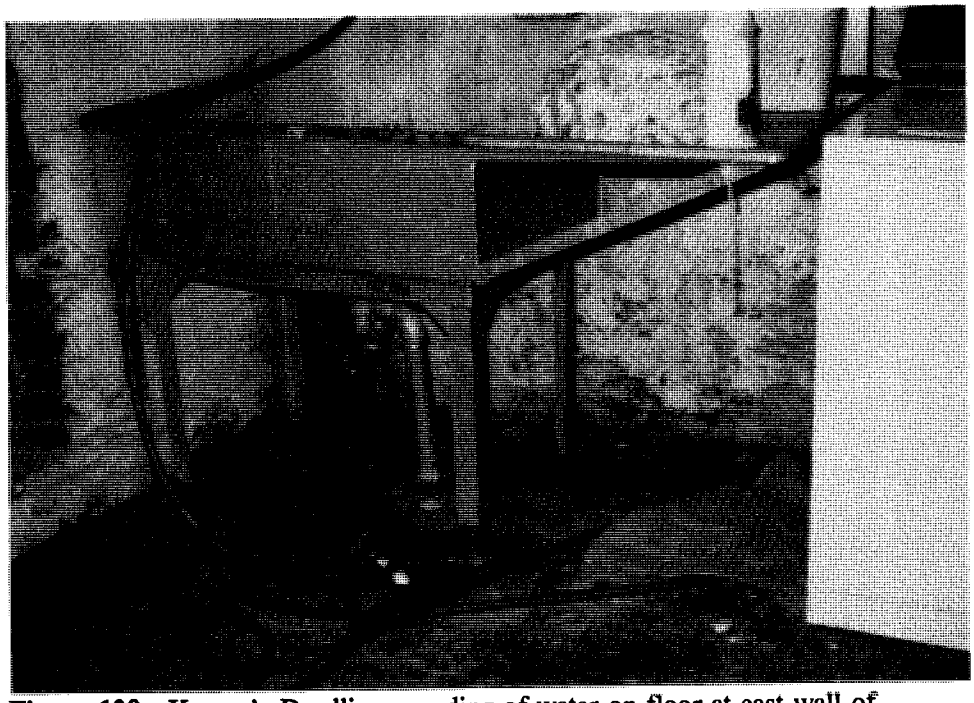
Figure 129. Keeper's Dwelling, ponding of water on floor at east wall of basement.

- Determine the source of the moisture penetration along the east wall.
- Regrade and/or damp-proof the bulkhead retaining walls.
- Install a new bulkhead with proper seal/flashing.
- Rebuild the damaged walls and repoint deteriorated mortar joints.
- Rebuild the cellar sashes with storm panels, and screened panels to ventilate the basement during the summer.

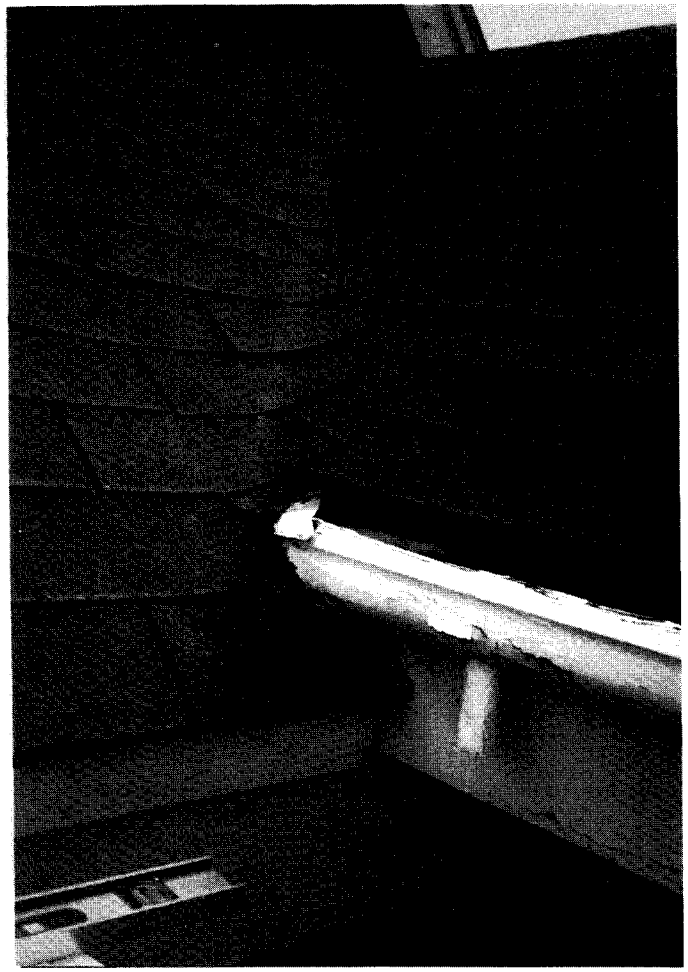
Figure 131. Connector at Keeper's Dwelling, east elevation, south end of built-in roof gutter.

- Regrade to provide positive drainage from the base of walls and blocked entry doors.
- Install leader, downspout, elbow, and splash block at the south end of gutter.
- Consider combining the two downspouts between the Connector at the Keeper's Dwelling and the Tower Connector.
- Install proper flashing where the gutter meets the roof edge.
- Install a proper building joint between the connector and Keeper's Dwelling using a backer rod and sealant.
- Use only noncorroding fasteners, such as galvanized or stainless steel nails.

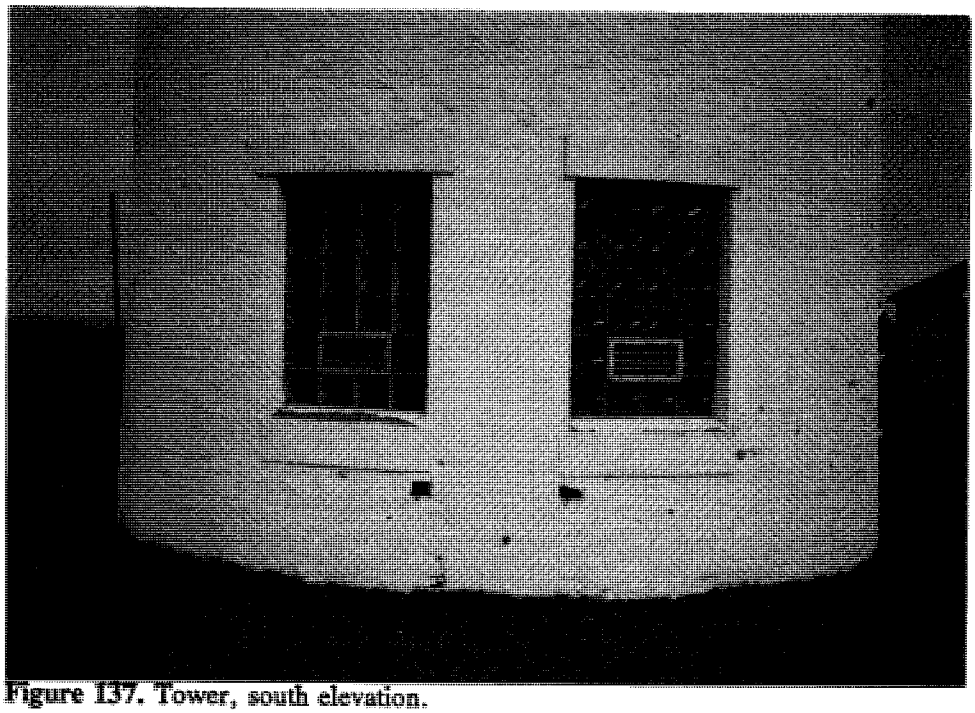
- There are two spalled brick ends below each window (figs. 137 and 138).

Figure 137. Tower, south elevation.

- Replace/consolidate spalled bricks and recoat them.
- Provide a more controlled means of ventilation to allow drying out of the interior after periods of high humidity.
- Use of a waterproof coating should be considered only if the problem persists after all other remedial and repair work is completed.

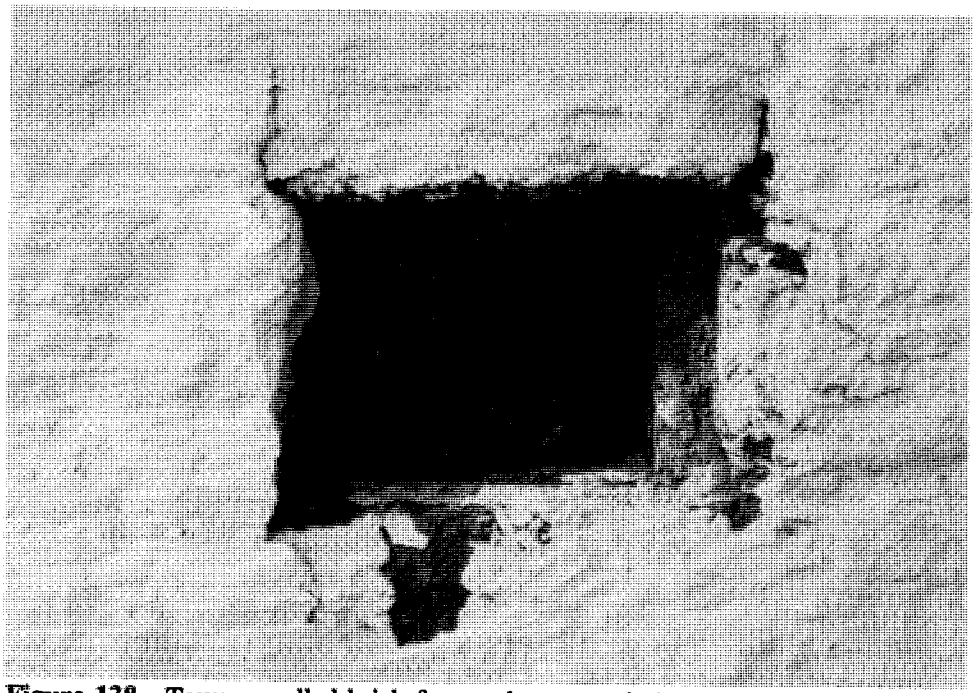
Figure 138. Tower, spalled brick face under west window of south elevation.

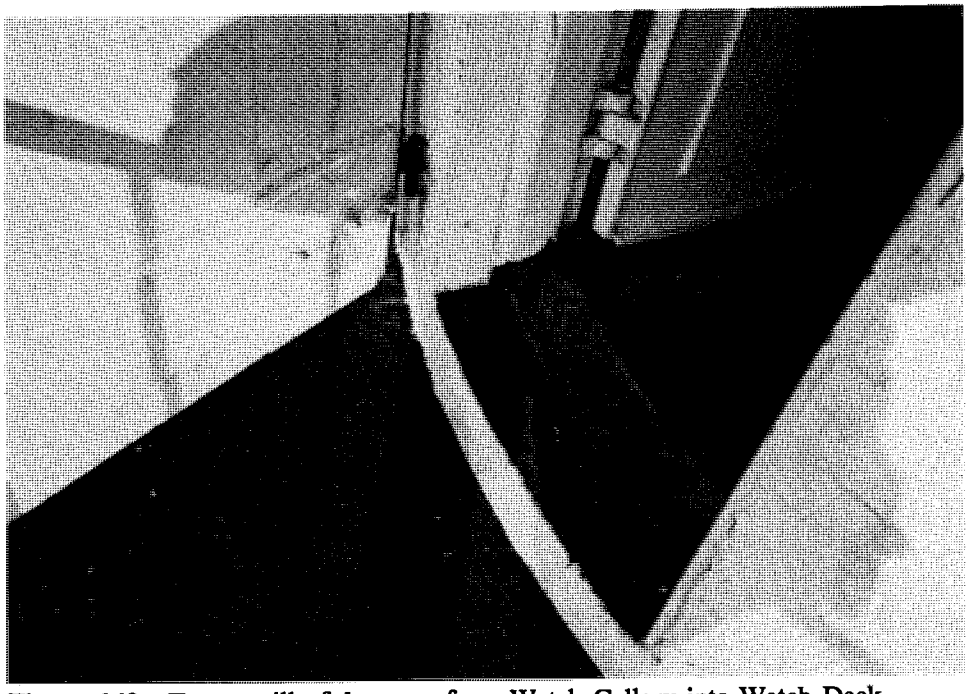
- The hinges of the exterior door in the doorway to the Watch Deck exhibit corrosion due to the wearing of paint surface coatings (figs. 141 and 142).
- The Watch Gallery railing appears to be original. Consisting of eight sections, it has flat metal handrails and bottom rails, and round metal balusters. The amount of corrosion visible is consonant with the severity of the location.

Figure 142. Tower, sill of doorway from Watch Gallery into Watch Deck.

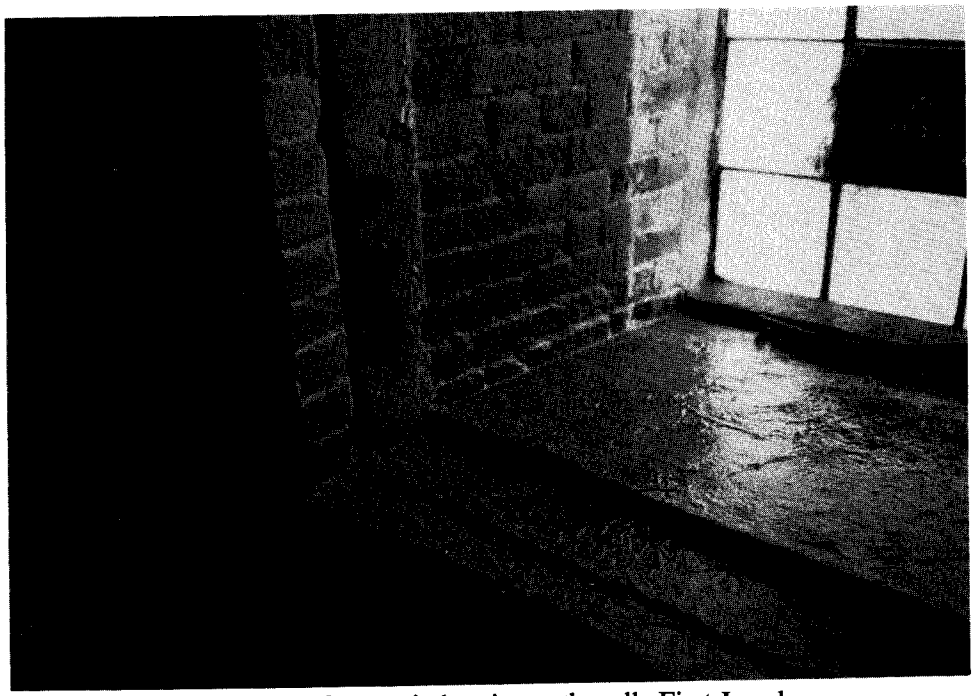
Figure 147. Tower, sill of east window in south wall, First Level.

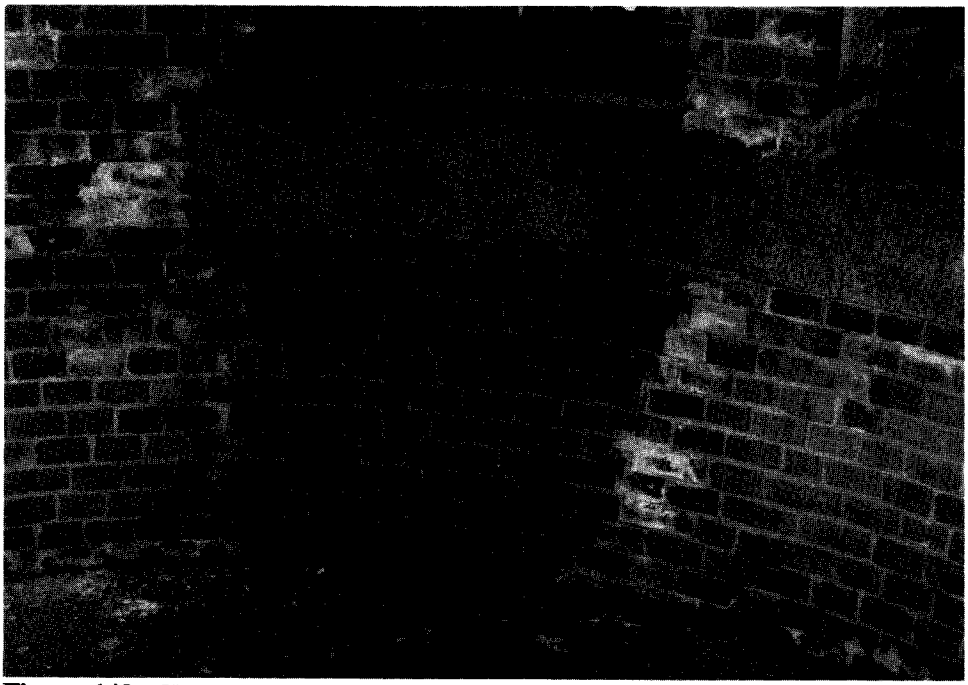
Figure 149. Tower, water saturation below sill of east window in south elevation, First Level.

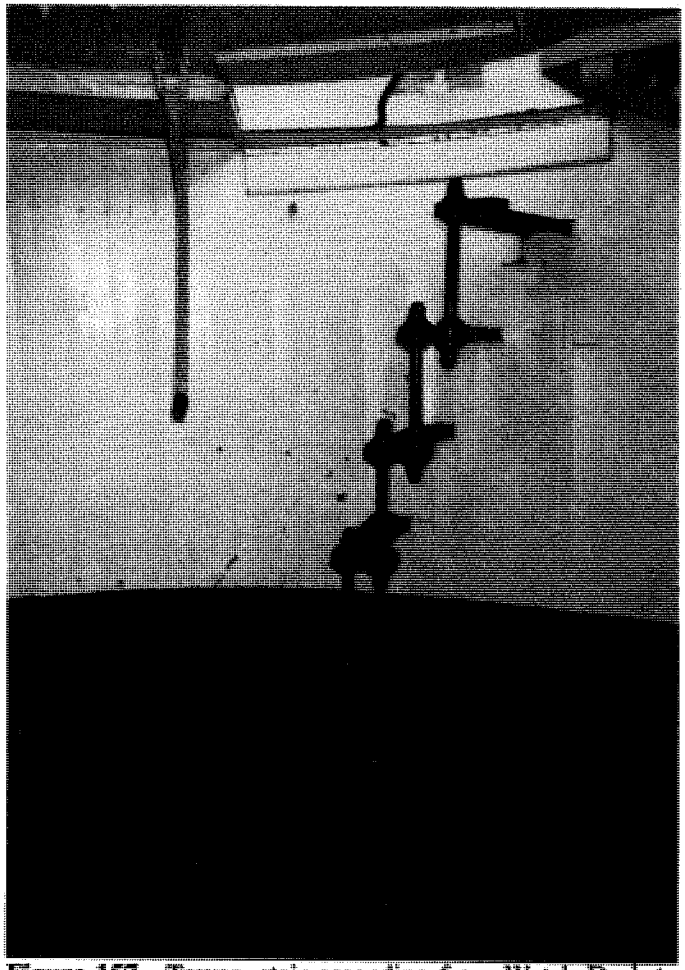
- Orange staining is visible emanating from behind the furred-out wooden interior wall where it is cut out for the top tread of the stairway to the Lantern Deck (fig. 157).

Figure 157. Tower, stair ascending from Watch Deck to Lantern Deck.

- Install an astragral seal at the perimeter of the steel door to the exterior Watch Gallery.
- Install hardware to assure tight closure of the door.
- Determine the source of moisture penetration and the consequent corrosion of the top tread of the stairway to the Lantern Deck.
- As a temporary measure to reduce the ingress of water, apply sealant to all of the exterior joints and seams of the four floor plates. Permanent repair of the corrosion evident between the flanges at the connections of the four floor plates will be problematic. To adequately clean the metal surfaces for application of new paint, the sections would have to be dismantled, which would require the Lantern to be lifted off entirely.

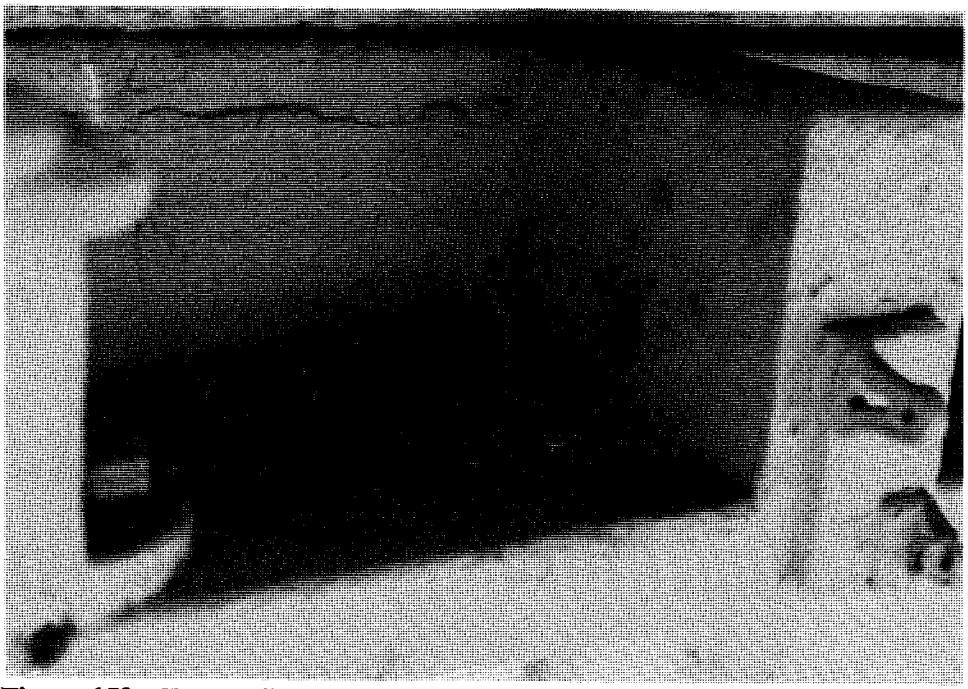
Figure 159. Tower, displaced pin at top of Lantern Deck window wall.
