PLUNKETT - MEEKS STORE AND HOUSE
(Building Number 9)

APPOMATTOX COURT HOUSE NATIONAL HISTORICAL PARK

Supp. No [redacted] I: Architectural Survey Report

Prepared by Henry A. Judd, Architect May 19, 1958

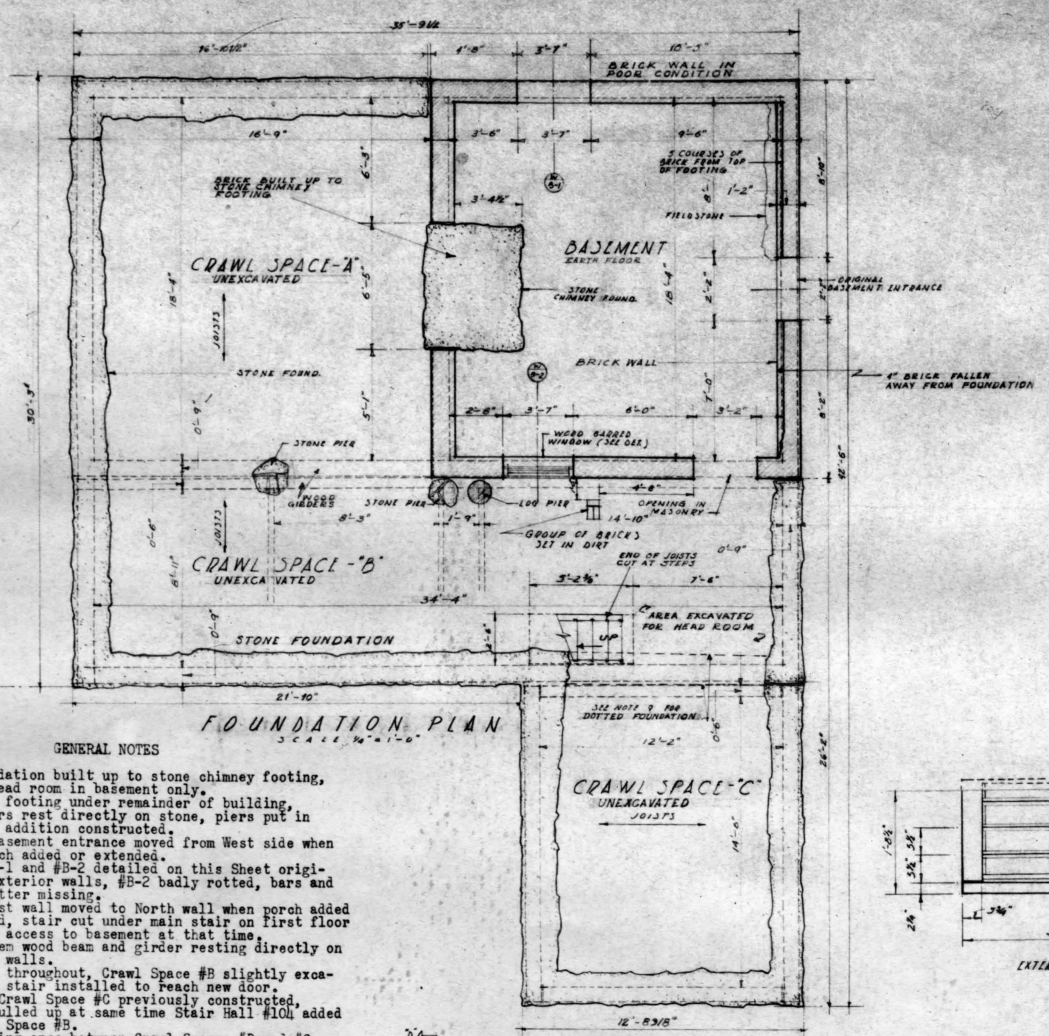
SHEETS 1, 2, 3, 4, 5, 6, 7, 8 and 9

FOUNDATION PLAN
SCALE 3/16"=1'-0"

1) Brick foundation built up to stone chimney footing, standing head room in basement only.
2) Fieldstone footing under remainder of building, wood girders rest directly on stone, piers put in when stair addition constructed.

3) Original basement entrance moved from West side when wooden porch added or extended.
4) Windows #B-1 and #B-2 detailed on this Sheet originally on exterior walls, #B-2 badly rotted, bars and wooden shutter missing.

6) Floor system wood beam and girder resting directly on foundation walls.
7) Dirt floor throughout, Crawl Space #B slightly excavated when stair installed to reach new door.

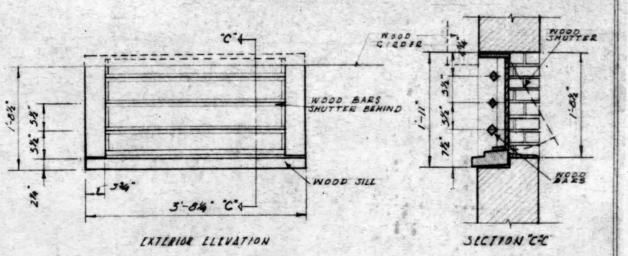
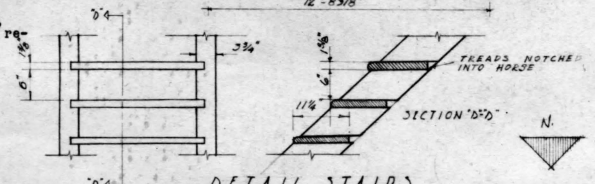
5) Door on West wall moved to North wall when porch added or extended, stair cut under main stair on first floor to provide access to basement at that time.

8) Wing over Crawl Space #C previously constructed, building pulled up at same time Stair Hall #10A added over Crawl Space #B.
9) Stone footing once between Crawl Spaces #B and #C, indicating rear wing not originally planned, wall removed at time of addition.

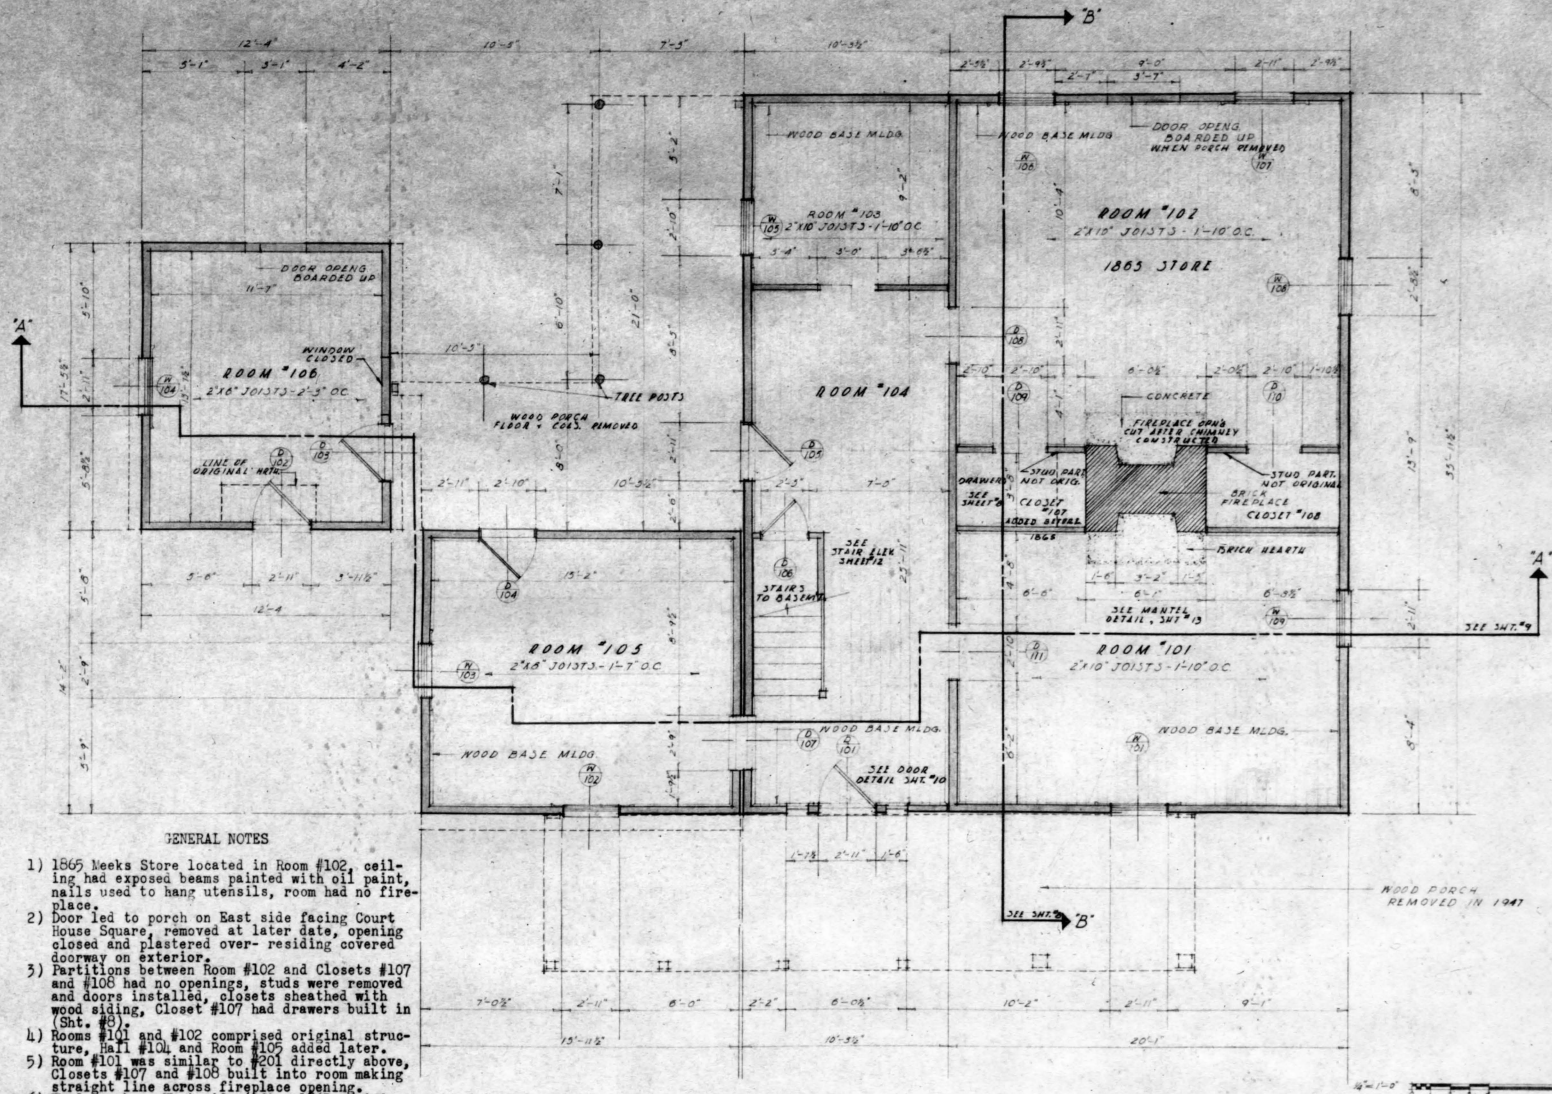
1ST FLOOR PLAN

1) 1865 Meeks Store located in Room #102, ceiling had exposed beams painted with oil paint, nails used to hang utensils, room had no fireplace.
2) Door led to porch on East side facing Court House Square, removed at later date, opening closed and plastered over- residing covered doorway on exterior.

3) Partitions between Room #102 and Closets #107 and #108 had no openings, studs were removed and doors installed, closets sheathed with wood siding, Closet #107 had drawers built in (Sht. #8).

4) Rooms #101 and #102 comprised original structure, Hall #104 and Room #105 added later.
5) Room #101 was similar to #201 directly above, Closets #107 and #108 built into room making straight line across fireplace opening.

6) Wood porch on West side (after 1865 period, removed 1947) had two large columns, perhaps from earlier porch at Door #101, remainder of columns added when porch extended.

7) Room #106 addition pulled up, was office facing Court House Square.
8) Plaster removed from all rooms in 1942.
9) Stair to Basement added under main stair when West porch extended.

10) Lock on Door #104 "Patented 1869-73."
11) Door #107 cut at later date, holes in frame where let-in studs removed, lack of nail holes on back of studs show Room #105 not planned but added before Room #104 finished.

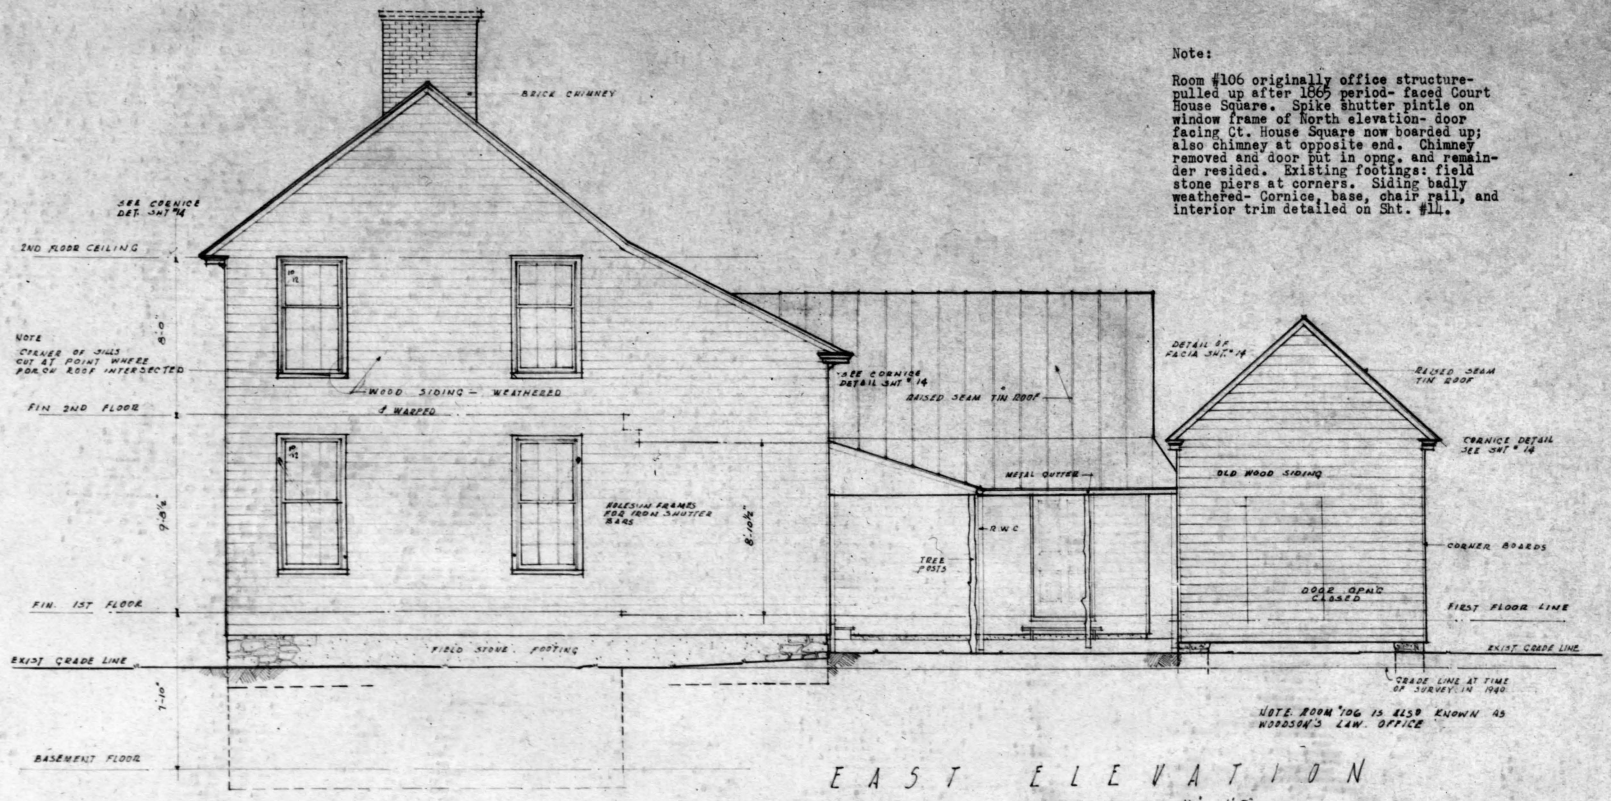
EAST ELEVATION

Room #106 originally office structure- pulled up after 1865 period- faced Court House Square. Spike shutter pintle on window frame of North elevation- door facing Ct. House Square now boarded up; also chimney at opposite end. Chimney removed and door put in opng. and remainder resided. Existing footings: field stone piers at corners. Siding badly weathered- Cornice, base, chair rail, and interior trim detailed on Sht. #11.

1) Second floor window sills beveled at edges where porch roof intersected.
2) Walls resided, covering jointing of the subsequent additions, siding badly weathered.
3) Wood floor and square cols. removed from covered way in 1942, cols. replaced with tree posts to support roof.
4) First floor windows have holes in frames to receive shutter bars and bolts.
5) Door and porch original entrance to Store on East side.
6) Fieldstone foundations for all walls in East elevation.
7) Capping removed from chimney, originally higher.
8) Beveled moulding on first and second floor window frames.

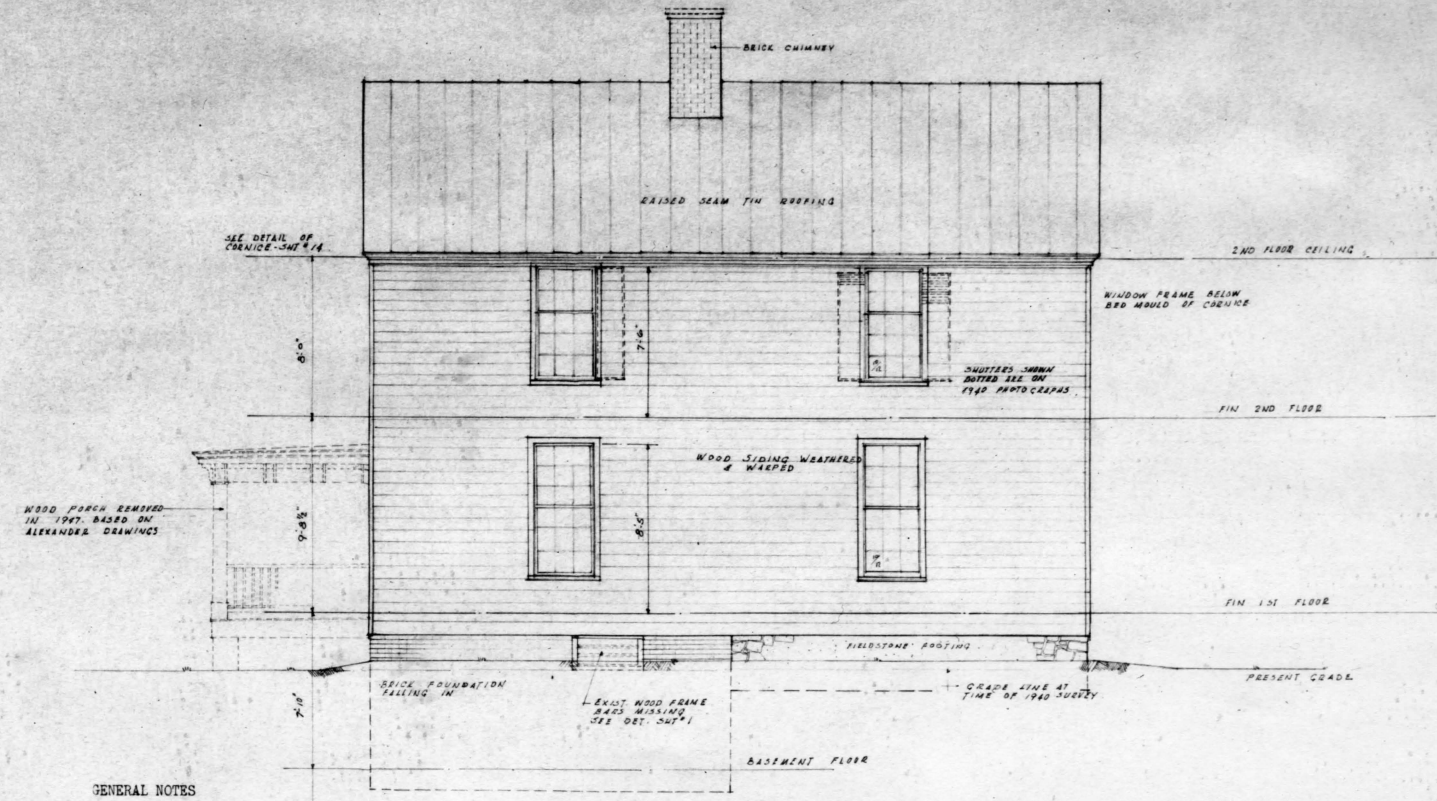
SOUTH ELEVATION

1) Shutter hardware on window frames stamped "Patented 1870," shutters missing.
2) Wooden porch on West removed in 1947.
3) Brick chimney cap removed, originally higher.
4) Wood siding badly weathered and warped, some replaced in 1947 under major repair program.
5) Beveled trim on second floor window frames, missing from first floor frames.
6) Cornice detailed on Sht. #14, top crown mould replaced with beveled board.
7) Brick foundation under left section of basement only, fieldstone foundation under rest of building.

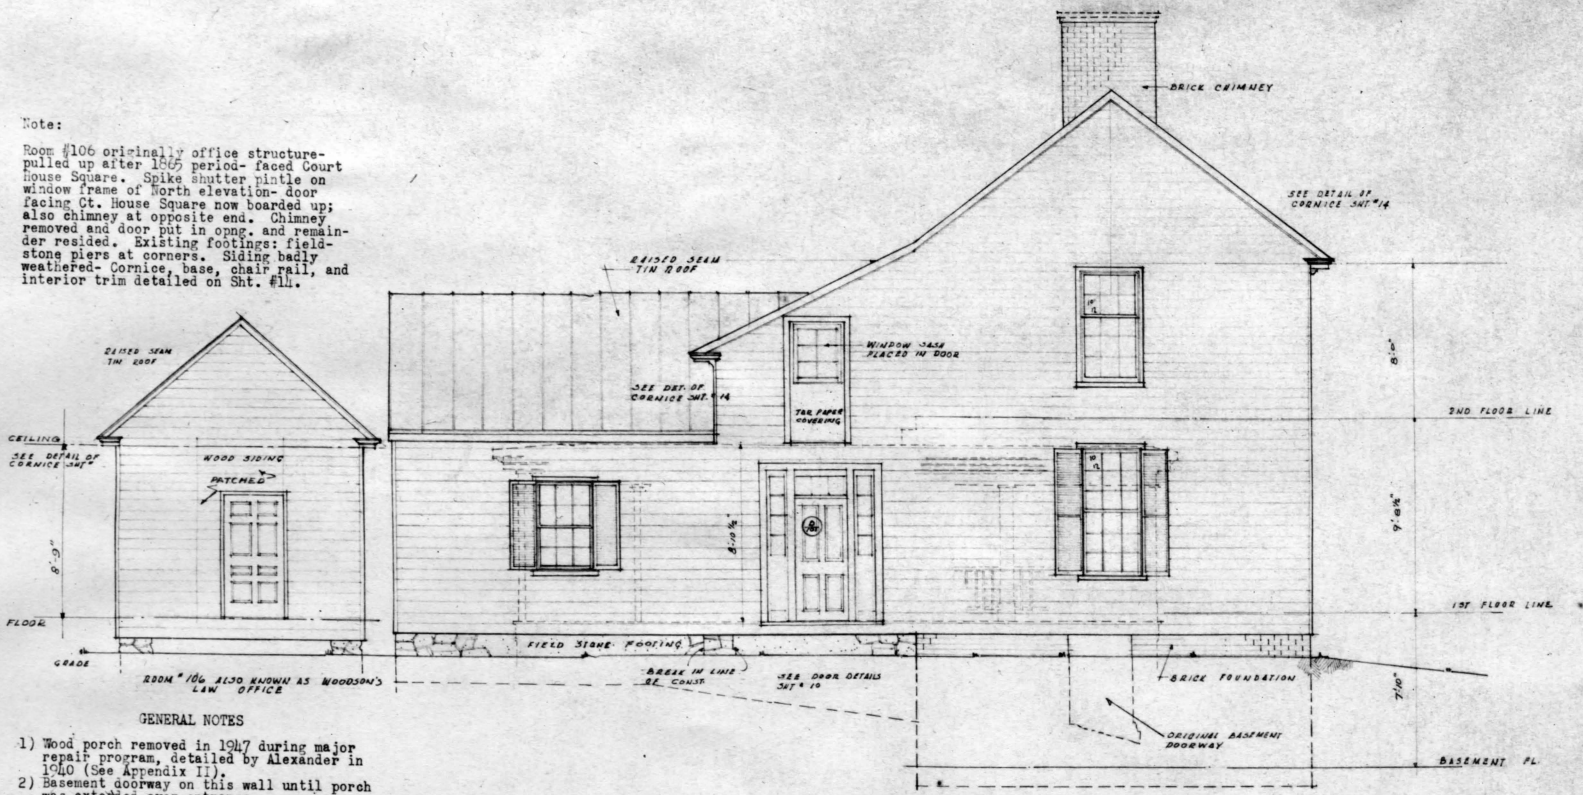
WEST ELEVATION

1) Wood porch removed in 1947 during major repair program, detailed by Alexander in 1940 (See Appendix II).
2) Basement doorway on this wall until porch was extended over entrance.
3) Brick foundation under part of original structure.
4) Fieldstone foundation shows break in construction between Additions #1 and #2.
5) Windows have "1870 Patented" shutter hardware.
6) Second floor window has beveled mould, no trim on rest of openings.
7) Door #101 is detailed on Sht. #10.

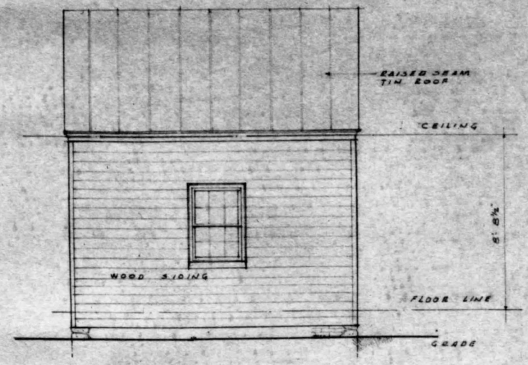
NORTH ELEVATION
OF ROOM #106
SCALE ¼"=1'-0"

Room #106 originally office structure- pulled up after 1869 period- faced Court House Square. Spike shutter pintle on window frame of North elevation- door facing Ct. House Square now boarded up; also chimney at opposite end. Chimney removed and door put in opng. and remainder resided. Existing footings: fieldstone piers at corners. Siding badly weathered- Cornice, base, chair rail, and interior trim detailed on Sht. #14.

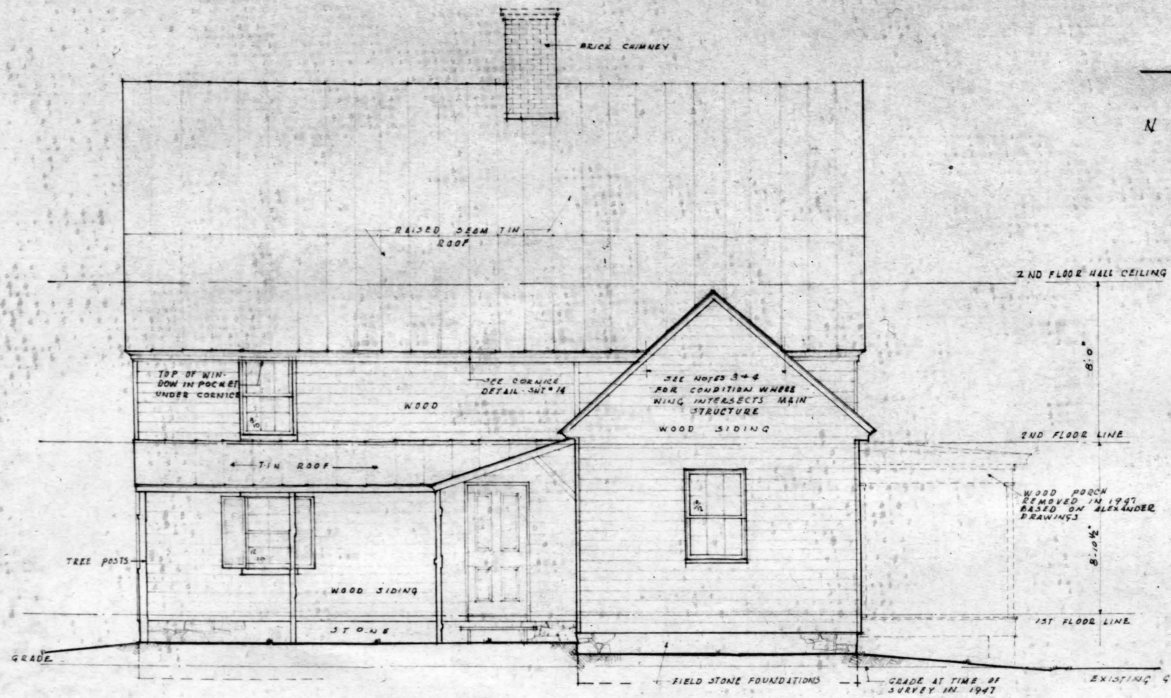
NORTH ELEVATION
SCALE ¼"=1'-0"

1) Wood Porch removed in 1947 under major repair program.
2) Window on second floor fits into pocket behind cornice.
3) Outlookers never existed for section of cornice where small frame wing intersects.
4) Wood siding continues behind gable end of wing. Line indicates place where residing stopped due to difficulty of removing siding.
5) Wood floor and columns removed from covered way in 1942, cols. replaced with tree posts to support roof.
6) Fieldstone footings under walls.

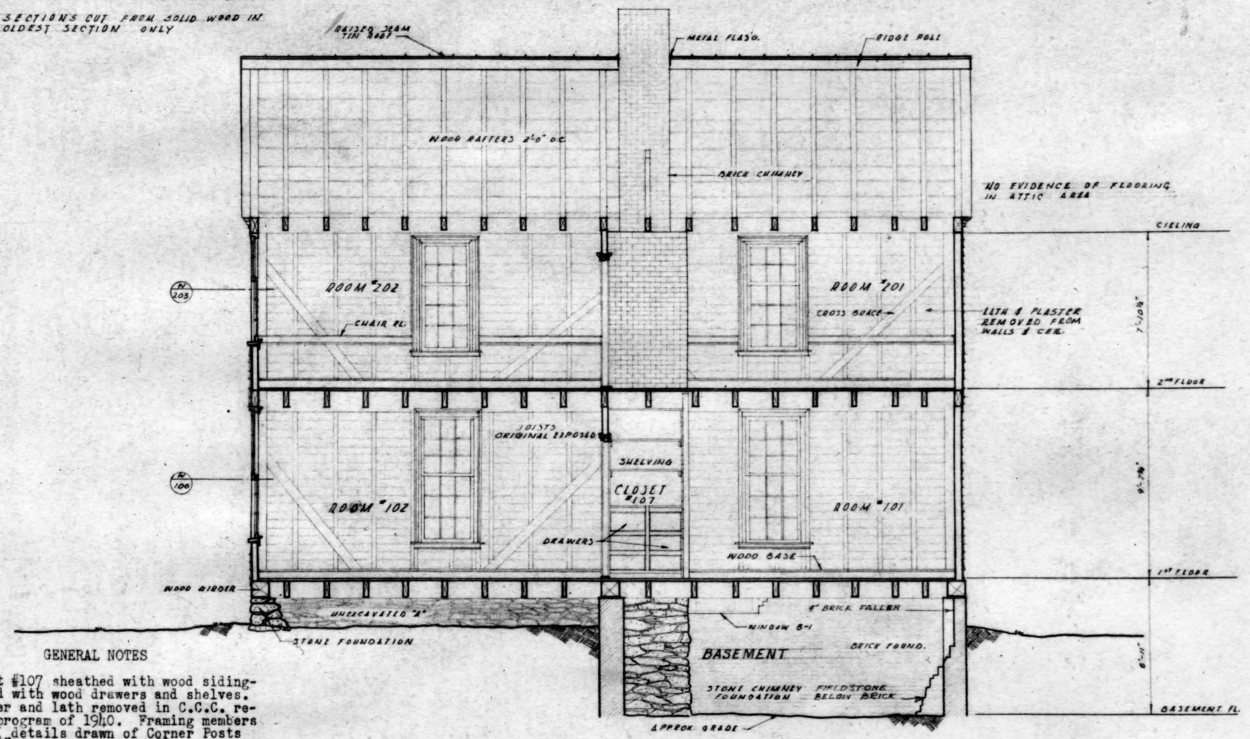
SECTION "B"-"B"

1) Closet #107 sheathed with wood siding- fitted with wood drawers and shelves.
2) Plaster and lath removed in C.C.C. repair program of 1940. Framing members shown, details drawn of Corner Posts and "T" Sections on Sht. #8.
3) Brick foundation wall in poor condition, part of brick wall fallen away, East of original opening top five courses replaced in 1940 but stone used below.
4) Flooring of Room #202 even sawed- smooth surface on ceiling of room below, joists and underside of flooring originally exposed in Room #102. Joists and flooring painted.
5) Flooring of Room #201 uneven, beveled at each joist to make floor level.
6) Door #204 cut thru, crossbracing cut, trim later than rest in Rooms #201 and #202.
7) Wall plastered to trim.
8) Wood siding nailed directly on exterior walls- no sheathing.

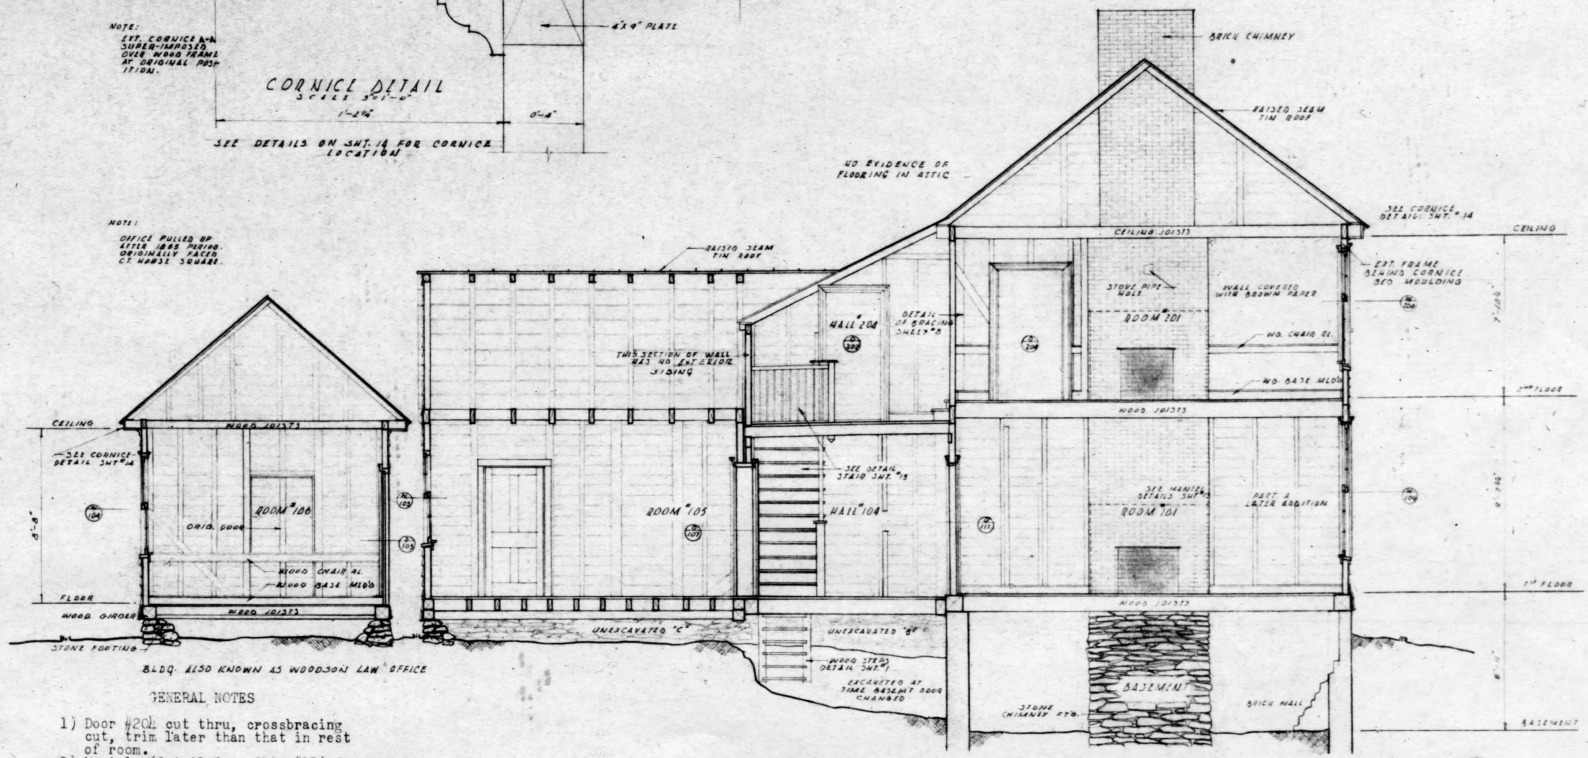
SECTION "A-A"
SCALE ¾"=1'-0"

1) Door #204 cut thru, crossbracing cut, trim later than that in rest of room.
2) Mantels (detailed on Sht. #13) from 1874 renovation, walls at one time plastered behind present mantels.
3) Steps from Rooms #201 and #202 added when Hall #204 constructed so that head room at top of stairs would be sufficient.
4) Brick walls built up to stone chimney foundation in basement.
5) Door #107 cut at later date, stone footing removed directly below when Room #105 pulled up. Lack of nailing on back of studs indicates wing pulled up before Rooms #104 and #204 completed.
