CULTURAL LANDSCAPE REPORT • HISTORIC STRUCTURE REPORT

Apostle Islands National Lakeshore – Bayfield, Wisconsin

VOLUME II OF VI: MICHIGAN ISLAND CLR/HSR

JULY 2011

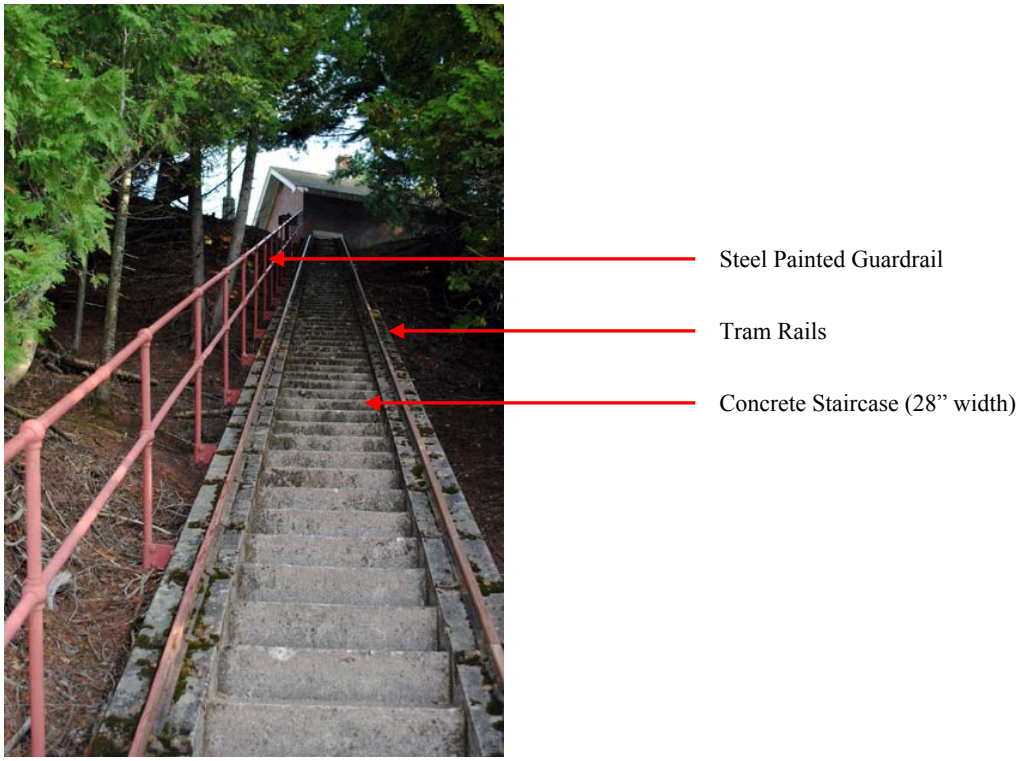
Site Image MI-39: Upper section of tramway, 2009 (Source: MBD DSC_0037.jpg)

Site Image MI-40: Upper section of tramway, tram tracks, and railing, 2009 (Source: MBD DSC_0037.jpg)

Site Image MI-41: Tramway, railing, and footings, 2009 (Source: MBD DSC_0037.jpg)

- Minor repair of cast iron tramway rails. The rails should be reattached where plates are missing, loose, or lacking bolts.
- Minor repair of railing including painting and repair of attachments on the west side of concrete tramway.
- Maintain the concrete tramway abutments by insuring that adequate soil and rock protection remains at the base of each abutment.
- The tramway lacks a handrailing meeting ABAAS standards; however installing a handrail meeting these standards may impede the use of the tram carts on the tramway.
- Retain the tram turntable in its current location and condition. The turntable does not rotate.
- Recommendations for replacing the tramway hoist and other work in the Power House are included in the HSR.

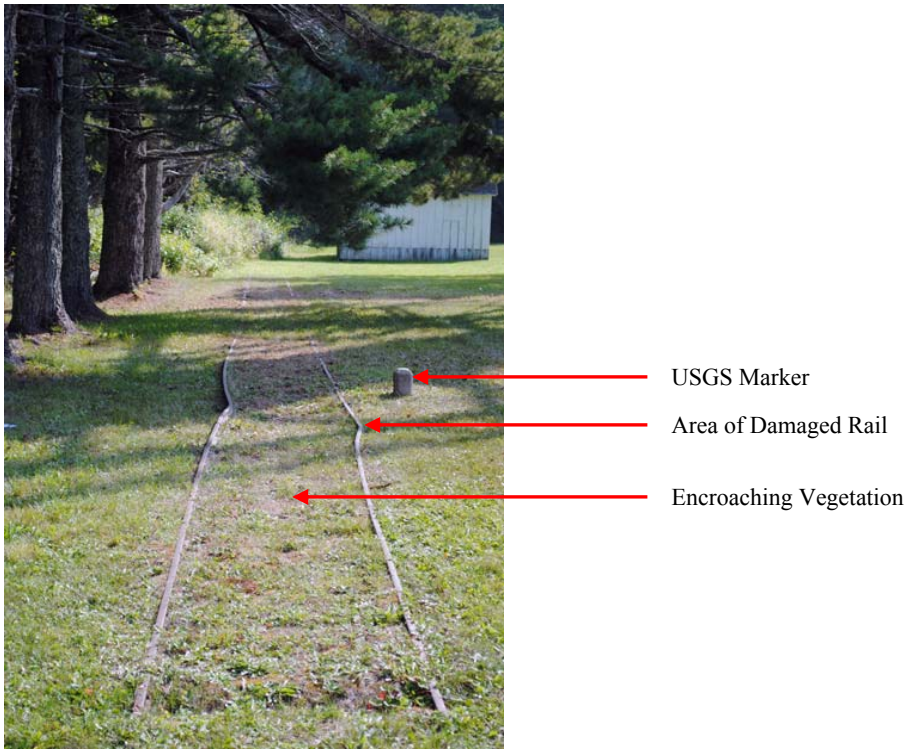
Site Image MI-42: Tram turntable, 2009 (Source: MBD DSC00599.JPG)

Site Image MI-43: Tram tracks, 2009 (Source: MBD DSC_0054.jpg)

Repair the tram tracks connecting the Power House to the Shed to a working condition. The work includes complete rail removal, repair and resetting on new timbers and setting bed (gravel or cinders). The majority of the milled lumber timbers require replacement as they are severely rotted. New material shall match

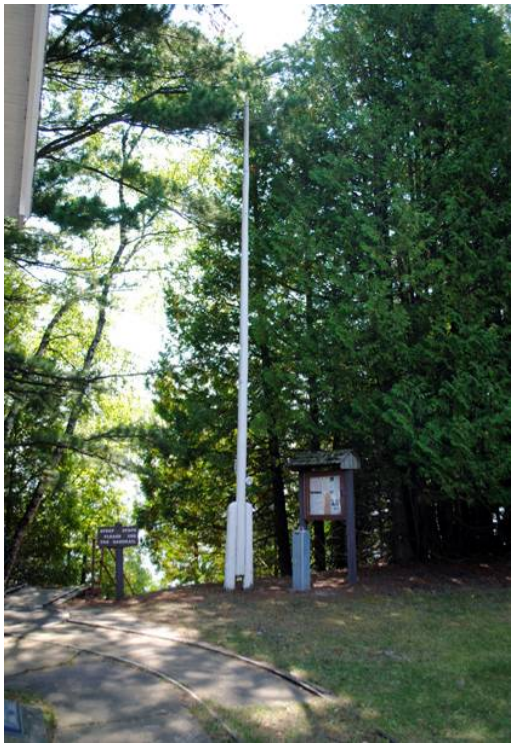
Existing Condition. The radio antenna poles (north and south) are features that were installed between 1929 and 1931 along with the other technological advances (Light Tower, Power House, and tramway) related to improvements in navigational aid. An annotated 1928 drawing from the APIS archives indicates that one or both of the poles were moved from their original locations once if not twice. They are currently located just east of the Power House, and another directly north from the first, near the tram tracks. They are cast iron poles, with a height of approximately 40', and identical concrete bases, approximately 18" tall, with a 36"×36" width. Radio Antenna Pole – South is in good condition. Radio Antenna Pole – North is in fair condition, the foundation needs to be reset as the pole is leaning to the north.

Site Image MI-50: Radio antenna pole – north (possibly relocated), 2009 (Source: MBD DSC_0052.jpg)

Maintain Radio Antenna Pole and Base

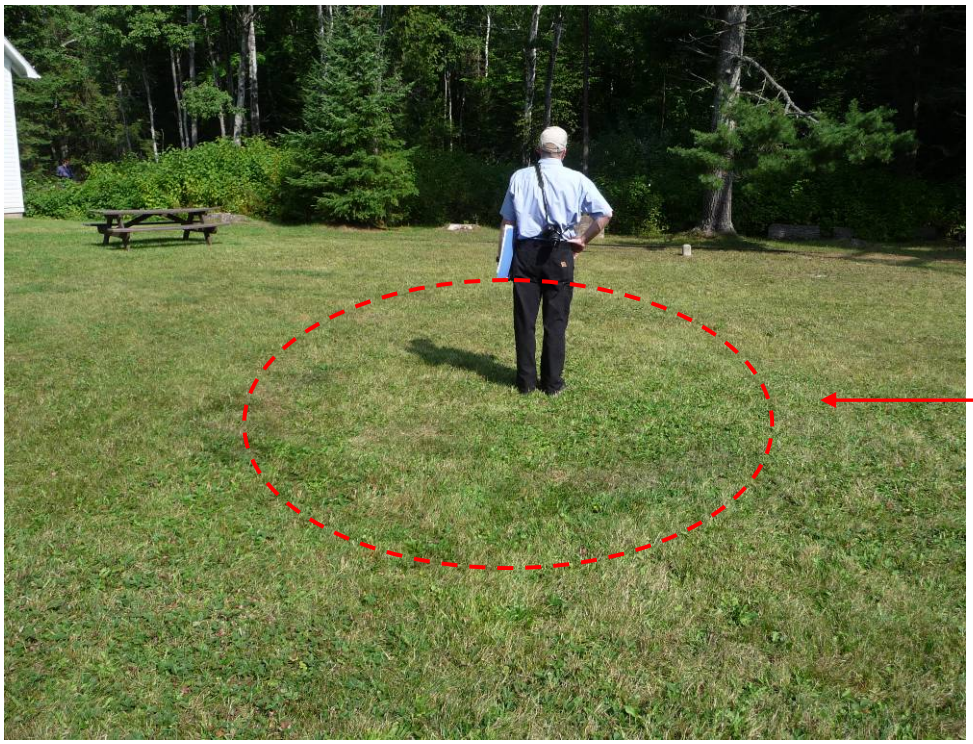
Circular Depression (1930s)	MI-69	Depression at site of large stone edged planter between Light Tower and fern bed.	Fair	Contributing; evidence of planter from period of significance
Orchard Planting (c. 1875)	MI-70	Remnant apple tree southeast of Old Lighthouse	Poor	Contributing; remnant of orchard present during the period of significance
Cherry Tree East of Old Lighthouse	MI-71	Cherry (*Prunus sp.*) tree at Old Lighthouse	Fair	Contributing; present during period of significance
Cherry Trees North of Privy	MI-72	Cherry (*Prunus sp.*) trees just beyond lawn clearing, north of the Privy	Fair	Contributing; present during the period of significance
Domestic Perennial Plantings	MI-73	Daylilies (*Hemerocallus sp.*) planted on west side of Keepers Quarters	Fair	Contributing; planted during the period of significance
Vegetation at Tramway	MI-74	Encroaching Forest Vegetation at Tramway	Fair	Noncontributing; has encroached following the period of significance

Site Image MI-69: Circular depression in area of stone edged planter; top, c. 1930; bottom, 2009; (Source: MBD P1010785.jpg)

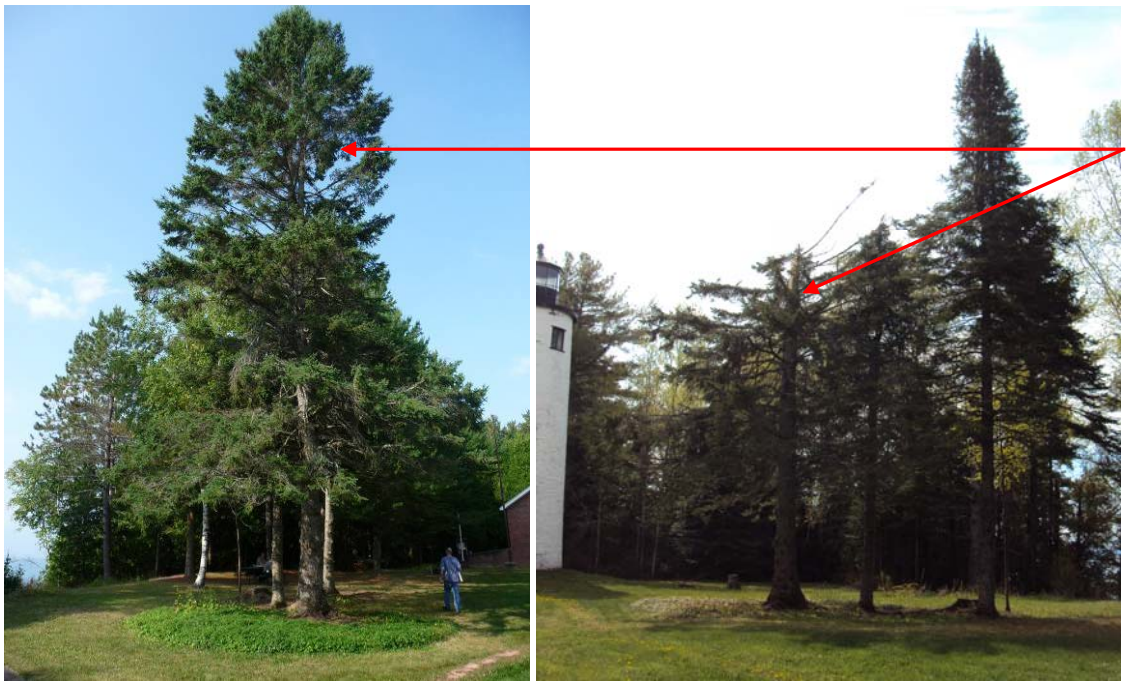
Site Image MI-78: White spruce tree west of Old Michigan Island Lighthouse before and after recent damage: left, 2009 (Source: MBD P1010758.JPG); right, 2011 (Source MBD DSC00882.JPG)

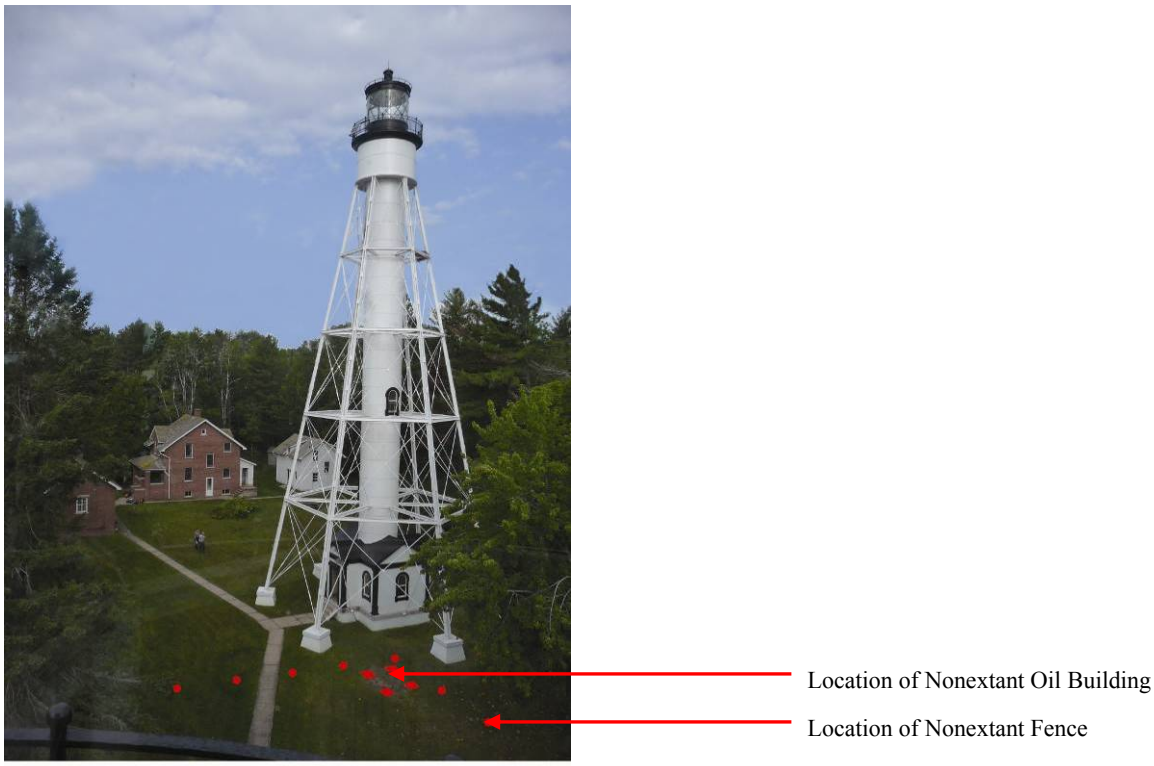
Site Image MI-84: Mark the location of the nonextant oil building and fencing, 2010
(Source: MBD P1010698_annotated.JPG)

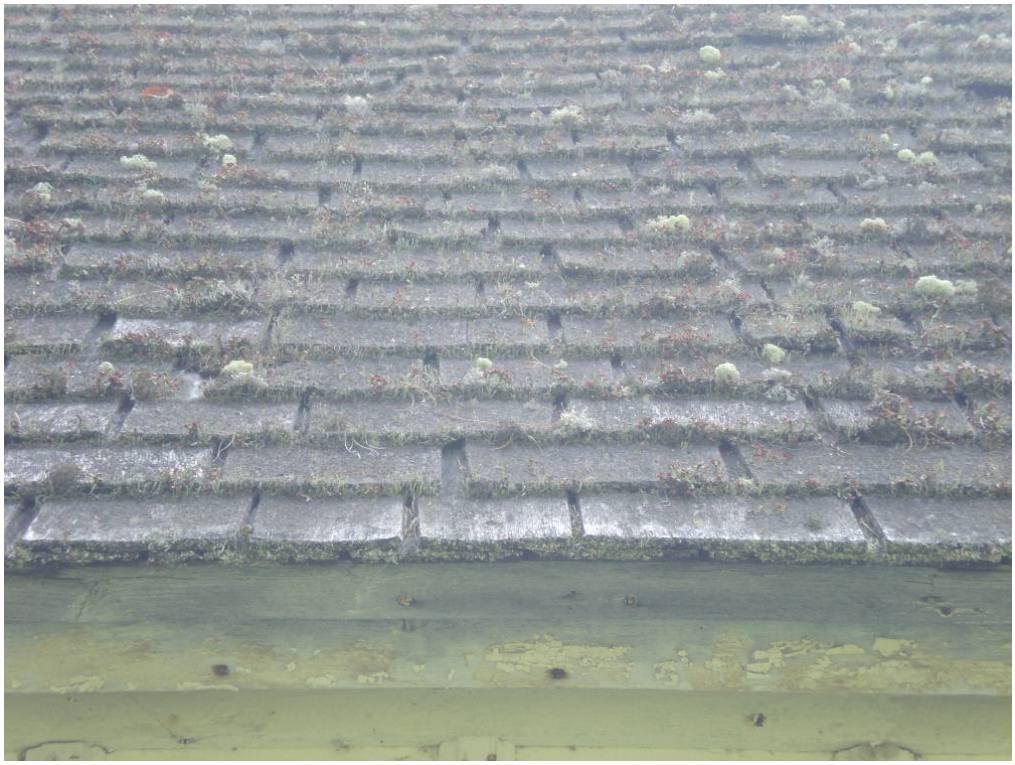
MI-S-04: North elevation, 2009 (Source: AH CIMG3243)
