CULTURAL LANDSCAPE REPORT • HISTORIC STRUCTURE REPORT

Apostle Islands National Lakeshore – Bayfield, Wisconsin

VOLUME III OF VI: OUTER ISLAND CLR/HSR

JULY 2011

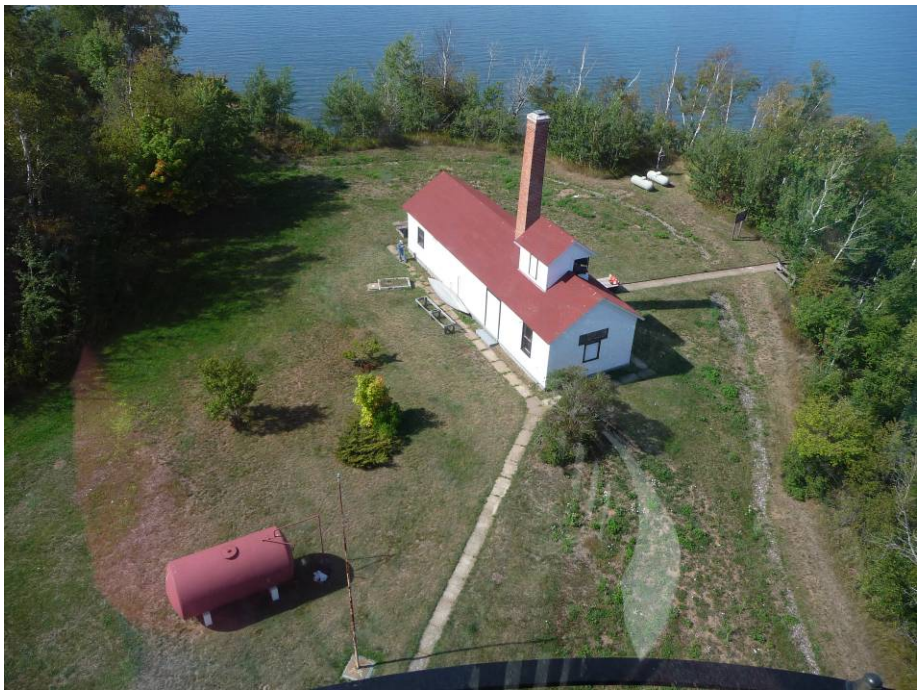
Site Image OI-26: View west from Light Tower with boat dock, tram tracks, and concrete walk from Fog Signal Building to the Keepers Quarters: above, after 1934 (Source: NPS APIS Archives); below, 2009 (Source: MBD P1010893.JPG)

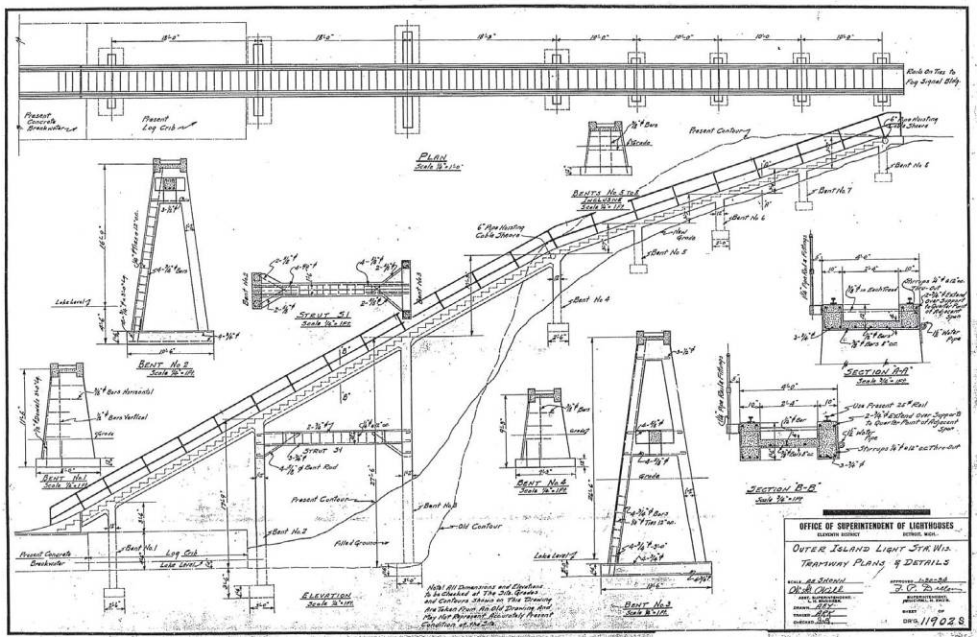
Historic Drawing of Tramway, 1934

The tramway is in good condition and retains all of its original elements including: concrete structural supports with footings and stairs, steel handrail, and cast iron tram rails.

Site Image OI-38: Historic Drawing of the Outer Island Tramway, 1934 (Source: NPS APIS Archives)

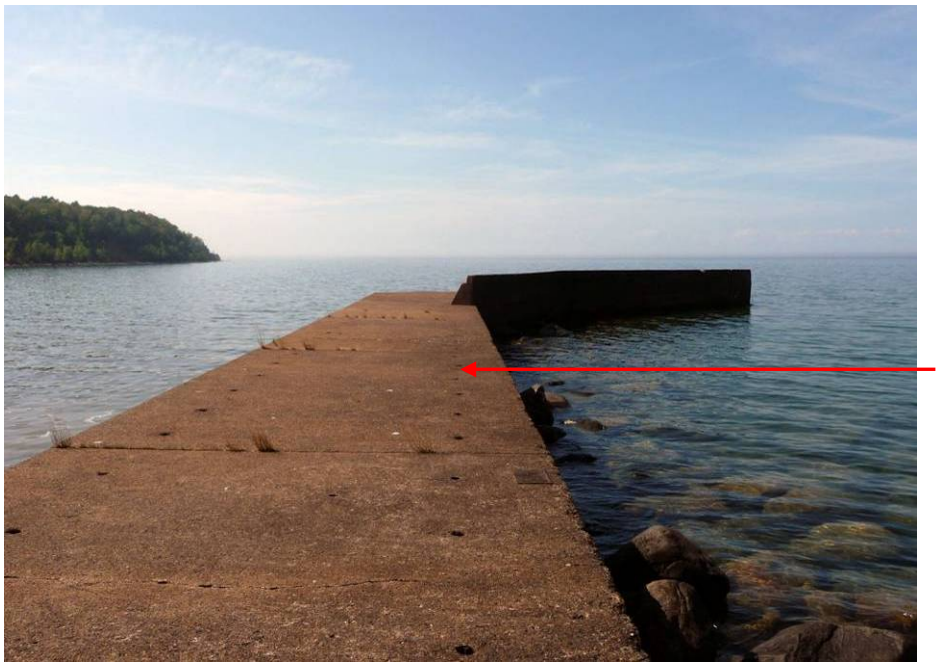
Site Image OI-39: Concrete boat dock viewed from the south, tram tracks in center, 2009 (Source: MBD P1010860.JPG)

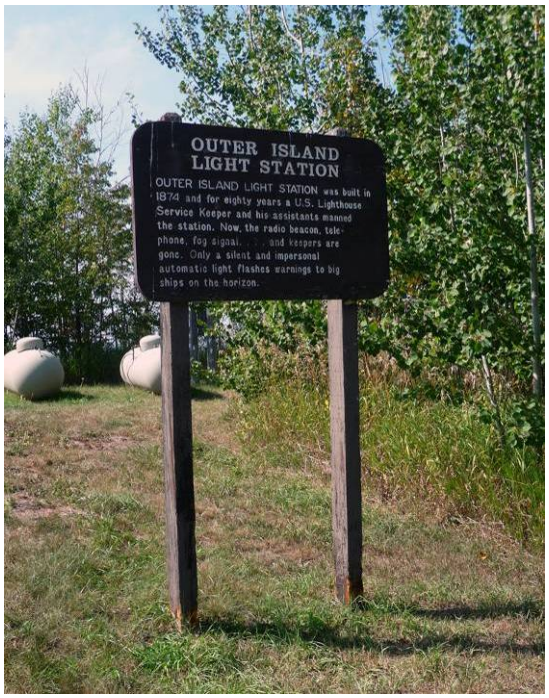
Site Image OI-53: Park sign, 2009 (Source: MBD P1010842.JPG)
