CULTURAL LANDSCAPE REPORT • HISTORIC STRUCTURE REPORT

Apostle Islands National Lakeshore – Bayfield, Wisconsin

VOLUME IV OF VI: DEVILS ISLAND CLR/HSR

JULY 2011

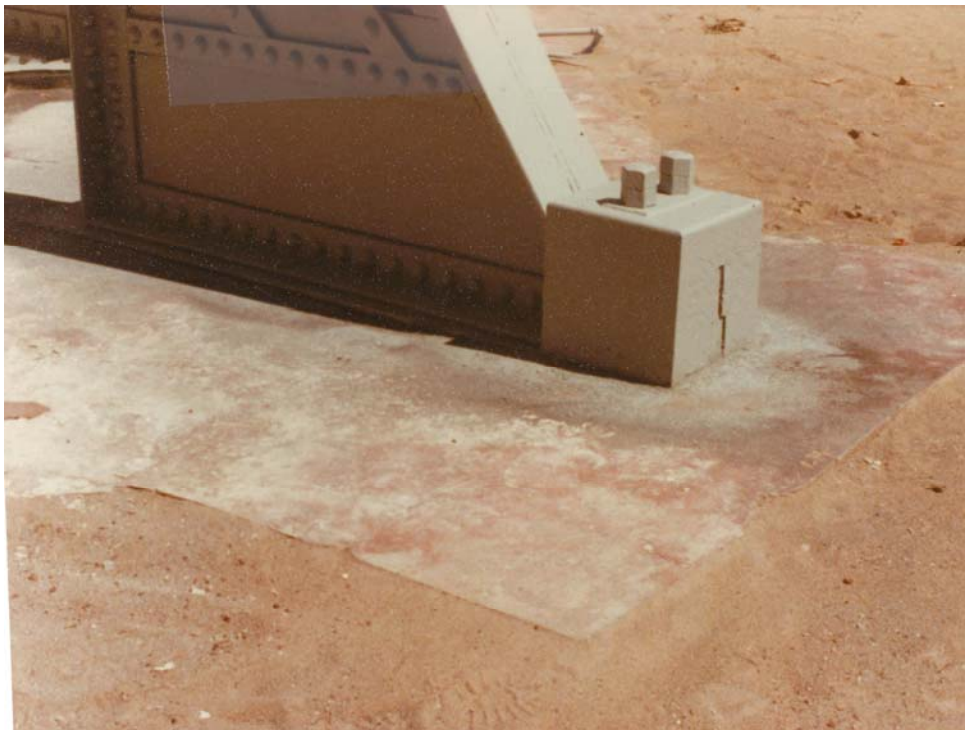
Historic Image DI-24: Devils Island Tower Foundation before repair work, 1978 (Source: NPS APIS Archives)

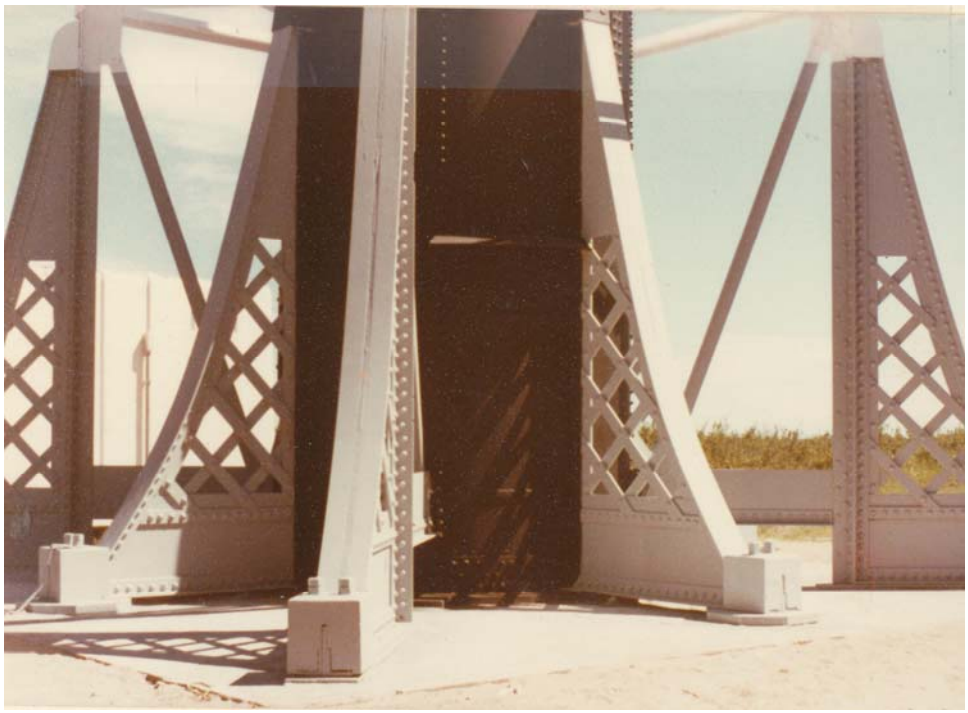
Historic Image DI-29: Devils Island Tower Foundation after repair work, 1978 (Source: NPS APIS Archives)

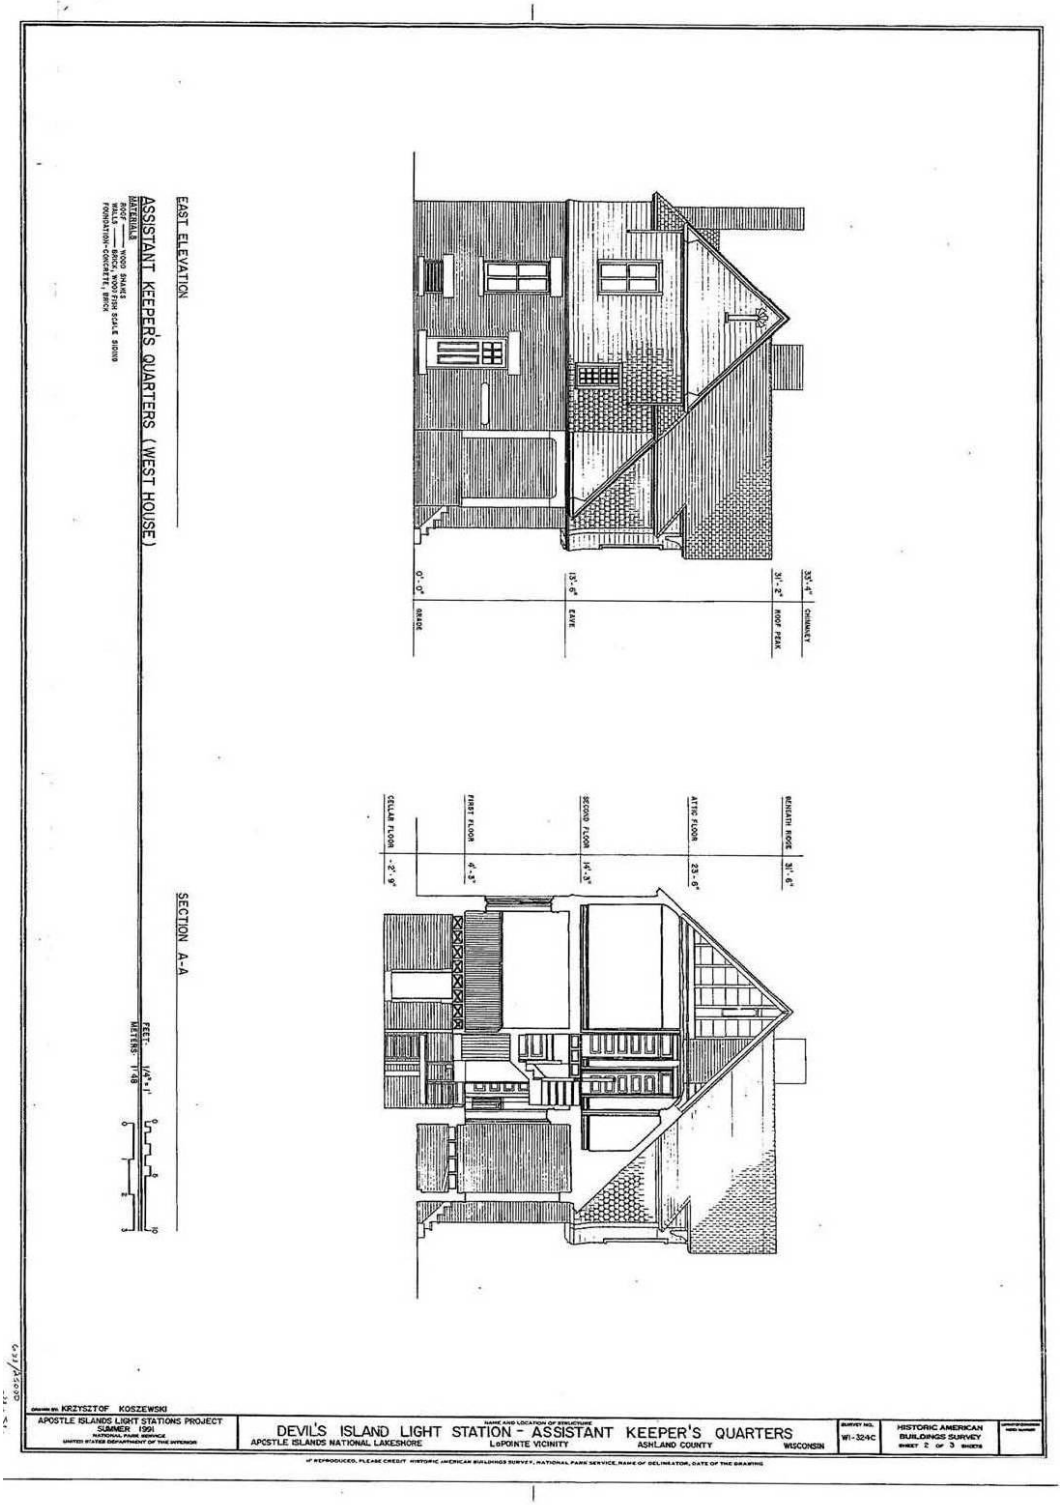
EAST ELEVATION
ASSISTANT KEEPER'S QUARTERS (WEST HOUSE)
MATERIALS
ROOF — WOOD SHAKES
WALLS — CLAPBOARD
FOUNDATION-CONCRETE, BRICK
SECTION A-A
FEET
METERS
1/4"=1'
1:48
0
2
3
10
BASE
EAVE
ROOF PEAK
CHIMNEY
0'-0"
15'-6"
31'-2"
33'-4"
CELLAR FLOOR
FIRST FLOOR
SECOND FLOOR
ATTIC FLOOR
BENEATH RIDGE
-2'-9"
-0'-3"
14'-3"
23'-6"
31'-6"
DRAWN BY: KRZYSZTOF KOSZEWSKI
APOSTLE ISLANDS LIGHT STATIONS PROJECT
SUMMER 1991
NATIONAL PARK SERVICE
UNITED STATES DEPARTMENT OF THE INTERIOR
NAME AND LOCATION OF STRUCTURE
DEVIL'S ISLAND LIGHT STATION - ASSISTANT KEEPER'S QUARTERS
APOSTLE ISLANDS NATIONAL LAKESHORE
LaPOINTE VICINITY
ASHLAND COUNTY
WISCONSIN
SURVEY NO.
WI-324C
HISTORIC AMERICAN BUILDINGS SURVEY
SHEET 2 OF 3 SHEETS
IF REPRODUCED, PLEASE CREDIT HISTORIC AMERICAN BUILDINGS SURVEY, NATIONAL PARK SERVICE, NAME OF DELINEATOR, DATE OF THE DRAWING

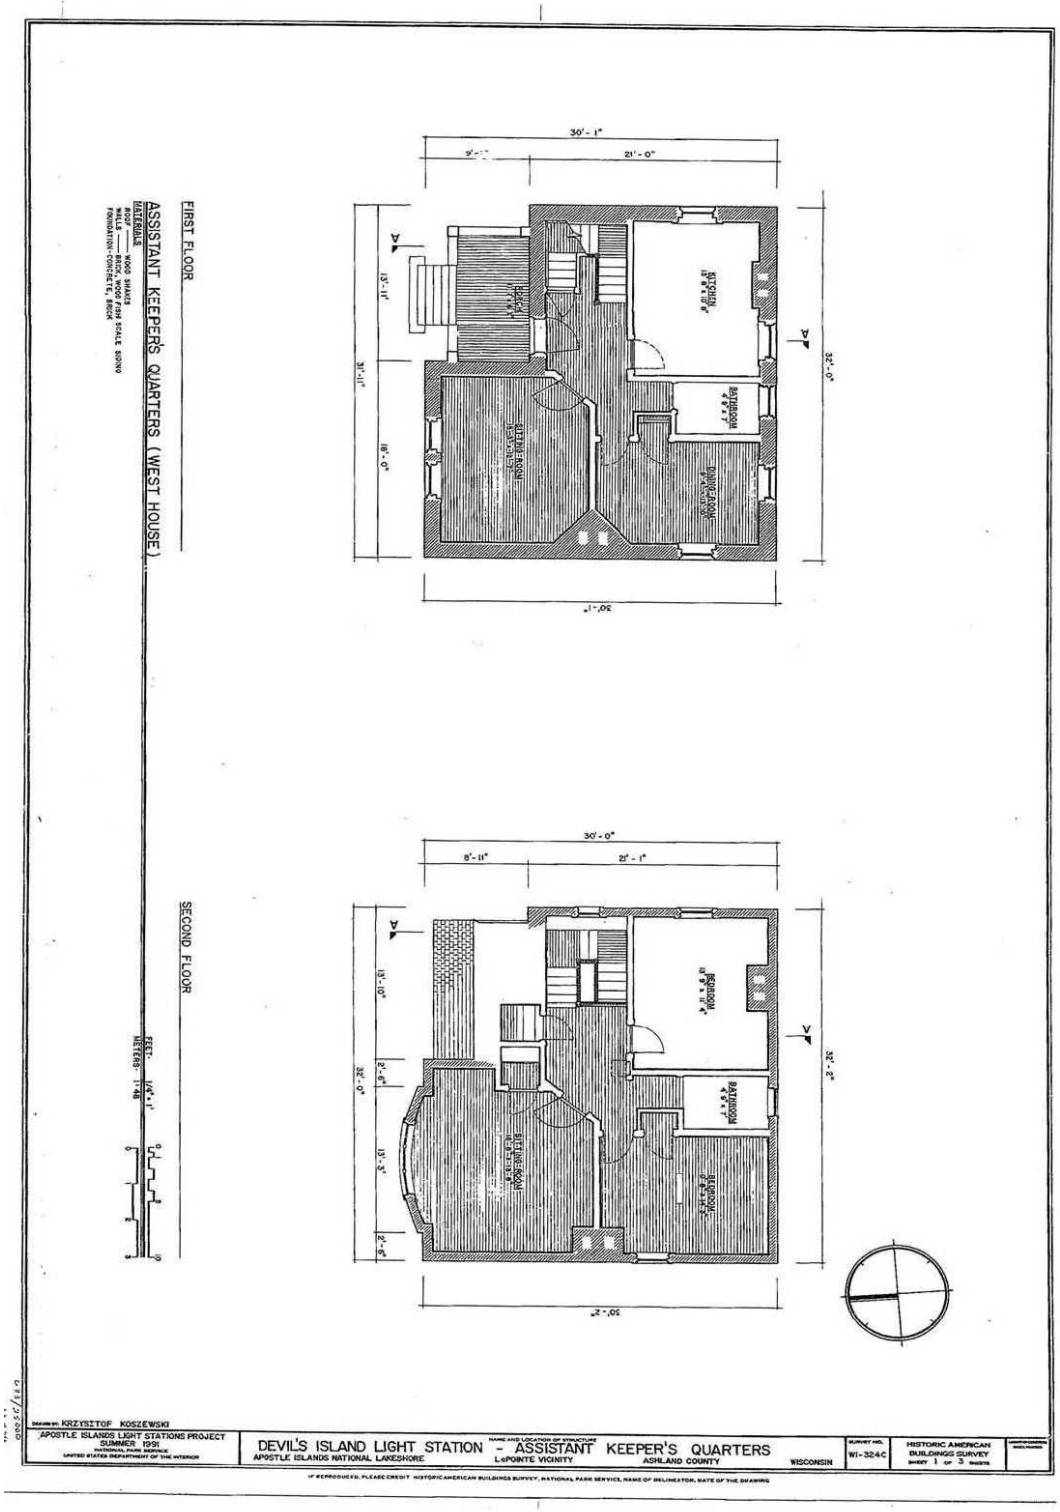
ASSISTANT KEEPER'S QUARTERS (WEST HOUSE)
FIRST FLOOR
SECOND FLOOR
MATERIALS
ROOF — WOOD SHAKES
WALLS — WOOD CLAPBOARD
FOUNDATION-CONCRETE, BRICK
30'-1"
21'-0"
32'-0"
30'-0"
8'-11"
21'-1"
32'-0"
APOSTLE ISLANDS LIGHT STATIONS PROJECT
SUMMER 1991
NATIONAL PARK SERVICE
UNITED STATES DEPARTMENT OF THE INTERIOR
DRAWN BY: KRZYSZTOF KOSZEWSKI
DEVIL'S ISLAND LIGHT STATION - ASSISTANT KEEPER'S QUARTERS
APOSTLE ISLANDS NATIONAL LAKESHORE
LaPOINTE VICINITY
ASHLAND COUNTY
WISCONSIN
WI-324-C
HISTORIC AMERICAN BUILDINGS SURVEY
SHEET 1 OF 5 SHEETS

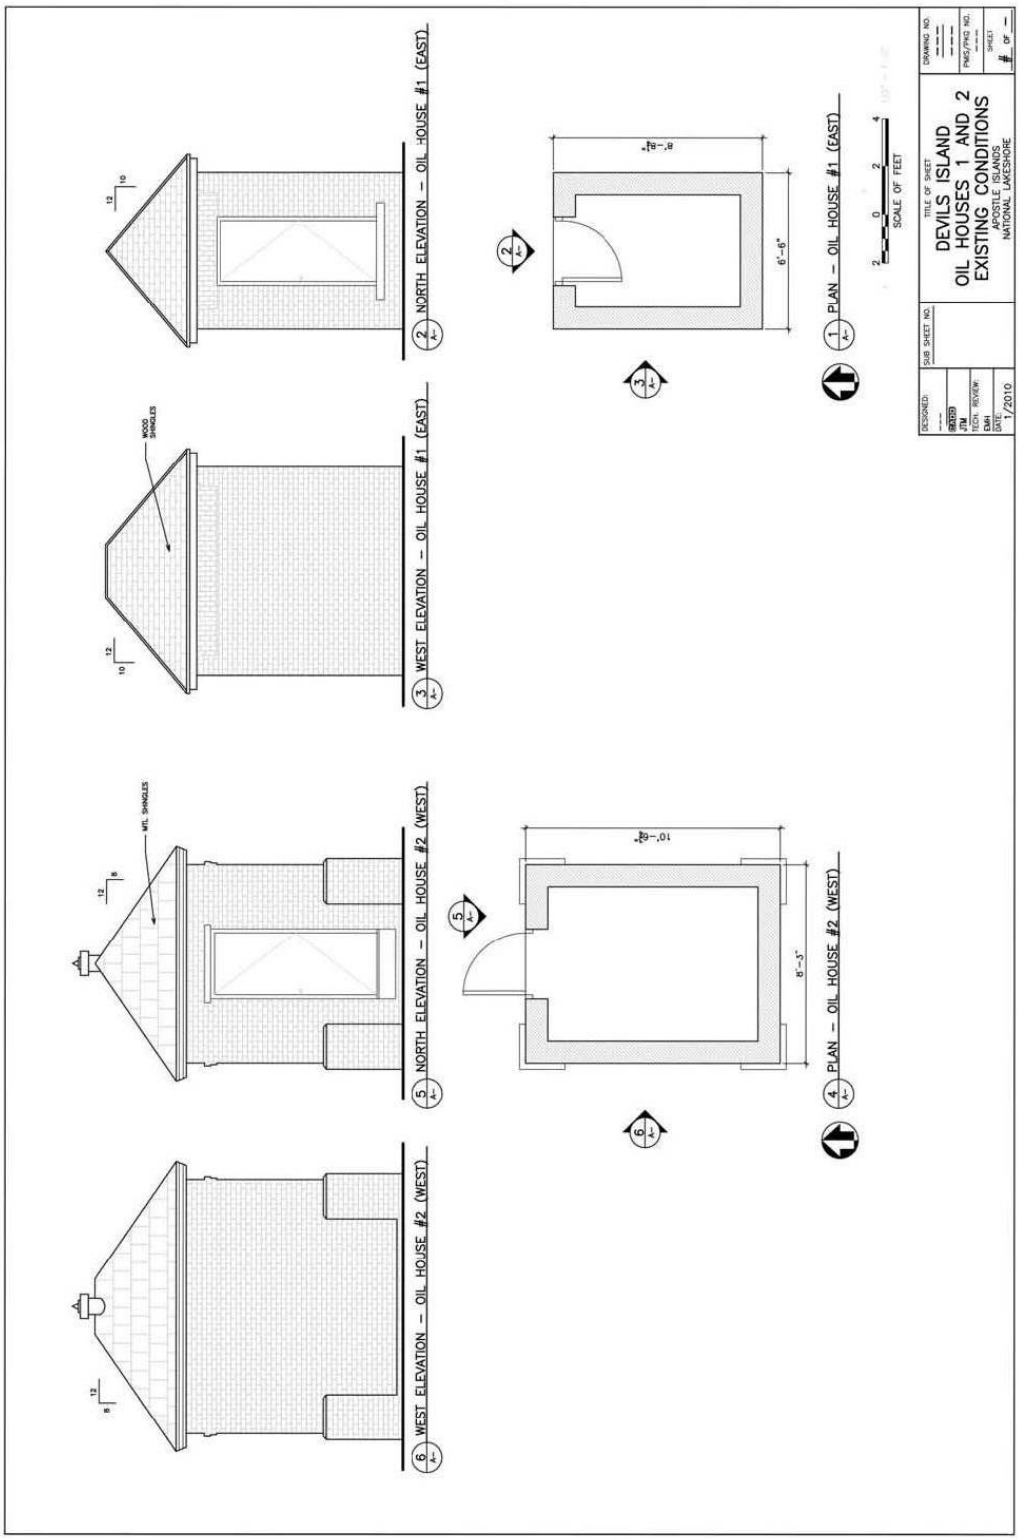
LOFT
MACHINERY ROOM
STORAGE
BATTERY ROOM
RADIO ROOM
40'-3"
12'-8"
22'-3"
20'-8"
14'-0"
20'-2"
1 PLAN – FOG SIGNAL BUILDING
2 EAST ELEVATION – FOG SIGNAL BUILDING
3 SOUTH ELEVATION – FOG SIGNAL BUILDING
ASPHALT SHINGLES
ASBESTOS SHINGLE SIDING
CORRUGATED MTL ROOFING
CORRUGATED MTL SIDING
SCALE OF FEET
DESIGNED:
DRAWN:
JTW
TECH. REVIEW:
NAA
DATE:
1/2010
SUB SHEET NO.
TITLE OF SHEET
DEVILS ISLAND
FOG SIGNAL BUILDING
APOSTLE ISLANDS
NATIONAL LAKESHORE
DRAWING NO.
PKG/PKG NO.
SHEET
OF –

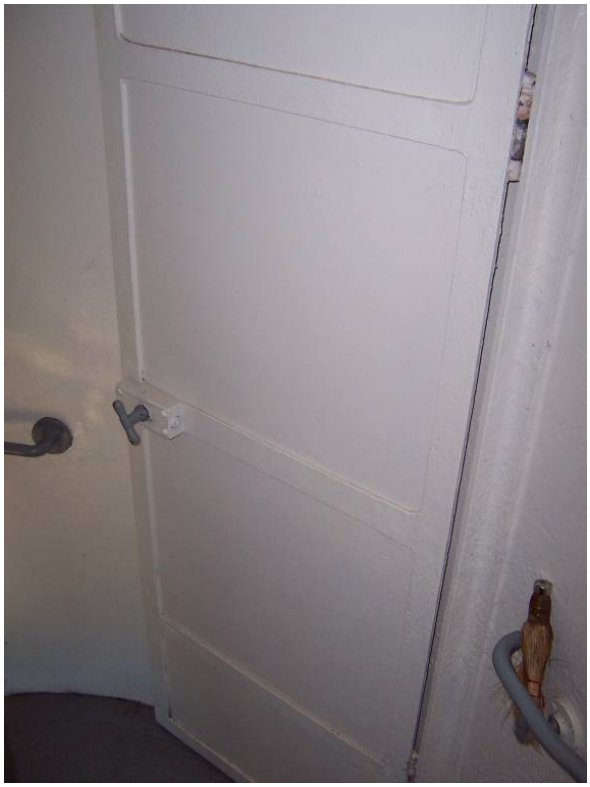
Entry Door at Base of Tower. This door has minor paint deterioration, minor rust and is missing mortise hardware.

DI-LS-04: Entry door (Source: AH 100_9715)

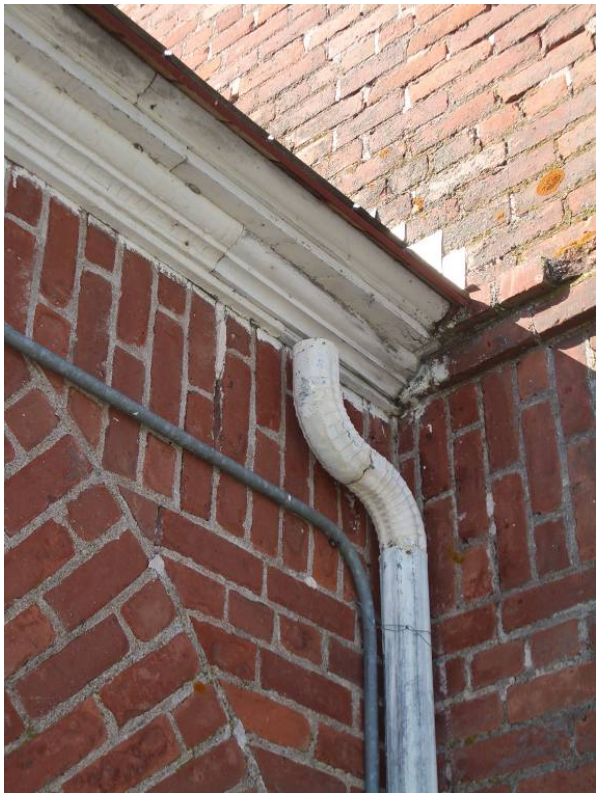
DI-KQ-02: East elevation, 2009 (Source: AH IMGP2881)

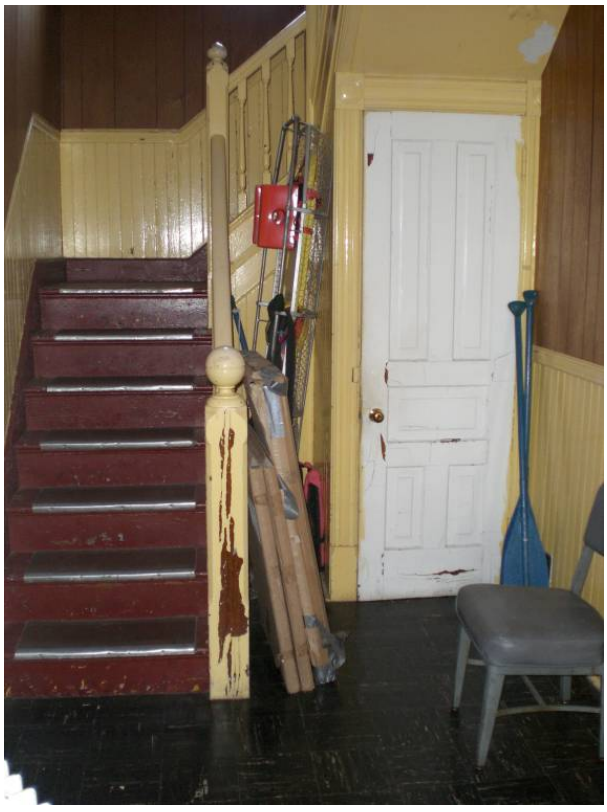
DI-KQ-14: Main entry door, interior (Source: AH 100_9723)

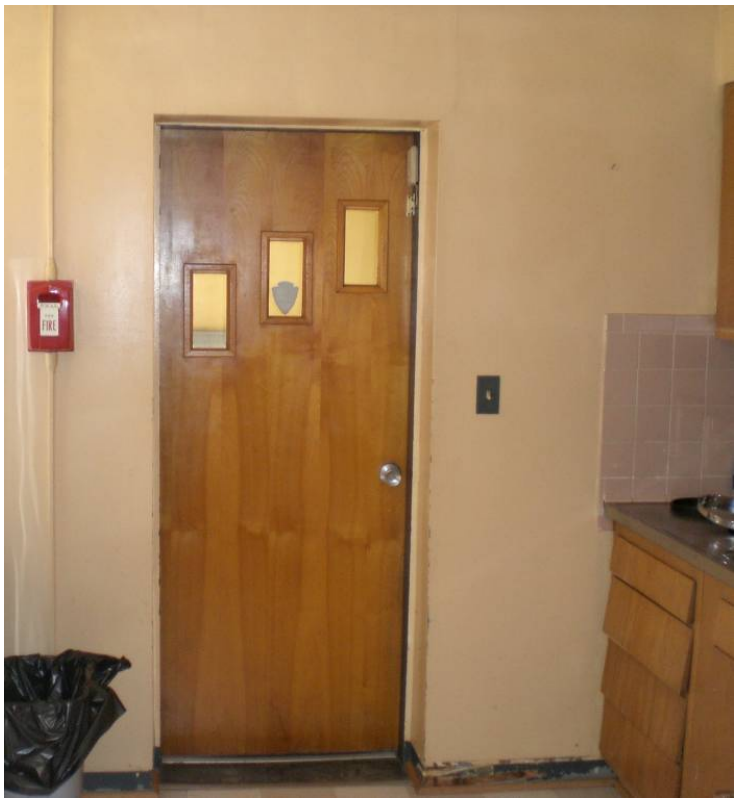
DI-KQ-18: Entry, east elevation, stairs to second floor and door to basement stair (Source: AH CIMG3717)

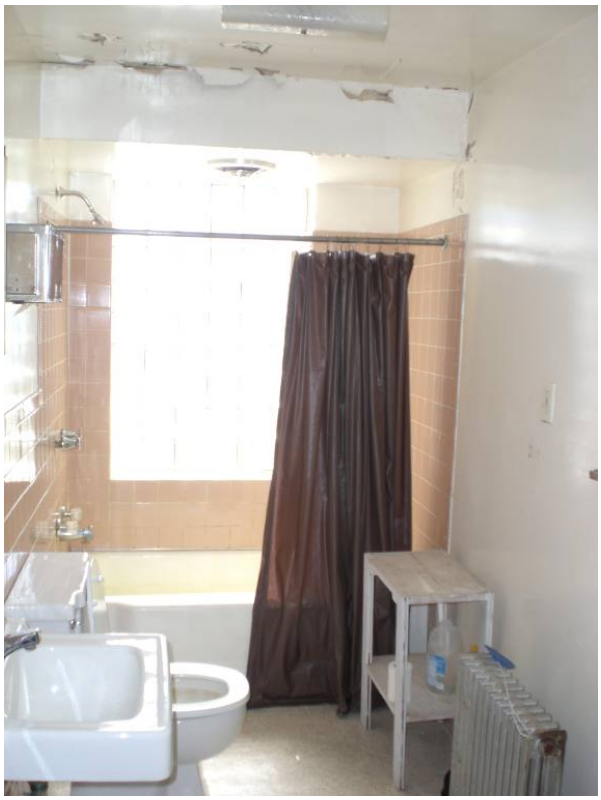
DI-KQ-23: South elevation kitchen entry stair, interior section (Source: AH CIMG3737)

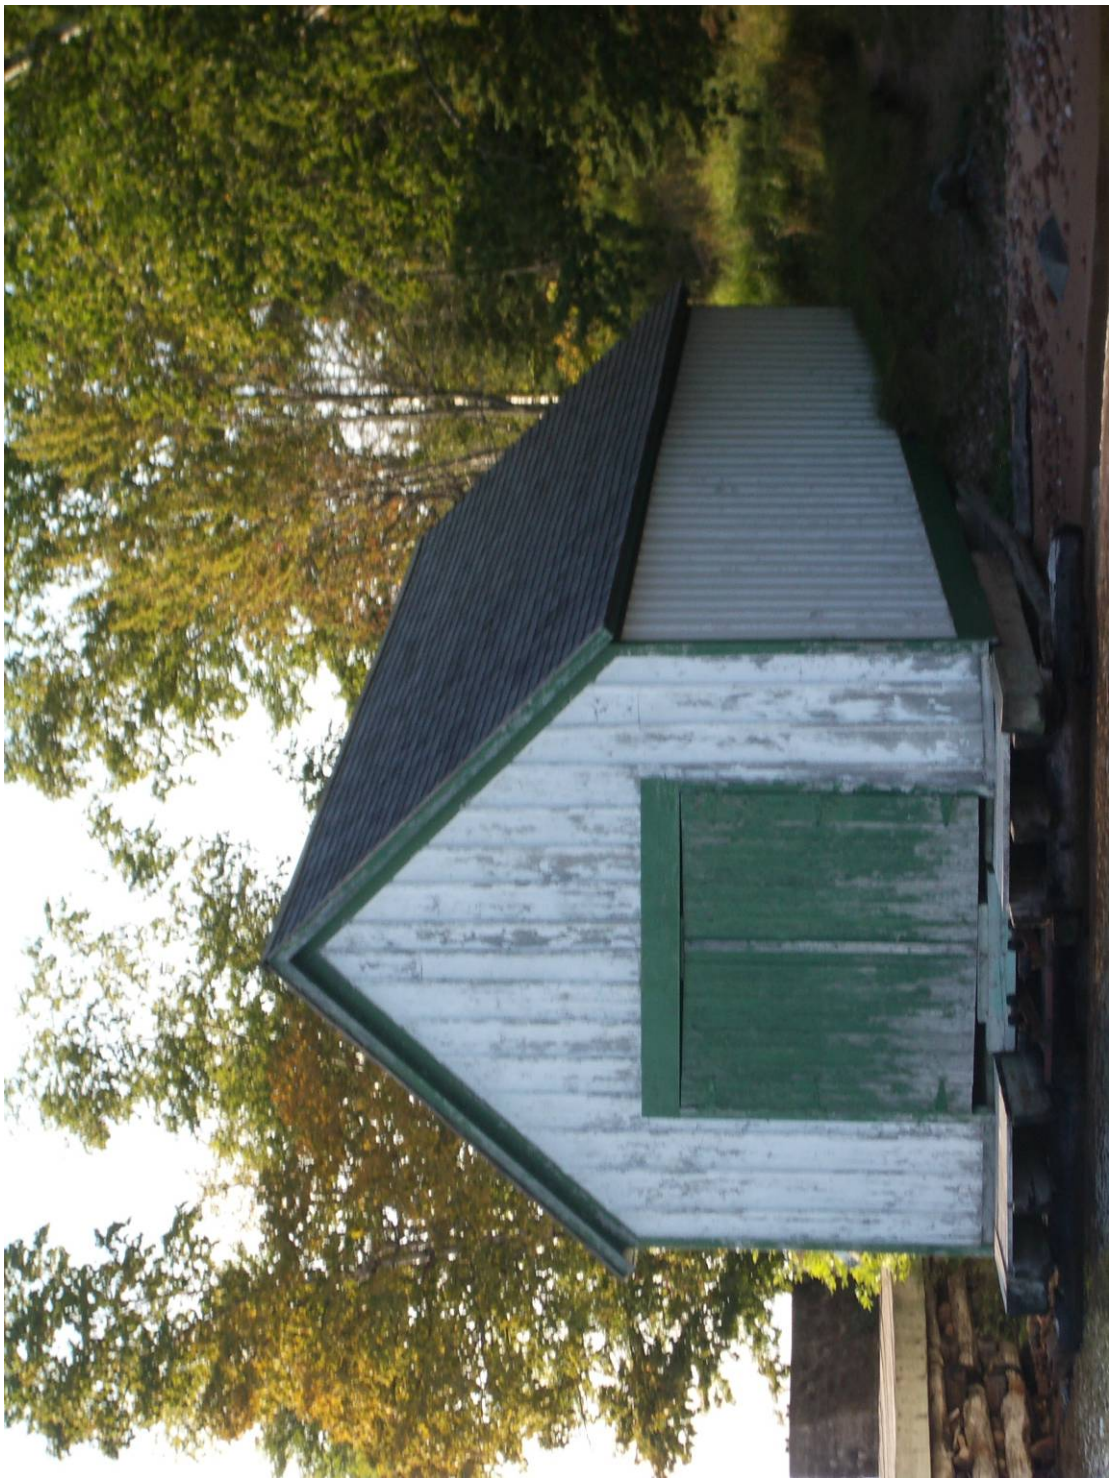
DI-BH-01: Approach from the west, 2009 (Source: AH IMGP2944)

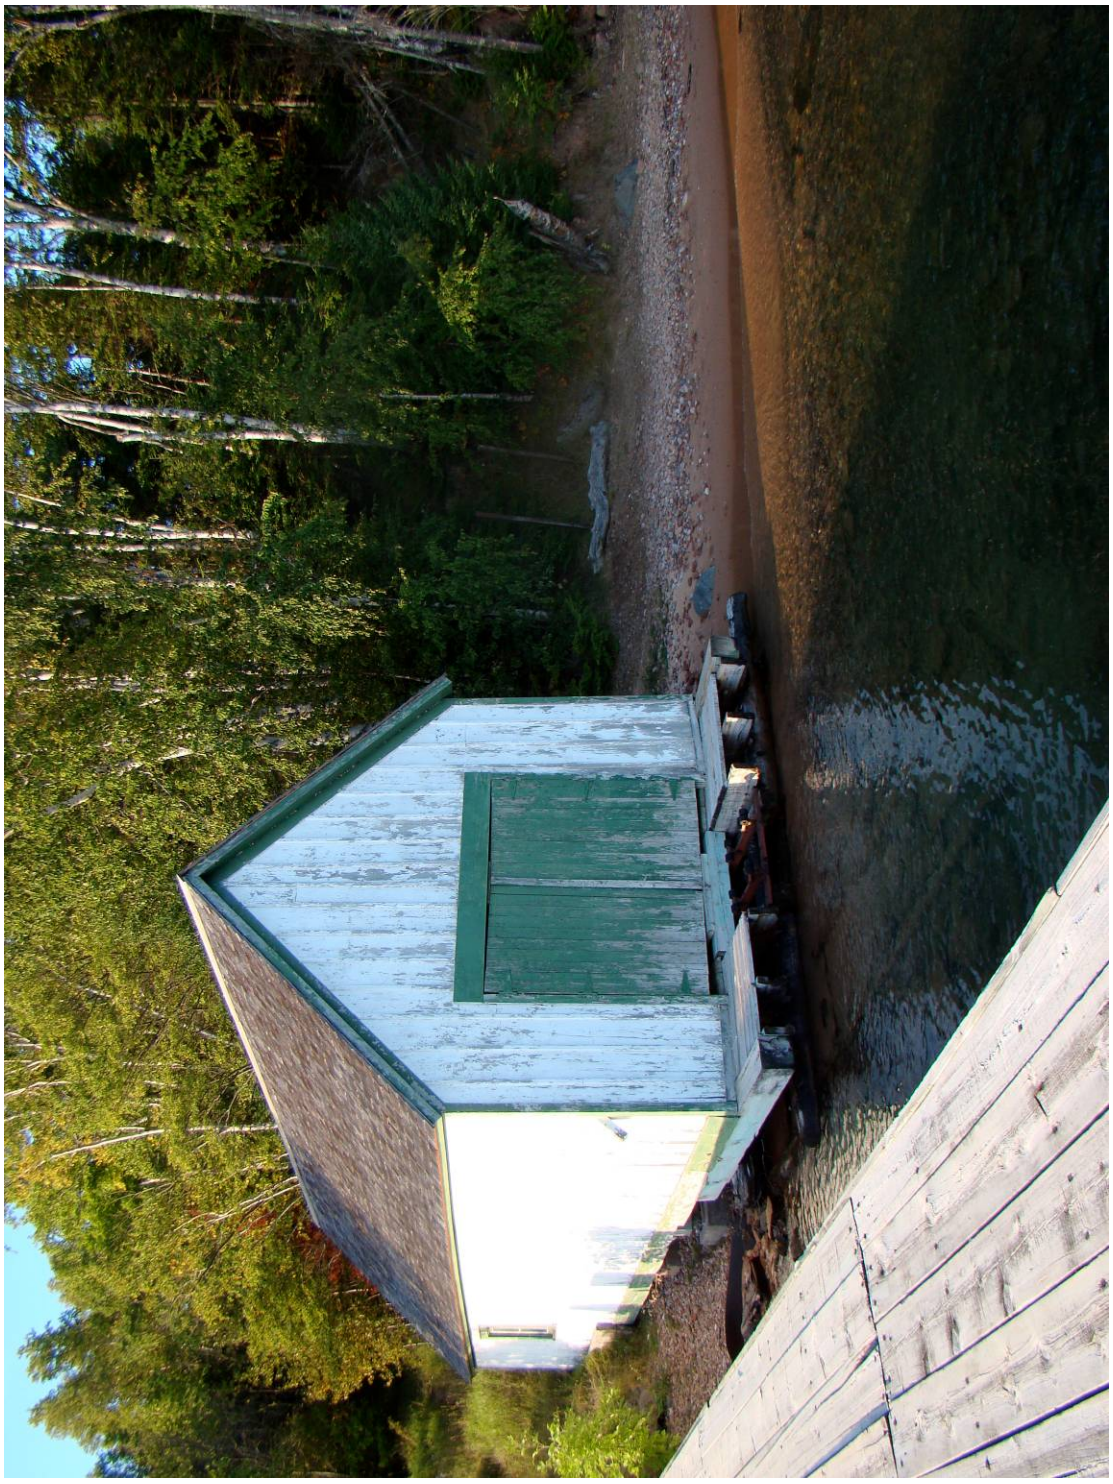
DI-BH-02: South elevation, 2009 (Source: AH IMGP2946)

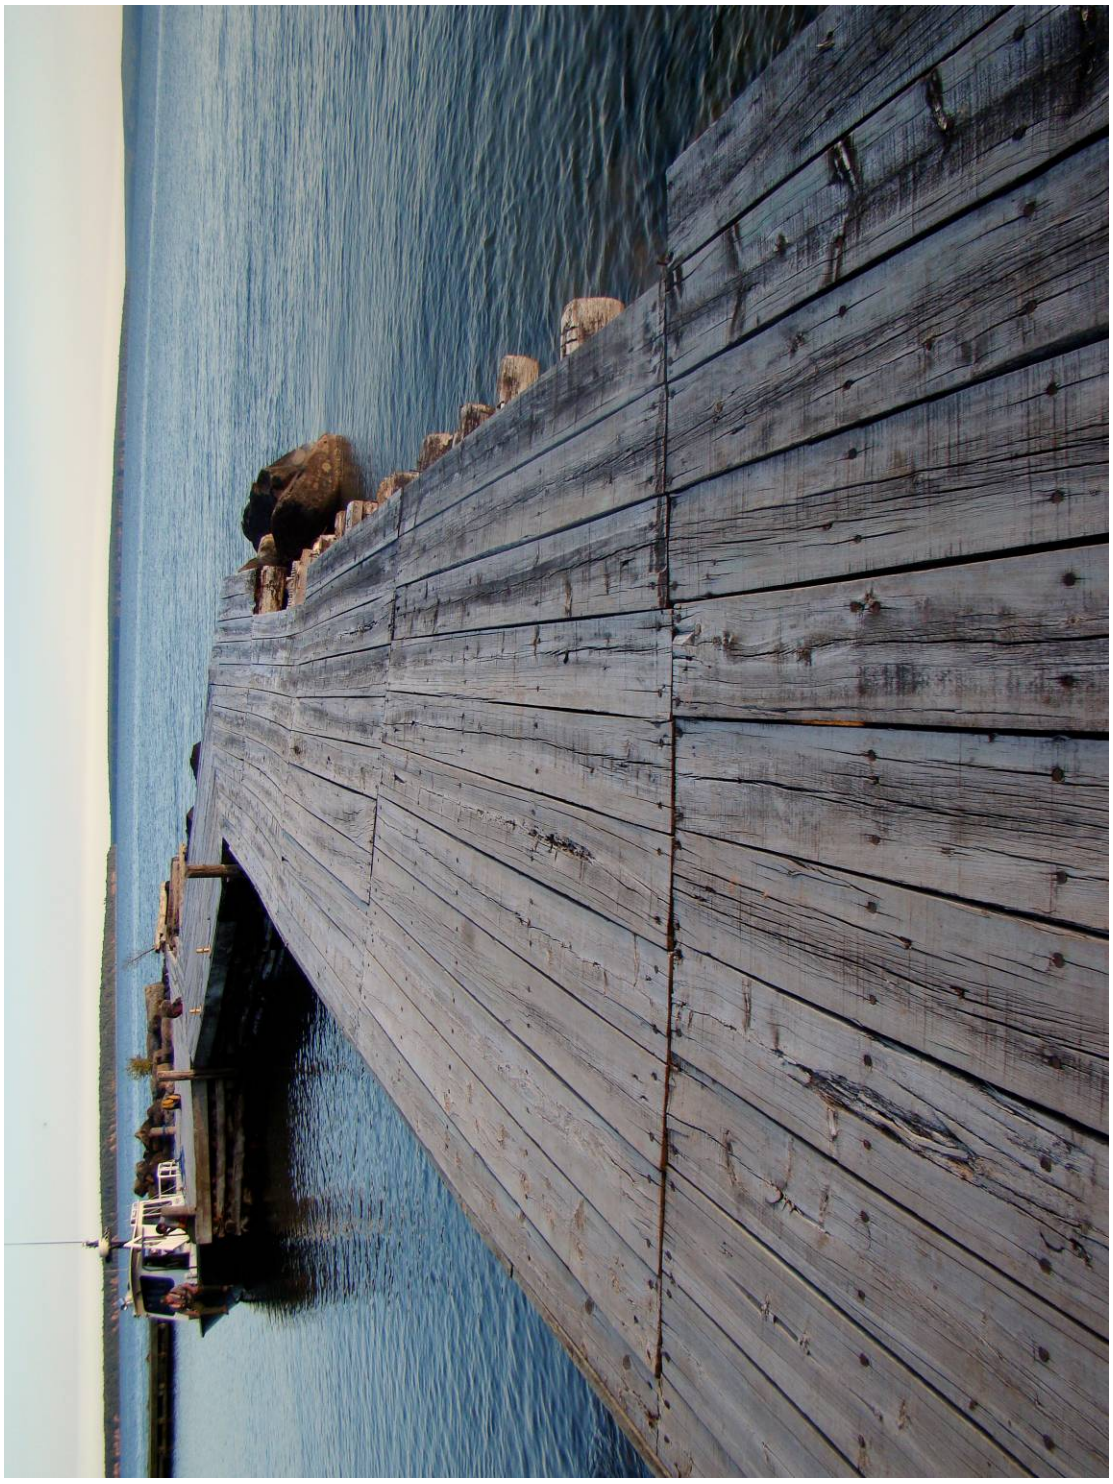
DI-BH-05: East elevation, 2009 (Source: AH DSC01040)
