CULTURAL LANDSCAPE REPORT • HISTORIC STRUCTURE REPORT

Apostle Islands National Lakeshore – Bayfield, Wisconsin

VOLUME V OF VI: LONG ISLAND CLR/HSR

JULY 2011

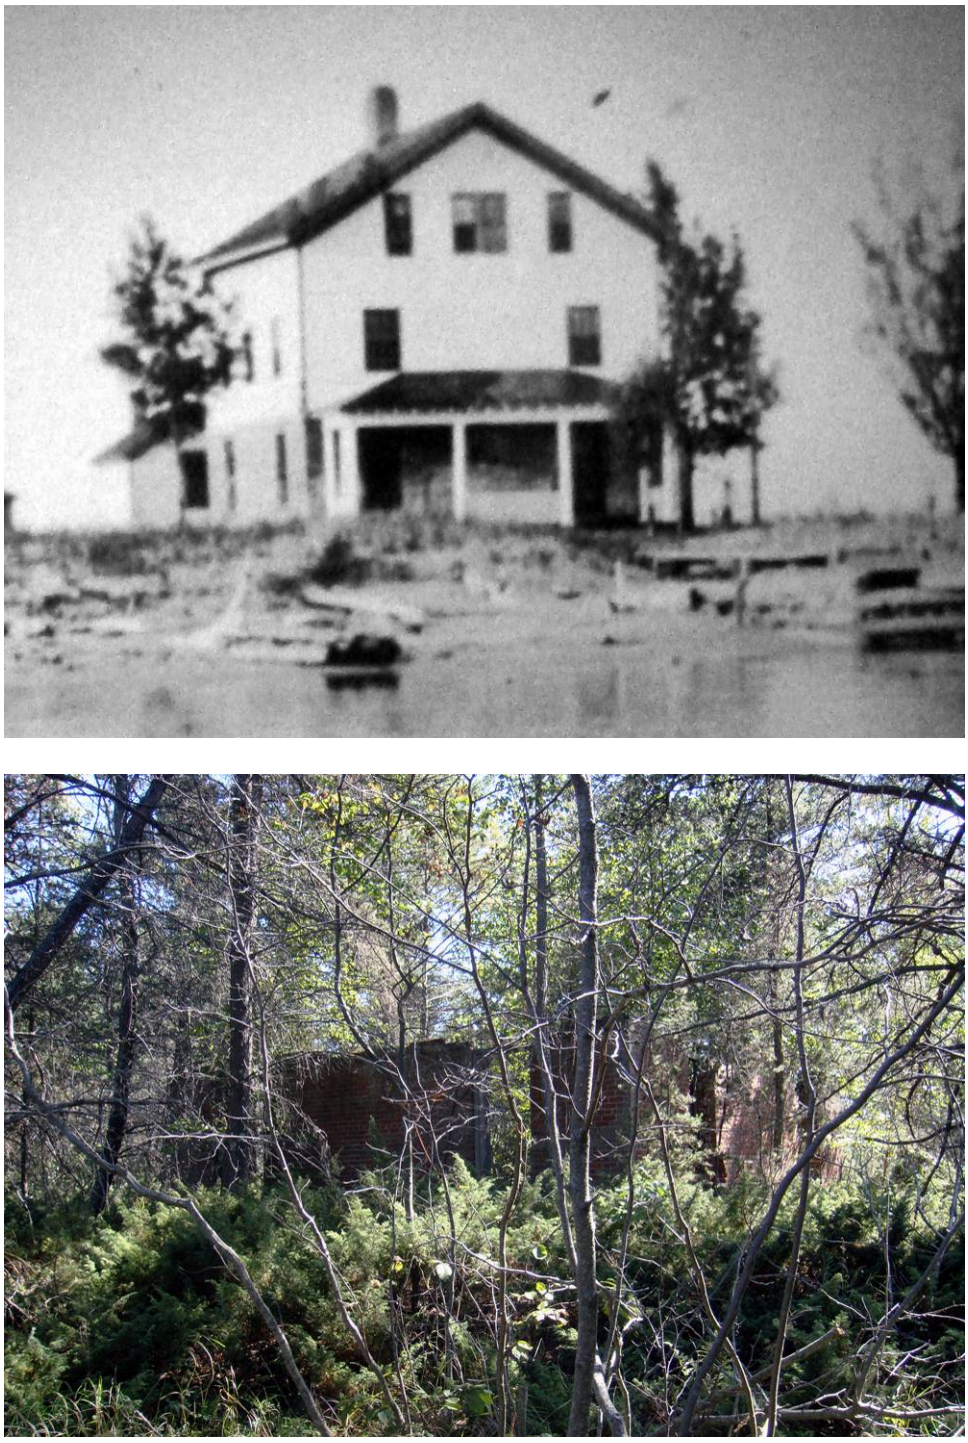
Site Image LI-25: View of Original LaPointe Lighthouse showing diminished spatial organization by encroaching vegetation; top, c. 1920 (Source: NPS APIS Archives); below, 2009 (Source: MBD DSC01285.jpg)

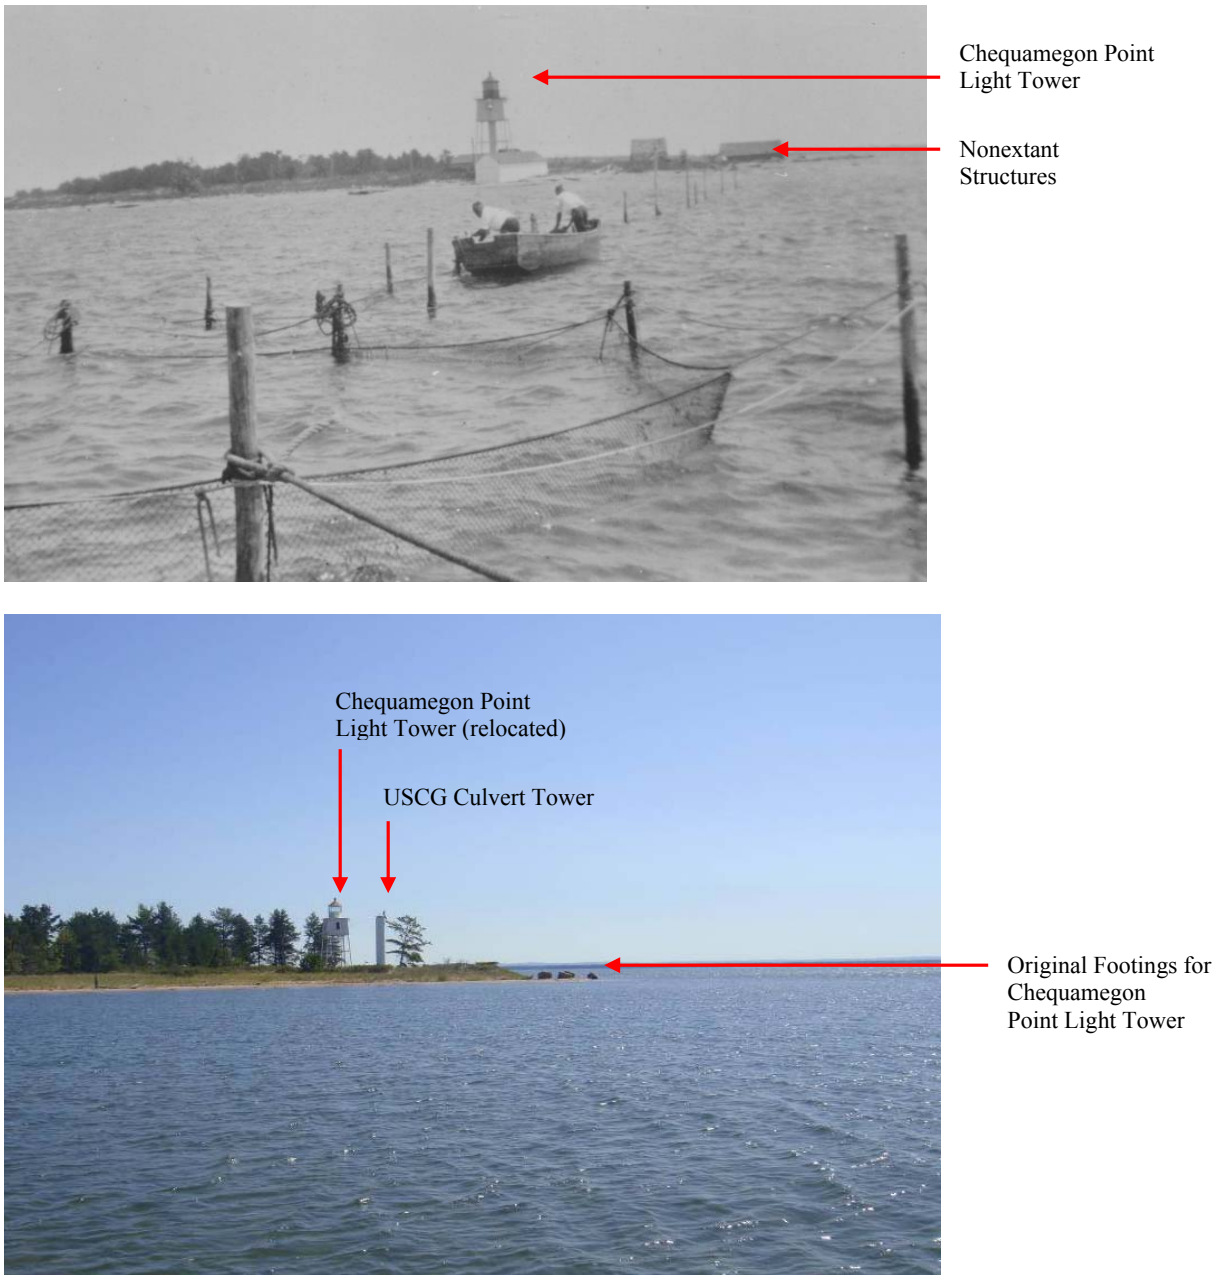
Site Image LI-28: View of Chequamegon Point showing diminished spatial organization and encroaching forest vegetation. Three nonextant structures visible in top image; top, c. Light Tower Period (Source: NPS APIS Archives); below, 2009 (Source: MBD DSC01260.jpg)

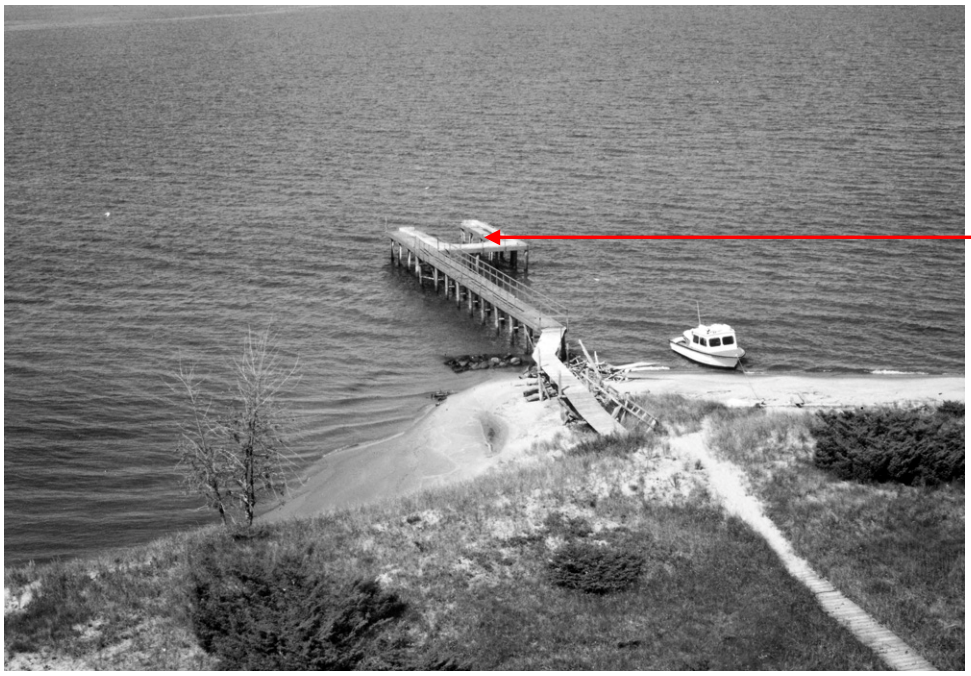
Site Image LI-40: Boat dock at LaPointe as viewed from LaPointe Light Tower; top, 1987; below, 2009 (Source: MBD DSC_0150.JPG)

Site Image LI-41: Boat dock at LaPointe, 2009 (Source: APIS LaPointe Boat Dock.JPG)

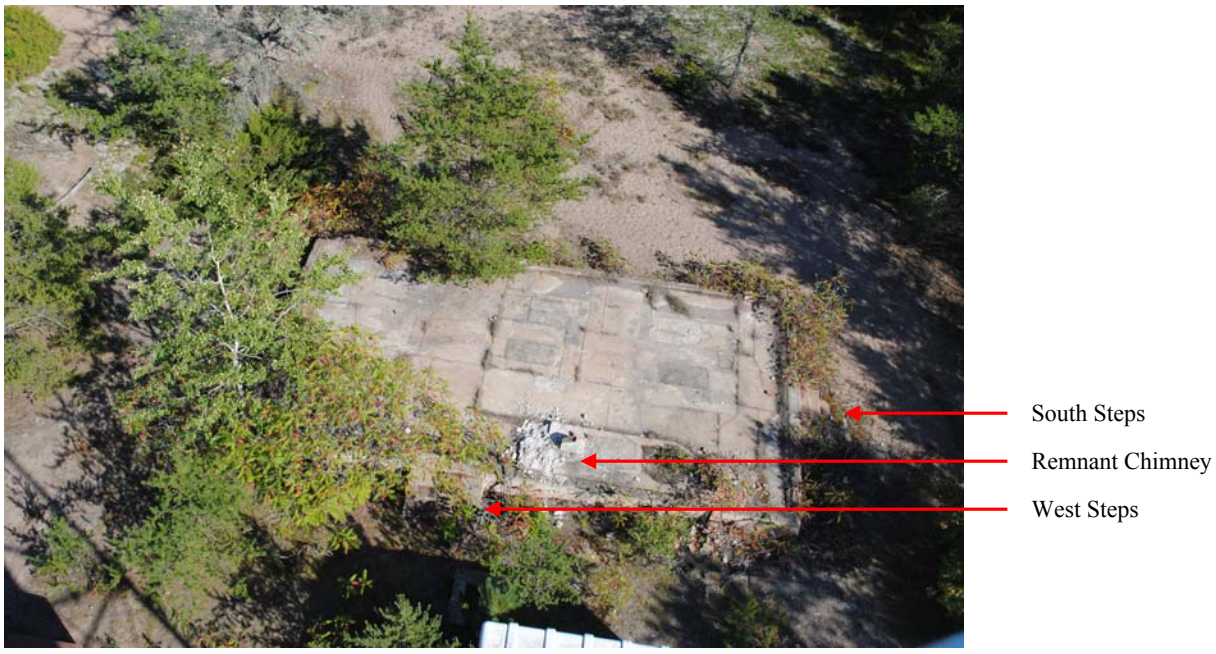
Site Image LI-42: Fog Signal Building foundation, 2009 (Source: MBD DSC01356.JPG)

Site Image LI-43: Fog Signal Building foundation as viewed from LaPointe Light Tower, 2009 (Source: MBD DSC_0152.JPG)

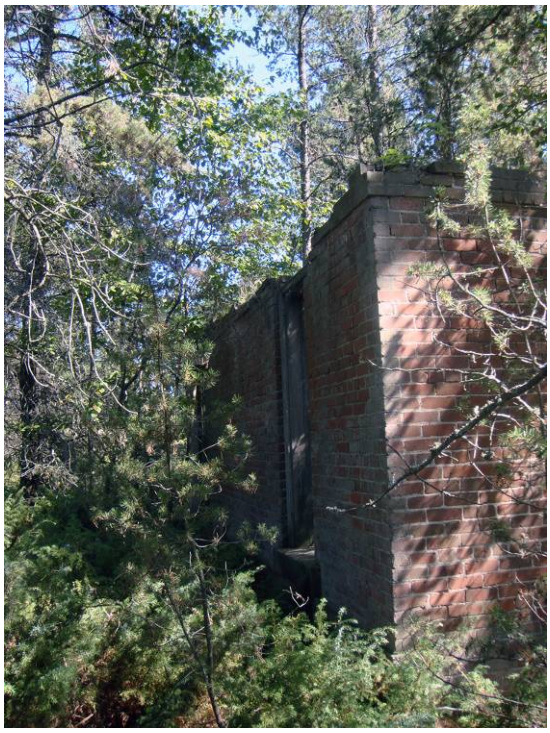
Site Image LI-46: Original LaPointe Lighthouse ruin, 2009 (Source: MBD IMG_9419.JPG)

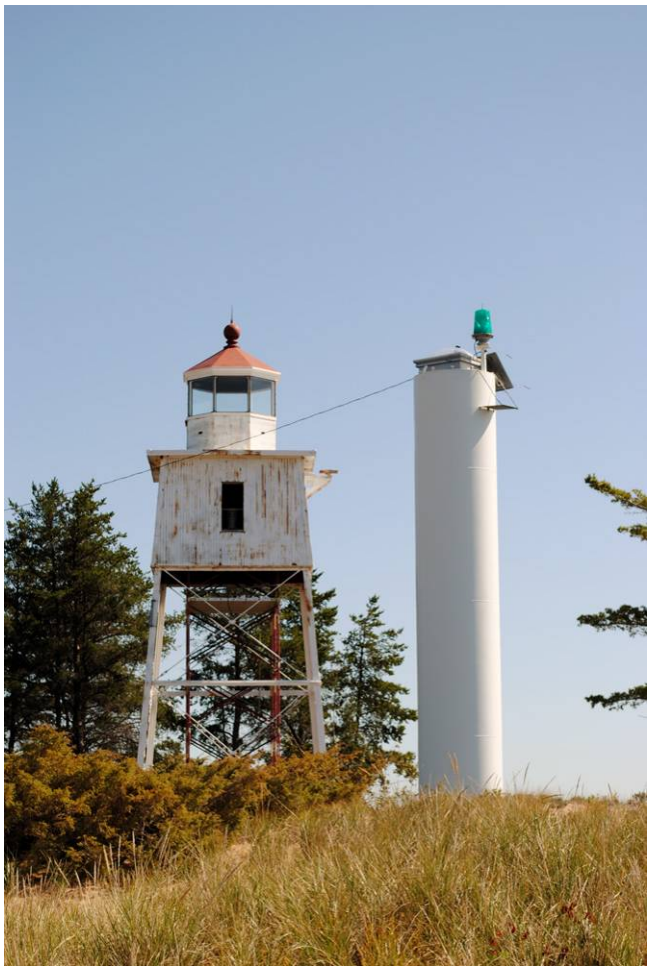
Site Image LI-50: Chequamegon Point Light Tower (left) and USCG Culvert Tower (right), 2009 (Source: MBD DSC_0057.JPG)

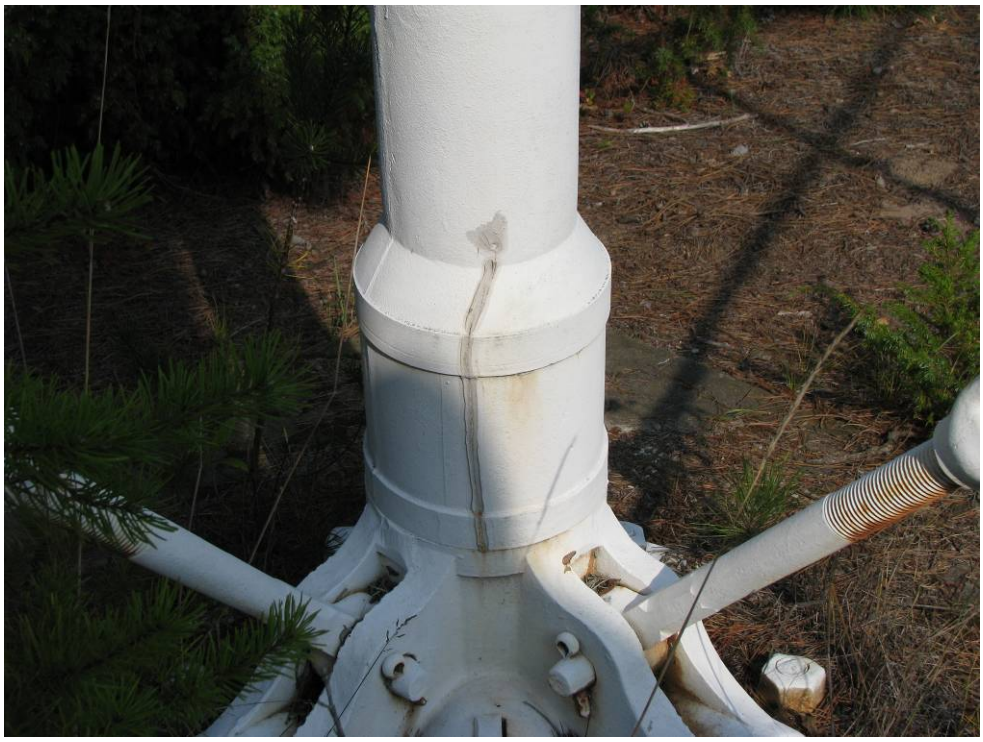
LI-LT-22: Surface delamination (Source: Martin/Martin)
