HISTORIC STRUCTURES REPORT

ENGINEERING STUDY
OF
CENTRAL BLOCK ROOF SUPPORT SYSTEM

ARLINGTON HOUSE

August 1982

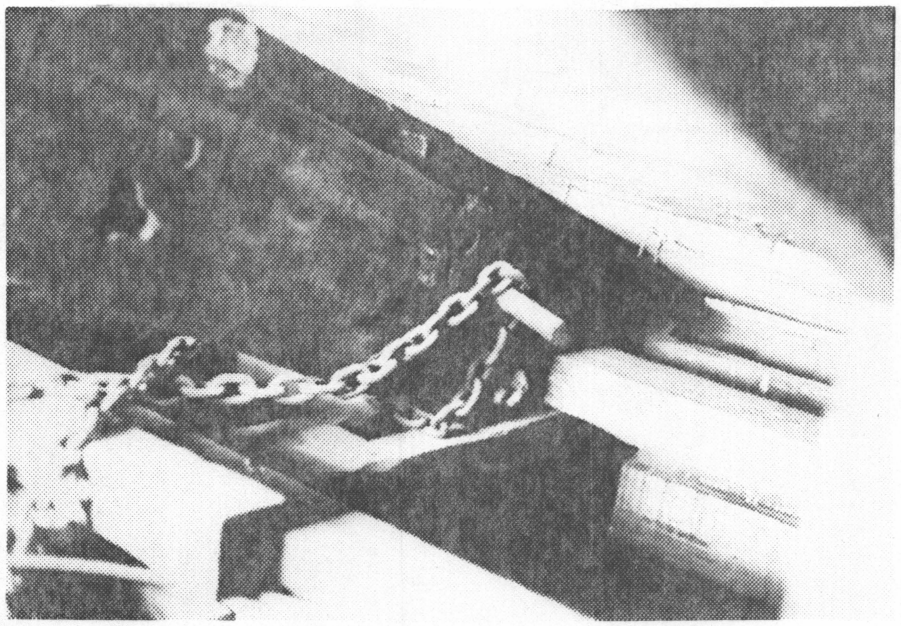
1. Heel joint on south side of truss "B" (Photo 1).

The failure of this connection was the result of a design characteristic unique to this truss - it spanned the entire width of the portico/main block. All the other trusses were, in addition to bearing on the end (N & S) walls, supported by either interior load bearing walls approximately 6 feet on each side of the king post or by a series of brick columns as exist along the east side of the Arlington House. To correct this problem, the Corps of Engineers installed two additional trusses (running east to west) to provide support to truss "B" at interior points. In addition, the failed heel joint was stabilized by inserting a metal pin through the top and bottom chords at the mortise and tenon type connection and by wrapping a heavy link chain around the members at this point to hold them together. Although this stabilization effort has functioned since its completion in the 1930s, its design strength cannot be accurately calculated. It is safe to assume, though, that it does not exceed the capacity of the other heel joints which were determined to be underdesigned.

Photo 1. Truss heel joint, south end of truss "B".

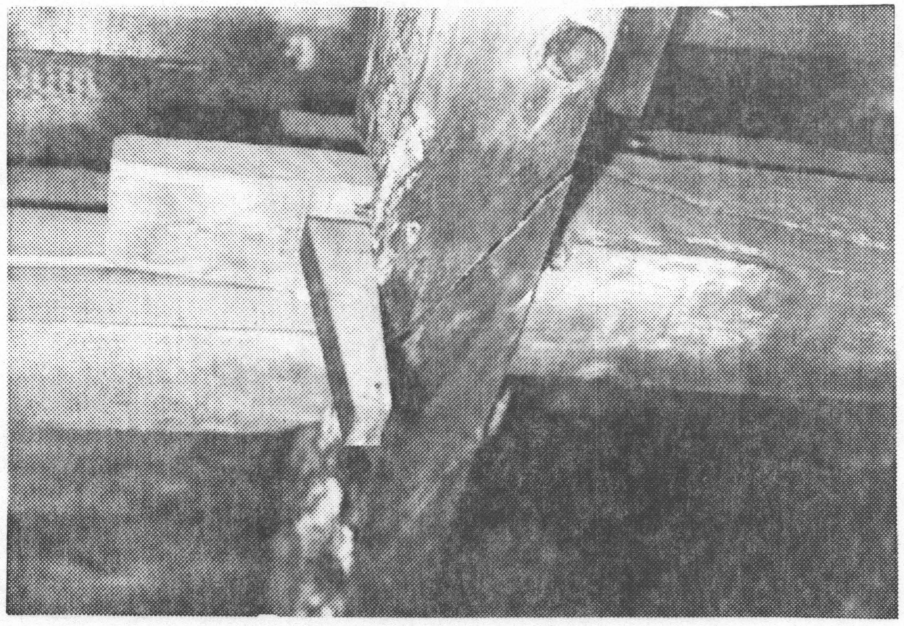
Isolated member or joint failure due to overstressing has occurred primarily in the truss members where the grain is twisted or contains knots. (See Photos 2 and 3). Other cases include several purlins which have split at their end bearing points between trusses "C" and "D" (Photo 7), the heel joint of truss "C" (Photo 8) and several purlin tenons which have been damaged and lost their pegs (Photo 9).

Photo 2. Partial failure of top chord of truss along twisted grain.

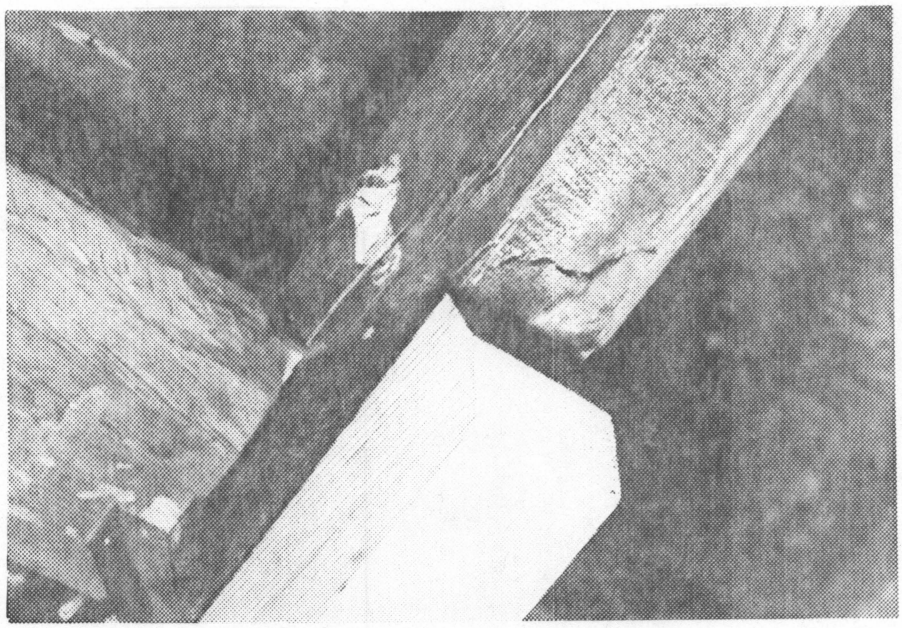
Photo 3. Failure of extreme fibers in bending, top chord, truss "E".

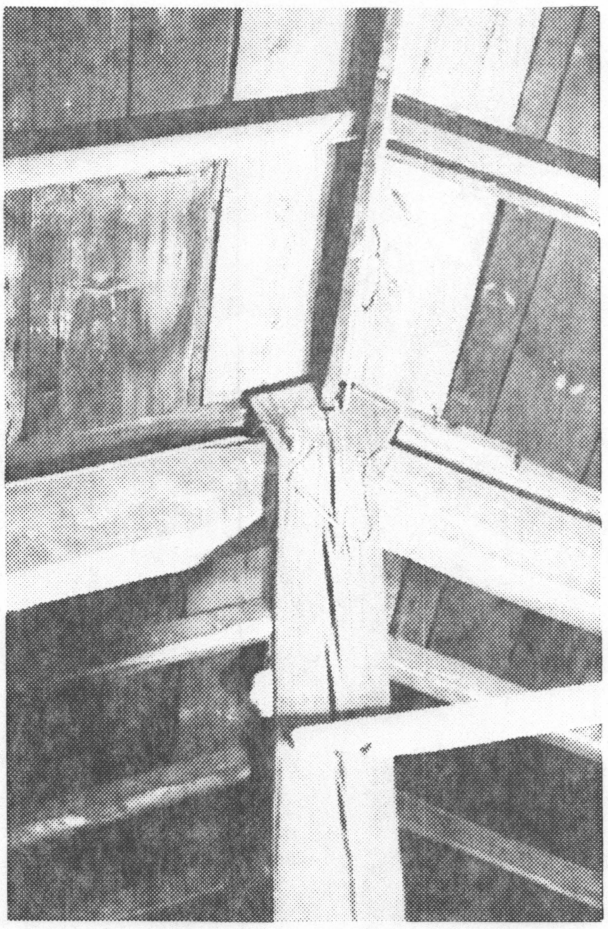
Natural wood defects such as checks, shakes, knots, or twists are fairly prevalent in the roof support structure, particularly the truss members, resulting in an unquantifiable reduction of its load-carrying capabilities. Examples of such defects are shown in Photos 2 through 4. While bolting, strapping, and other strenghtening procedures might be employed on the existing trusses and other framing members, this alone would be insufficient to insure structural safety.

Photo 4. Example of checking in truss members (kingpost) due to seasoning.

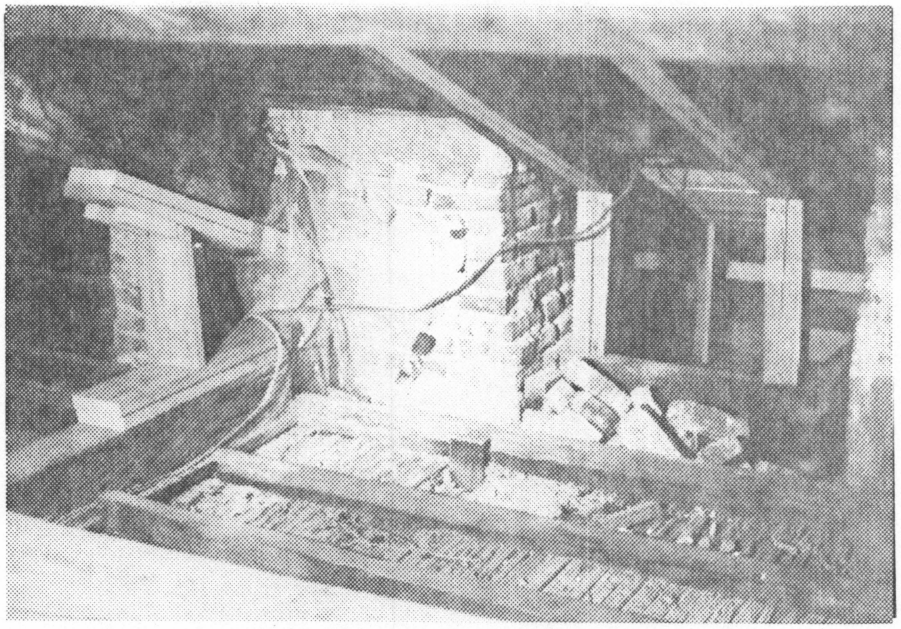
Isolated or low level cases of moisture and insect damage are visible in various members of the roof support system. In general, those members which experienced serious deterioraton due to these elements have been replaced, all infested areas made insect-free, and all leaks sealed. One area where a problem still exists, however, is at the south side chimney through which truss "D" passes. Faulty flashing around the chimney allowed water to accumulate around the top and bottom chords of this truss, creating a suitable habitat for powder post bettle colonies

and contributing to brown rot decay. Although the roof no longer leaks in this area, the deterioration and subsequent loss of section that has already occurred has significantly reduced the strength of this truss. (See Appendix B and Photos 5 and 6.)

Photo 5. South end of truss "D" on north side of masonry chinmey.

c. the deteriorated portion of truss "D" in the vicinity of the (south-side) chimney to be repaired as suggested in Appendix B.

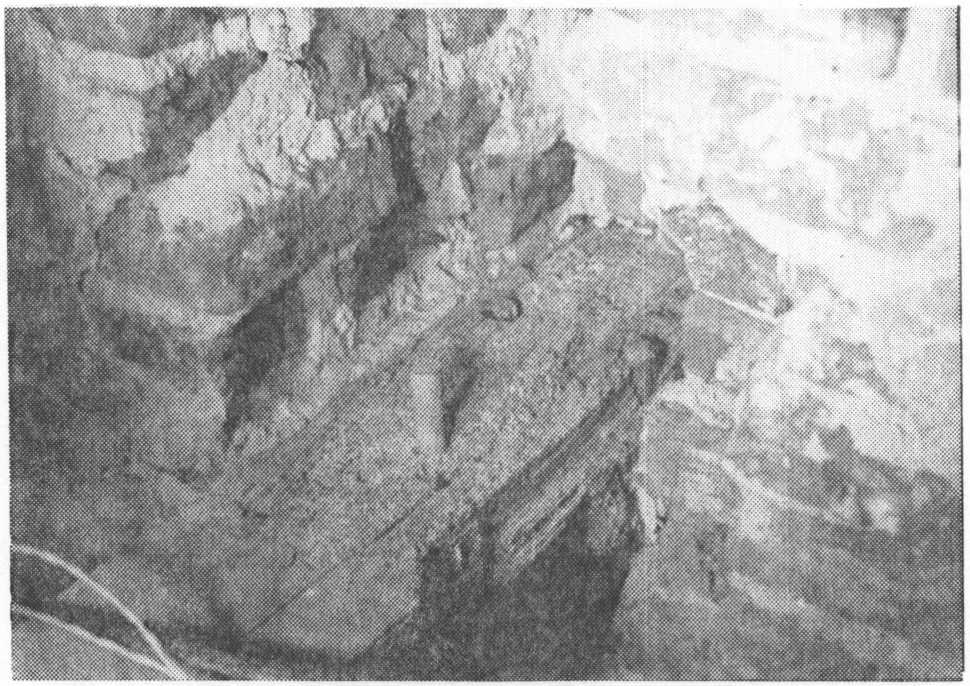
Photo 6. Portion of bottom chord of truss "D" exposed by partial dismantling of masonry chimney. Note extensive level of deterioration due to powder post beetle and brown rot.

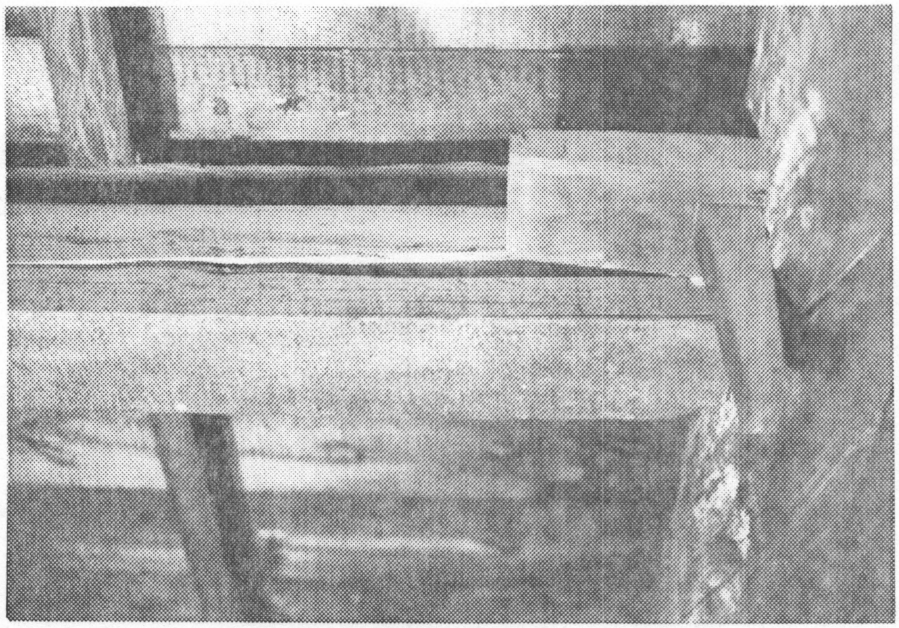
Photo 7. Purlin failure due to excessive loading. Recommended action - repair using metal straps or through bolts.

b. split purlins to be repaired by use of straps or through bolts and reinforced by the introduction of new members.

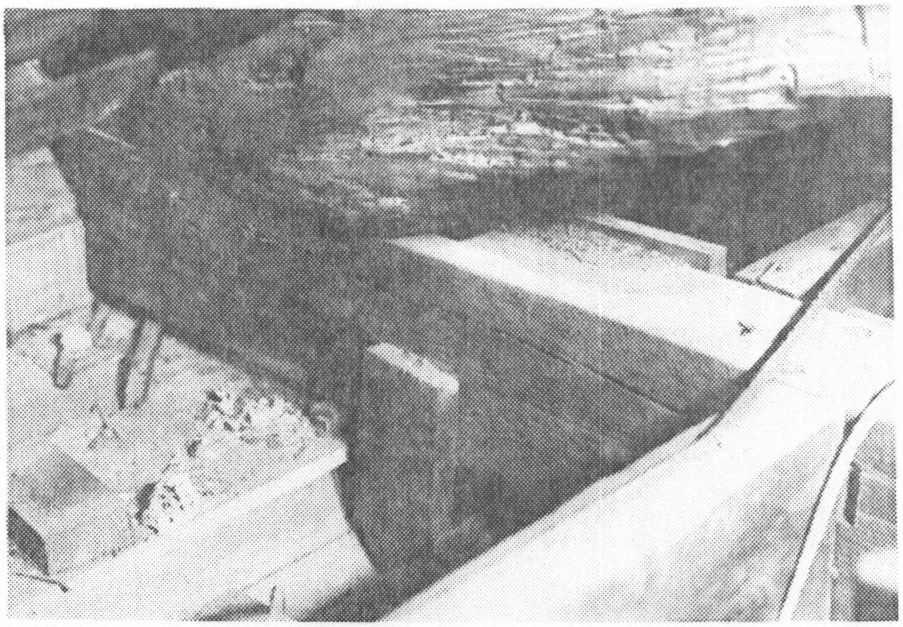
Photo 8. Truss heel joint, north end of truss "C".

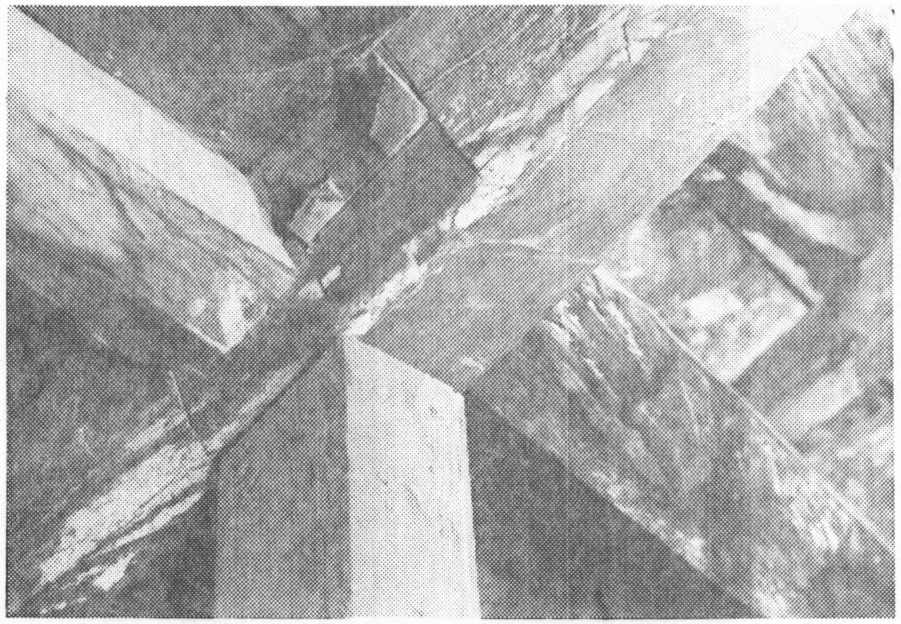
Photo 9. Tenon of purlin on right damaged and peg is missing, reducing ability of roof to resist lateral movement.

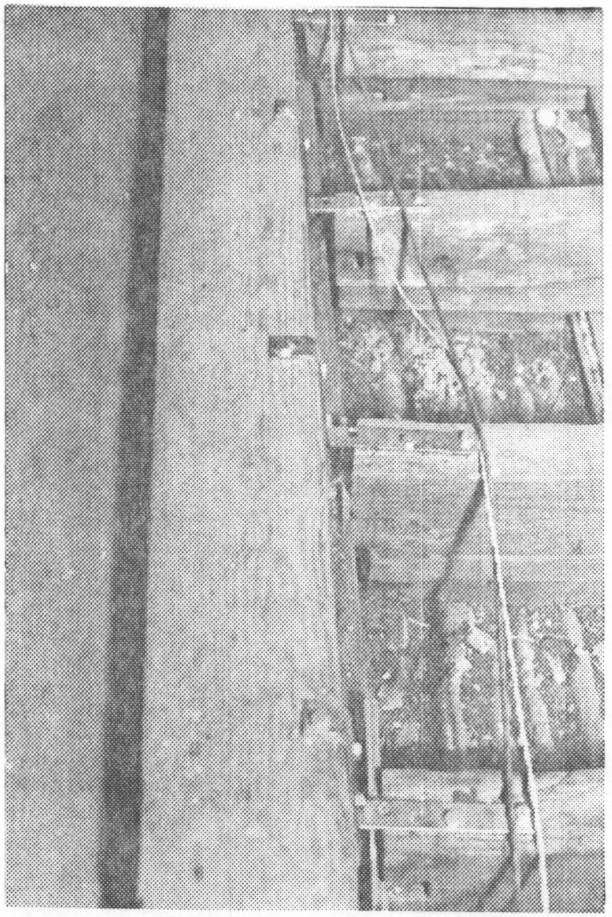
Photo 10. View of ceiling joists fastened to bottom chord by bent bar connectors.

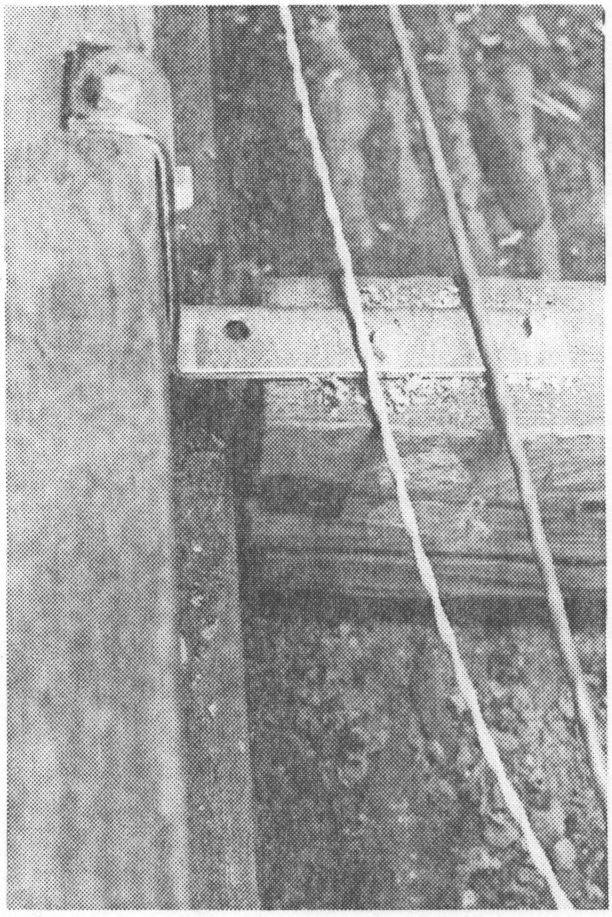
The frequent lack of support provided to the ceiling joists in this attic was diagnosed and partially treated during the investigative phase of the Historic Structure Report. Shrinkage and sagging of the joists had caused their notched ends to move away from the small ledger strip to the point where many joists had lost contact with their support system. To remedy this problem, bent strap connectors were fastened from the bottom chord of the adjacent truss to the tops of the joists which appeared to have insufficient bearing contacts with a ledger strip. (Photos 10 and 11.) A similar type of treatment should be used to secure support for the remaining joists, with the only modification being that the straps be fastened to the sides of the joists instead of their tops.

Photo 11. Close-up of ceiling joist showing loss of bearing support/contact w/ledger strip.

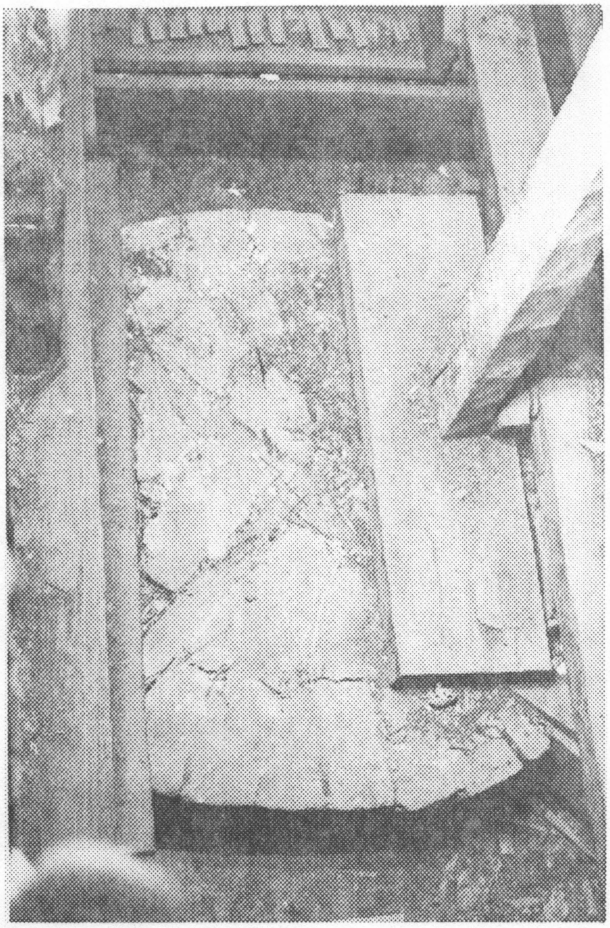
Photo 12. Top of brick column under south side of truss "B".
