HISTORIC STRUCTURES REPORT PART II

CONGRESS HALL

INDEPENDENCE NATIONAL HISTORICAL PARK

February 1960

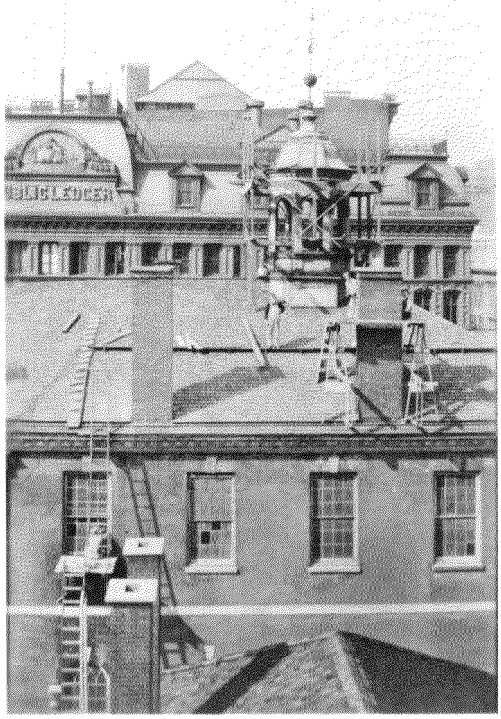
CHAPTER III
SECTION V
Illustration No. 8

East facade of Congress Hall during the Restoration of 1912. Note sag in the roof at left due to the failing roof truss in the 1793 extension.

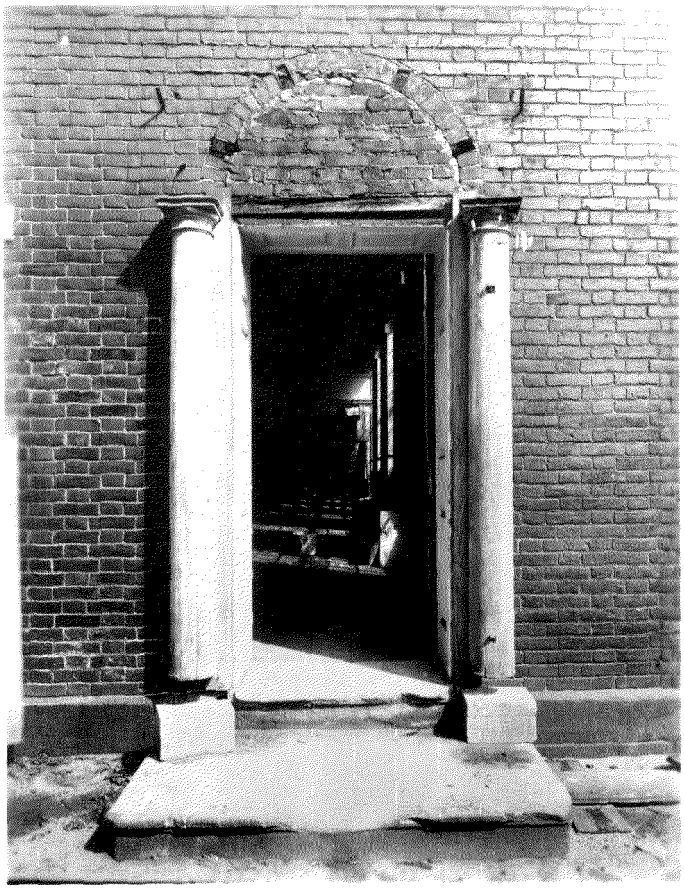
CHAPTER III
SECTION V
Illustration No. 9

Southeast door of Congress Hall during 1912 Restoration. Portions of the frontispiece are removed, showing the structural brick arch behind.

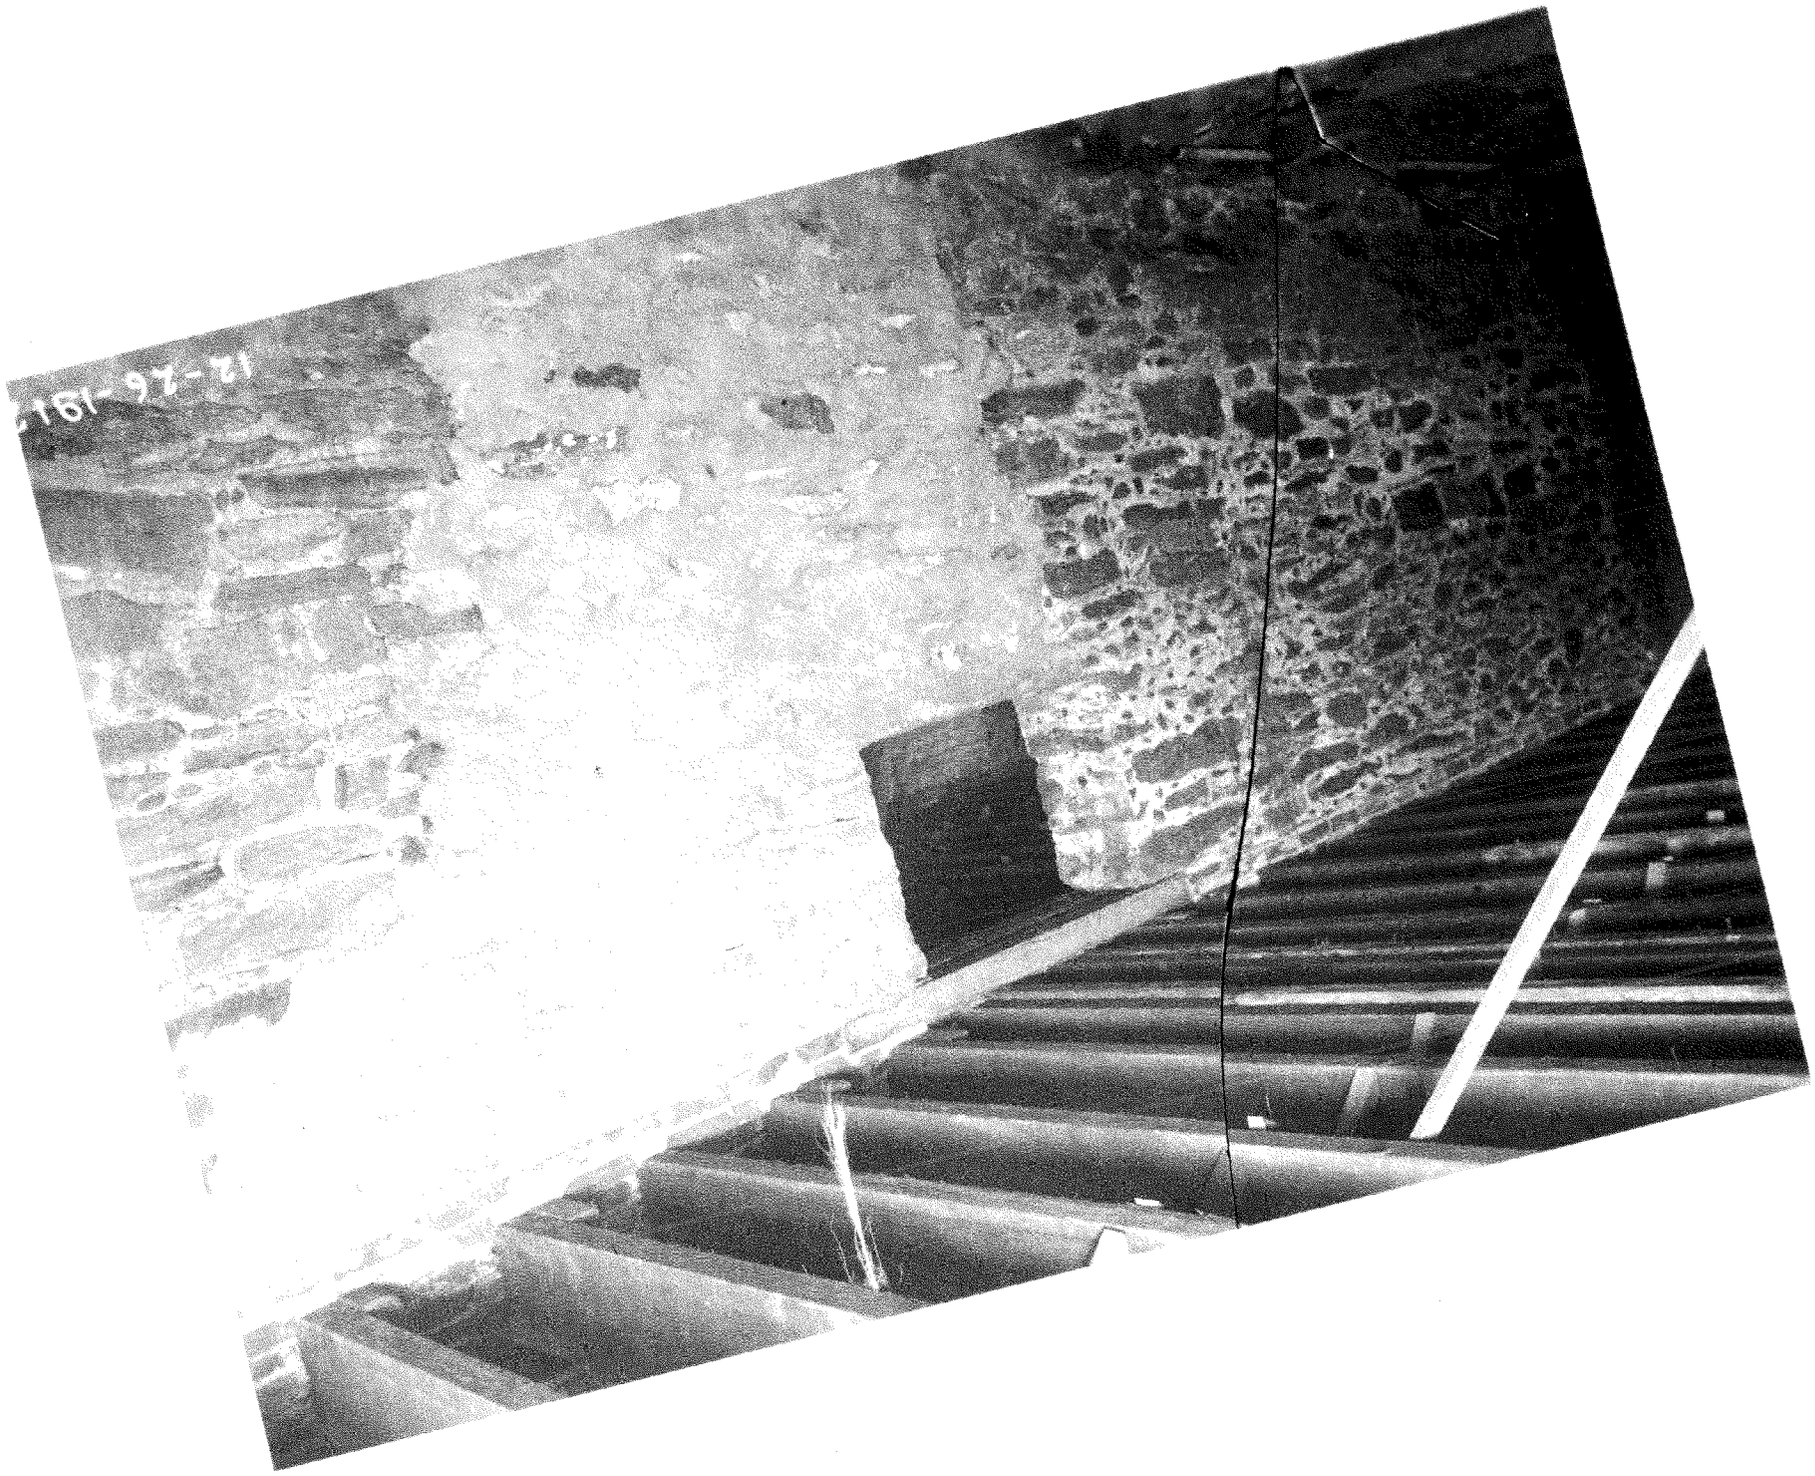
CHAPTER III
SECTION V
Illustration No. 10

Congress Hall Basement walls. Note original stonework with small stones inserted in mortar joints; i. e., galleted.

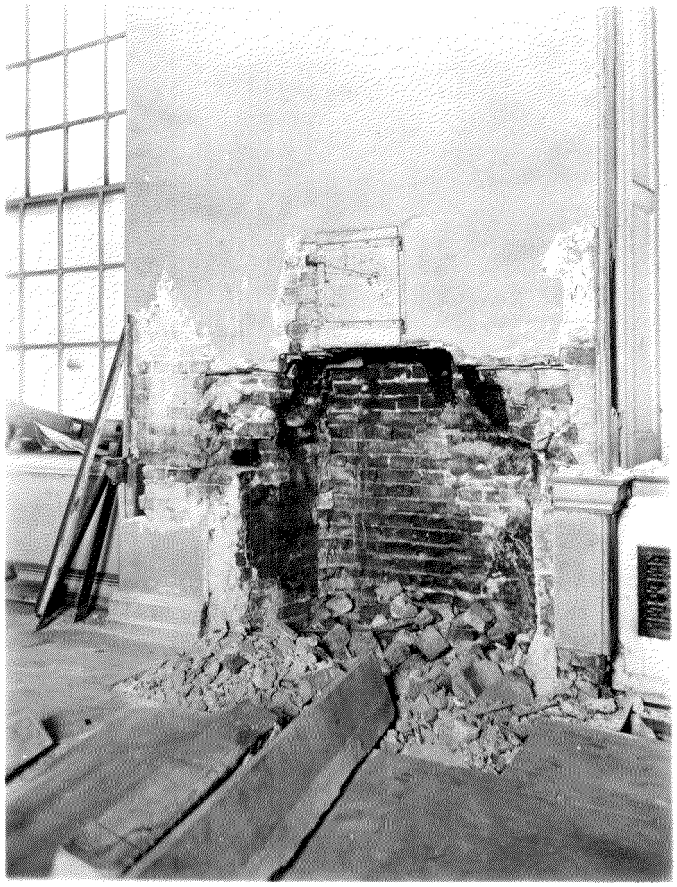
CHAPTER III
SECTION V
Illustration No. 16

Congress Hall, Senate Chamber, west fireplace after the removal of the marble mantelpiece and during the architectural investigation. See SECTION II (C-10, H-3, and K-2) for discussions of the evidence found.

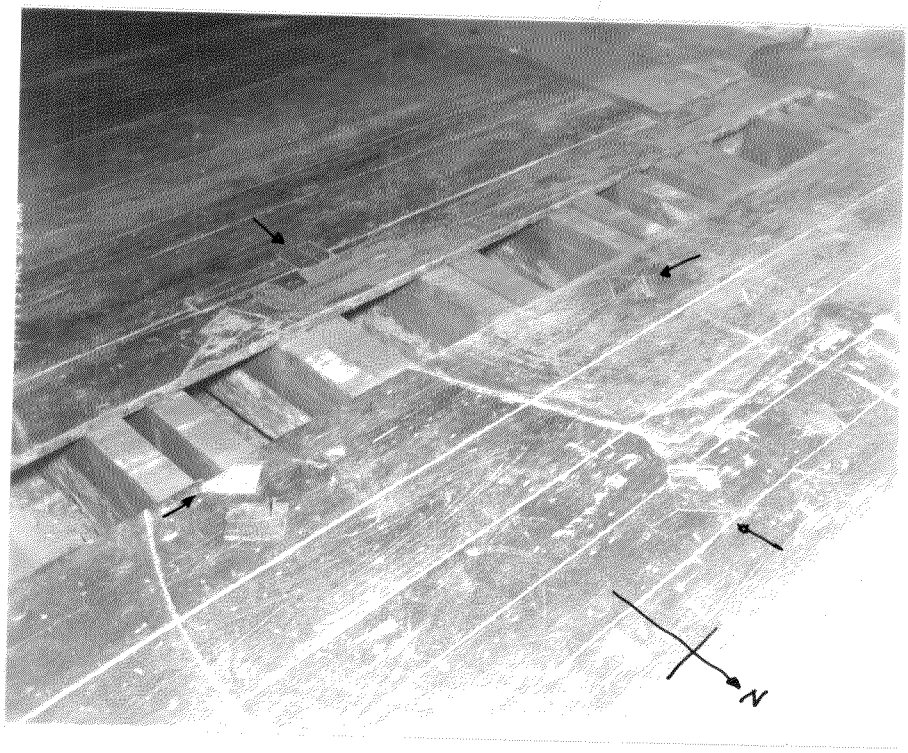
Congress Hall, House of Representatives, area of original flooring showing mortise holes, which may have been used with the original speaker's platform. The other outline on the floor shows the position of the twentieth-century restored platform.

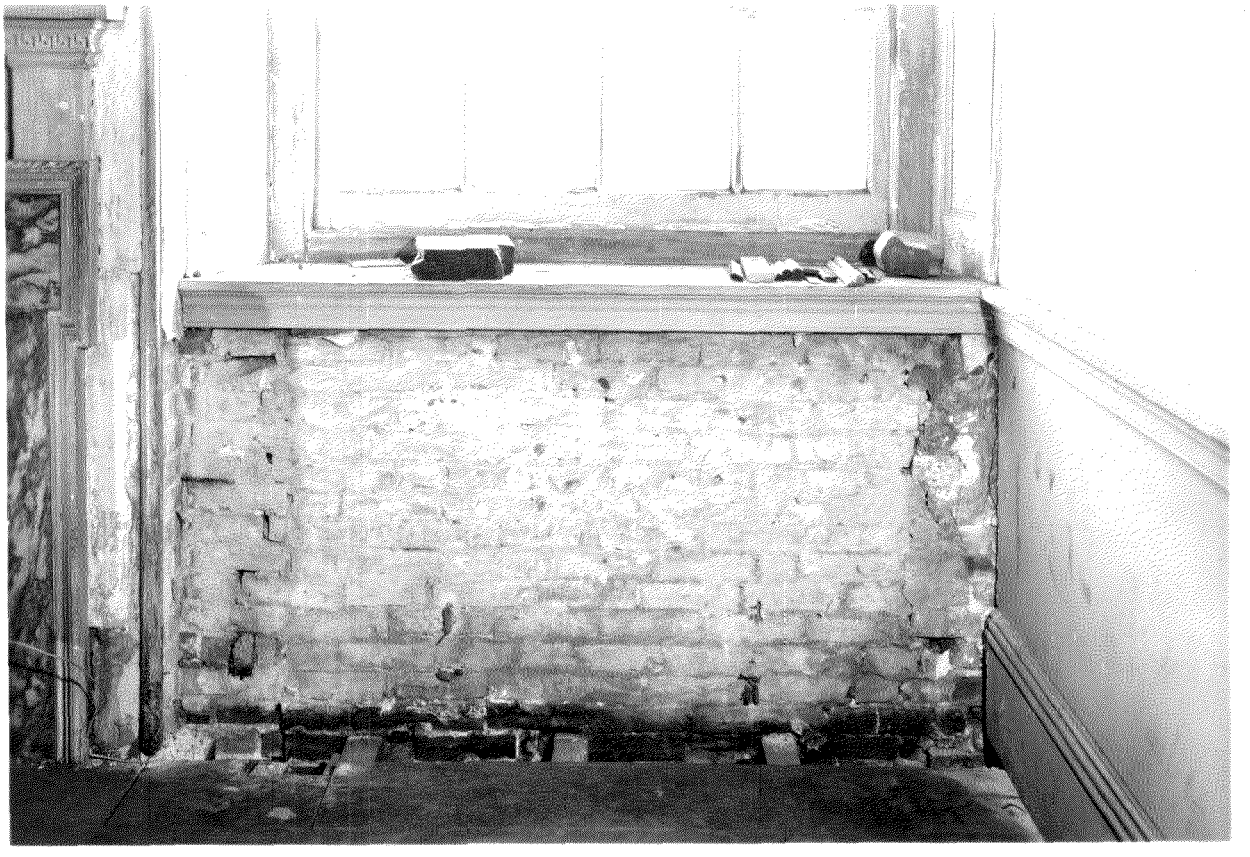
CHAPTER III
SECTION V
Illustration No. 28

Congress Hall, second floor, east middle room, window to the south of the fireplace. Note vertical joints in brickwork showing that this opening was once used as a door. See SECTION II, C-9, "The Portico."

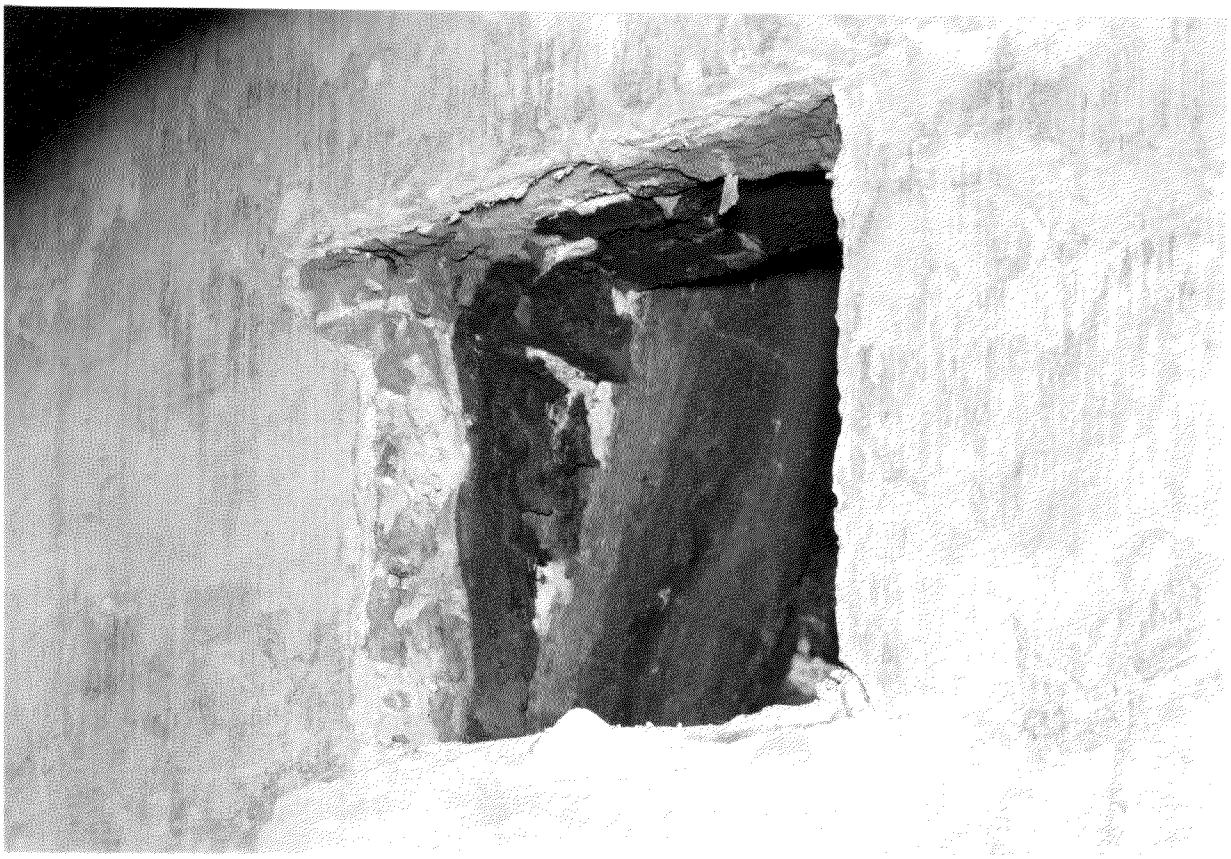
CHAPTER III
SECTION V
Illustration No. 30

Congress Hall, second floor, west middle room. "Clean-out" door over mantelpiece was uncovered in 1959. Note the broken bricks, which show that it was installed by breaking through an existing chimney breast.

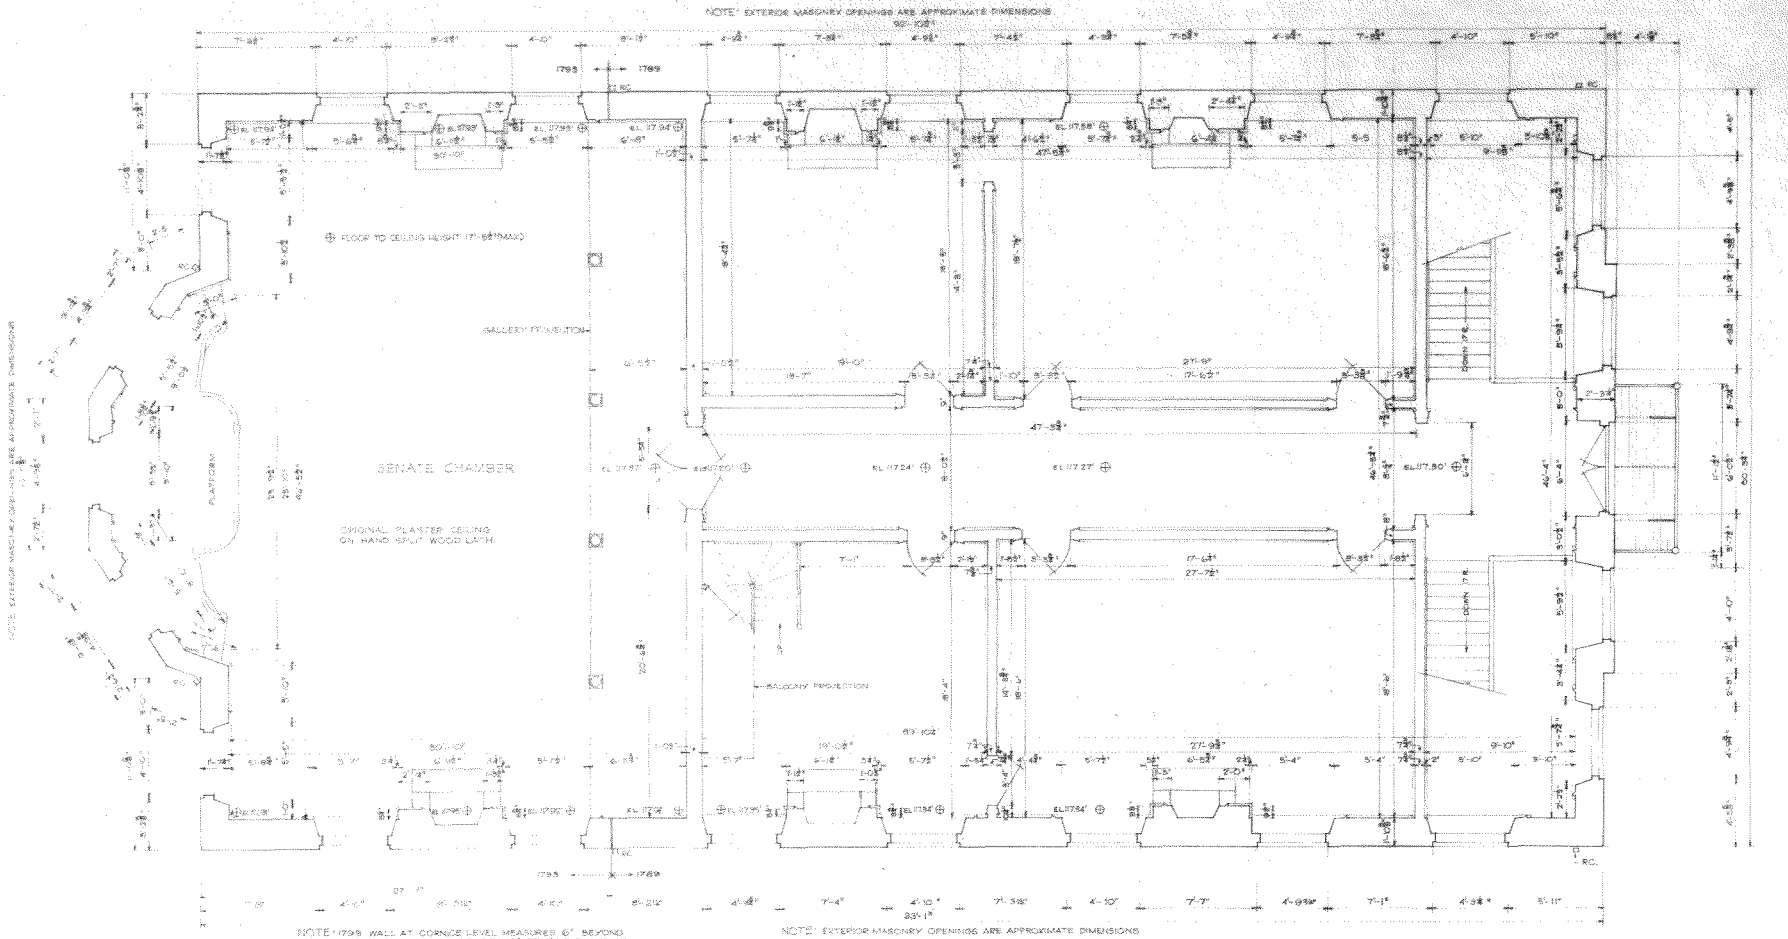
DRAWING NO. NCH-1-3-18

NOTE: 1795 WALL AT CORNICE LEVEL MEASURES 6" BEYOND PLUMB 1789 WALL MEASURES 3" BEYOND PLUMB AT EAST WALL JUNCTURE OF TWO STRUCTURES.

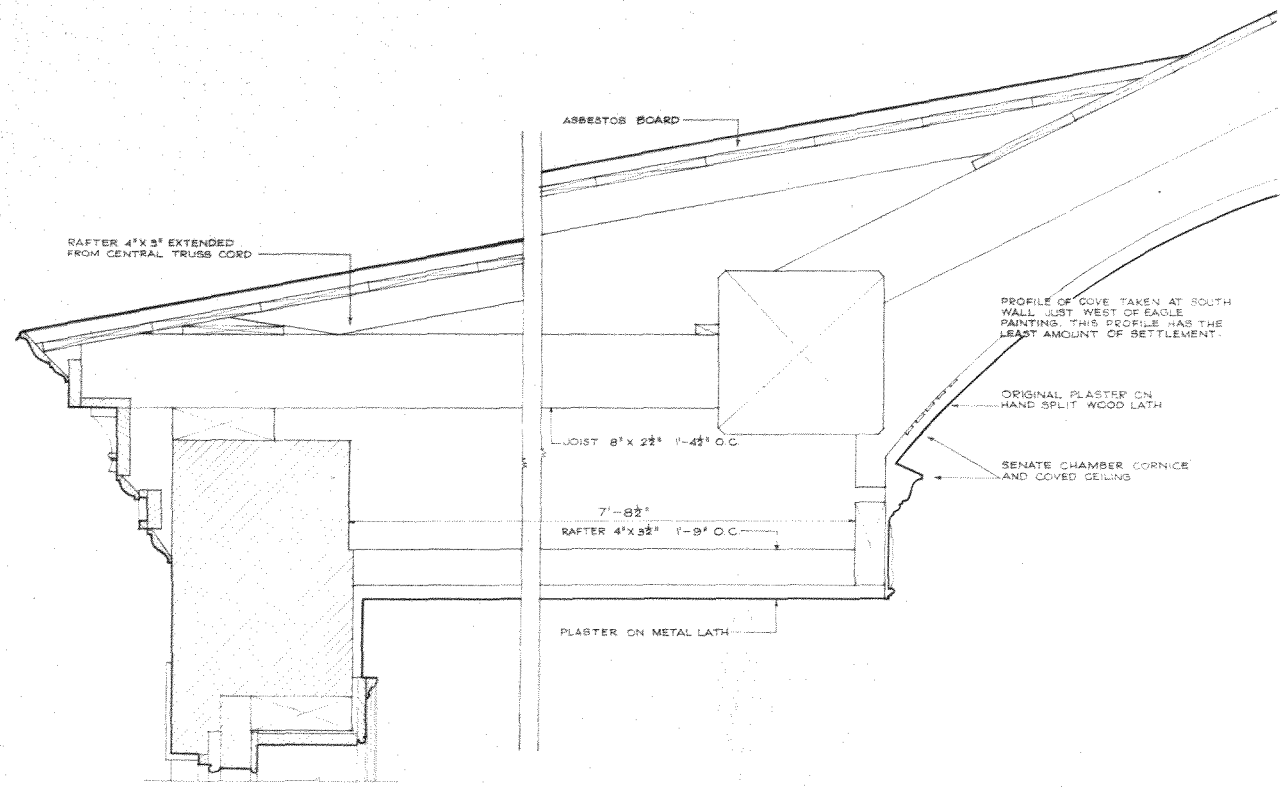
NOTE: THIS EXTERIOR CORNICE PROFILE SHOULD NOT BE CONSIDERED TRUE DUE TO THE SETTLEMENT OF ROOF TRUSSES AT THIS END OF THE BUILDING.

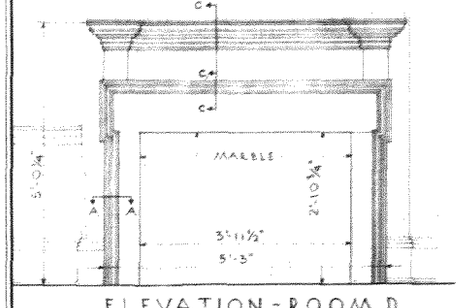
ELEVATION - ROOM D

CHIMNEY PIECE IN ROOM D DATES BACK AT LEAST UNTIL 1823. CHIMNEY PIECES IN ROOM A & B COPIED FROM IT IN 1912. MANTLES & ARCHITRAVES IN ROOMS C & E WERE ORIGINALLY PRE-1822 DOOR-HEADS REMOVED FROM ROOM A IN 1912.

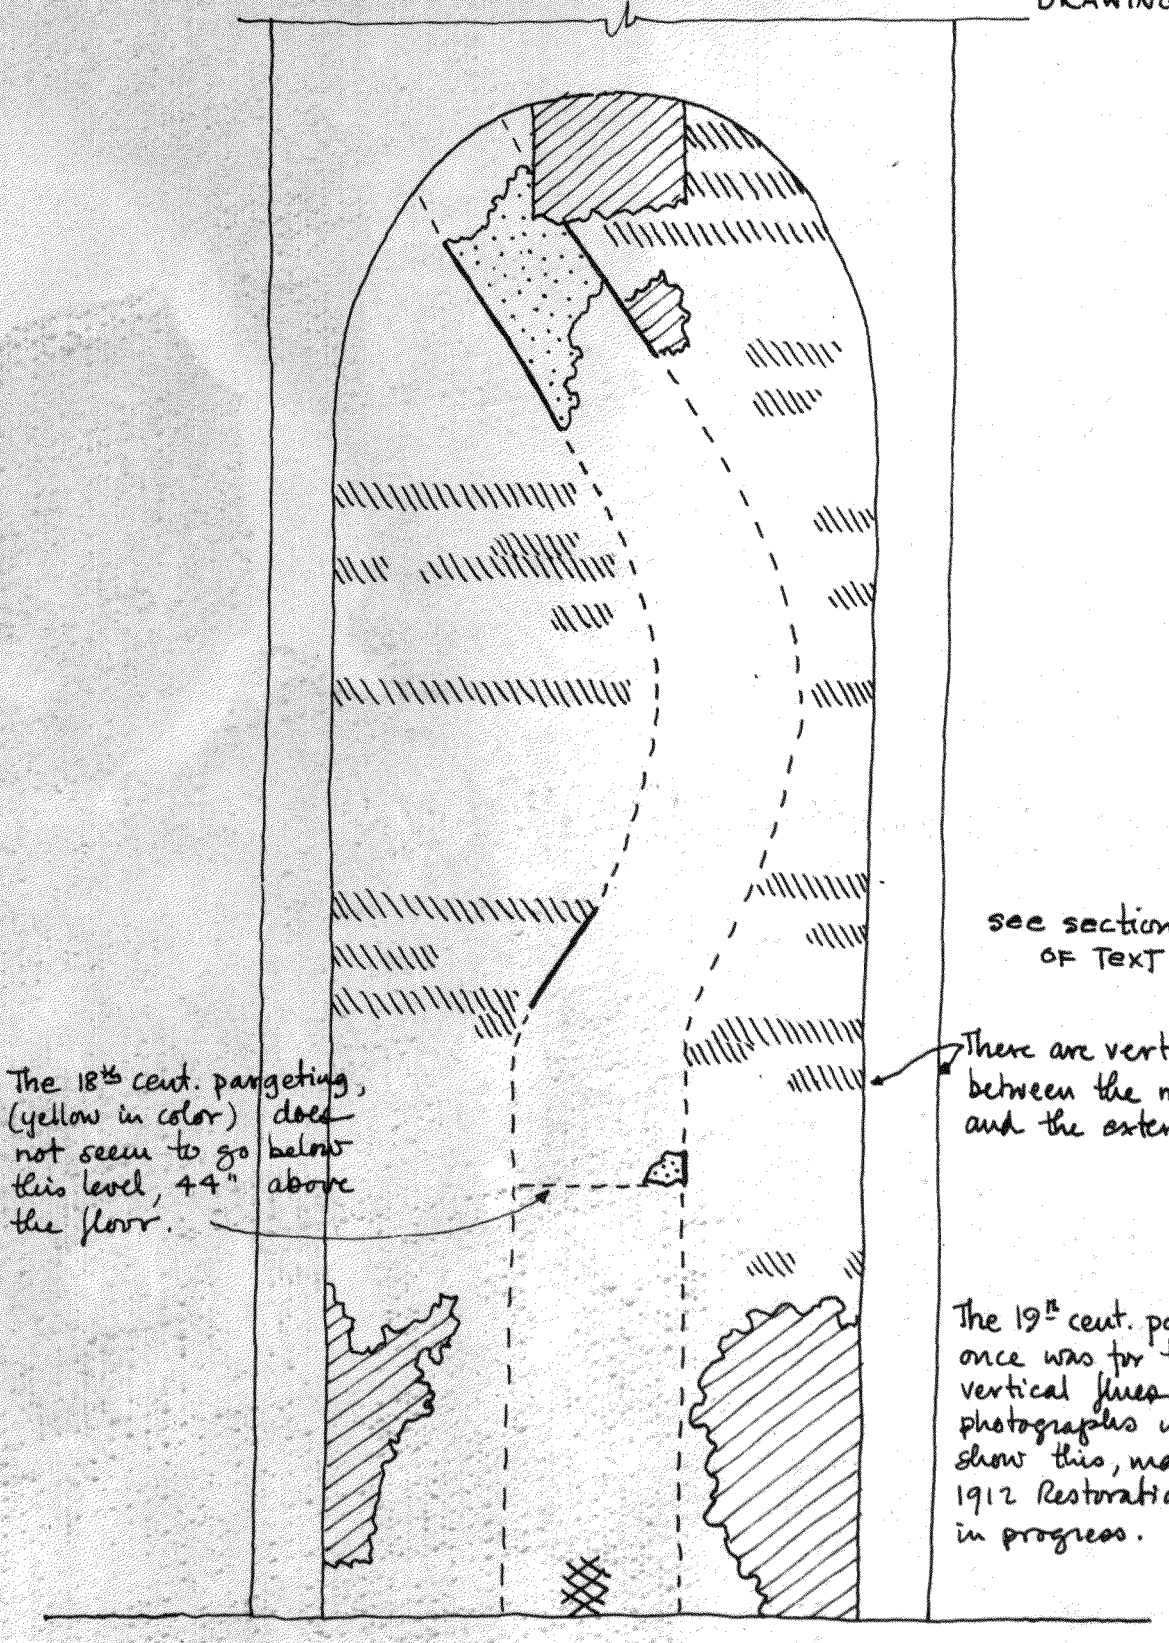
East Wall, Middle Opening, Evidence of Original Fireplace and Stove Arrangement

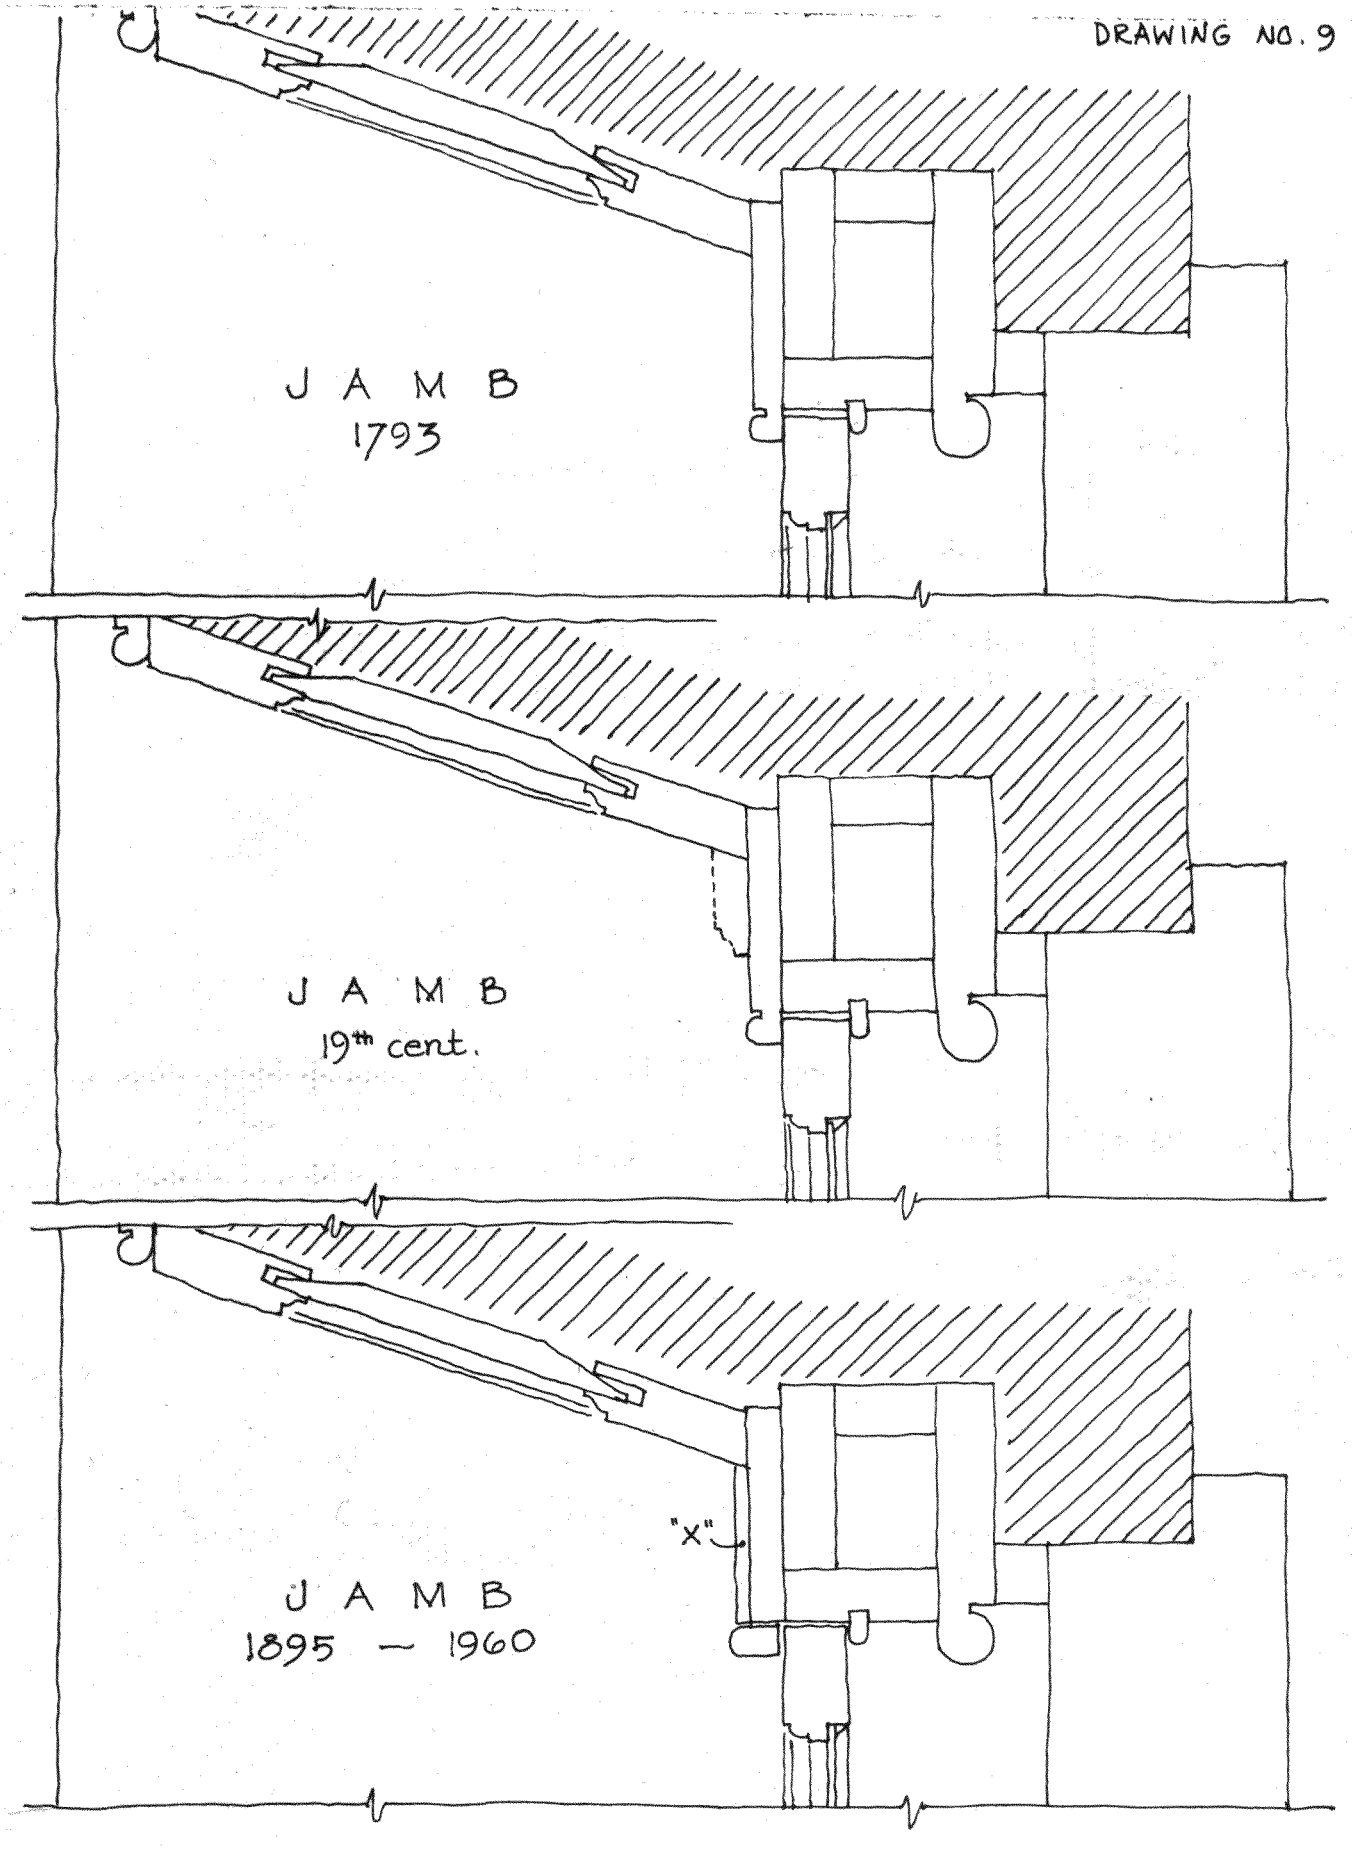
WINDOW TRIM – SENATE CHAMBER

ORIGINAL PAINT EVIDENCE FOUND BEHIND VENEER AT "X"
see section C-6a

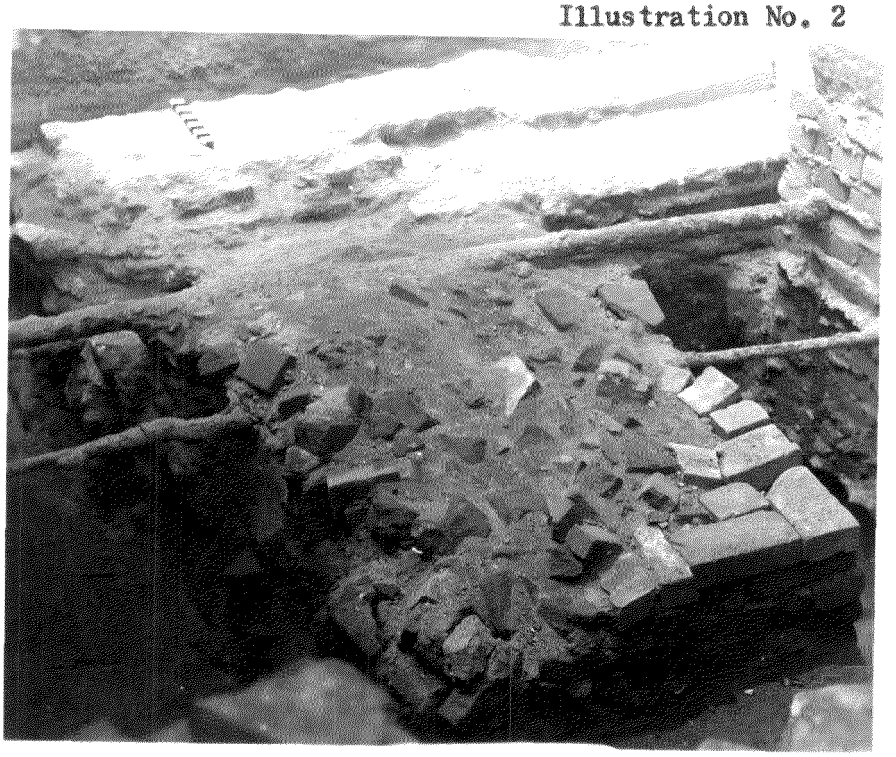
Chapter IV
Illustration No. 2

"Before" view of brick paving and East Wall of Congress Hall. Arrow indicates position of Portico's North Wall according to Davies Map Sketch.

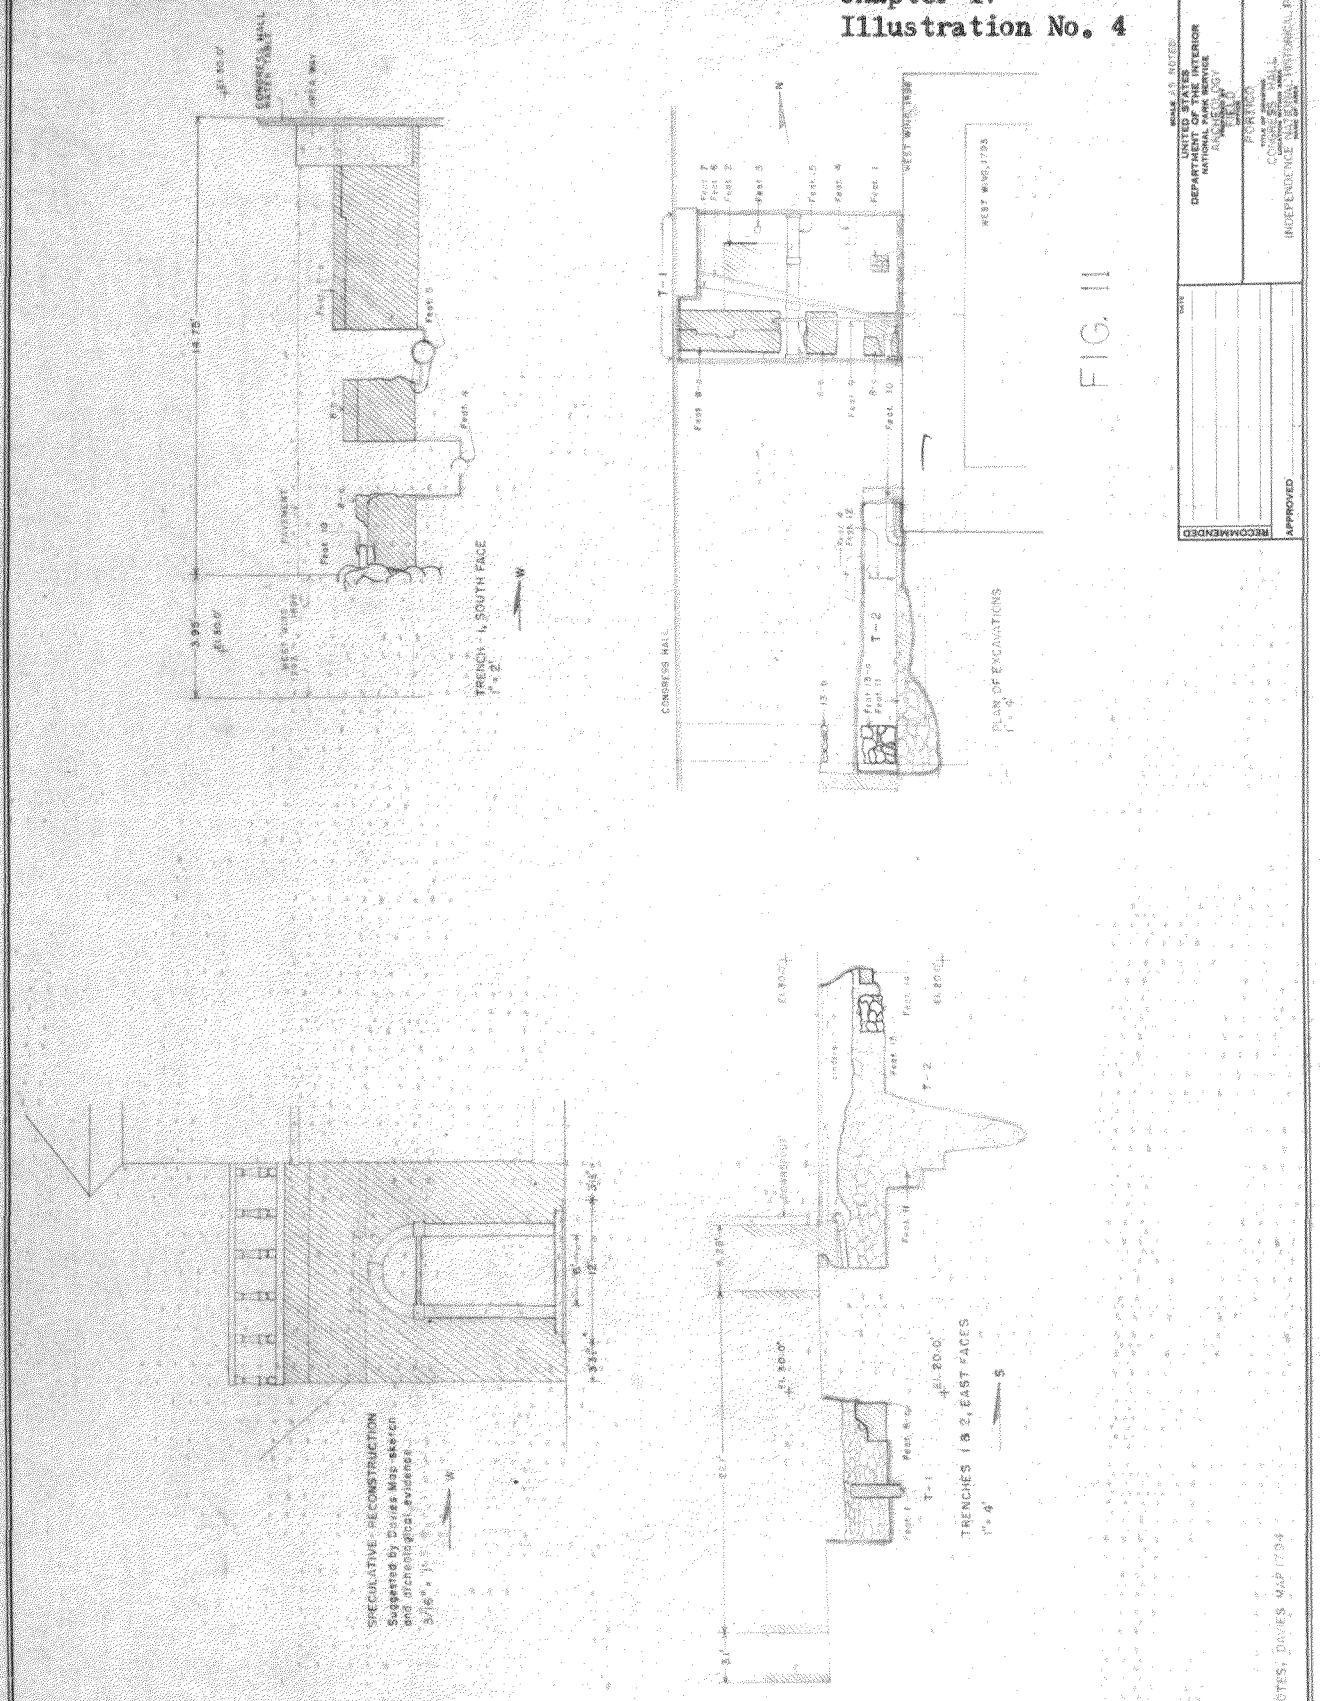
Chapter IV
Illustration No. 4

The north wall foundation of the Portico (Feature #8, Illustration No. 4) was found 56.5' from the present south wall of Congress Hall, at a depth of 1.62' - 3.94' below the surface. The wall at this depth is 2.6' in thickness and consists of two rows of brick on each side of a rubble core. Two gaps had been torn through the wall by the laying of two nineteenth century pipes (Features #4 and 5, Illustration No. 4). The remains of a step foundation (Feature #2, Illustration No. 4) built of unmortared brick was found to be fairly complete on the west, though elsewhere torn up by several later features. Since the step would have been symmetrically centered with the north wall, the east edge of the step would have been the same distance from the original West Wing as the west edge is from Congress Hall (3.3').

The south wall foundation of the Portico (Feature #13, Illustration No. 4) was found to be of mortared stone, rather than brick, 2.3' in thickness and 1.32' - 2.68' below the surface. The south face of this wall is 27.6' from the present south wall of Congress Hall; it thus coincides with the original southwest corner of the Hall before its enlargement in 1793. A two-foot gap had been torn through this wall by the iron pipe (Feature #4, Illustration No. 4) in the same manner as the north wall.

A wall of brick laid in a Portland-type mortar was found 0.7' south of the Portico's south wall (Feature #14, Illustration No. 4). It extends undamaged across the pipe trench and was identifiable as the south wall of the Late Mills Extension. The location of the north wall of the extension was already known from several excellent photographs taken in the late nineteenth century. The exact date of construction is not known.

Plans and profiles of Excavations. Suggested reconstruction of north elevation of Portico.
