San Juan National Historic Site
Quarter No. 211
Historic Structure Report

Final

October 2016

Historic Structures Report

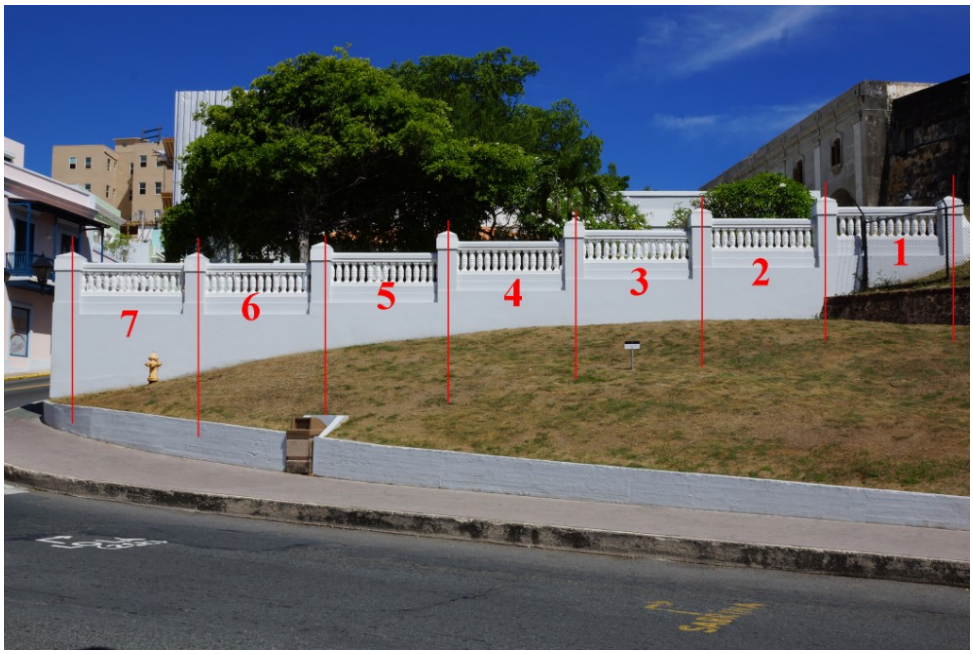
Figure 46 (JDF772): Overview of the south face of the boundary enclosure with seven sections. Number of sections has #1 at photo right.

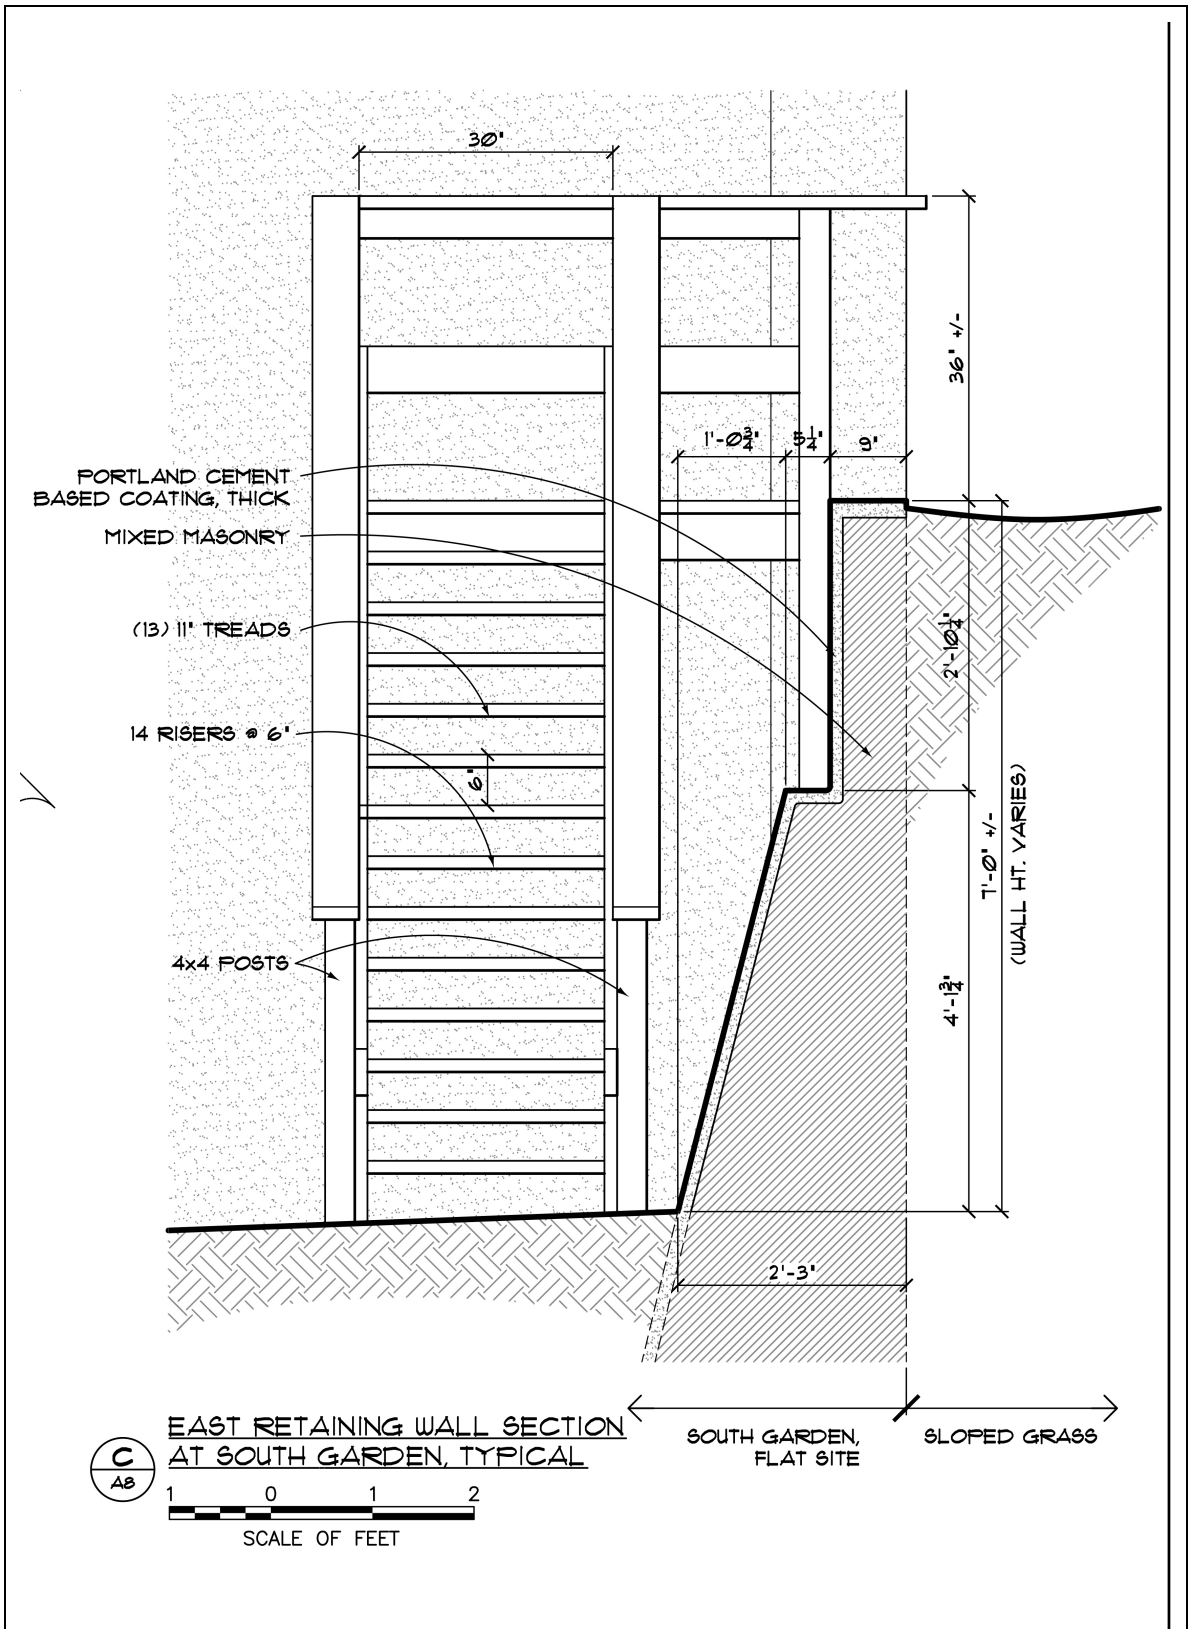
Figure 54: Section through east retaining wall at the flat south site

The visible face of the east retaining wall is concrete, however it appears to be constructed of concrete overlay of an earlier mixed material masonry wall. Examination by surface penetrating radar indicates the masonry as being fairly loose, exhibiting significant voids or containing a significant mortar fraction. Examination of the short section of the backside of the wall that is exposed due to the loss of the overlying concrete (see Figure 55), a small area of less than 1 square foot, exposed is the underlying mixed material masonry of stone and some brick. While only this area may have been constructed of these materials, in order to execute the stepped decorative end modeling as seen in the photograph, the radar results indicate a consistent condition in the scan along the upper 38% of the entire wall. The east wall has a bottom (lower 62%) section constituting a continuous battered buttress. The face of the concrete is rough, unlike the smooth faces of the fence retaining wall. The overlaying layer of concrete may have been shot on to the wall similar to “shotcrete” (patented in 1911).

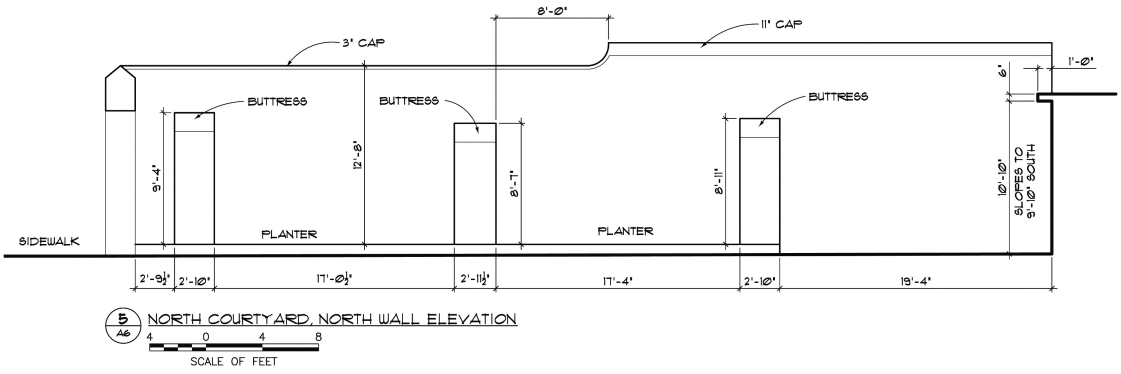
The north retaining wall extends from the northwest gate easterly to the west elevation of the servant's quarter's bathroom wall, and beyond as an interior wall, while still acting as a retaining wall. The wall serves as the north border of the north courtyard and is in variable condition. In the courtyard, three buttresses divide the wall into four sections (see the diagram in the figure below). They are between 2.83 and 1.96 feet in width, and average approximately 9 feet in height. The north retaining wall is 66.5 feet in length. The additional portion inside the servant's quarter is 21 feet. The wall is between 12.67 and 14.5 feet in height and is of unknown thickness except where exposed above grade at the yard of Quarter No. 210 where it is 11 inches. Buttresses are three in number (plus one in the servant's suite).

Figure 56: North courtyard's north wall elevation

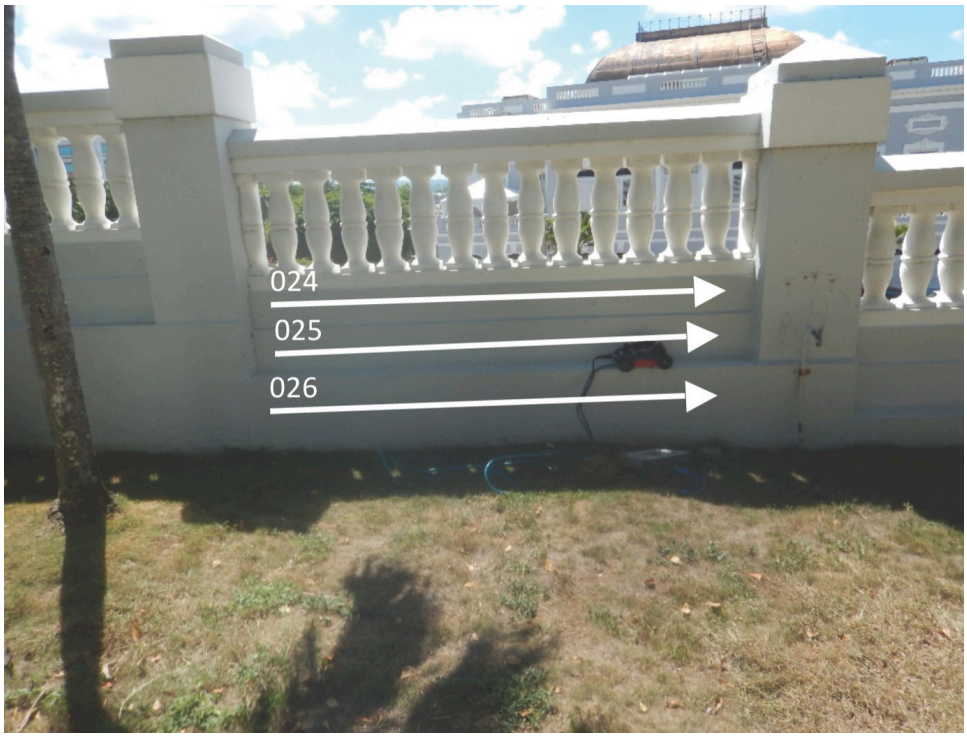
Figure 57 (MPS867, annotated): North side of south wall at lawn. Radar scan locations as shown.

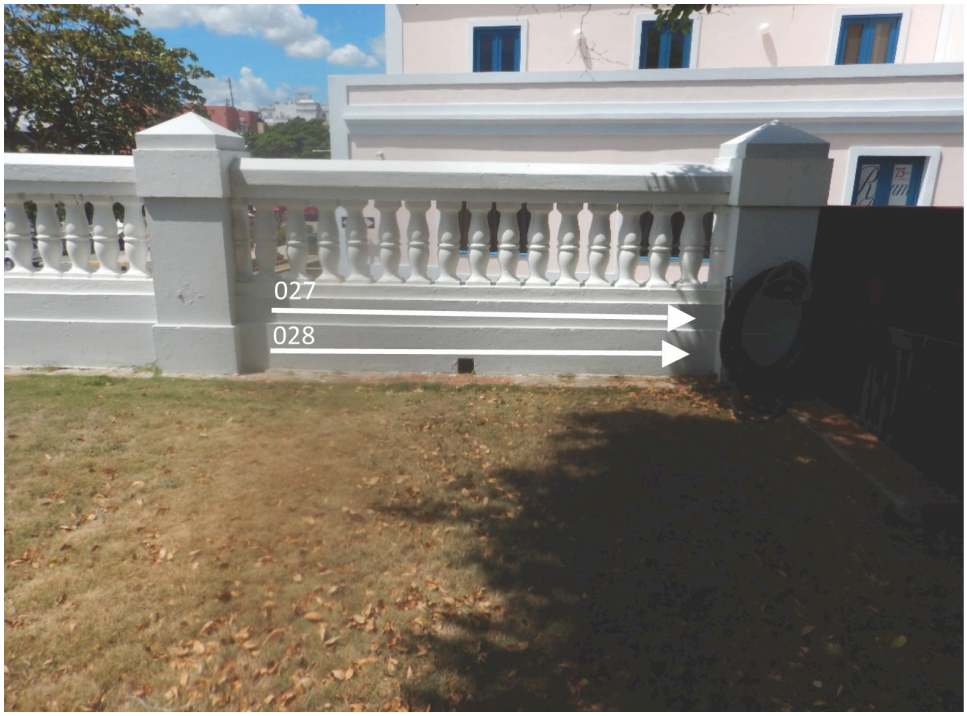
Figure 58 (MPS869, annotated): East side of west wall. Radar scan locations as shown.

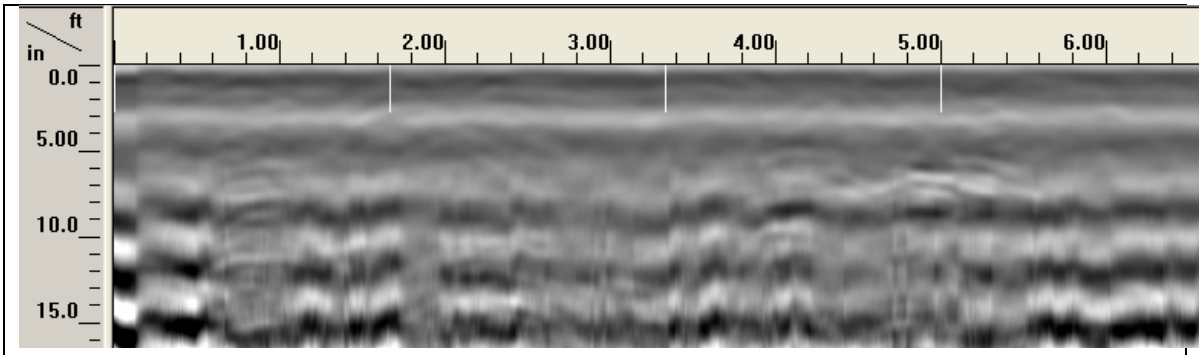
Figure 59 (Radar scan 029): east retaining wall, upper part above buttress. Scan area representative of very loose masonry, indicating rubble stone masonry with poorly consolidated or debonded mortar.

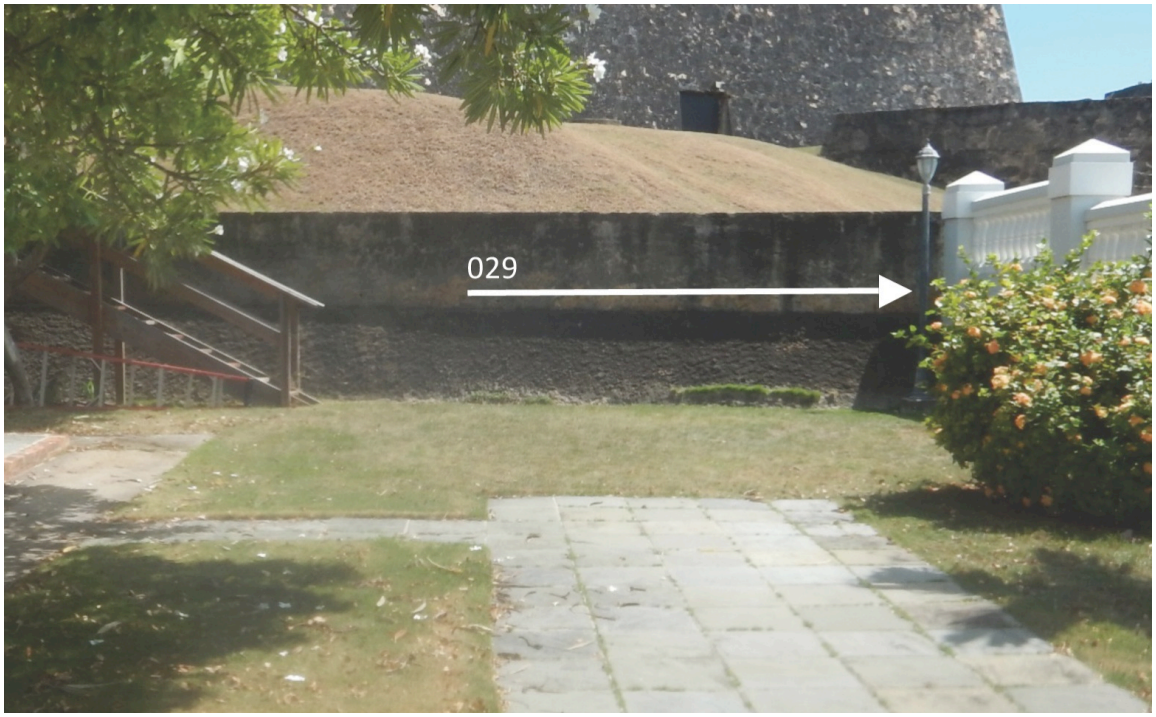
Figure 60 (MPS870, cropped + annotated): East retaining wall in courtyard. Location of radar scan 029 shown at arrow.

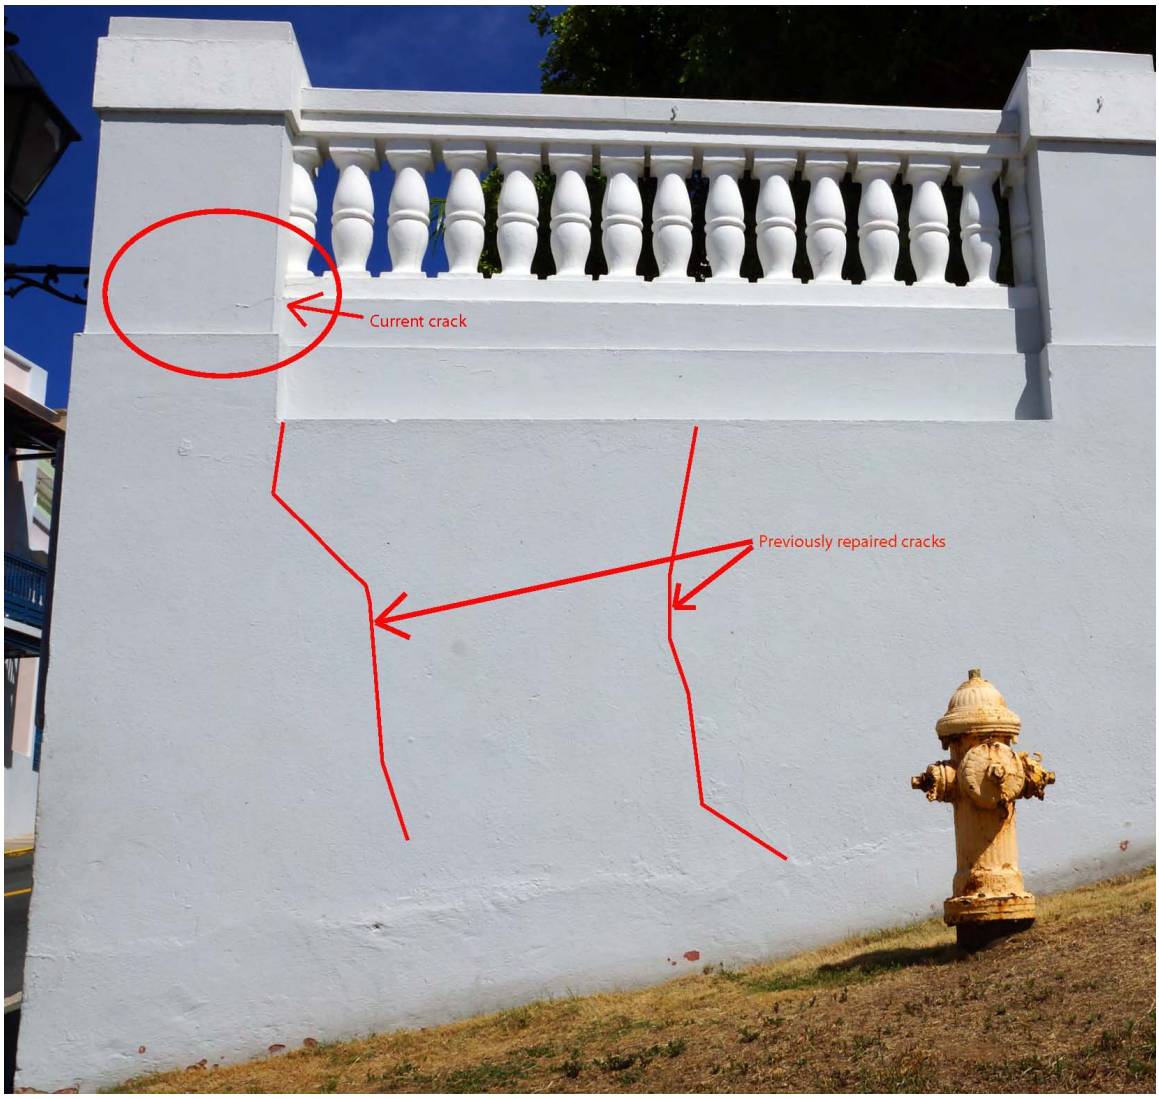
Boundary Enclosure Retaining Wall Condition: The retaining wall under the boundary enclosure sections is in good condition. Other than the crack at the southwest corner discussed above, the wall only has some minor cracks and a few small rust stains. The minor cracks are at the south wall exterior descending from the shelf upon which the plinth rests at the two columns bracketing section three. A horizontal minor crack is seen at section five. However, the biggest crack of any possible significance is at the southwest corner's west elevation, and on the south elevation there is evidence that there

was a previous repair of a diagonal crack and a vertical crack. The area should be monitored for crack reappearances, new cracks, and existing crack expansion (Figure 61).

Figure 61 (JDF771, cropped + annotated): South face of retaining wall along south boundary, west end.

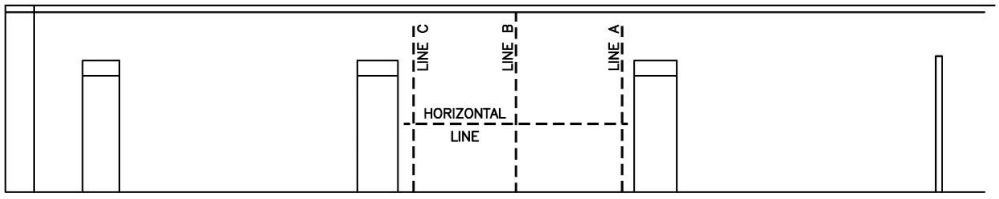
Figure 63: Locations of laser plumb measurements at the north retaining wall.

At Line A, the wall is essentially plumb up to the top of the buttress; above that point, the wall displaces sharply to nearly 2 inches outward. Displacements along Lines B and C are dominated by horizontal flexure of the wall panel between buttresses, with a

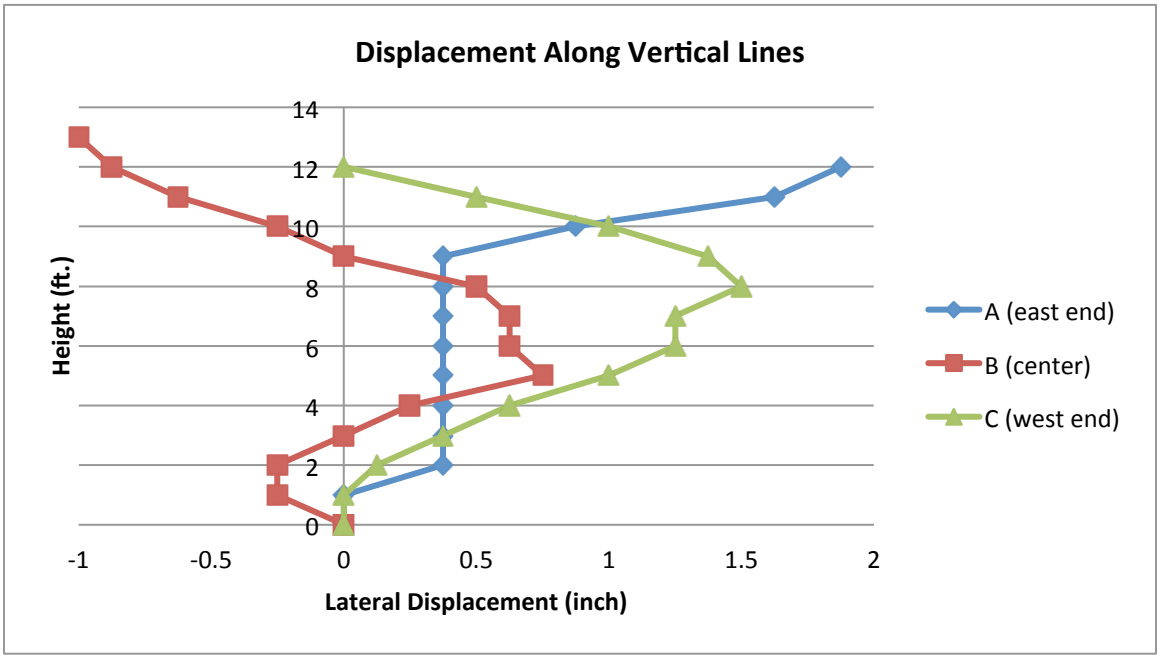
Figure 64: Horizontal displacement measured at the east end, center, and west end of the center panel at the north retaining wall. Positive measured displacement represents movement outward.

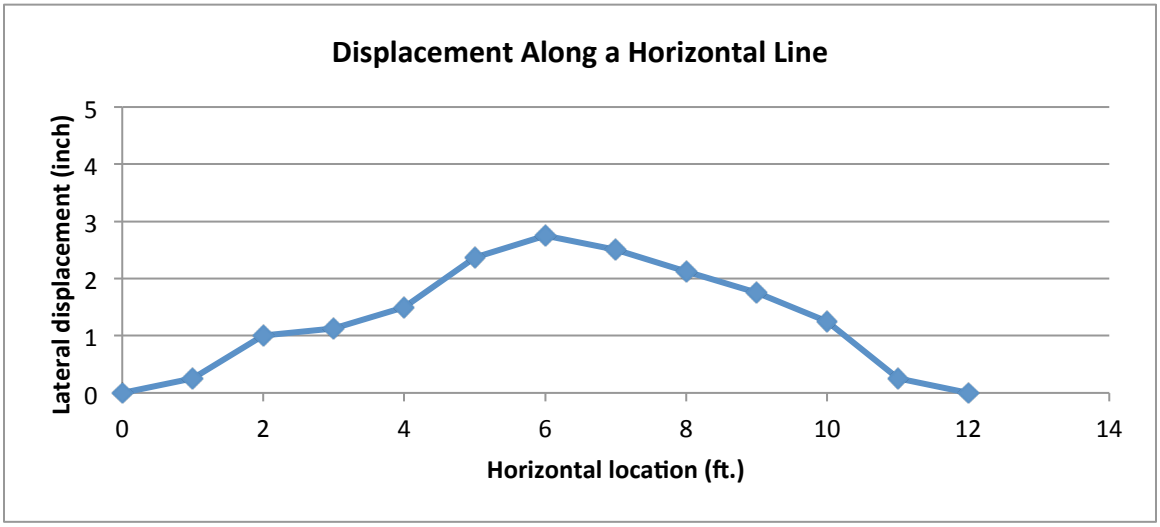
Figure 65: Horizontal displacement measured at the north retaining wall, center panel, at an elevation of 4'-11" above grade. Outward movement is represented as positive displacement.

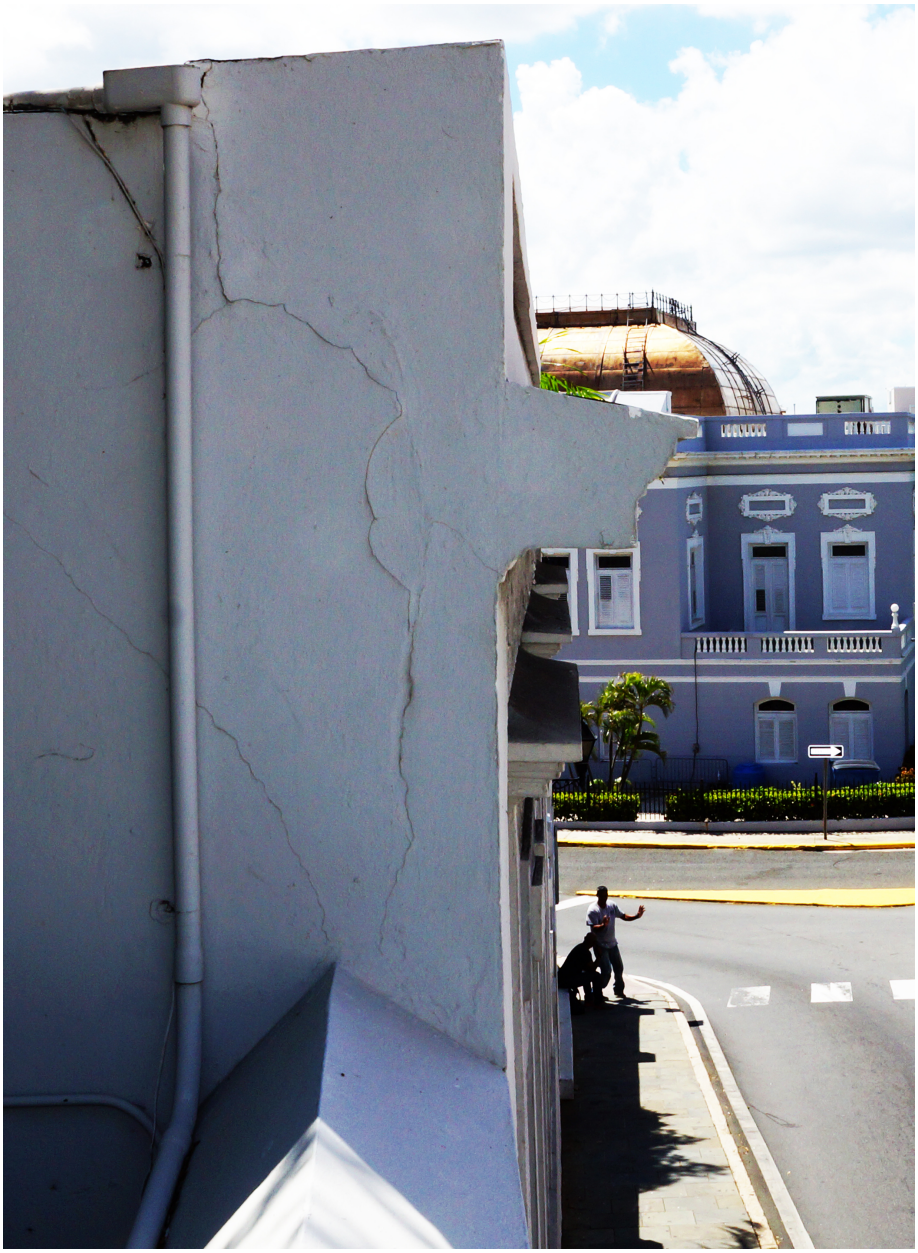
Figure 110 (JDF813, cropped): View from north looking south along west elevation parapet. Close up shows crack.

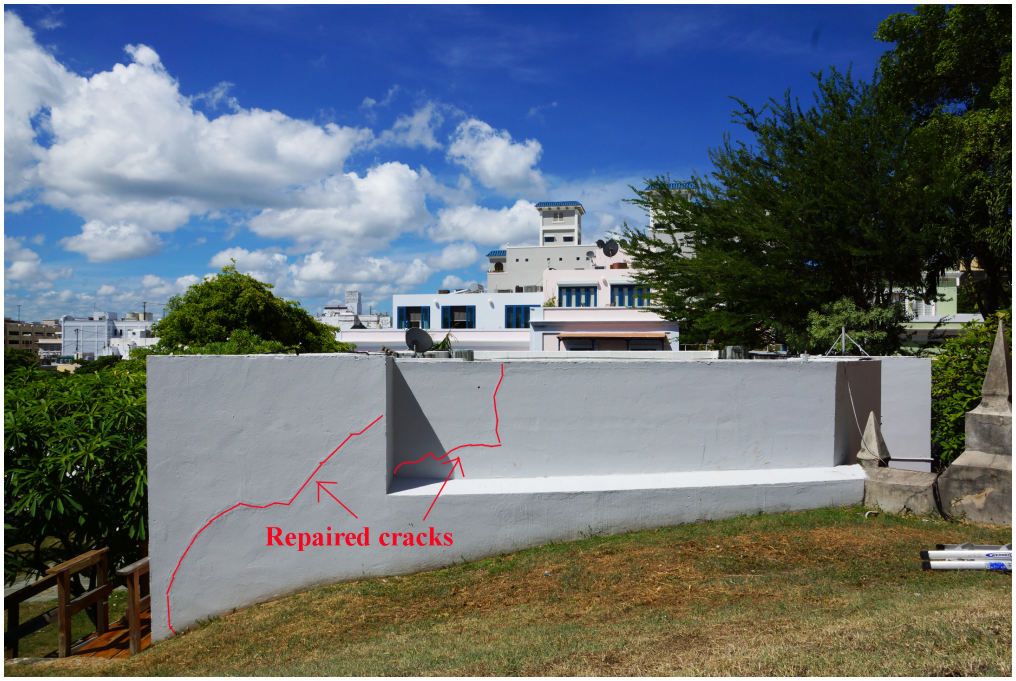
Figure 111 (JDF797, annotated): East elevation of Quarter No. 211. Red lines indicate repaired cracks.

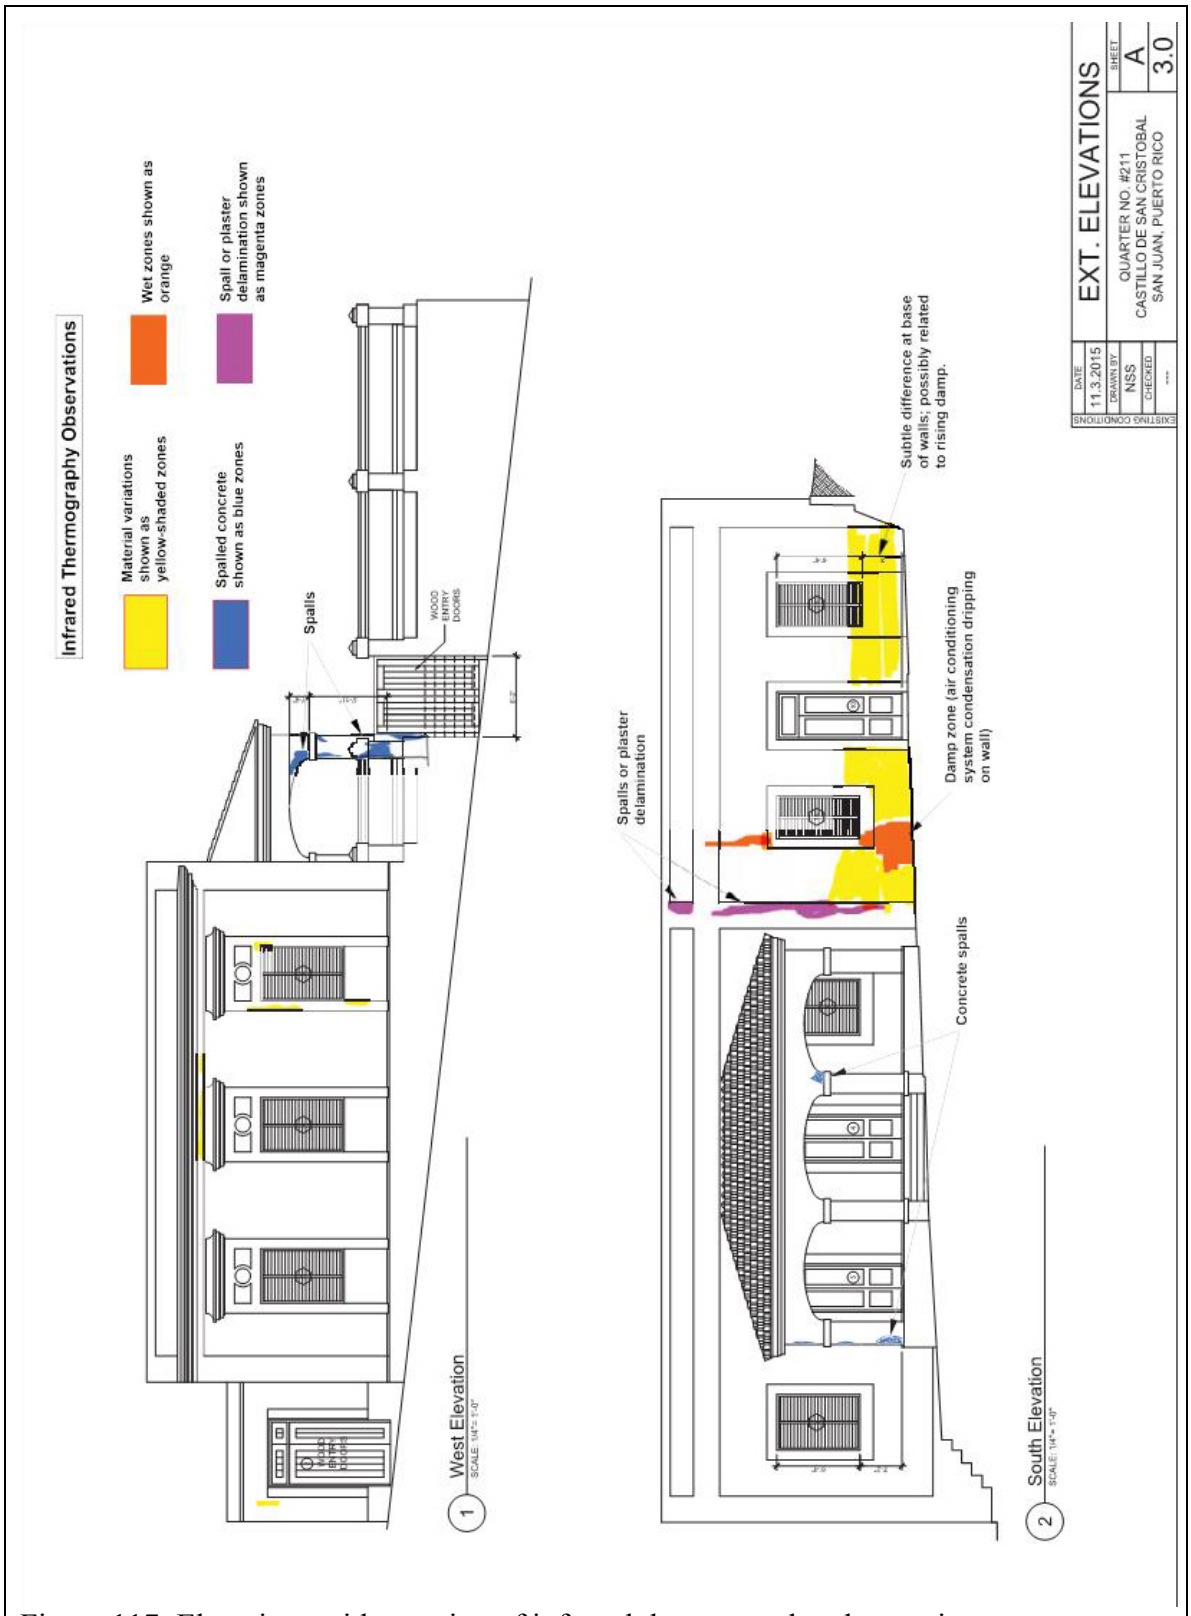
Delaminations of the parge coat are perhaps indicative of below surface issues typically where the interface with the substrate has deteriorated, causing the loss of adhesion. These areas were found by sounding, SPR, and thermographic imaging and are indicated on the below exterior elevation sheets.

Figure 117: Elevations with notation of infrared thermography observations.

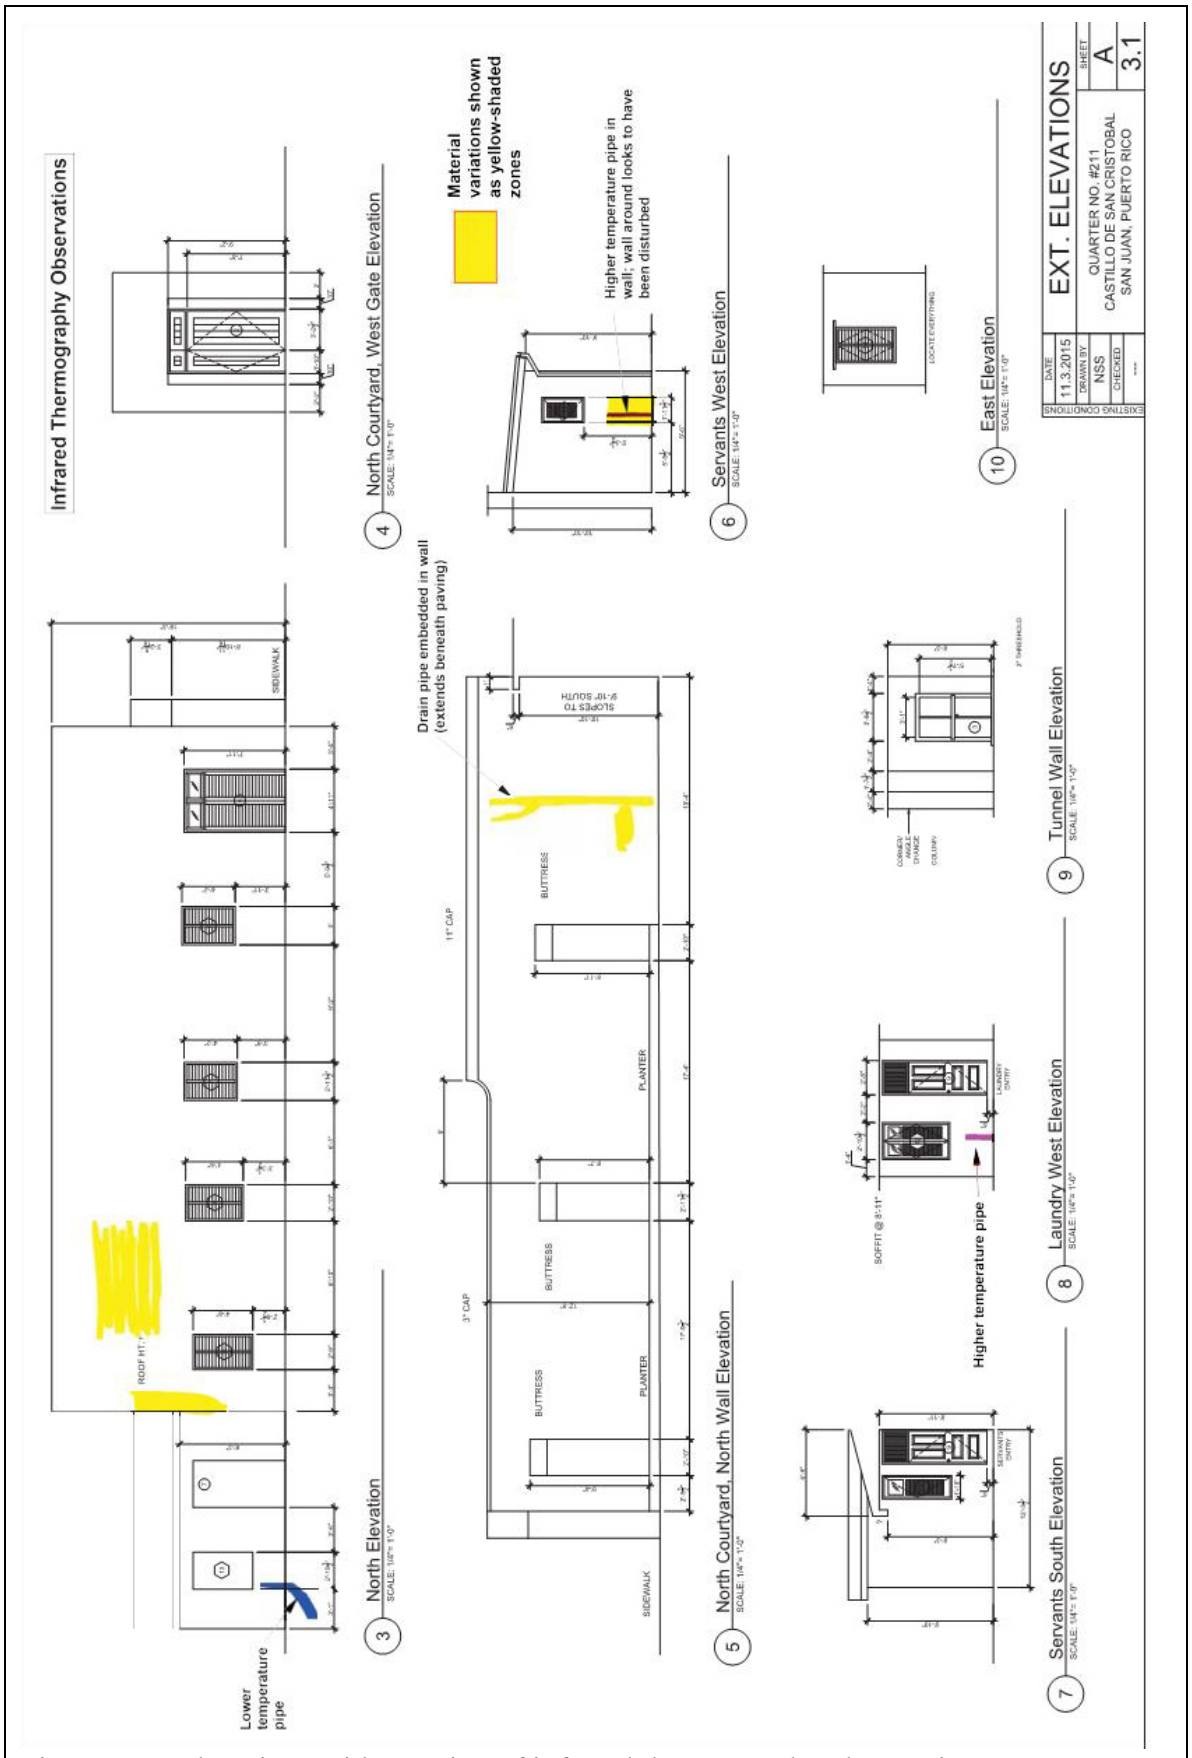
Figure 118: Elevations with notation of infrared thermography observations.

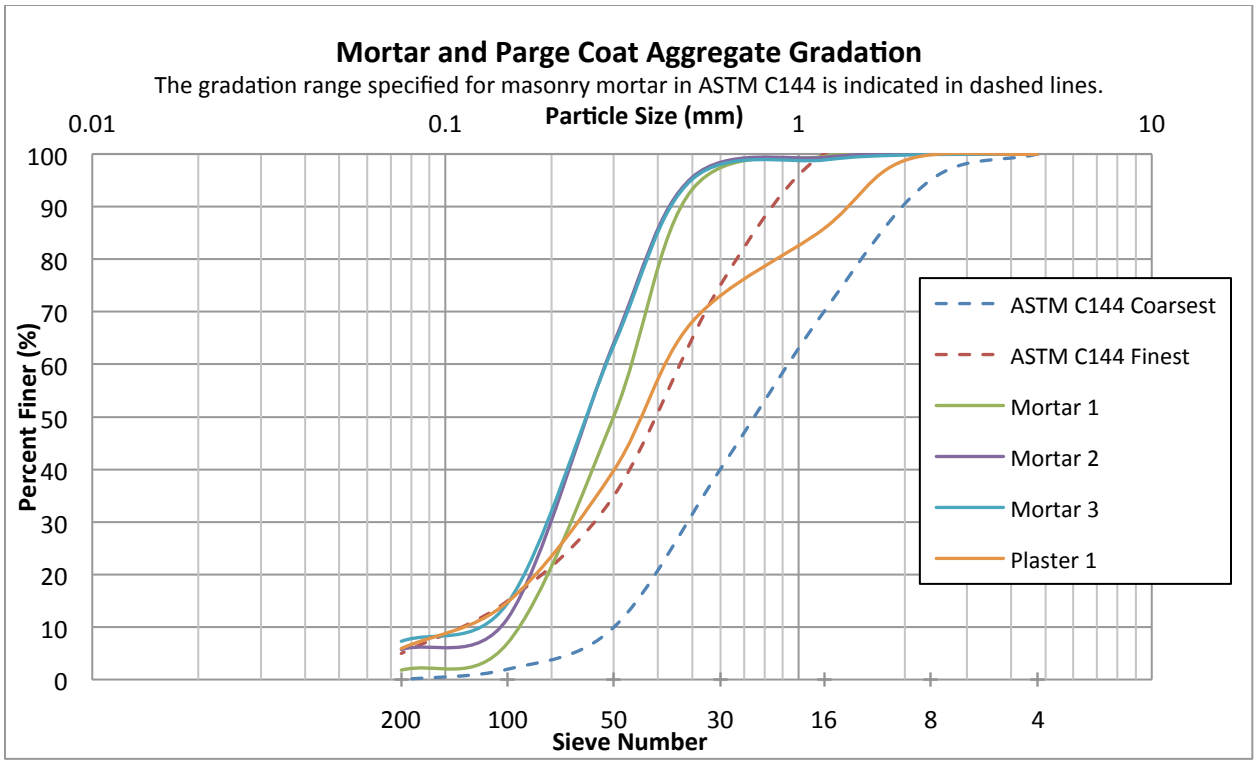
Mortar and parge coat samples were digested with acid and remaining aggregate was analyzed to determine sand gradation. The aggregate gradation curves, plotted in Figure A2-11, shows that all three mortar sands are much finer than permitted by ASTM C144, *Standard Specification for Aggregate for Masonry Mortars*. Sand used in Mortar 2 and Mortar 3 are essentially identical, and sand used for Mortar 1 is slightly coarser. Parge coat sand is similar to a fine mason's sand and is somewhat coarser than mortar sands. Aggregate distribution and aggregate colors are also shown in Figure A2-12.

Figure A2-11: Aggregate distribution by sieve size. Samples Mortar2 and Mortar 3 are nearly identical and occupy the same curve on the chart.

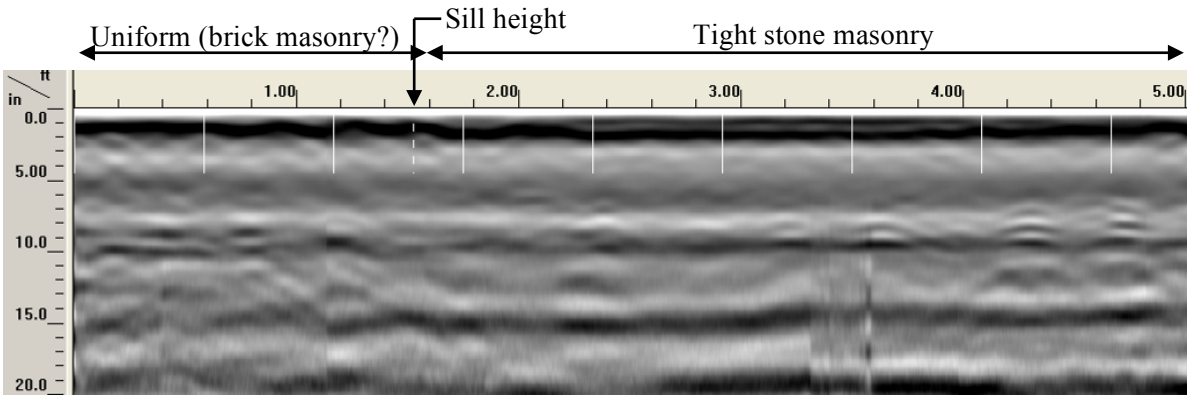
Figure A3-1. Scan No. 0126, vertical, north wall of dining room from exterior. Brick was detected up to the window sill, with tight masonry above. Bottom of wall is at left.

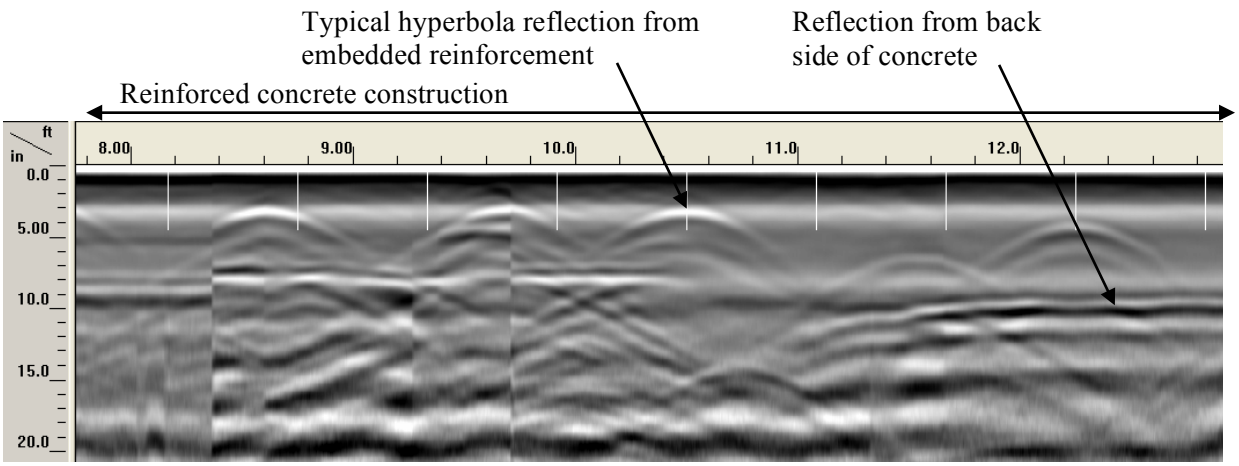
Figure A3-2. Continuation of scan 0126, vertical. Scan shows reinforced concrete construction above the window head. The back side of the masonry wall is not captured by this scan.

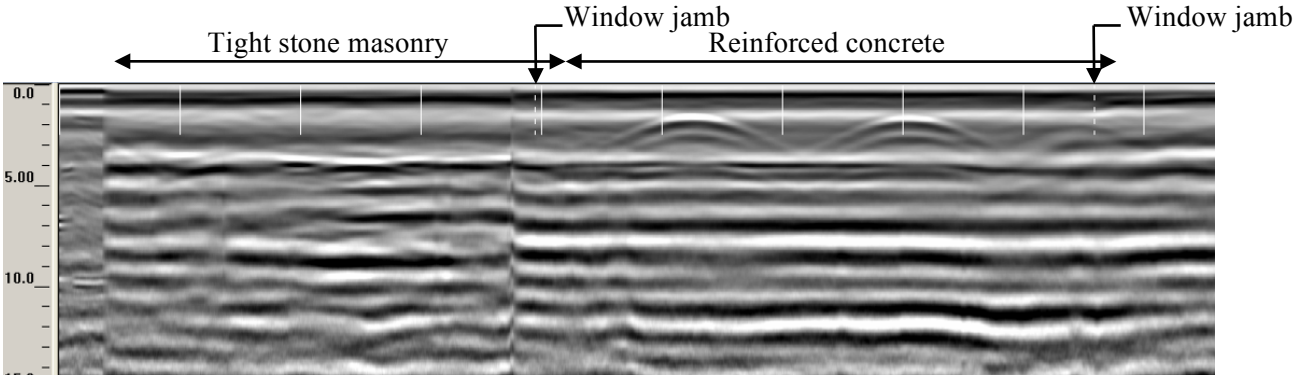
Figure A3-3. Radar scan 0122 at north wall below the window sill, horizontal, beginning at the northeast corner of the dining room and continuing west. Uniform stone construction is shown, infilled with reinforced concrete below the dining room window.

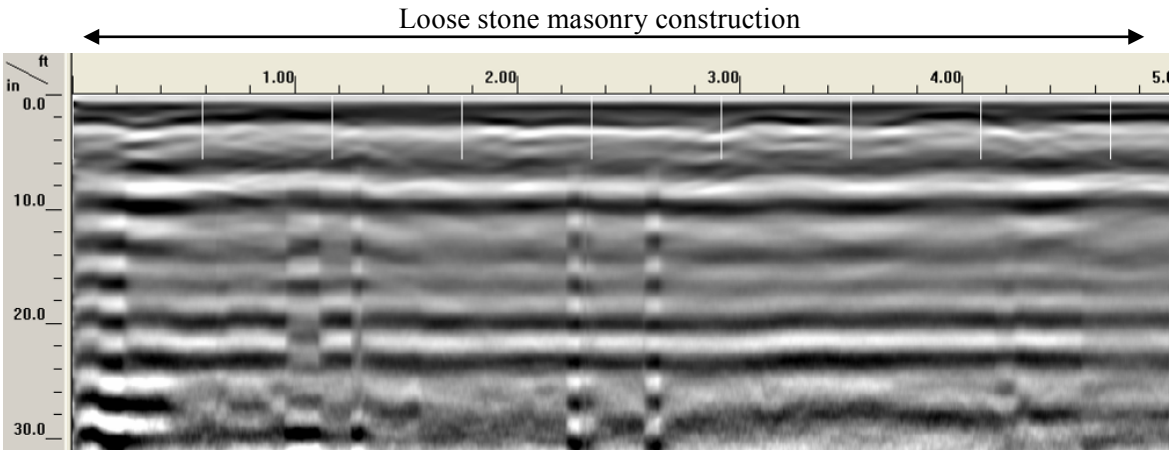
Figure A3-4. Scan 0146, horizontal at 4 feet above grade, recorded at the north retaining wall near the west end. Scan shows "loose" stone masonry construction with many internal discontinuities.

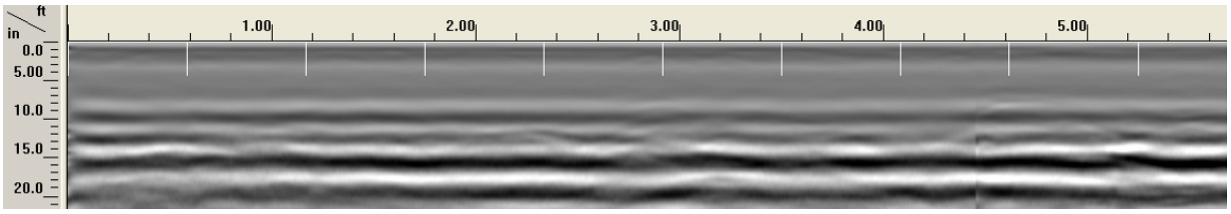
Figure A3-5. Radar Scan 053, horizontal at 4 feet above the floor, wall between breakfast room and hall at south end of hall. The radar scan represents very uniform unreinforced masonry construction.,

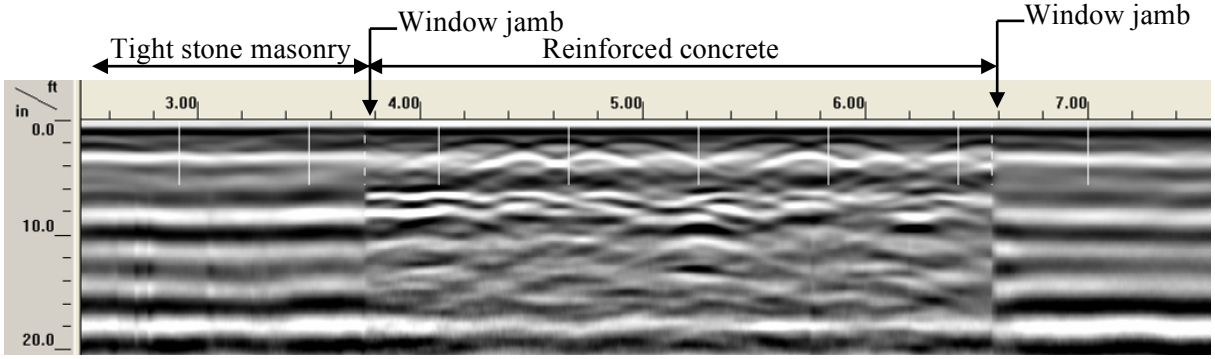
Figure A3-6. Scan 0116, horizontal below window sills, west elevation from exterior. Reinforced concrete was found beneath the window sill, with tight stone masonry at either side of the window.

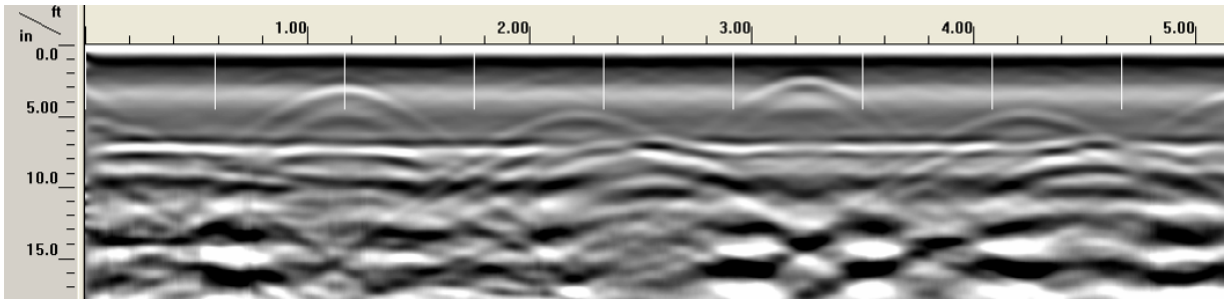
Figure A3-7. Scan 097, horizontal, recorded at 4 feet above the floor at the south wall of the servant's room. Construction appears to be reinforced masonry construction (possibly hollow clay tile) or concrete with localized surface parge coat delamination.

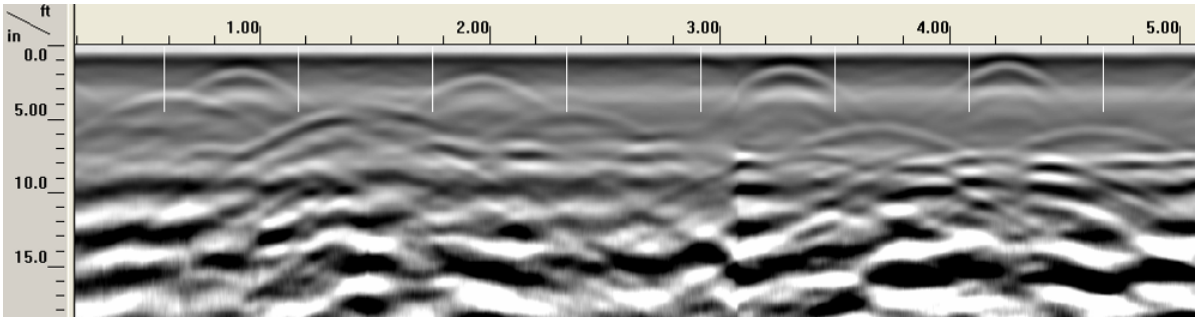
Figure A3-8. Scan 0103, horizontal, recorded at 4 feet above the exterior pavement at the west wall of the servant's room. This appears to be reinforced masonry construction, possibly hollow clay tile.

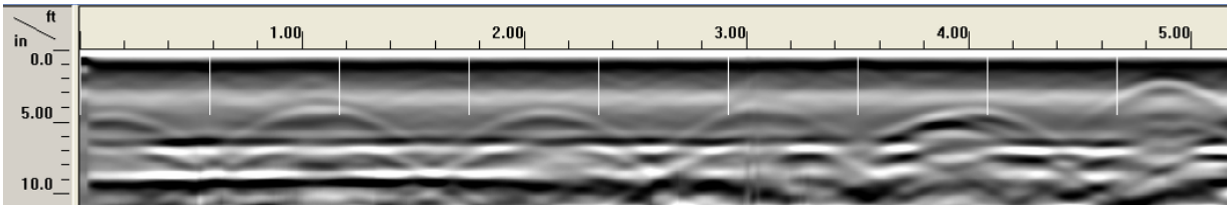
Figure A3-9. Scan 098, horizontal 40 inches above the exterior pavement at the west wall of the laundry. Reinforced construction.

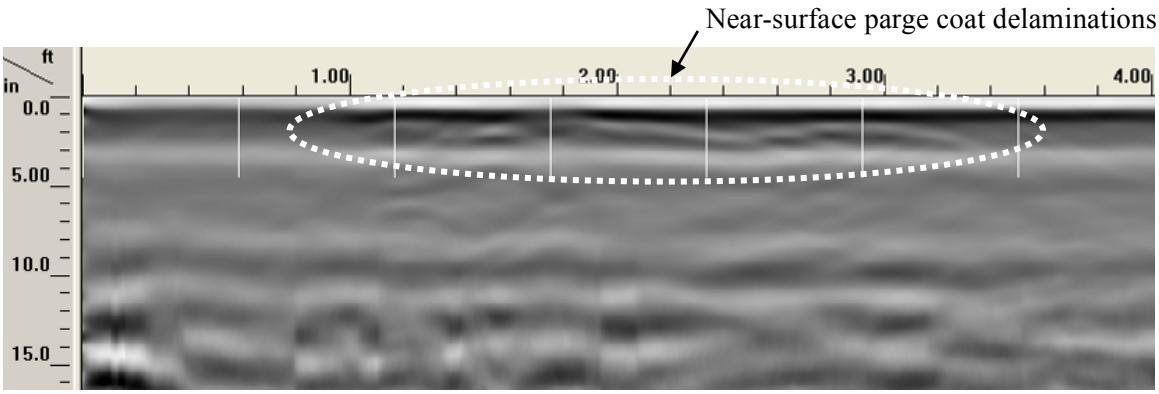
Figure A3-10. Scan 066, horizontal scan at the east wall on the interior of the laundry room. Parge coat delaminations were discovered, measuring 0.3 to 1.0 inch thick.

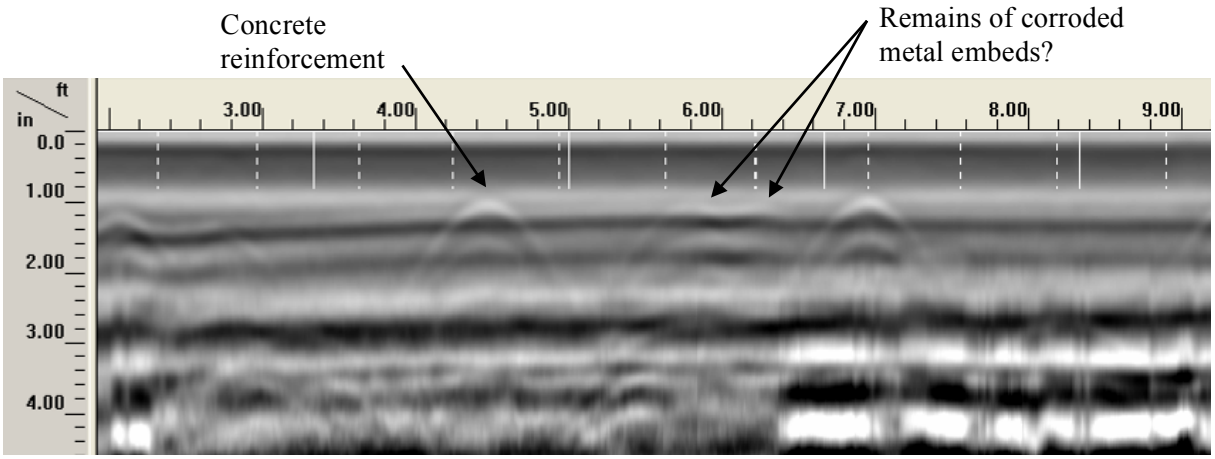
Figure A3-11. Radar scan 027, horizontal, recorded beneath balusters at the west fence wall, to the south of the entry gate. Vertical reinforcement is clear; also seen are slight reflections that may indicate locations of previous metal fence embedments. These embed spacing appears to be approximately 5 inches.

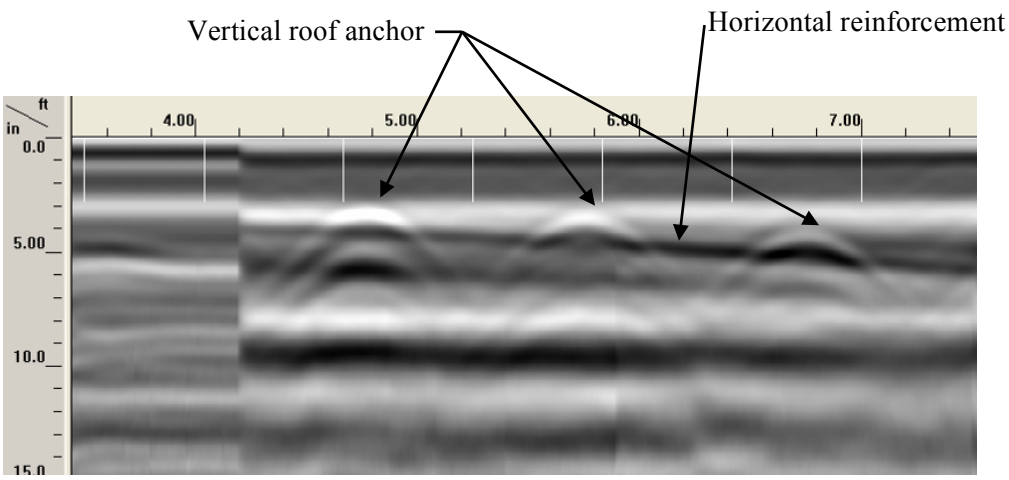
Figure A3-12. Scan 036, horizontal at the north wall of living room near ceiling. A series of metal roof anchors were observed.
