San Juan National Historic Site
Quarter No. 211
Historic Structure Report

Final

October 2016

Historic Structures Report

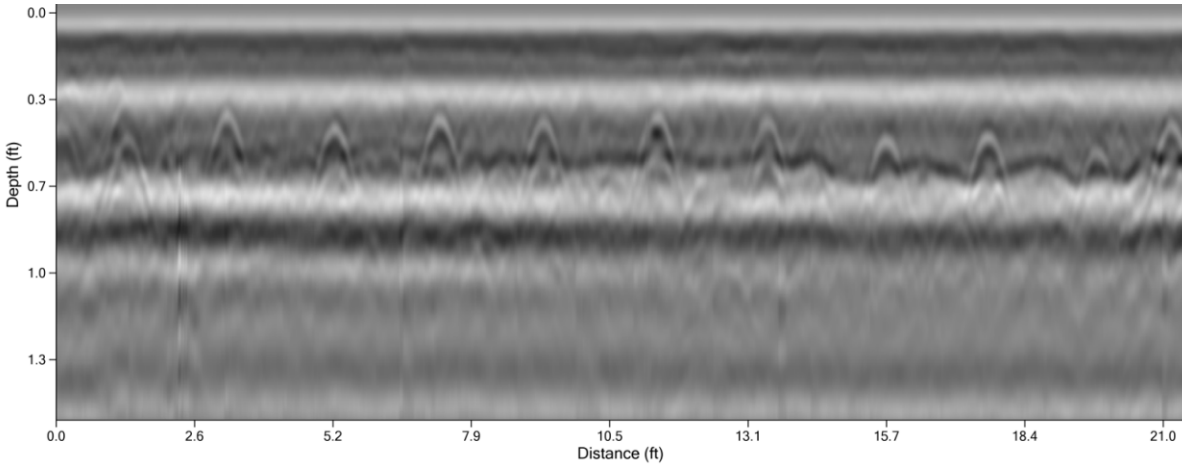
Figure A3-13. Scan 014, recorded from south to north at the living room floor slab. Many typical reflections observed at embedded reinforcement. Reinforcement spacing = 16 to 20 inches on center, at a depth of 4 ¾ to 6 inches. Slab thickness 6 ½ to 6 ¾ inch.

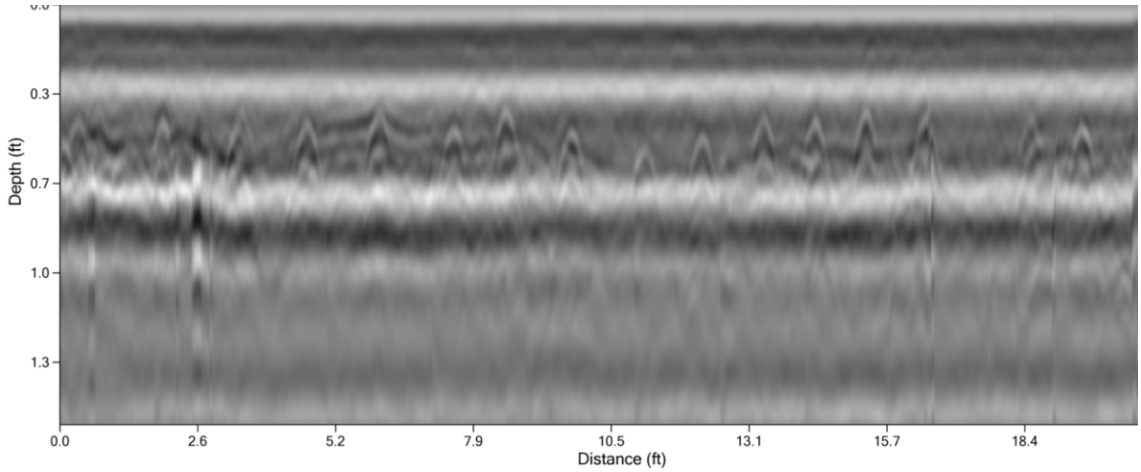
Figure A3-14. Scan 015, recorded from west to east at the living room floor slab. Reinforcement spacing = 24 inches on center, at a depth of 4 ¾ to 7 ½ inches. Slab thickness is variable from 5 ¼ to 7 ¼ inch.

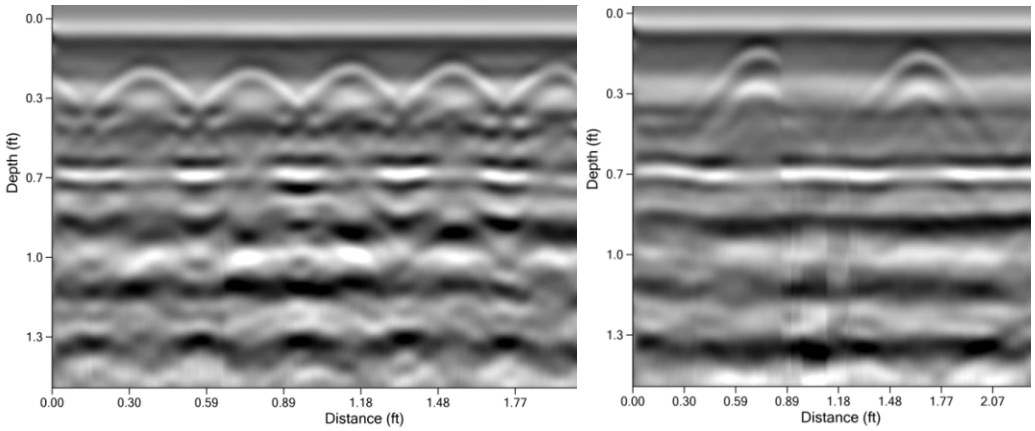
Figure A3-15. Scans 031 (left) and 032 (right), recorded at the family room ceiling. Reinforcement oriented north-south is at a spacing of 6 ½ to 7 inches; reinforcement spanning east-west is spaced at 12 inches. Roof slab thickness = 7 inches.

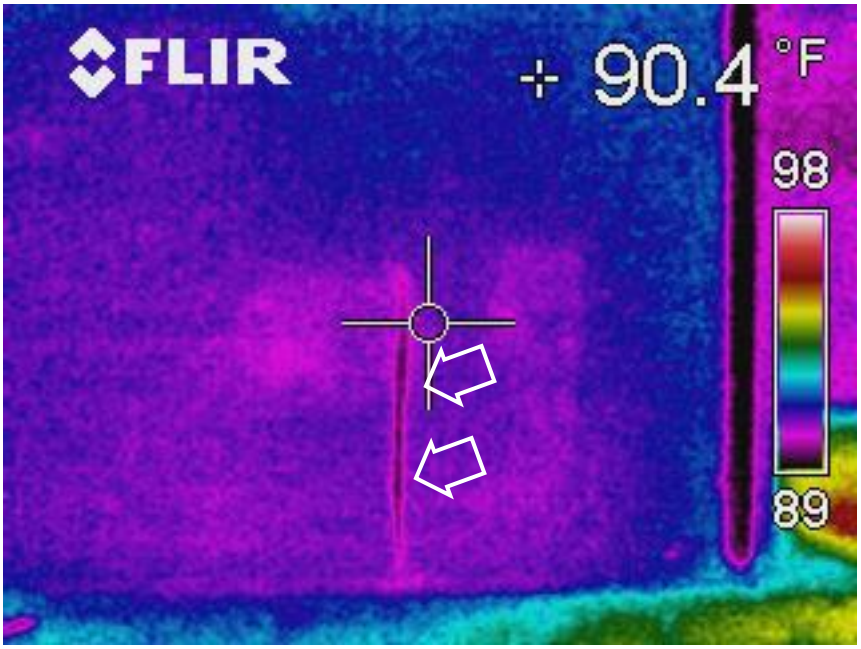
Figure A3-20. Lower temperature pipe in wall, west elevation servant's quarter, below window.

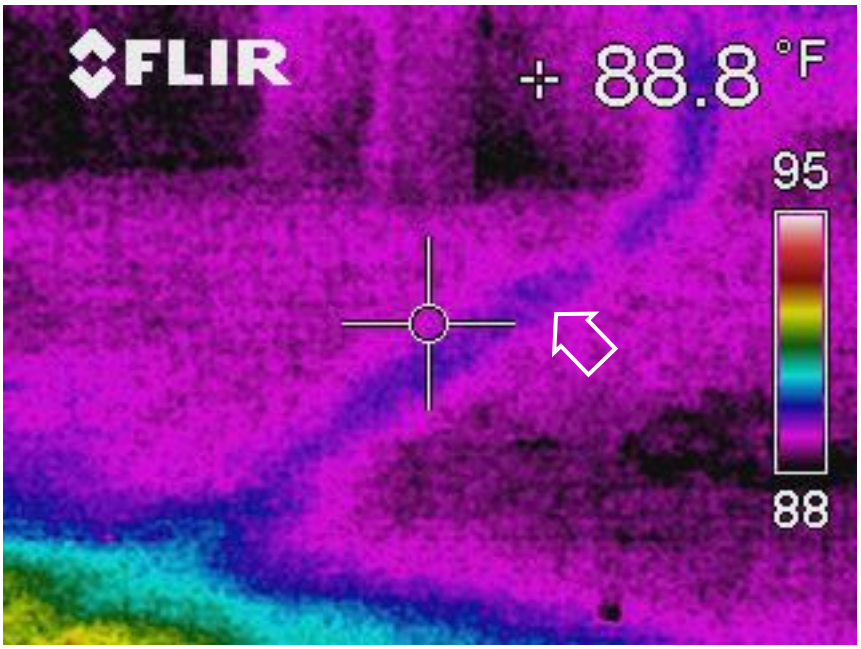
Figure A3-21 Lower temperature pipe, embedded in north kitchen wall and travelling under paving to the servant's room.

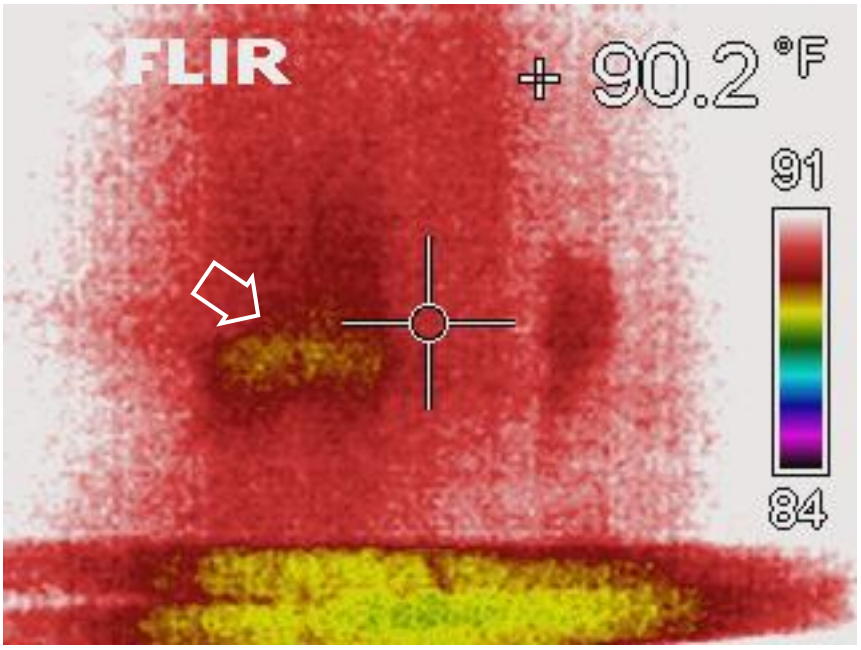
Figure A3-22. Disturbed masonry zone at embedded drain pipe, east end of north retaining wall.

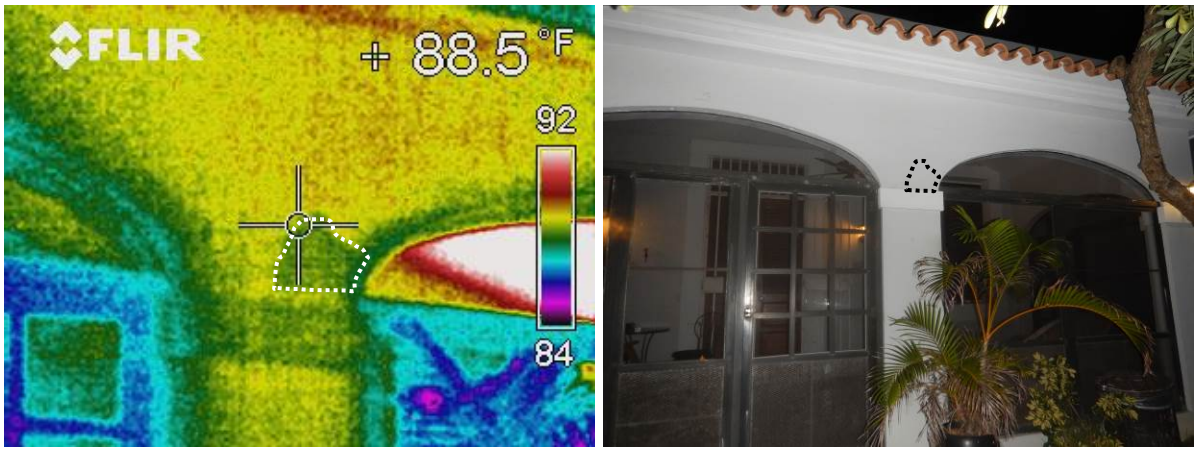
Figure A3-23. Spalled concrete, porch support column, outlined with dashed line.

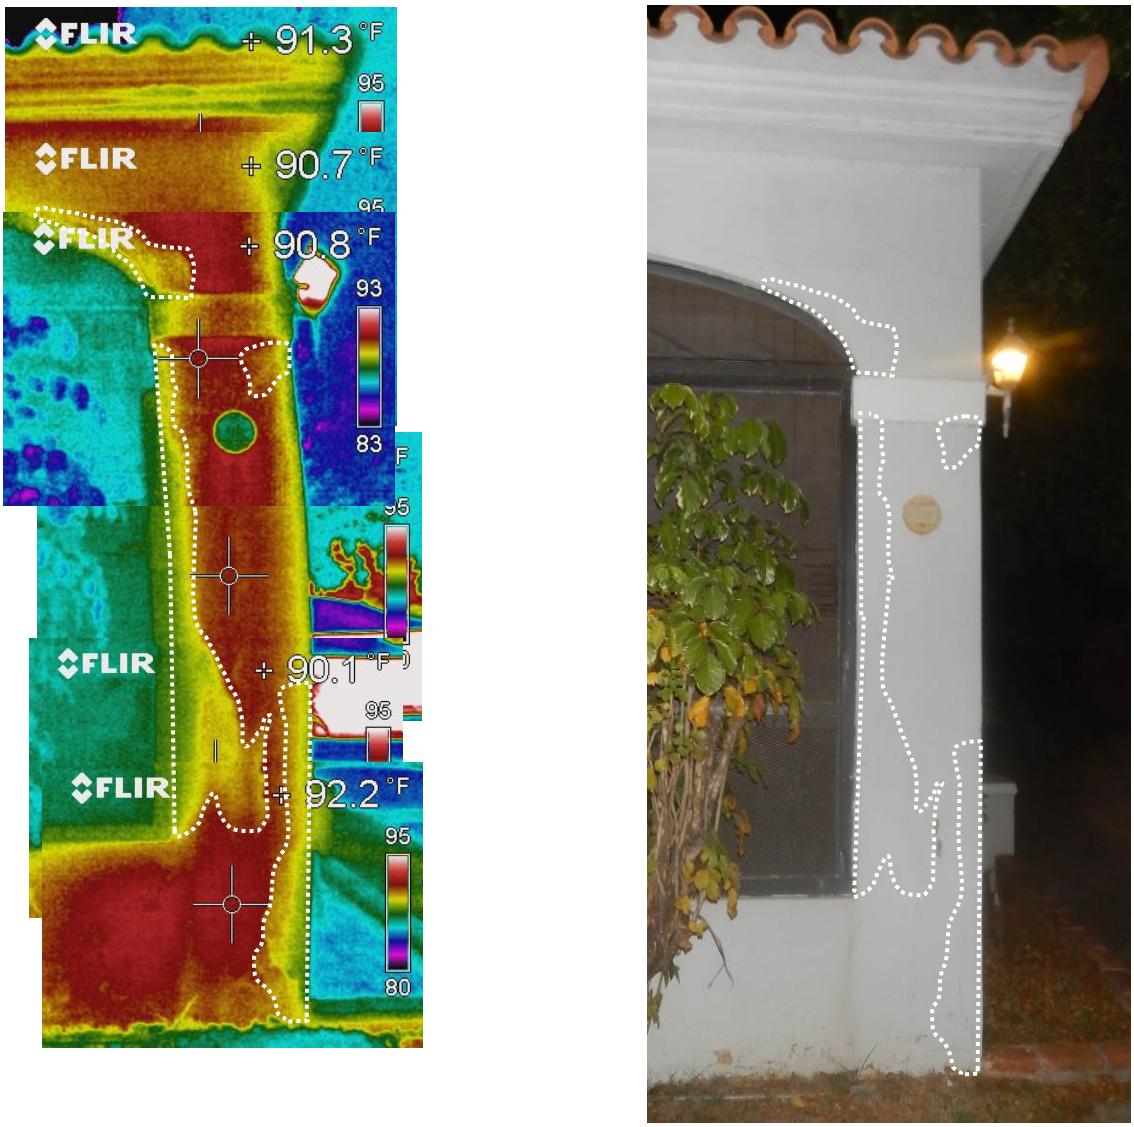
Figure A3-24. West elevation concrete column at entry porch. Left: composite infrared thermogram; right: photograph. Concrete spall areas outlined in each image.

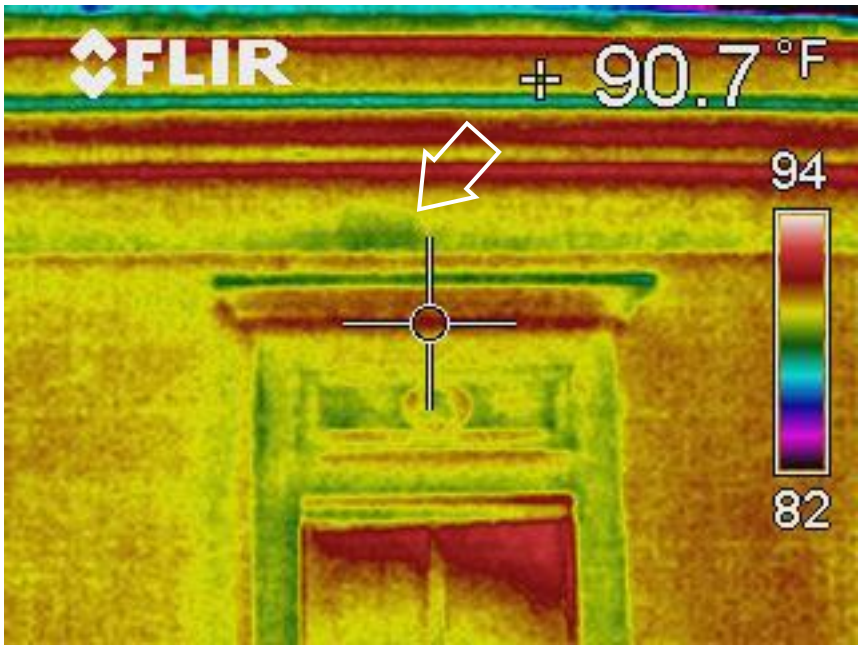
Figure A3-25. Thermogram taken at west elevation, central window. Slight color variations above the window head under the cornice indicate moisture or localized parge coat delamination, indicated by the arrow.

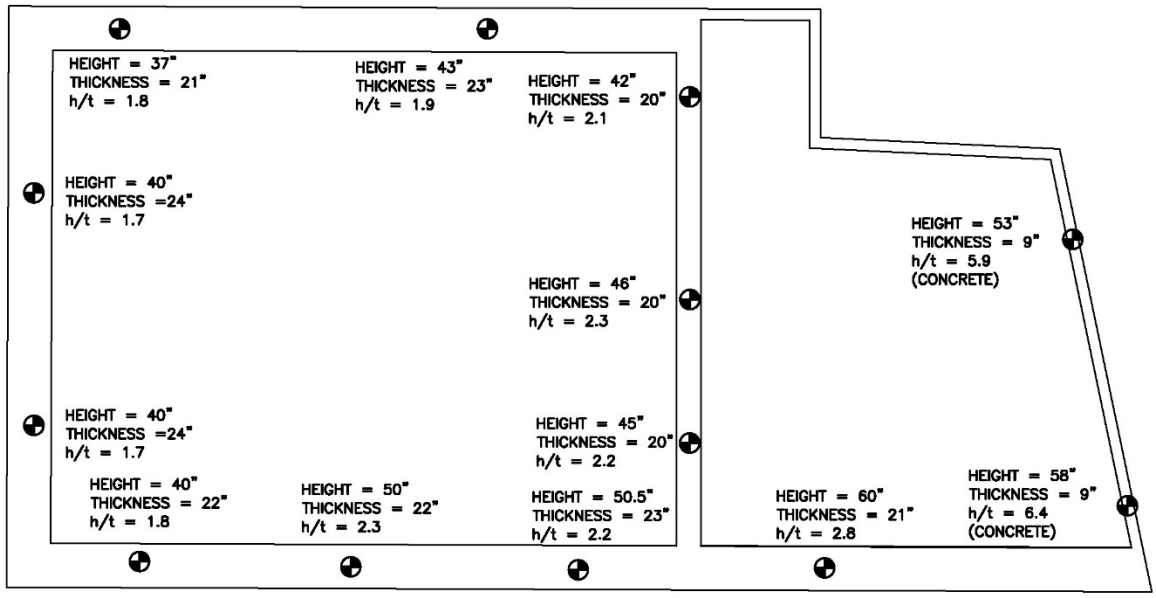
Unreinforced masonry parapets and concrete parapets all exceed ASCE 41 slenderness limits. All parapets require seismic evaluation and potential retrofit. Retrofit may be simple braces visible only from above, or internal reinforcement.

Figure A4-1. Roof parapet height and thickness measurements.

3. Recommendations
   Performance in past seismic events appears to be satisfactory with no visibly evident distress. Recommendation is for no treatment at this time, although consideration should be given to strengthening west elevation parapets and cornices that pose a falling hazard to persons on the public sidewalk directly adjacent to the building's west elevation.

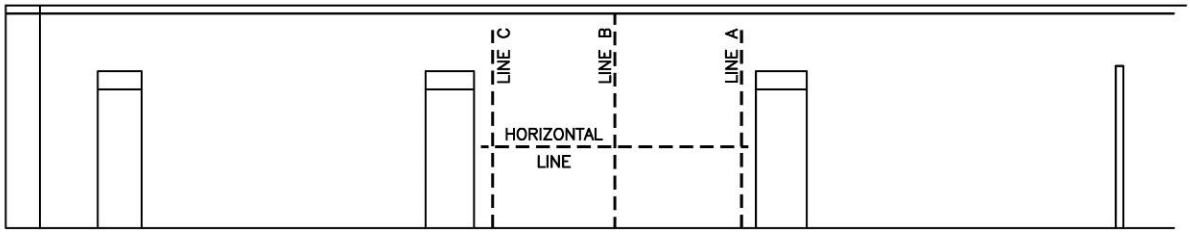
Figure A4-2. Locations of laser plumb measurements at the north retaining wall.

At Line A, the wall is essentially plumb up to the top of the buttress; above that point the wall displaces sharply to nearly 2 inches outward. Displacements along Lines B and C are dominated by horizontal flexure of the wall panel between buttresses, with a maximum displacement of 0.75 and 1.5 inches above mid-height, returning to negative 1 and 0 inches at the top of the wall. Vertical profiles reflect cracking and confirm outward bulging of the wall.

Significant lateral movement was recorded at the north retaining wall. Displacements appear related to vertical and horizontal flexure action rather than rigid-body rotation of the wall. Movement is most likely caused by overloading as a result of soil loads and surcharge loads from Quarter No. 210, located directly to the north of Quarter No. 211. The south wall of Quarter No. 210 is built into the top of the retaining wall, partially compromising wall thickness. Retaining wall movement may be exacerbated by vegetation growth within the wall, in close proximity to the wall at its base, and on the grounds of Quarter No. 210. Movement may also have been caused by past seismic events. Structural analysis is required to determine adequacy and the need for any retrofit or strengthening.

3. Recommendations
   Remove vegetation with root growth into the wall, repair cracks, and install tiebacks with duckbill anchors to restore structural capacity.

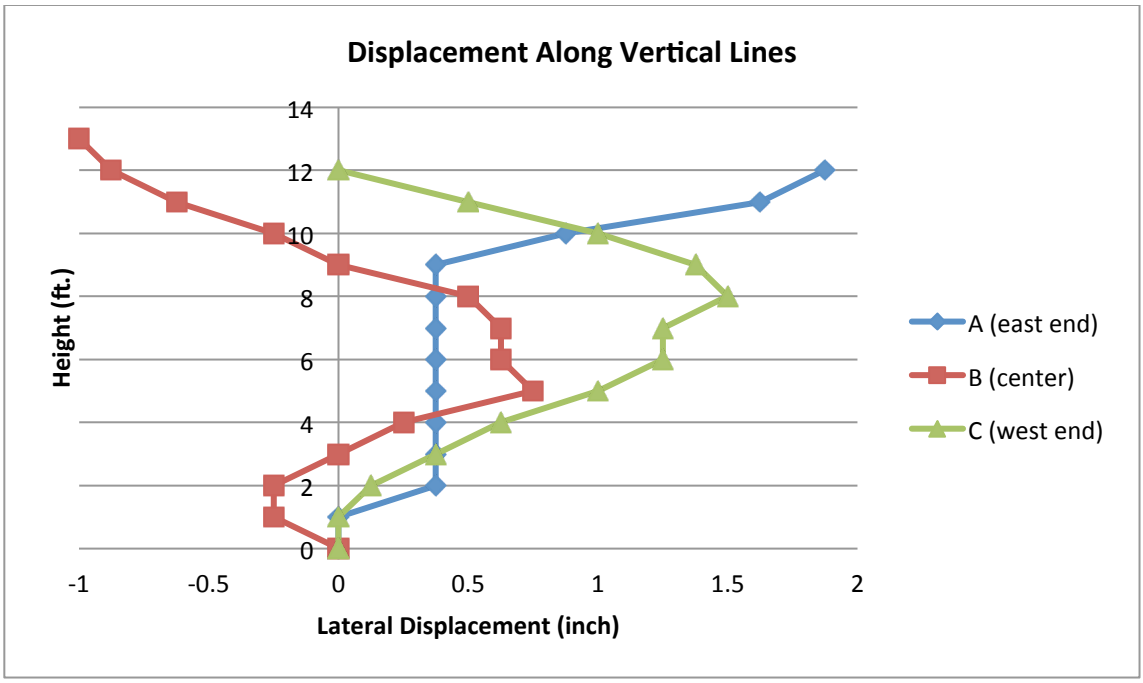
Figure A4-3. Horizontal displacement measured at the east end, center, and west end of the center panel at the north retaining wall along vertical lines A, B, and C shown in Figure A4-2. Positive measured displacement represents movement outward. Measured movement is representative of flexural displacement due to soil loads exceeding the wall's lateral capacity. The wall leans back inward (towards the retained soil) at the top of the wall at Lines B and C. Displacements measured along Line A suggest progressive movement of the wall away from retained soil.

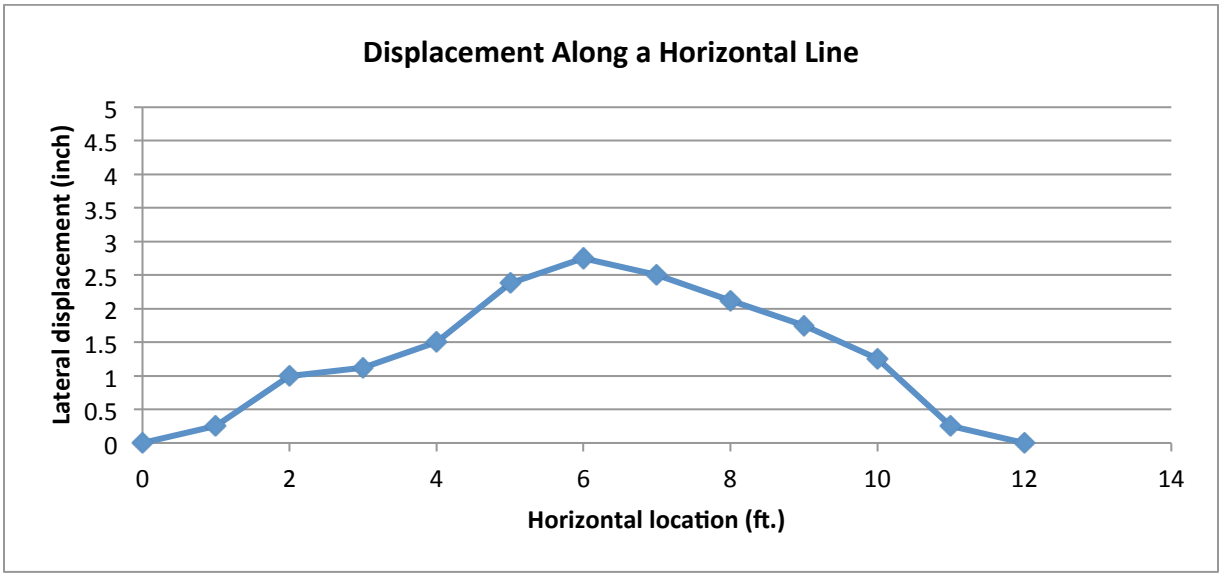
Figure A4-4**.** Horizontal displacement measured at the north retaining wall, center panel, at an elevation of 4'-11" above grade, along the horizontal line indicated in Figure A4-2. Outward movement is represented as positive displacement. Deflections represent flexural displacement of the wall between buttresses as a result of soil loads exceeding the wall's lateral capacity. A maximum displacement of nearly 3 inches was measured at midspan between buttresses.

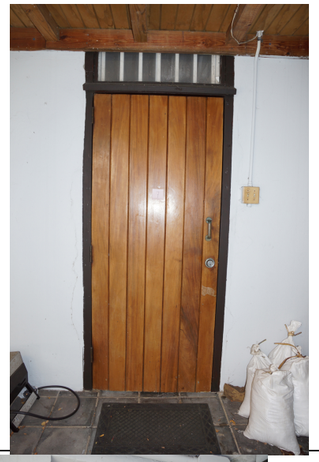
Door No.	Photo nos.	Location	H	W	Configuration	Hardware	Screen or Bars	Photo	Photo	Condition
7	Ext: 977, Int: 978/979	Exterior, north elevation, east end: entry to hall	84.5	35 in	Transom has metal bars and glass panel; wood drip edge below, and door itself has seven vertical boards, T&G, bronze pull and deadbolt.	Modern deadbolt and bronze handles (interior and exterior), interior steel security door with modern deadbolt.			 	Good; Transom glass is broken.
8	Ext: 980/981 Int: 982	Exterior, west elevation of servant's building; laundry entry.	75 in	30.5 in	Open transom with wood insect screen above wood door with two vertical panels over two horizontal panels	Screen door: secured by steel hook and screw eye latch, interior modern closer, and with bronze handles. Entry door: modern lock set with center key.	yes	 		Fair; Screen door has loss of coating [revarnish]; door has varnished wood that is cracked (UV and age) and scraped.

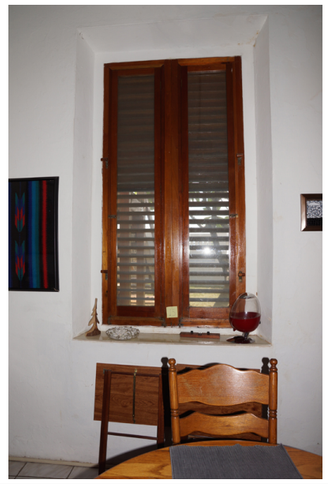
Window No.	Photo nos.	Elevation	H	W	Configuration	Hardware	Screen	Plexiglass	Louvers	Exterior Photo	Interior Photo	Condition Photo and Description if applicable
13	Ext: 945 Int: 947	North elevation, east end	34.5 in	53 in	Double casement	B	no	no	yes, controls are on interior sides of both windows and typically are stuck.			Good
14	Ext: 946 Int: 948	East elevation	56 in	33.25 in	Double casement	B	no	no	yes, controls are on interior sides of both windows and typically are stuck.			Good
15	Ext: 950/951 Int: 949	South elevation, east end	75.25 in	39.5	Double casement	B	no	no	yes, controls are on interior sides of both windows and typically are stuck.			Poor; Rotted lower frame, inside and out

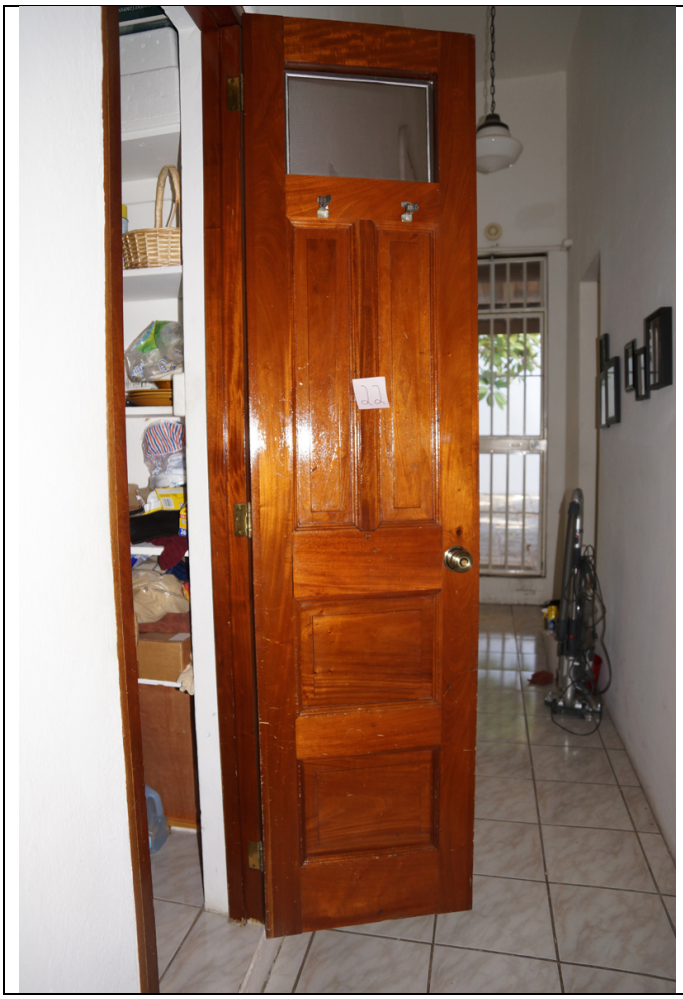
1016: Door 22, from Room 110

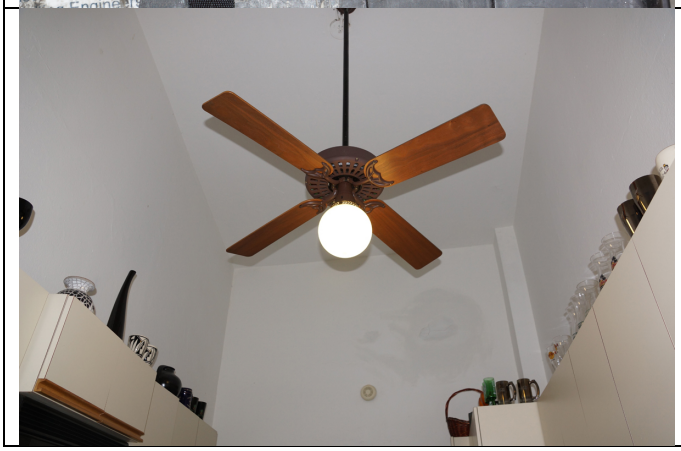
1081: Mortar Sample #3, from common wall with Building 210 site, e.g., north wall of north courtyard.
	1082: Mortar samples, locations noted.
	1083: Fans and Light Fixtures: Kitchen (Room 112). Four paddle, brown, globe light
