HISTORIC STRUCTURE REPORT

ST. PHILOMENA CATHOLIC CHURCH

KALAUPAPA NATIONAL HISTORIC PARK
Molokai, Hawaii

January 1985

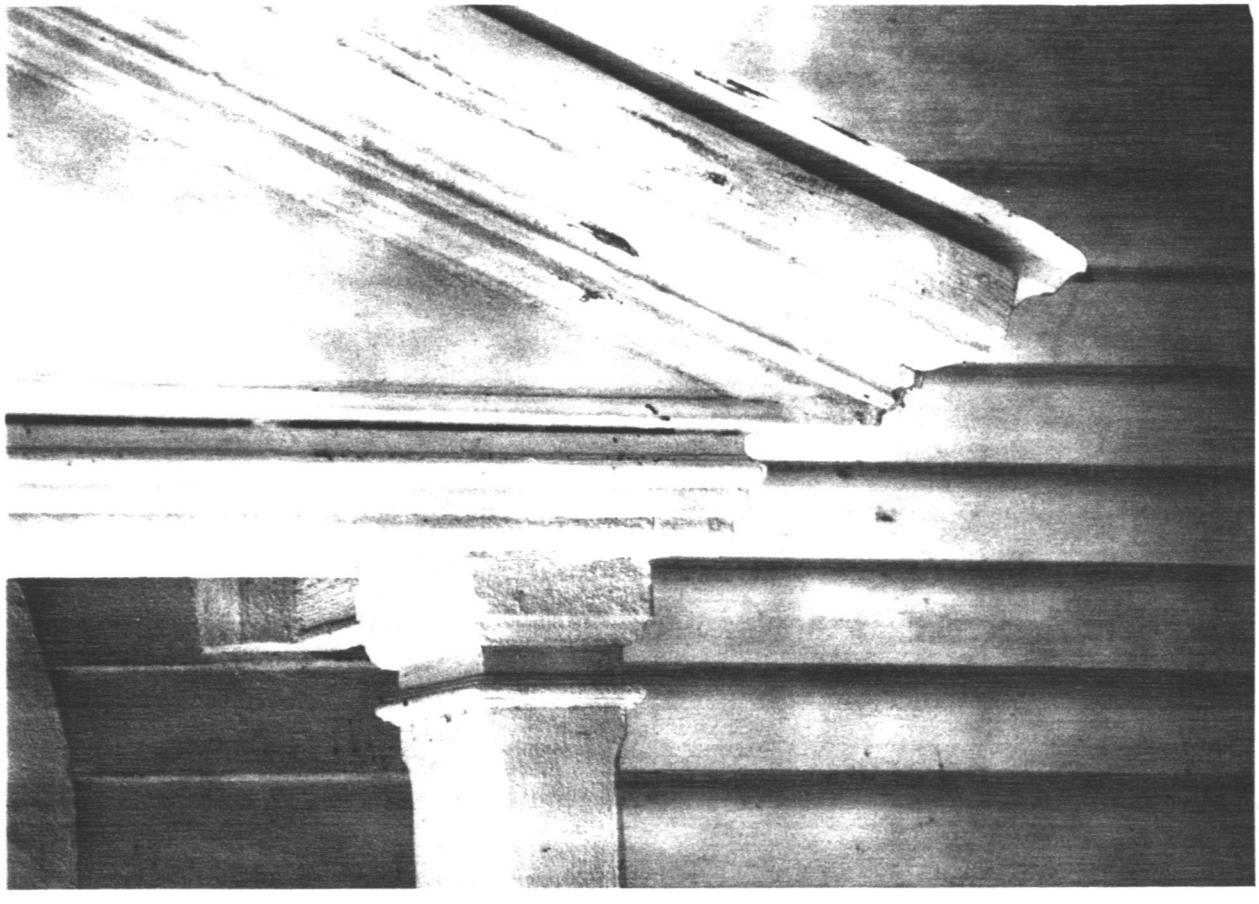
Illustration A15.

The majority of the paint finish is in good condition, and in some areas hides extensive wood deterioration. Significant deterioration was found in the west portico structure, especially the roof framing and boarding, but in trim and columns as well. Siding and trim at this (west) end of the 1876 building also contain rot and termite deterioration.

Detail at 'southwest' corner of 'west' portico roof, 1876 nave. 6/84. R.L.C.

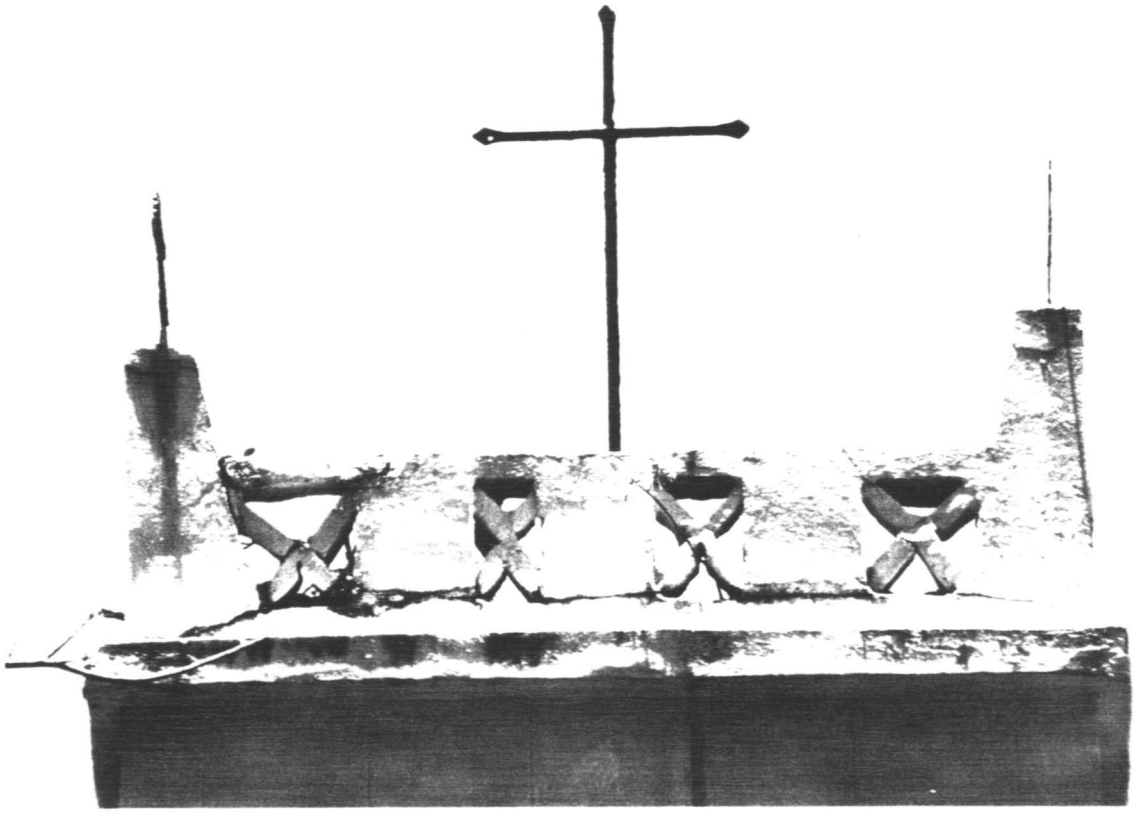
Illustration A22.

The parapet is in poor condition, with two major problems--structural cracks and vegetation growth. A major horizontal crack is very visable along the base of the west and south parapets and through the two southerly pinnacles. This cracking may be of earthquake origin. The southwest pinnacle is unstable, a possible hazard.

Vegetation growth in these cracks and in exposed masonry joints of the back sides of the parapet is causing additional loosening of the masonry and allows considerable water penetration into the masonry. A plastered drainage gutter between the parapet and the base of the pyramidal roof is in need of re-forming to achieve more positive drainage.

'South' parapet of bell tower. Note especially the crack along the base of the parapet and pinnacles. The 'southwest' pinnacle and cross (at left) appears to be the only original material and form of the four. 6/84. R.L.C.

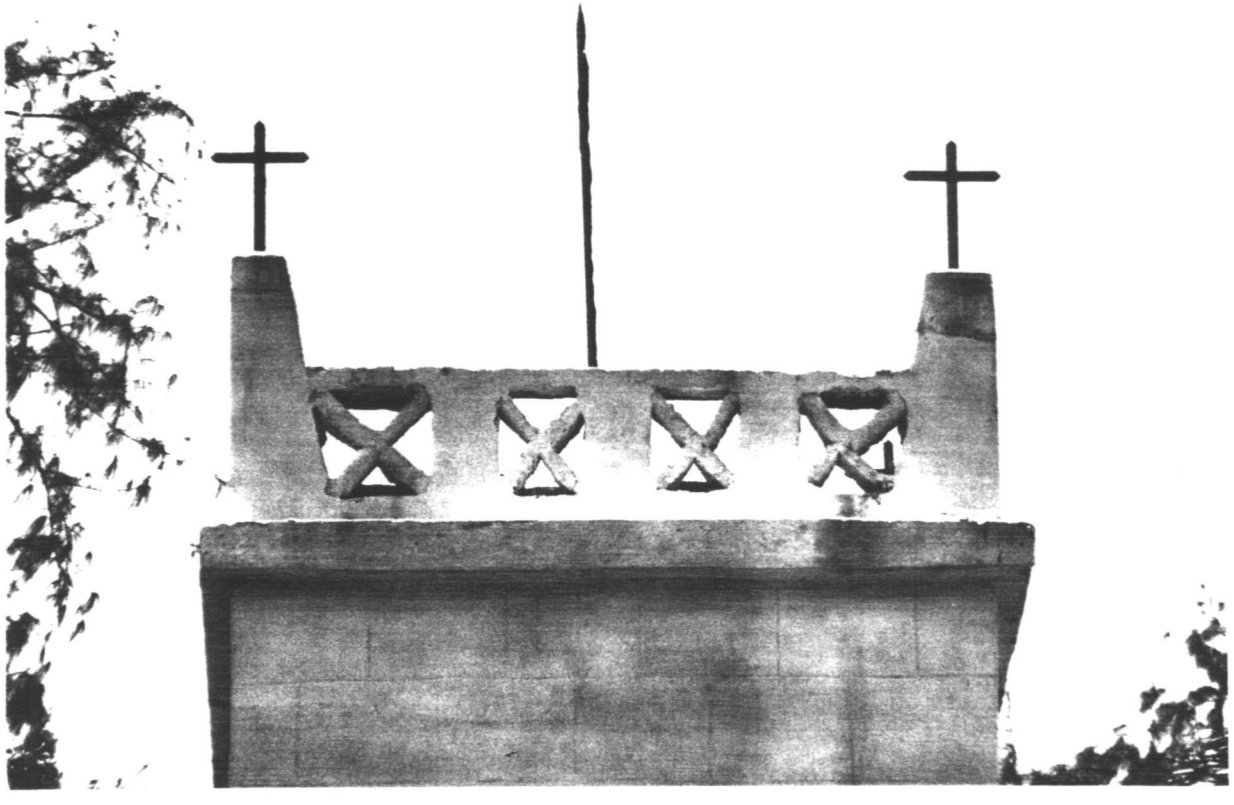
Illustration A24.

It appears that the only pinnacle and cross retaining their original materials and forms are the ones at the southwest corner of the tower. The other three small crosses and the uppermost portions of the pinnacles are replacements. The original parapet construction was plastered stone. Considerable replacement material is visible, brick in the piers, and concrete block in the cap and "X" units. The re-plastering of the parapet and the pinnacle repairs were done with cement mortar rather than an attempt to match the original.

'North' and 'west' parapets of bell tower. Note repair caps on pinnacles resulting from replacement of crosses. 6/84. R.L.C.

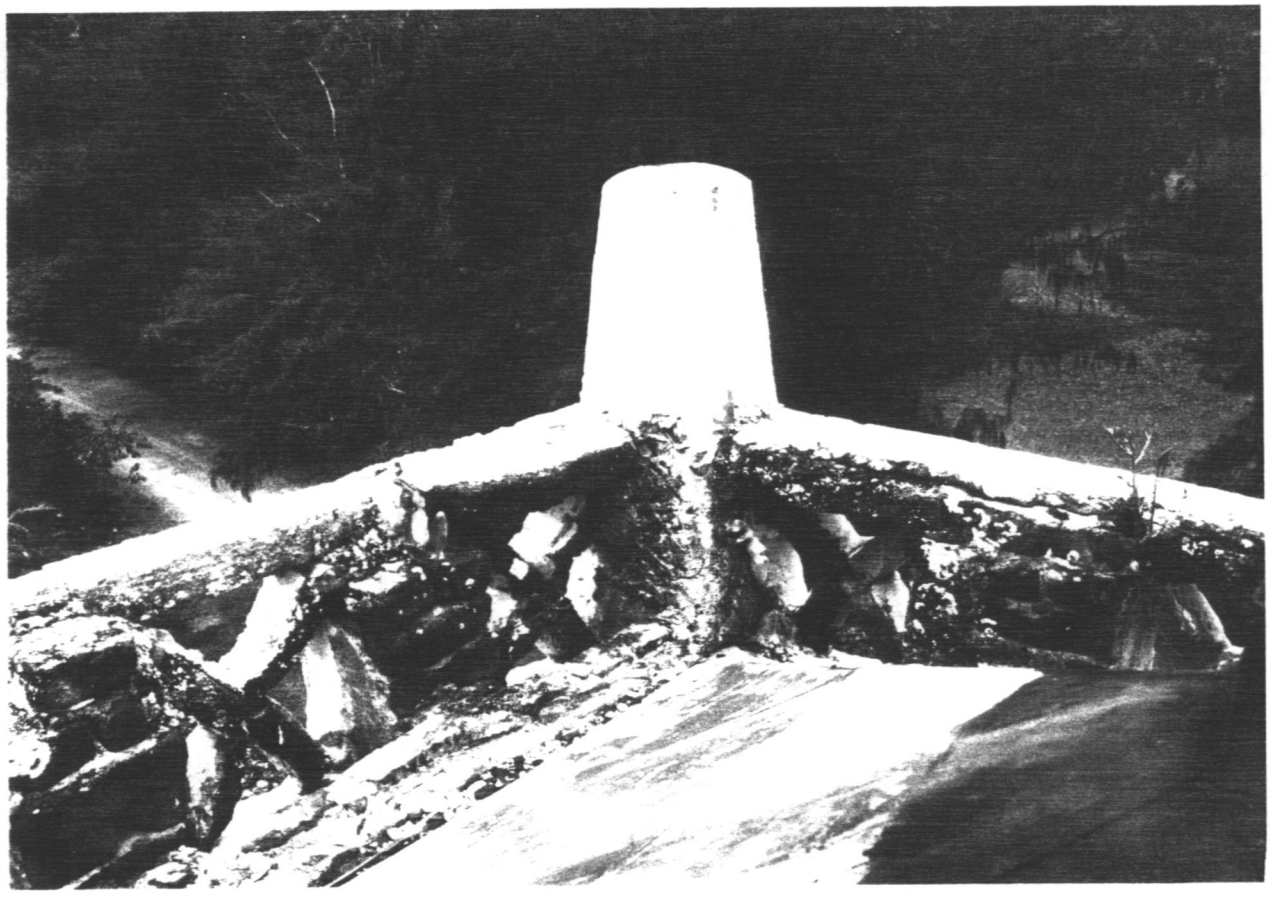
'East' parapet. Note concrete masonry units used for repairs. The copper roofing is in reasonably good condition but the drainage gutter around the base of this square pyramidal roof does not drain well and the base plate of the roof framing is rotted. All crosses are rusted and exfoliated. 5/84. H.G.L.

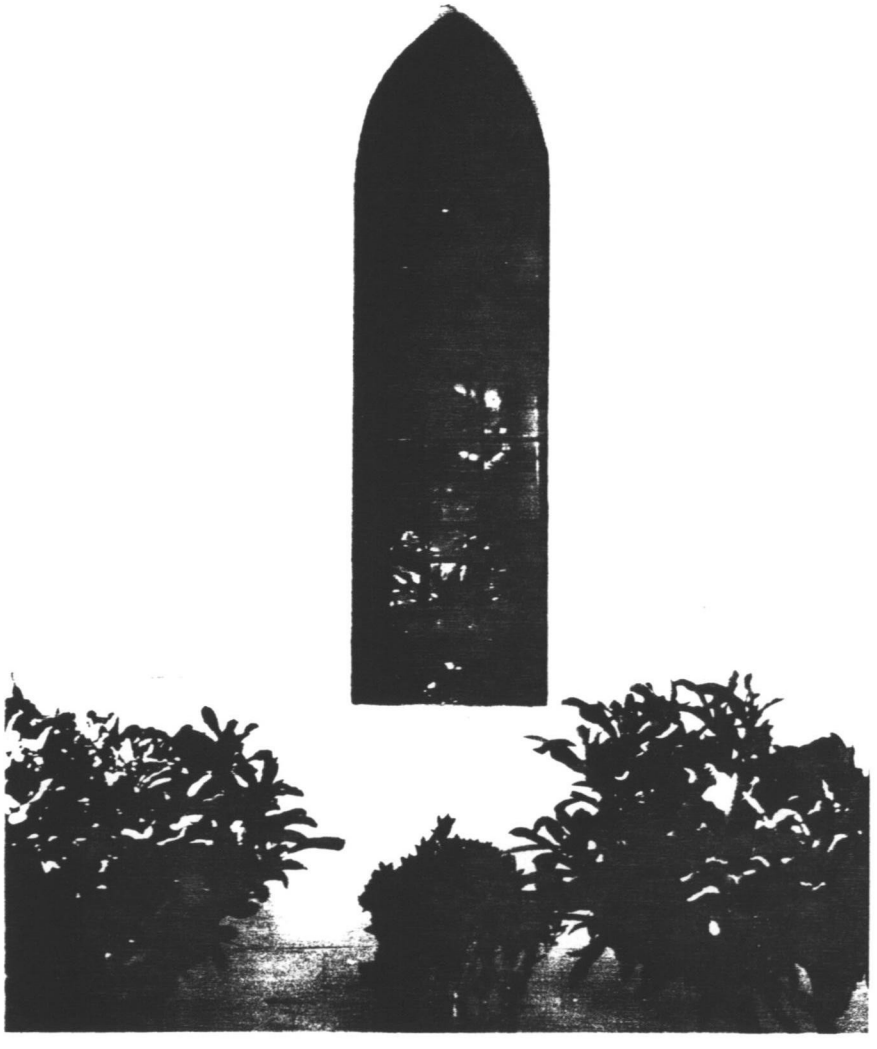
Illustration A32.

The rear wall of the later building is reported to have collapsed in a wind storm; most of the wall and rear entry enclosure is replacement material. This rear wall has an appearance similar to the previous wall but the shield shaped element below the ridge is a more simplified shape than the previous one. This consists of an additional layer of vertical siding. The rear entry enclosure now projects about half as far from the building wall as it had at an earlier time. Formerly, this also contained a doorway providing access to the cellar. Present access to the cellar is a hinged panel at the rear of the entry enclosure. Whether the entry enclosure projection was reduced during the wall replacement work or at an earlier time is not known at present.

Rear ('north') elevation of 1888-89 portion of building. This wall was replaced after collapse during a storm. The sand density in the paint on this wall does not match that of the other siding of the building. 6/84. R.L.C.

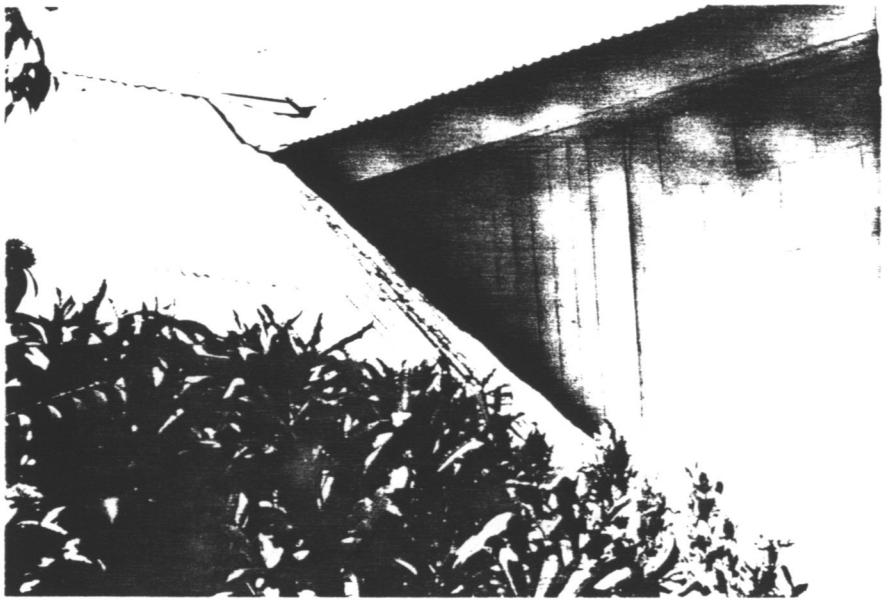
Illustration A41.

View of 1888 nave from above principal altar. 8/84. P.C.C.

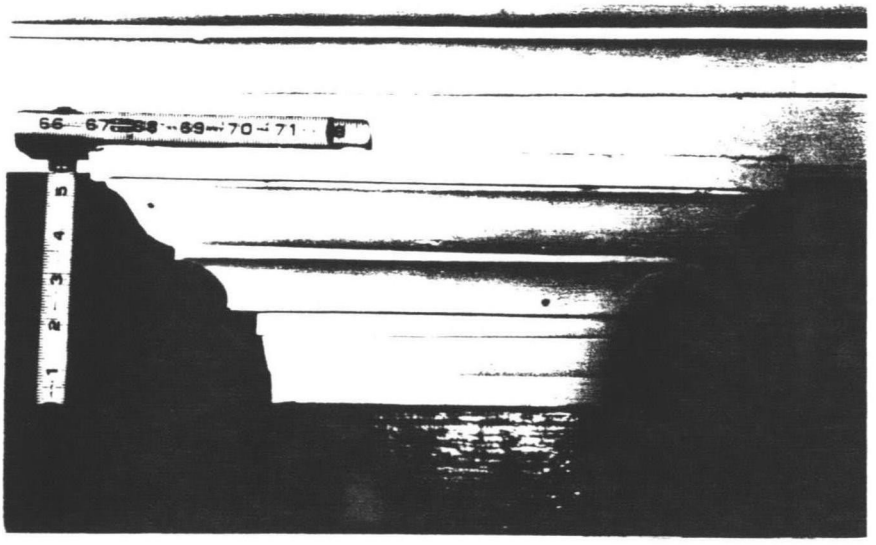
Illustrations A42 and A43.

Details of capital and base of one of two columns toward 'west' end of 1876 nave. 8/84. P.C.C.

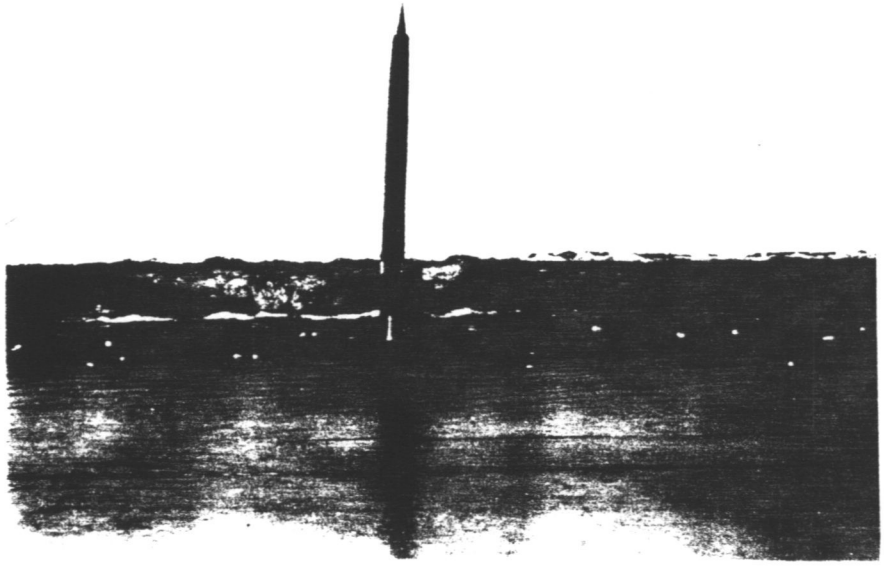
Details showing subsidence of floor of 1888 nave. The greatest settlement occurred in the area of the two 'southern-most' columns. Repairs to the wall plaster have failed as the cement plaster mix did not bond to the earlier lime plaster. 8/84. P.C.C.

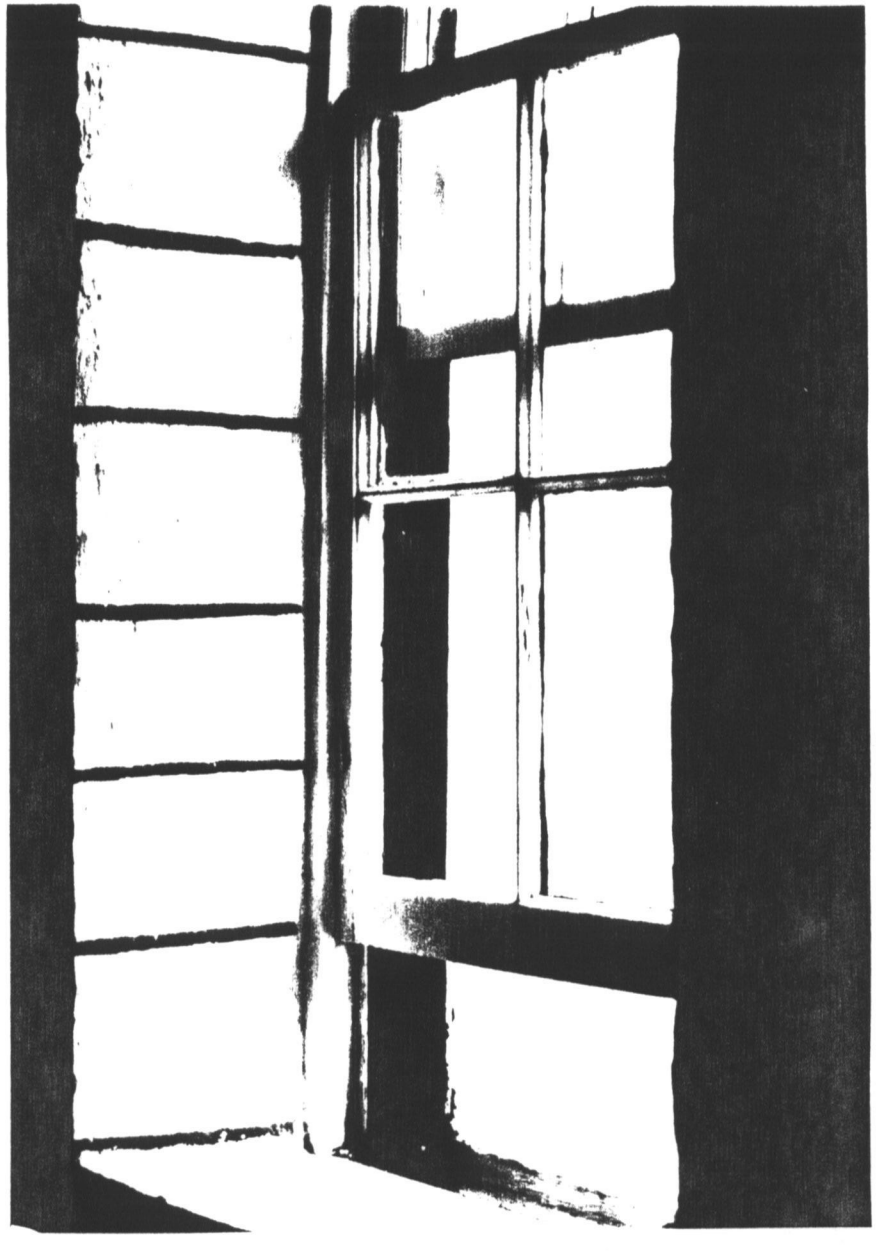
Window details, 1888 nave. Only the lower sash units of these windows are operable. There is no hardware, nor does it appear that there ever was, so they must be proped open. Some glazing is missing, as illustrated here, or broken. Sash, sash guides, wood jambs and sills need refurbishing, and in some cases, elements need replacement. 6/84. R.L.C.

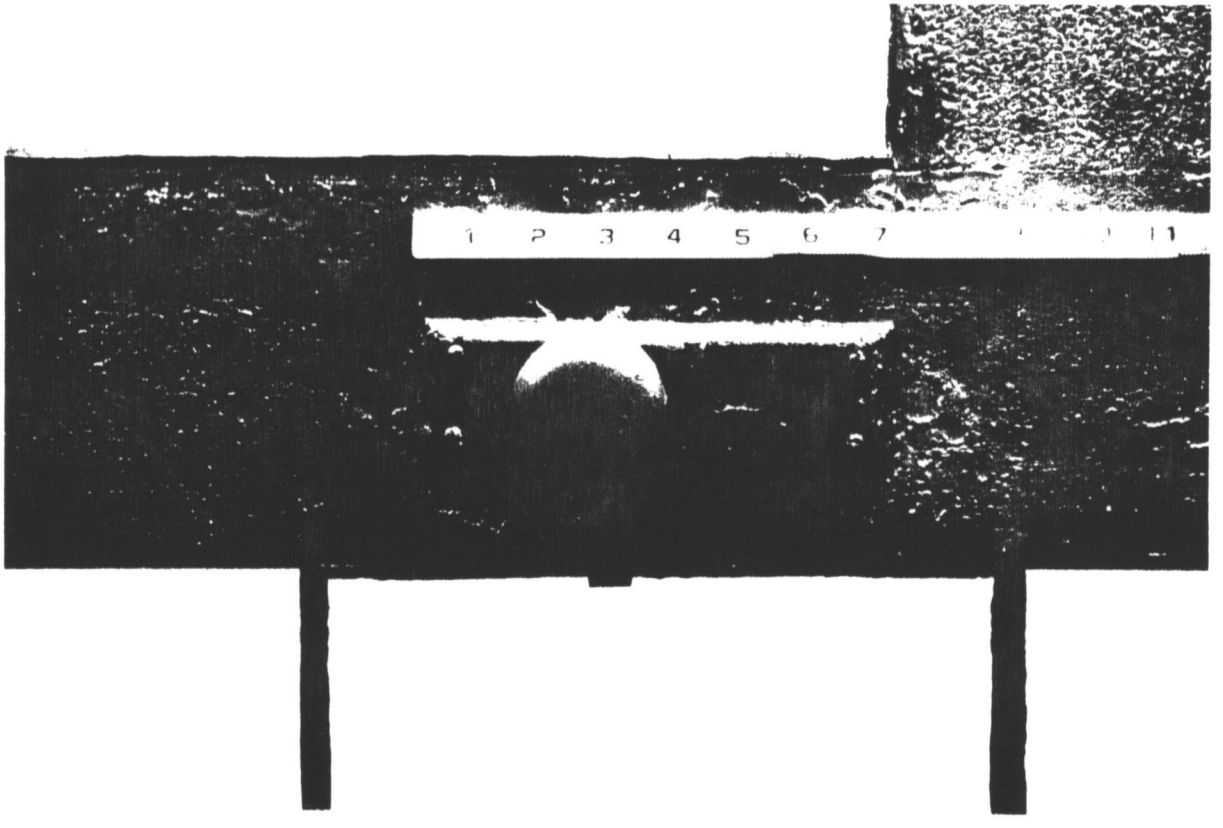
Hardware detail, 'south' entry, 1888 nave. This lockset is only partially operable. 8/84. P.C.C.

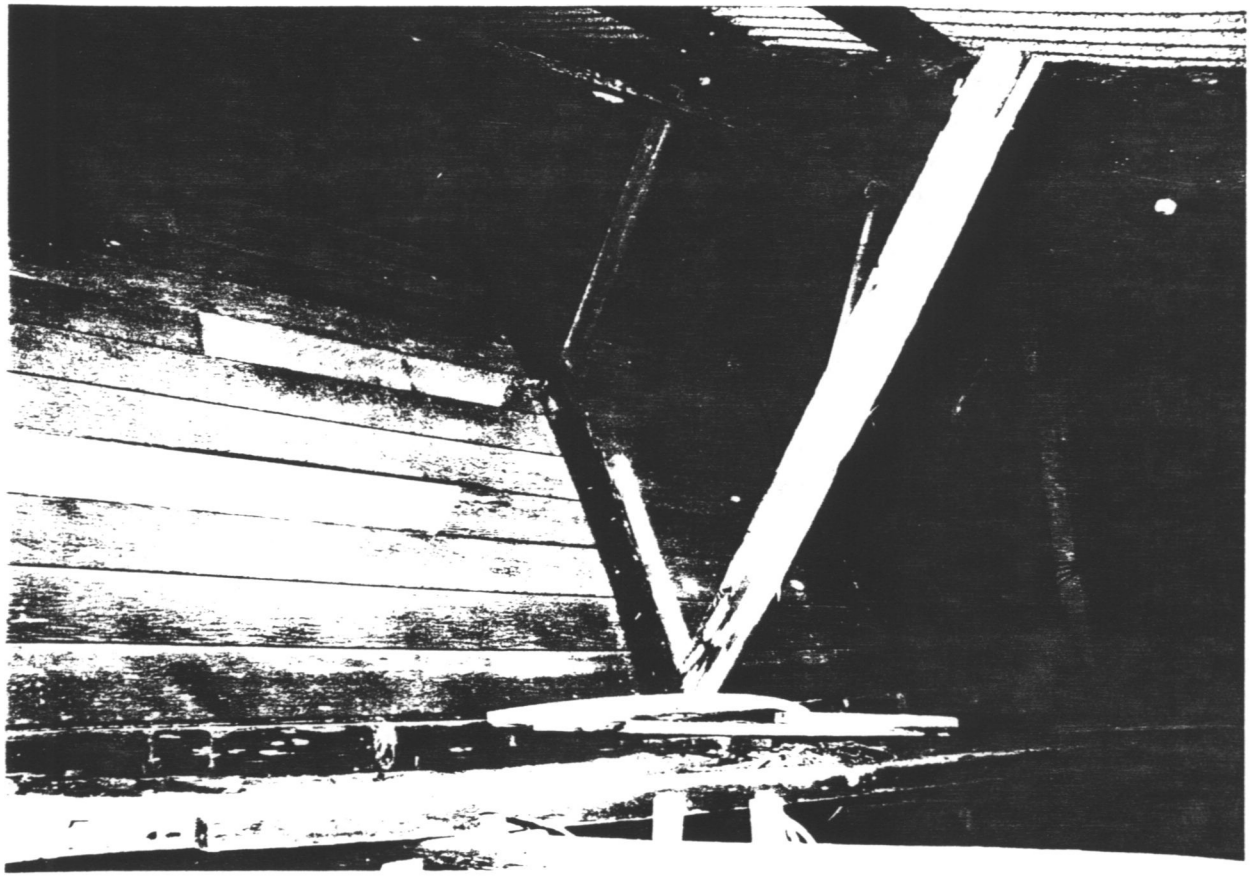
Illustration A63.

Attic along 'east' side of 1888 nave vault, view toward south. Most rafters and vault ribs are sound, but the vault base plates, a flat 2 inch by 10½ inch member on this side (lower center of photo), are extremely deteriorated from air-borne termite infestations. Most of the weight of the vault is probably carried in suspension from the rafters. The end of the stone wall is also visible in this photo. 8/84. P.C.C.

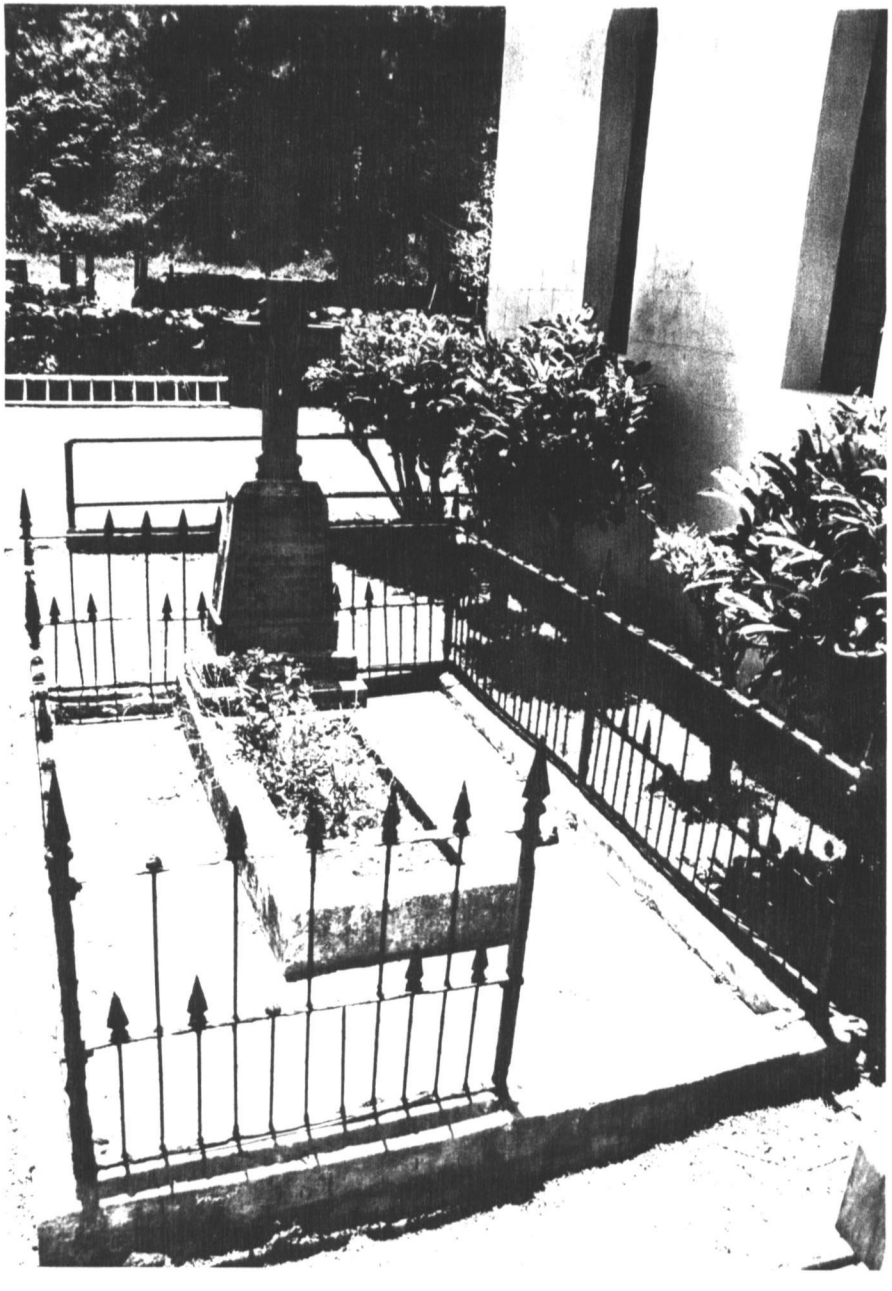
Illustration A111.

Fr. Damien's grave. Note deterioration of decorative railing and missing elements. Part of gate still exists. 8/84. P.C.C.

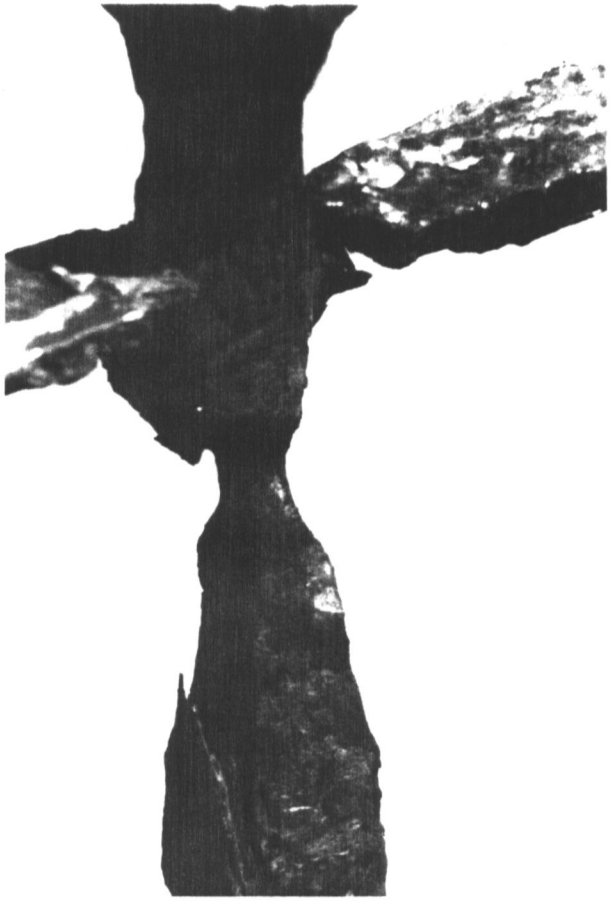
Illustrations A115 and A116.

Details of railing, Fr. Damien's grave, showing deterioration of metal. 6/84. R.L.C.

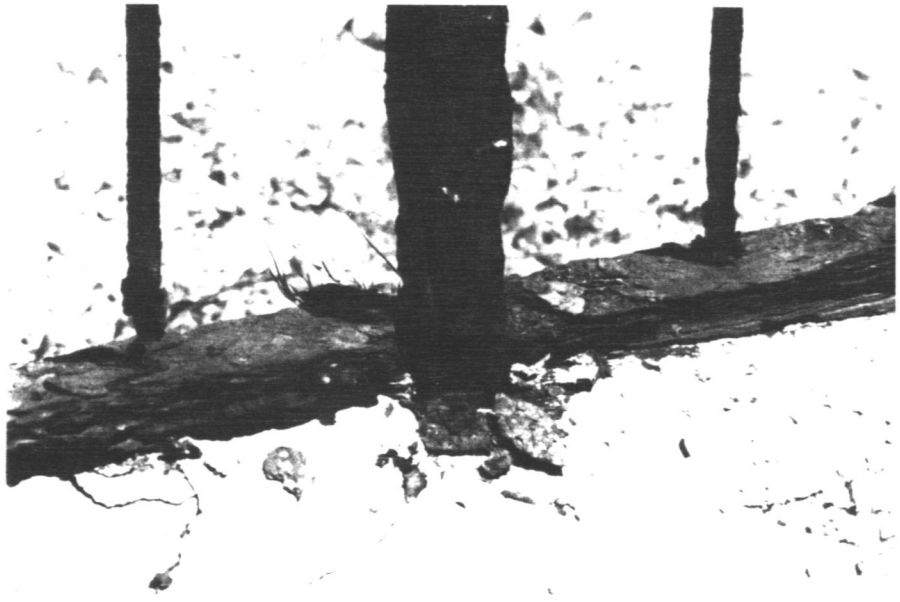
Illustrations A117 and A118.

Details of intermediate and corner post at bottom rail, Fr. Damien's grave. 6/84. R.L.C.

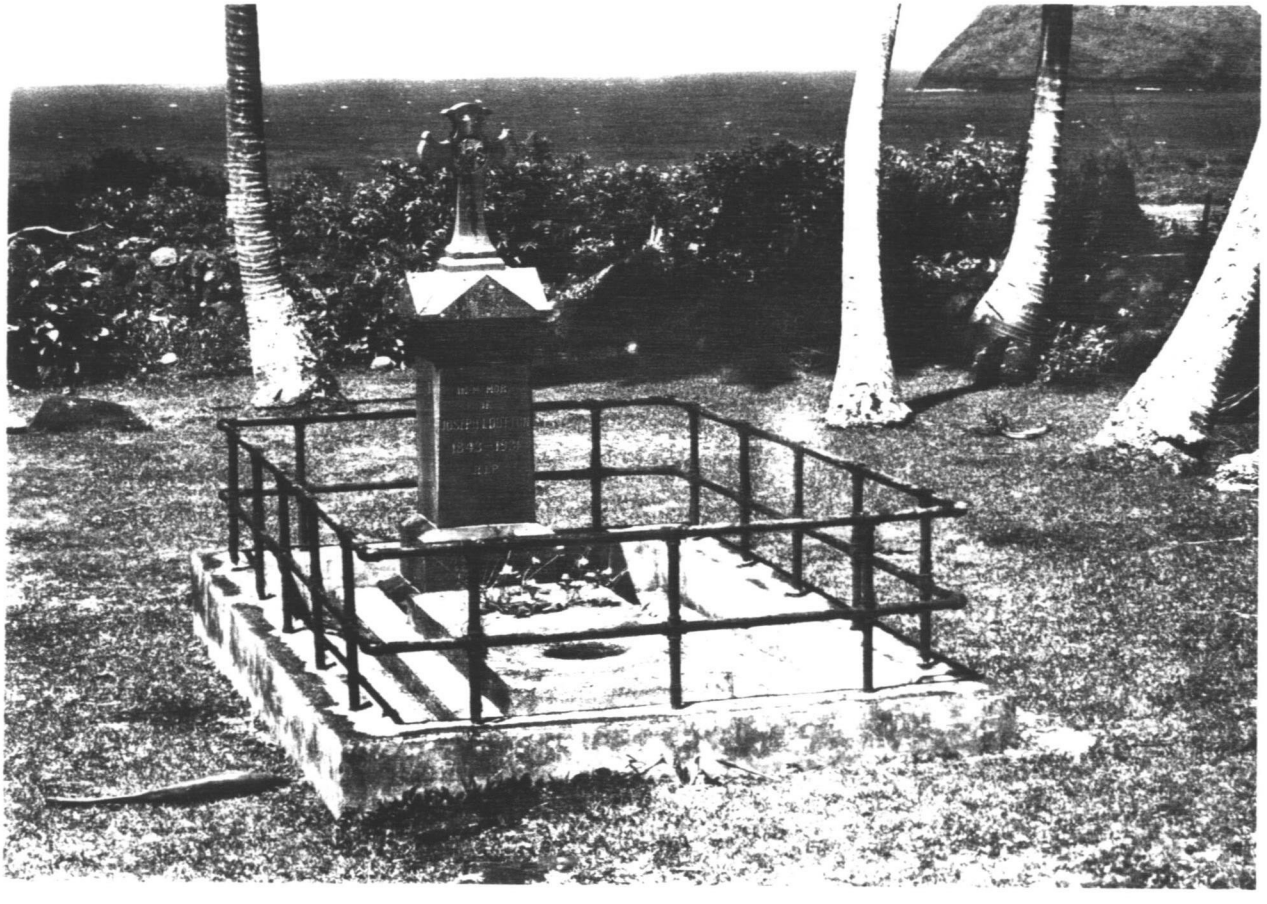
Illustration A123.

Detail of deteriorated pipe railing of Br. Dutton's grave. 6/84. R.L.C.

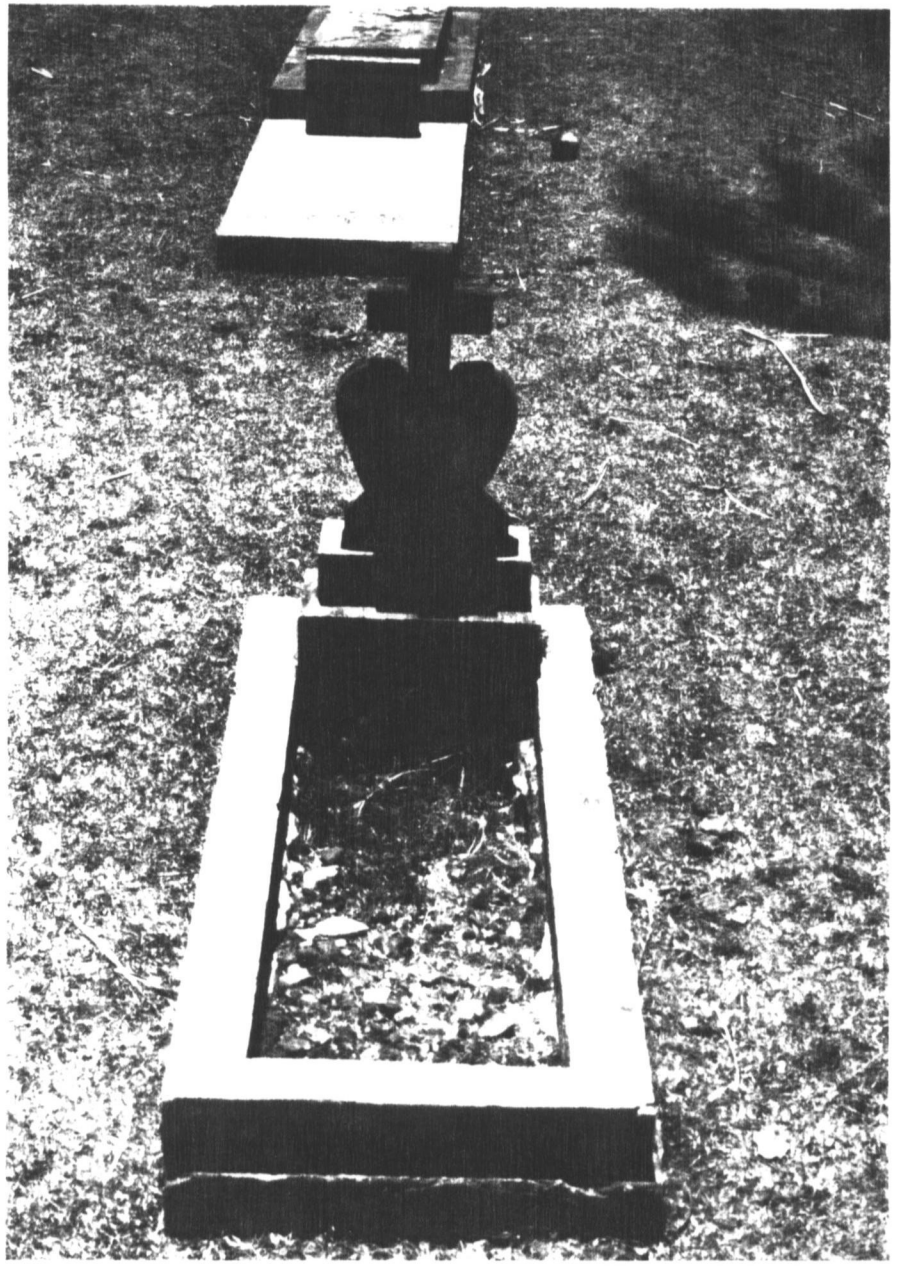
Illustration A126.

Grave of A. Kulani, died Apr. 3, 1927 (No. 6 on Site Plan drawing). 8/84. P.C.C.

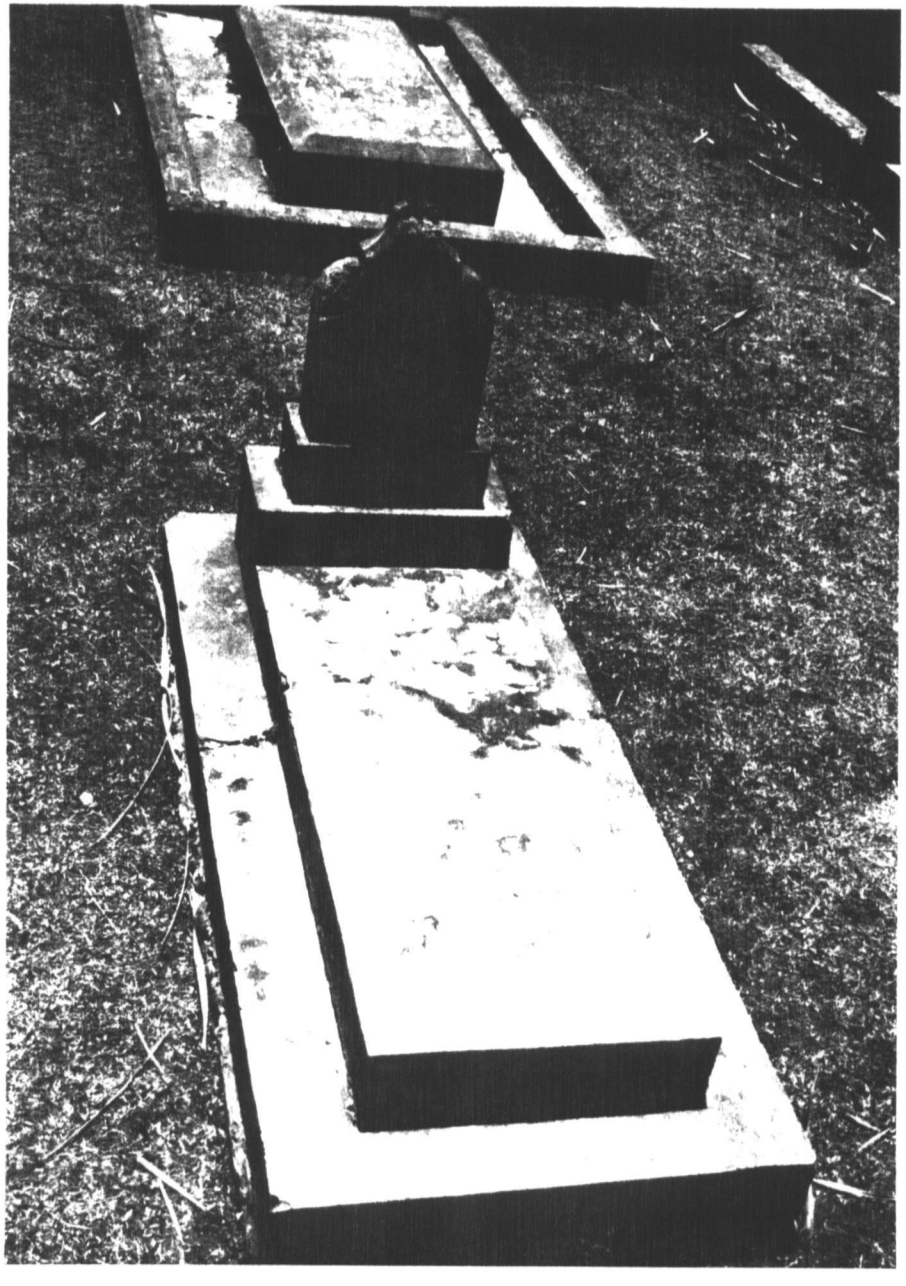
Illustration A129.

Grave of W. (K?)uhia, died May 27, 1924 (No. 9 on Site Plan drawing). 8/84.

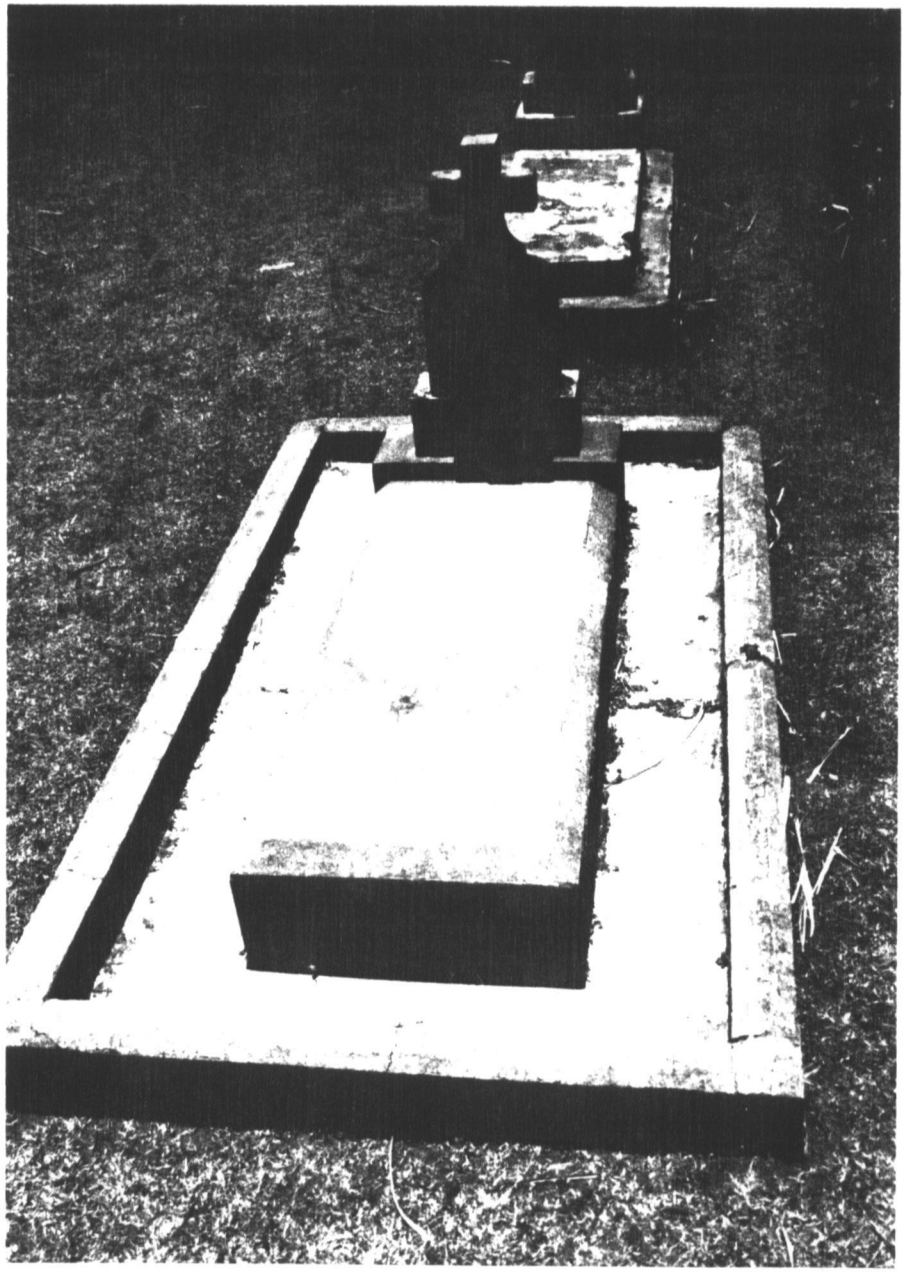
Illustration A130.

Grave of B. Palikapu, died Oct. 23, 1919 (No. 10 on Site Plan drawing). 8/84. P.C.C.

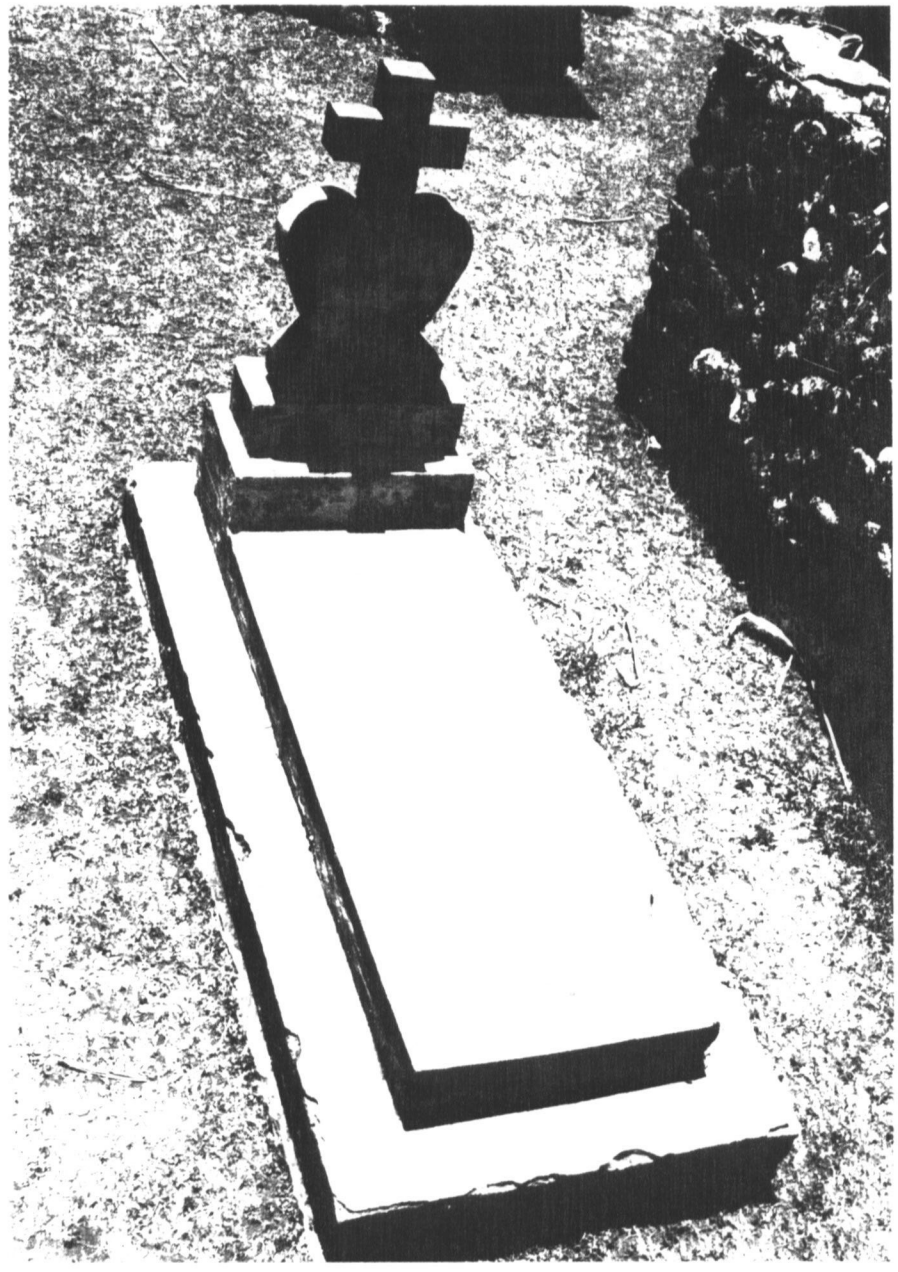
Illustration A132.

The person buried here was unidentified as the headstone is missing (grave No. 12 on Site Plan drawing). 8/84. P.C.C.

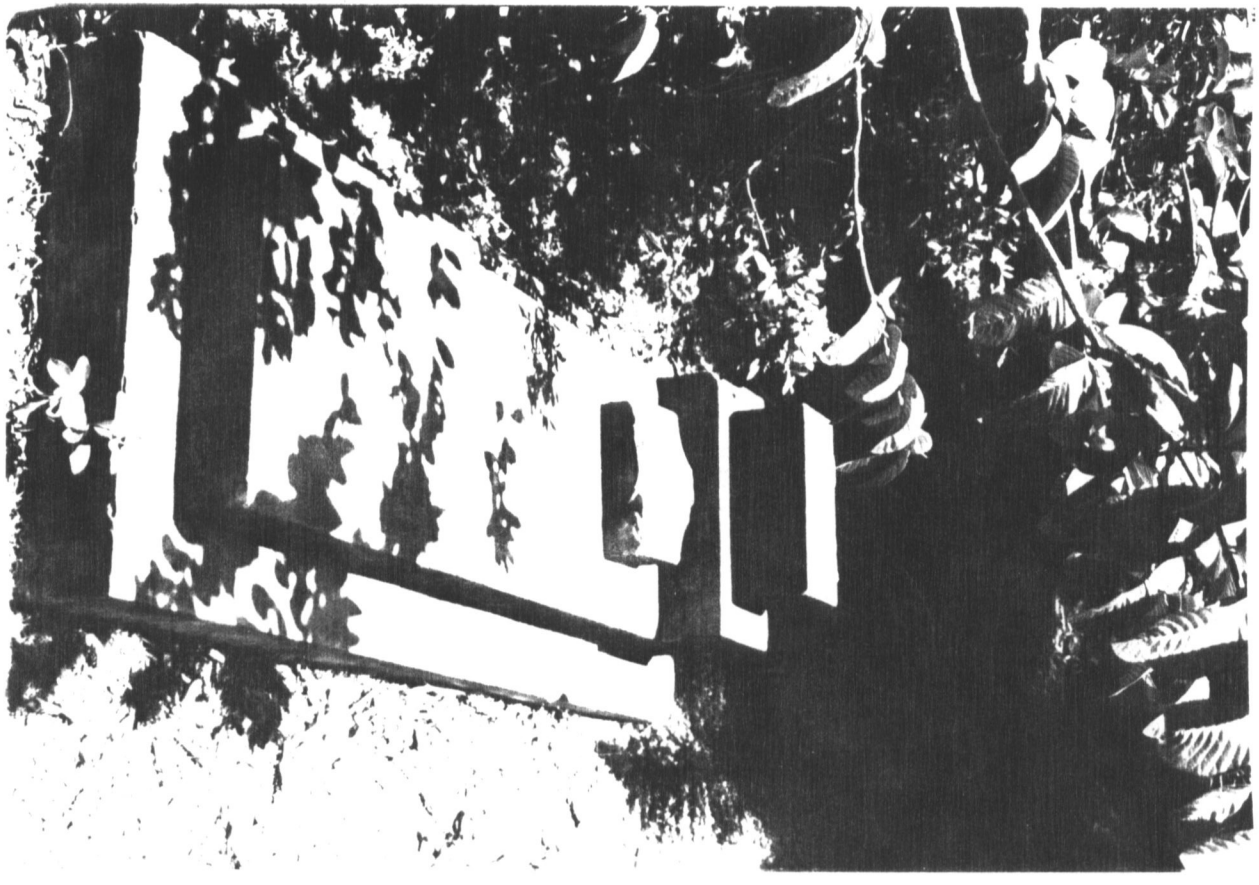
Illustration A135.

Grave of Br. Rochus Rech, Nov. 10, 1902 (No. 15A on Site Plan drawing). 8/84. P.C.C.

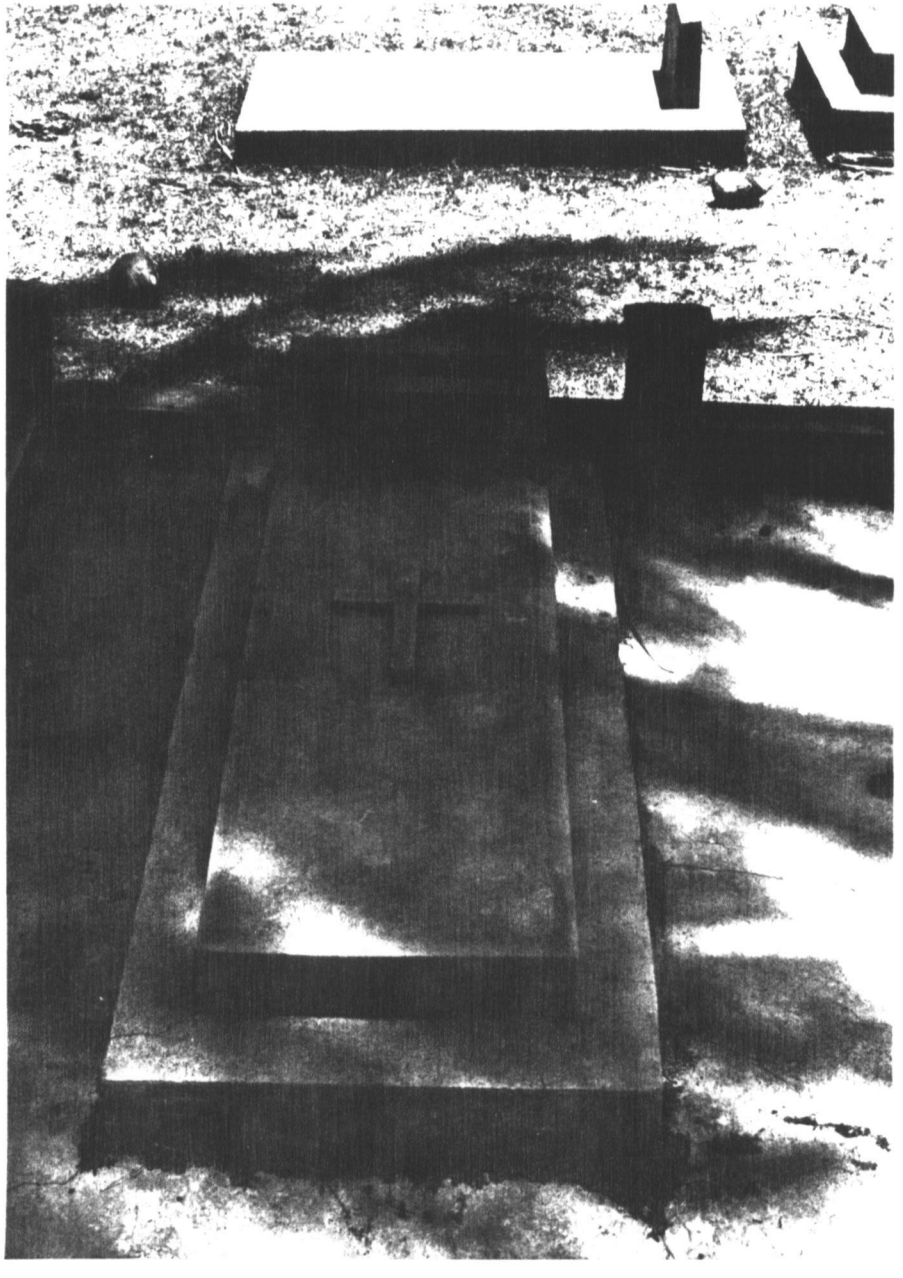
Illustration A136.

Grave of Br. Victor Schumpf, Feb. 20, 1900 (No. 15B on Site Plan drawing). 8/84. P.C.C.

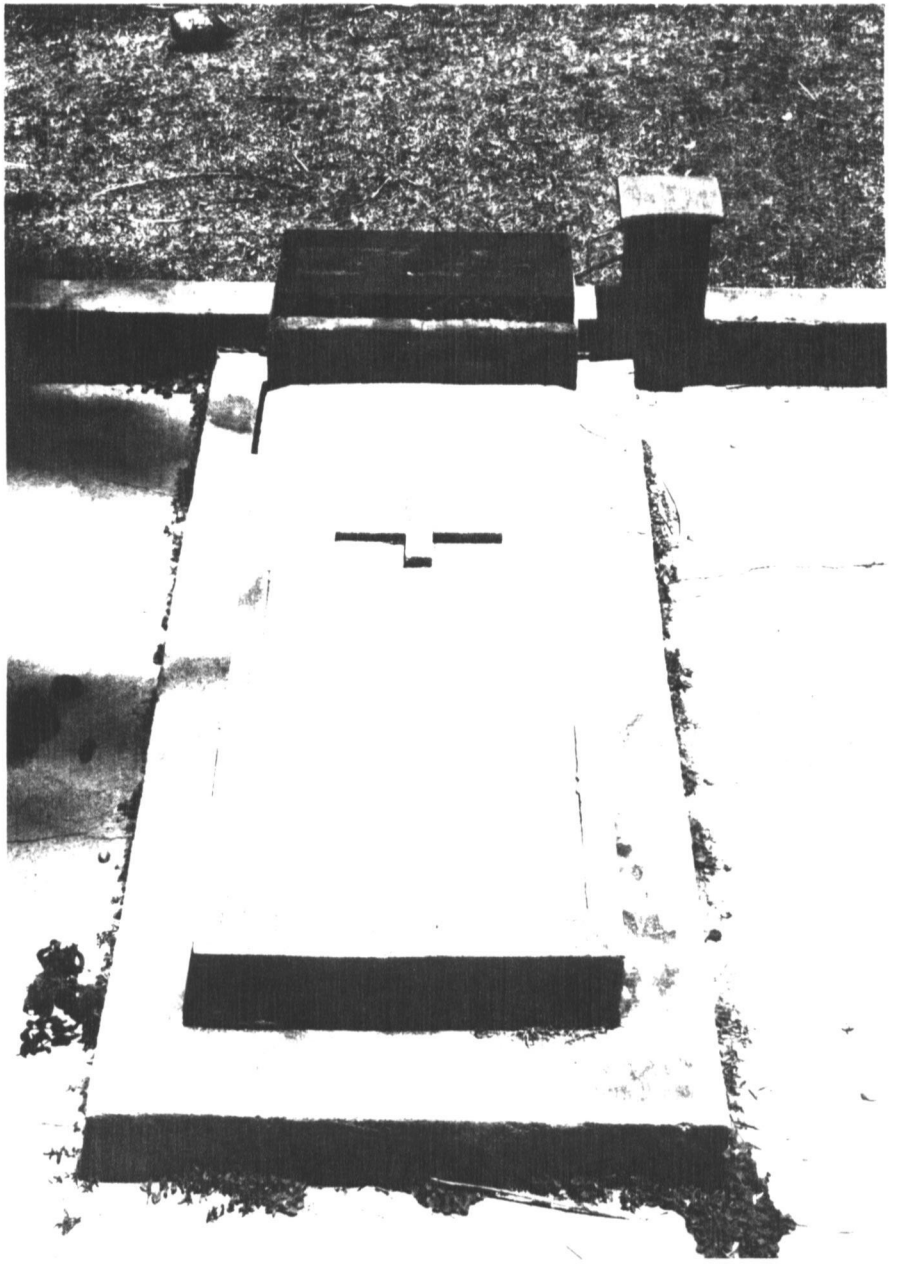
Illustration A137.

Br. Maria Serapion Van Hoof, May 12, 1910 (No. 15C on Site Plan drawing). 8/84. P.C.C.
