HISTORIC STRUCTURE REPORT

ST. PHILOMENA CATHOLIC CHURCH

KALAUPAPA NATIONAL HISTORIC PARK
Molokai, Hawaii

January 1985

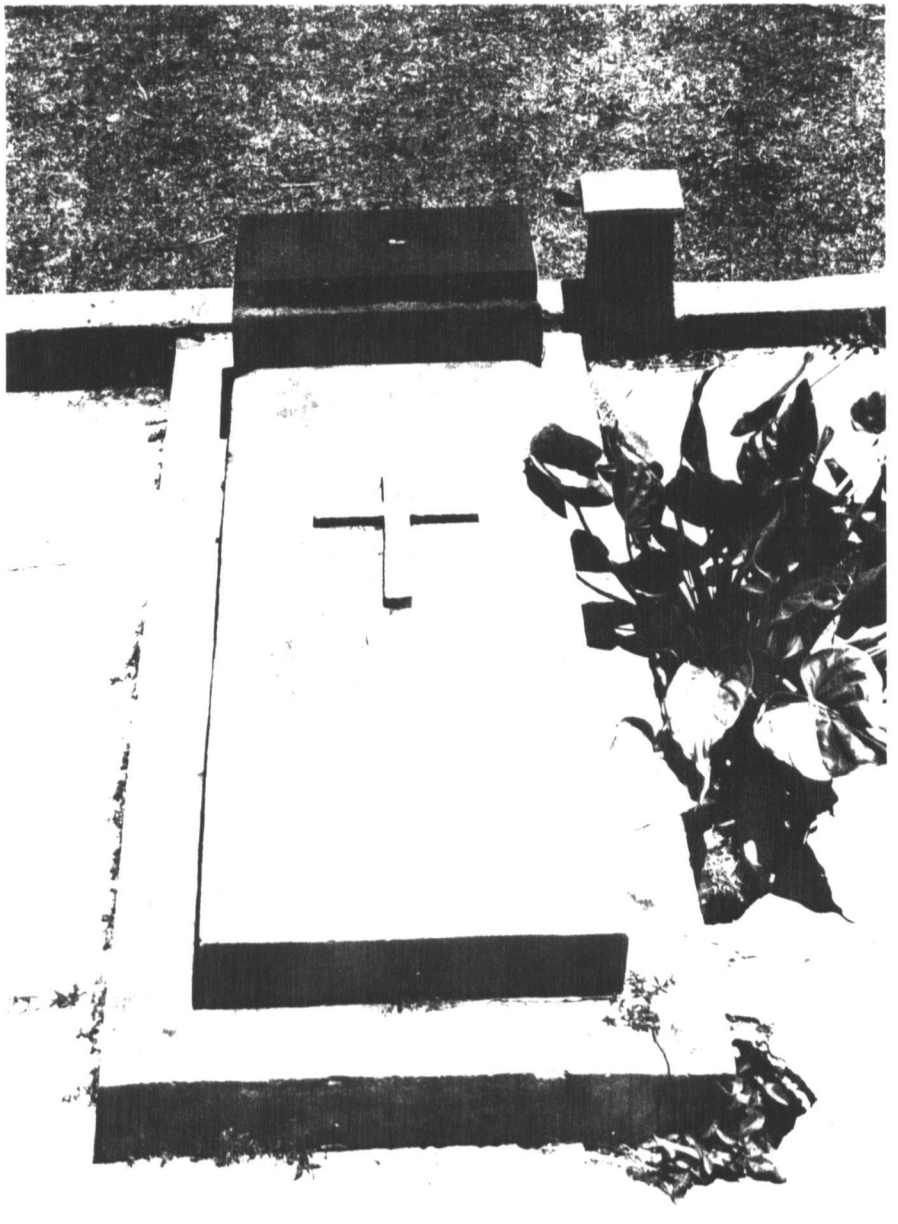
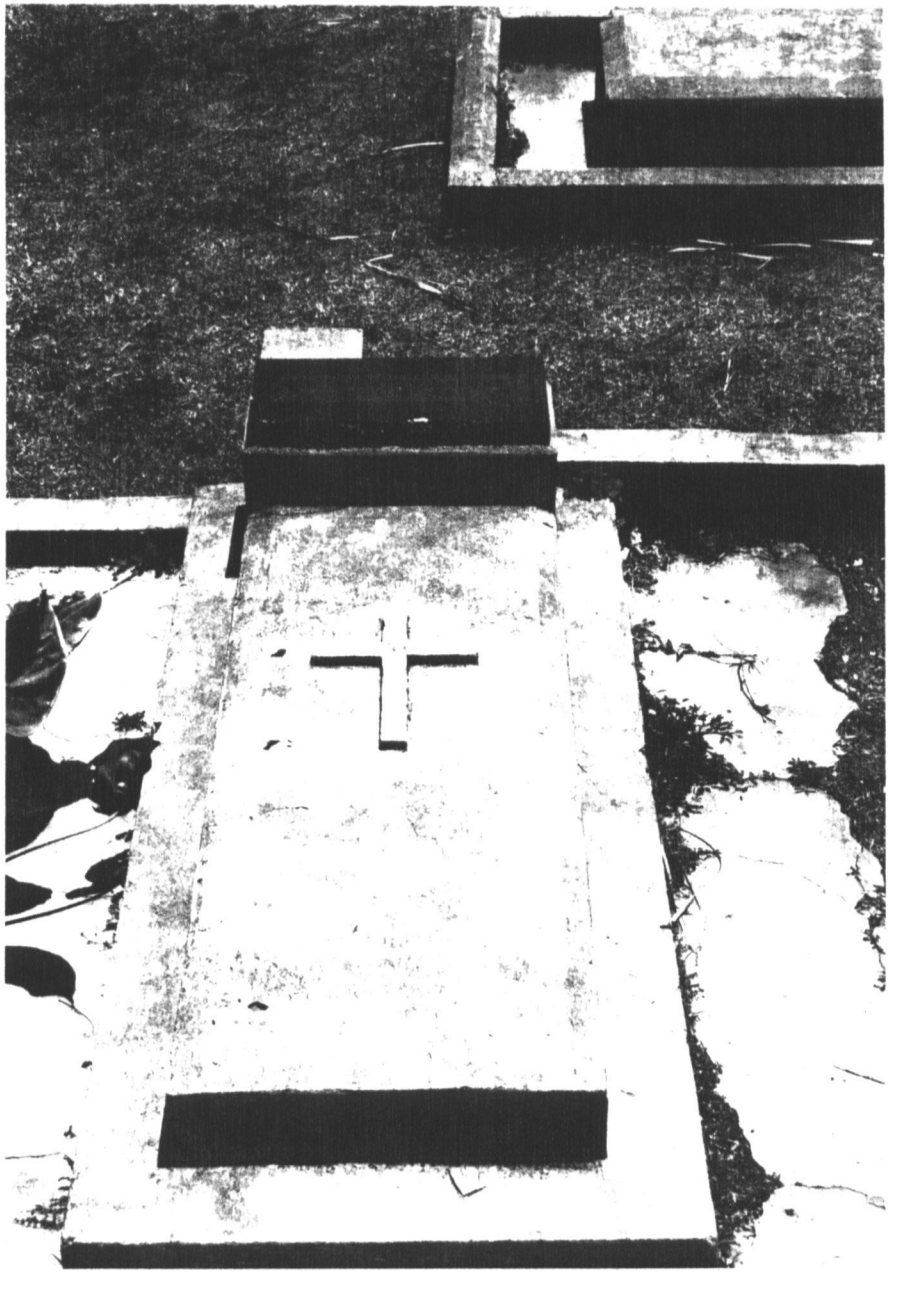
Illustration A138.

Grave of Br. Severin Baltes, Sept. 19, 1921 (No. 15D on Site Plan drawing). 8/84. P.C.C.
