HISTORIC STRUCTURES REPORT

AREA F

ARCHITECTURAL DATA SECTION

INDEPENDENCE NATIONAL HISTORICAL PARK

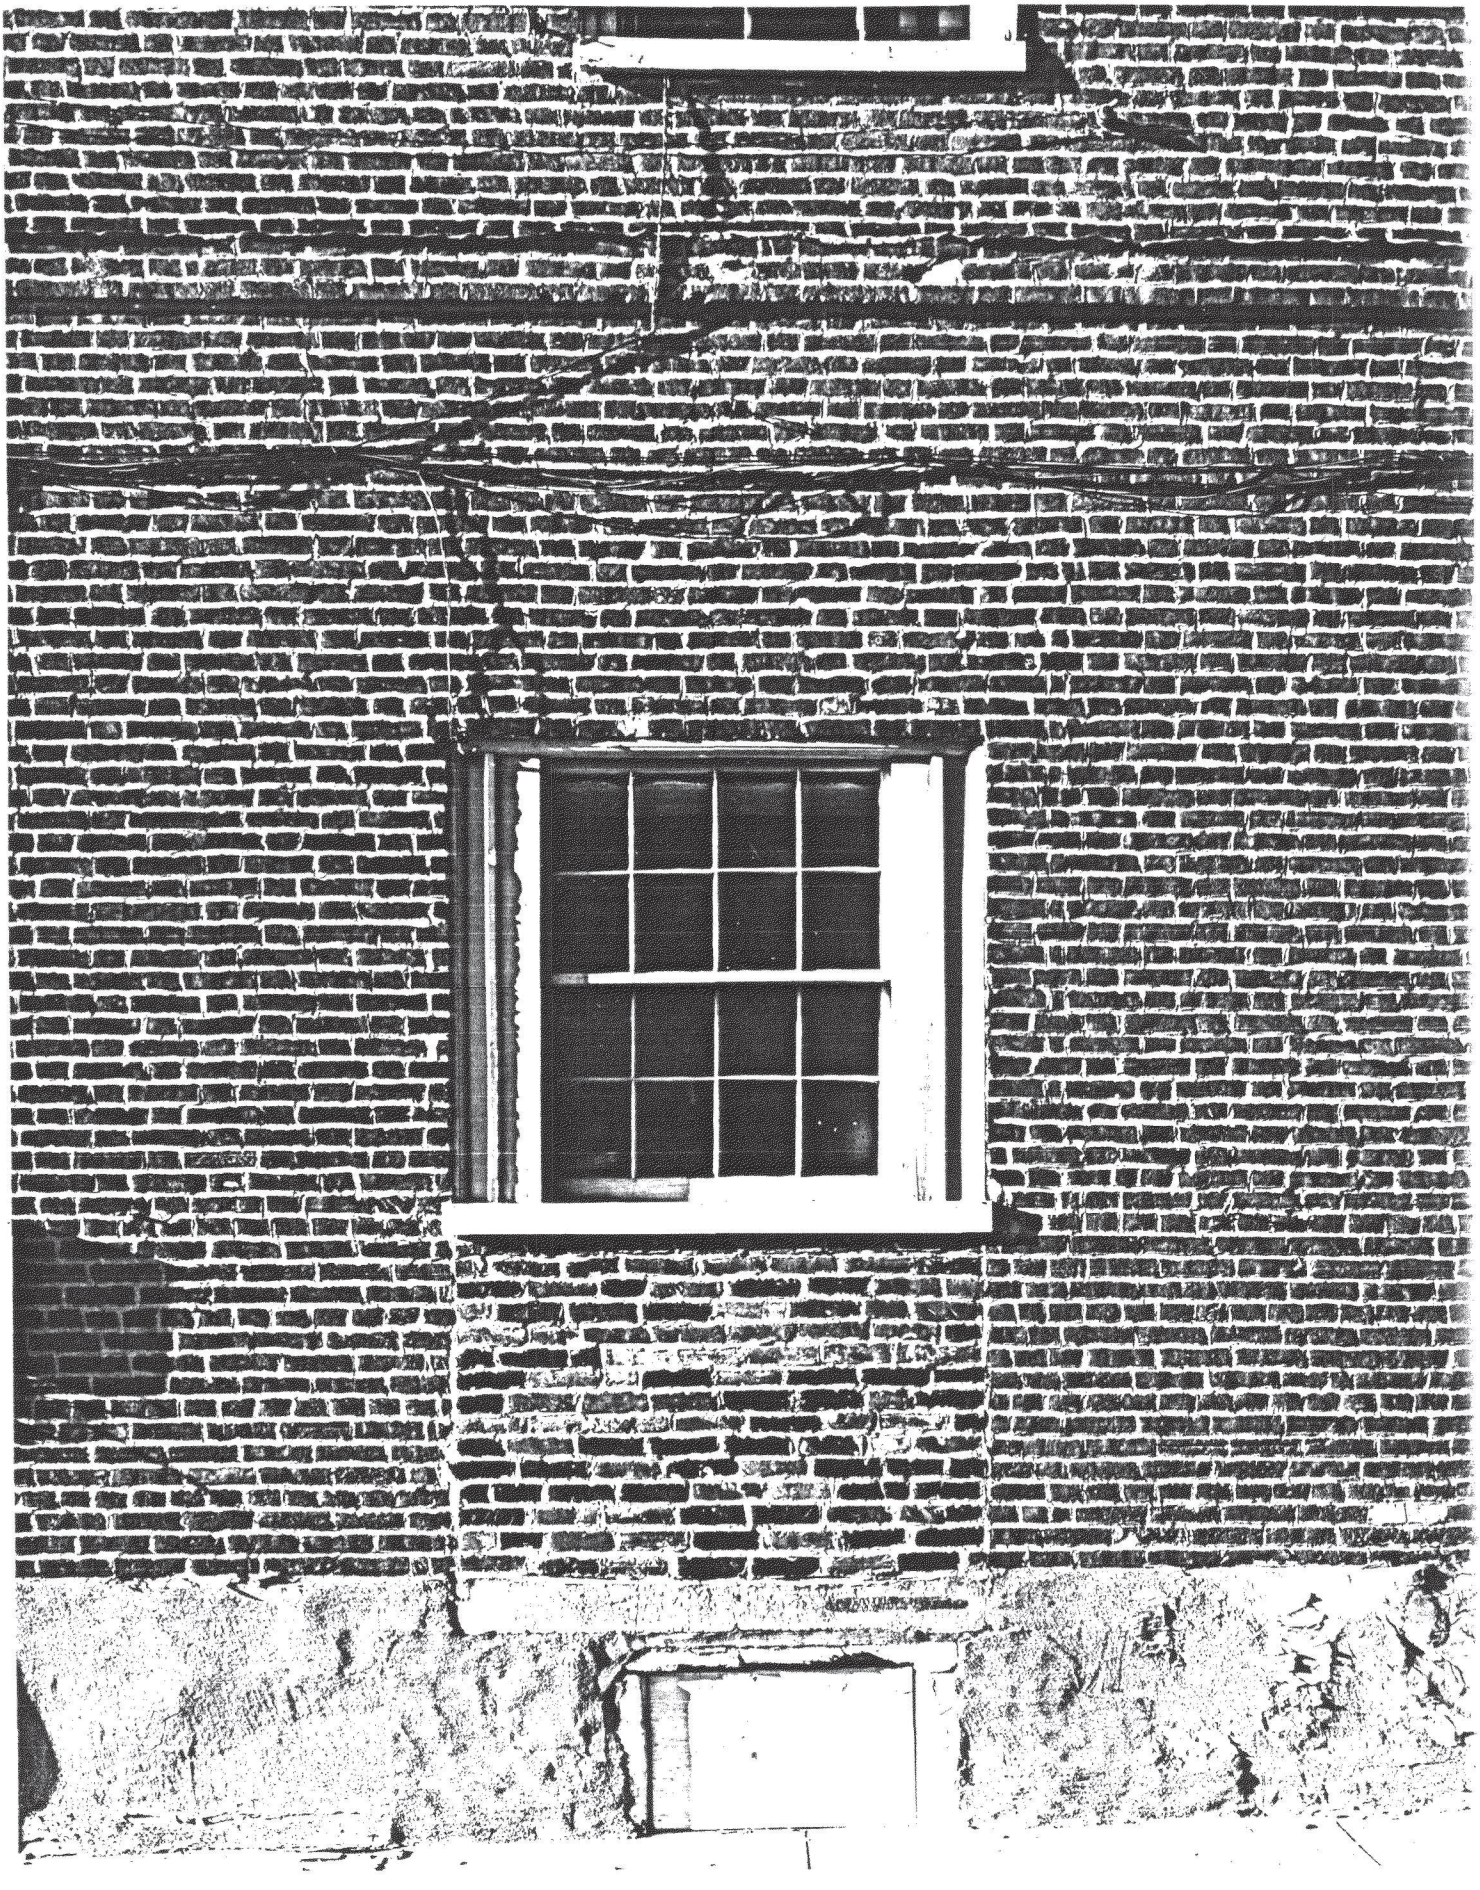
RESTORATION 1769 SOUTH CORNICE
129 S. 2ND ST. PHILA., BOND HSE., INHP

For lack of flashing and/or roof repair, the south 1769 horizontal cornice members apparently rotted and caused the removal of this feature.

Wood Cornice: As the existing paint adhesion is good, no paint removal is necessary; the fastening of each member should be reinforced as one modillion block is missing and another recently became unfastened due to rusted-through nails; replace missing modillion; and construct new horizontal cornice with new fastening devices to attach it to the wall.

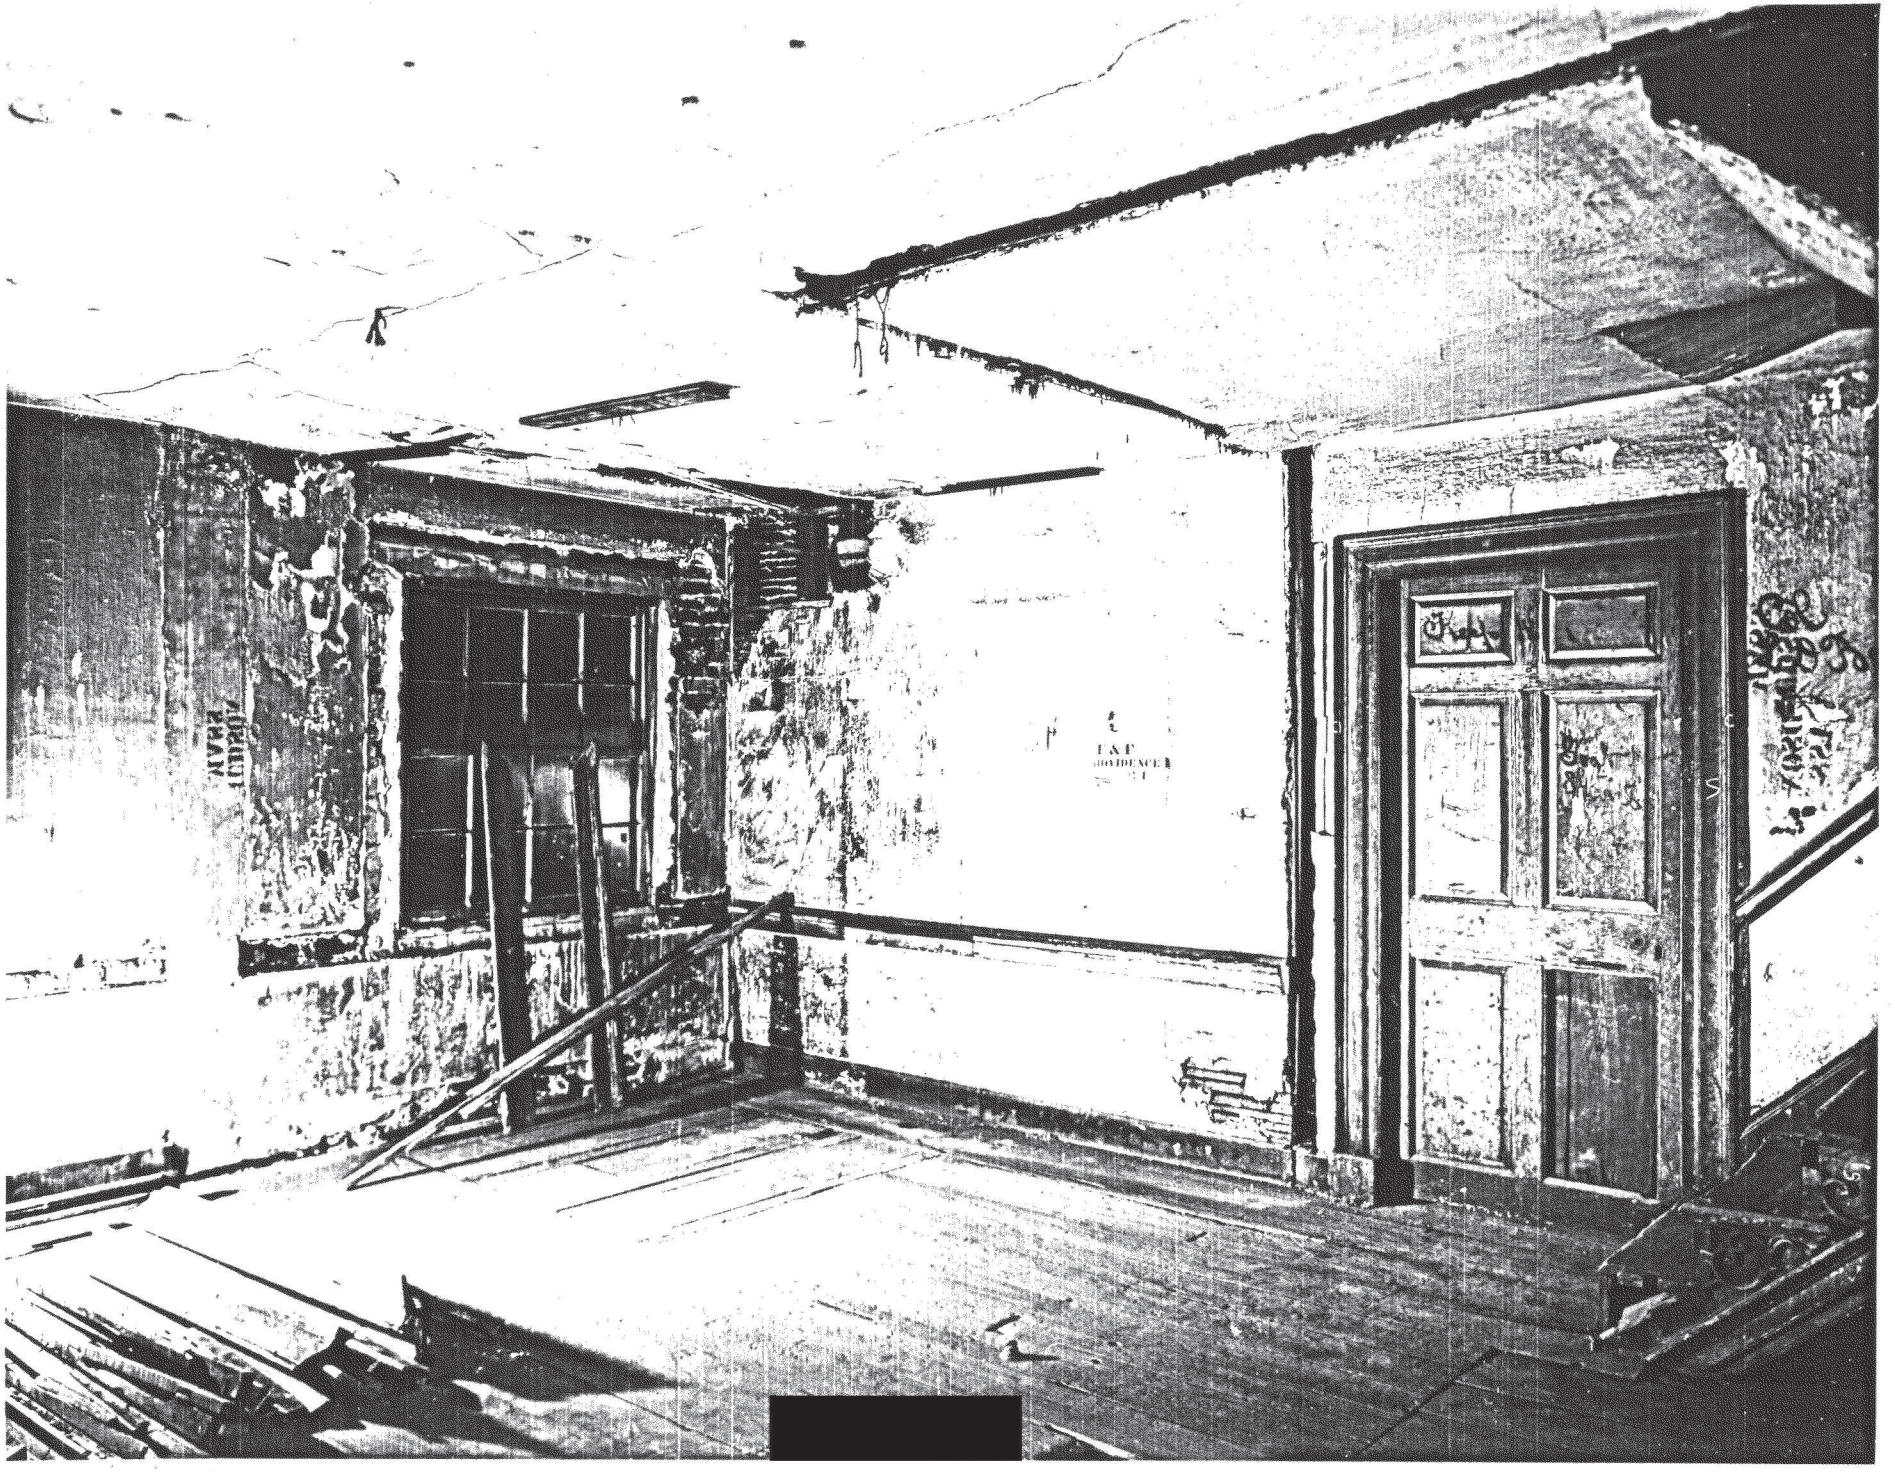
This view is looking southwest toward the center south window of the 1769 Bond House with the foot of the original stair at right. The stud partition shown separates the west chamber from what was the south center room and center stairhall. Missing is the north-south partition separating these spaces from the east chamber (in which the camera is standing), and the east-west partition between the stairhall and center south room.

At an early date a doorway was cut through the standing partition and soon closed up. The patch woodwork matches the original trim exactly and was installed with the care usually used for a finish space.

For the nineteenth century warehouse use of this space, a hatchway was cut in the floor before the window (now closed over with 19th century shutters), A hole was dug in the south wall brickwork and adjacent partition, and round holes were cut in the flooring, all probably for a hoist which was attached to the wall.

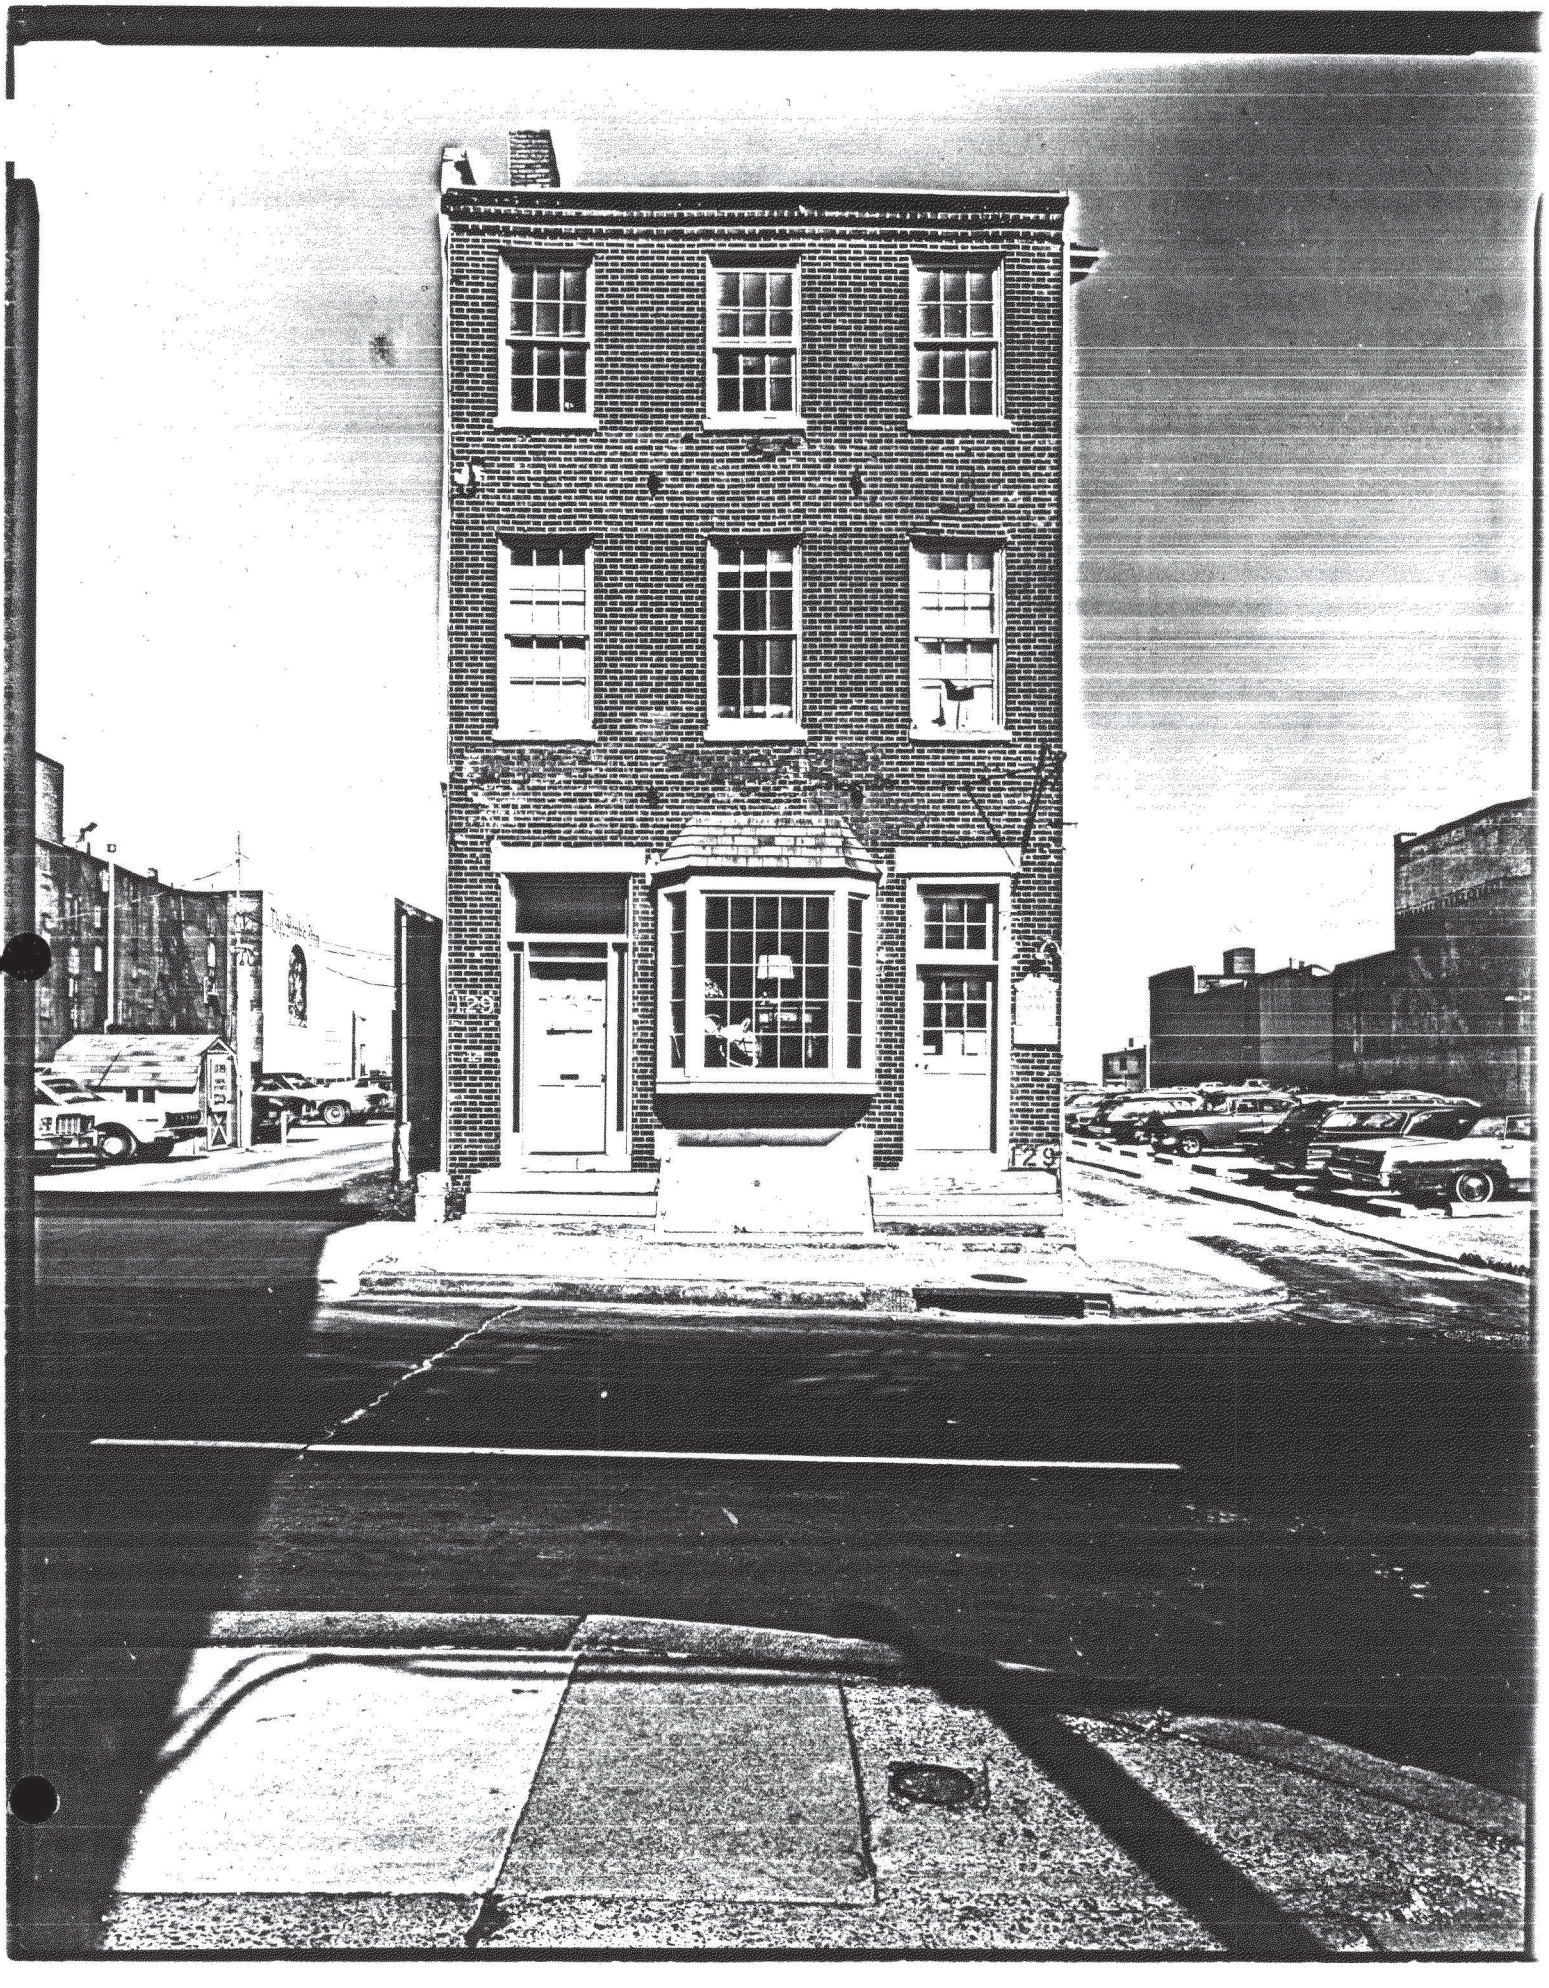
The west elevation of 129 South Second Street, Philadelphia. Photograph by Anthony S. Bley, June 12, 1978. Historic Structures Negative 157.4416.

This photograph shows the existing conditions of the 1824 west facade. It was taken to develop overlay drawings of evidence and restoration presentations. It may also be useful in developing construction drawings.

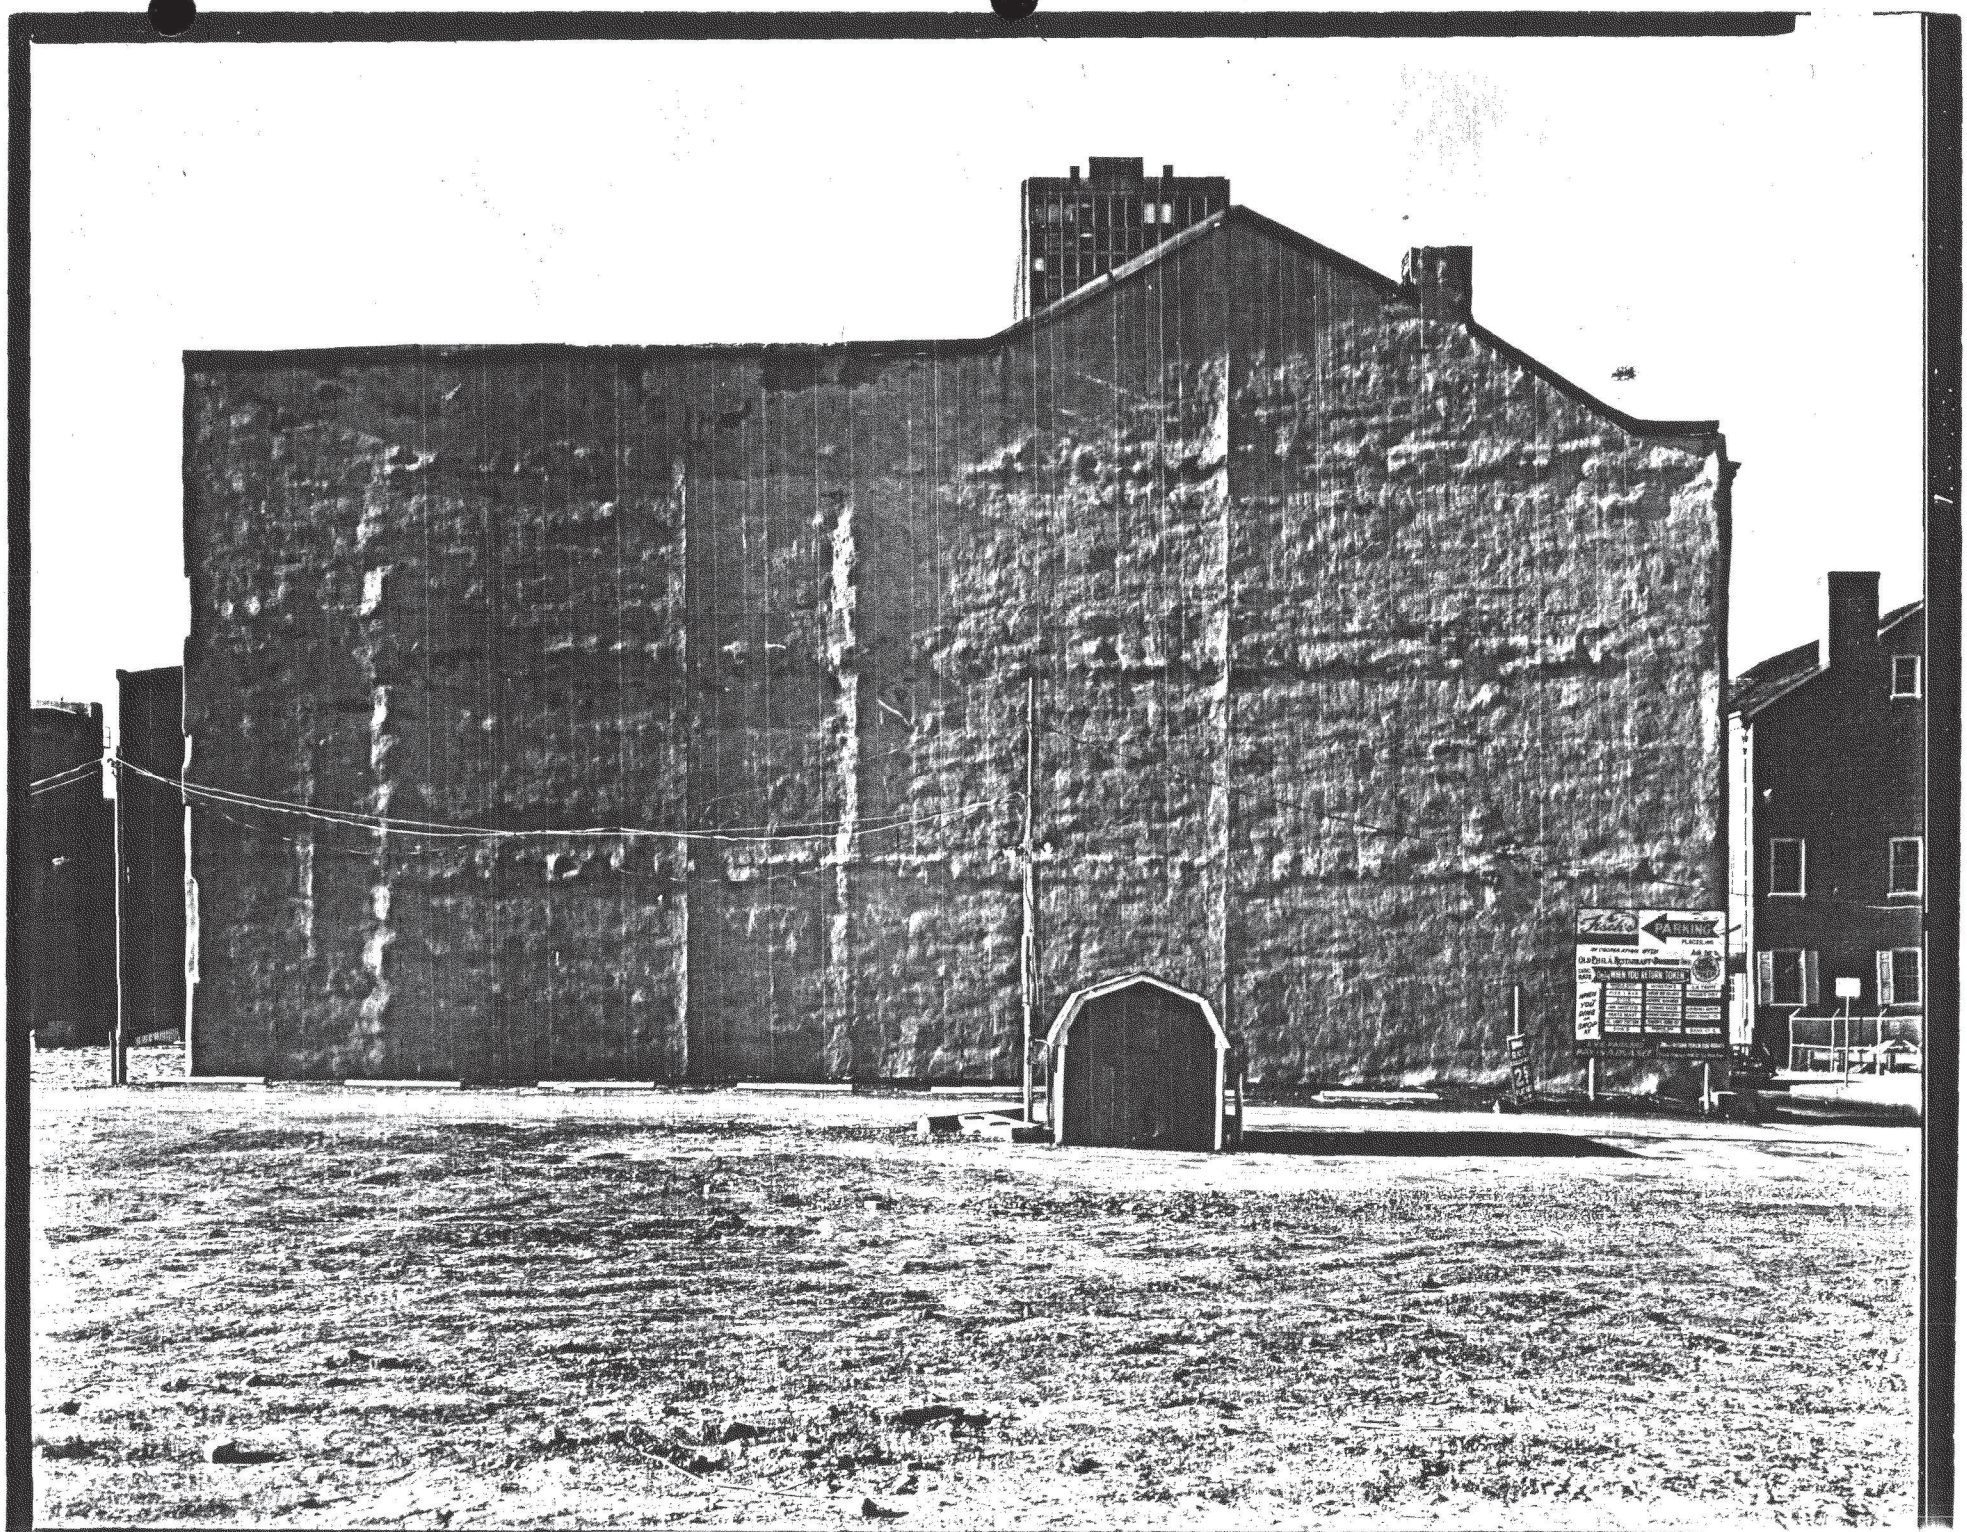
The shadows formed by the uneven wall surface represent floor levels and building divisions of the nineteenth century structure demolished, the second building on this lot.

By evidence on the south face of this wall we can say that the major portion of it was first built c.1757 as the south wall of the first structure built on the lot by Dr. Thomas Bond Sr.. Thus, if development of the house at #129 is to include refacing this north face, provision should be made to research and record any evidence of the 1757 (#127) house which might be uncovered.

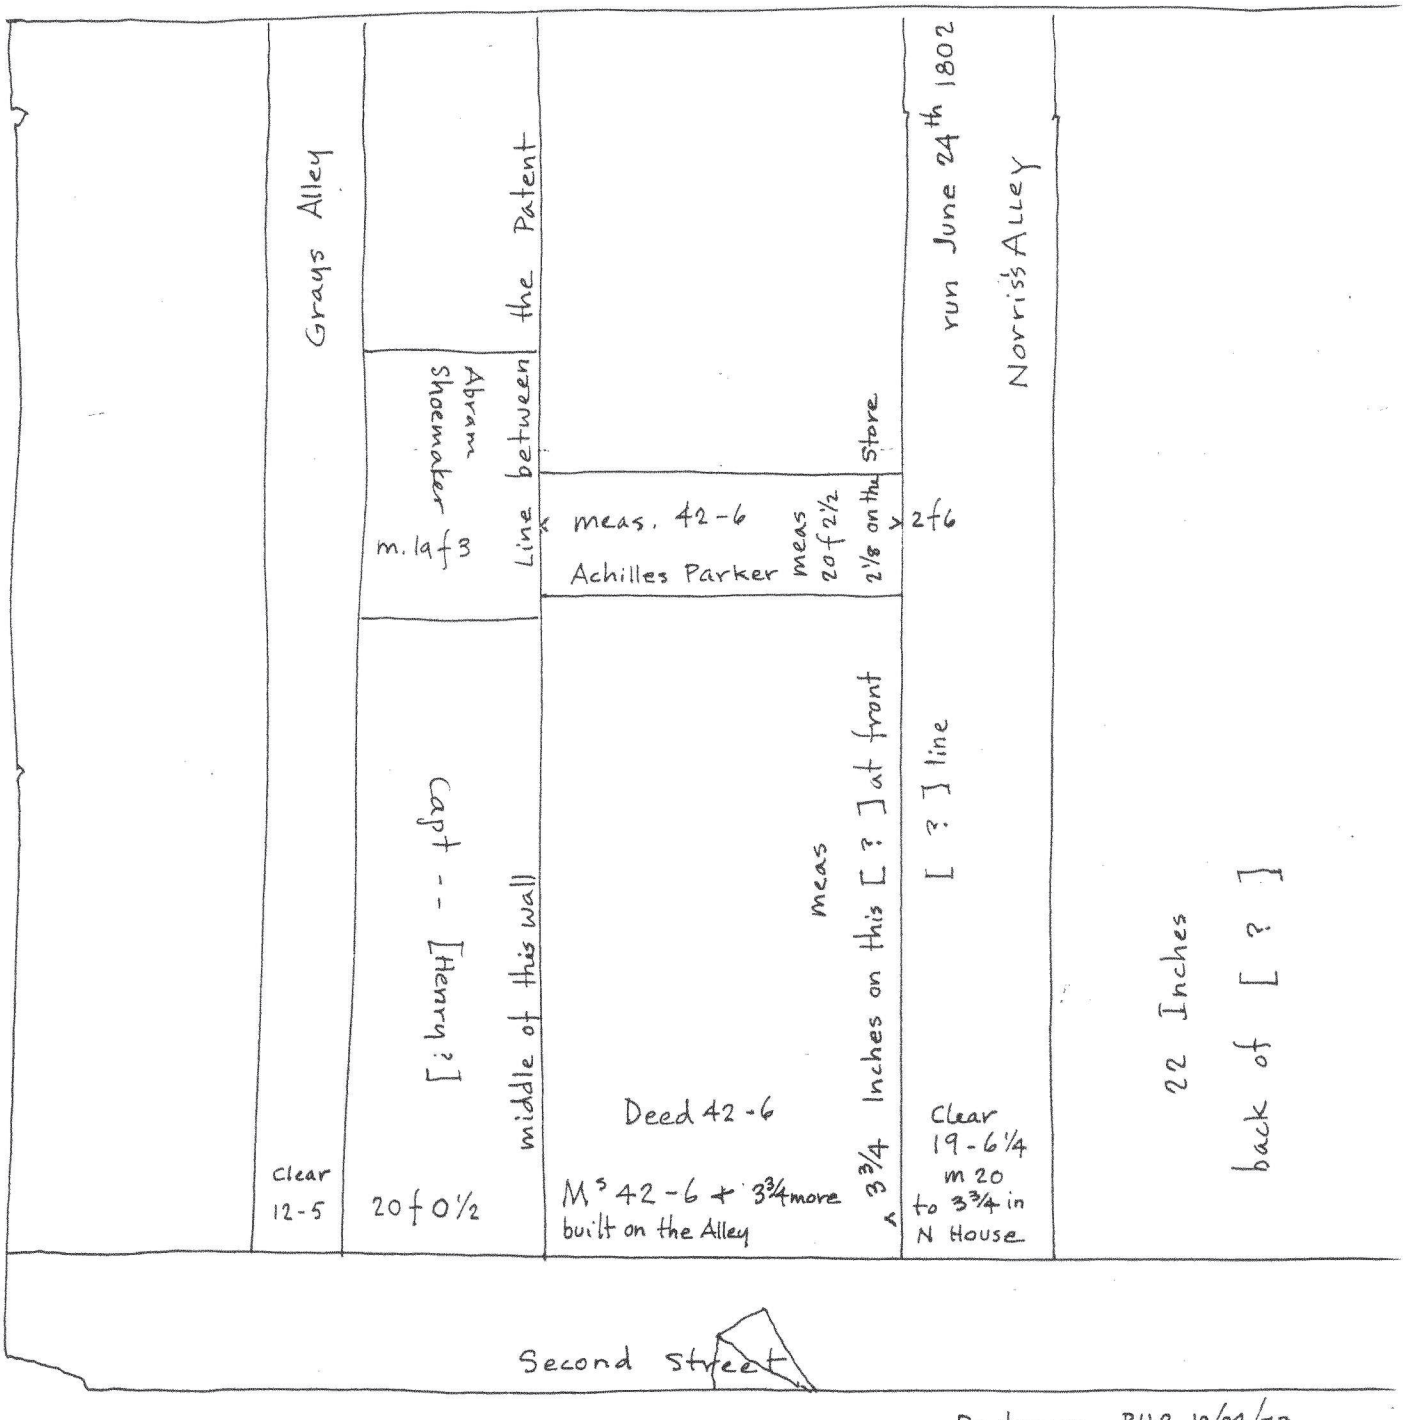
SIGNIFICANCE : SURVEY INDICATES THE BOND HOUSE WAS BUILT 3¾" ONTO THE PLANNED ALLEY RIGHT OF WAY.

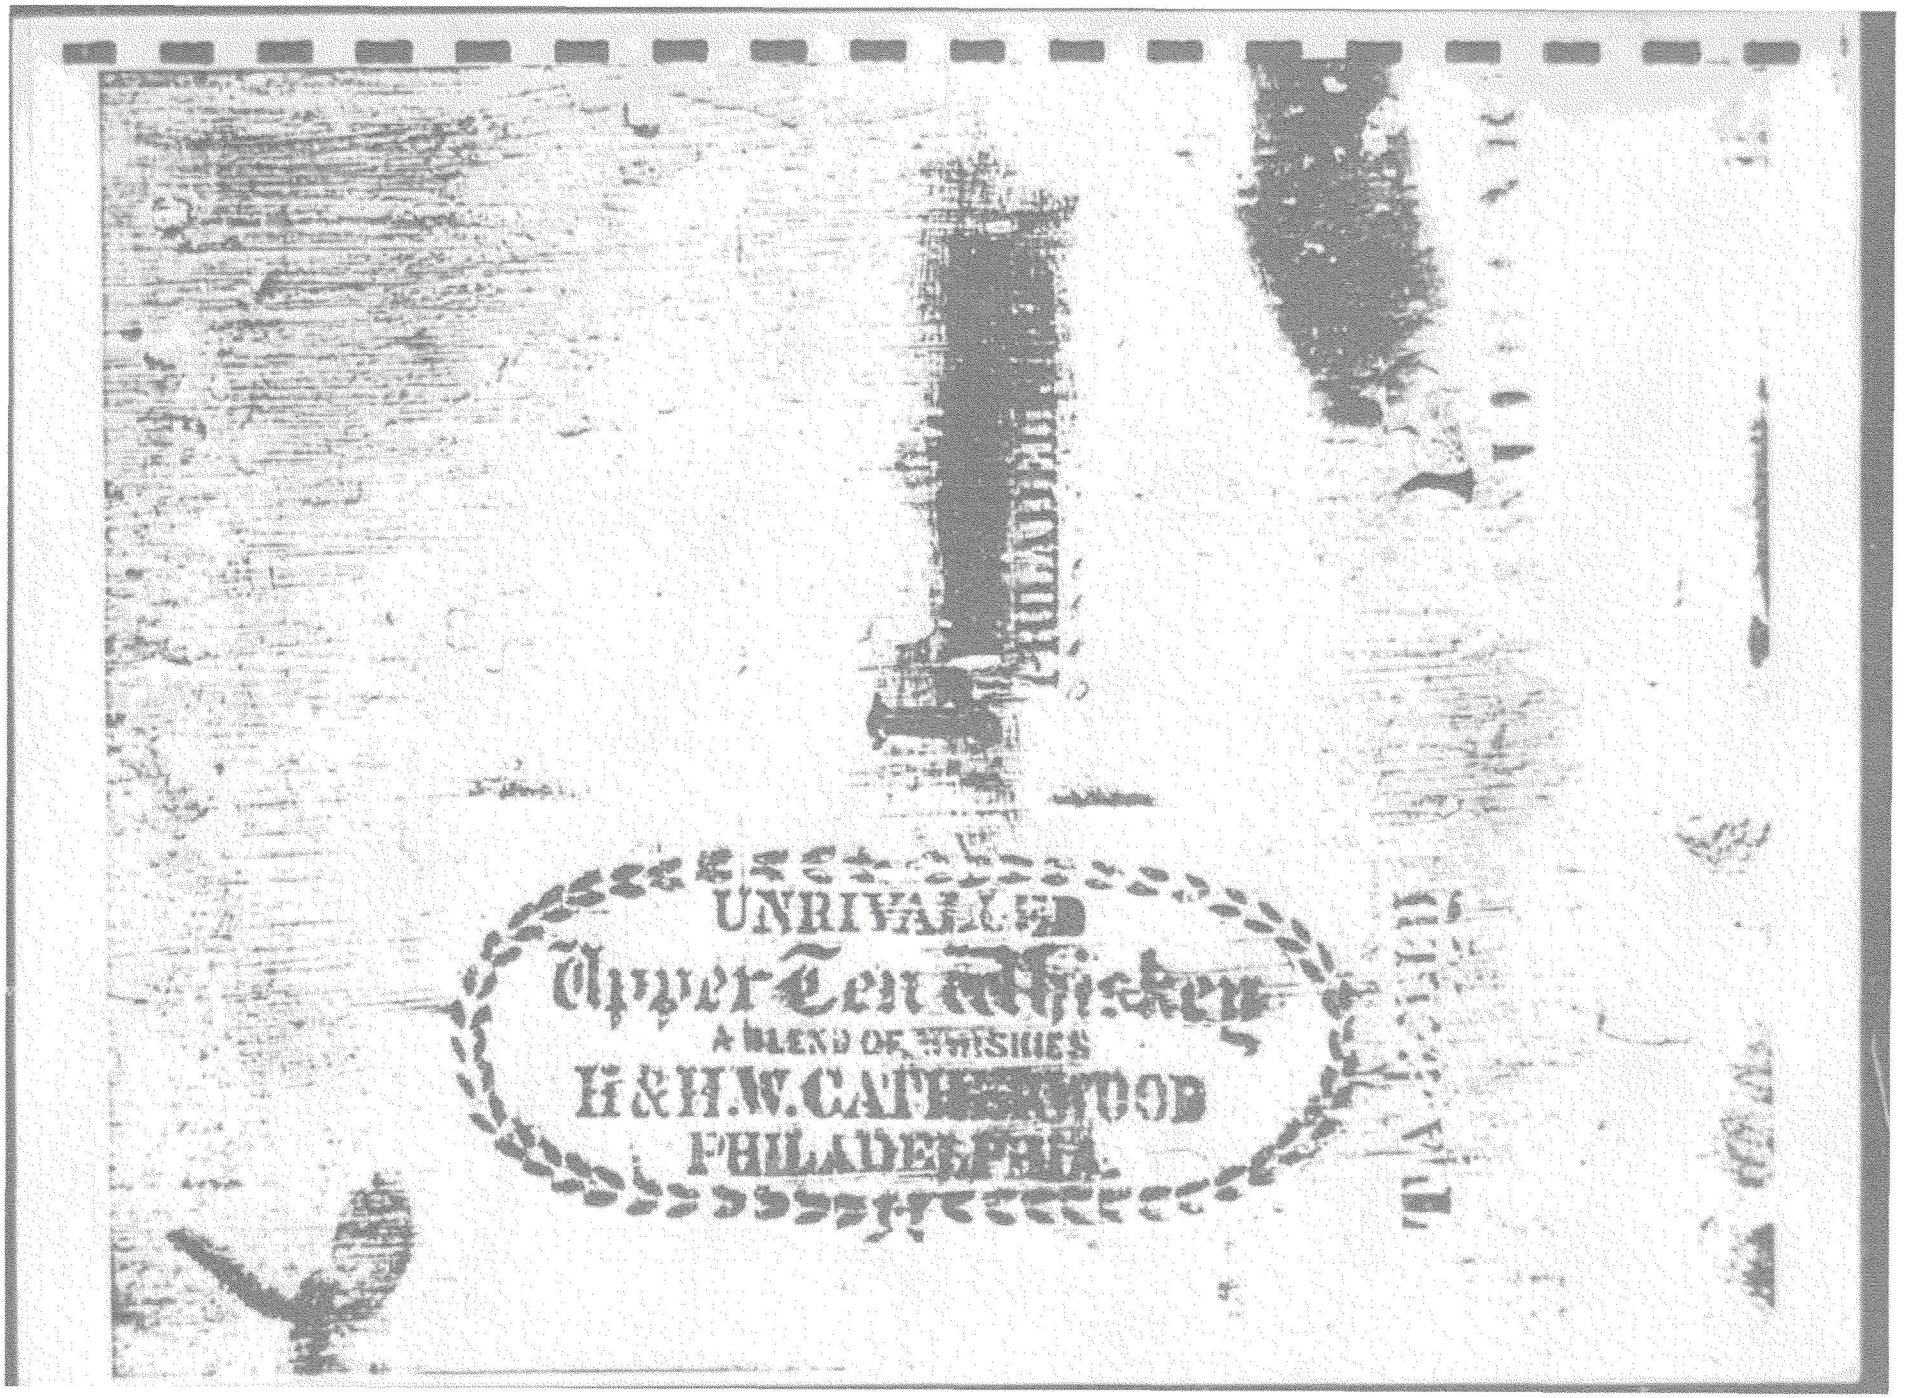
The stencil of the Hugh Catherwood liquor firm was found applied to the eroding paint on the plaster wall. It was not possible to preserve except by photography.

#114 S. Front Street, Philadelphia. Third floor front building, north wall. Photograph by George Eisenman, James L. Dillon & Co. Inc., September 21, 1977. Historic Structures negative #157.4343.

Stencil of the H & H. W. Catherwood liquor firm from sometime in the period of 1856-1892 when this firm occupied the building.
The original stencil size is 14 1/4" wide by 6" high (not including bow at bottom).

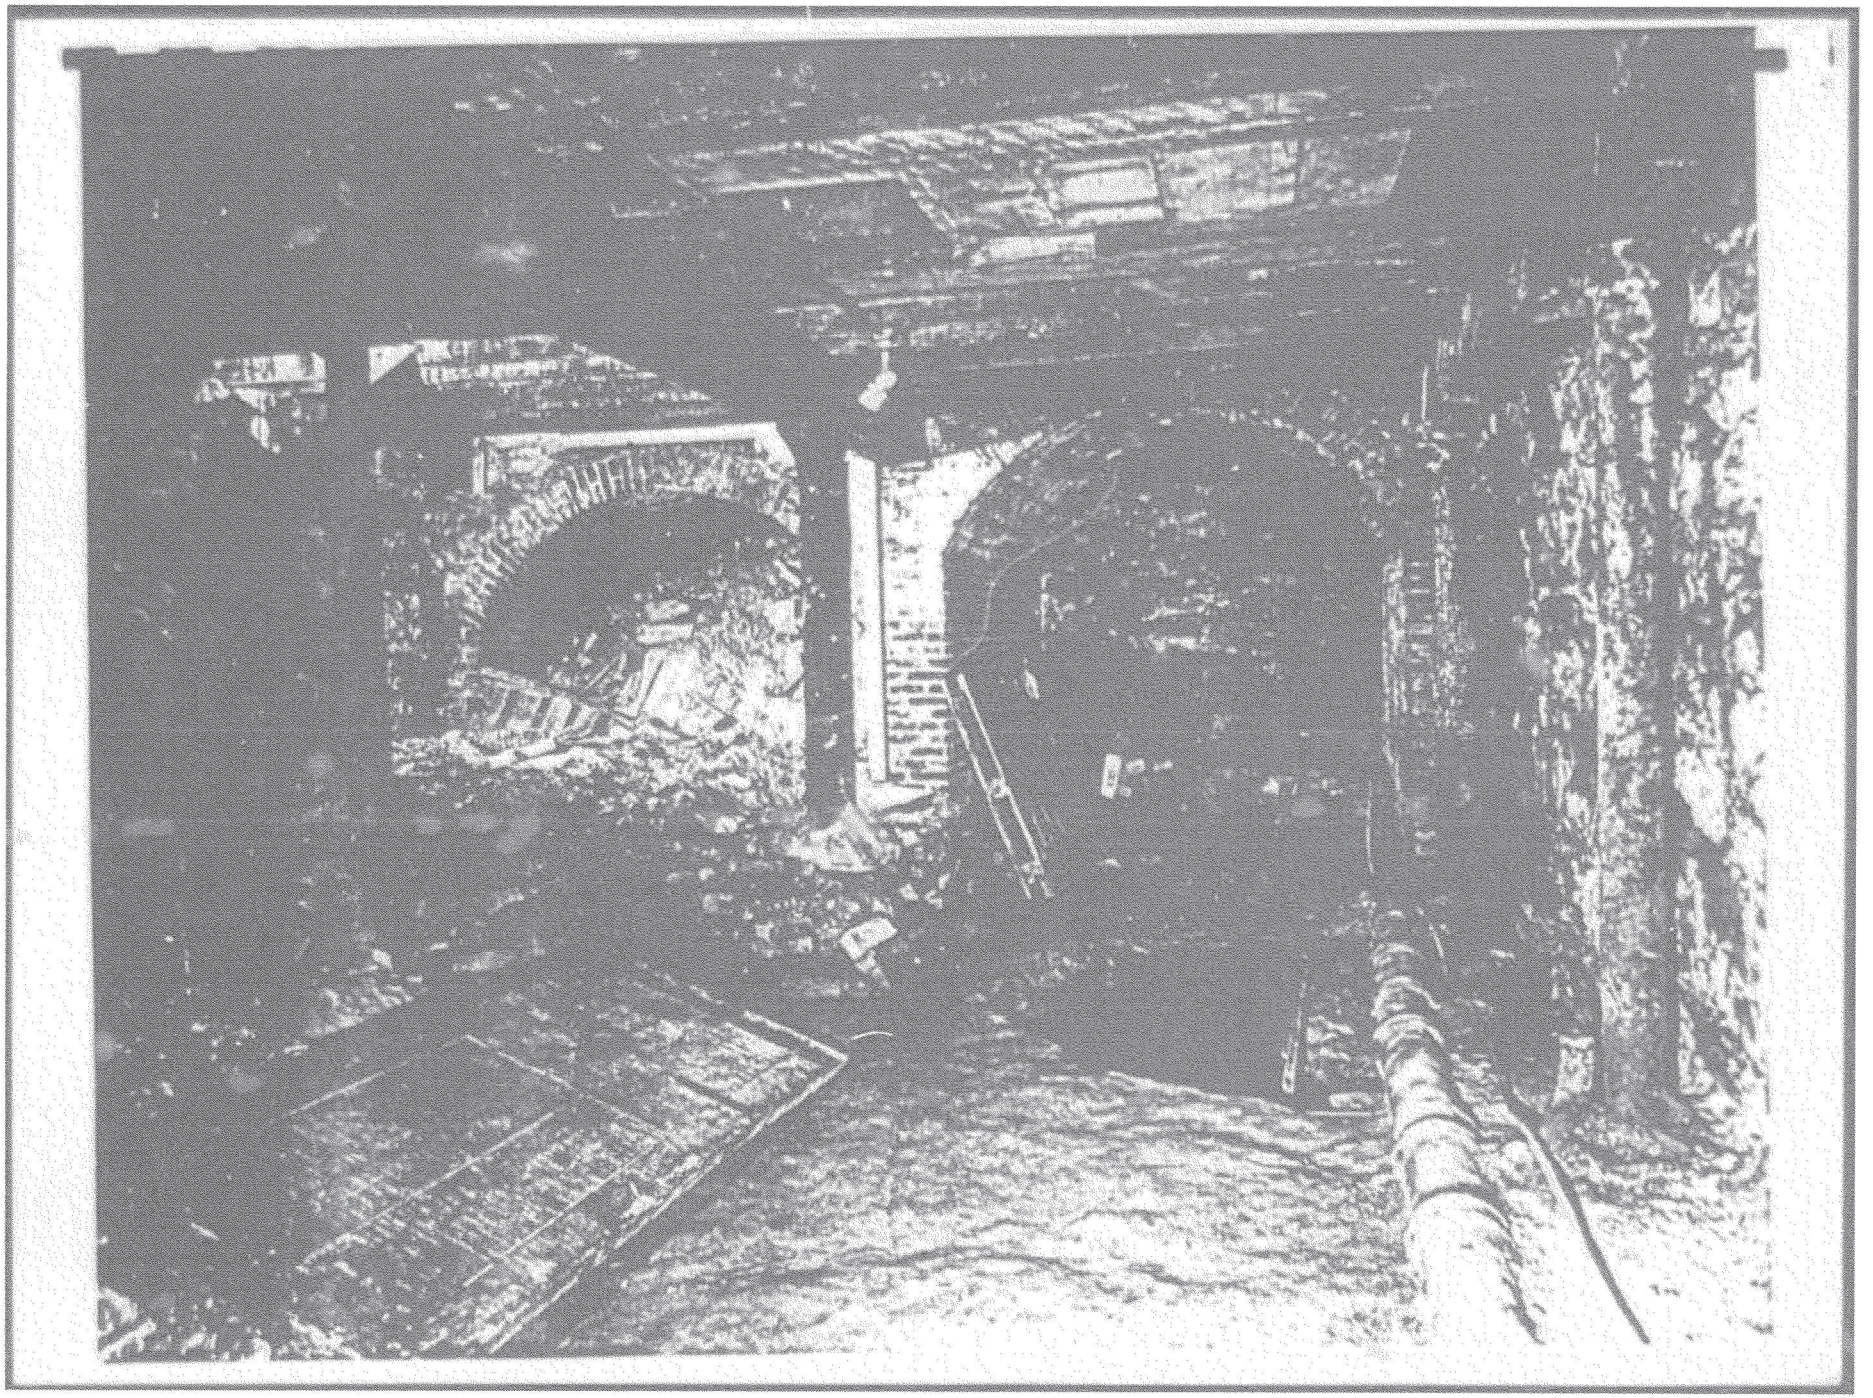
#114 South Front Street, Philadelphia, rear building cellar looking east. Photograph by Anthony S. Bley, Philadelphia, November 5, 1977. Historic Structures negative 157.4379.

The camera is stationed within an archeological feature which could have been a large brick and mortar lined ice pit. In the far face a lead pipe drain can be seen near the floor level and extending eastward. This pipe may have drained melted ice water into a brick rectangular sub cellar where it would have helped to keep food cool. These features probably related to the 1792 house built on this site by Robert Smith.

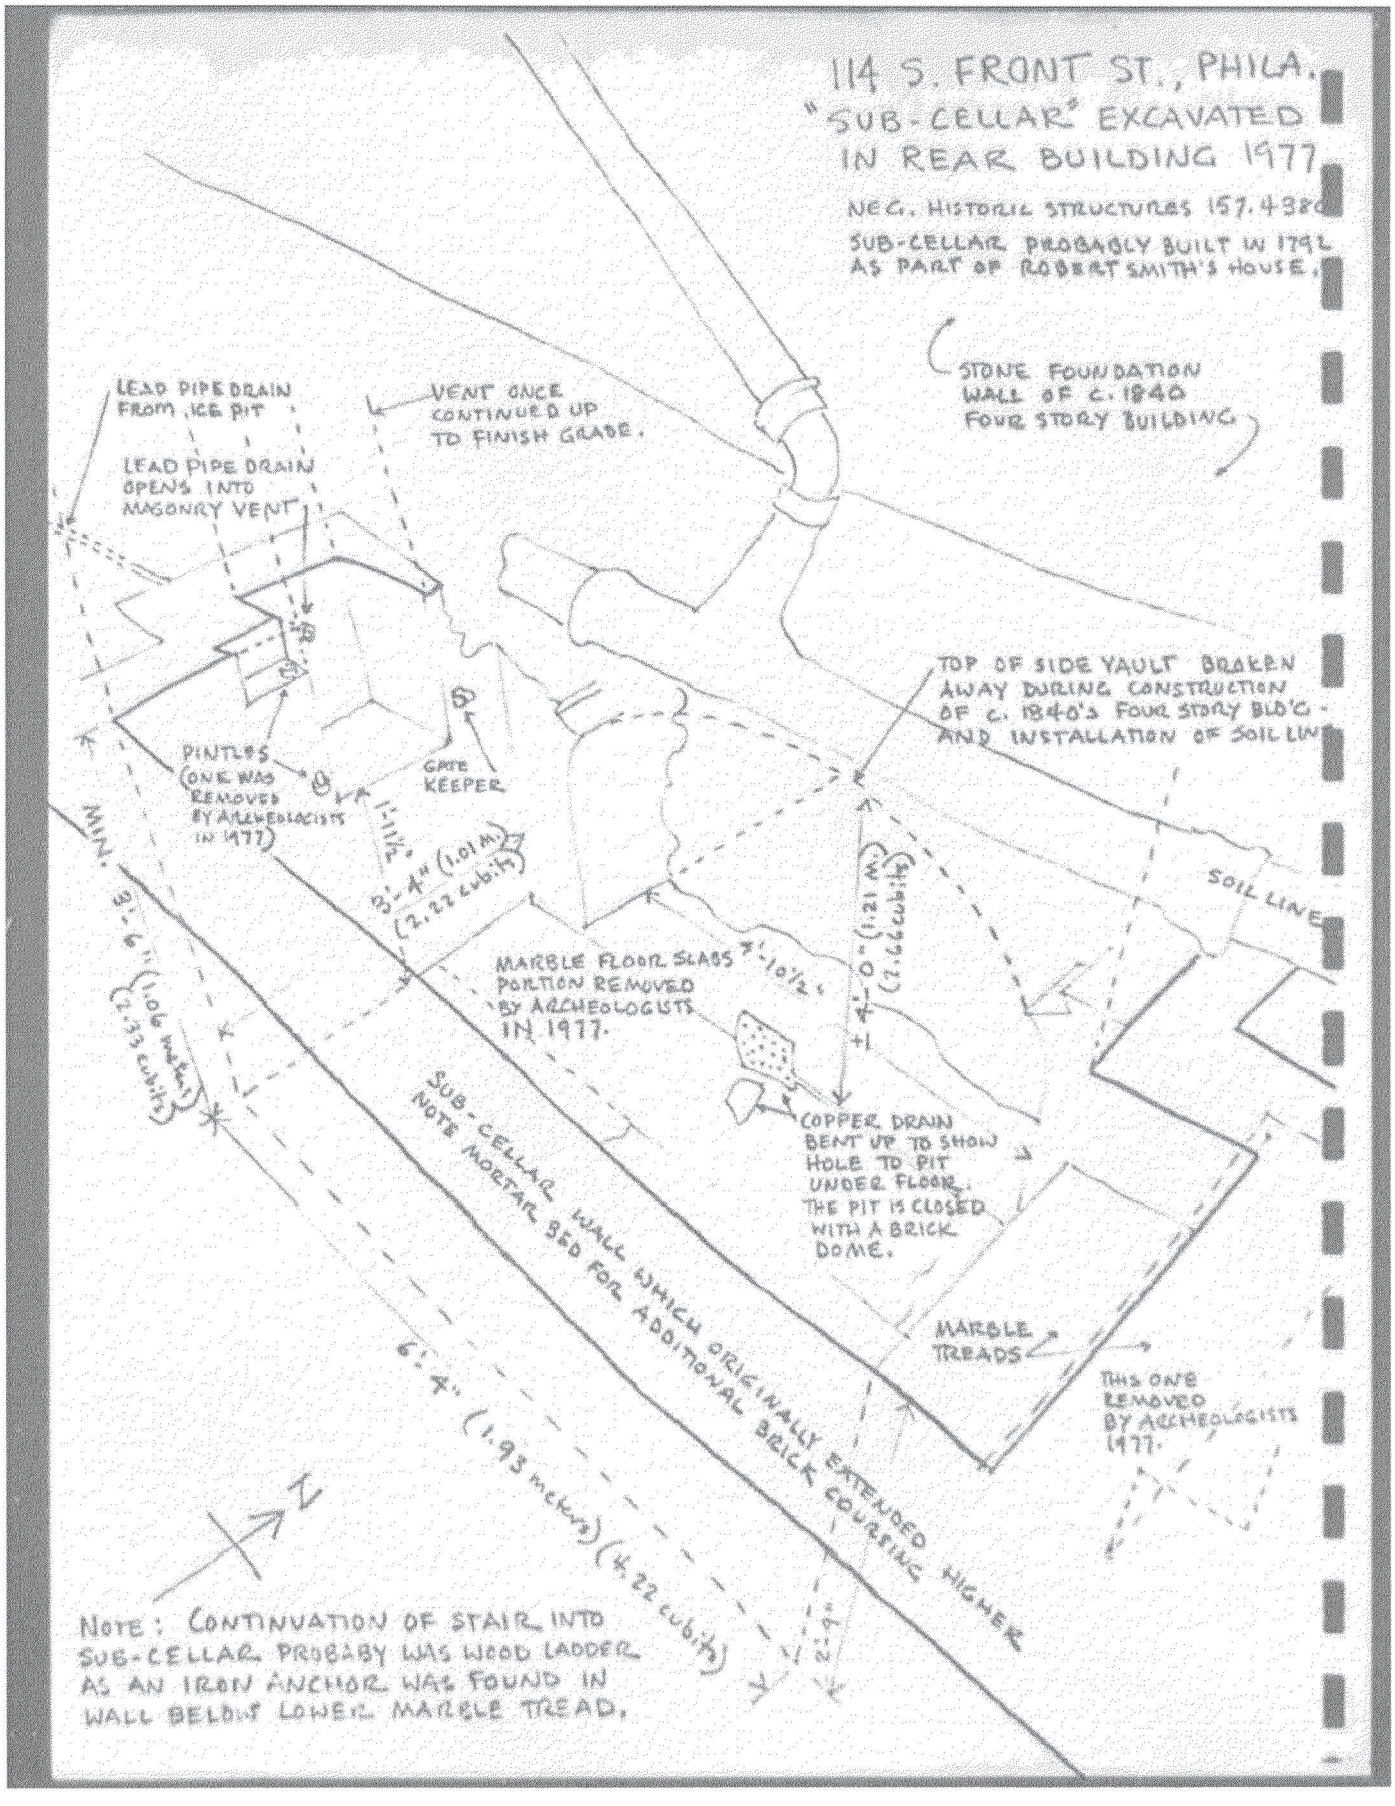
114 S. FRONT ST., PHILA.
"SUB-CELLAR" EXCAVATED IN REAR BUILDING 1977
NEG. HISTORIC STRUCTURES 157.4380
SUB-CELLAR PROBABLY BUILT IN 1792 AS PART OF ROBERT SMITH'S HOUSE.
STONE FOUNDATION WALL OF c. 1840 FOUR STORY BUILDING.
LEAD PIPE DRAIN FROM ICE PIT
LEAD PIPE DRAIN OPENS INTO MASONRY VENT
VENT ONCE CONTINUED UP TO FINISH GRADE.
TOP OF SIDE VAULT BROKEN AWAY DURING CONSTRUCTION OF c. 1840's FOUR STORY BLD'G. AND INSTALLATION OF SOIL LINE
PINTLES (ONE WAS REMOVED BY ARCHEOLOGISTS IN 1977)
GATE KEEPER
SOIL LINE
MARBLE FLOOR SLABS PORTION REMOVED BY ARCHEOLOGISTS IN 1977.
COPPER DRAIN BENT UP TO SHOW HOLE TO PIT UNDER FLOOR. THE PIT IS CLOSED WITH A BRICK DOME.
SUB-CELLAR WALL WHICH ORIGINALLY EXTENDED HIGHER NOTE MORTAR BED FOR ADDITIONAL BRICK COURSING
MARBLE TREADS
THIS ONE REMOVED BY ARCHEOLOGISTS 1977.
N
NOTE: CONTINUATION OF STAIR INTO SUB-CELLAR PROBABLY WAS WOOD LADDER AS AN IRON ANCHOR WAS FOUND IN WALL BELOW LOWER MARBLE TREAD.
