HISTORIC STRUCTURES REPORT

AREA F

ARCHITECTURAL DATA SECTION

INDEPENDENCE NATIONAL HISTORICAL PARK

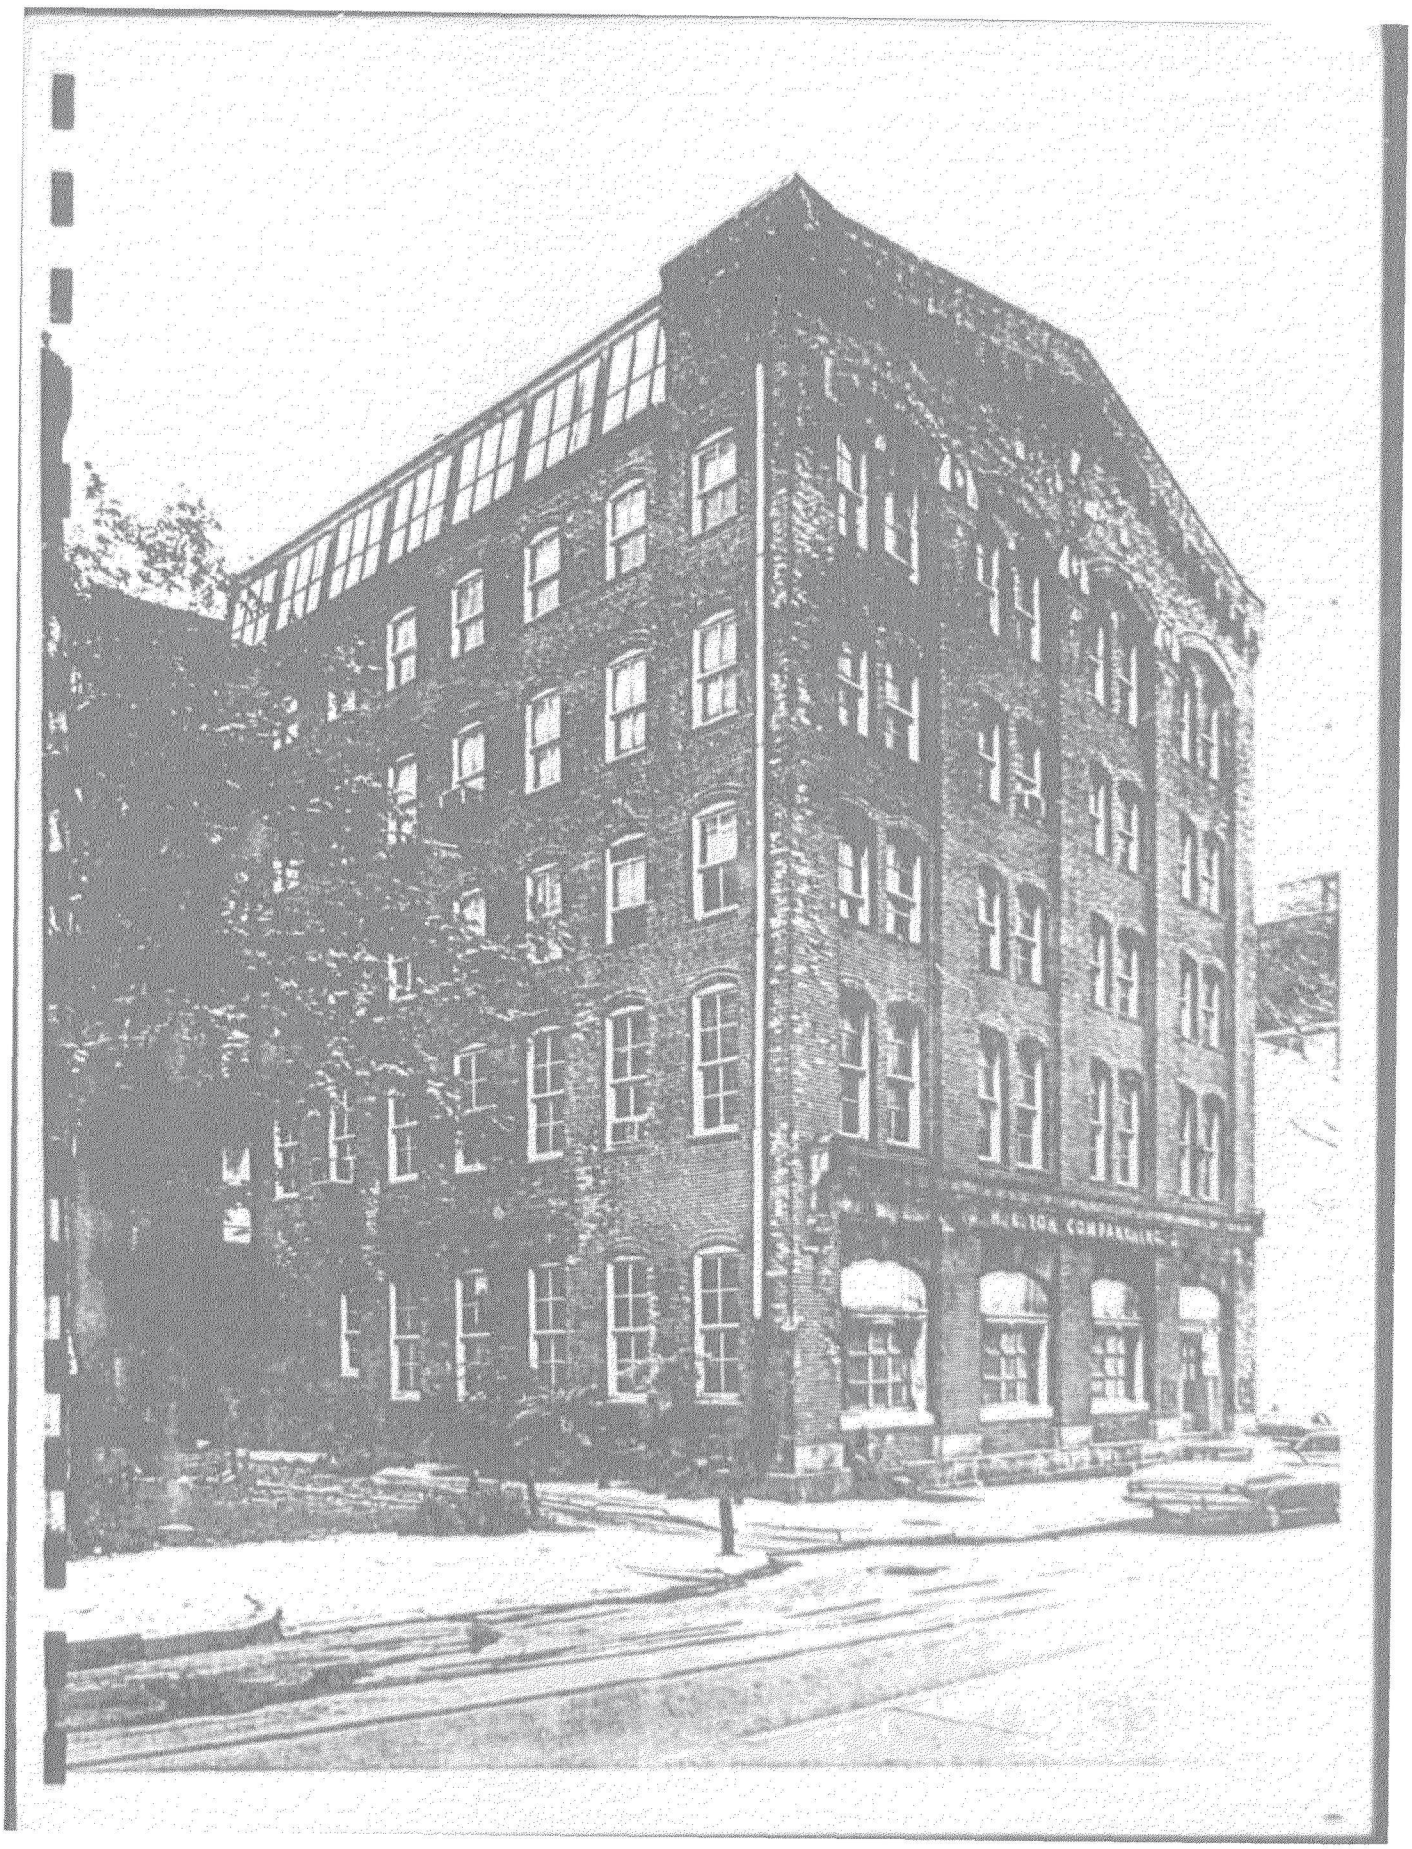
This view looks north across the middle of "Area F" and includes the 19th - 20th century warehouses demolished in January, 1978 by the National Park Service to make way for the projected visitor parking garage. Photograph by George Eisenman of James L. Dillon and Co., Inc., October 25, 1977. Historic Structures negative 157.4357.

The structural systems help to date these buildings. 103 Gatzmer probably was built c.1895, 105-107 Gatzmer c.1900, and 123 South Second Street c.1905-8.

The buildings were demolished in January, 1978.

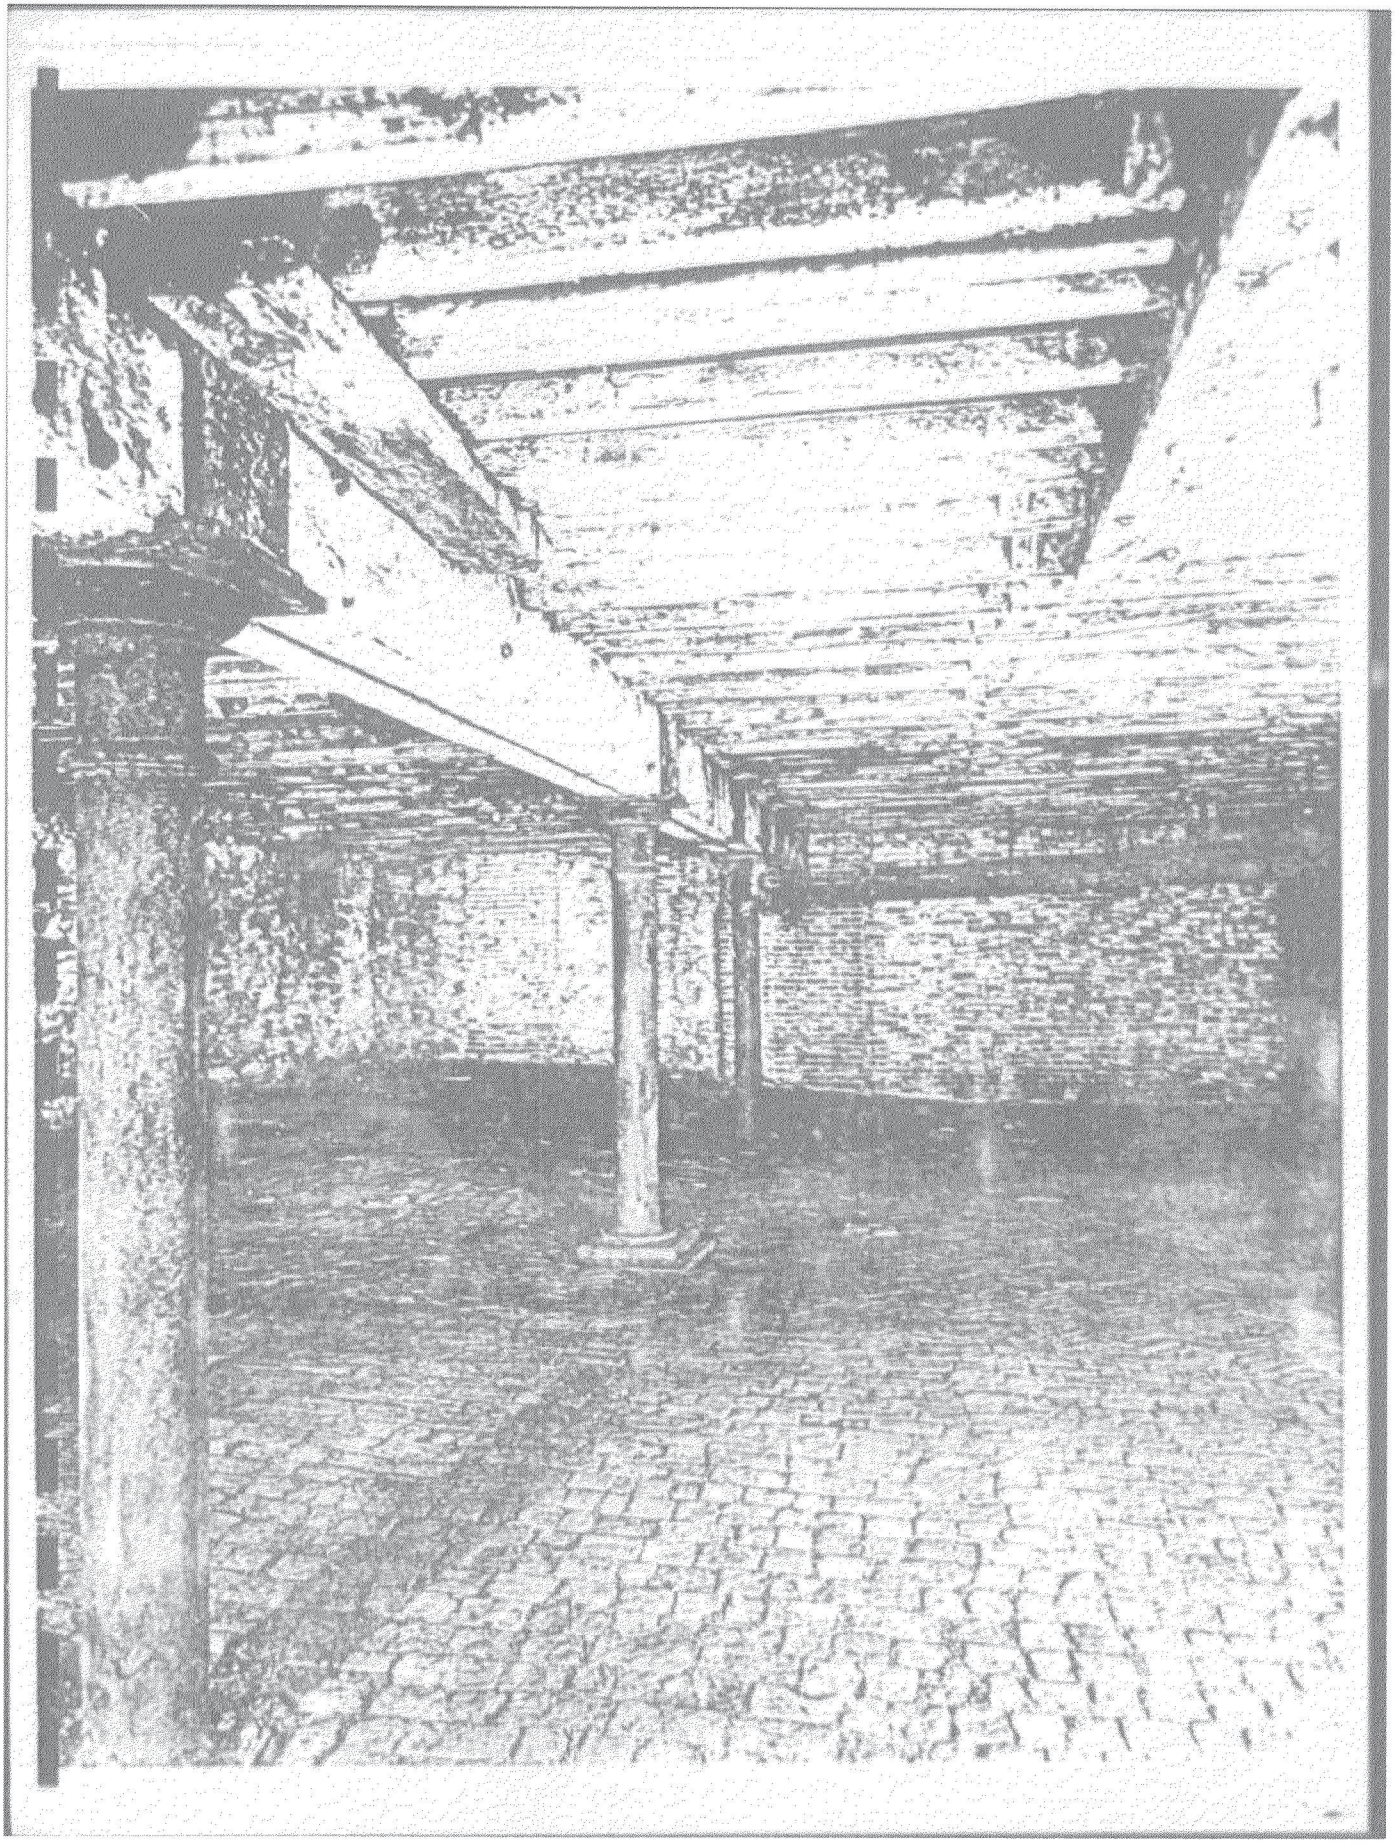
#105 Gatzmer Street, Philadelphia, Fourth Floor, looking southwest. Photograph by Anthony S. Bley, Philadelphia, October 4, 1977. Historic Structures negative 157.4369.

This structure, used as a wool warehouse, was built around 1900. Note its plank floor construction, with built-up girders which seat on cast iron capitals and champfered wood columns. Note also that the columns from the floor above extend down thru the floor to also seat on the cast iron capitals and the wood columns below. The lower floors utilized cast iron pipe columns. At the far wall the plank flooring seats directly on a brick ledge corbeled out from the normal wall thickness.

This building was demolished in January 1978.

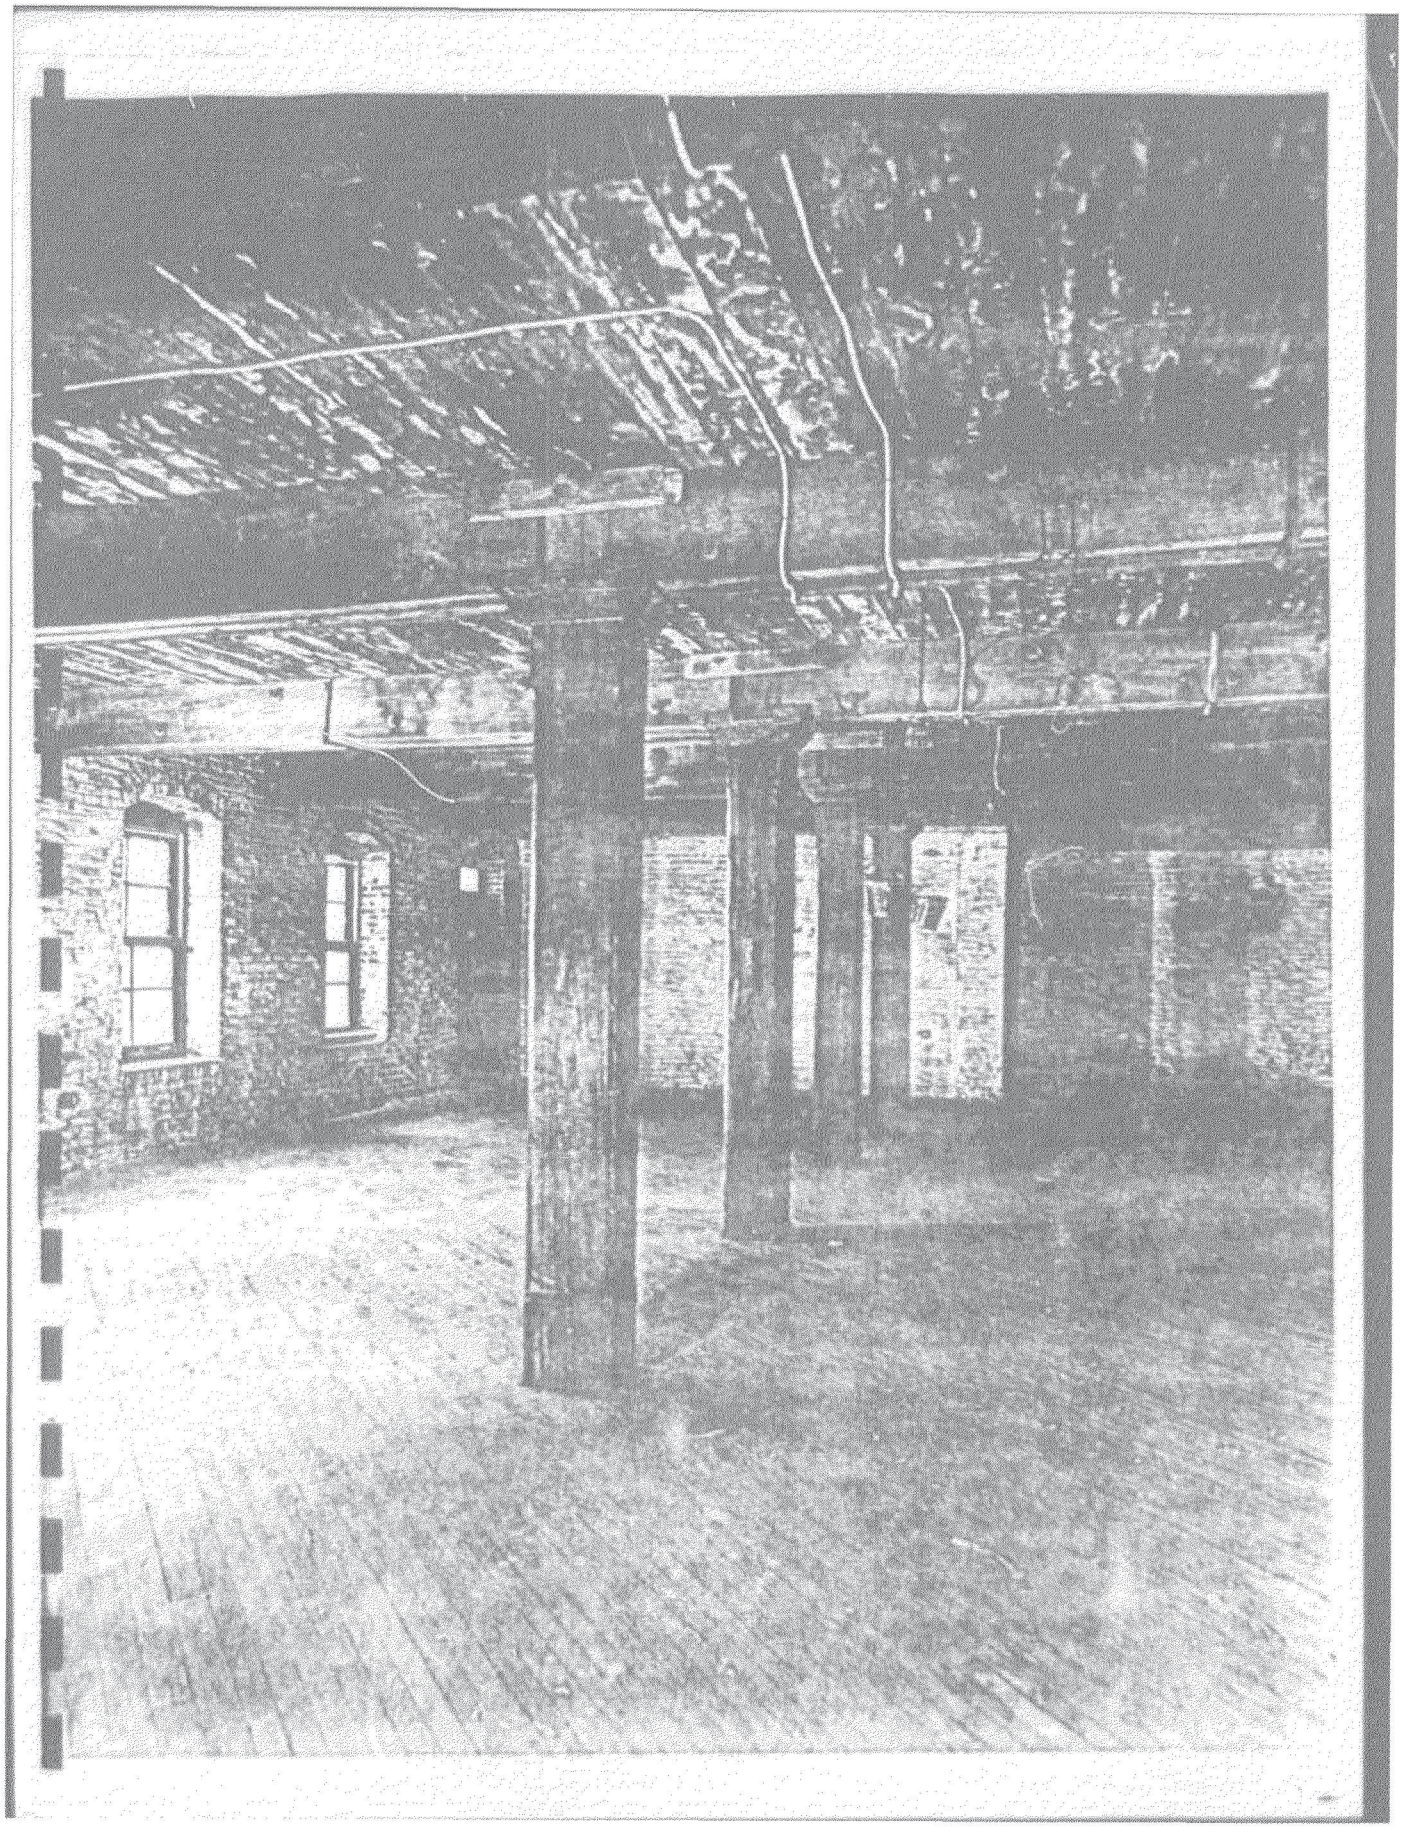
117-119 South Second Street, Philadelphia.

Cellar looking west. Photograph by Anthony S. Riley, Philadelphia, October 18, 1977. Historic Structures negative 157.4358.

Before this photograph was taken an archeological contract surveyed the basement floor area for possible features. None were found.

This building was probably built c.1905-1908. Note the construction system using plank-flooring, built-up girders, U-strap hangers, and poured concrete columns and caps. The building was demolished in January, 1978.
