Subject: Historic Structures Report, Part II, on Old City Hall

The Historic Structures Report, Part II, Congress Hall, Independence National Historical Park has been reviewed by the interested Divisions in the Washington Office and is recommended for approval.

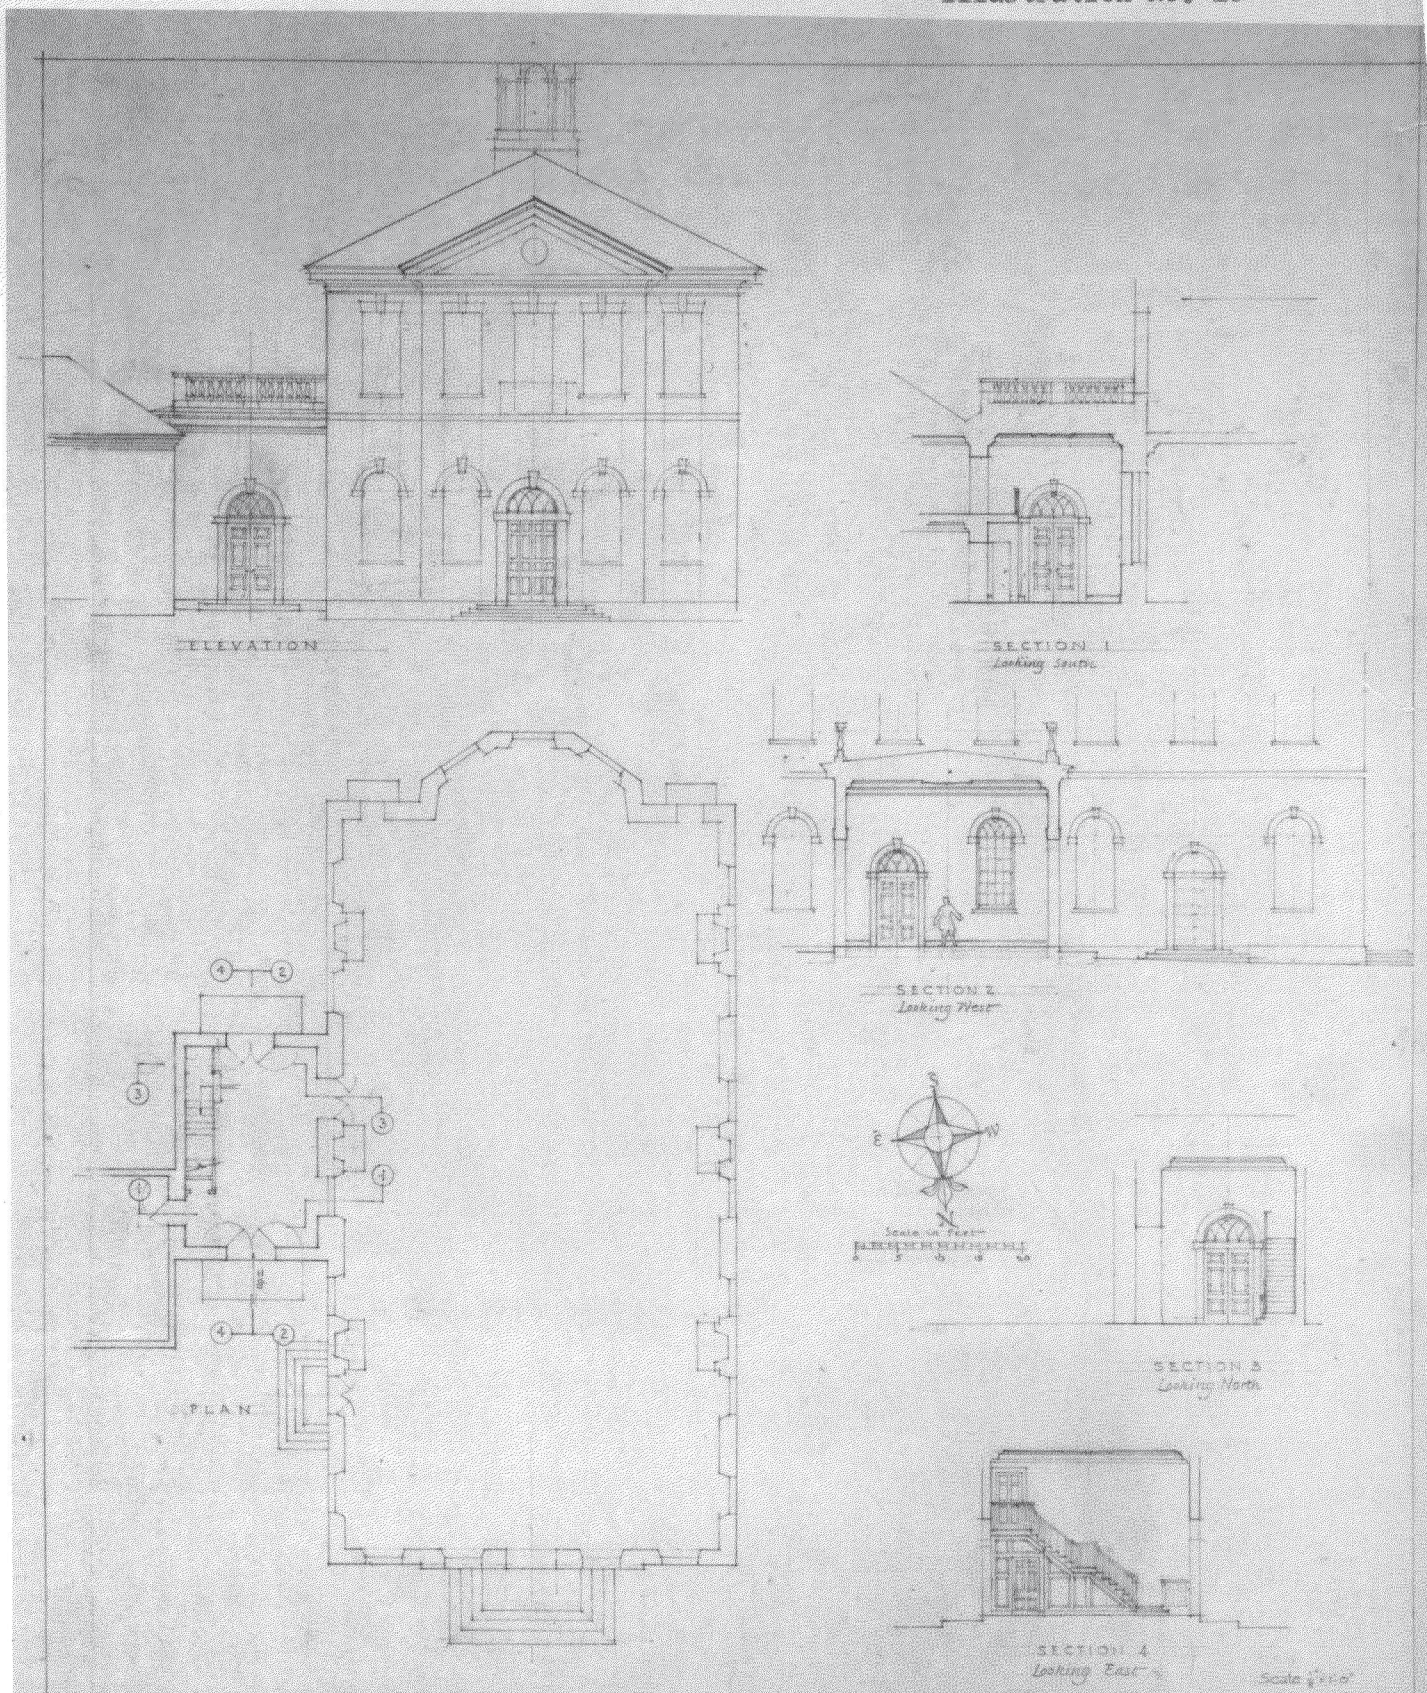
Photograph of Congress Hall facade taken immediately after cleaning of stonework in 1913. Note high relief and sharpness of detail. In the forty-six years since this photograph was taken, the seal has lost both of these characteristics.

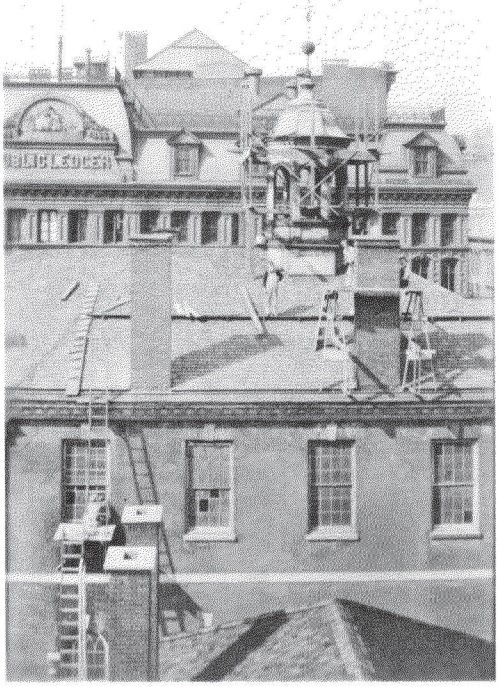
INHP Negative No. 3681

East facade of Congress Hall during the Restoration of 1912. Note sag in the roof at left due to the failing roof truss in the 1793 extension.

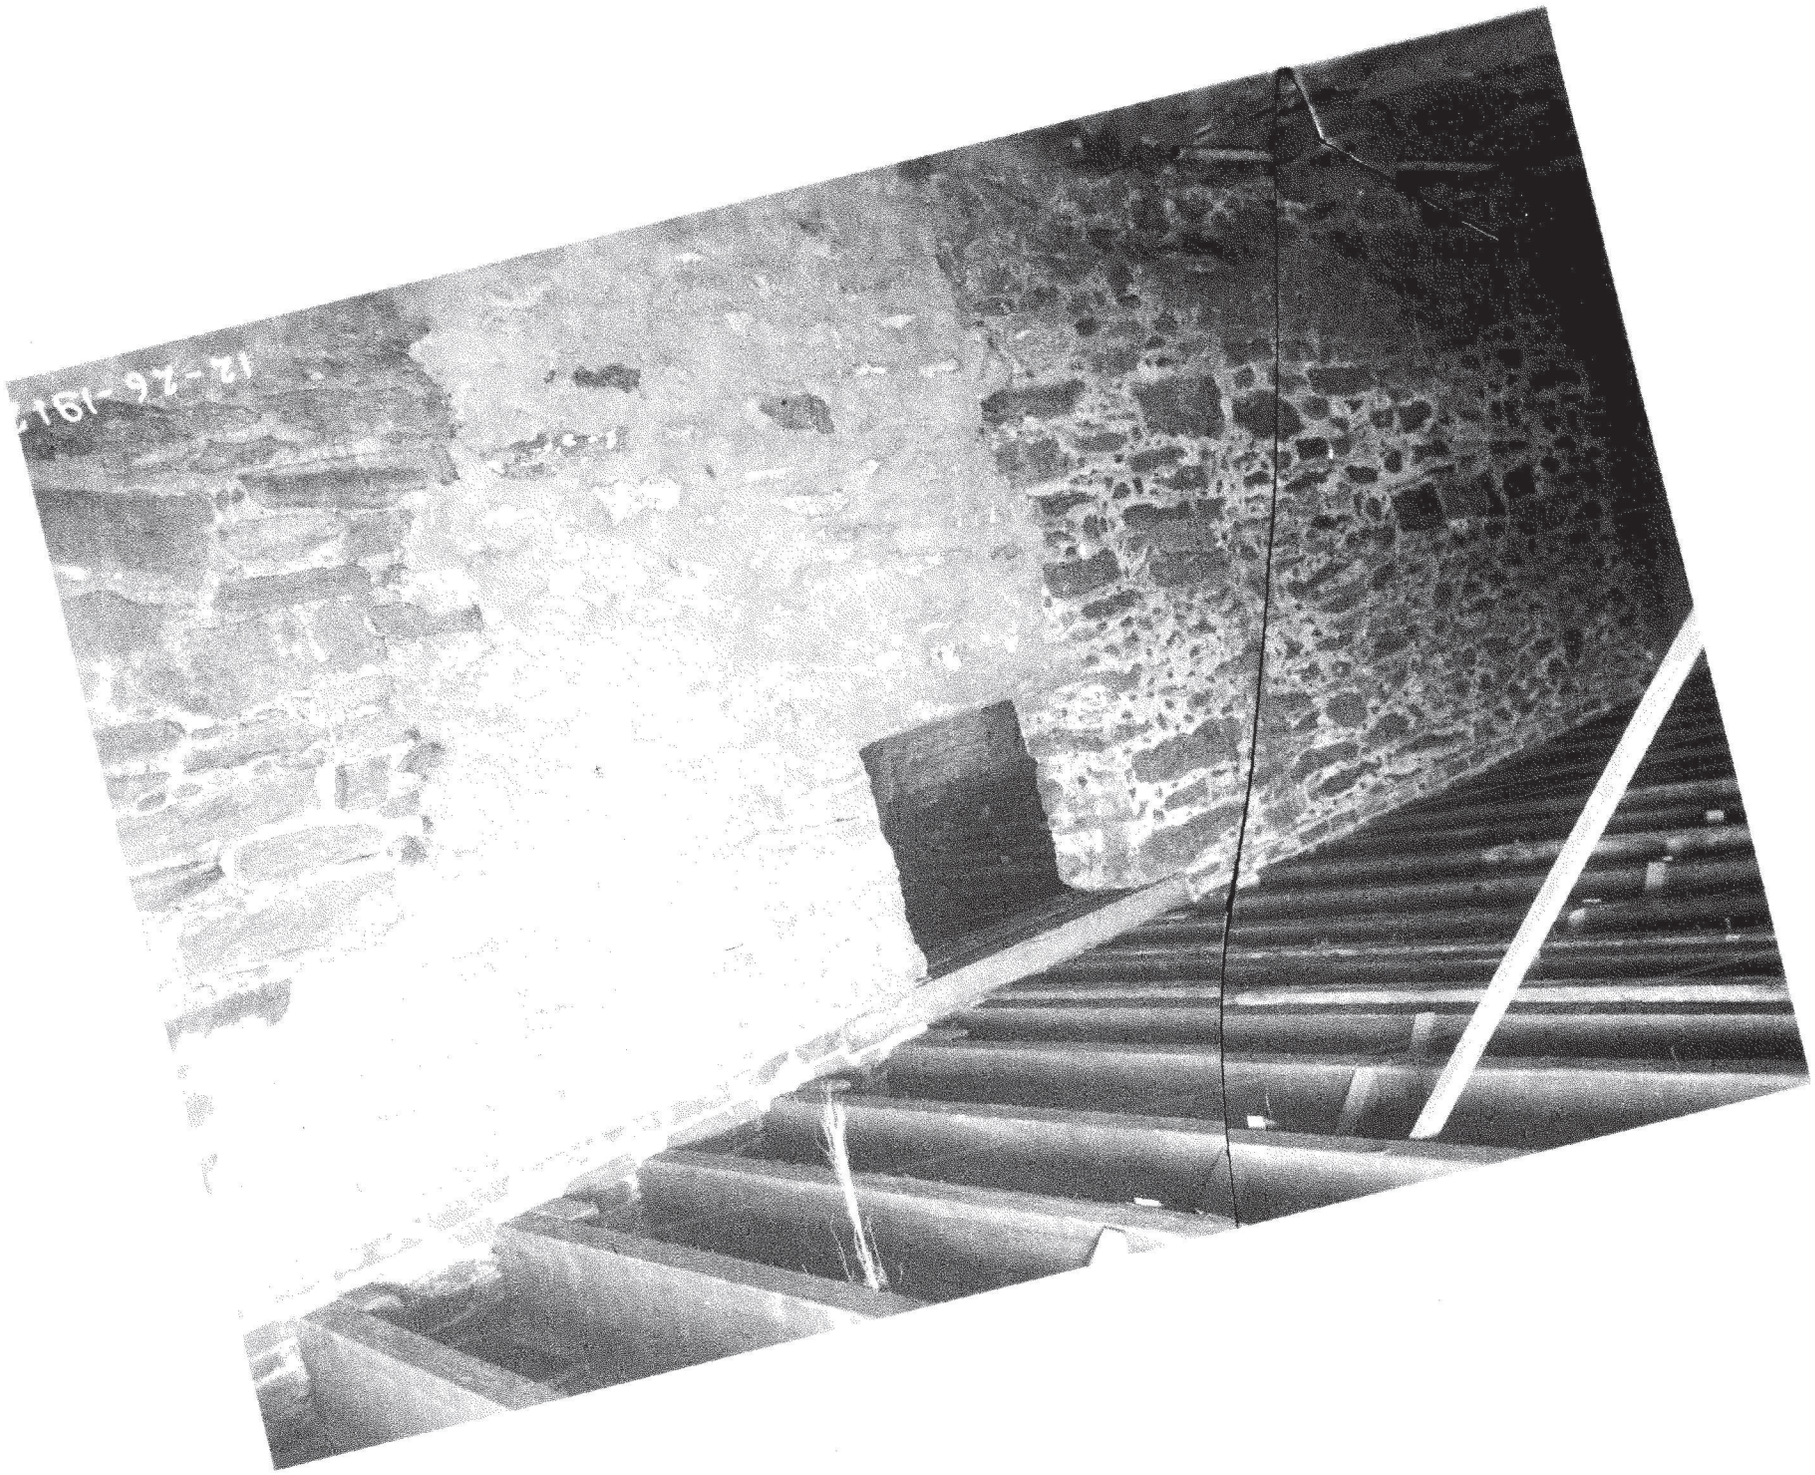
INHP Negative No. CN-6081

Congress Hall Basement walls. Note original stonework with small stones inserted in mortar joints; i. e., galleted.

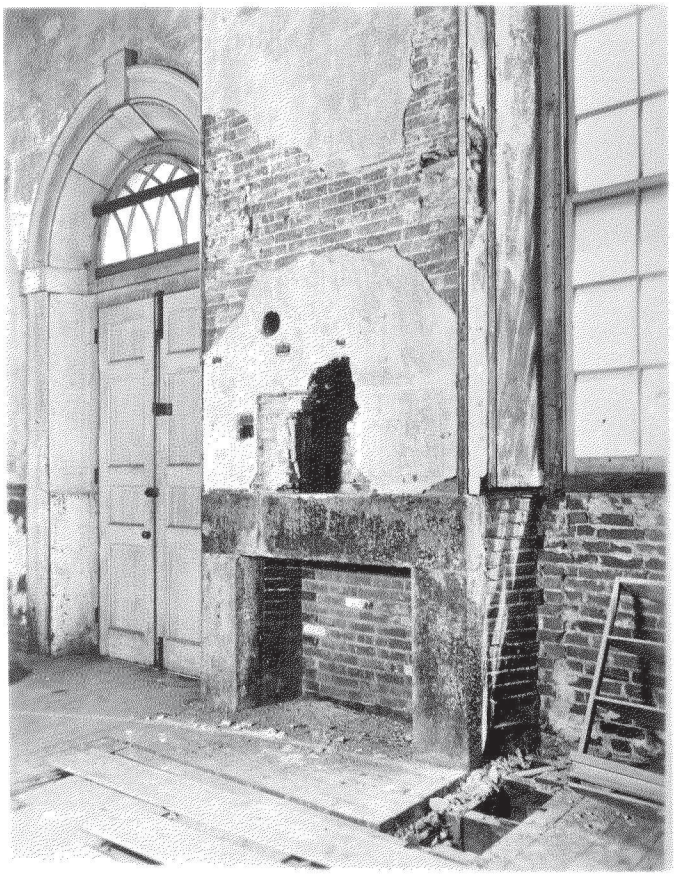
INHP Negative No. 3689

Congress Hall, House of Representatives, northeast fireplace during architectural investigation for the 1912 Restoration. Note structural stone jambs and lintel, "clean-out" hole, and evidence above of original gallery.

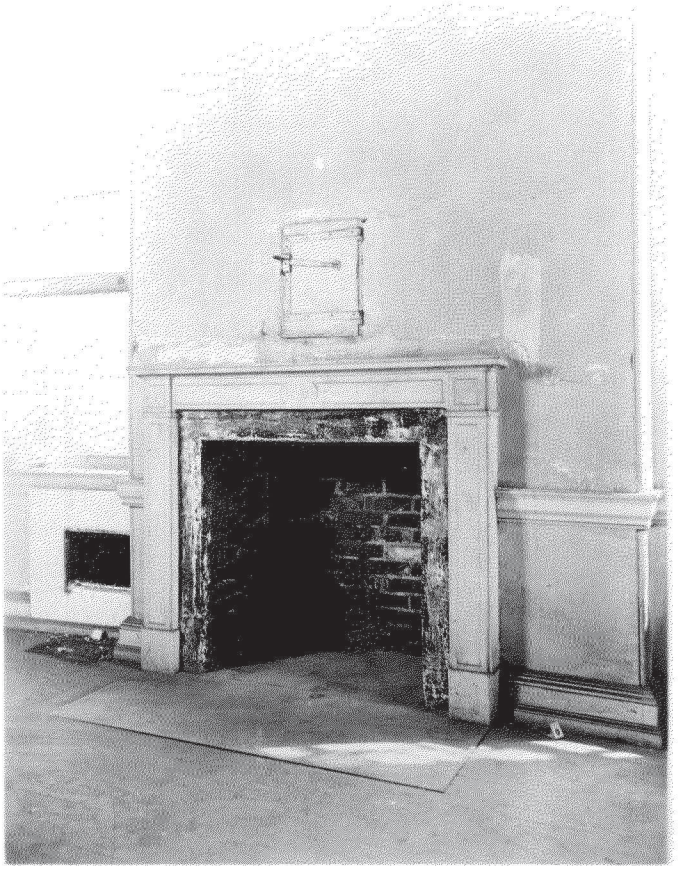
INHP Negative No. 3692

Congress Hall, Senate Chamber, east fireplace, showing one of two white marble mantelpieces removed in the 1912 Restoration but now believed to be original.

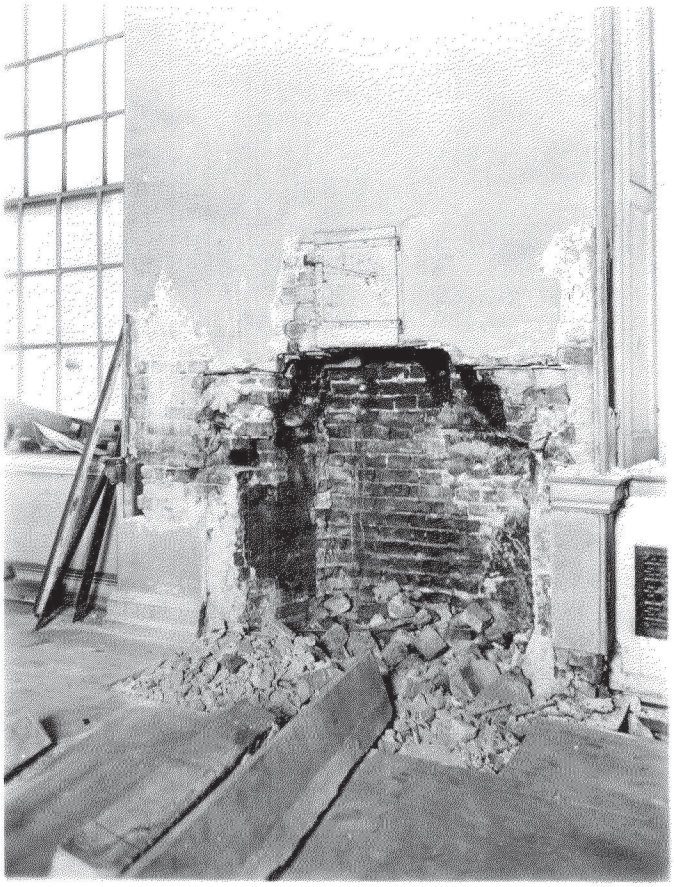
INHP Negative No. 3693

Congress Hall, Senate Chamber, west fireplace after the removal of the marble mantelpiece and during the architectural investigation. See SECTION II (C-10, H-3, and K-2) for discussions of the evidence found.

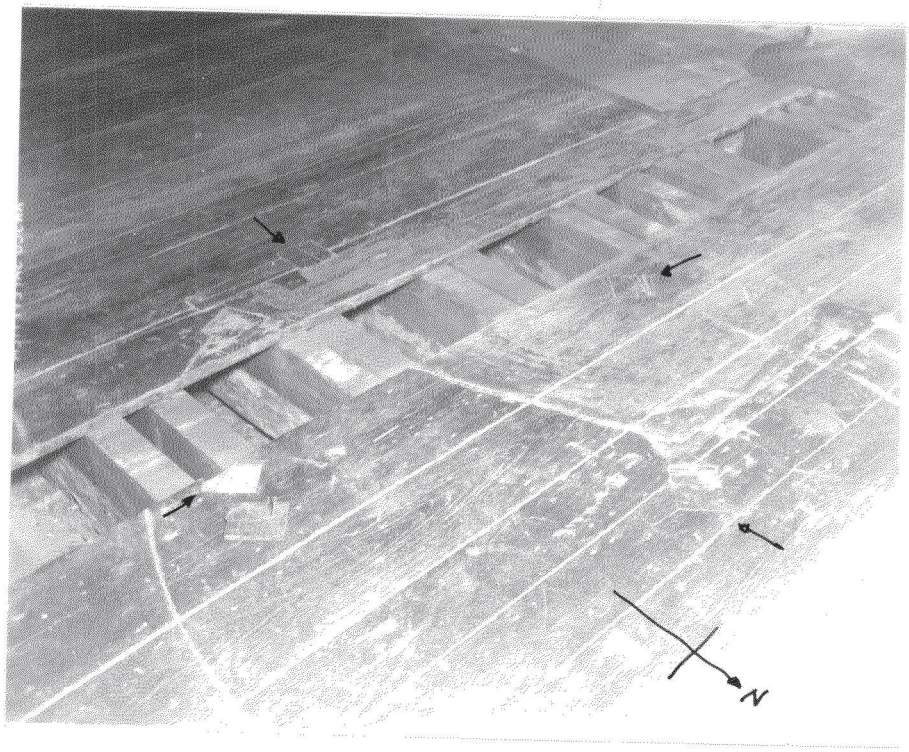
INHP Negative No. 6288

Congress Hall, House of Representatives, area of original flooring showing mortise holes, which may have been used with the original speaker's platform. The other outline on the floor shows the position of the twentieth-century restored platform.

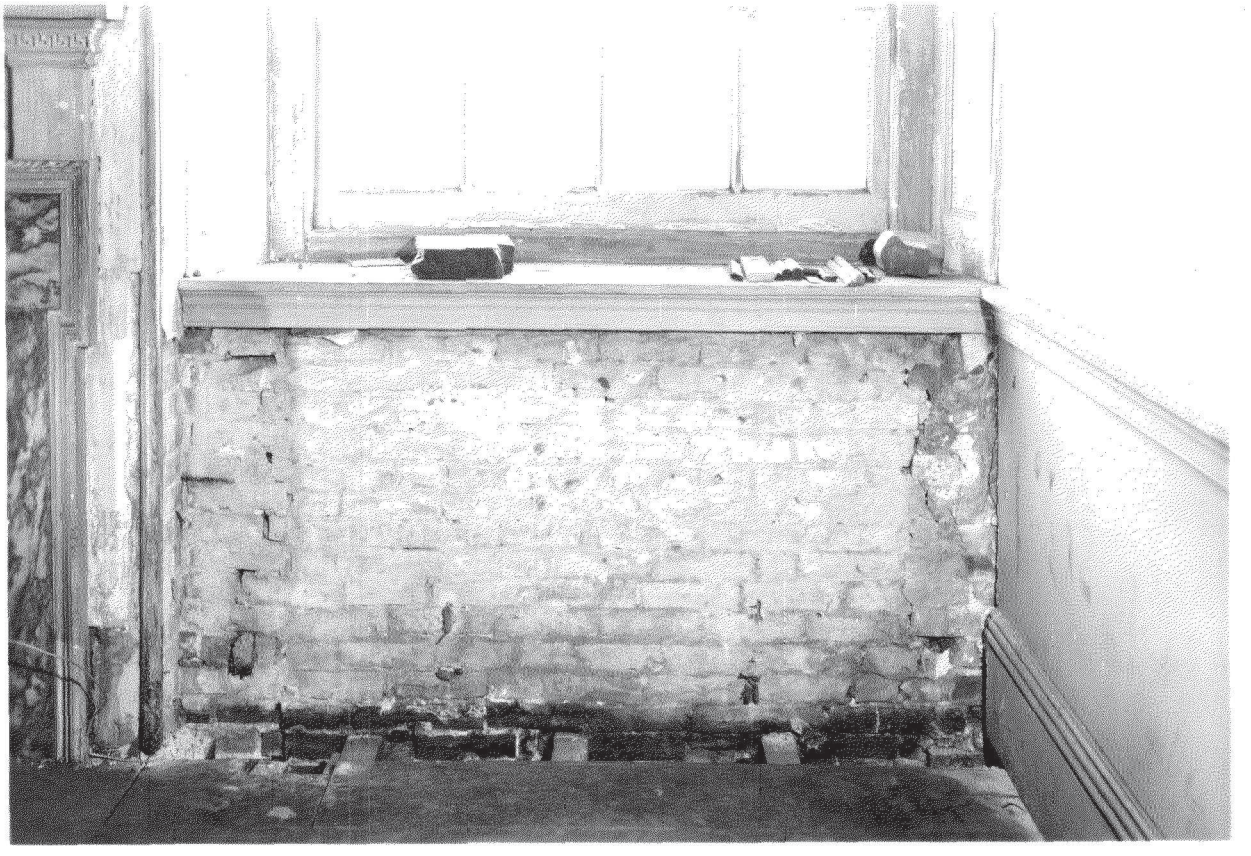
Ph: Jack E. Boucher, March 1960
EODC Negative No. 785

Congress Hall, second floor, east middle room, window to the south of the fireplace. Note vertical joints in brickwork showing that this opening was once used as a door. See SECTION II, C-9, "The Portico."

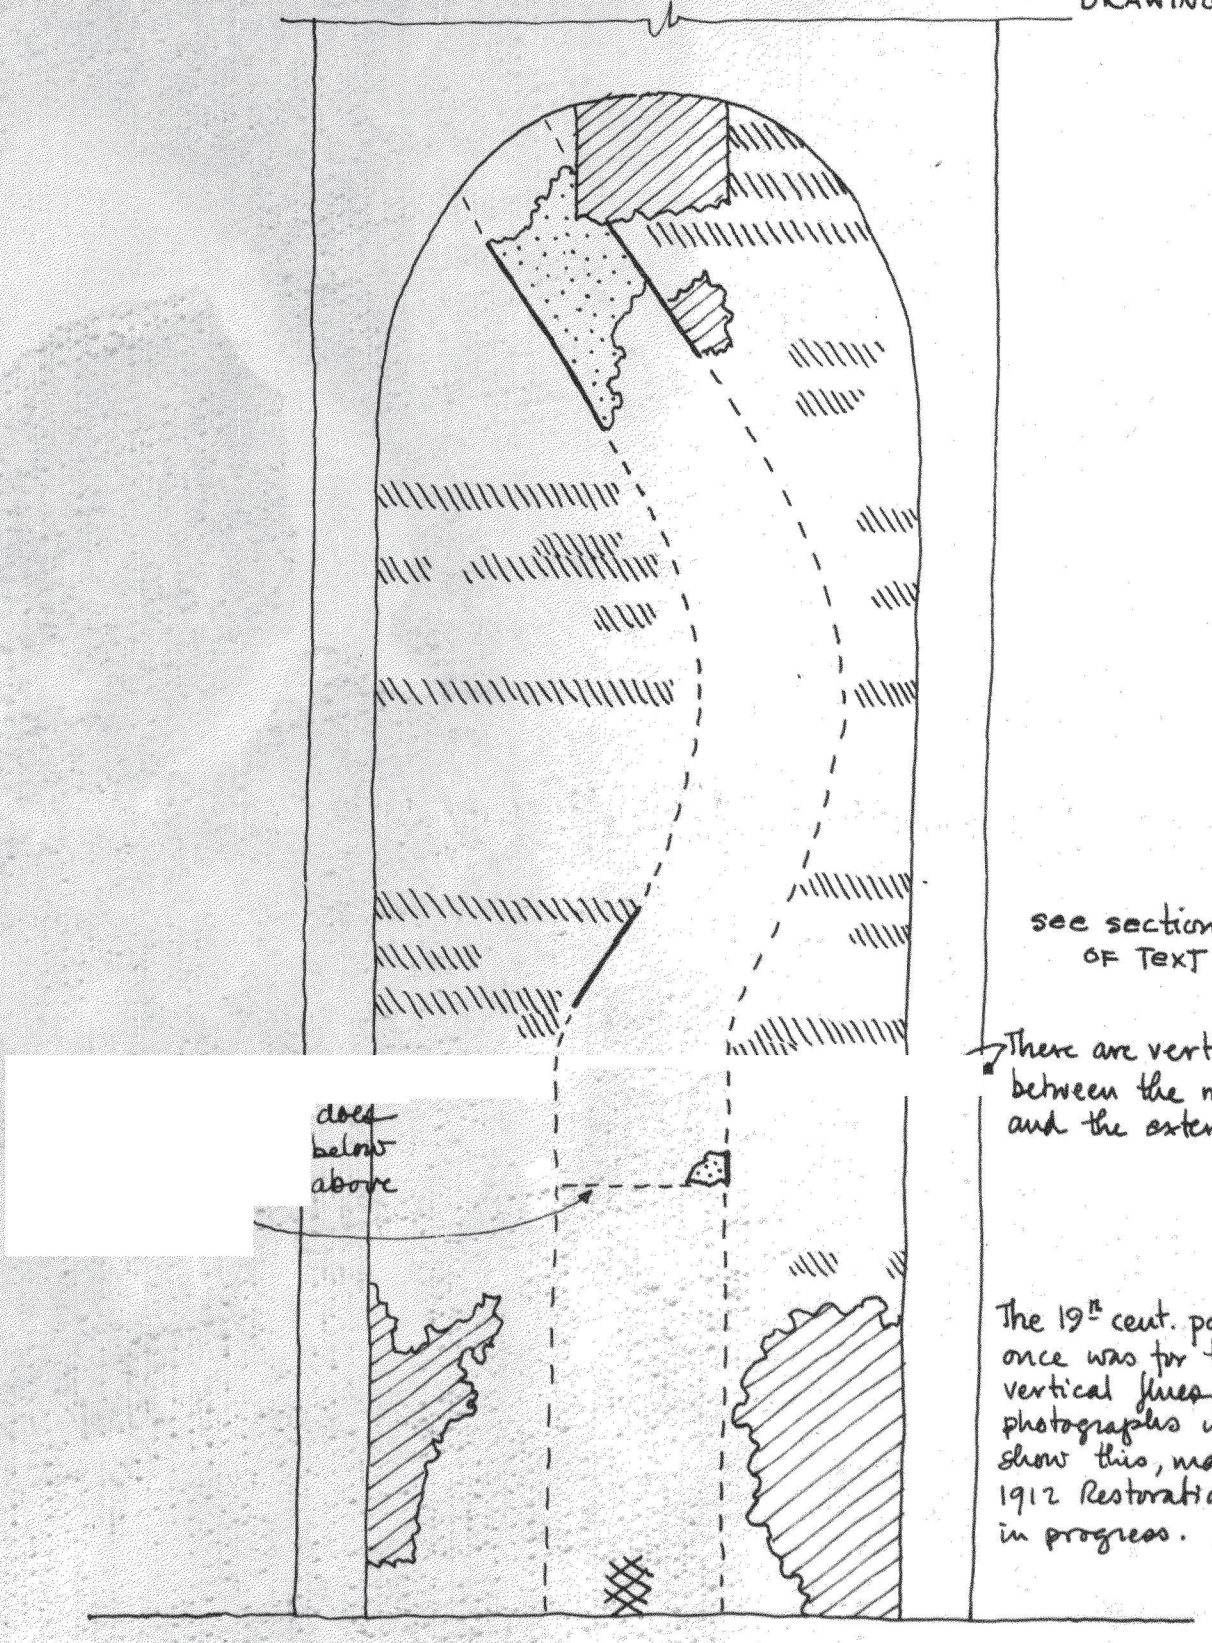
DRAWING NO. 7

East Wall, Middle Opening, Evidence of Original Fireplace and Stove Arrangement

see sections A-8 + B-5

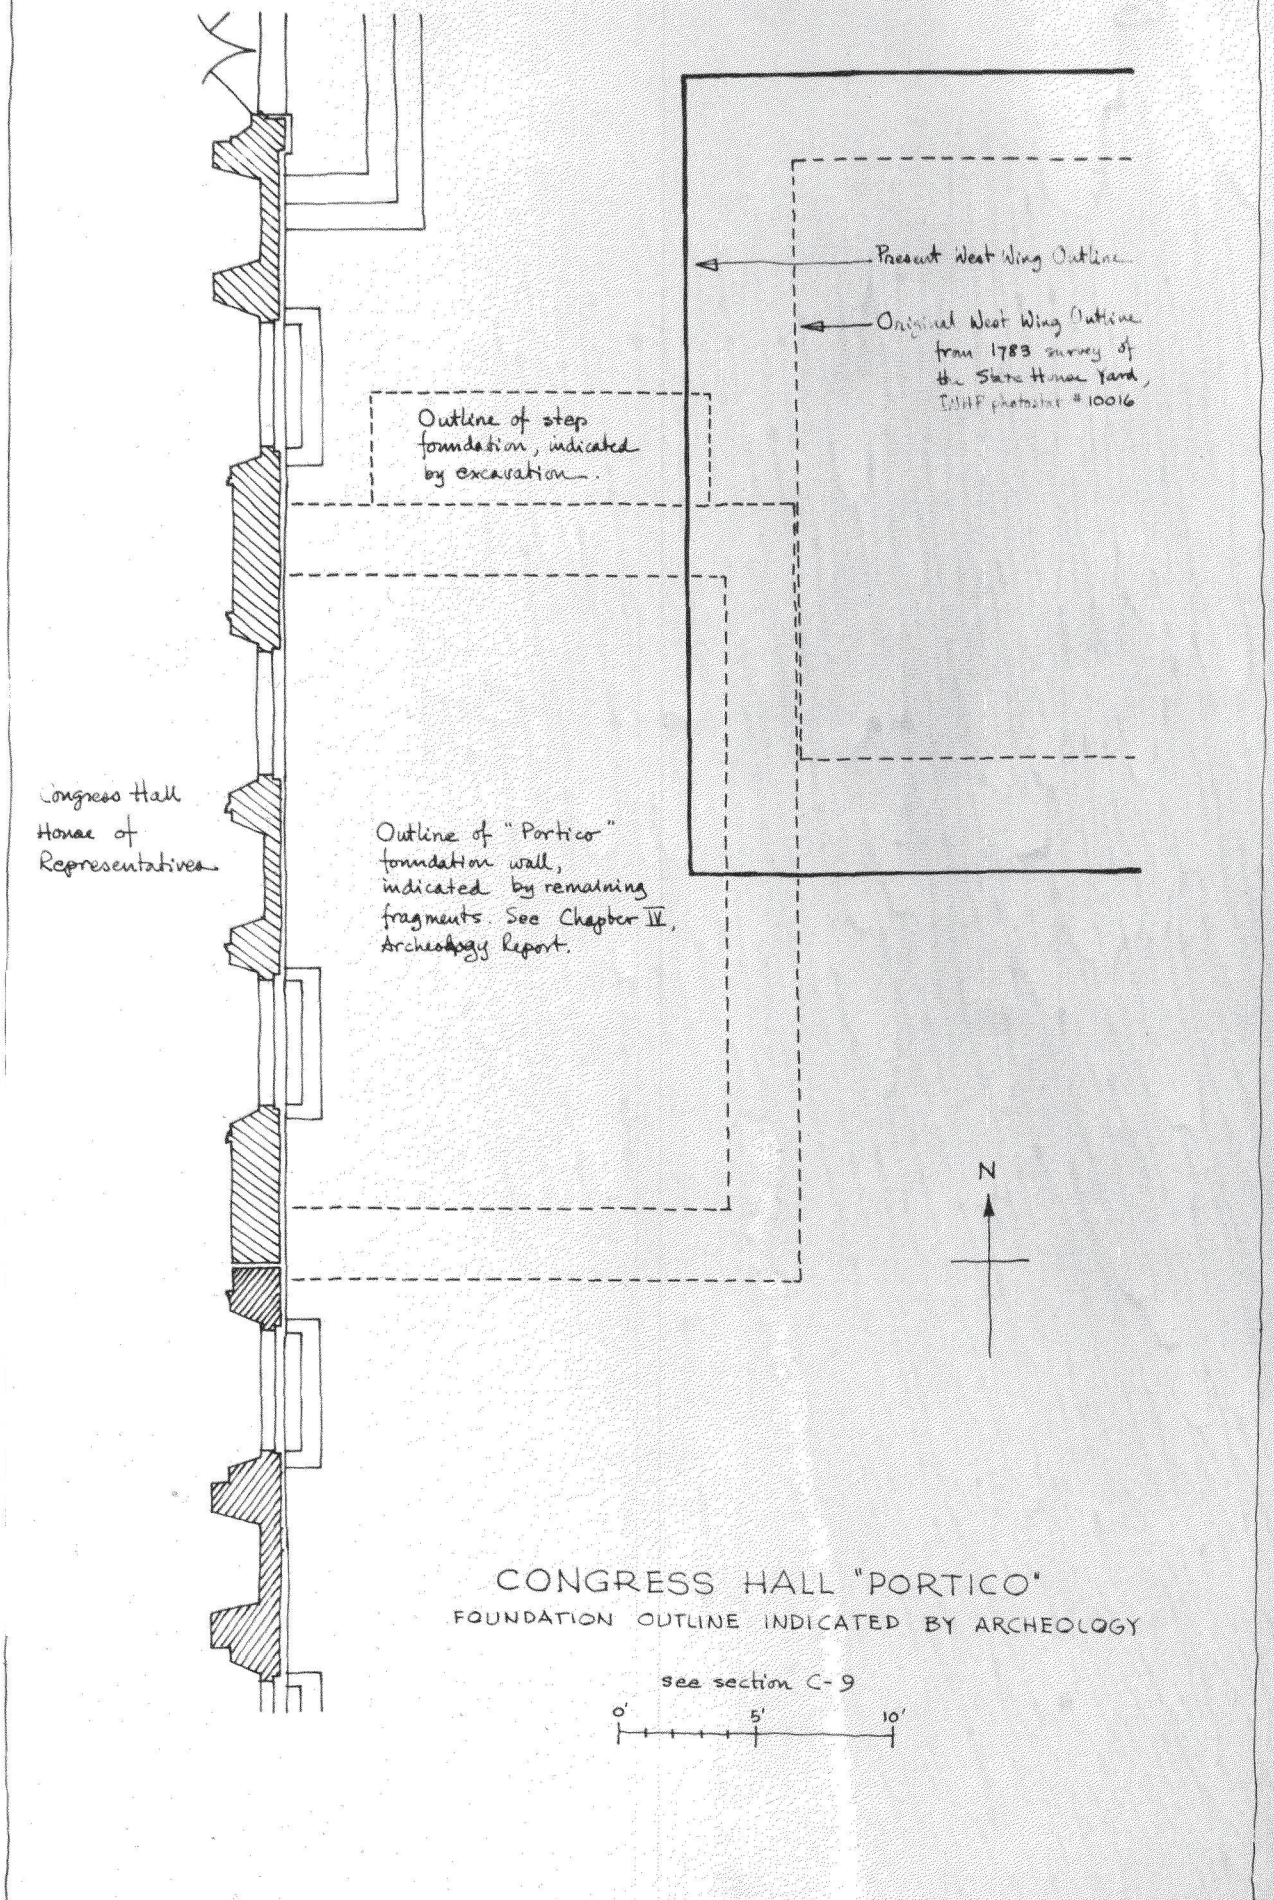
DRAWING NO. 10

CONGRESS HALL "PORTICO"

FOUNDATION OUTLINE INDICATED BY ARCHEOLOGY

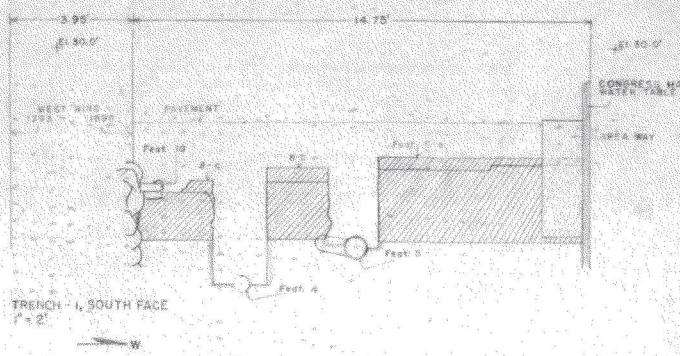
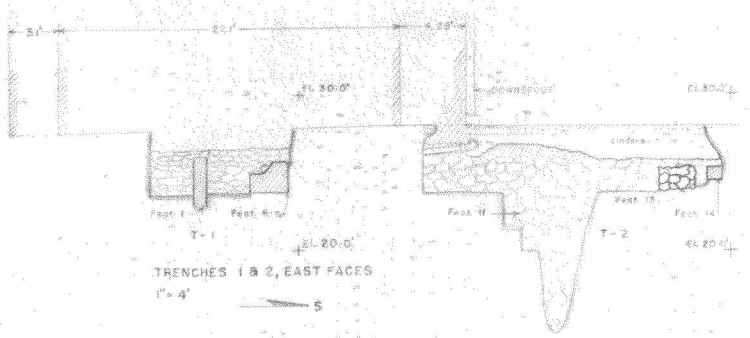
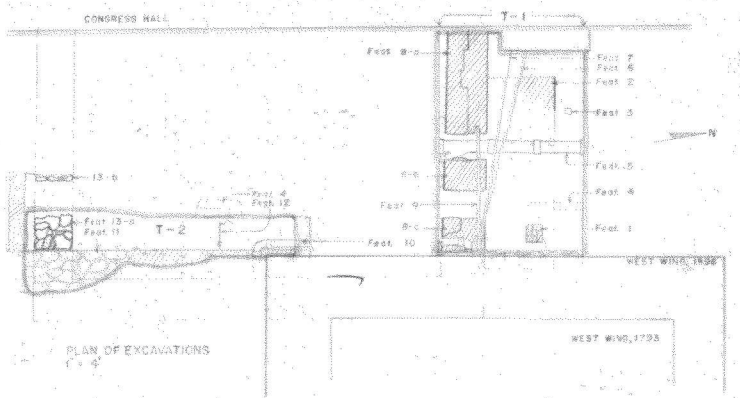
Chapter IV
Illustration No. 4

The north wall foundation of the Portico (Feature #8, Illustration No. 4) was found 56.5' from the present south wall of Congress Hall, at a depth of 1.62' - 3.94' below the surface. The wall at this depth is 2.6' in thickness and consists of two rows of brick on each side of a rubble core. Two gaps had been torn through the wall by the laying of two nineteenth century pipes (Features #4 and 5, Illustration No. 4). The remains of a step foundation (Feature #2, Illustration No. 4) built of unmortared brick was found to be fairly complete on the west, though elsewhere torn up by several later features. Since the step would have been symmetrically centered with the north wall, the east edge of the step would have been the same distance from the original West Wing as the west edge is from Congress Hall (3.3').

The south wall foundation of the Portico (Feature #13, Illustration No. 4) was found to be of mortared stone, rather than brick, 2.3' in thickness and 1.32' - 2.68' below the surface. The south face of this wall is 27.6' from the present south wall of Congress Hall; it thus coincides with the original southwest corner of the Hall before its enlargement in 1793. A two-foot gap had been torn through this wall by the iron pipe (Feature #4, Illustration No. 4) in the same manner as the north wall.

All traces of the east wall were destroyed by the construction of the Mills Building about 1811. The latter was found to have a depth below the surface of 12.74'. Calculations drawn from a comparison of the present ground plan of the Independence Group with a recently found one drawn in 1783[2] indicate that the original west wall of the West Wing was 3.95' plus/minus 0.5' farther east. This would give the Portico dimensions of 28.9' x 18.6' plus/minus 0.5'. The steps are recknoned at 4.15' x 12.0' plus/minus 0.5'.

A wall of brick laid in a Portland-type mortar was found 0.7' south of the Portico's south wall (Feature #14, Illustration No. 4). It extends undamaged across the pipe trench and was identifiable as the south wall of the Late Mills Extension. The location of the north wall of the extension was already known from several excellent photographs taken in the late nineteenth century. The exact date of construction is not known.

Additional data is certain to be obtained from further historical research, especially from the private papers of the individual congressmen of the period. However, in the event that a reconstruction of this structure is programmed, the remainder of the south wall should be excavated to determine whether there were any other features (i. e., a step foundation) in association.
