U.S. Geological Survey, Virginia Tech Field Unit
FINAL RESEARCH REPORT

Improving the Sustainability of the Appalachian Trail: Trail and Recreation Site Conditions and Management

Final Report, May 2020

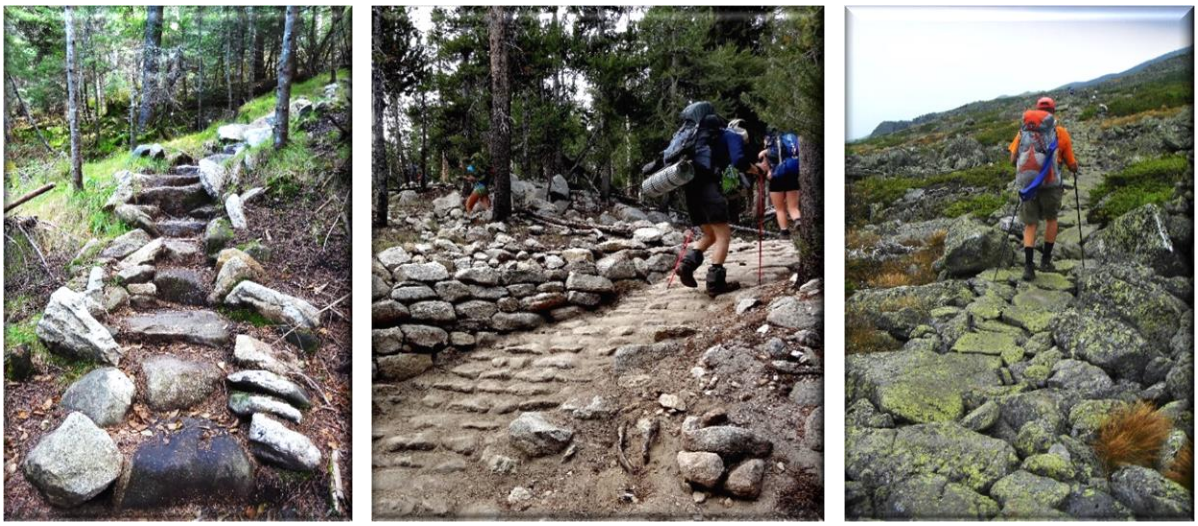
Figure 29. Tread construction with stone steps or stone armoring of trail treads can help minimize soil loss in steep terrain.

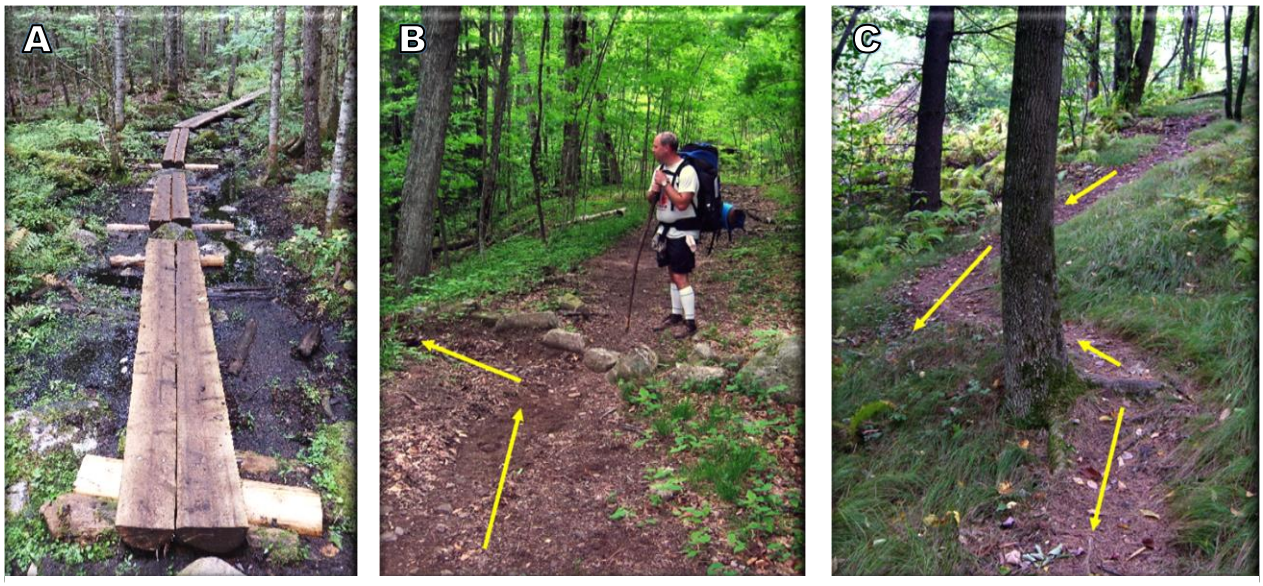
Figure 31. Bog-bridging (A) is an effective practice for raising the tread above wet soils. Rock or wood water bars (knicks) (B) remove water from treads but must be maintained annually to remain effective. Grade reversals of the entire tread (C) will always remove all water and require little to no maintenance.
