John Gordon House

Interior Finishes Analysis

Natchez Trace Parkway, Tennessee

April 2011

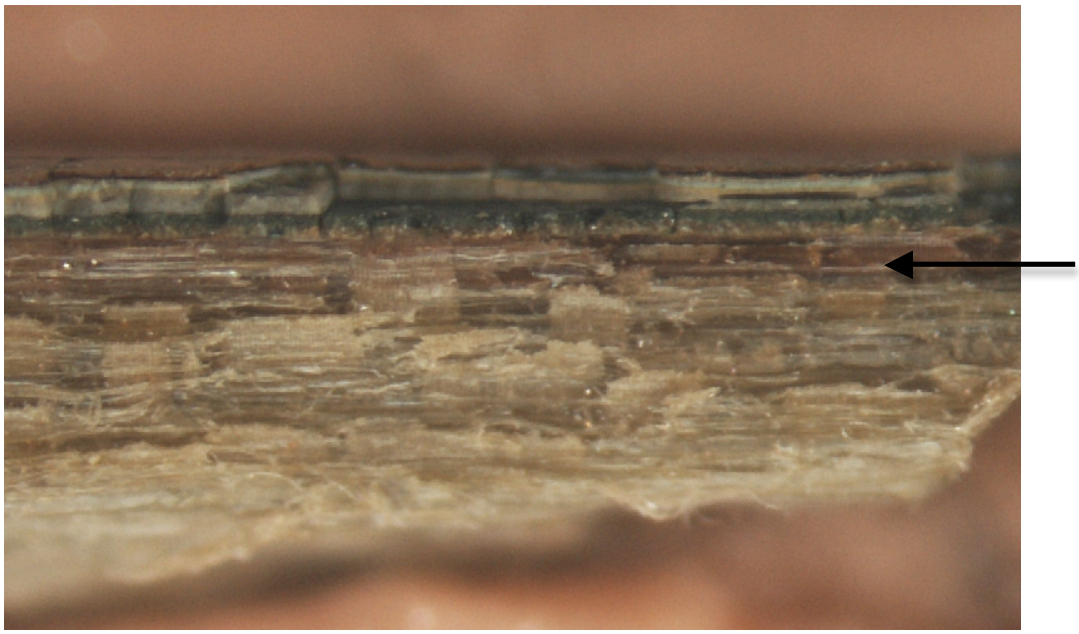
Nearly all of wood substrates are darker at the surface than deeper within the wood (*Figure 6*). In cross-section, this looks like a saturated surface (*Figure 7*). This saturated surface sometimes appears reddish in visible light, suggesting that the woodwork may have been stained. However, no pigment particles are visible within this area of saturation in any of the samples as would be expected of a stain. It is possible that the woodwork was stained with a dye that contained no pigments, but this would be somewhat unusual. Although the surface of the wood appears saturated, there is no evidence of early varnish or clear coatings, nor does it appear that the

Figure 6: Sample JGH.101.1 (chair rail, 18x magnification) illustrates the saturation visible at the surface of the wood in this bulk sample.

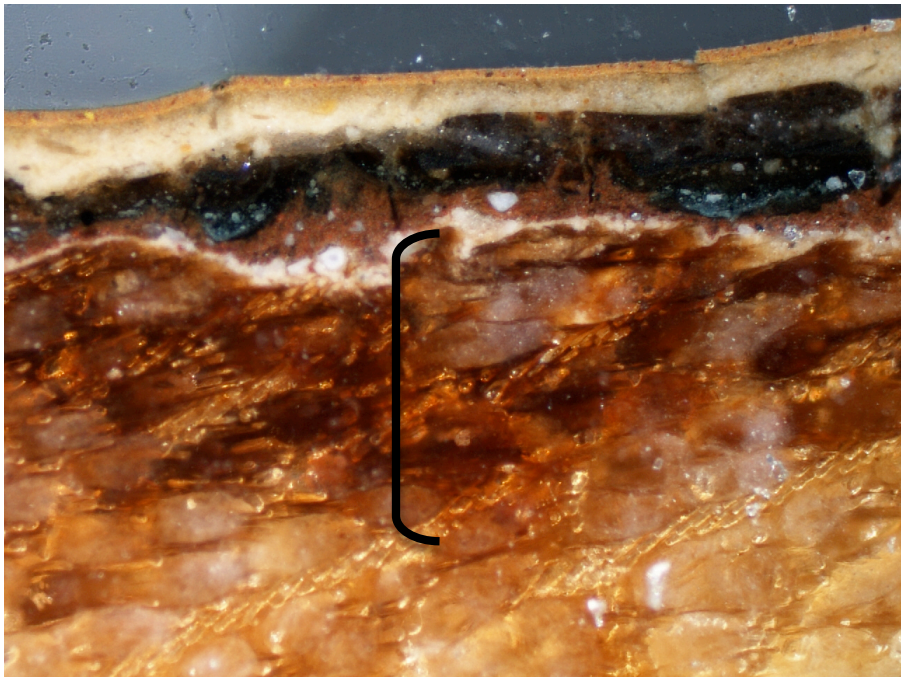
Figure 7: Sample JGH.201.5 (handrail, 100 x magnification – visible light). Note the darker, saturated surface of the wood under the cream layer.

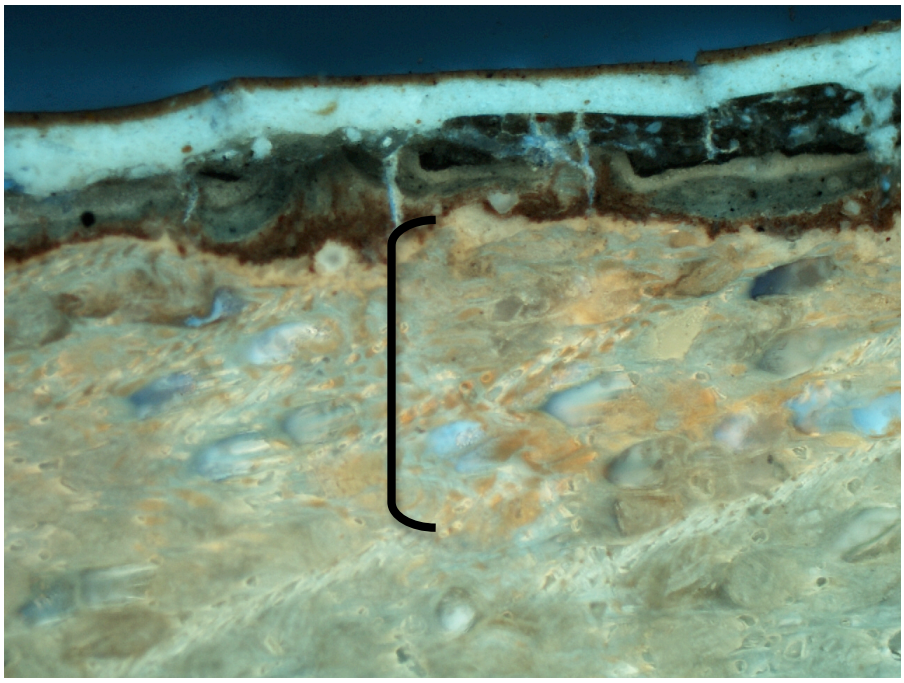
Figure 8: Sample JGH.201.5 (handrail, 100x magnification – UV light). The saturation visible in many samples in visible light auto-fluoresces orange and yellow in UV light.

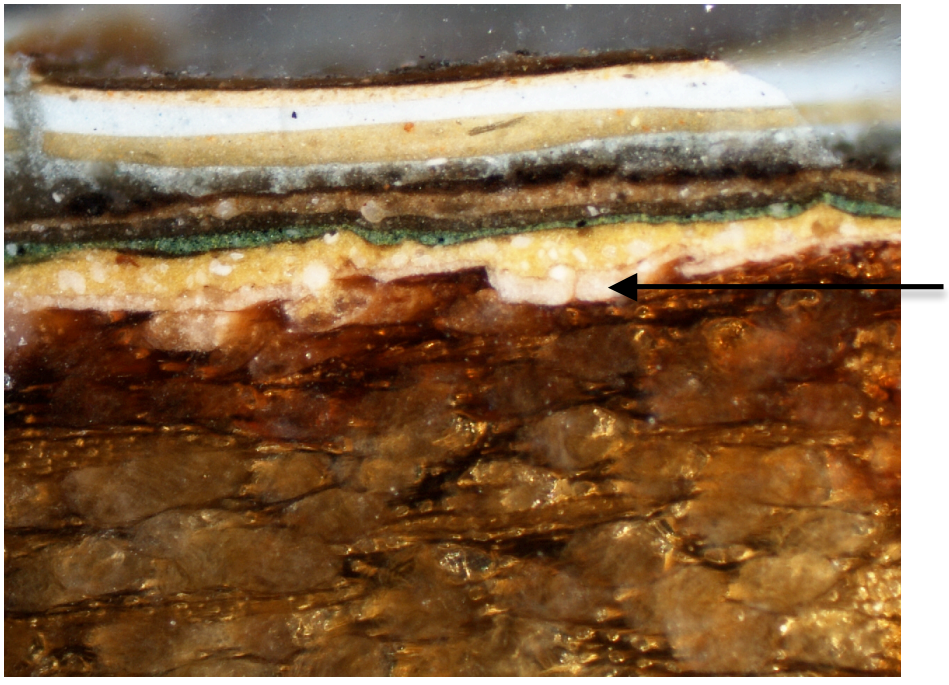
There is also evidence of a wood filler used before the first paint layer. Several samples contain an early whitish layer that is found only in the pores or as an extremely thin layer on the wood surface (*Figure 9*). Paste fillers were often used on open-grain woods, like oak, to fill in the pores and provide a smooth wood surface. Paste filler traditionally was made from finely ground silica or whiting, linseed oil and japan drier. It was spread on the surface, allowed to dry until sticky, and the excess wiped off across the grain to deposit the filler in the pores, leaving a smooth wood surface.

Figure 9: Sample JGH.101.1 (chair rail, 100x magnification – visible light). An early cream layer found in the wood pores or as a thin coating is believed to be a wood filler used to create a smooth wood surface.

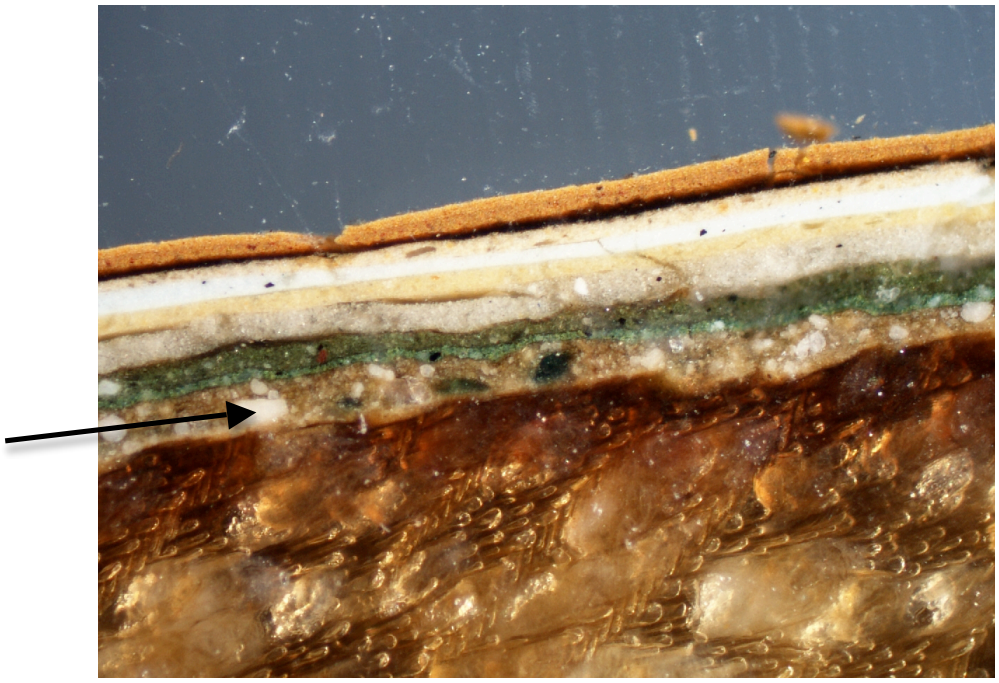
Figure 10: Sample JGH.101.1 (chair rail, 100x magnification – visible light). Note the large, variable size pigment particles in the first tan/light brown layer as compared to the more uniform yellow and brown layers later in the paint history.

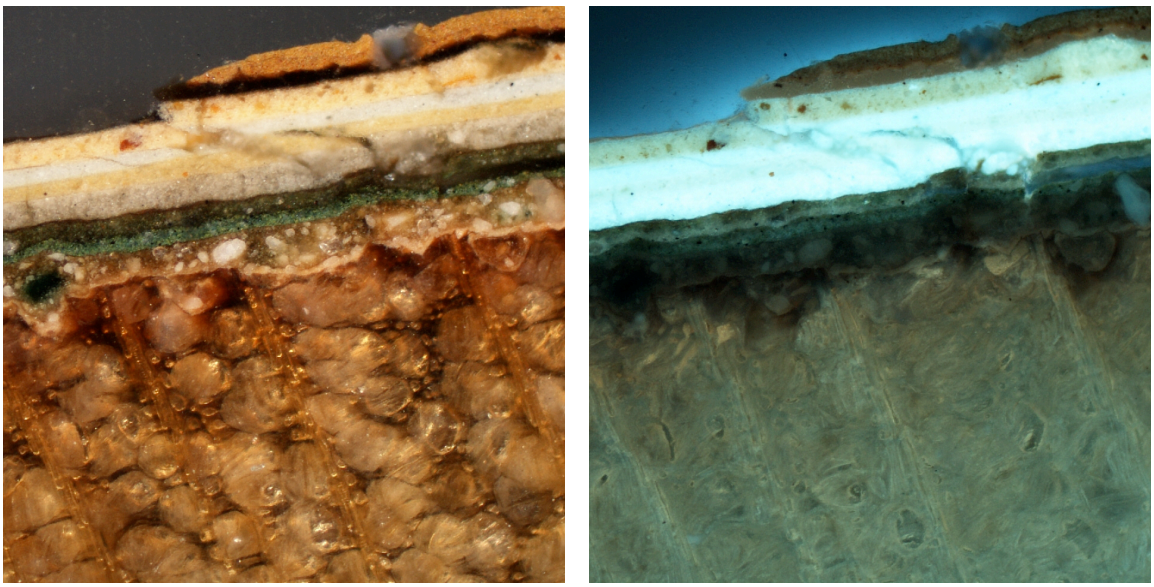
The window casing, chair rail, door jamb, stair string, and paneling all share the same light brown paint layer, characterized by large pigment particles and lack of auto-fluorescence under UV light, as the first finish (*Figure 13*). After the light brown are two dark greens, similar to the greens found in the Parlor and probably contemporary. Overall these elements have between 10-13 layers, and are consistent with each other.

Figure 13: JGH.101.11 (wall paneling, 100x magnification- - visible light, left, and UV light, right). The earliest campaign is a light brown paint with coarsely ground pigment that does not auto-fluoresce.

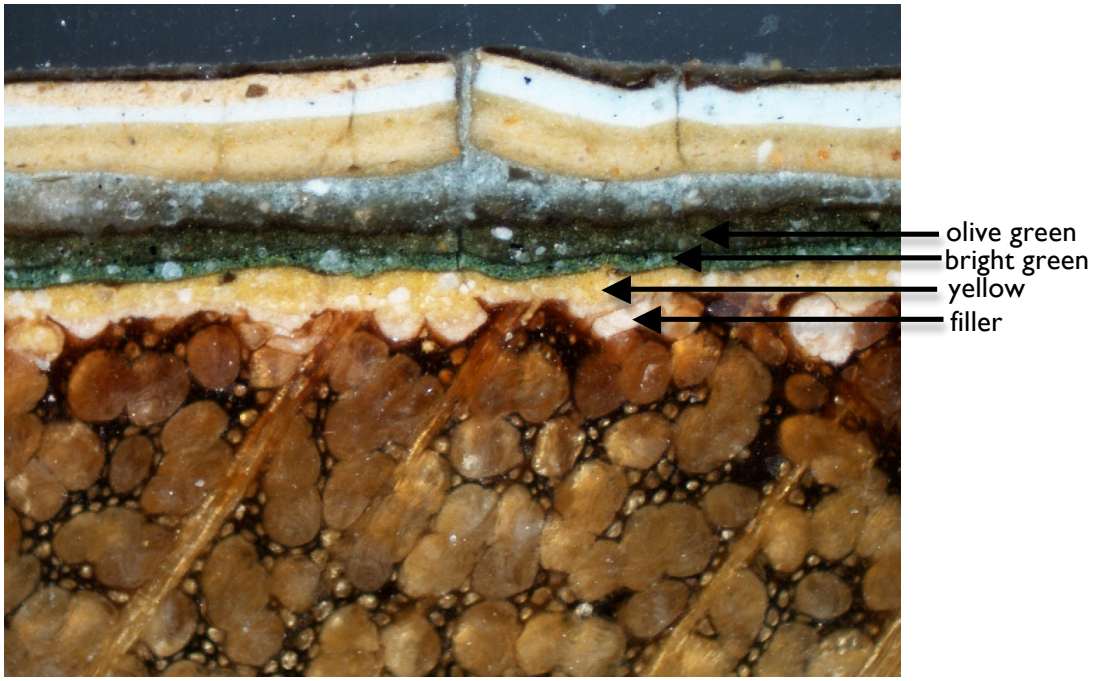
The first finish layer found on most the wood trim in the Parlor is a warm yellow. This includes the door, door surround, chair rail, and window casing. This consistent yellow layer is a coarsely ground paint with large pigment particles visible (*Figure 17*). A layer of soiling divides the yellow from the next layer, a dark green. Given this evidence, the yellow is likely the original finish.

Figure 17: Sample JGH.102.2 (door surround, 100x magnification – visible light). The first finish campaign is a coarsely ground warm yellow, followed by several coarsely ground green layers. Note the cream filler in the pores and the dark saturation at the wood surface.

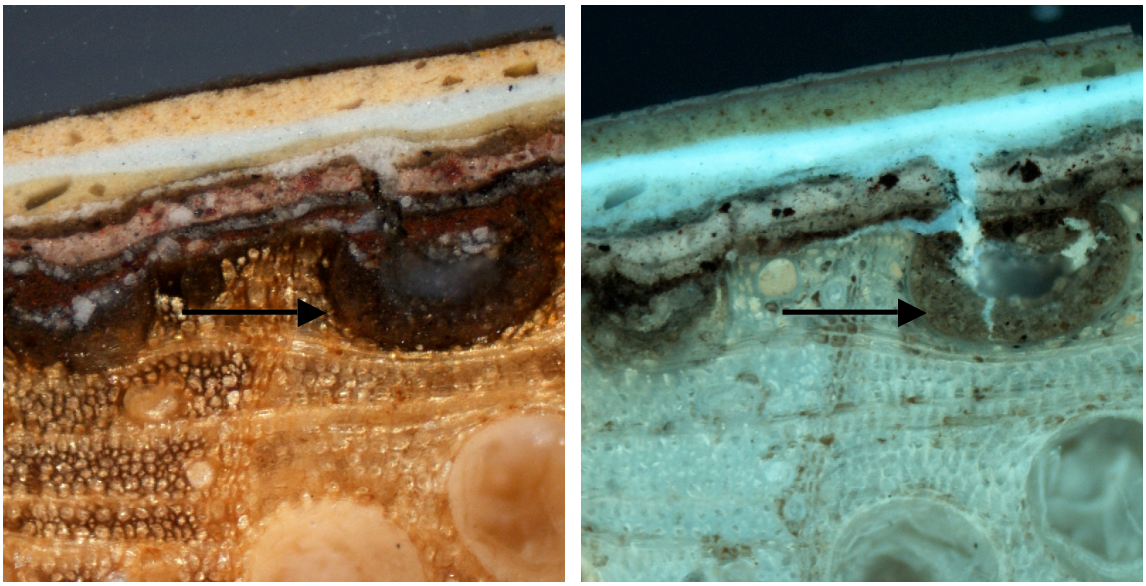
Figure 18: Sample JGH.102.5 (baseboard, 100x magnification - visible light, left, and UV light, right). An early brown paint is visible in the pores of the wood.

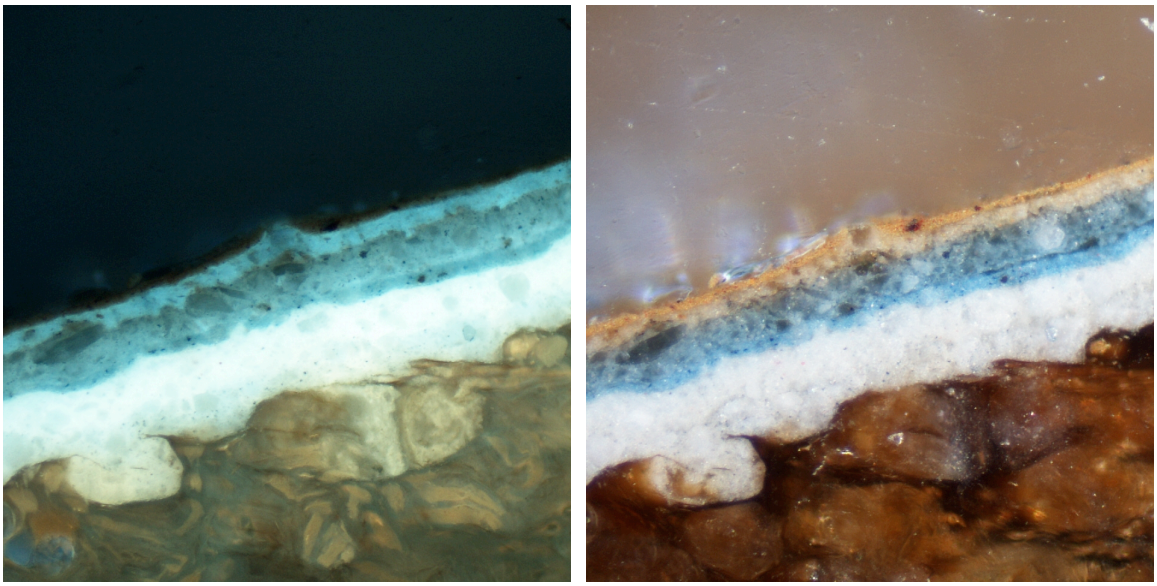
Figure 19: Sample 201.9 (chair rail, 200x magnification - visible light, left, and UV light, right). The first campaign is a white primer and white finish coat.

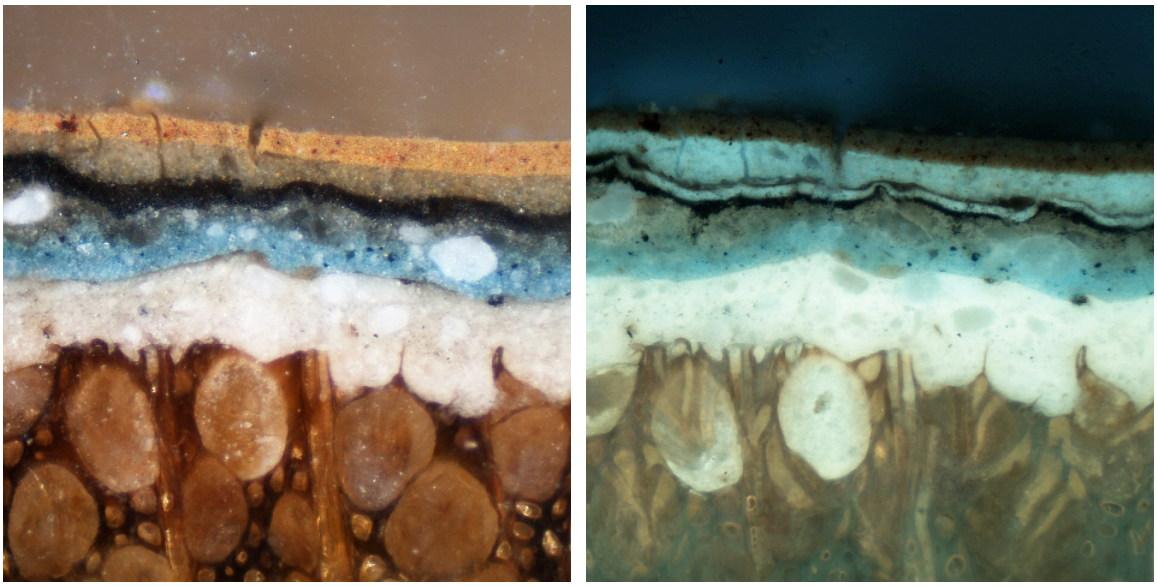
Figure 20: Sample 201.18 (mantel, flat header above firebox opening, 200x magnification - visible light, left, and UV light, right). The first campaign has a white finish. A blue, also found on other samples, is then followed by a varnish.

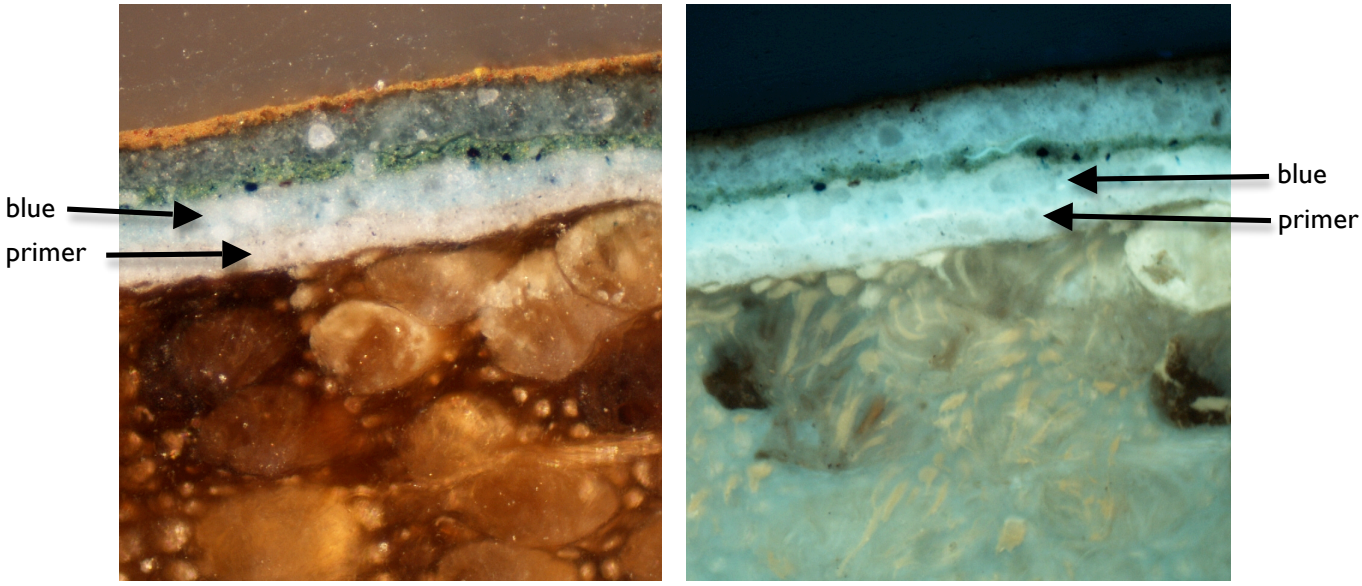
An early campaign of a white primer with blue finish paint is on the majority of the wood trim in the east bedroom (*Figure 21*). This includes the door surround, chair rail and window casing. After the blue is a green and then a blue-gray, both coarsely ground paints and thus believed to still be fairly early. The last layer is the current brown, and appears more modern. It matches the most recent brown found elsewhere in the building. The scarce number of paint layers suggests that this room was not refinished as frequently as the other rooms of the house, perhaps because it is less public or perhaps because it was used less throughout the house's history.

Figure 21: Sample 202.3 (chair rail, 200x magnification - visible light, left, and UV light, right). The first campaign is a white primer and blue finish coat.

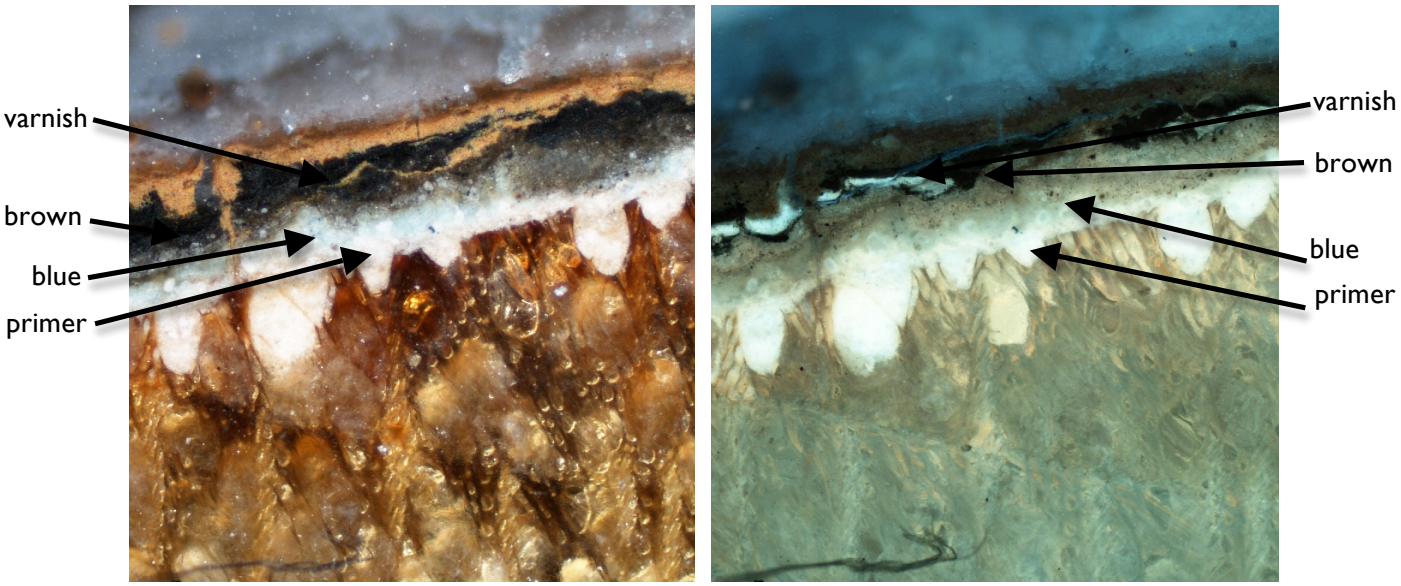
Two samples from the mantel were also examined in cross section. The layers in both samples are somewhat rough and damaged. One sample (JGH.202.13, *Figure 22*) contains similar early layers as the rest of the room, including traces of the blue paint. Later layers in both samples include dark browns and a varnish, similar to the mantel samples from Room 201.

Figure 22: Sample 202.13 (mantel leg, 100x magnification - visible light, left, and UV light, right). The early layers appear similar to those on the other wood trim. Later layers include dark browns and varnish.

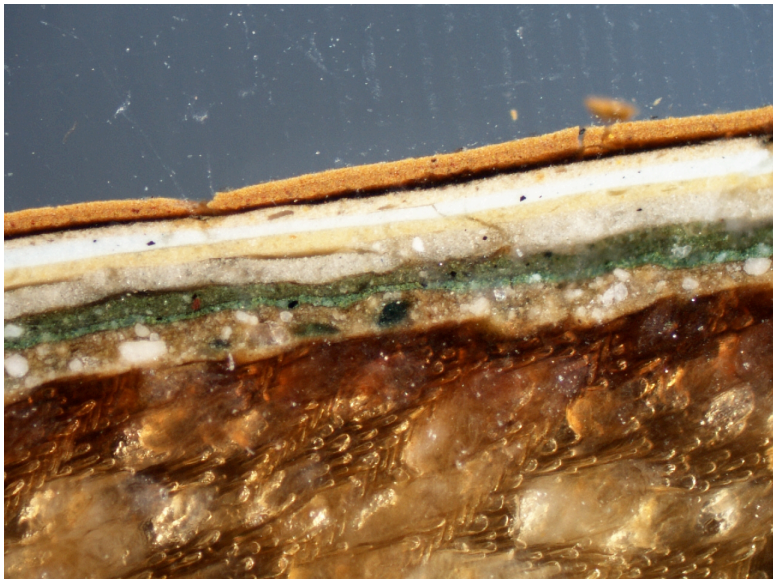
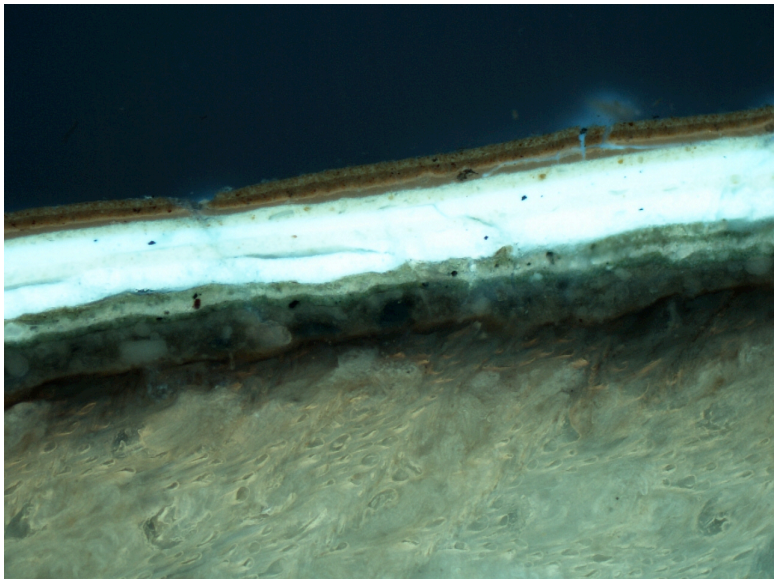
SAMPLE NO:	JGH.101.1
LOCATION:	Chair rail

LAYER	***COLOR***	***NOTES***
Substrate	Wood	Sat. in wood; autofl. slightly
1	Light Brown	Green pigment within; coarse
Dirt		
2	Green	Coarse
Dirt		
3	Green	Coarse
Dirt		
4	Cream	
Dirt/Sep.		
5	Yellow-peach	
6	White

LAYER	***COLOR***	***NOTES***
7	Light peach	
8	Red-brown	
9	Orange-brown	
10	Orange-brown

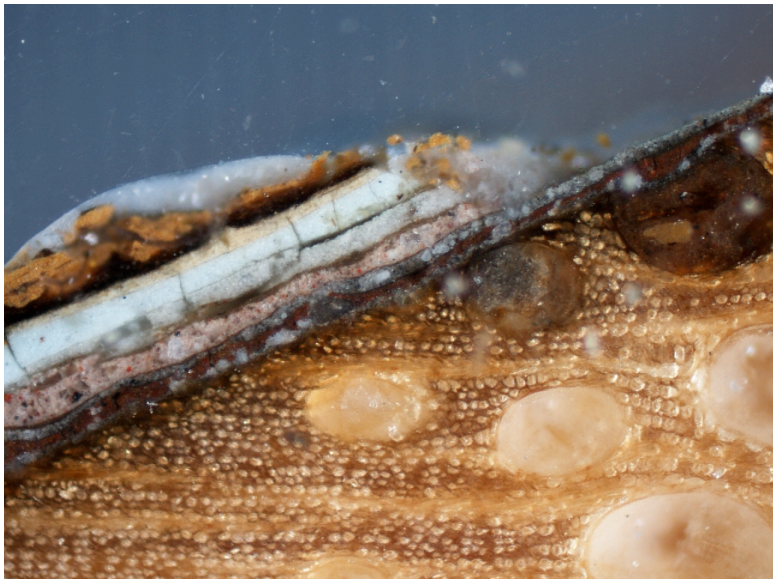
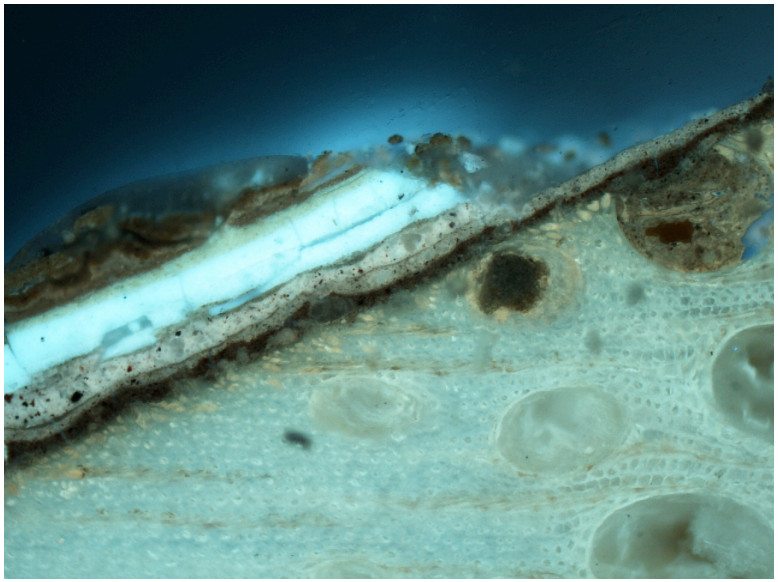
SAMPLE NO:	JGH.101.3
LOCATION:	baseboard

Figure 12: JGH.101.3 (baseboard, 100x magnification - visible light). Traces of brown paint are found in the wood pores on the surface of the wood.

LAYER	***COLOR***	***NOTES***
Substrate	Wood	
1	Brown	Only in pores
2	Blue-gray	Thin
Dirt		
3	Brown	
Dirt		
4	Gray-blue	
Dirt		
5	Pink	
Dirt		
6	Gray/Light blue	
Dirt/sep		
7	Light aqua blue

LAYER	***COLOR***	***NOTES***
8	Yellow-peach	
9	Brown	
10	Brown	
11	Orange-brown	
Dirt/sep.		
12	Orange-brown

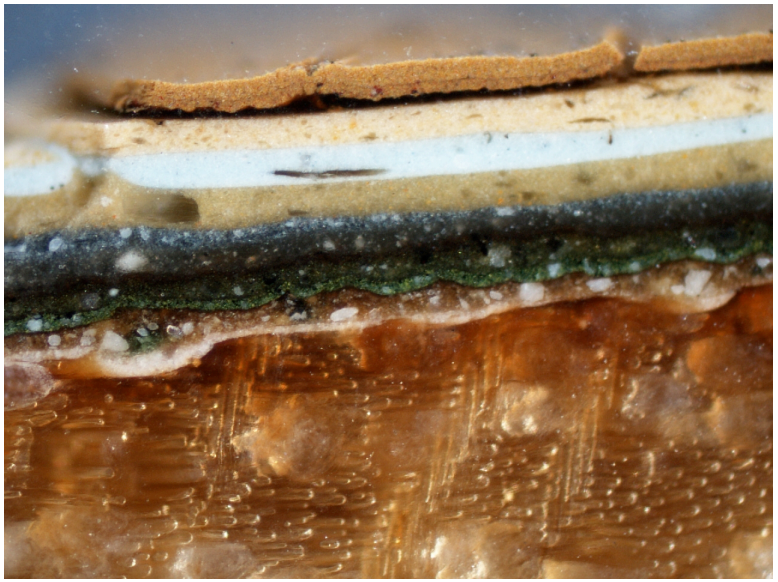
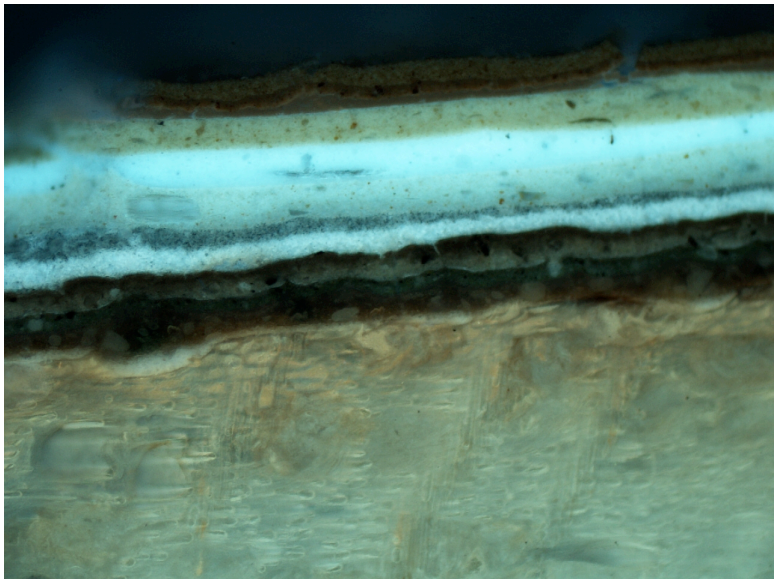
SAMPLE NO:	JGH.101.5
LOCATION:	Door jamb

LAYER	***COLOR***	***NOTES***
Substrate	Wood	Sat. in surface; autofl. orange
1	Cream	Thin, in crevices 2.5-5Y 9/2
2	Light Brown	Coarse
Dirt		
3	Green	Coarse
Dirt		
4	Green	Coarse
5	Brown	
Dirt		
6	Gray	
7	Blue	
8	Peachy-tan	
9	White

LAYER	***COLOR***	***NOTES***
10	Peach	
11	Brown	
12	Orange-brown	
Dirt		
13	Orange-brown

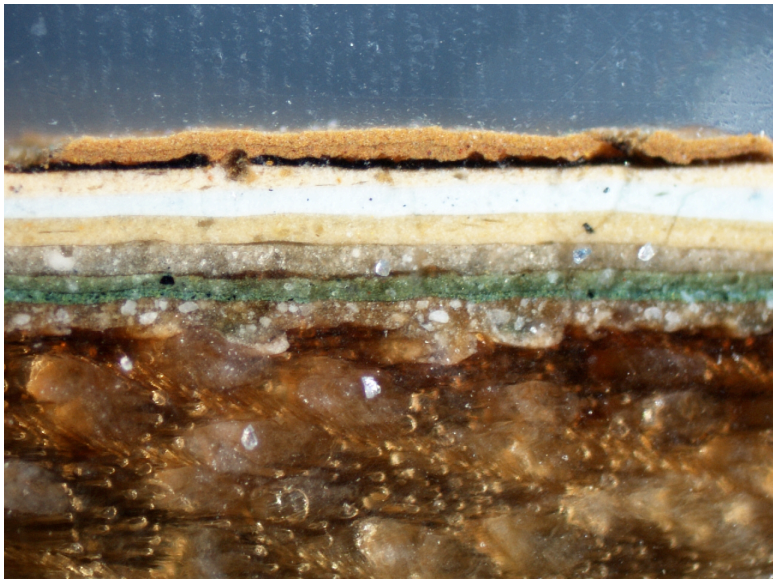
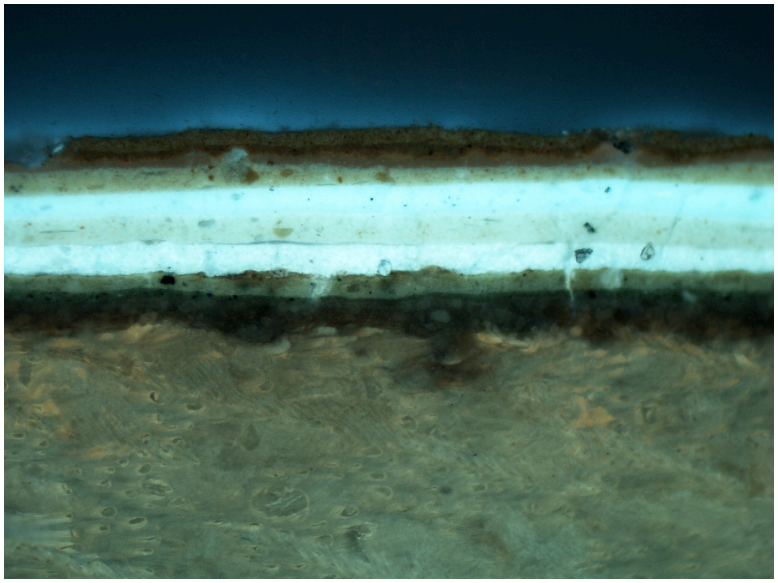
SAMPLE NO:	JGH.101.6
LOCATION:	Window casing

LAYER	***COLOR***	***NOTES***
Substrate	Wood	Sat. in surface; autofl. orange
1	Cream	Traces only, in crevices
2	Light brown	Coarse
3	Green	Thin in places
4	Yellowish Green	
5	Brown	Traces
Dirt		
6	Gray	
Dirt/sep.		
7	Yellow-peach	
8	White	
9	Peach	
10	Brown

LAYER	***COLOR***	***NOTES***
11	Orange-brown	
Dirt		
12	Orange-brown

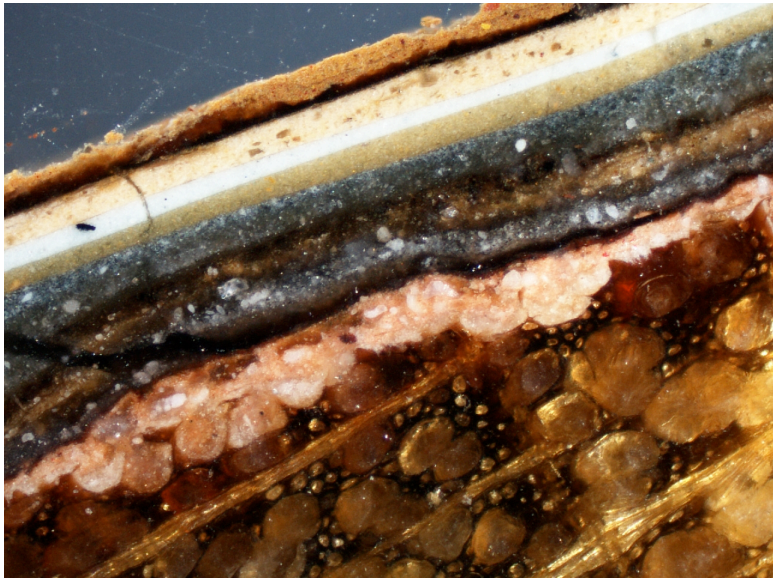
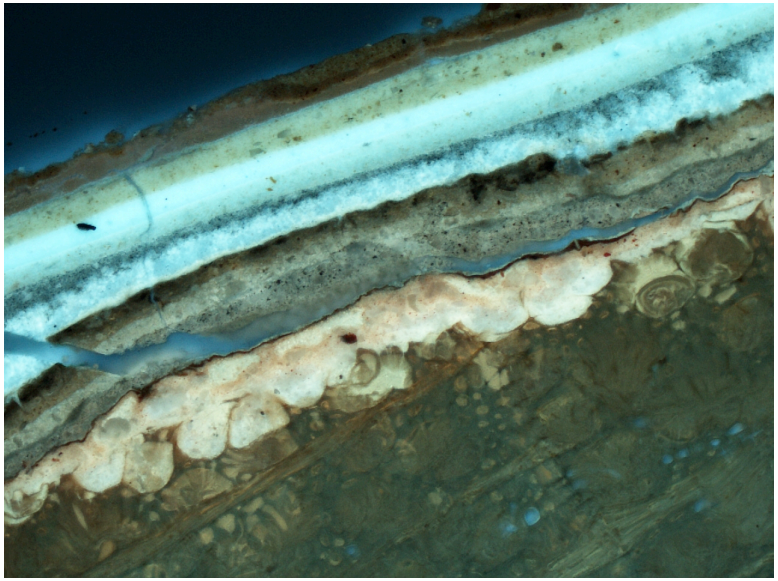
SAMPLE NO:	JGH.101.7
LOCATION:	Door

LAYER	***COLOR***	***NOTES***
Substrate	Wood	Red sat. in surface; autofl.
1	Cream	Thin, in pores, 5Y 9/2
2	Peachy-pink	
3	Red	Very thin, decorative?
Dirt/Sep.		
4	Gray	
Dirt		
5	Light brown	
6	Brown	
Dirt		
7	Gray	
8	Gray-blue	
9	Yellow-peach	
10	White	
11	Peach	
12	Brown

LAYER	***COLOR***	***NOTES***
13	Orange-brown	
Dirt		
14	Orange-brown

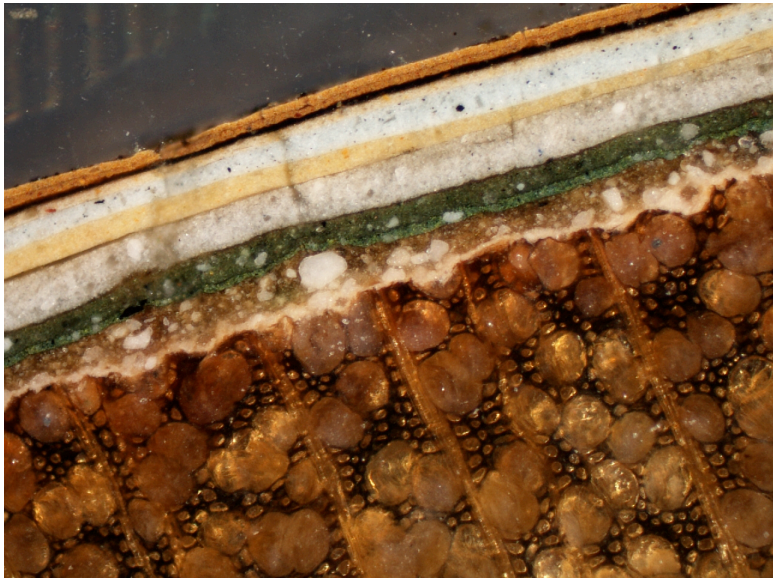
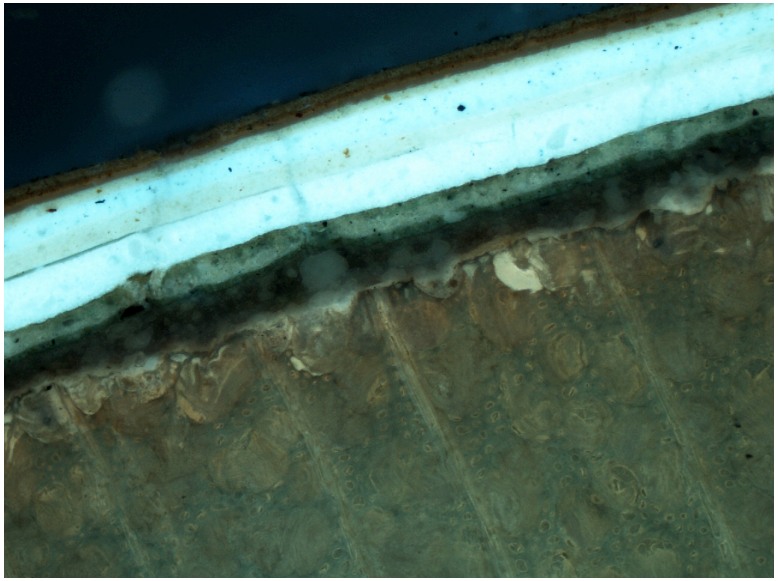
SAMPLE NO:	JGH.101.9
LOCATION:	Stair string

LAYER	***COLOR***	***NOTES***
Substrate	Wood	Red sat. into surface; autofl. orange
1	Cream	Thin, uneven
2	Light brown	Very coarse
Dirt		
3	Green	Coarse
4	Yellow-green	Coarse
Dirt		
5	Whitish	
Dirt/Sep.		
6	Yellow-peach	
7	White	
8	Light peach	
9	Brown	
10	Orange-brown

LAYER	***COLOR***	***NOTES***
Dirt		
11	Orange-brown

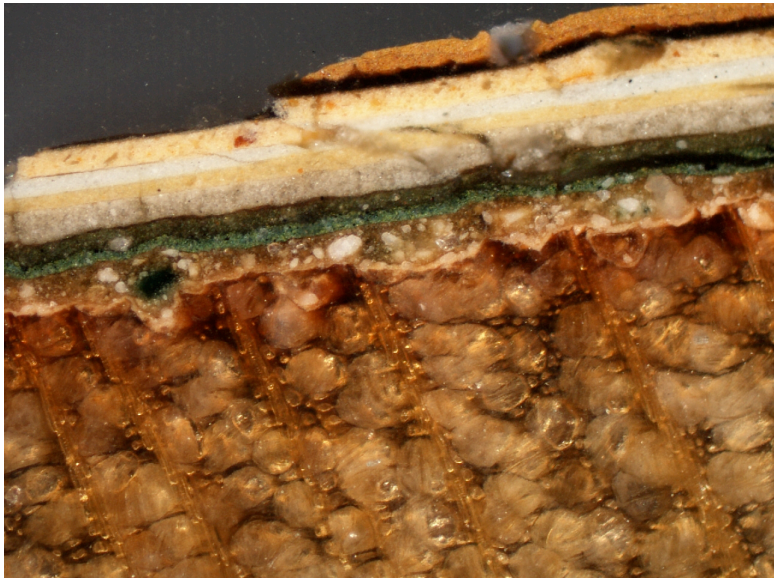
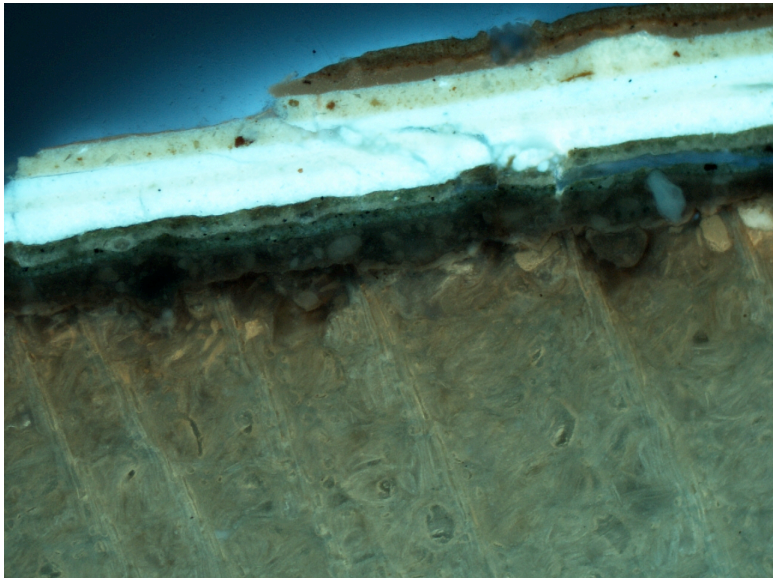
SAMPLE NO:	JGH.101.11
LOCATION:	paneling

LAYER	***COLOR***	***NOTES***
Substrate	Wood	Red sat. into surface; some autofl.
1	Cream	Very thin & uneven
Dirt		
2	Light brown	With green blobs; very coarse
Dirt		
3	Green	
Dirt		
4	Green	
Dirt		
5	Whitish	
6	Yellow-peach	
7	White	
8	Peach

LAYER	***COLOR***	***NOTES***
9	Brown	
10	Orange-brown	
Dirt		
11	Orange-brown

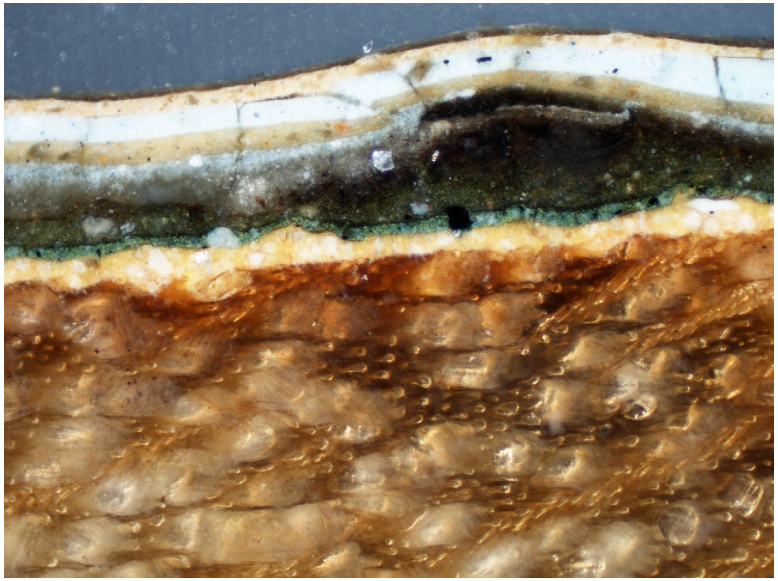
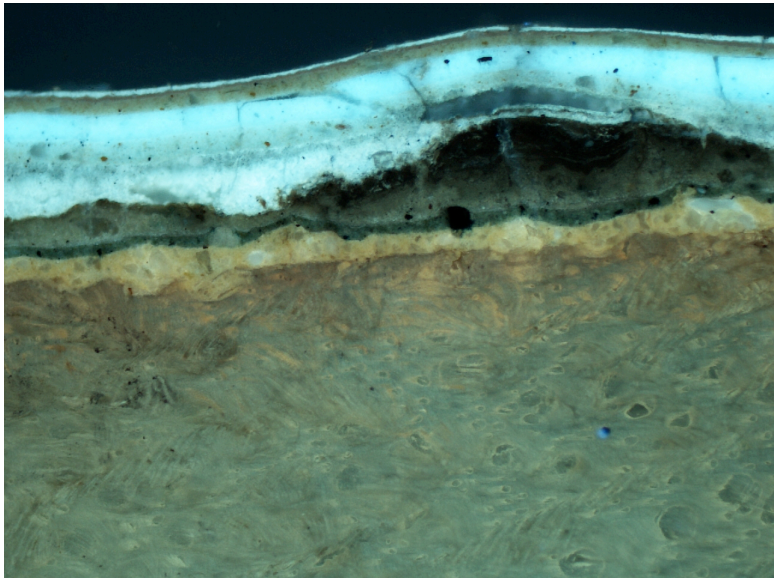
SAMPLE NO:	JGH.102.1
LOCATION:	Chair rail

LAYER	***COLOR***	***NOTES***
Substrate	Wood	Saturation at surface but no pigment particles; autofl. slightly
1	Yellow	Coarsely ground
Dirt		
2	Green	Thin
Dirt		
3	Yellow-green	
4	Brown	
Dirt		Potentially a different brown layer
5	Gray	
6	Blue-gray	
Dirt		
7	Peach	
8	White	
9	Light peach	
Dirt		
10	Brown	Current graining
11	Brown/Varnish	Current graining

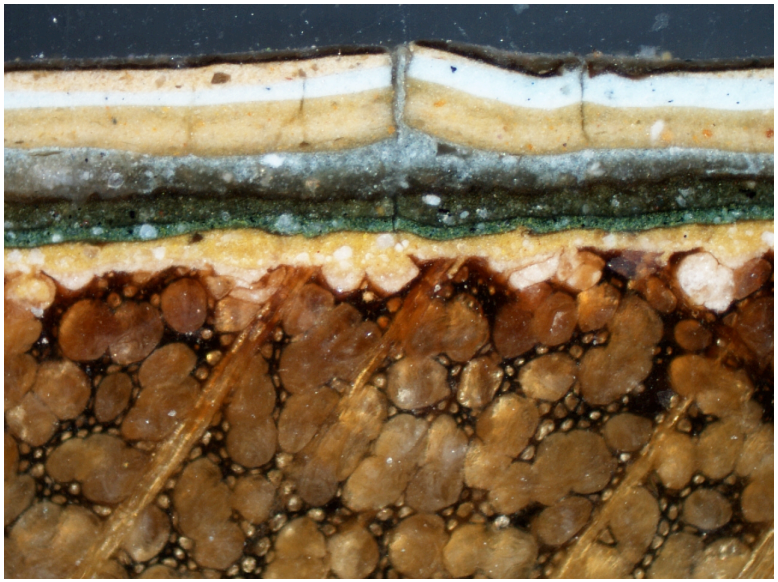
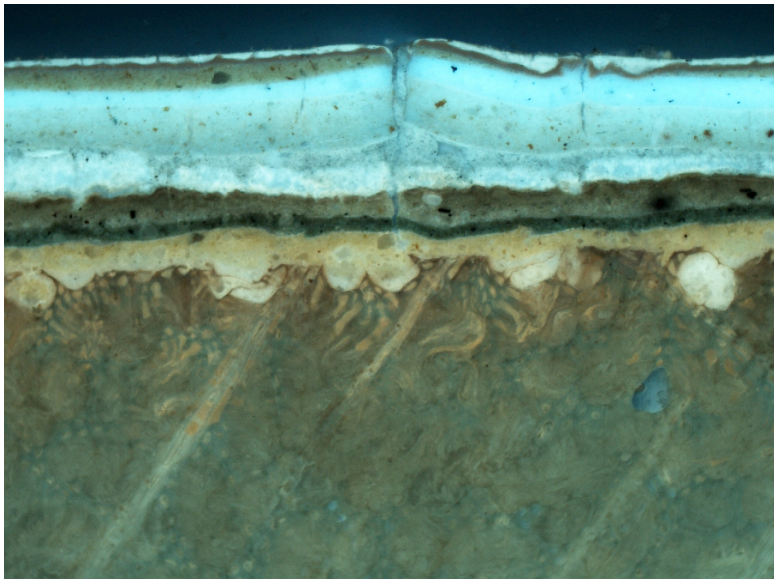
SAMPLE NO:	JGH.102.2
LOCATION:	Door surround

LAYER	***COLOR***	***NOTES***
Substrate	Wood	Sat. surface; no pigment; autofl. slightly
1	Cream	Traces, in pores; some sep. in areas
2	Yellow	Coarse pigment
Dirt/Sep.		
3	Green	Coarse
4	Green	Coarse
5	Brown	
6	Gray	Coarse
7	Blue-gray	
8	Peach

LAYER	***COLOR***	***NOTES***
9	White	
10	Light peach	
11	Brown	Current graining
12	Brown/Varnish	Current graining

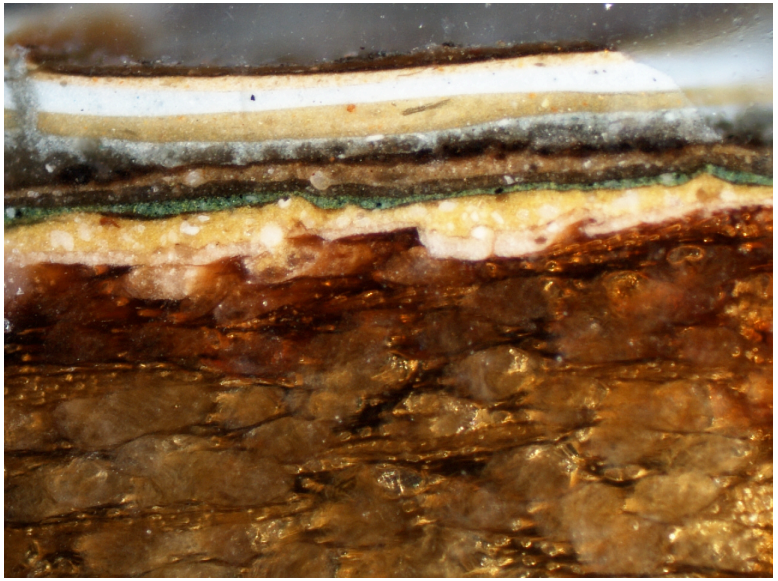
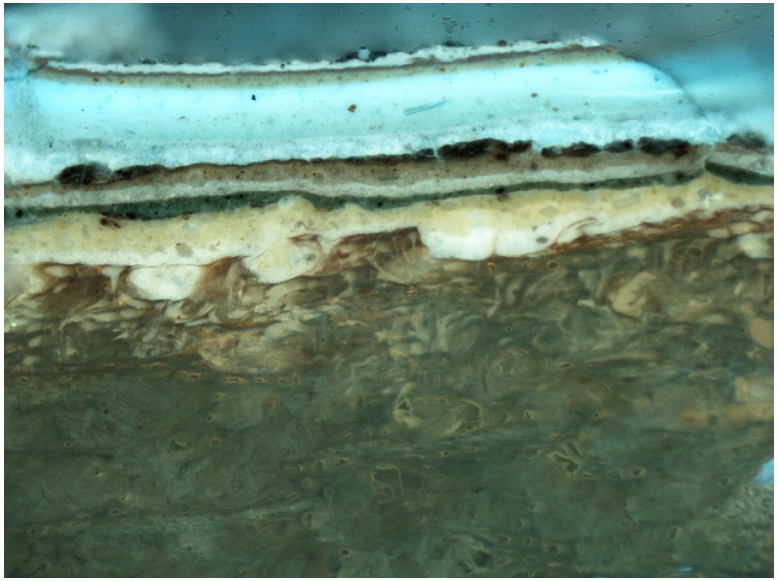
SAMPLE NO:	JGH.102.3
LOCATION:	door

LAYER	***COLOR***	***NOTES***
Substrate	Wood	Red sat. into wood; autofl. orange
1	Cream	Traces in crevices, thin
Dirt/Sep.		Between cream and yellow
2	Yellow	Coarsely ground
Dirt		
3	Greenish brown	
4	Brown	
5	Light brown	Coarse
6	Brown	
7	Gray	
8	Peach

LAYER	***COLOR***	***NOTES***
9	Light blue	
10	Light peach	
11	Brown	Current graining
12	Brown/Varnish	Current graining

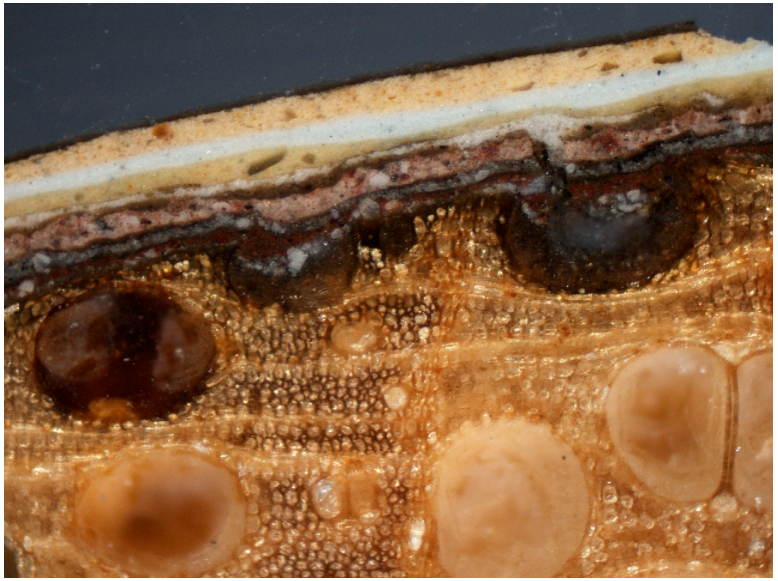
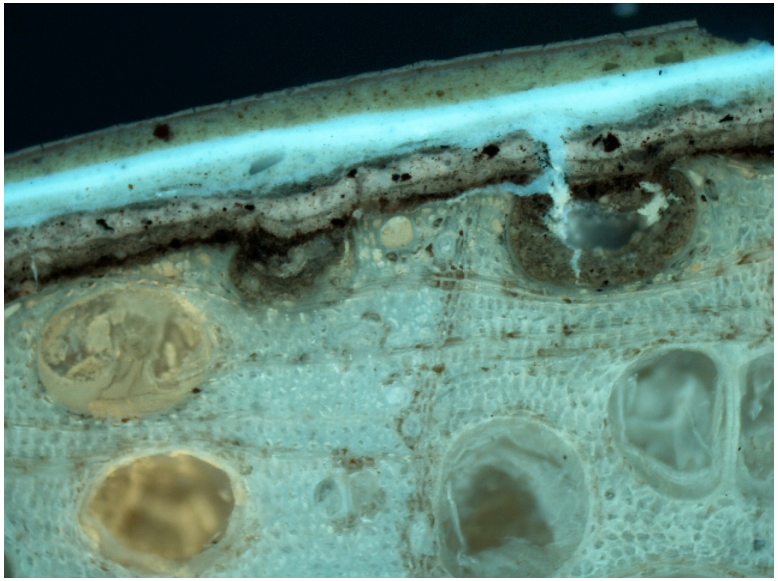
SAMPLE NO:	JGH.102.5
LOCATION:	baseboard

LAYER	***COLOR***	***NOTES***
Substrate	Wood	
1	Brown	In crevices only
2	Blue-gray	Coarser than 2nd blue-gray
3	Red-brown	
Dirt		
4	Blue-gray	
Dirt		
5	Pink	Multicolored pigments
6	Brown	Partial; damaged
7	Whitish	
Dirt		
8	Peach	
9	White	
10	Light peach	
11	Brown	Current graining
12	Brown/Varnish	Current graining

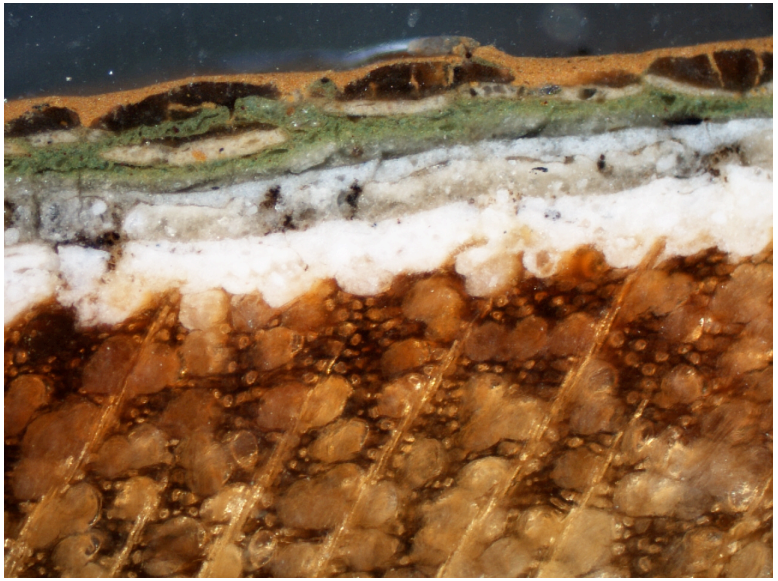
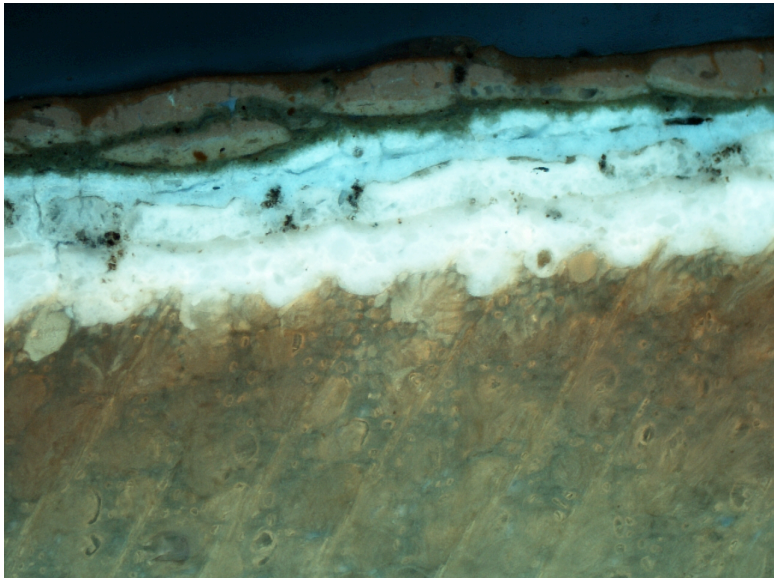
SAMPLE NO:	JGH.102.7
LOCATION:	Exterior door jamb

LAYER	***COLOR***	***NOTES***
Substrate	Wood	Saturated wood surface; autofl. orange
1	Cream	2.5Y 9/2
Dirt		
2	Cream	
Dirt		
3	Light gray	Damaged
Dirt		
4	Gray	Damaged
5		
6	Green	Damaged
Dirt		
7	Cream	Damaged
8	Brown	Damaged
9	Orange-brown

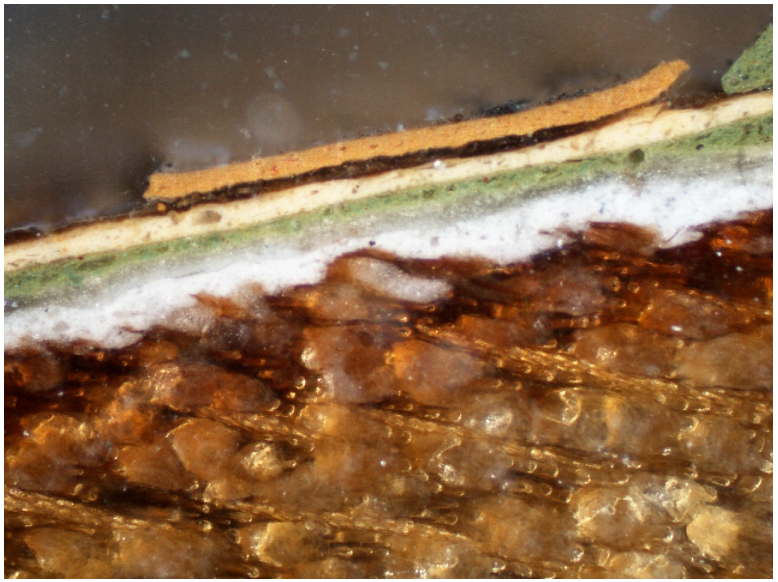
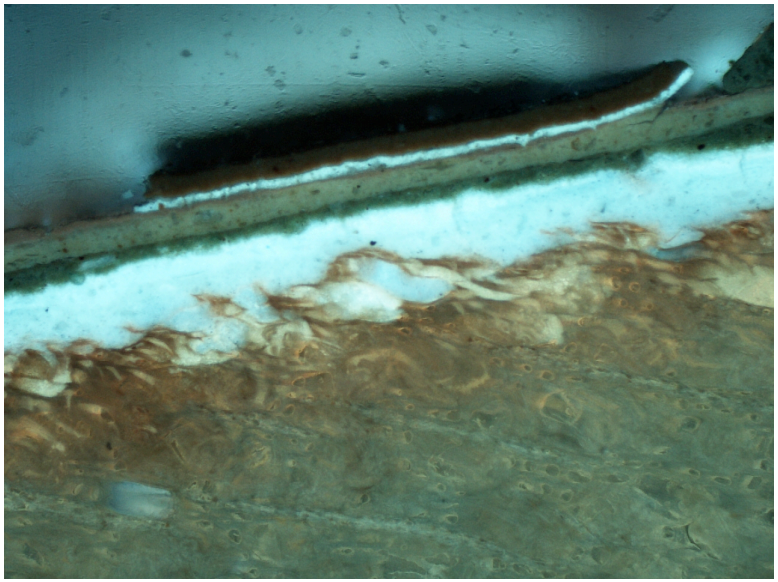
SAMPLE NO:	JGH.102.9
LOCATION:	Exterior door, exterior side

LAYER	***COLOR***	***NOTES***
Substrate	Wood	Saturation at surface; autofl. orange; surface looks damaged – missing early paint
1	White	
2	Gray	
3	Green	
Dirt		
4	Cream	
5	Yellow-peach	
6	Brown	Thin
7	Brown	Varnish
8	Orange-brown
